Bridge Inspection Report

056B00197R

12/17/2024

<u>IDENTIFICATION</u>			
Structure Num (8):	056B00197R		
NBI Number	056B00197R		
Structure Name:			
Location (9):	0.2 MI N OF MUH ALI BLVD		
Carries (7):	I-65 NB		
Type of Service (42A):	1 Highway		
Feature Crossed (6):	E LIBERTY ST		
Type of Service (42B):	1 Highway		
Placecode (4):	Not Applicable		
County (3):	Jefferson (056)		
State (1):	21 Kentucky		
Admin Area:	Inventory		
District:	District 5		
Latitude (16):	38° 15' 7"		
Longitude (17):	85° 44' 52"		
Owner (22):	State Highway Agency		
Maint. Resp. (21):	State Highway Agency		
Year Built (27):	1963	Border State (98A):	Not Applicable (P)
Year Recon (106):	1980	Border Number (99):	
		% Responsibility (98B):

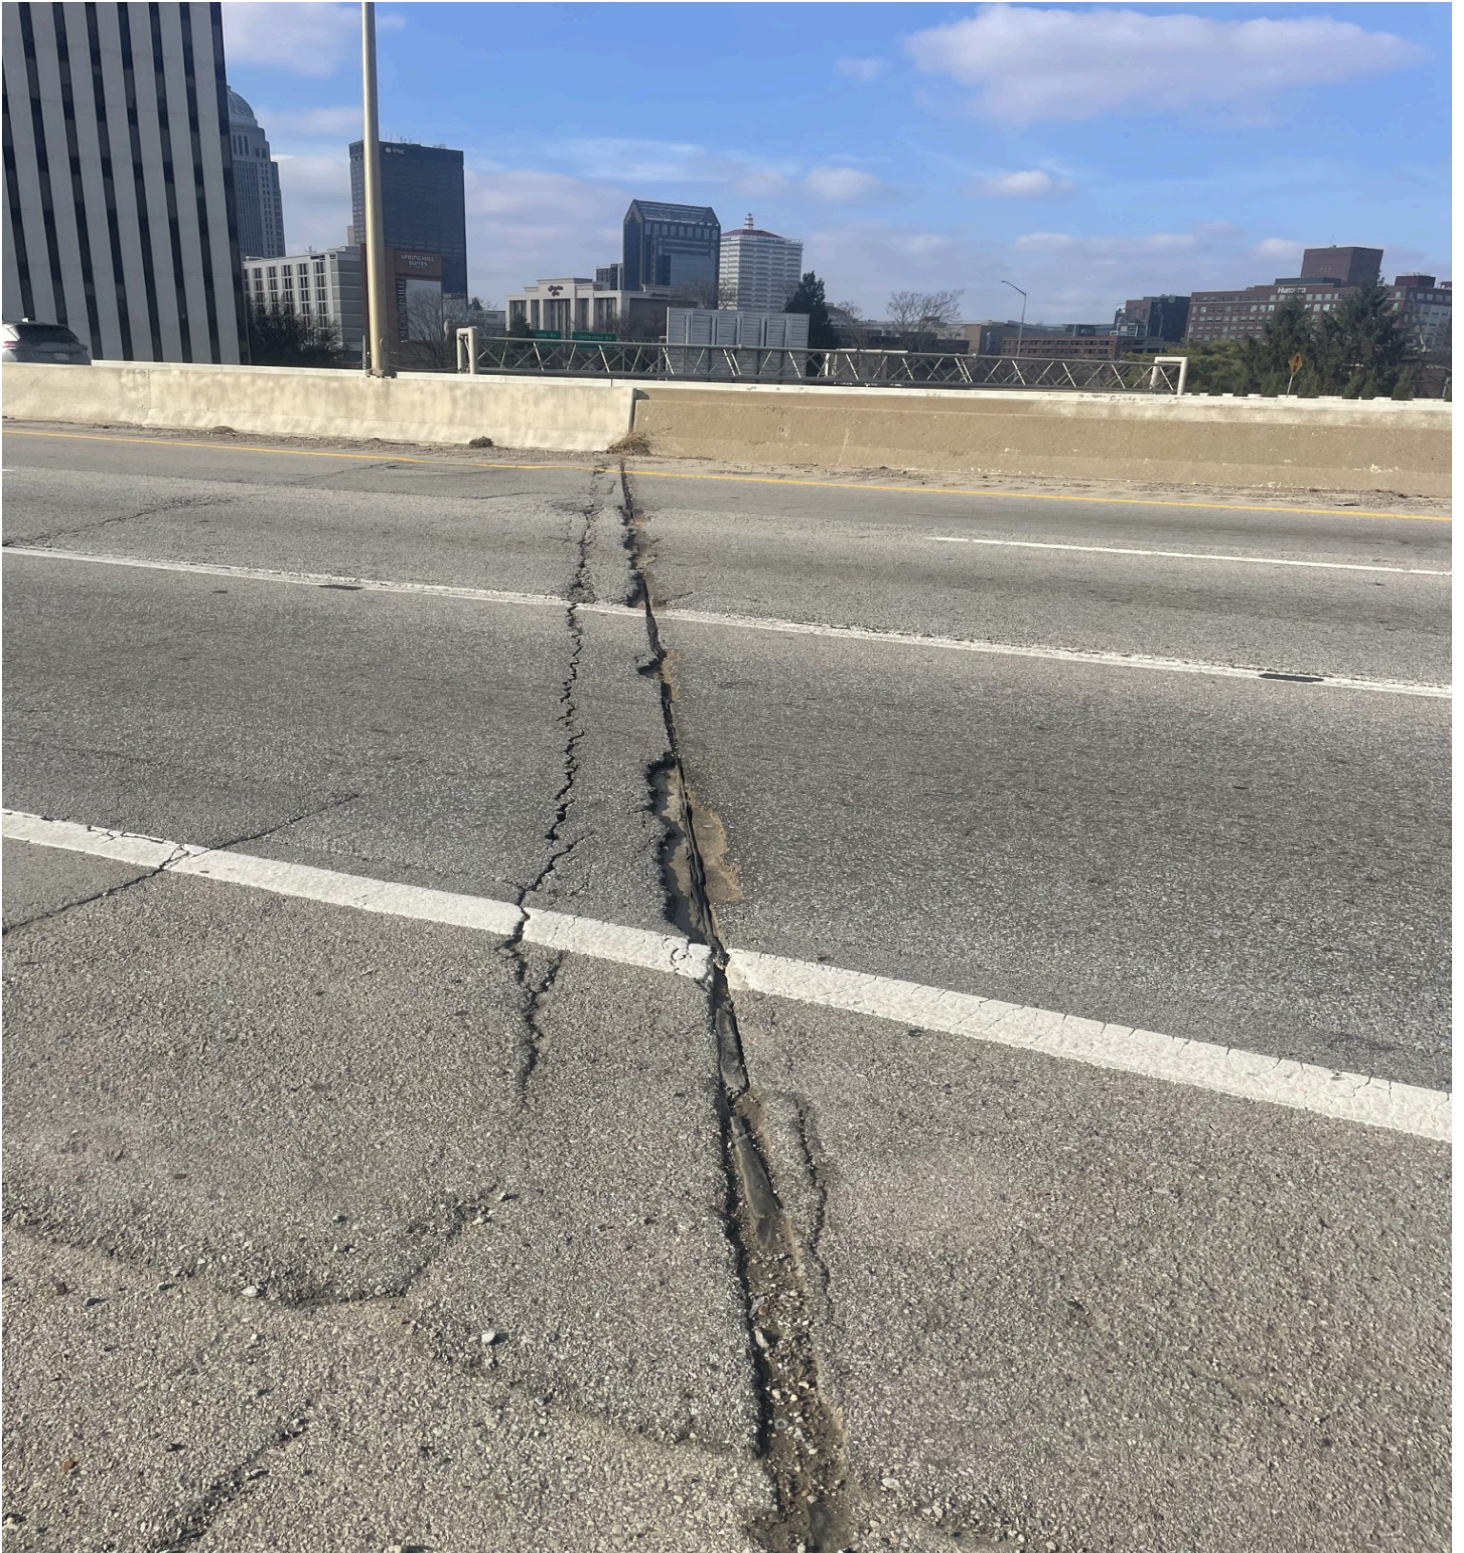
Pourable joint seals have lost adhesion and are missing nearly throughout, exposing original, ineffective compression joint seals. Adjacent overlay has cracking and spalling. Water drains moderately to freely onto elements below; standing water was noted on the Abutment 2 seat.

Pourable joint seal over Abutment 1.

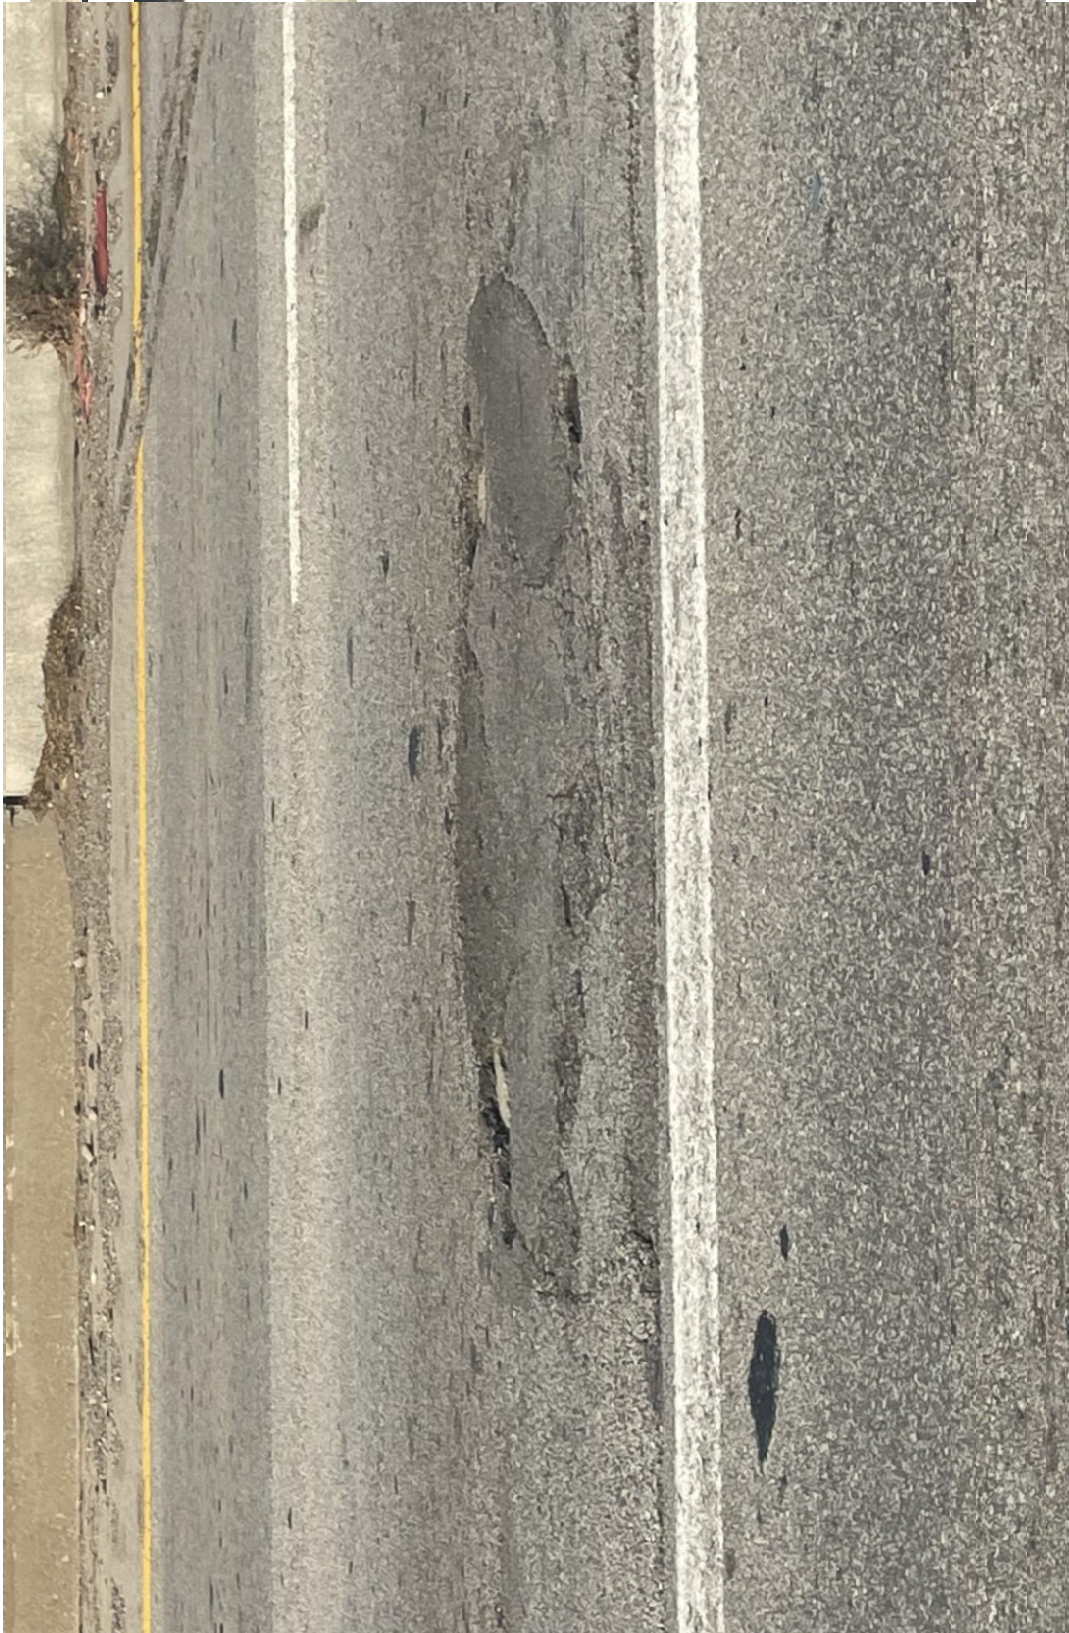
Deck was patched and overlaid with 2 inches of Rosphalt in 2006. Overlay has several cracks and spalls, mostly along the joints. Center lane near the north bridge end has asphalt patching roughly 7 feet in diameter and spalling exposing the bridge deck. Approximately 2 square feet of deck is exposed at least 3 inches deep.

Deck overlay has several cracks and spalls. Center lane near the north bridge end has asphalt patching and spalling exposing the bridge deck.

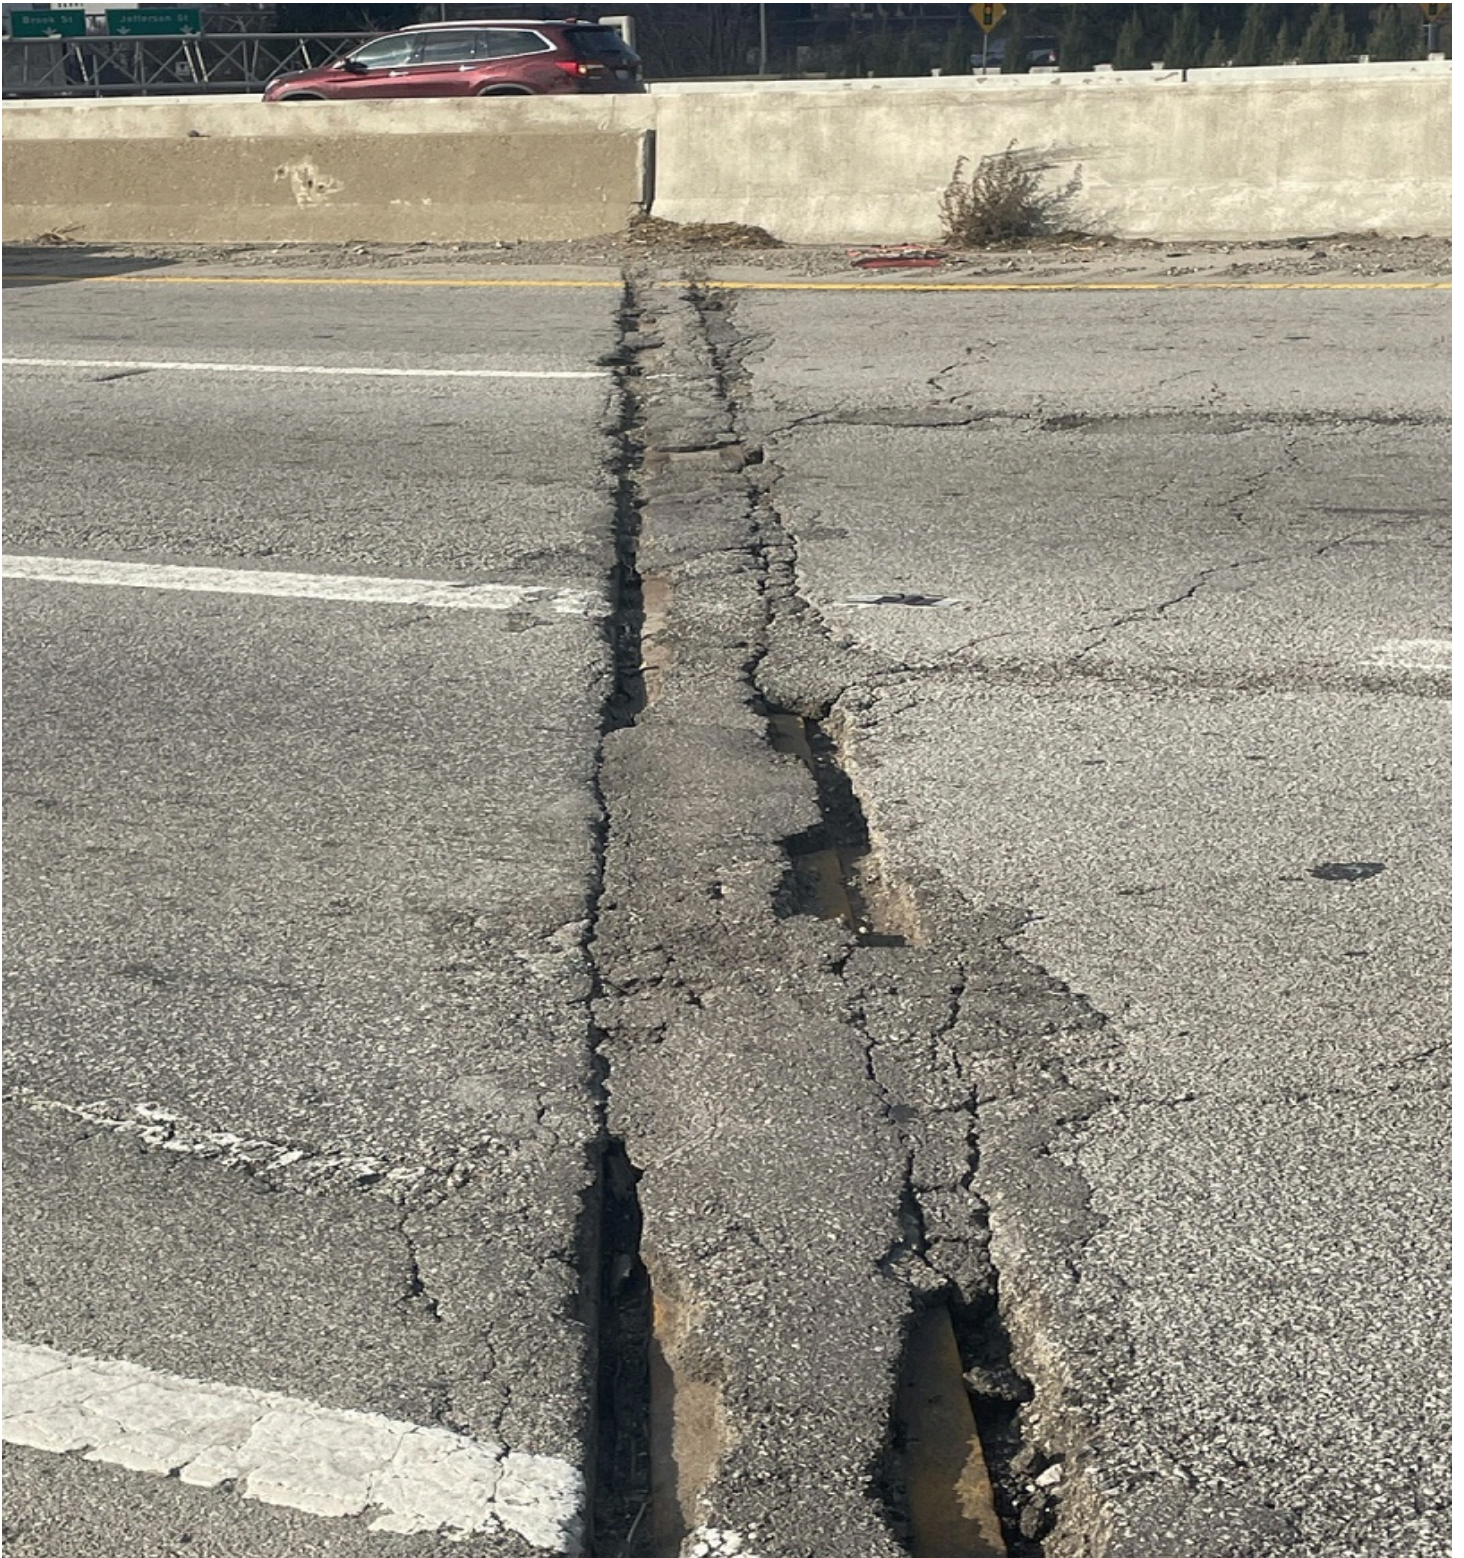
Pourable joint seal over Abutment 2.

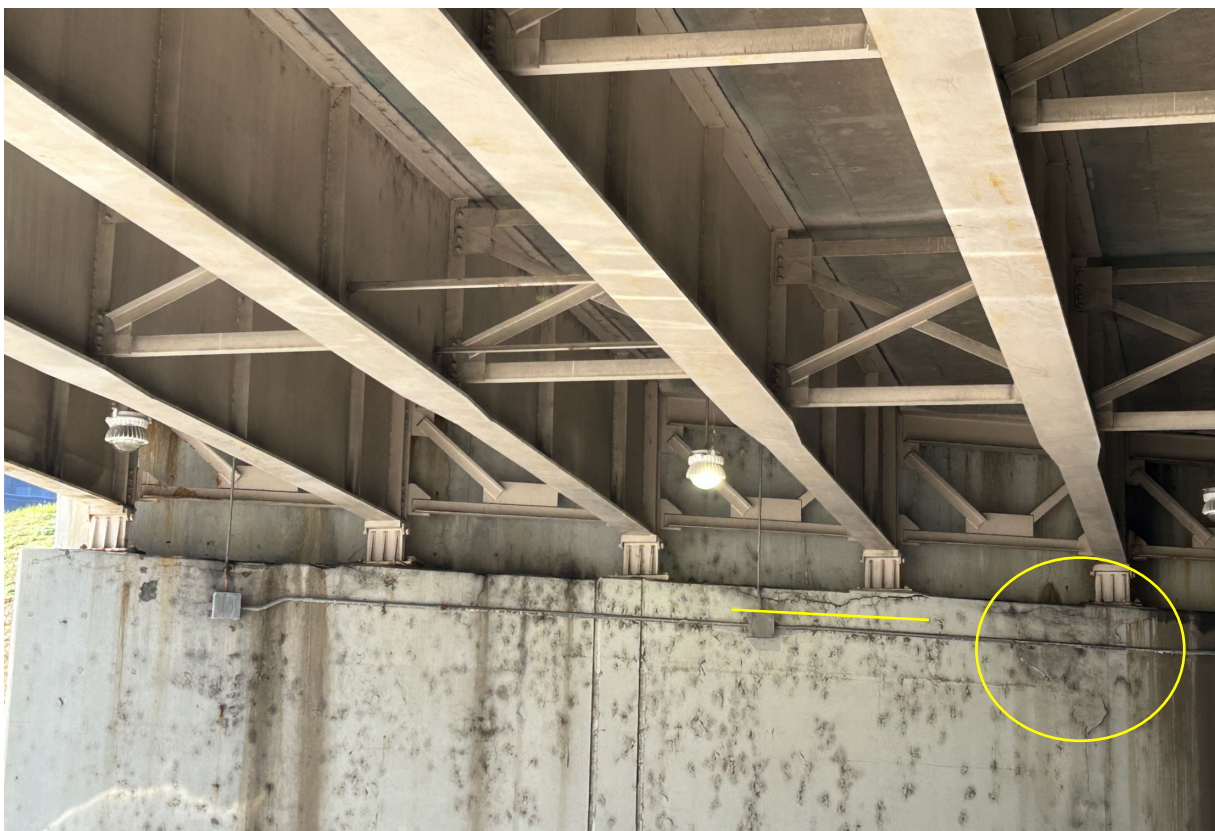
Abutments have moderate to wide horizontal and vertical cracking - some with rust staining - plus diagonal cracking and spalling at the ends of the backwalls. Abutments also have several delaminated areas. Abutment 1 has a spall with exposed rebar below Beam 3. Abutment 2 has 8 feet of spalling with exposed rebar below Beam 6.

Abutments have moderate to wide horizontal and vertical cracking plus some delaminated areas.

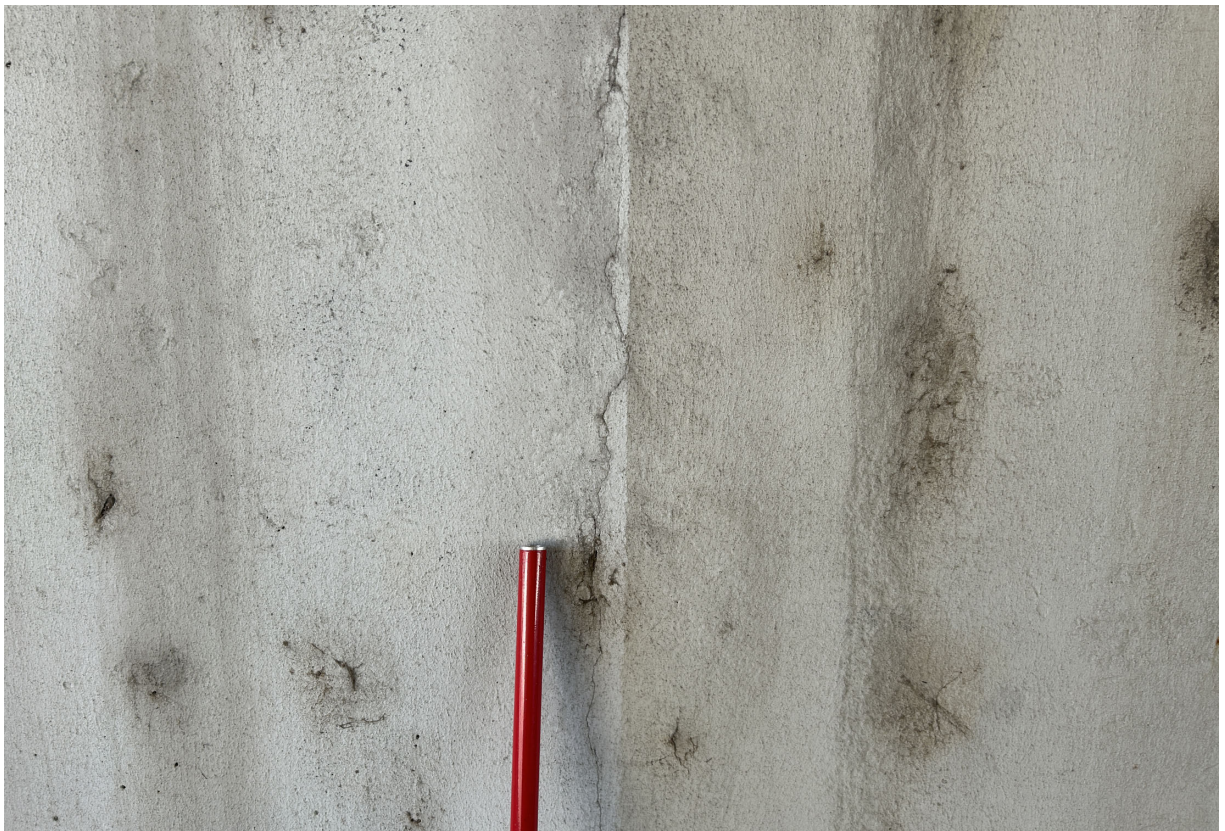
Abutment 1 vertical crack.

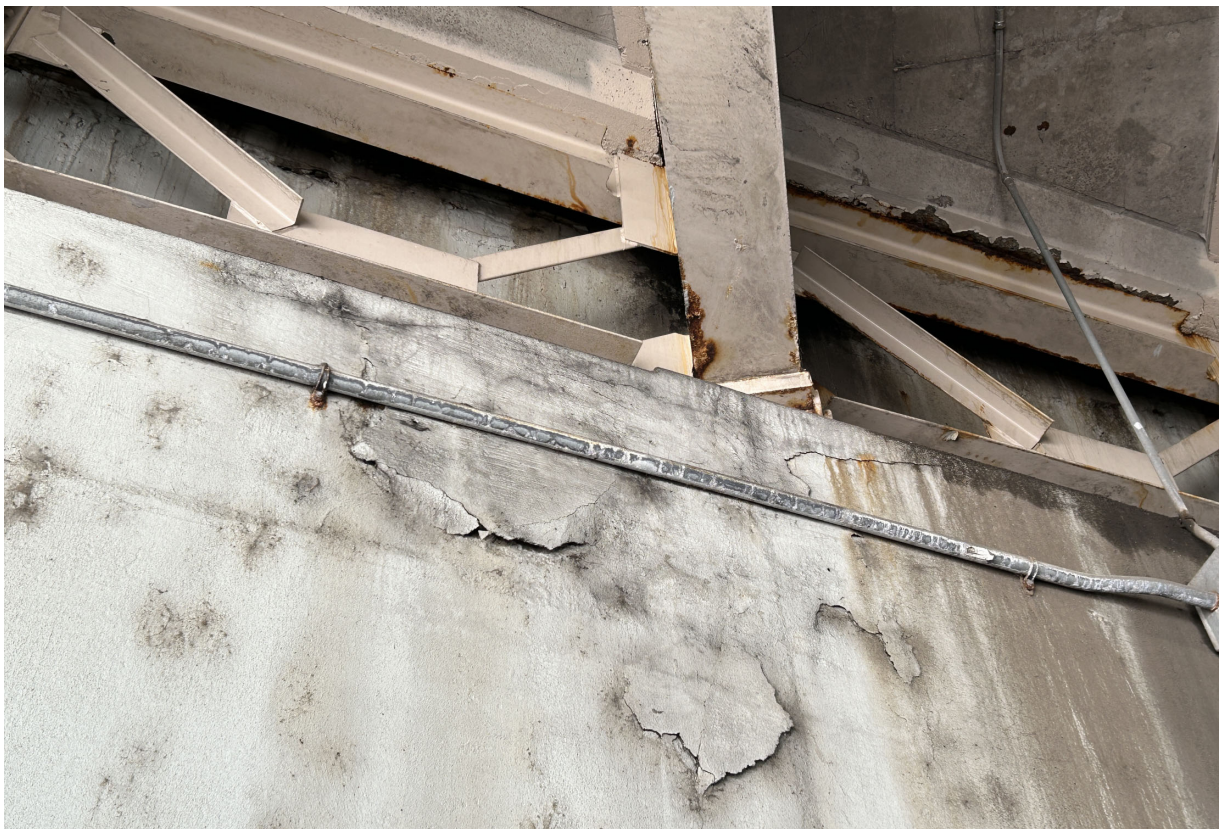
Abutment 1 delamination below Beam 2.

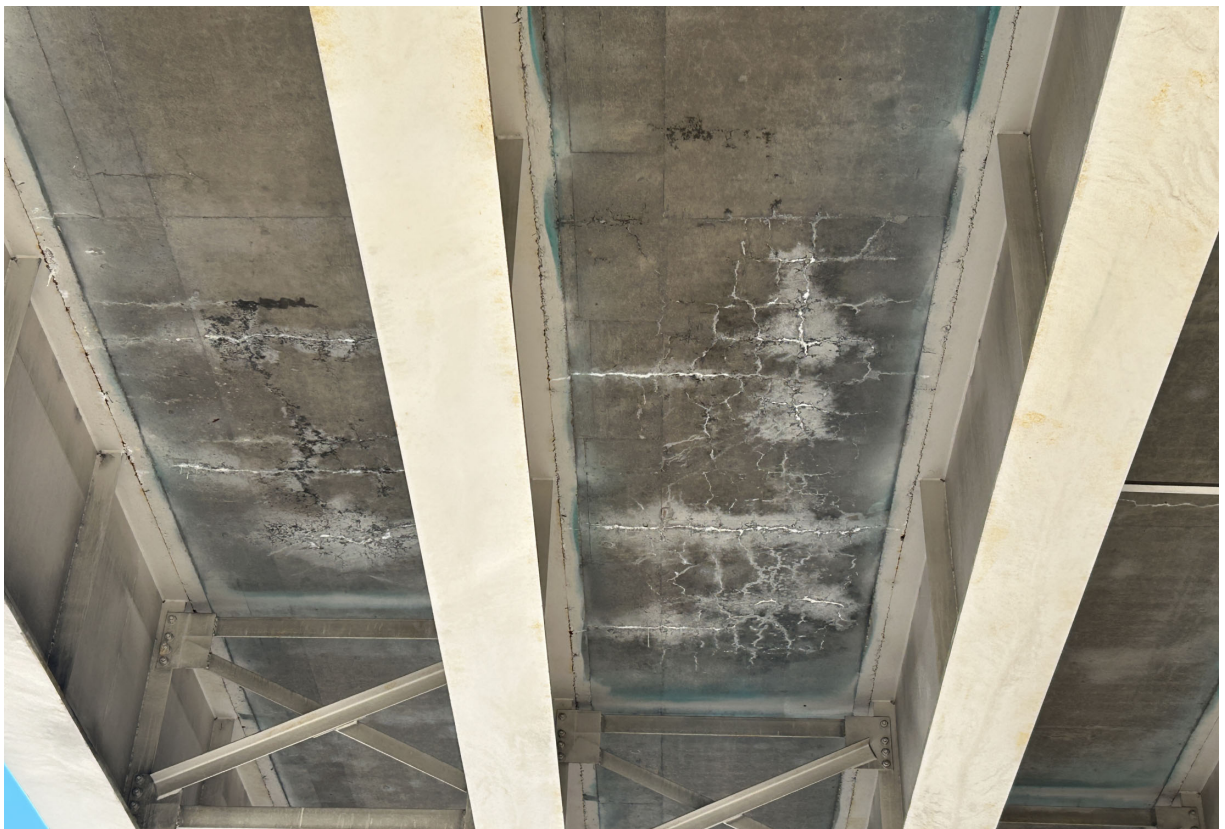
Top of deck cannot be inspected due to 2006 Rosphalt overlay. In the middle lane near the north bridge end, overlay has failed, exposing 2 square feet of deck with spalling at least 3 inches deep. Soffit has areas of full depth deterioration in Bays 4, 6, and 7 located below spalled areas in overlay. West overhang below the longitudinal joint and Bay 1 soffit have possible full depth deterioration and staining plus a few spalls with exposed rebar.

Soffit has areas of full depth deterioration in Bays 4, 6 and 7. Bays 6 and 7 shown.

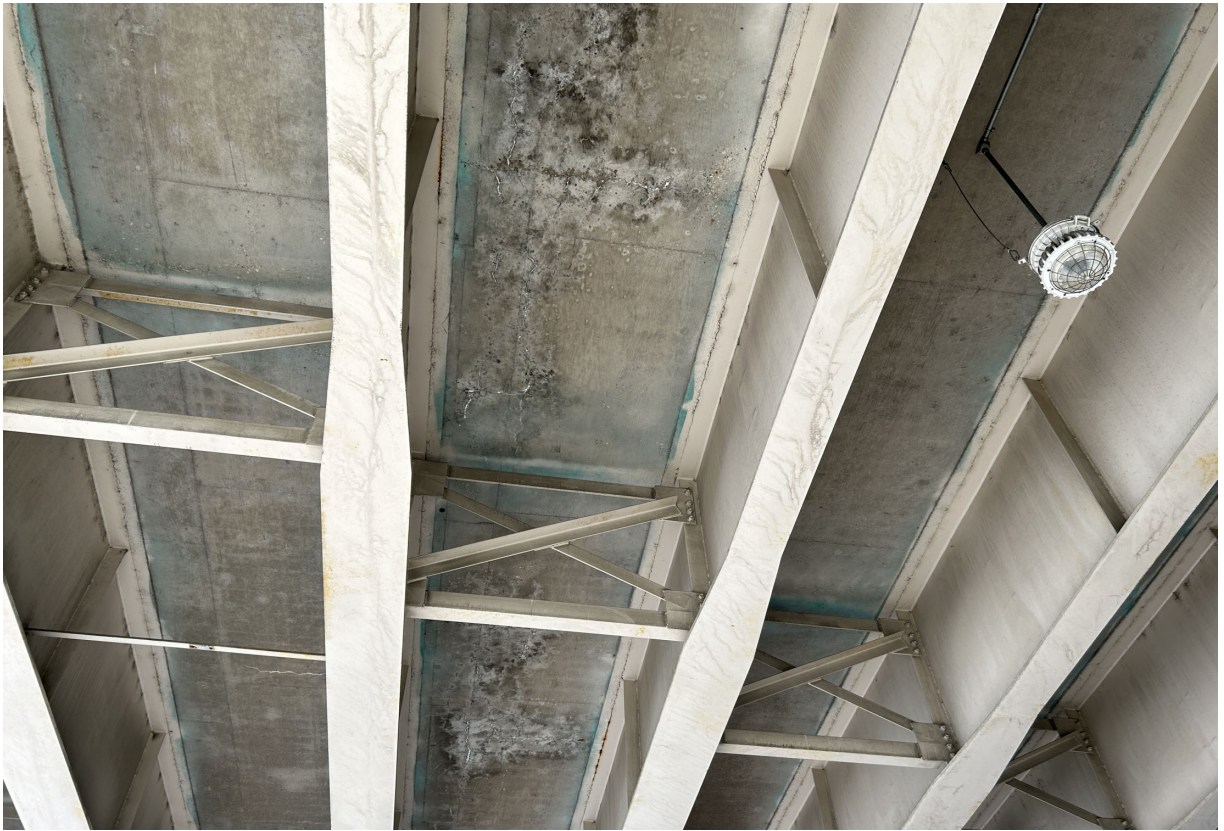
Bay 4 deterioration near Abutment 2.

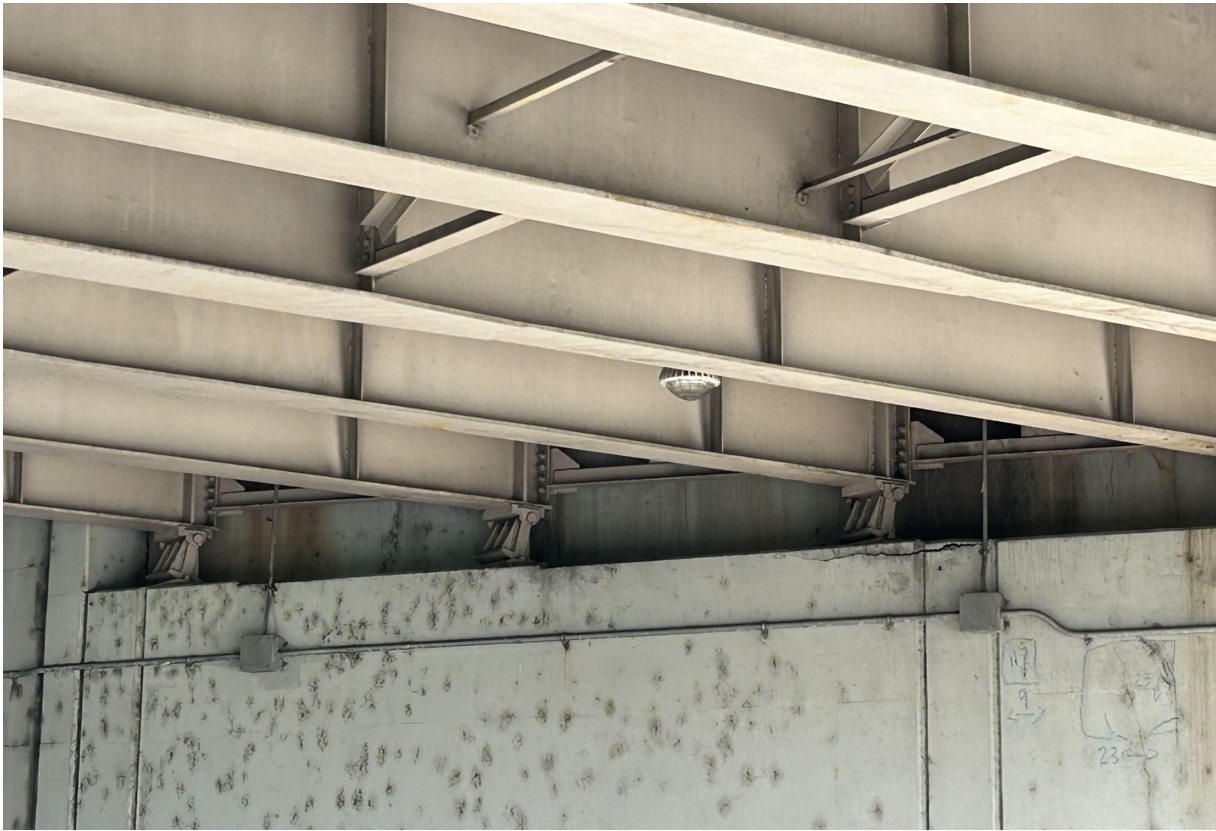
Rocker bearings at Abutment 2 are expanded. Rocker bearings have corrosion, and Beams 6 and 8 bearings have corrosion with pitting in the masonry plate.

Rocker bearings at Abutment 2 are expanded.

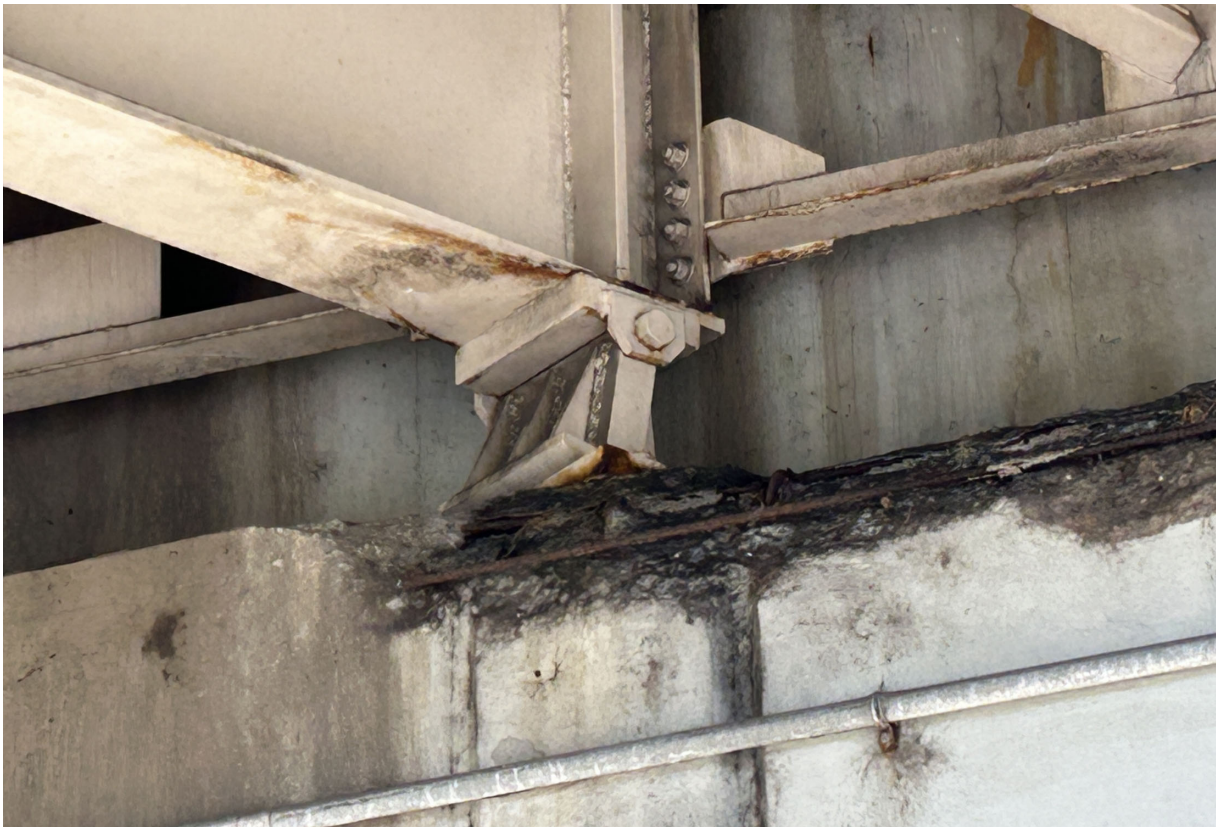
Abutment 2 has 8 feet of spalling with exposed rebar below Beam 6.

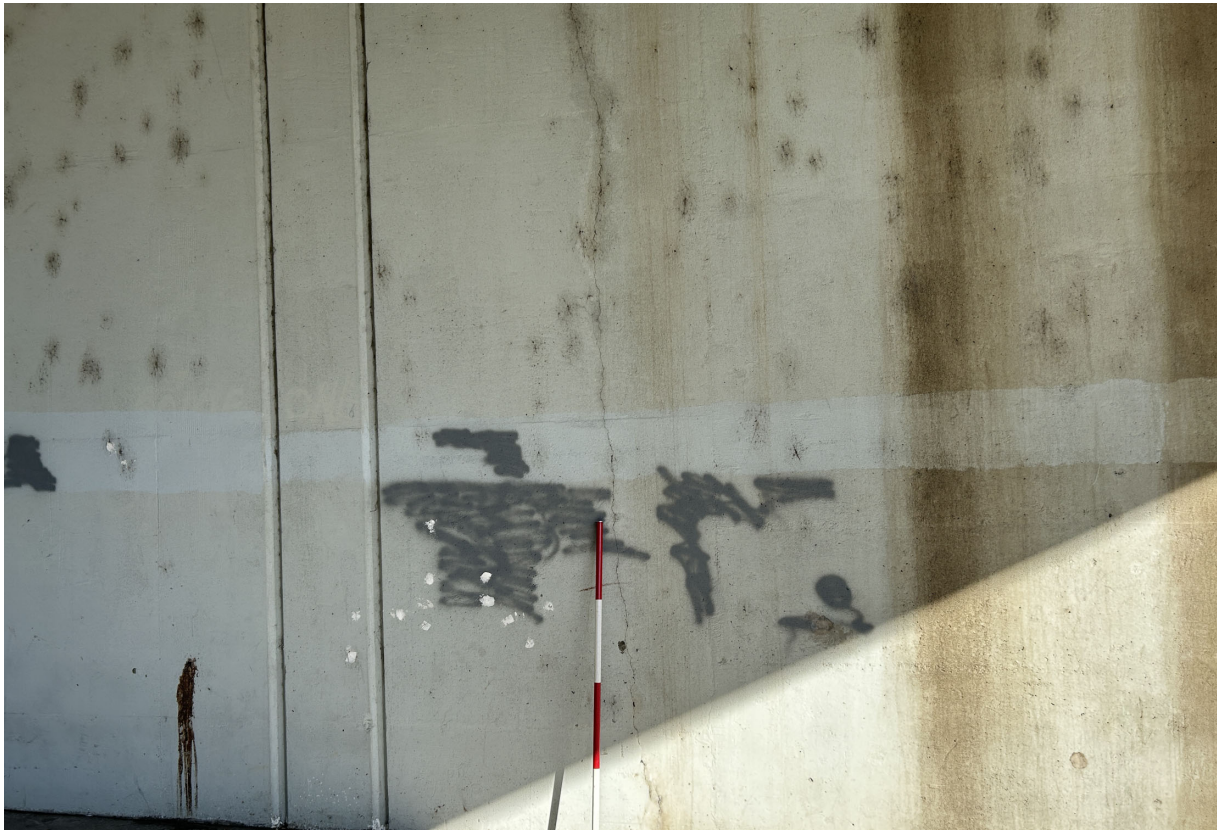
Abutment 2 vertical crack.

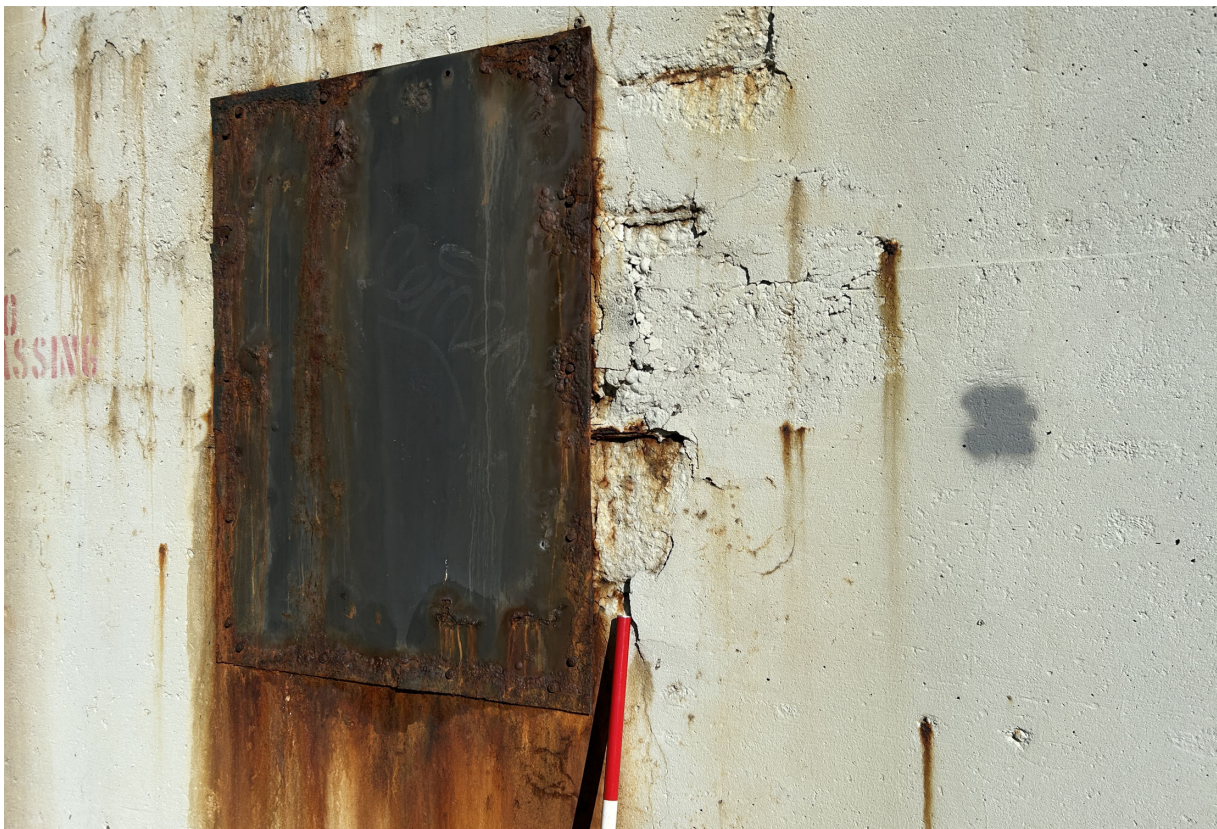
Abutment 2 has spalls with exposed rebar and rust staining around utility box at the east end.
