Bridge Inspection Report

056B00205N

12/04/2024

<u>IDENTIFICATION</u>			
Structure Num (8):	056B00205N		
NBI Number	056B00205N		
Structure Name:			
Location (9):	500 FT N OF CRITTENDEN DR		
Carries (7):	I-65		
Type of Service (42A):	1 Highway		
Feature Crossed (6):	NS RAILROAD		
Type of Service (42B):	2 Railroad		
Placecode (4):	Not Applicable		
County (3):	Jefferson (056)		
State (1):	21 Kentucky		
Admin Area:	Inventory		
District:	District 5		
Latitude (16):	38° 12' 31"		
Longitude (17):	85° 45' 8"		
Owner (22):	State Highway Agency		
Maint. Resp. (21):	State Highway Agency		
Year Built (27):	1957	Border State (98A):	Not Applicable (P)
Year Recon (106):	1982	Border Number (99):	
		% Responsibility (98B):

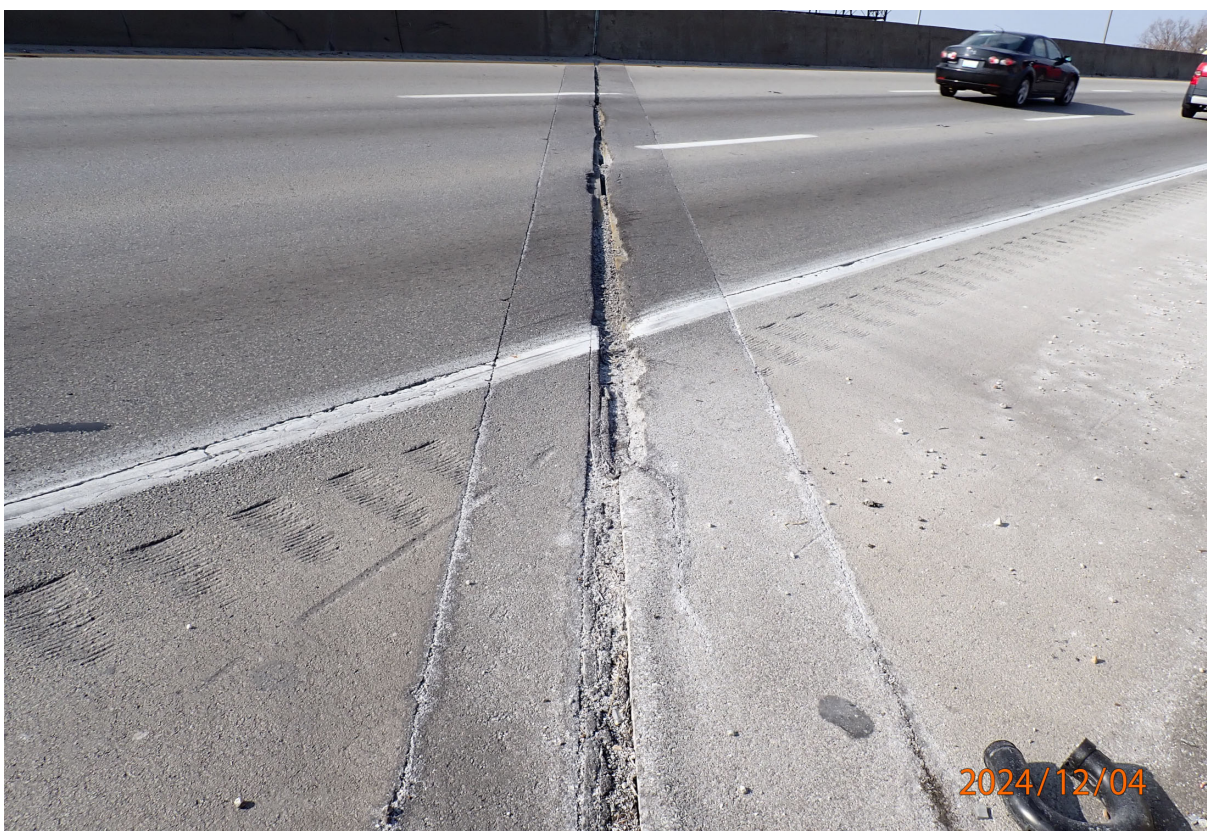
Asphalt plug joint over Abutment 1 (NB)

Asphalt plug joints over the abutments have failed and leak throughout, exposing portions of the original joints in the traffic lanes. The joints are heaving in some areas in the shoulders.

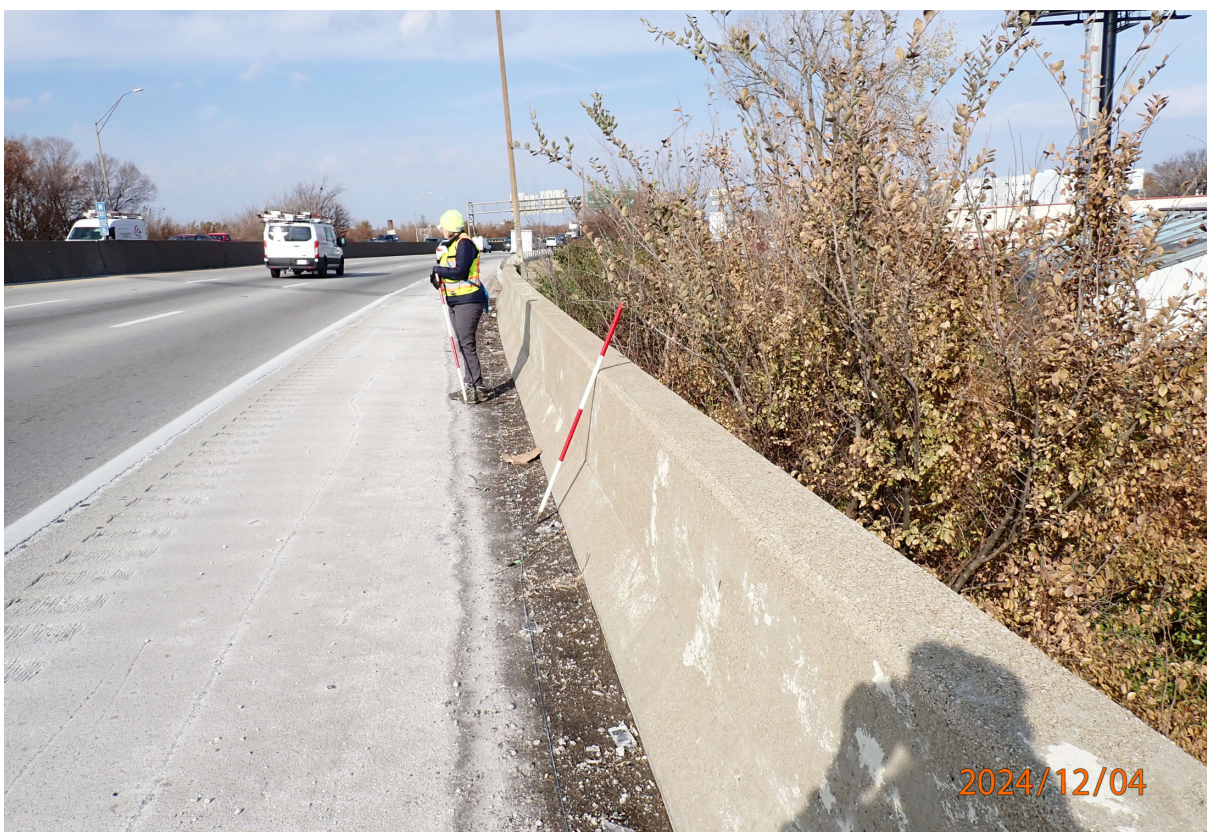
Vegetation is beginning to overhang the bridge railings. Trees are growing against the superstructure in a few areas, especially Span 3.

Dirt and debris are piling in the gutter lines. Vegetation is beginning to overhang the bridge railings (east side shown).

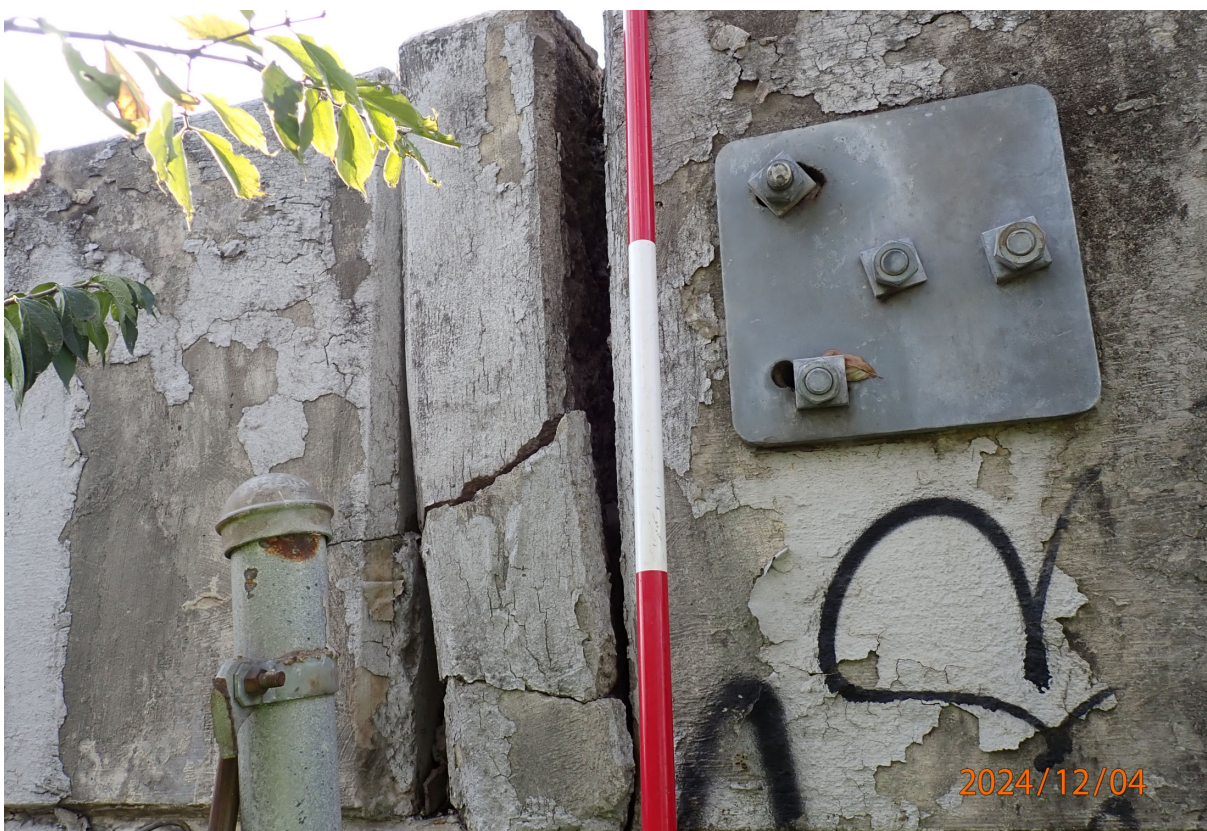
The section of the east railing above the Abutment 4 expansion plate is fractured (exterior face shown).

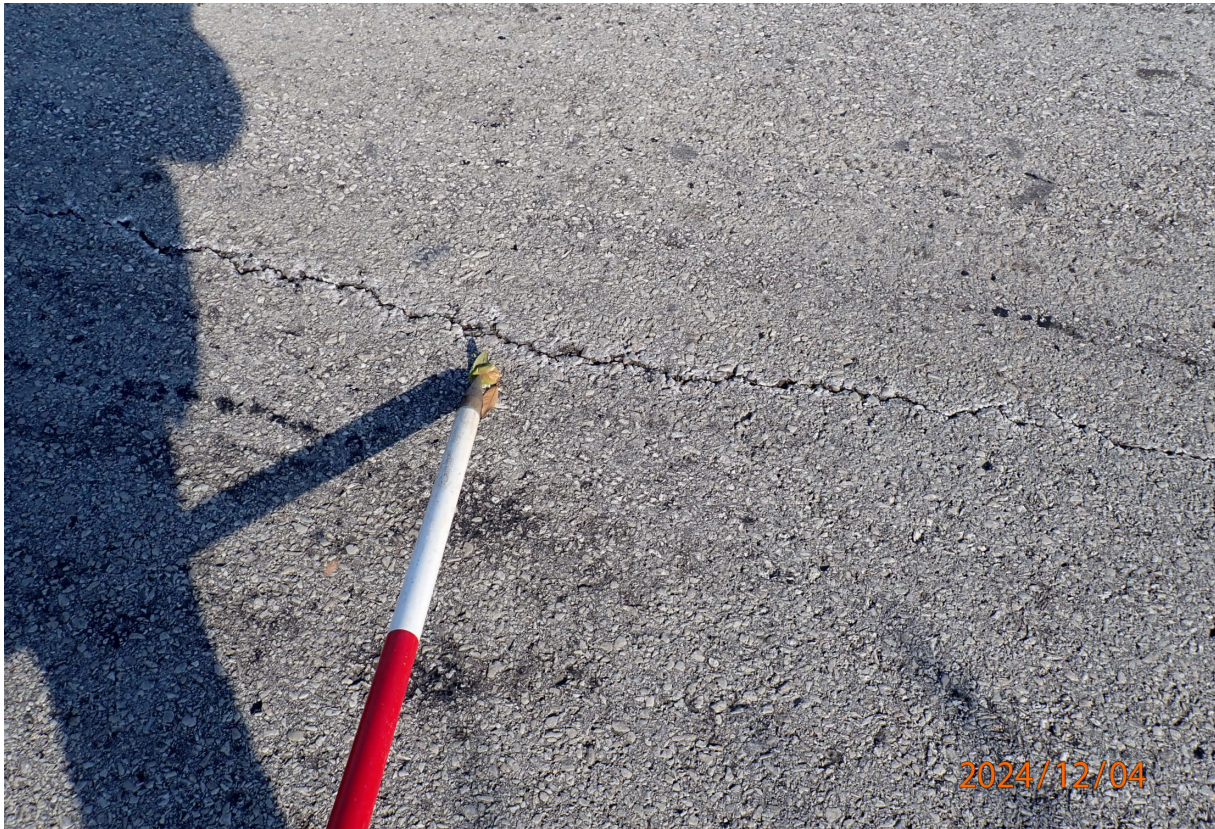
Overlay has minor wearing throughout, and intermittent longitudinal cracking in the right SB lane in Spans 1 and 2.

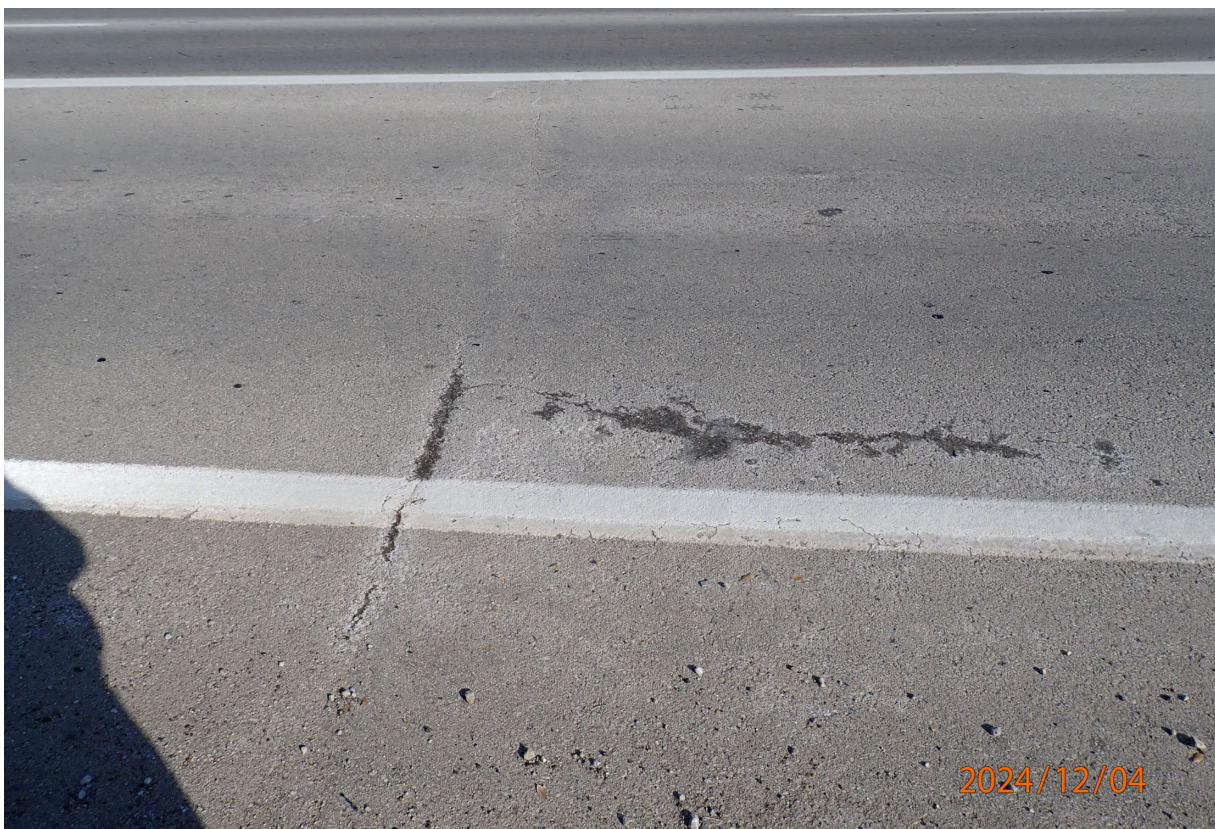
Overlay has transverse cracking in the right SB lane north of Pier 2 in Span 2.

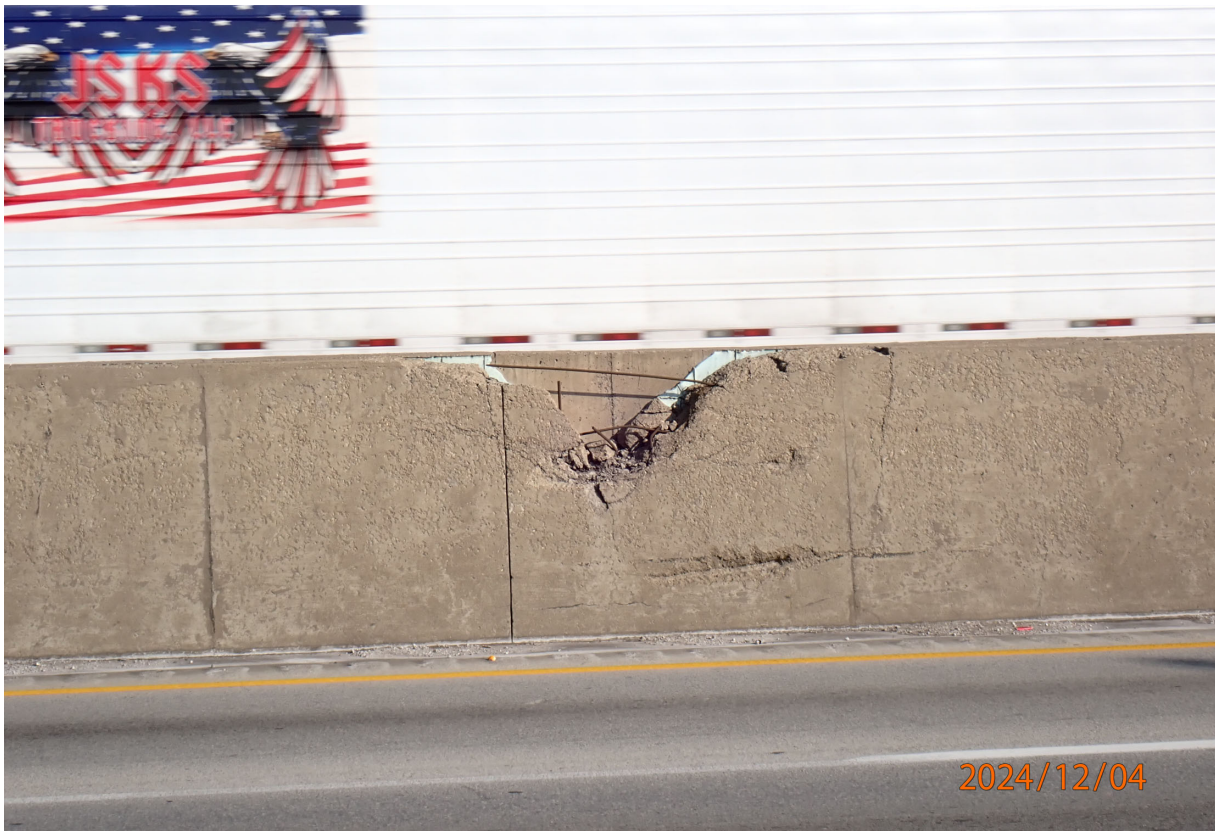
The SB median barrier has a 6' L x full depth spall with exposed rebar in Span 3.

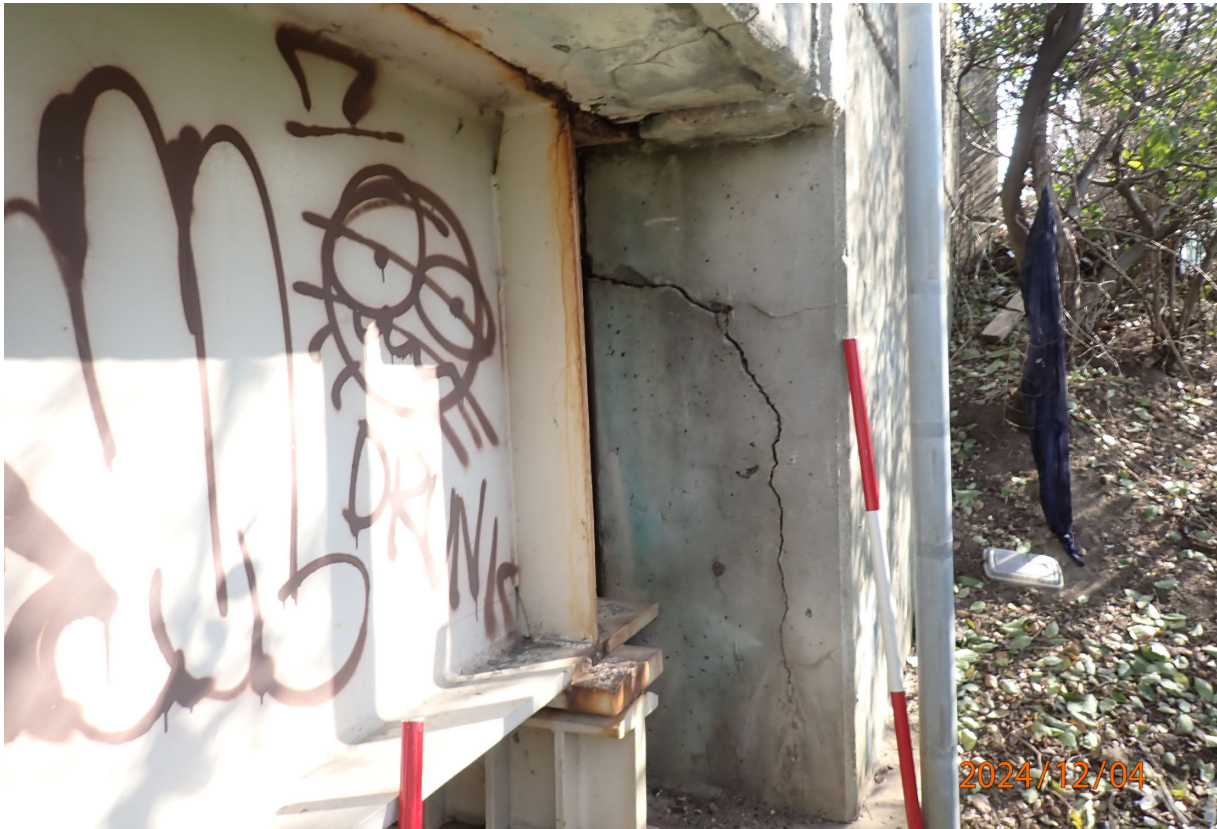
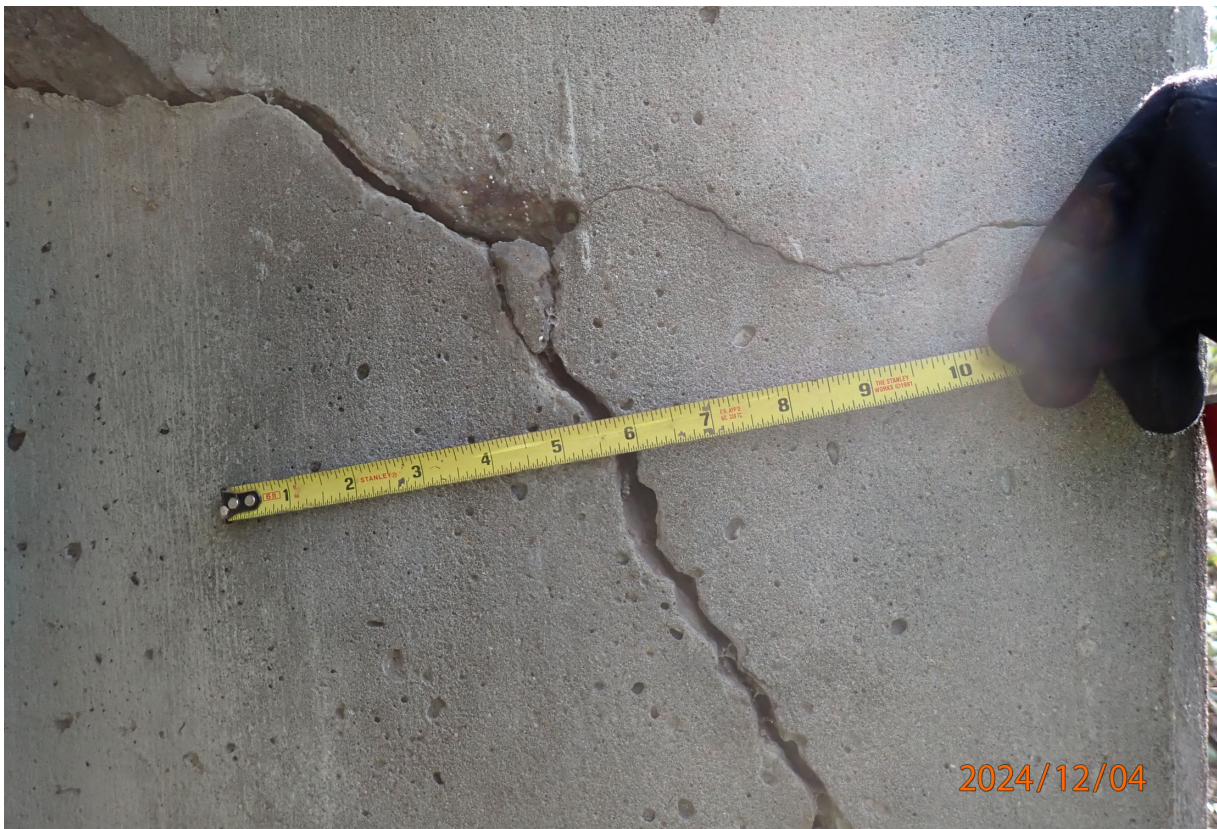
Abutment 1 backwall has 1/4" wide diagonal cracking at both ends (west end shown).

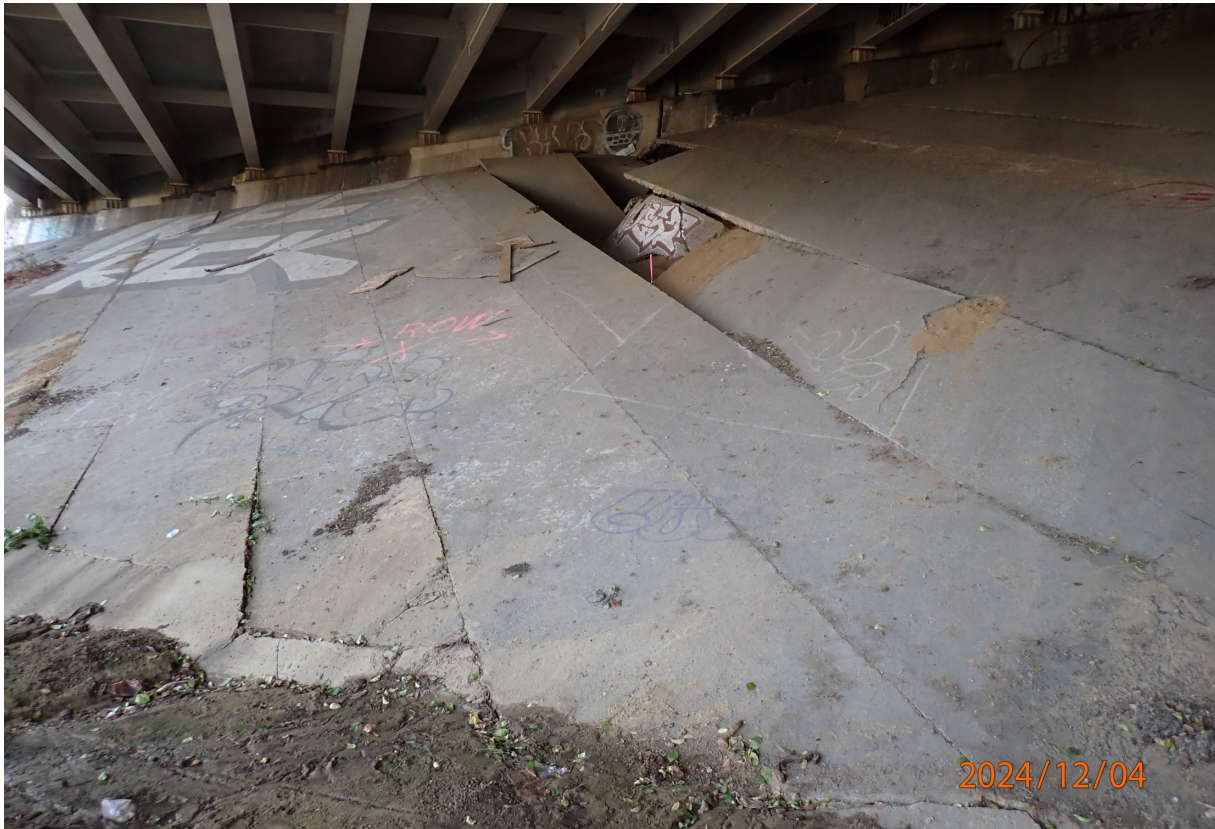
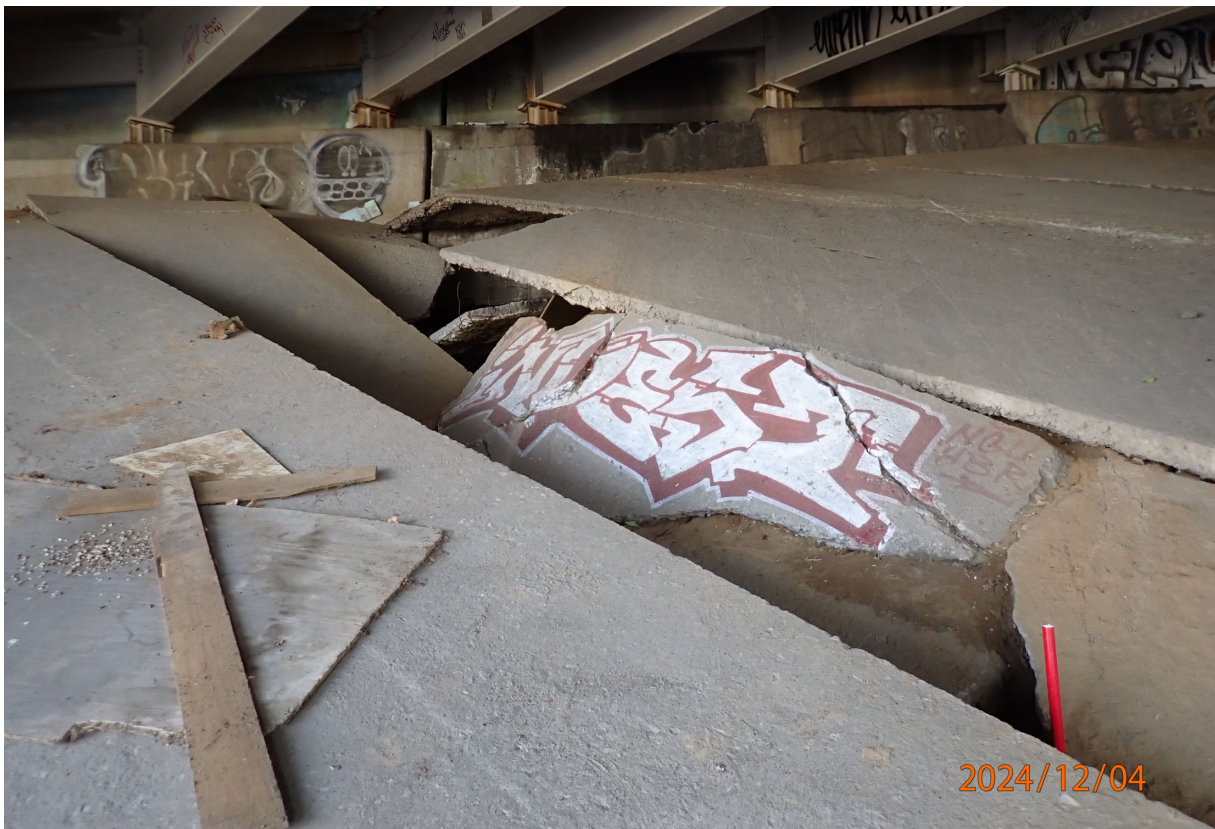
Abutment 1 concrete slope has two fractured panels between Beams 15-17; the broken sections have fallen into the 5' deep void in the underlying embankment. At the failed sections of concrete slope, the Abutment 1 cap is undermined 22' L x 6' D x 1' T with at least three exposed piles. Erosion and/or settlement appears to extend from Beams 13-17 (judging from the gap between the top of the slope and the abutment cap).

Abutment 1 concrete slope has two fractured panels between Beams 15 and 17; the broken sections have fallen into the 5' deep void in the underlying embankment.

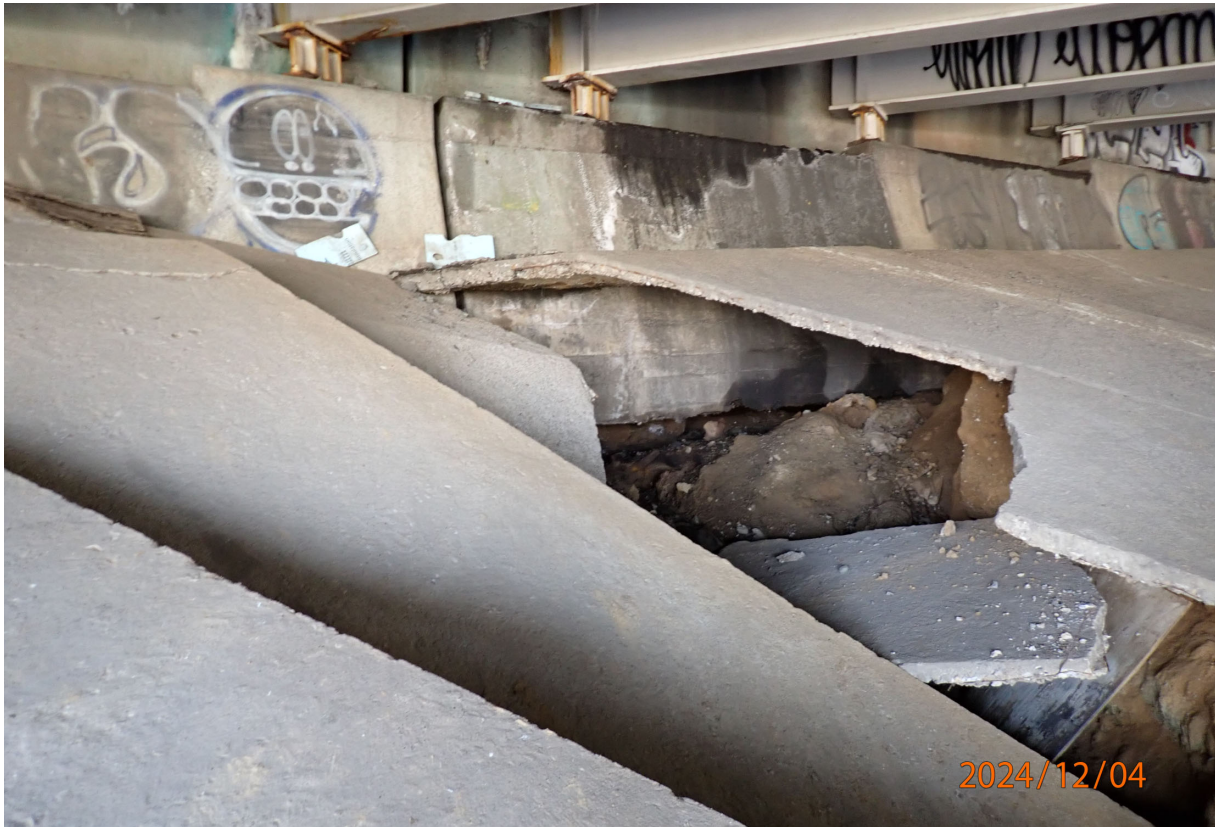
At the failed sections of concrete slope, the Abutment 1 cap is undermined 22' L x 6' D x 1' T with at least three exposed piles.

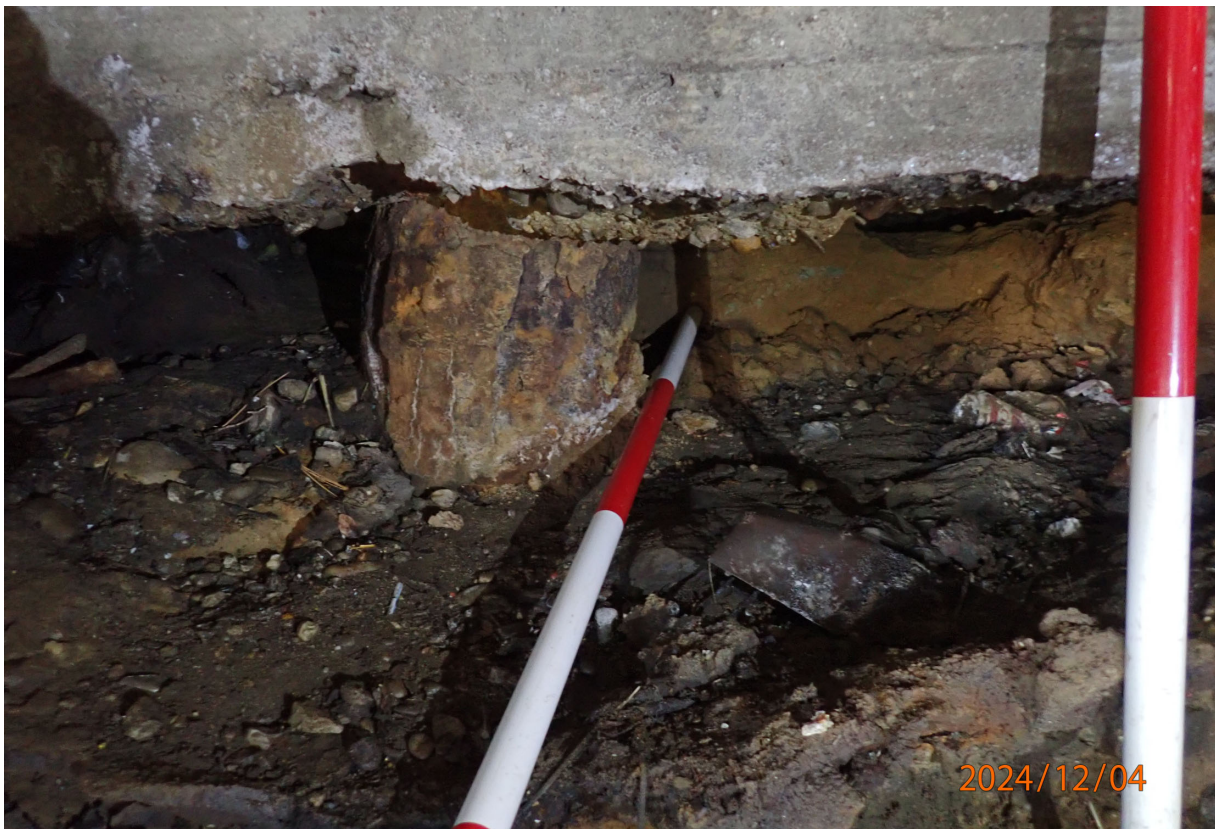
At the failed sections of concrete slope between Beams 15-17, the Abutment 1 cap is undermined 22' L x 6' D x 1' T with at least three exposed piles. One of the exposed piles has flaking corrosion with section loss.

One of the exposed piles has flaking corrosion with section loss.

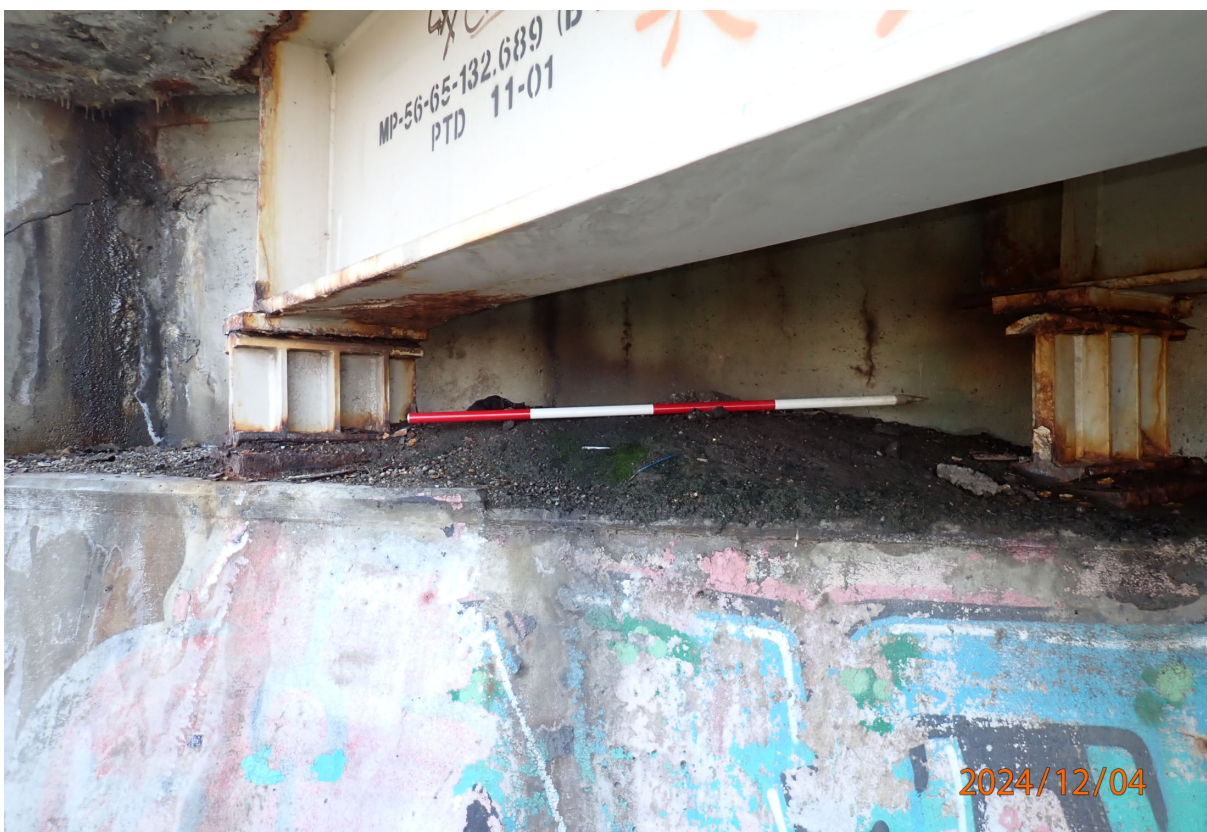
There is up to 1 foot of debris piled on the abutment seats (east end of Abutment 1 shown).

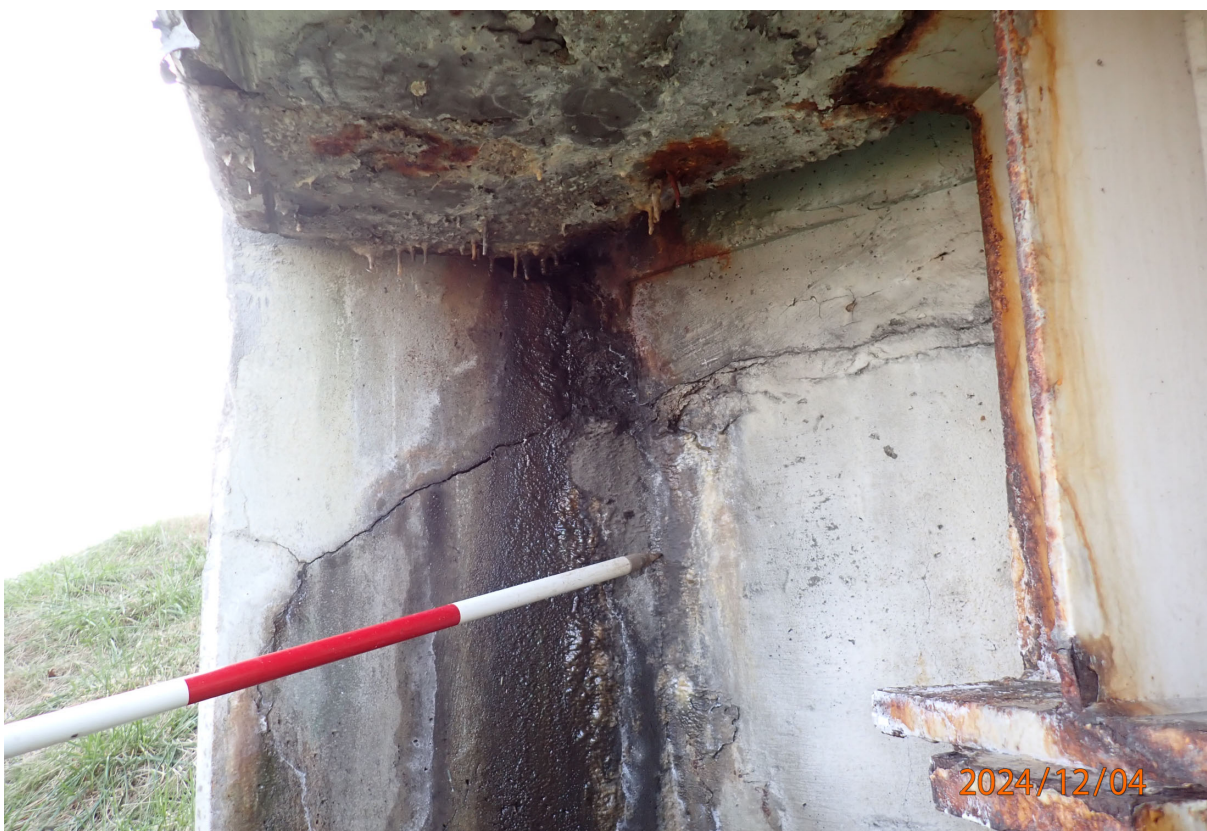
Abutment 1 backwall has 1/4" wide diagonal cracking at both ends (east end shown).

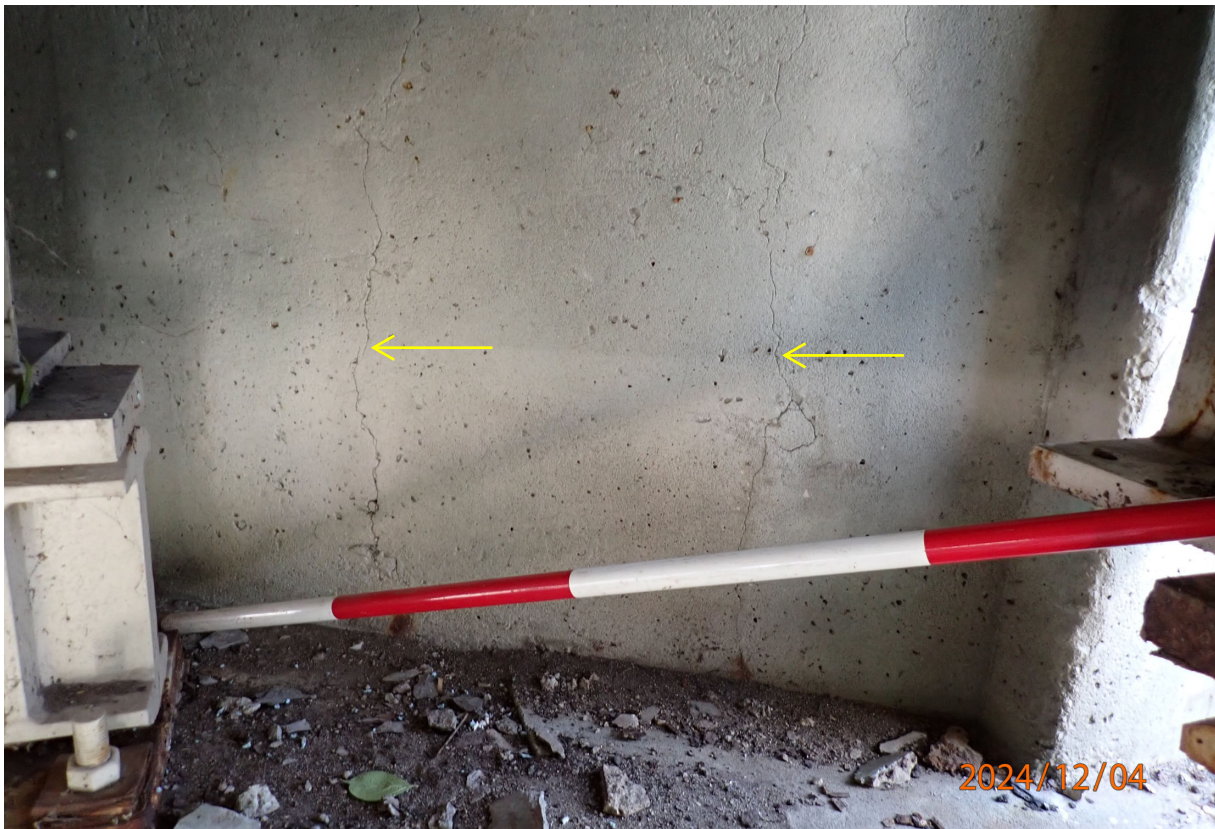
The backwalls have vertical cracks spaced at less than 3 feet in some areas (west end of Abutment 1 shown).

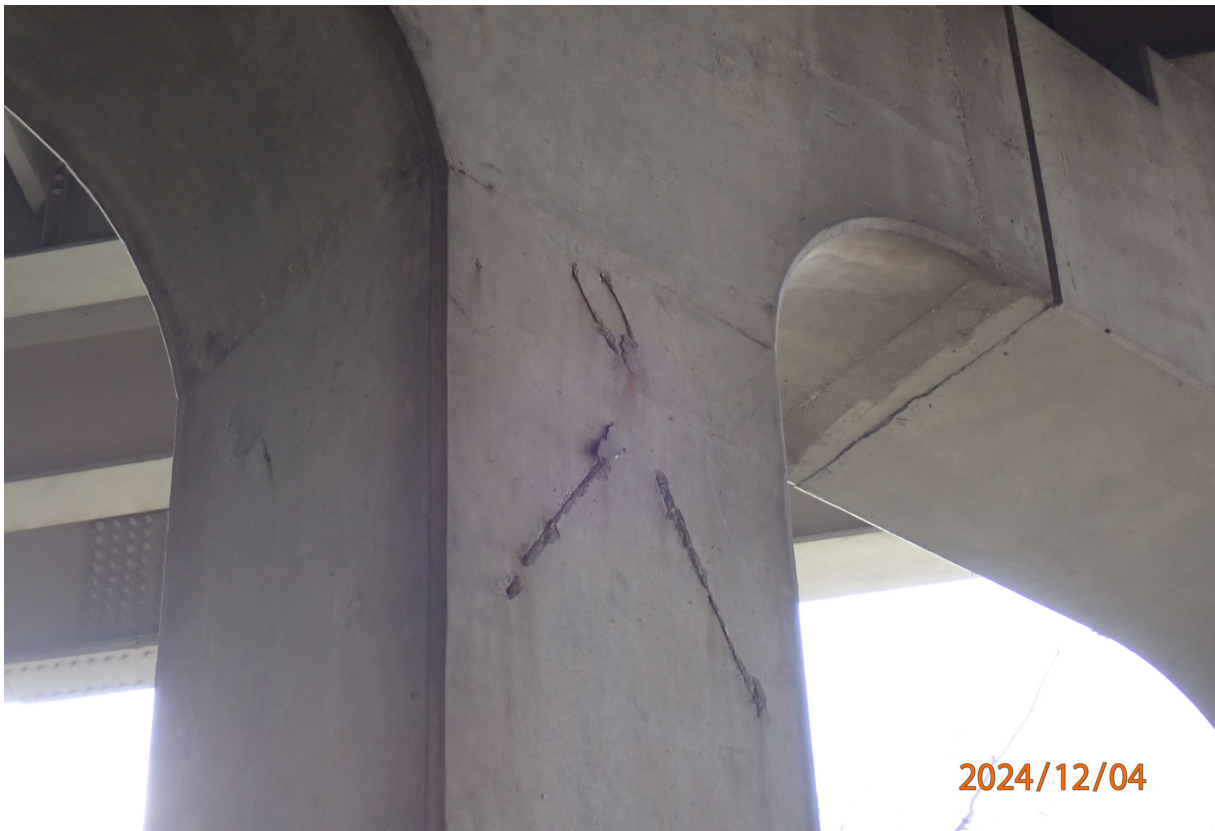
Pier 2-Columns 2 and 4 and Pier 4-Column 4 have shallow spalls with exposed tie wire. Pier 4-Column 5 has a few spalls with exposed rebar and greater than 6" diameter (1 CS3). Some columns have moderate vertical and/or horizontal cracking, delaminations, and small spalls.

Pier 2-Columns 2 and 4 and Pier 4-Column 4 have shallow spalls with exposed tie wire (Pier 2-Column 2 shown).

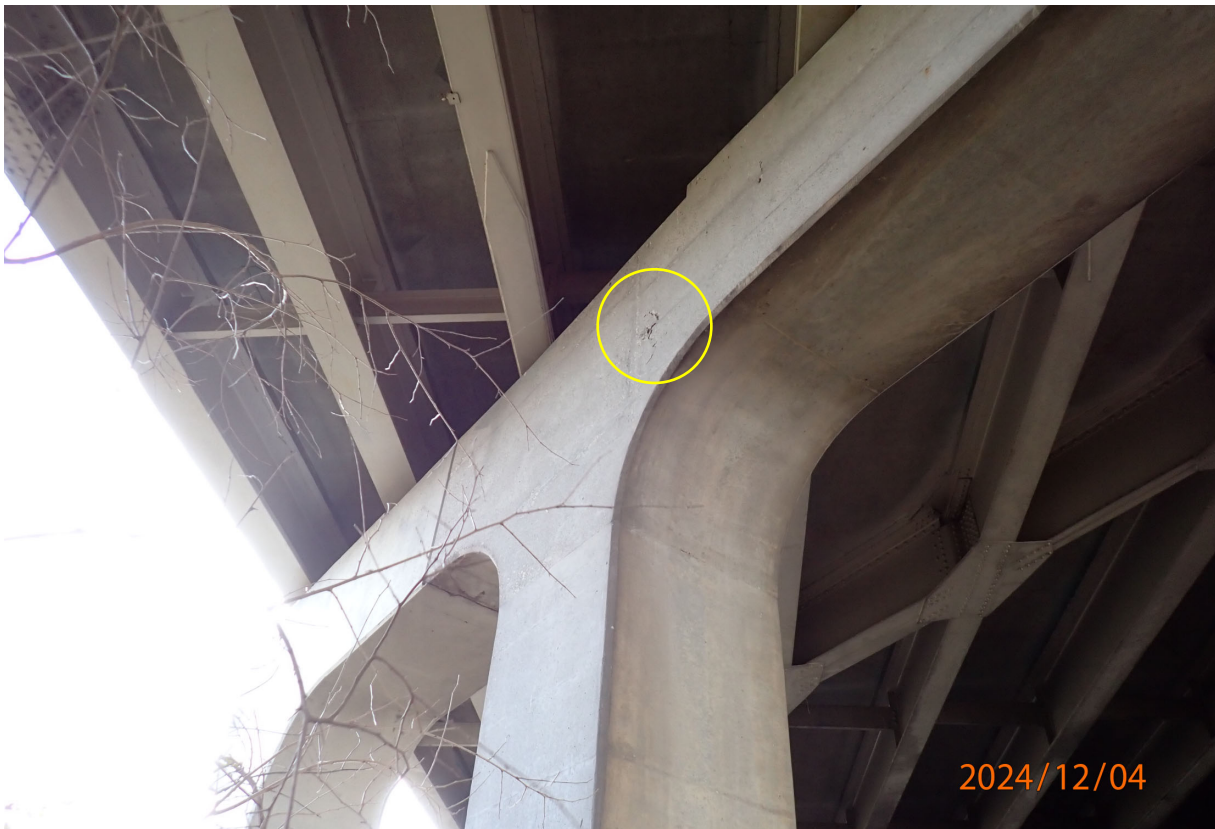
Pier caps have scattered moderate cracks, delaminations, and small spalls (north face of Pier 3 shown).

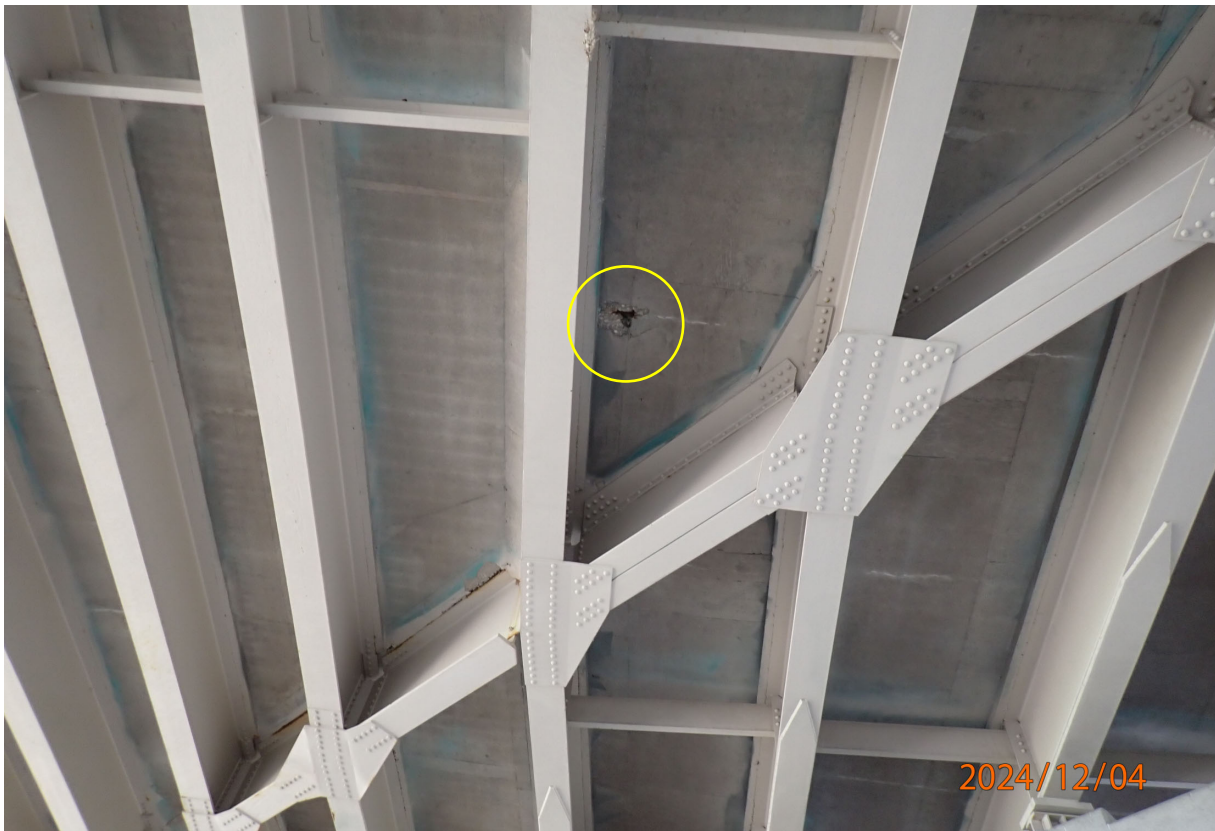
Soffit has a few scattered spalls with exposed rebar (Span 3-Bay 13 shown).

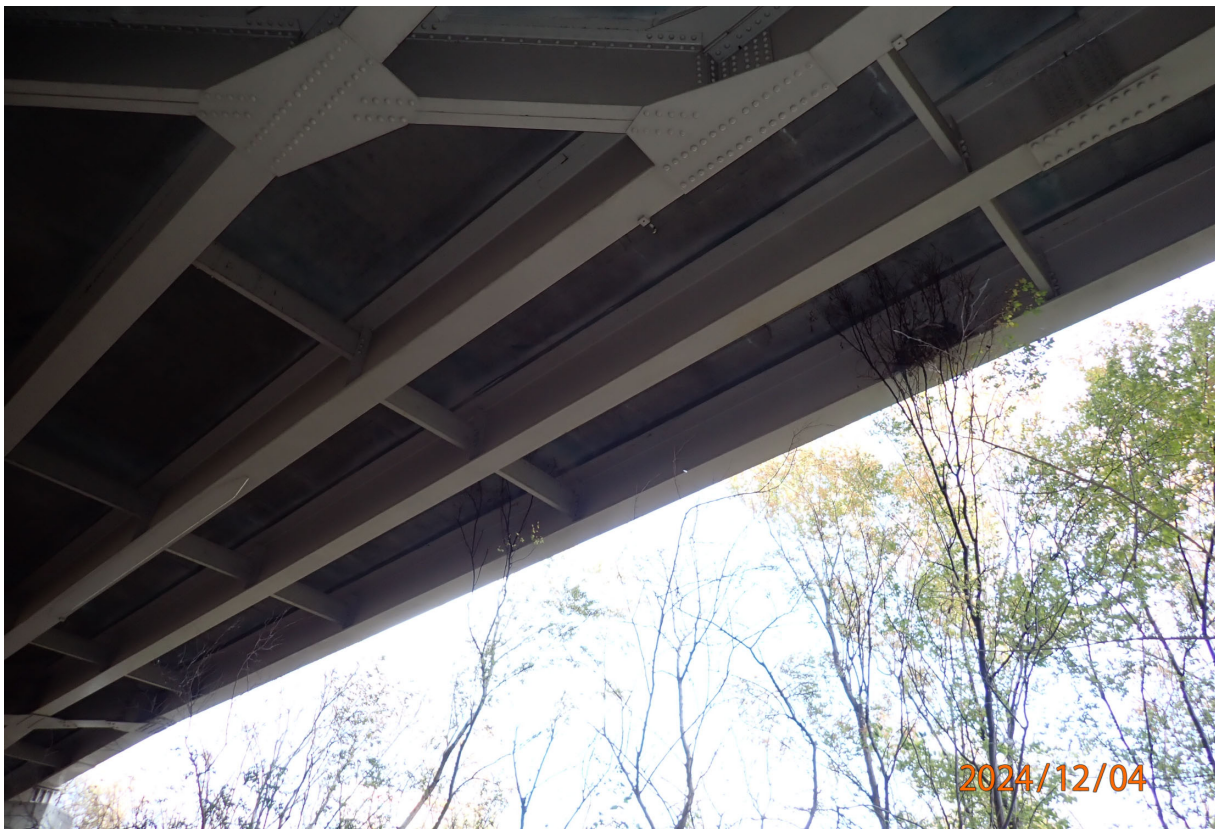
Trees are growing against the superstructure in a few areas (east side of Span 3 shown).

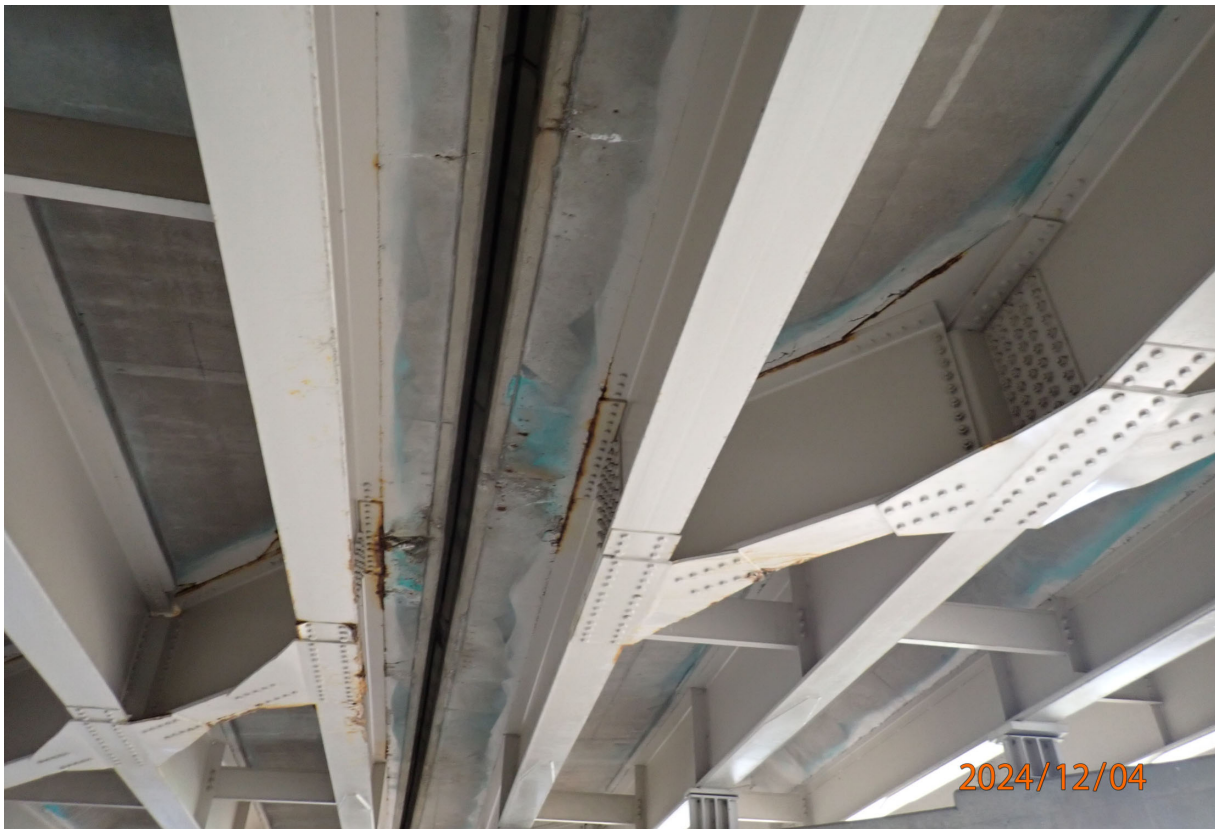
Some diaphragms have flaking corrosion near the abutments and longitudinal joints.

Beams and diaphragms have flaking corrosion scattered throughout the top flanges, especially near the longitudinal joints (Span 4 shown).

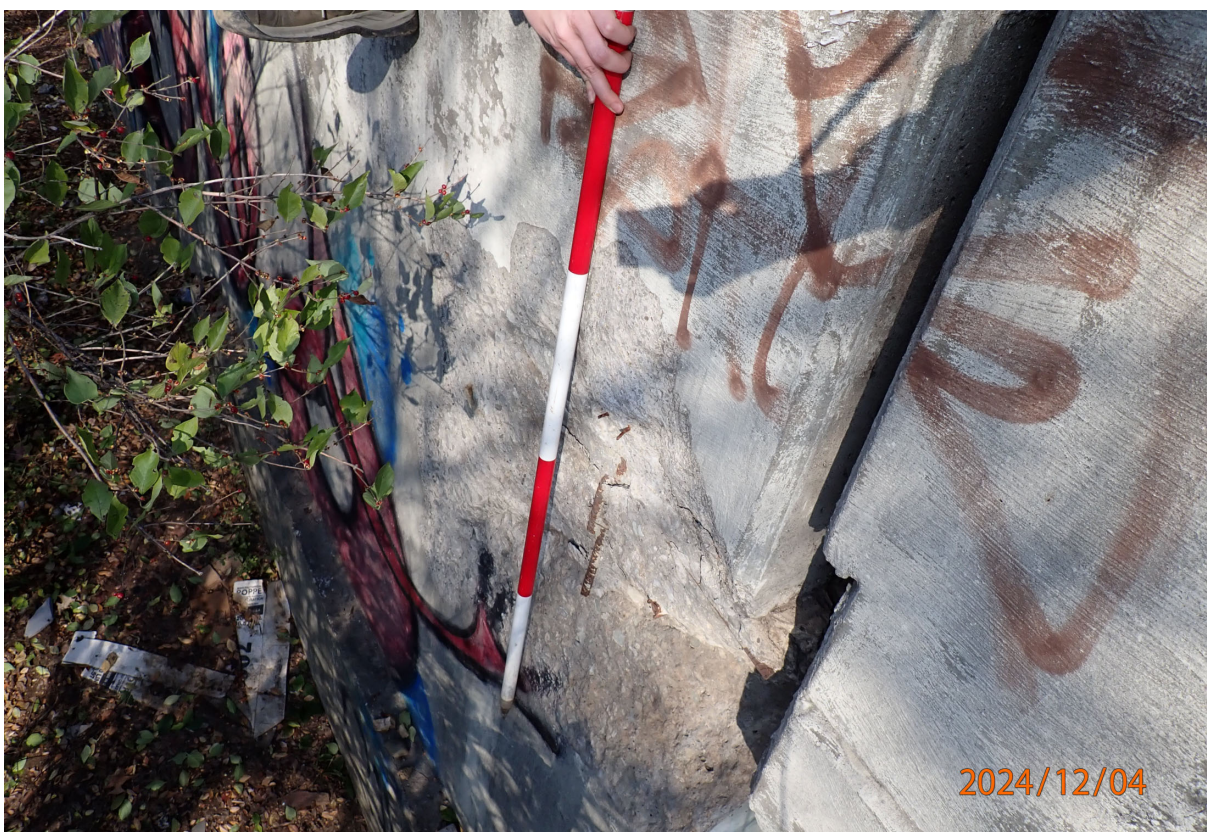
Northwest wingwall has a 3-foot-diameter spall with exposed rebar.

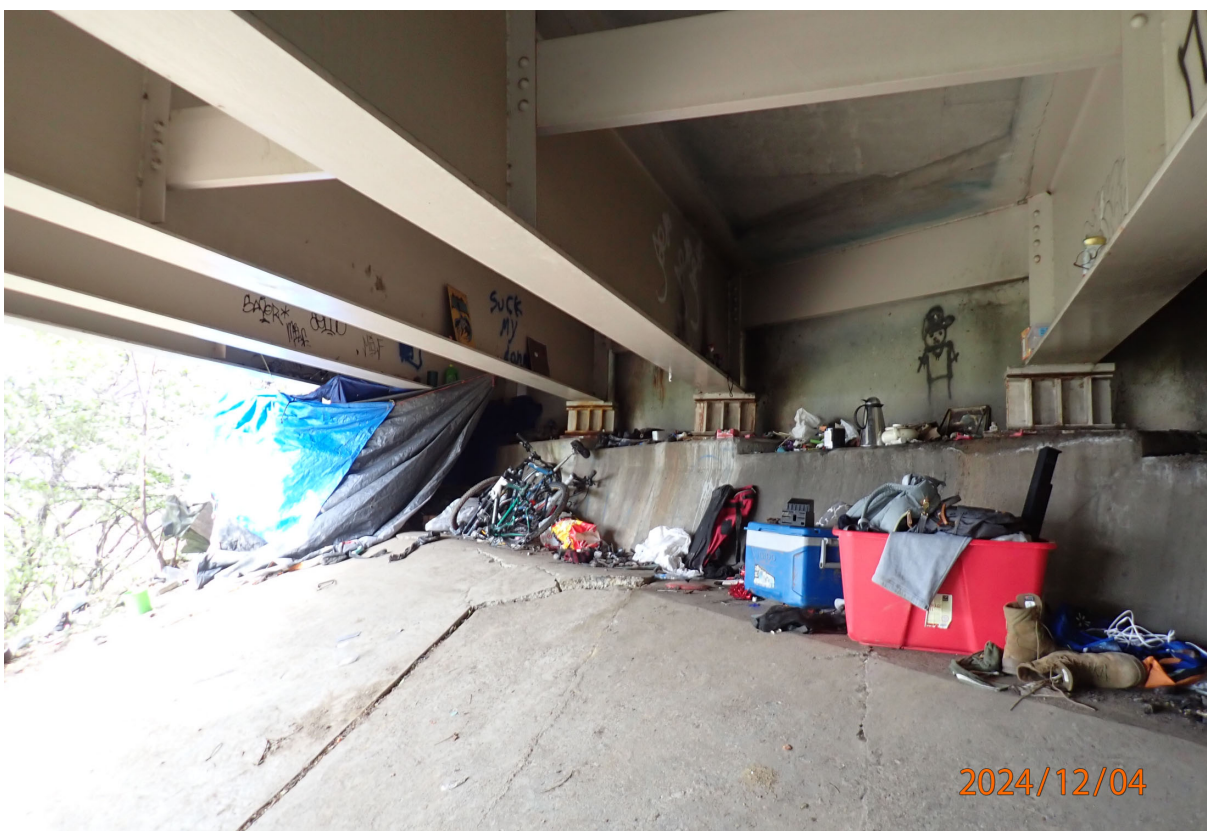
Due to an encampment at Abutment 5, the ends of Beams 1 and 2 and Abutment 5 below Bays 1 and 2 were not visible for inspection.
