Bridge Inspection Report

056B00205N

12/04/2024

<u>IDENTIFICATION</u>			
Structure Num (8):	056B00205N		
NBI Number	056B00205N		
Structure Name:			
Location (9):	500 FT N OF CRITTENDEN DR		
Carries (7):	I-65		
Type of Service (42A):	1 Highway		
Feature Crossed (6):	NS RAILROAD		
Type of Service (42B):	2 Railroad		
Placecode (4):	Not Applicable		
County (3):	Jefferson (056)		
State (1):	21 Kentucky		
Admin Area:	Inventory		
District:	District 5		
Latitude (16):	38° 12' 31"		
Longitude (17):	85° 45' 8"		
Owner (22):	State Highway Agency		
Maint. Resp. (21):	State Highway Agency		
Year Built (27):	1957	Border State (98A):	Not Applicable (P)
Year Recon (106):	1982	Border Number (99):	
		% Responsibility (98B):

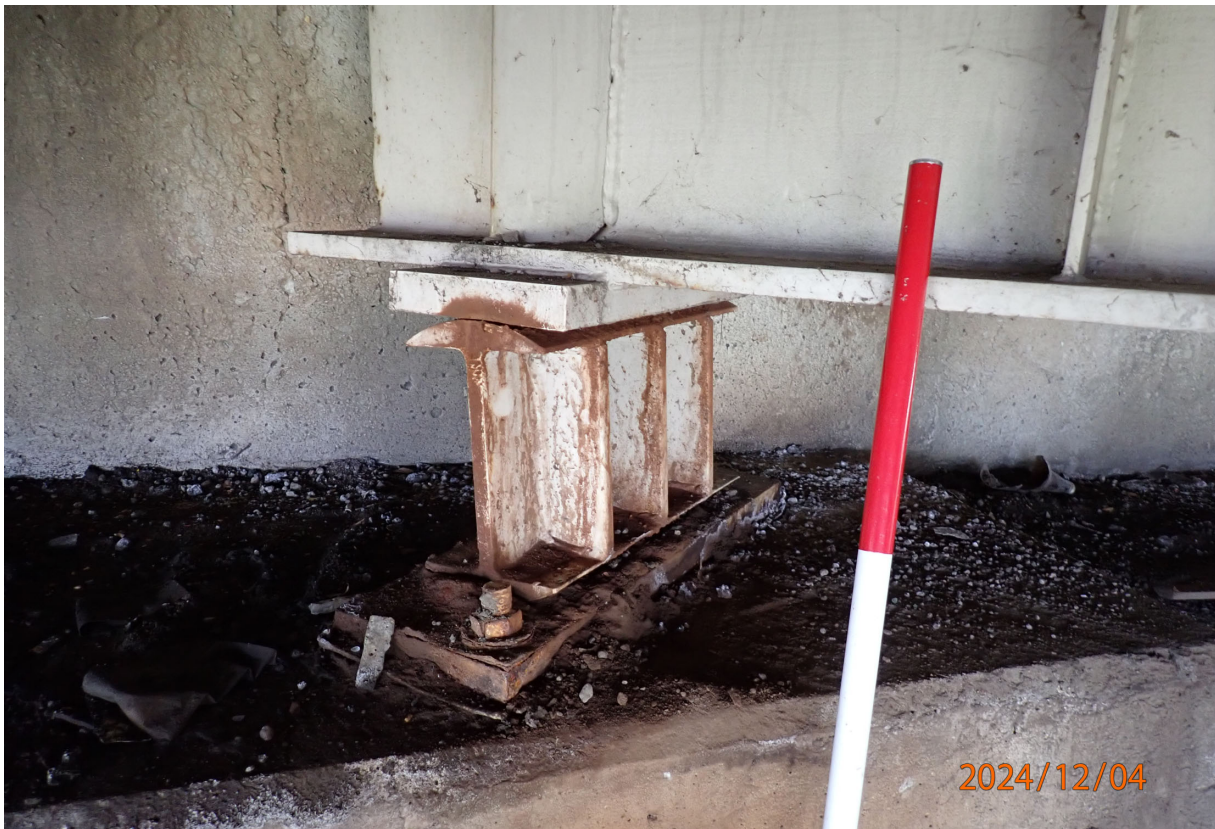
At Abutment 5-Beams 7 and 8, the sole plates are not in contact with the rocker bearings and can be moved by hand, except under live load (Beam 8 shown). Note fretting rust.

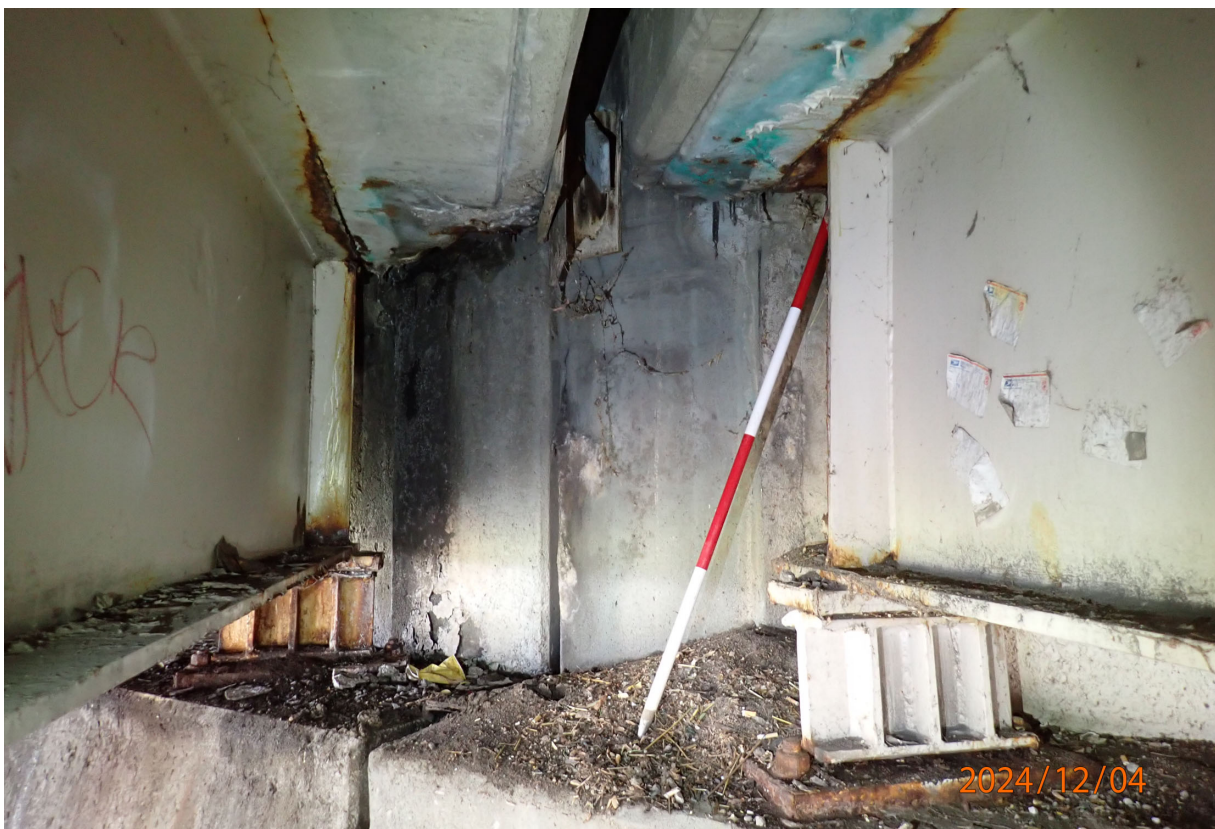
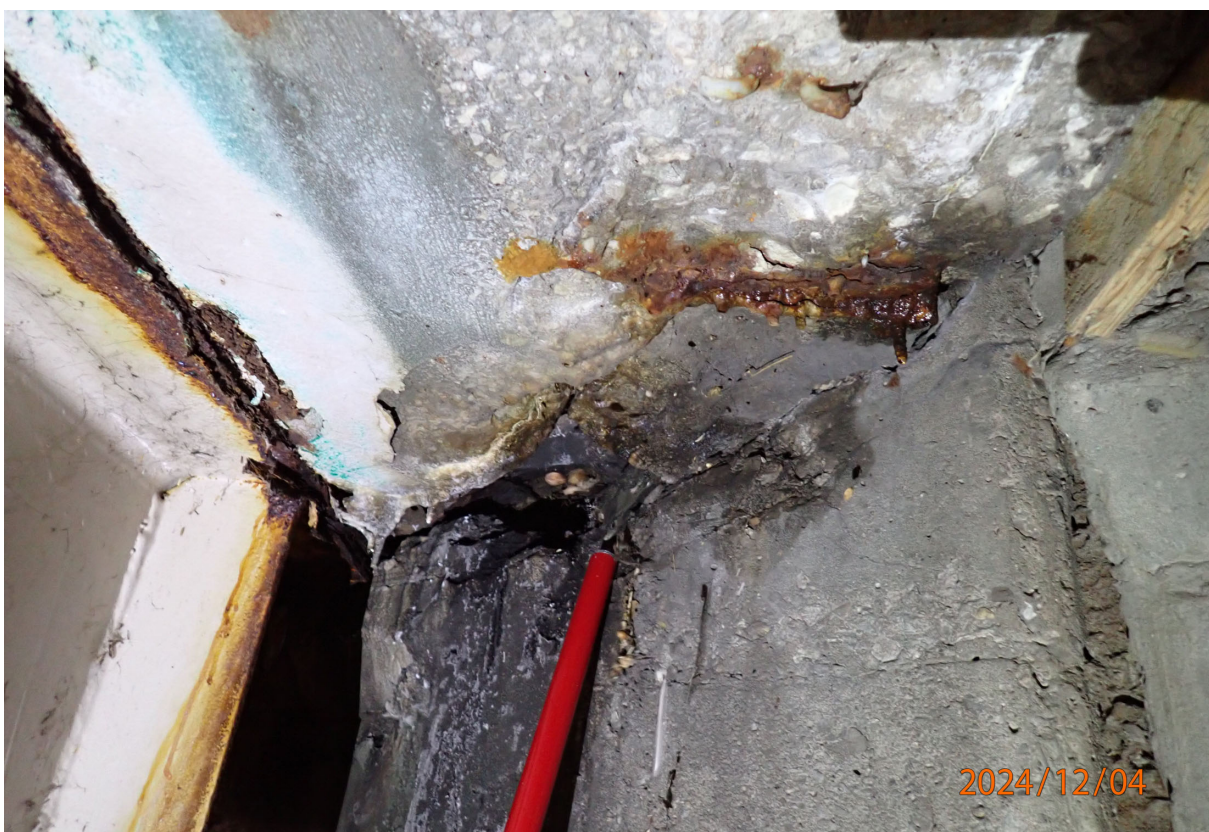
Soffit and backwalls have spalls at the longitudinal joint (Abutment 5 shown, see next photo).

Spalling in Abutment 5 backwall and soffit at longitudinal joint

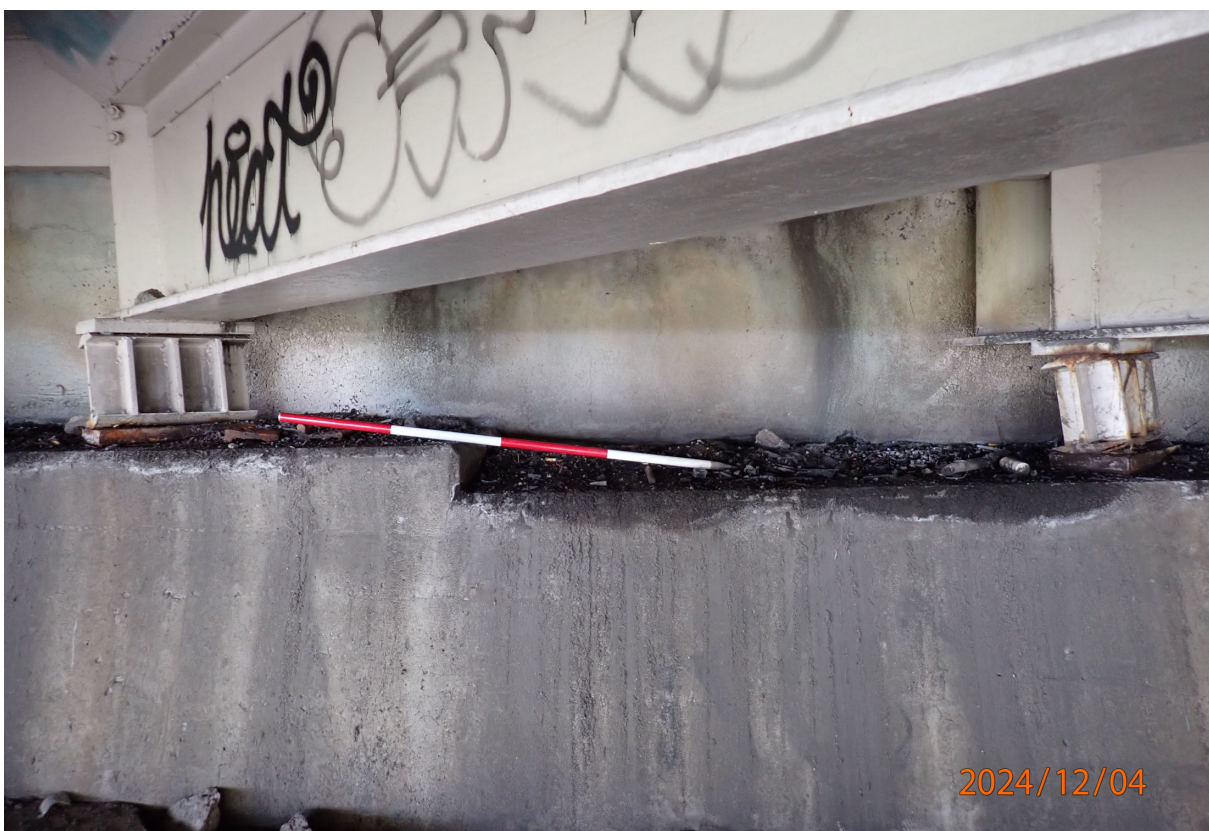
Abutment bearings are expanded at 40° F (tolerable alignment, inconsistent with temperature; typical Abutment 5 NB beams shown). Note debris and moisture on seat.

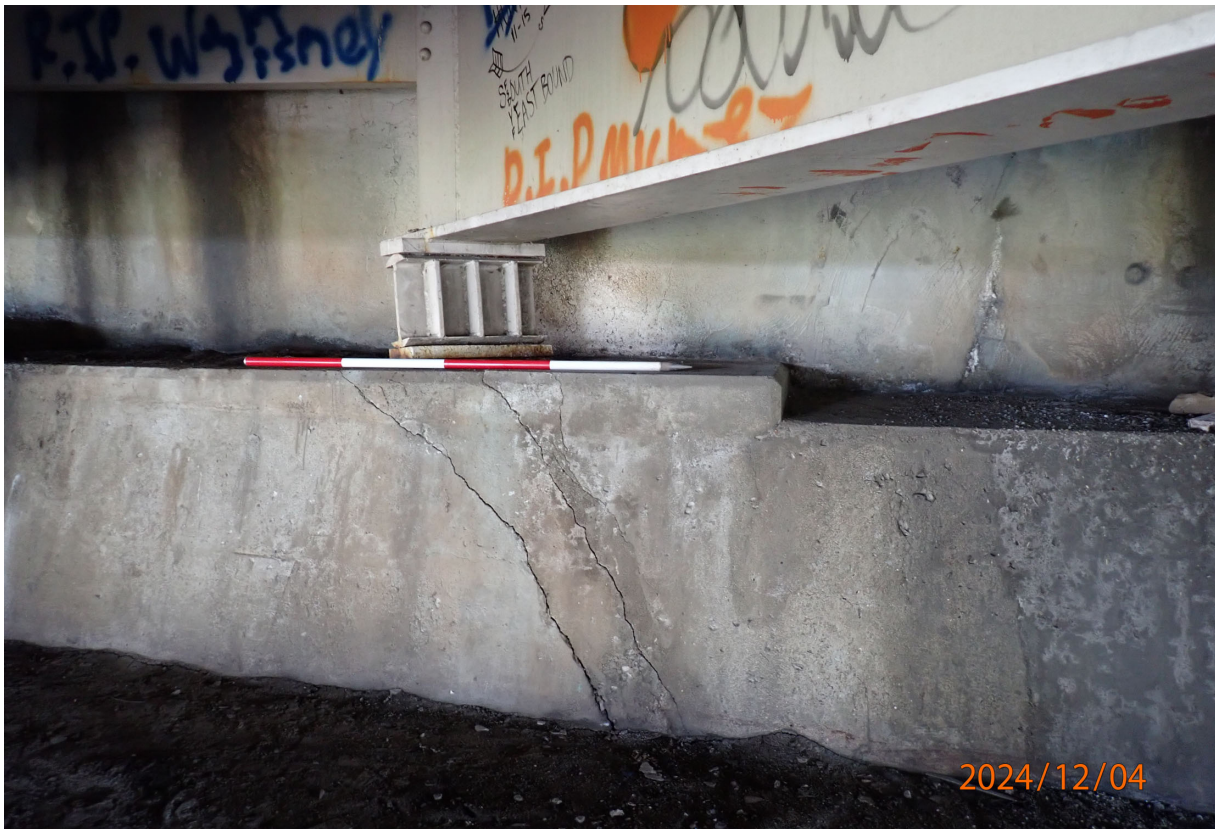
Abutment 5 cap has two wide diagonal cracks below Beam 16.

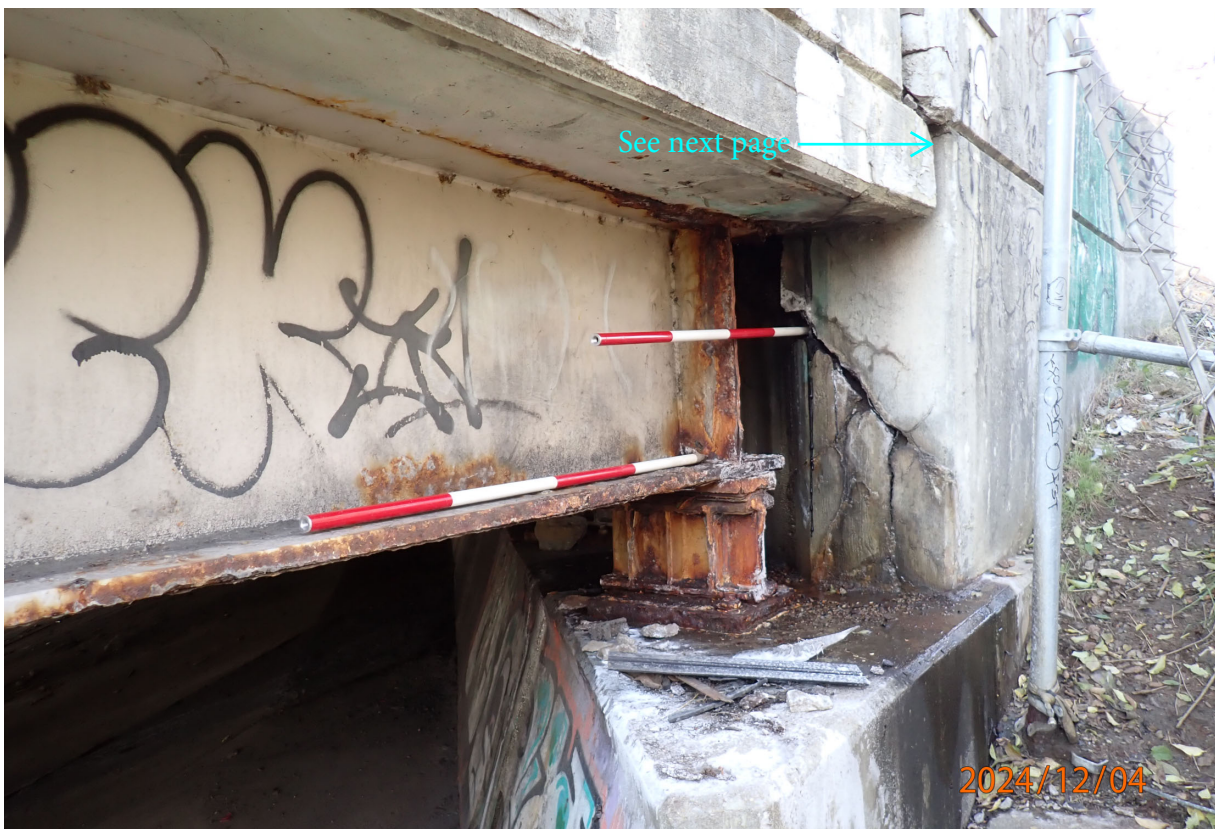
Abutment 5 backwall has a 1" wide diagonal crack/fracture at the east end with map cracking. The northeast wing is tilting out by 1.5" as measured at the top of the deck.

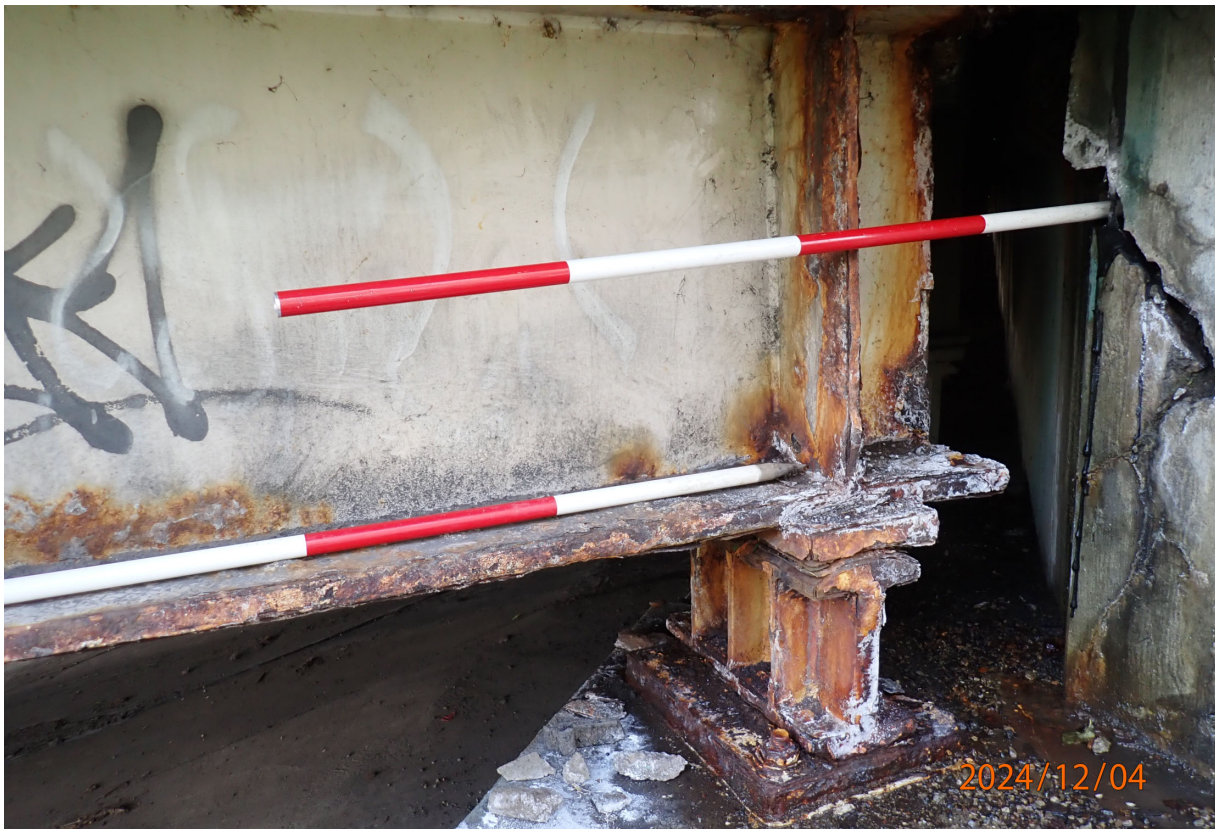
The beams have surface rust scattered throughout the flanges. Some beam ends have flaking corrosion on the flanges, especially near the substructure units, longitudinal joint, and splices (125' CS3). Previous in-depth inspections noted cracks in the stiffener to top flange tack welds; some are visible from the abutments.

Some beam ends have flaking corrosion on the flanges (Beam 19 at Abutment 5 shown).

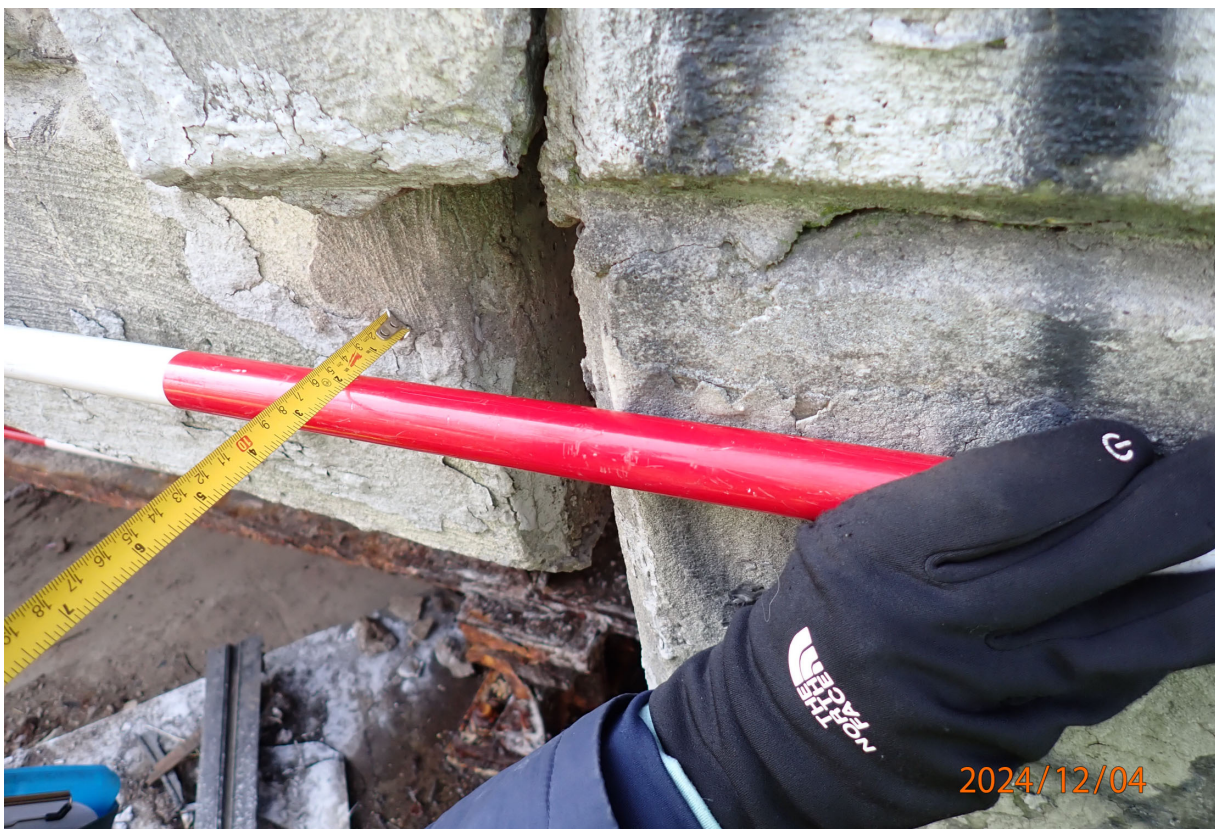
The northeast wing is tilting out by 1.5" as measured at the top of the deck (close up).

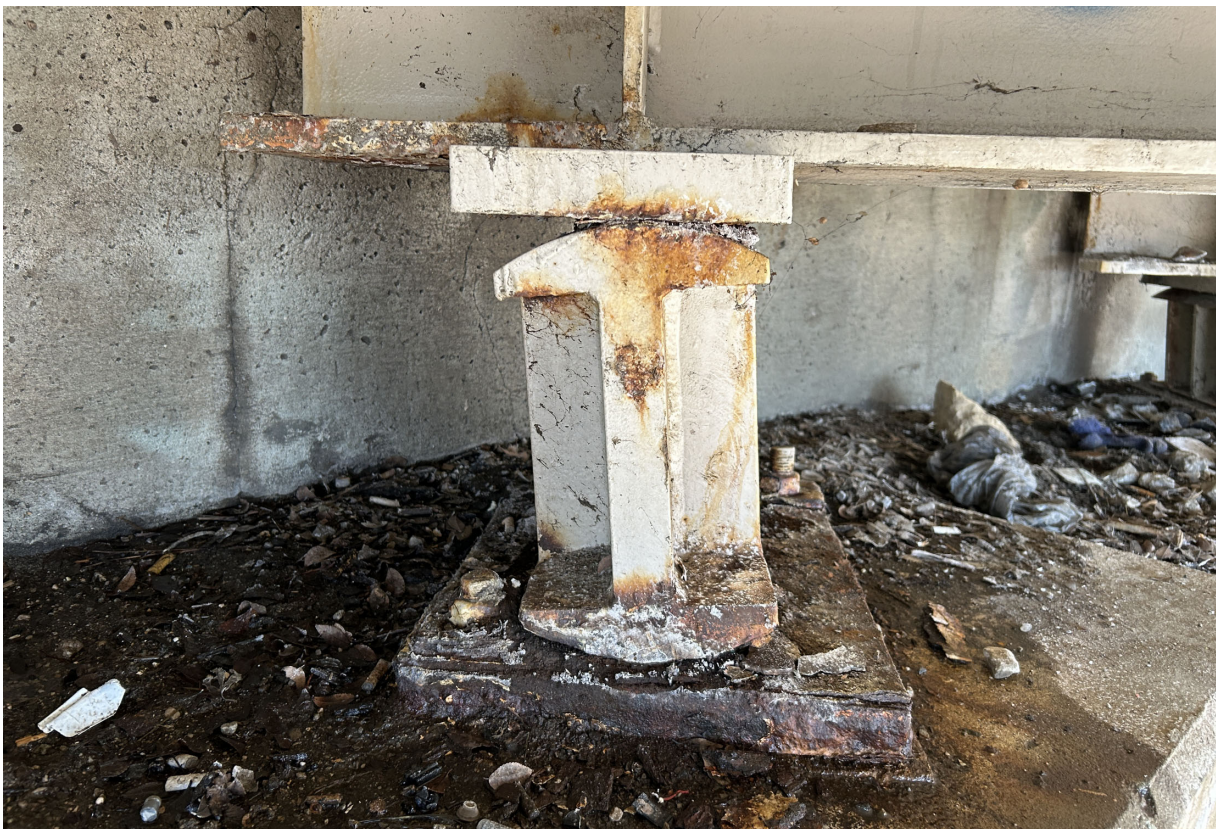
Typical rocker bearing expanded at 40° F (Girder 3 at Abutment 5 shown)

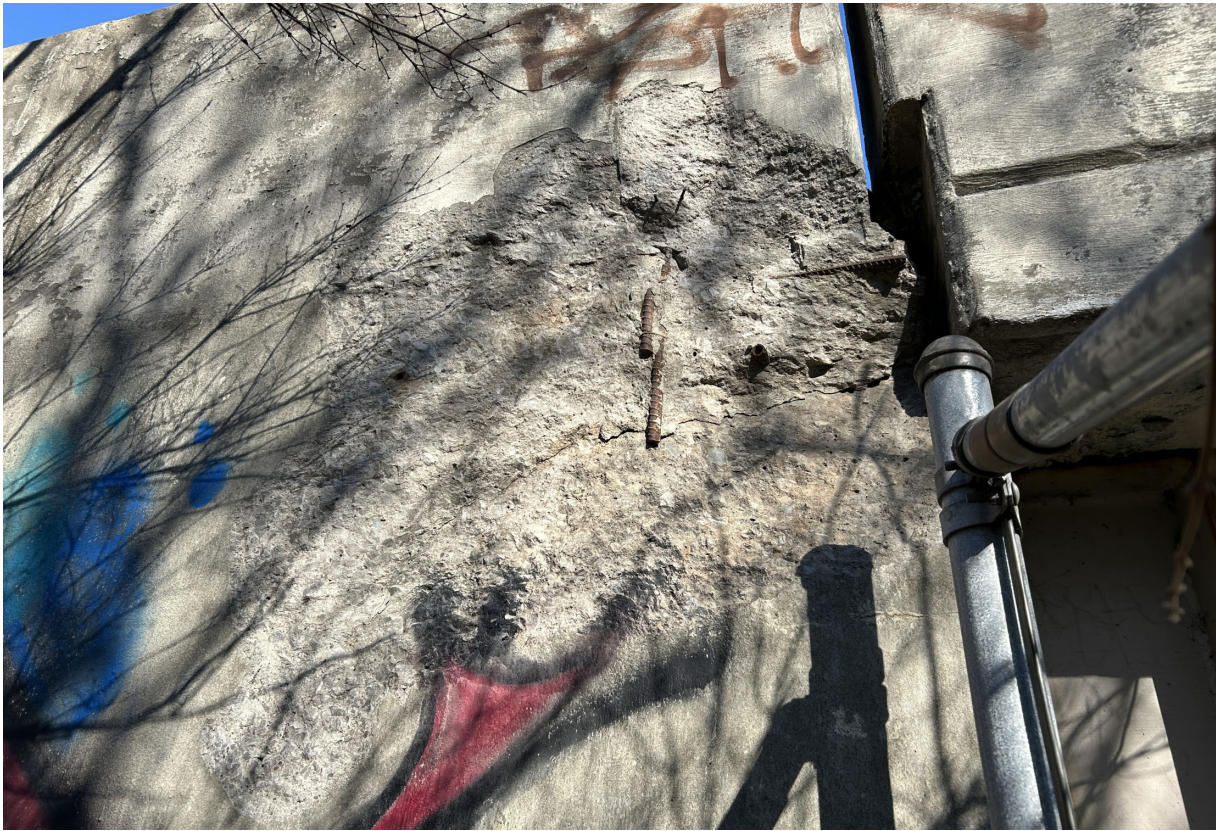
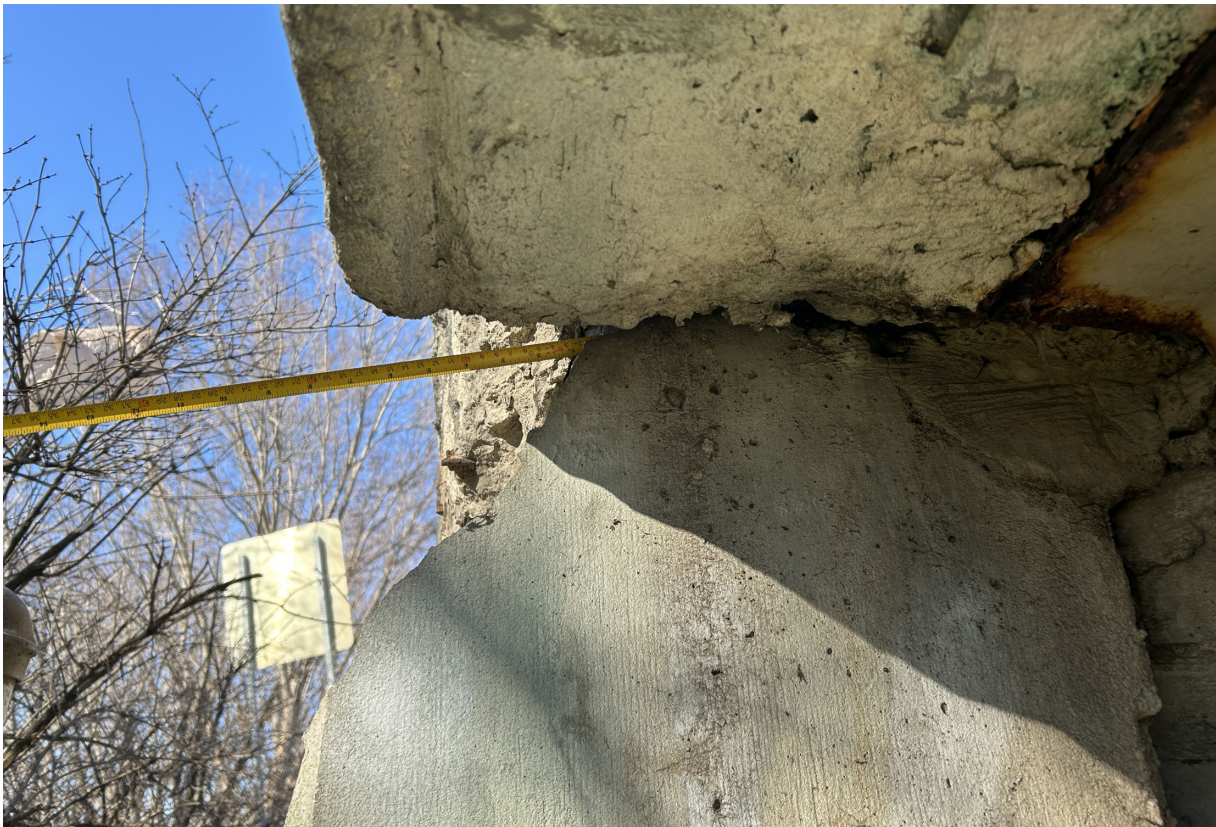
3' diameter by 8" deep spall with exposed rebar in northwest wingwall
