Bridge Inspection Report

056B00209N

12/02/2024

Standard (24 months)

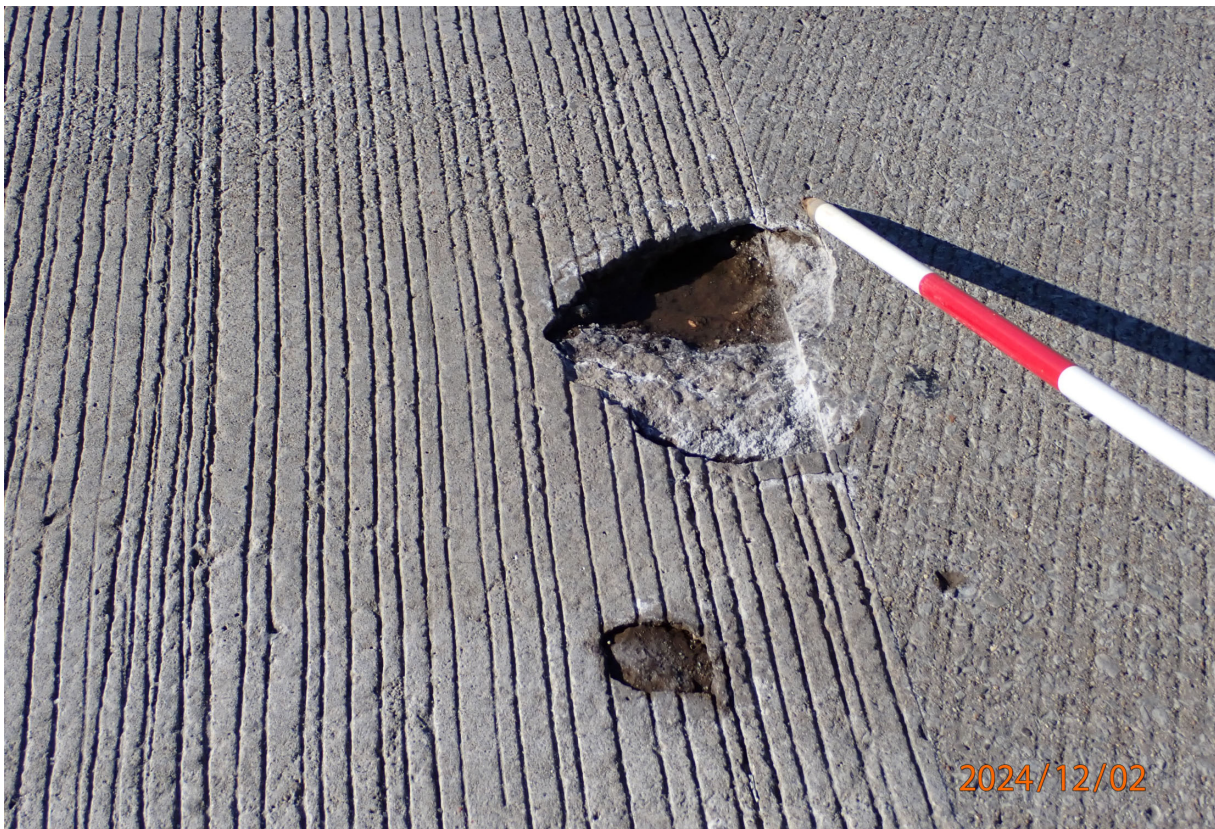
Top of the deck has a 2-foot-diameter by 2-inch-deep spall near the south bridge end in the right NB lane.

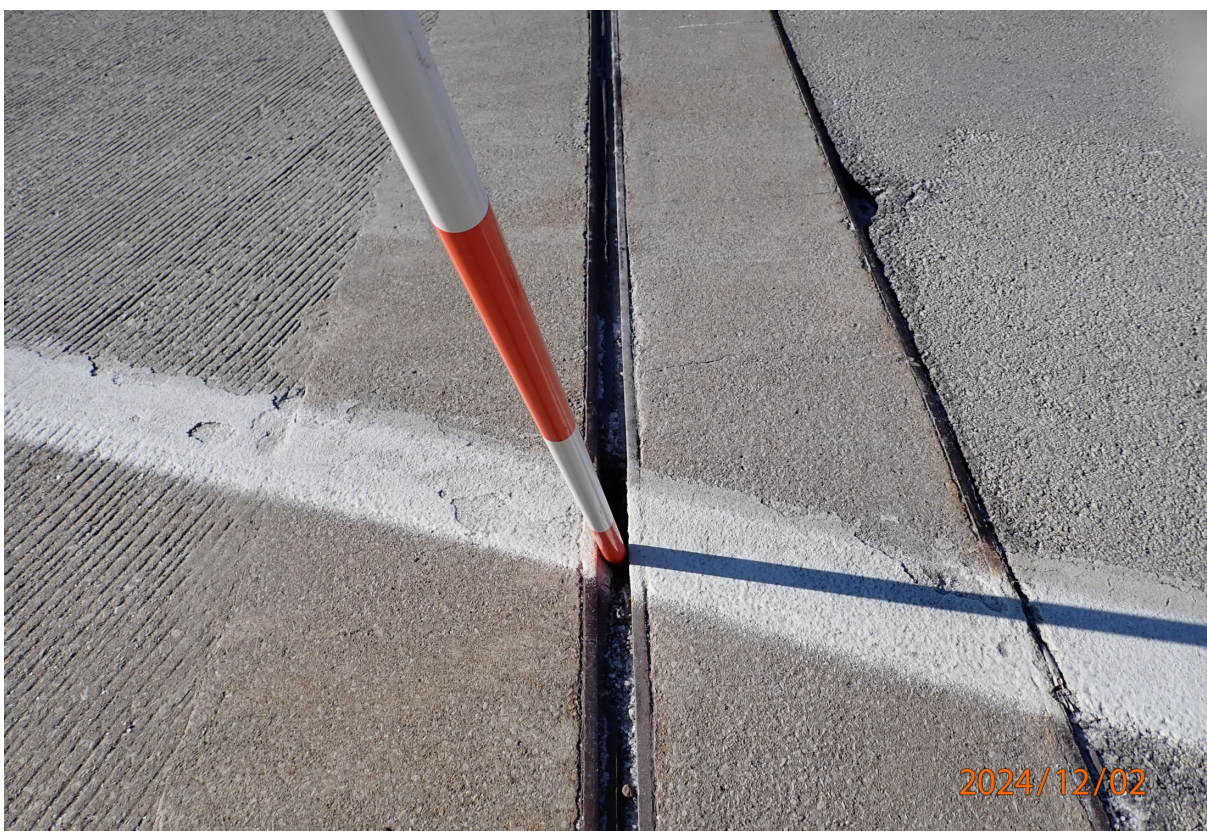
Compression joint seal over Abutment 4 has total loss of adhesion in several areas, notably in the left two NB lanes and left three SB lanes. The remainder of the NB seal has partial depth tears, adhesion loss. The remainder of the SB seal has surface cracks and loose debris.

Compression joint seal over Abutment 4 has total loss of adhesion in intermittent areas (right NB edge line shown).

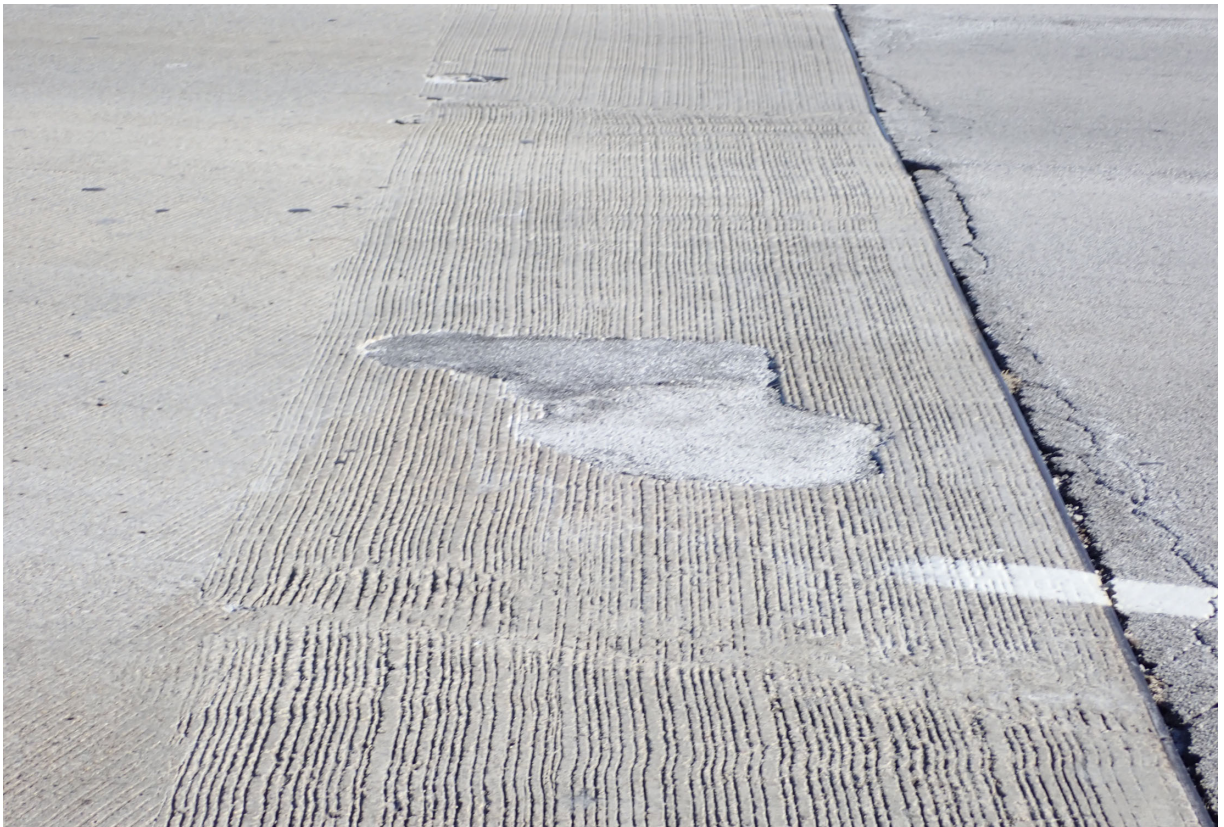
Top of the deck has a 4-foot by 4-foot asphalt patch at the south bridge end in SB Lane 4.

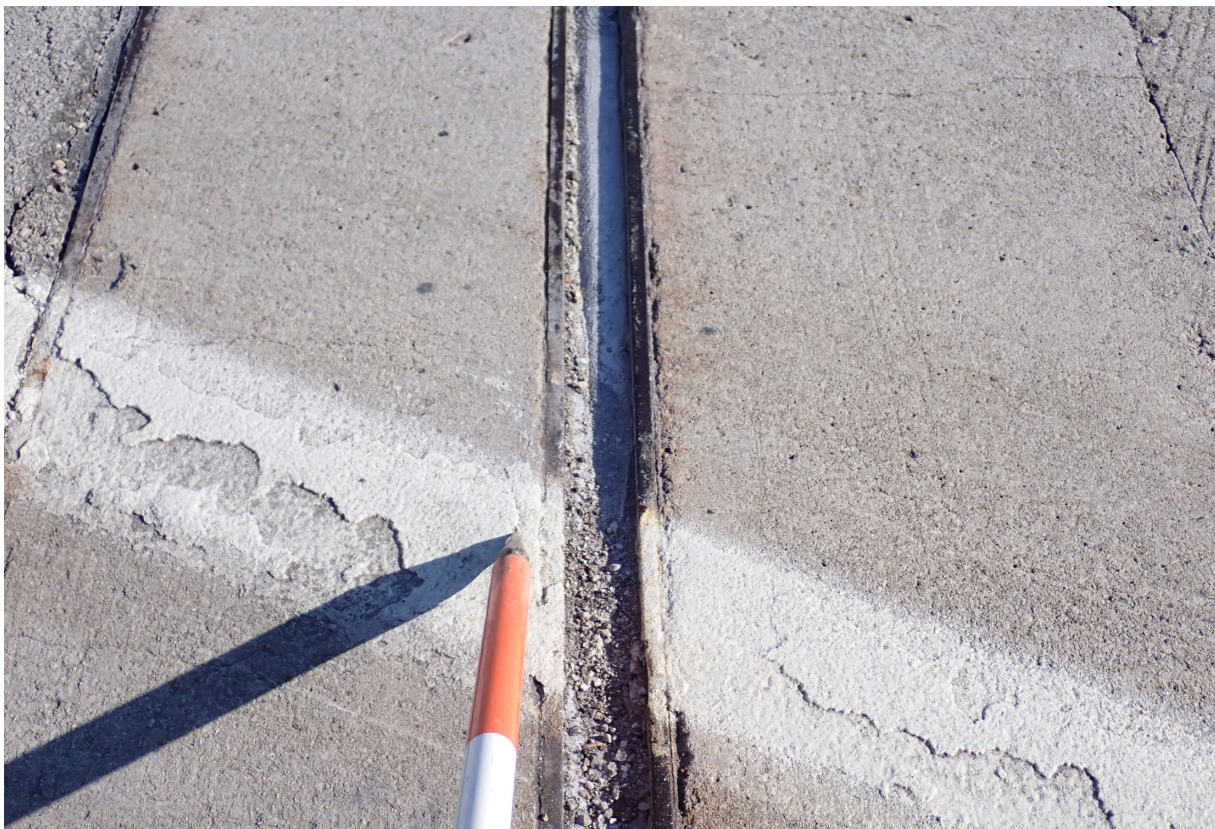
Close up of debris at right SB edge line

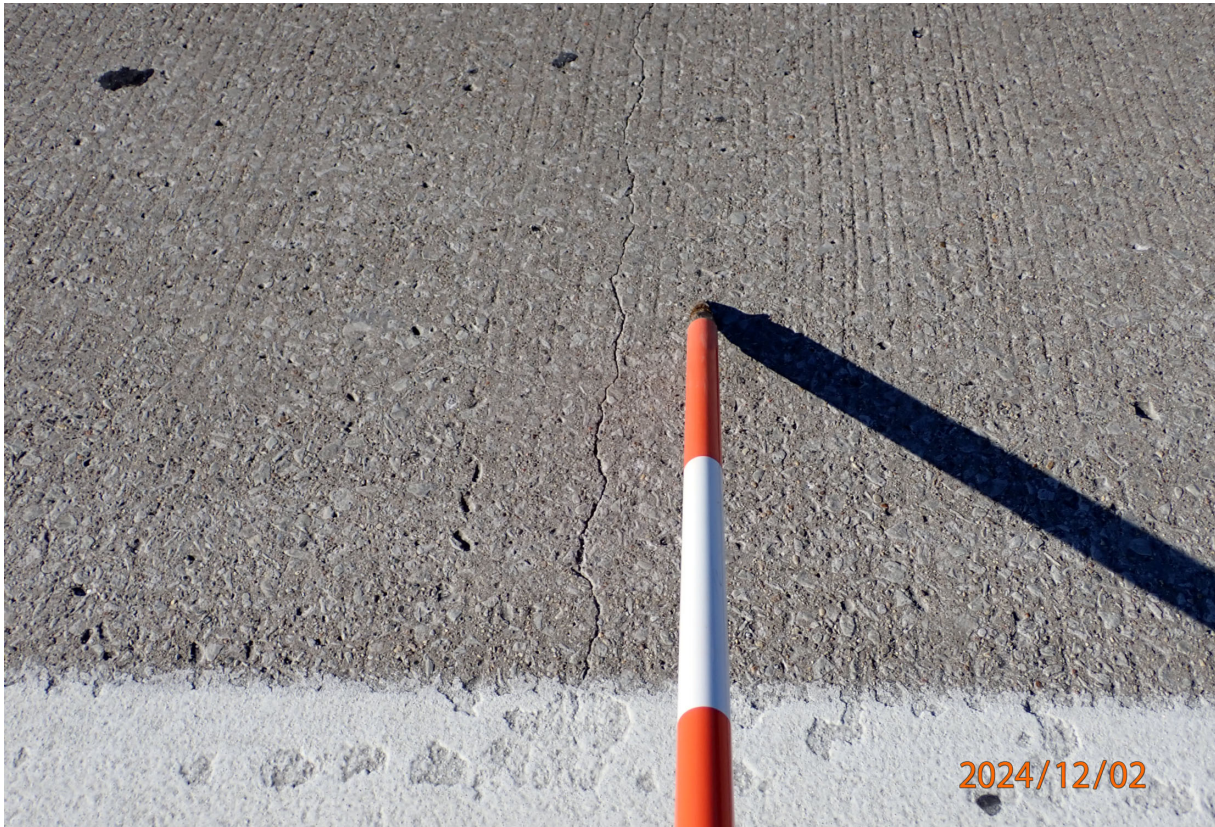
The deck has wearing with exposed coarse aggregate throughout the top surface with scattered pop outs, plus intermittent transverse cracking; some cracks are wide (1000 SF CS3). There is moderate longitudinal cracking in the flared portion of the SB right lane. There is a 2-foot-diameter by 2-inch-deep spall near the south bridge end in the right NB lane, a 1-foot-diameter spall in SB Lane 3, and a 4-foot by 4-foot asphalt patch at the south bridge end in SB Lane 4 (21 SF CS3). Soffit has transverse cracking with efflorescence spaced at less than 3 feet nearly throughout. Some cracks are spaced at less than 1 foot, typically without efflorescence (5000 SF CS3). There is a haunch spall along Beam 22 at the impact damage in Span 2 (25 SF CS3), and a few other isolated haunch spalls (25 SF CS3). The deck moves independently from the beams at Abutment 4, Beams 7-12 and 16-18 under heavy live load.

Top of the deck has wearing with exposed coarse aggregate, plus intermittent transverse cracking (NB right lane shown).

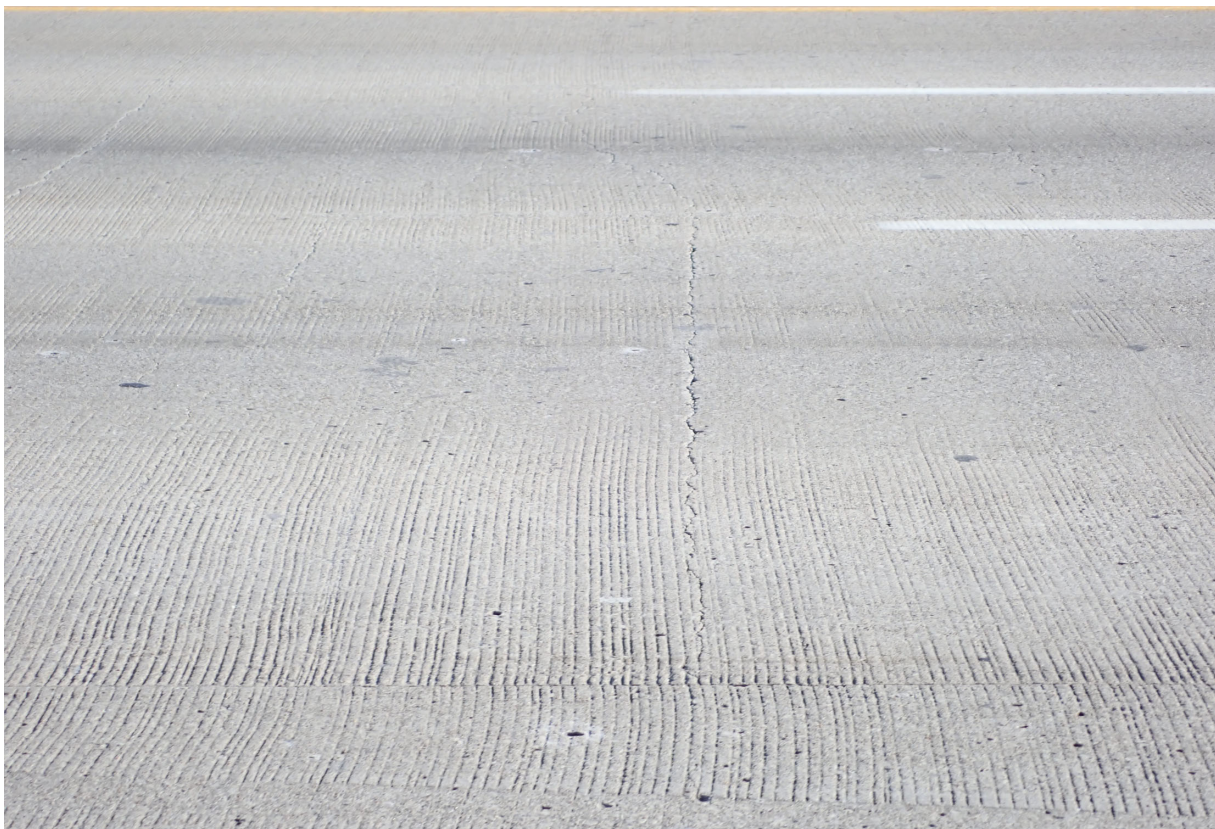
Top of the deck has some wide transverse cracks (SB lanes shown).

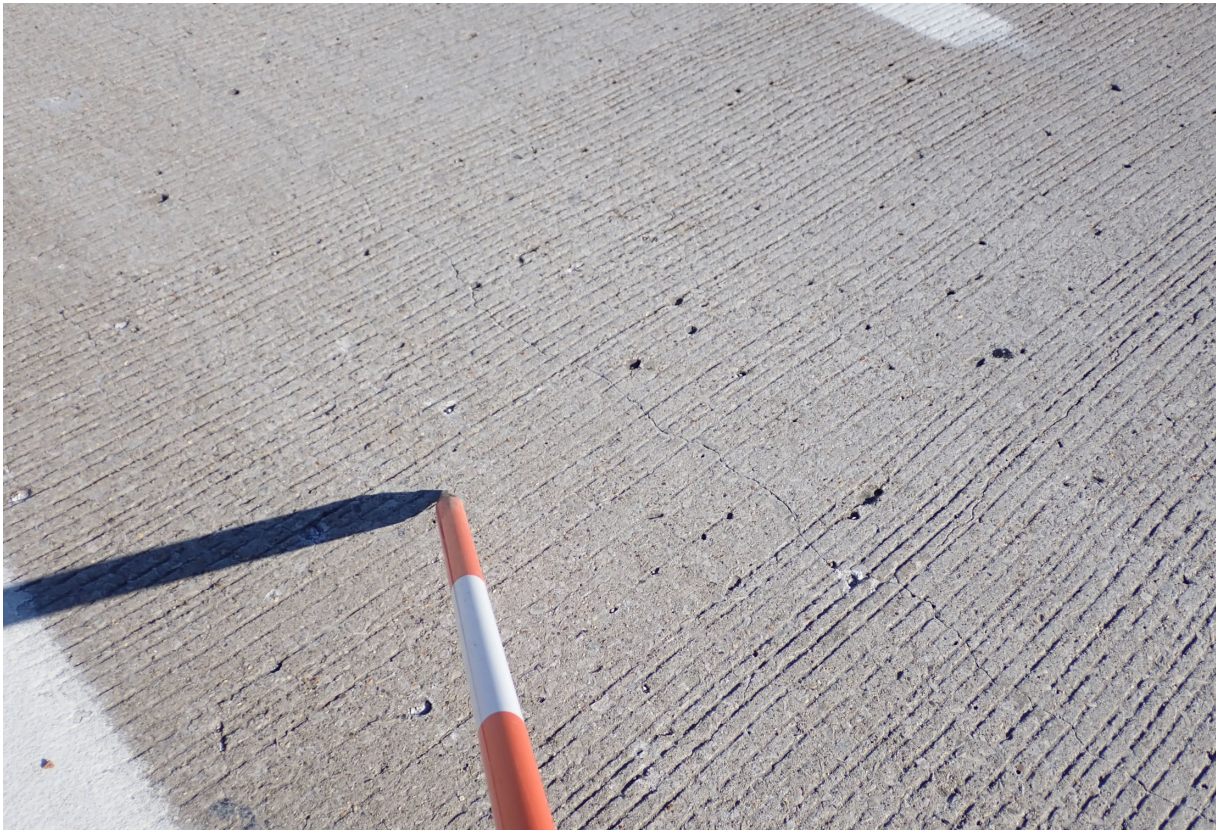
Top of the deck has moderate longitudinal cracking in the flared portion of the SB right lane.

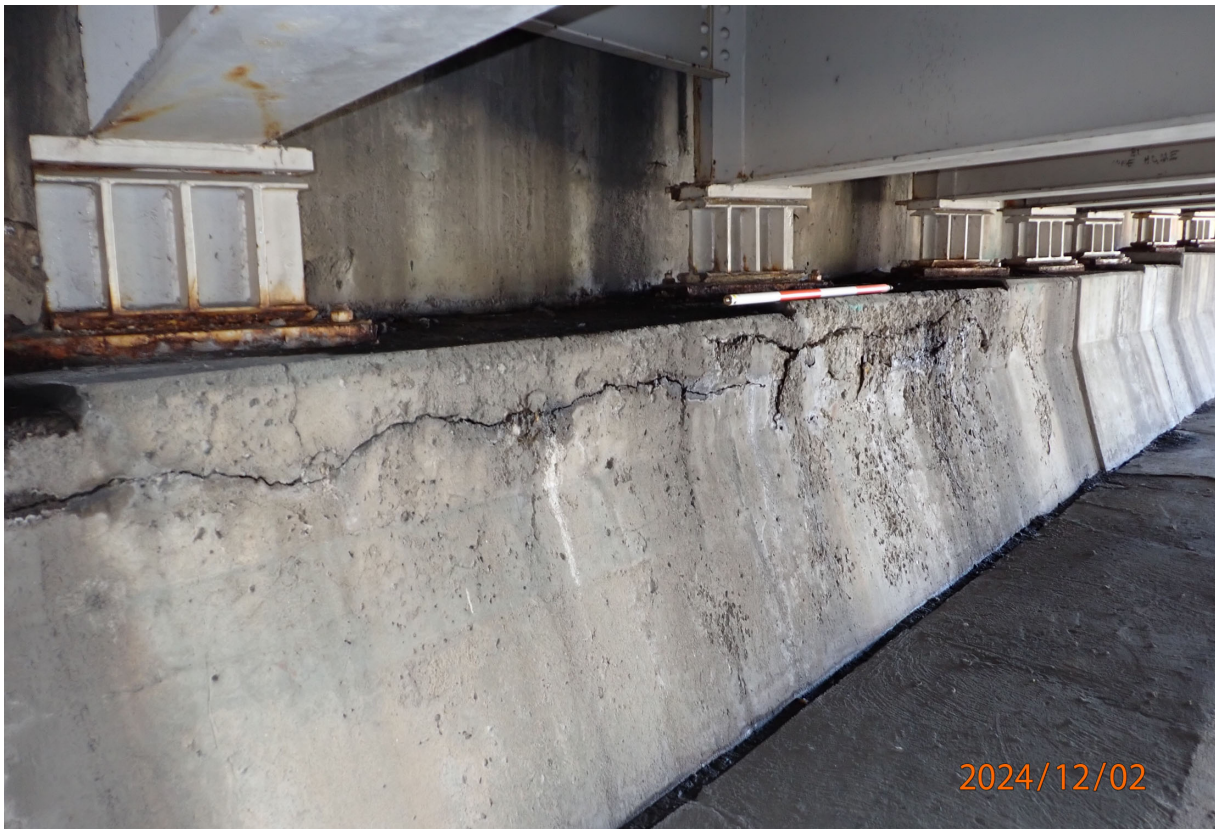
Abutment 1 has 1/4-inch-wide horizontal cracking below Bays 7-11, with some delaminations and scaling.

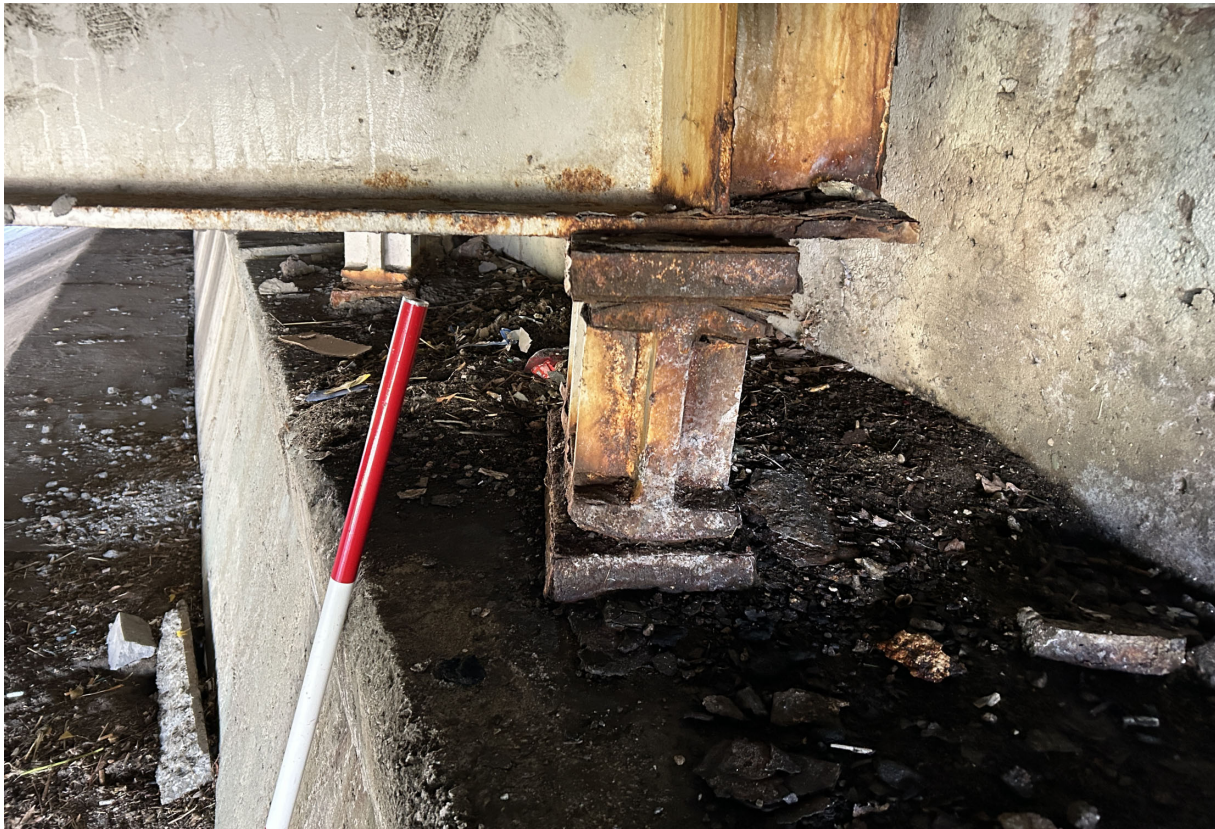
Abutment bearings are expanded at 20° F (tolerable alignment, inconsistent with temperature; Beam 12 at Abutment 1 shown). Note debris on abutment seat.

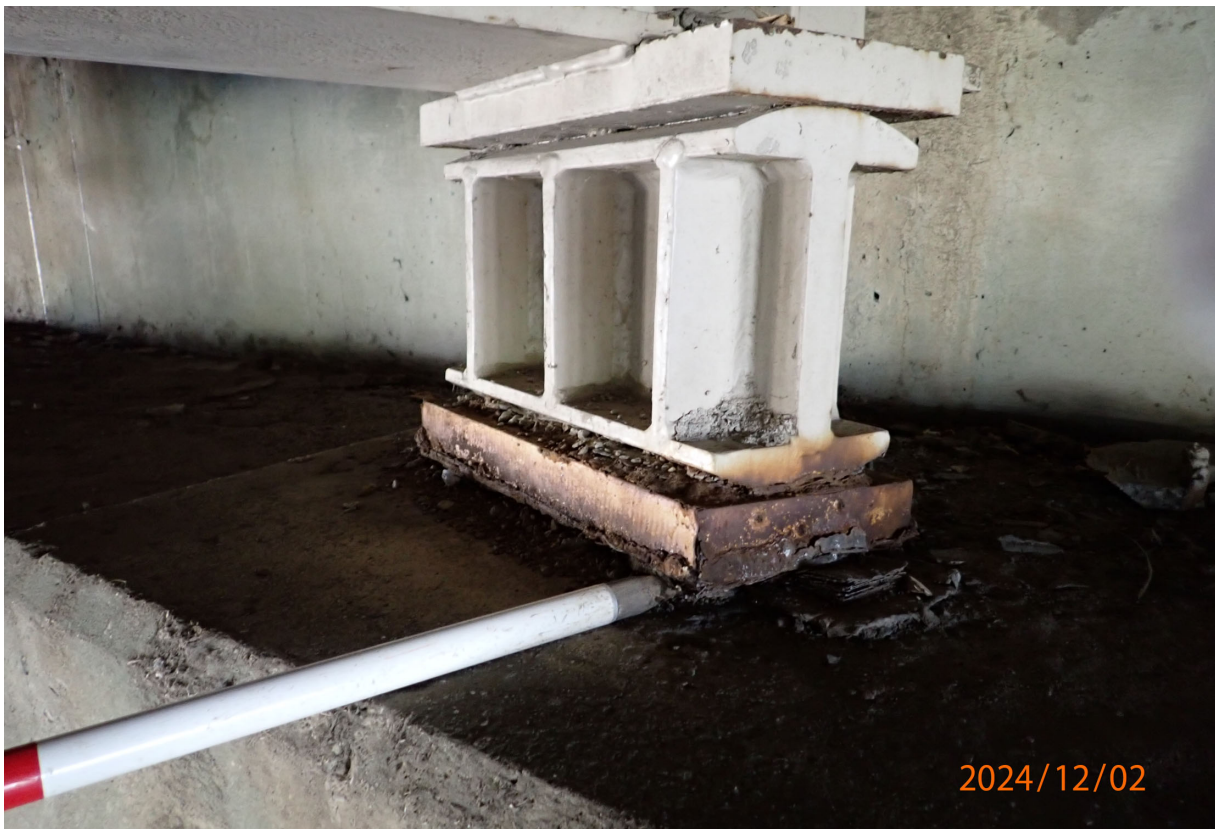
The movable bearings are located at the abutments and Pier 3. Abutment bearings typically have pack rust between the rocker and bearing plates; corrosion is heavier at exterior bearings and near the longitudinal joint. Several abutment bearings have gaps between the plates and rocker and/or below the masonry plates due to pack rust. Abutment bearings are expanded at 20° F (tolerable alignment, inconsistent with temperature). Abutment 4-Girder 9 sole plate is not in contact with the rocker bearing (1/8" gap), except under live load (1 CS4). Pier 3-Beam 2 bearing and exterior bearings have surface corrosion.

Several abutment bearings have gaps between the rocker and plates and/or masonry plate and abutment seat due to pack rust (Beam 15 at Abutment 1 shown).

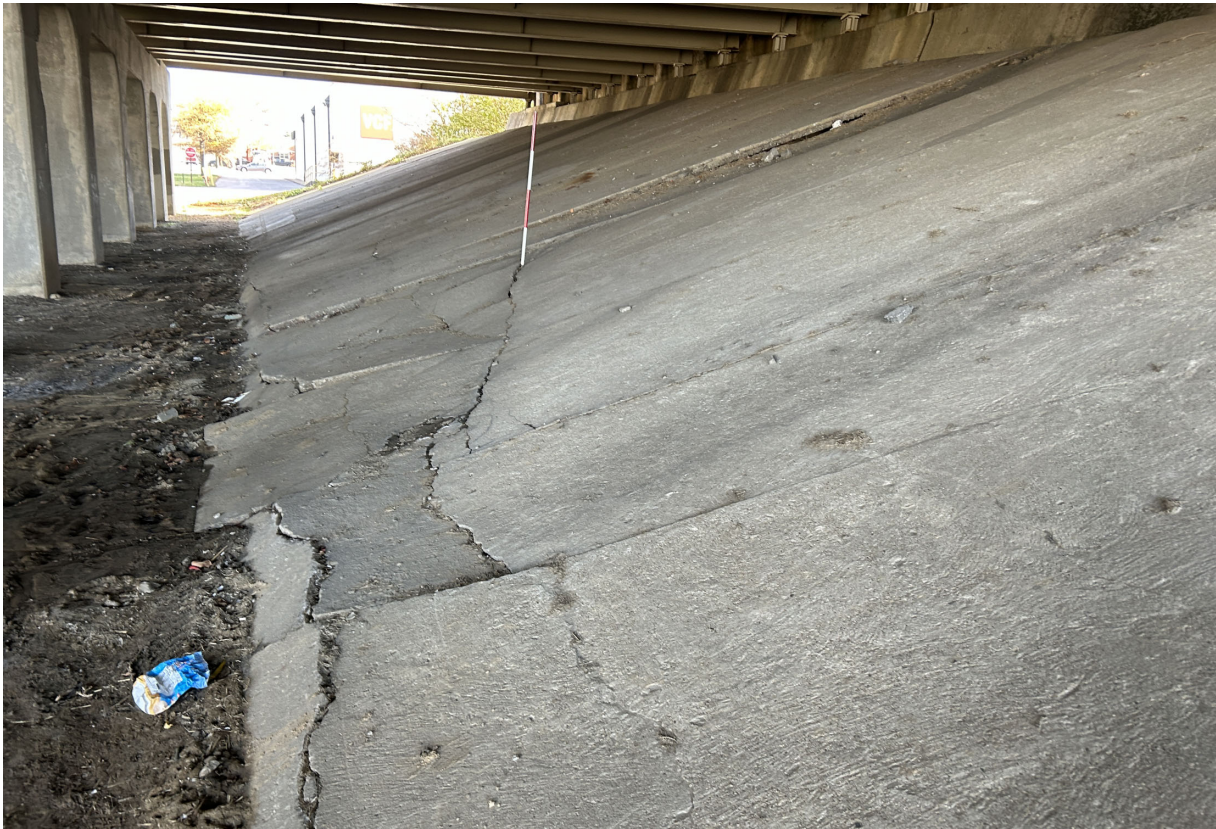
Concrete slope protection has fractured and settled at several locations, including between Beams 10-12 at Abutment 1 and Beams 10-12 at Abutment 4. There is a 3" gap between the slope protection and Abutment 4 cap below Beams 11-16, with up to 50" embankment settlement below the panels.

Concrete slope protection has fractured and settled at several locations (looking east along Abutment 1 slope shown).

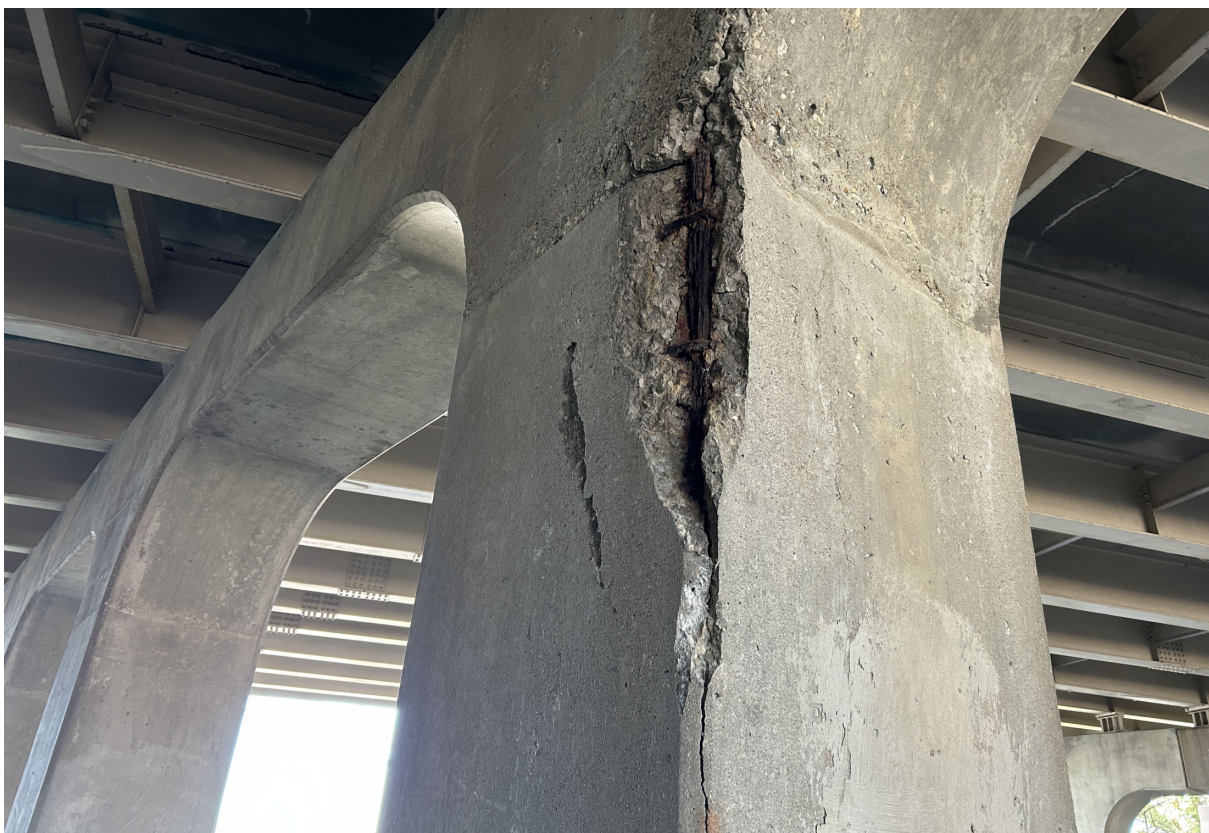
Pier 2-Column 6 has 3' T x 1' W x 3" D spalling with exposed rebar in the south face at the top (1 CS3). Pier 3-Columns 4, 5, and 7 have spalls, up to 2' T x 3' W x 2" D, with exposed reinforcement (3 CS3). Pier 3-Column 6 has wide vertical cracks at the top of the east face (1 CS3).

Pier 2-Column 6 has 3' T x 1' W x 3" D spalling with exposed rebar in the south face at the top.

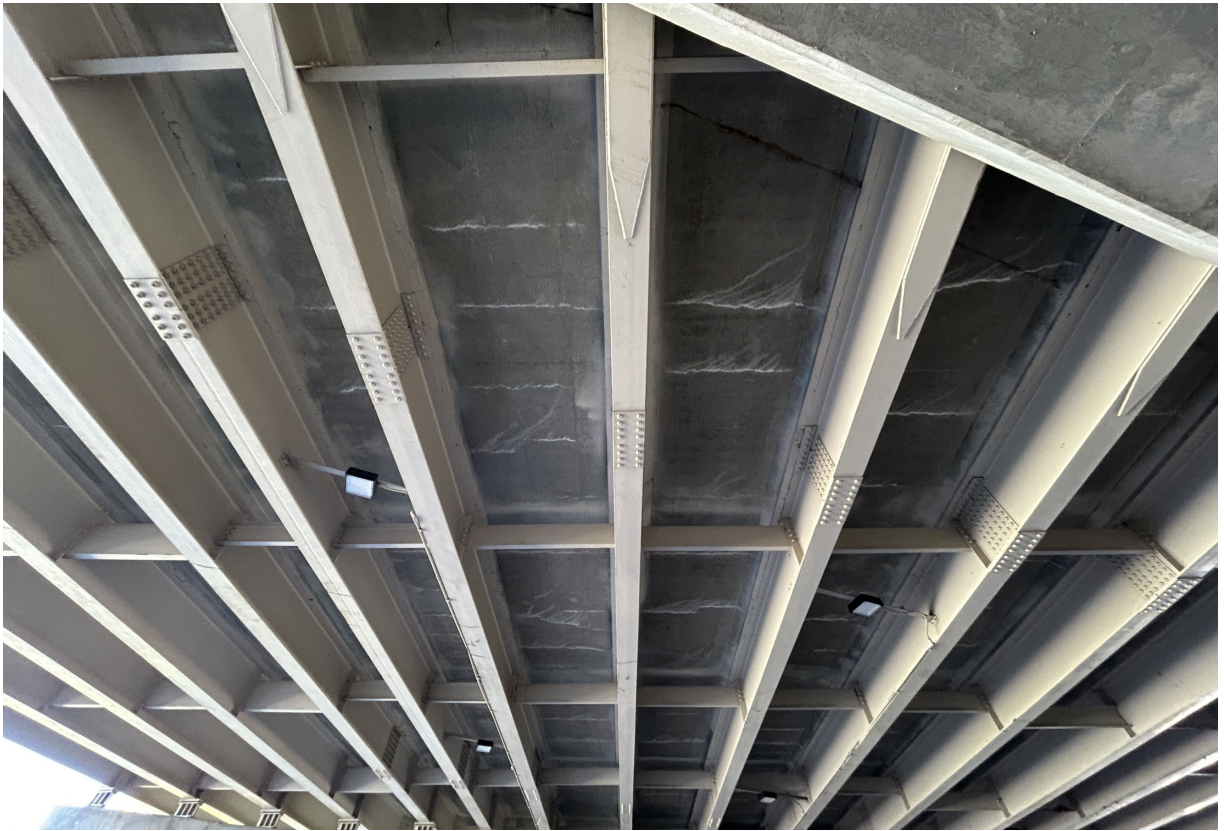
Span 2 soffit
Soffit has transverse cracking spaced at less than 3 feet nearly throughout.

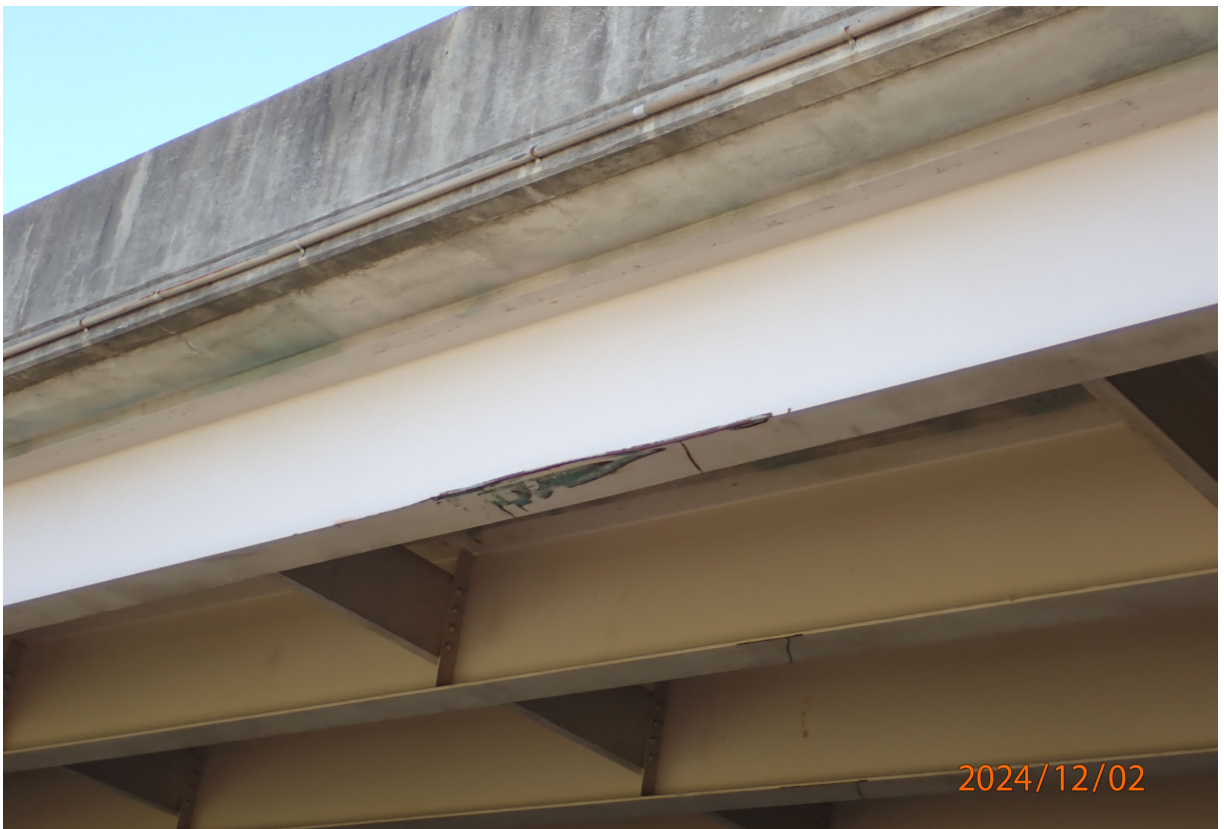
Minor impact damage in Span 2-Beam 1

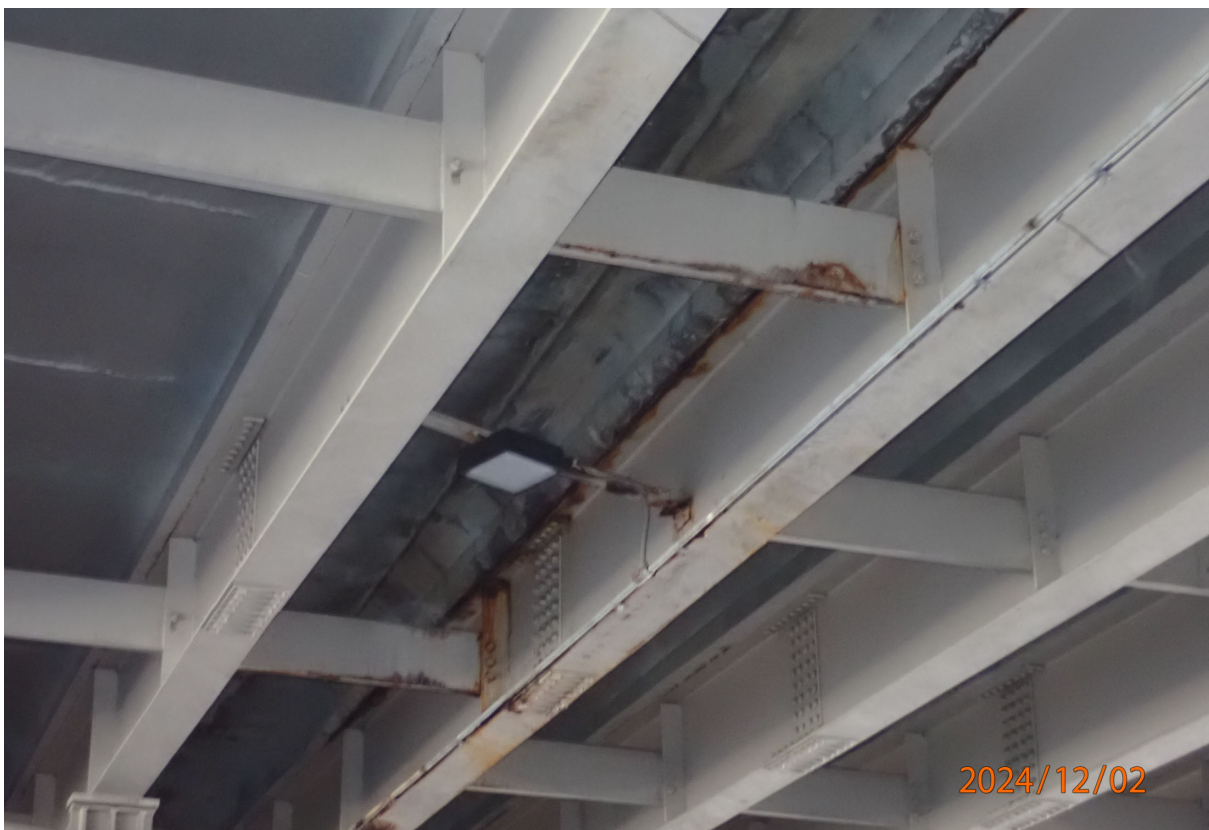
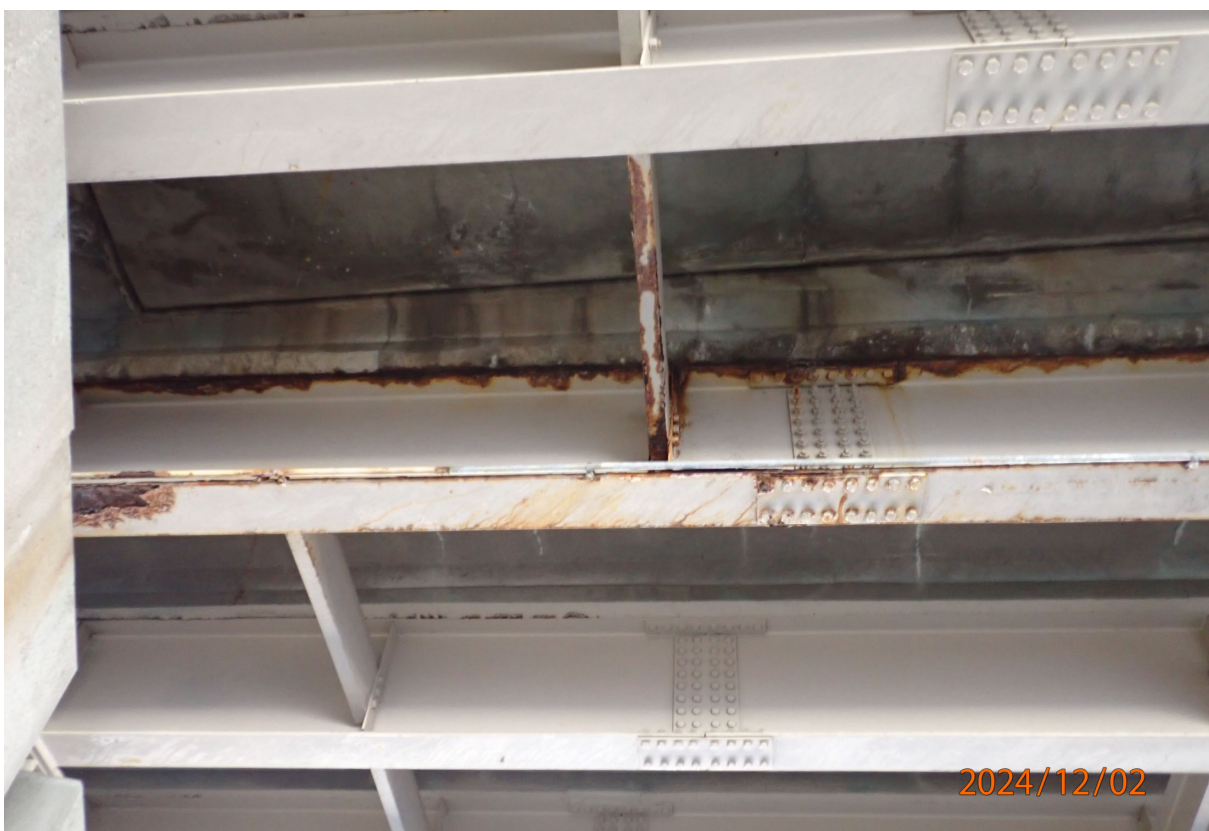
Beam 13 has flaking corrosion on the flanges in Spans 2 and 3 near Pier 3.

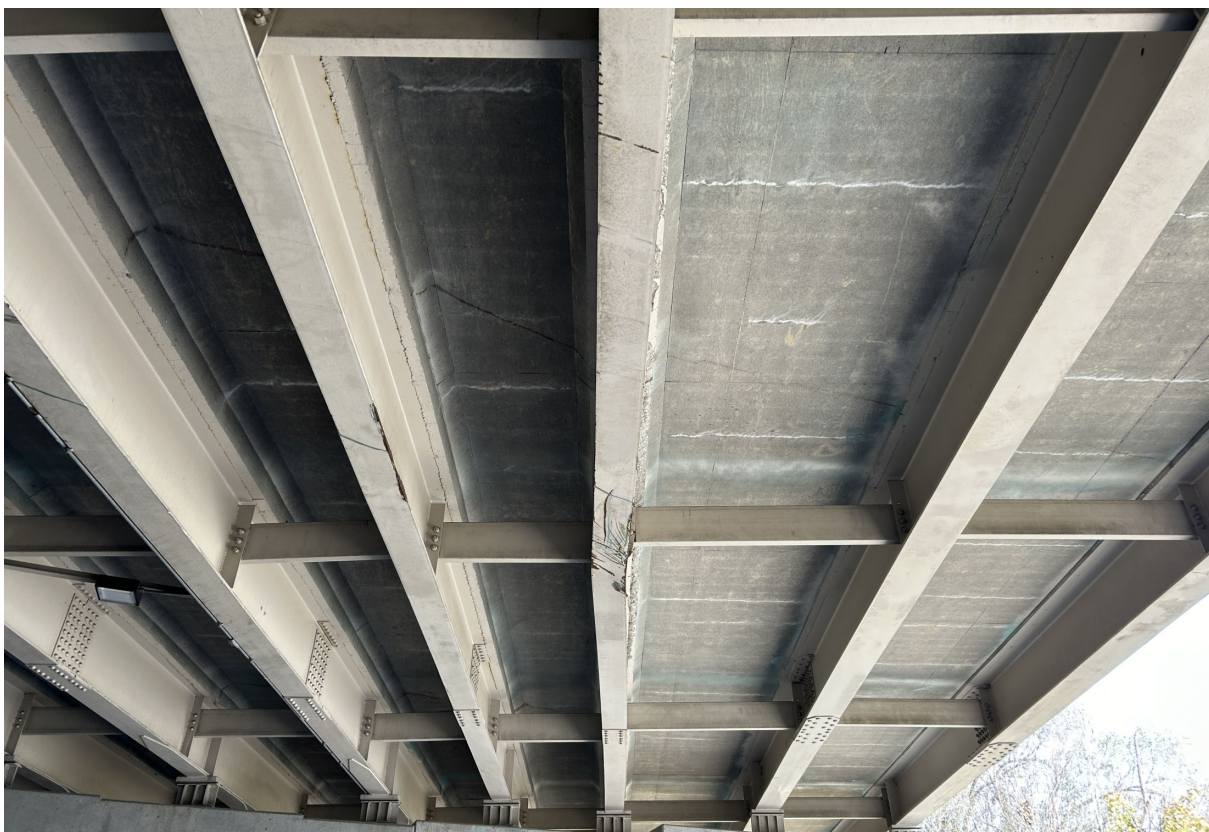
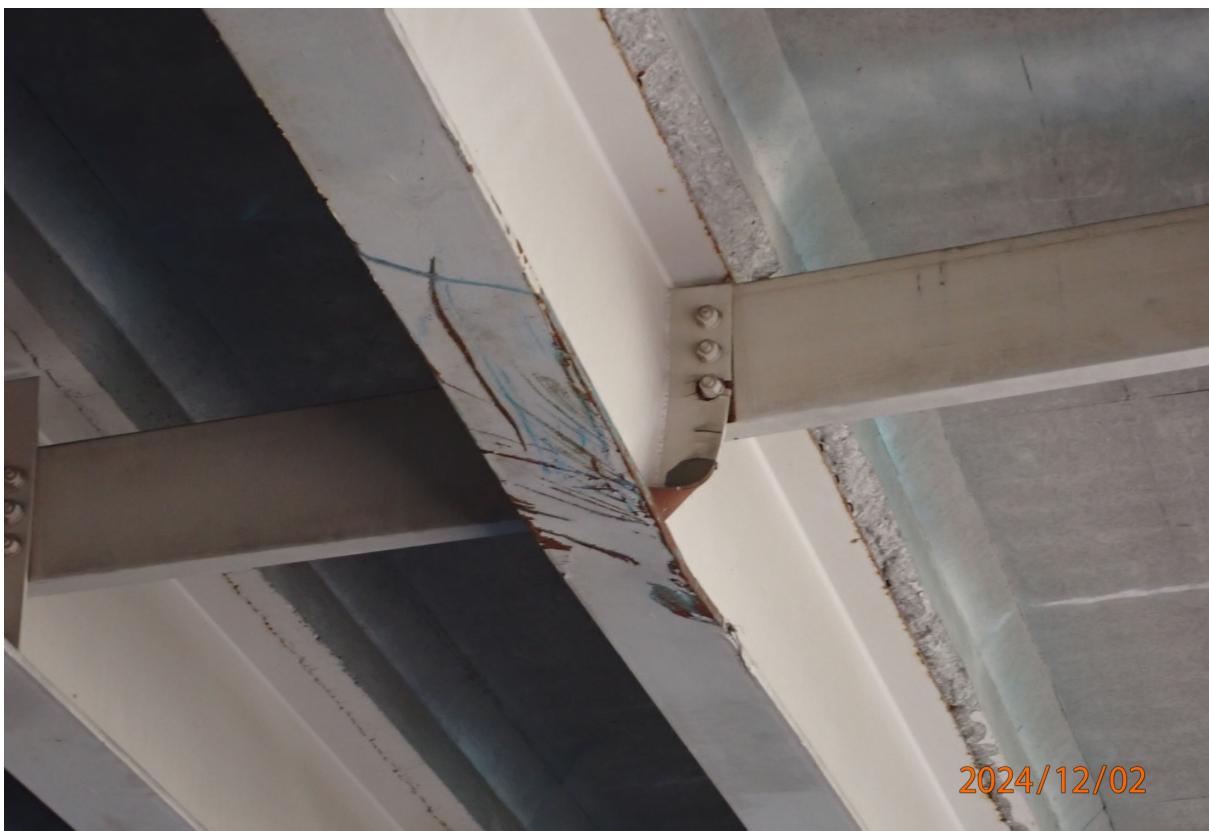
- 9/13/18 Controlling member is beam 23 with beam 22 out of service. No field posting required, EV posting required. DGA
- 9/2/20 Due to changed guidance from FHWA, post for EVs: 16, 29, 41 tons. DGA

Span 2-Beam 22 has impact damage initially noted during 09/11/18 inspection; out-of-plane distortion is worst at the midspan diaphragm, but appears to affect the full length between field splices (33 feet CS4).

Close up - note haunch spalling and distorted stiffener

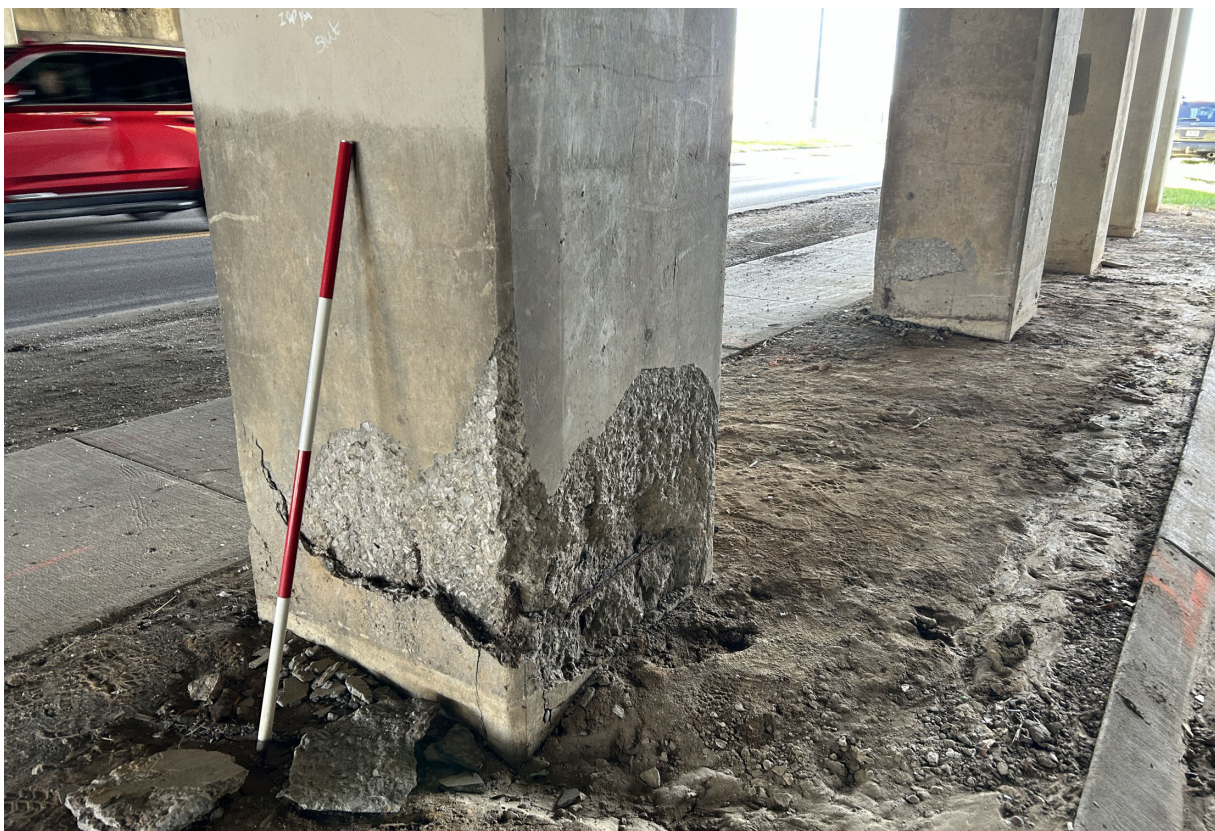
Pier 3-Column 5 has spalling with exposed rebar at the base, roughly 2 feet high.

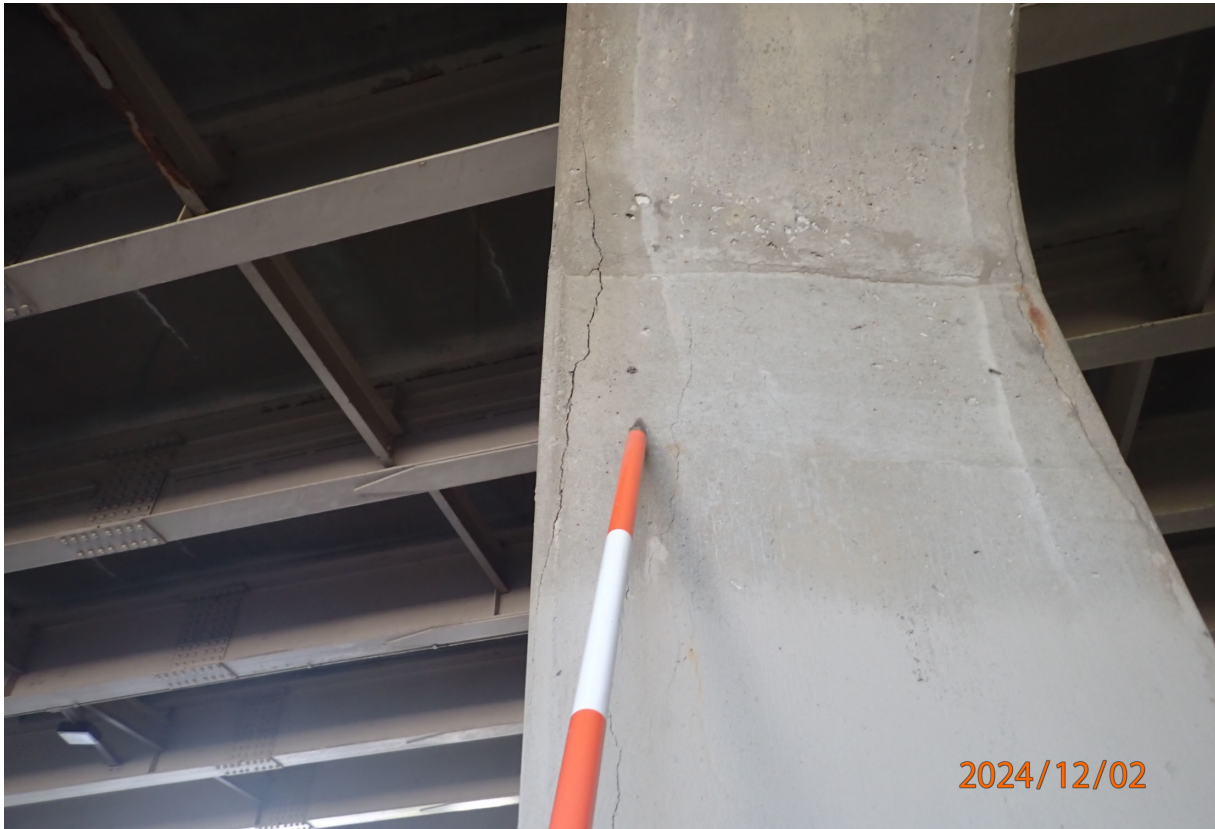
Pier 3-Column 6 has wide vertical cracks in the east face at the top.

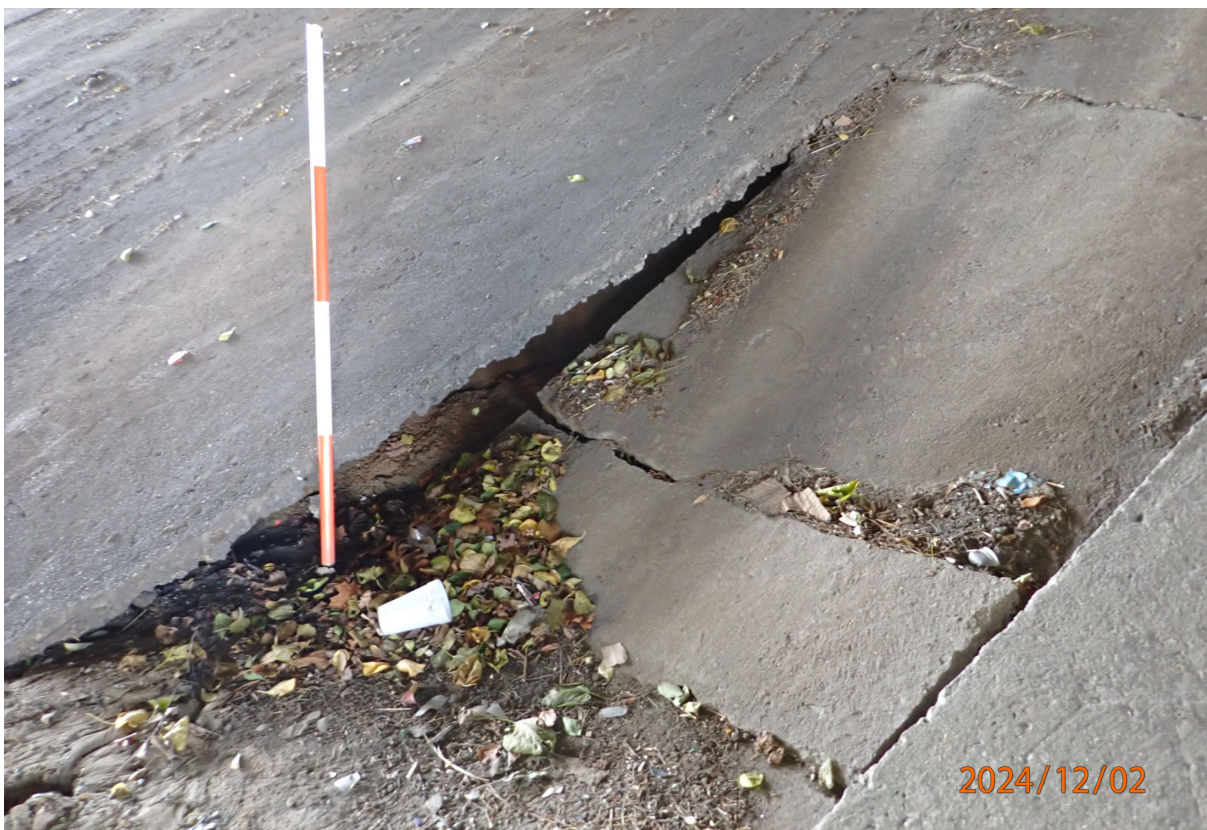
Concrete slope protection has fractured and settled at several locations (Abutment 4 slope shown).
