Bridge Inspection Report

056B00209N

12/02/2024

Standard (24 months)

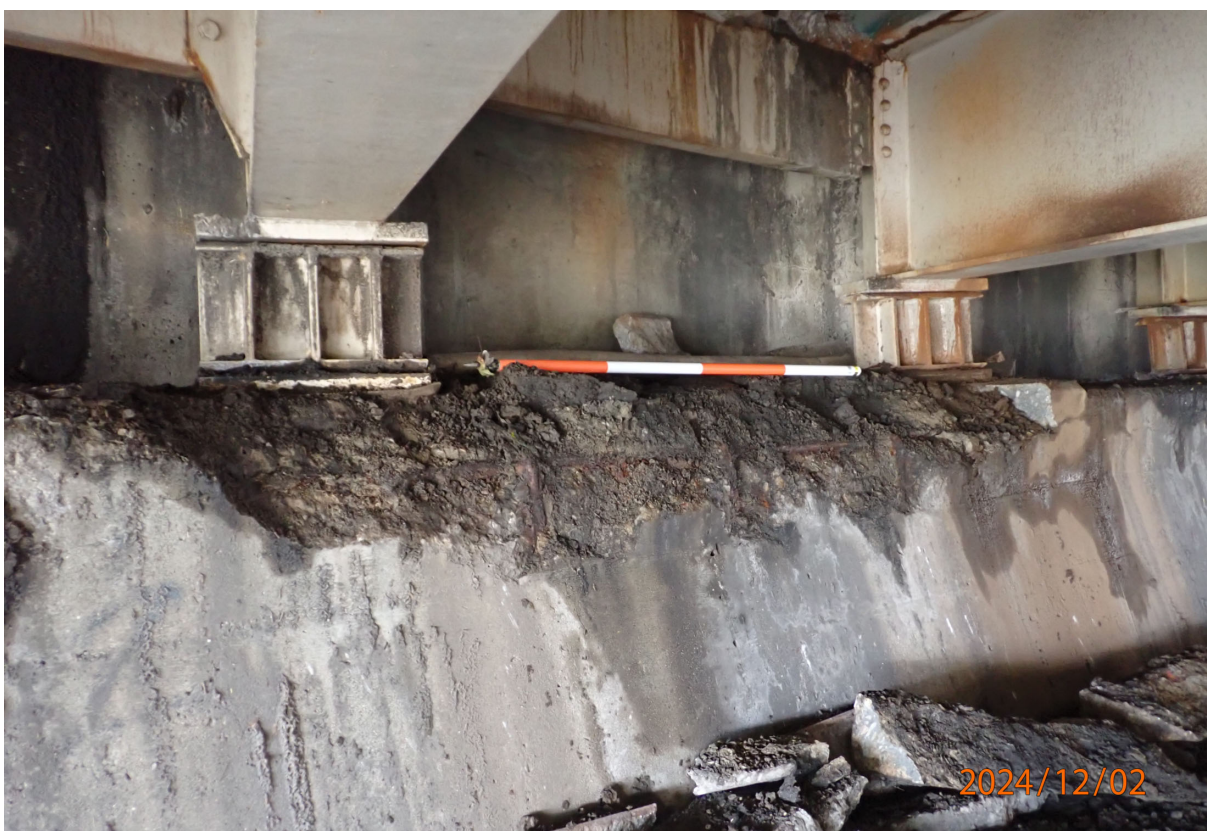
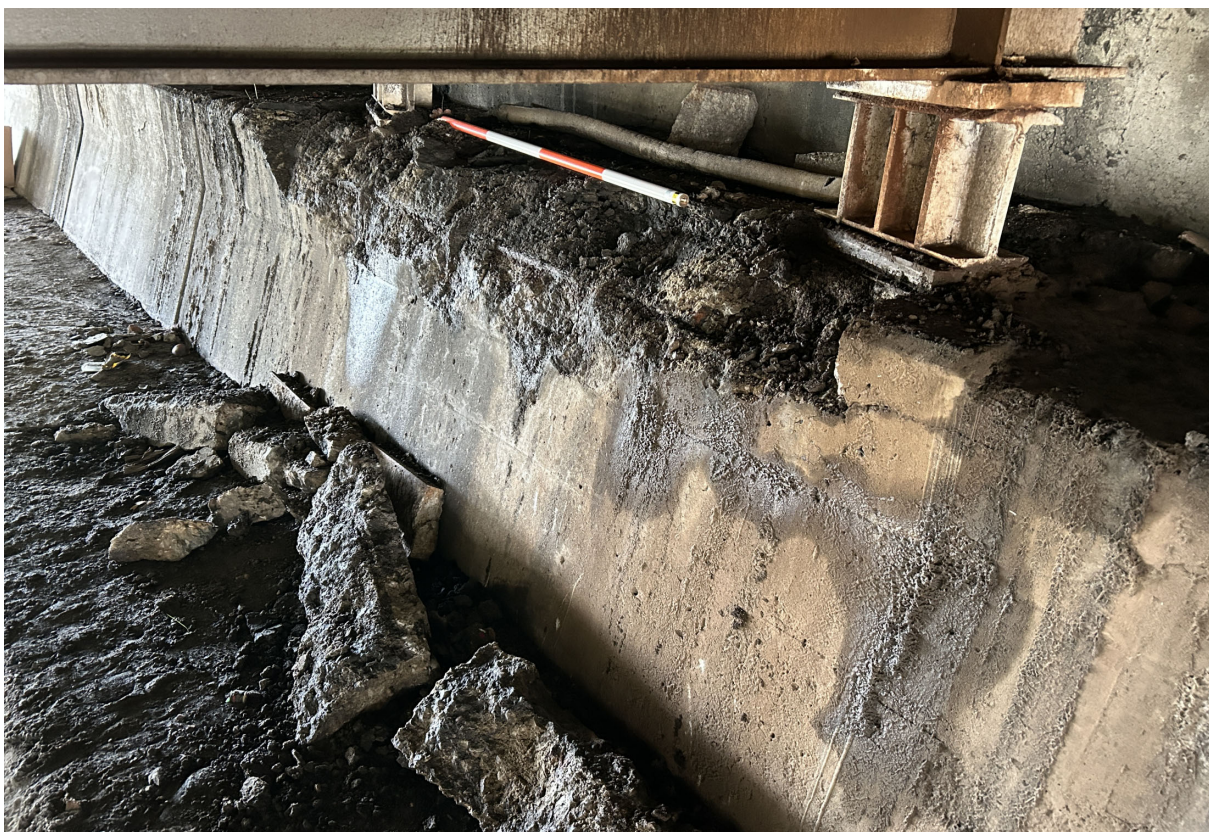
Abutment 1 cap has 1/4-inch-wide horizontal cracking below Bays 7-11, with some delaminations and scaling (32' CS3). Abutment 4 cap has spalling with exposed rebar as follows: two 12" diameter spalls below Beam 5, a 10' L x 1' T x 6" D spall in Bay 7 extending to the front edges of two masonry plates, a 5' L x 1' T x 3" D spall in Bay 19, and a 2' L x 3' T x 1" D spall at the east end (19' CS3). Abutment 4 cap also has wide horizontal cracking below Bay 16 (9' CS3). The backwalls have intermittent wide cracking and wide diagonal cracks with efflorescence at the ends (40' CS3). The abutments otherwise have scattered moderate cracks, plus sound patching throughout the backwalls. There are no deficiencies noted in the wingwalls.

Abutment 4 cap has spalling with exposed rebar below Bay 7, 10' L x 1' T x 6" D; spalling extends to the front edges of the masonry plates for Beams 7 and 8.

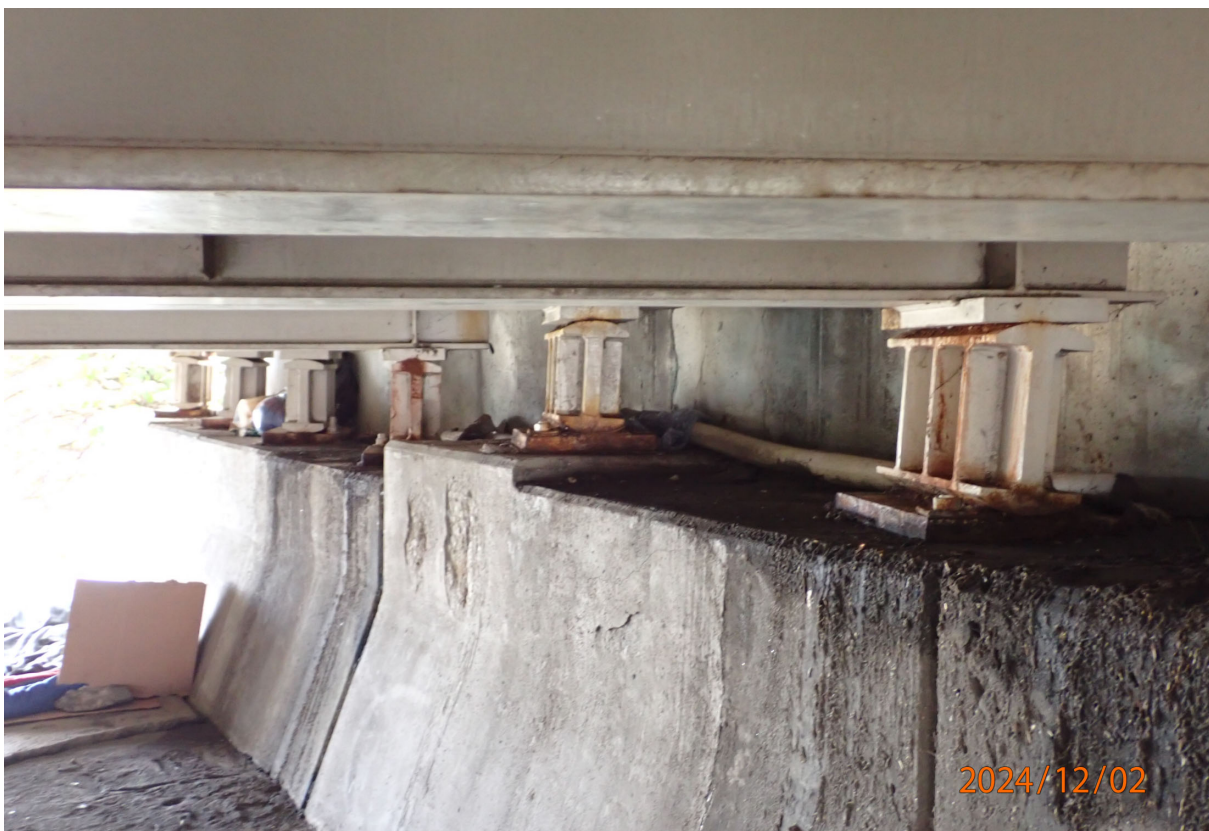
Abutment bearings are expanded at 20° F (tolerable alignment, inconsistent with temperature; Beams 1-6 at Abutment 4 shown).

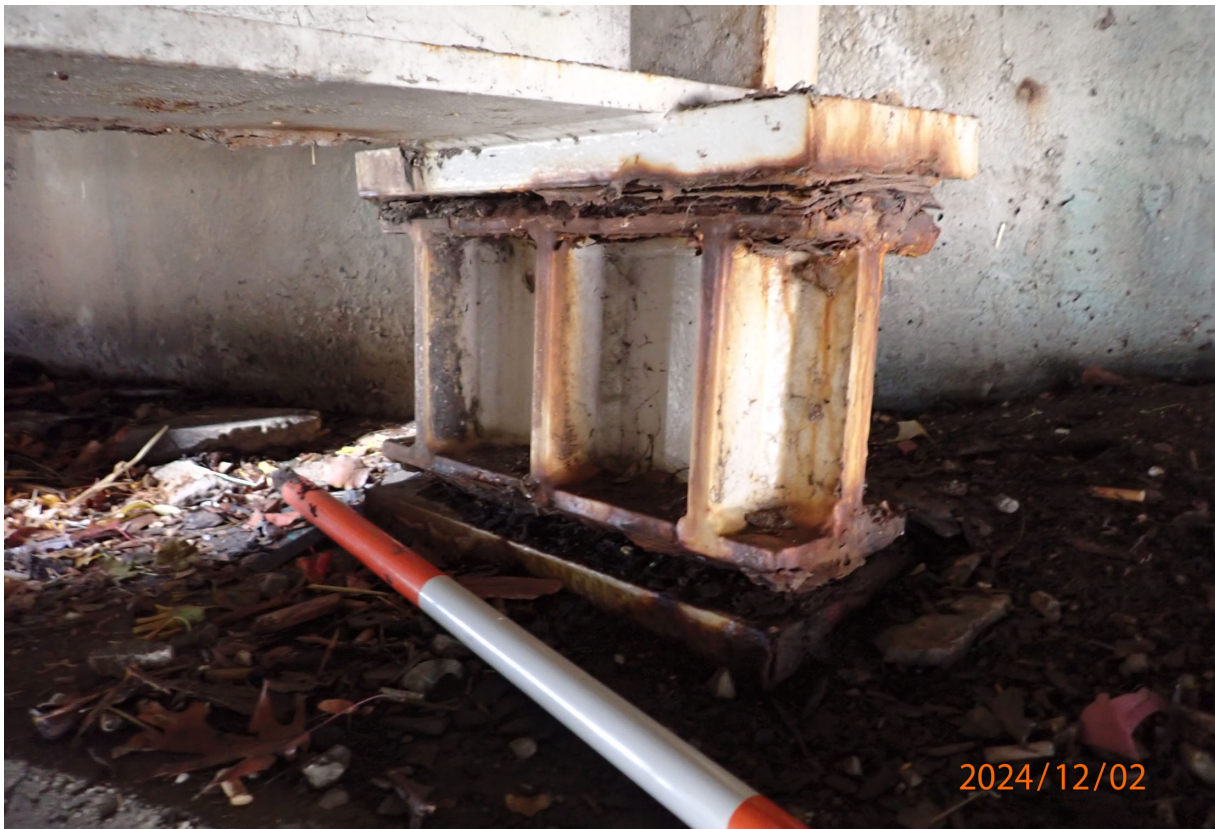
Abutment bearings typically have pack rust between the rocker and bearing plates; corrosion is heavier at exterior bearings and near the longitudinal joint (Abutment 4-Beam 13 bearing shown).

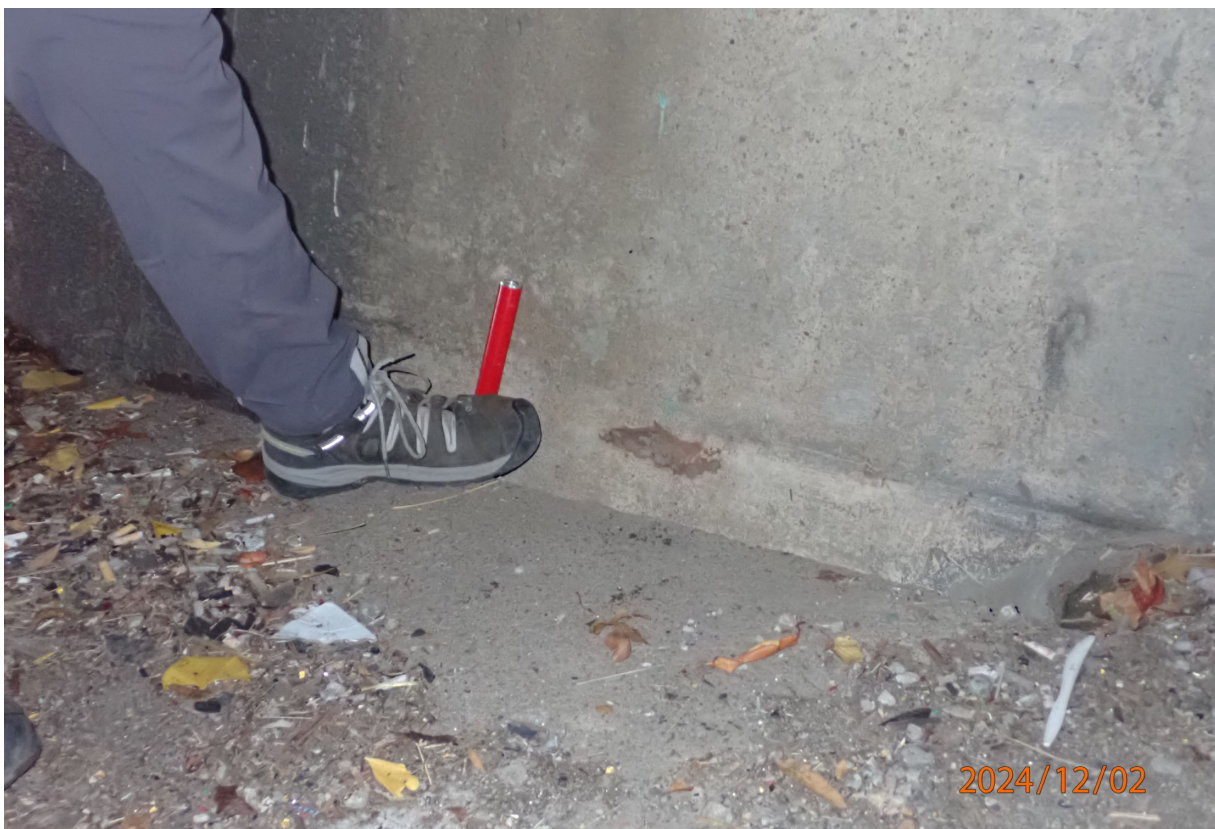
There is a 3" gap between the slope protection and Abutment 4 cap below Beams 11-16, with up to 50" embankment settlement below the panels.

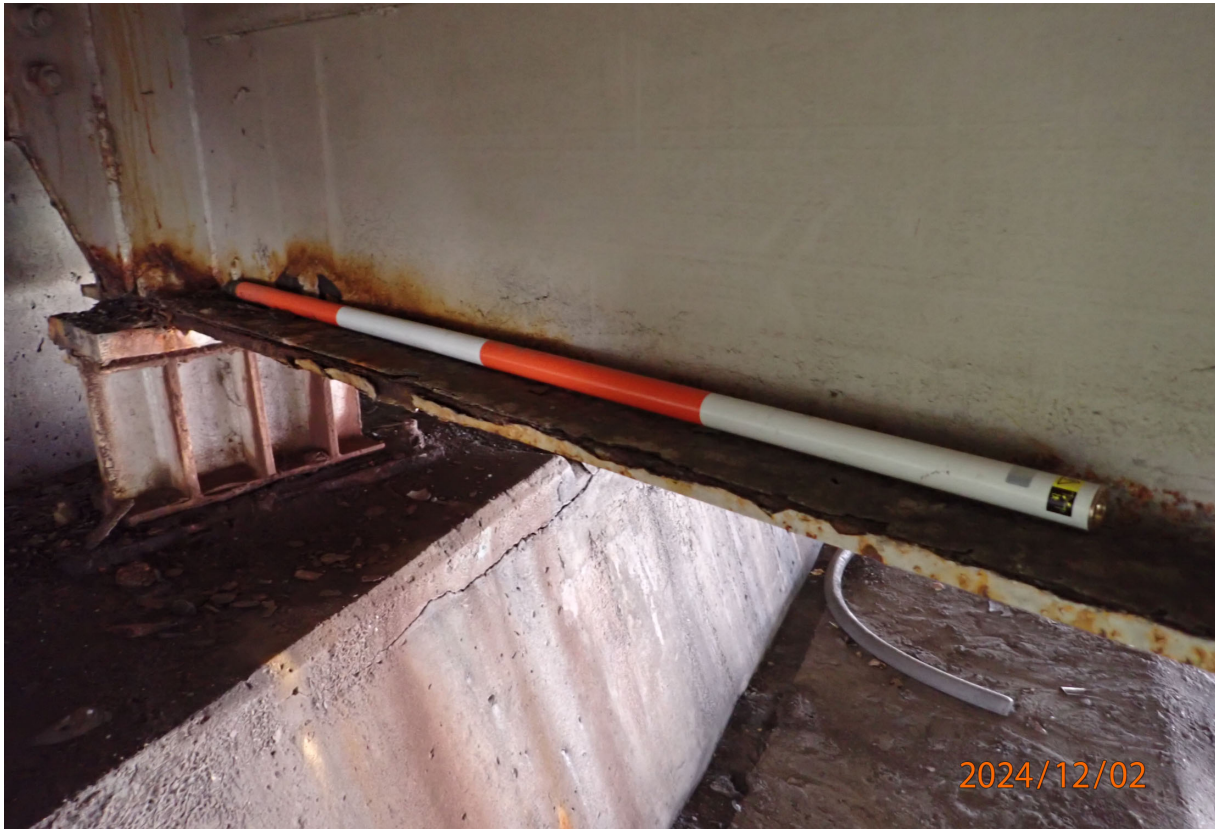
The deck moves independently from the beams at Abutment 4, Beams 7-12 and 16-18 under heavy live load, with gaps up to 3/8 inch between the deck and top flanges. Some beam ends have flaking corrosion near the abutments (50' CS3). Beam 13 has flaking corrosion on the flanges in Spans 2 and 3 near Pier 3 and on the top flange near Abutment 4 (50' CS3). Span 2-Beam 22 has impact damage initially noted during 09/11/18 inspection; there is up to 4 inches of out-of-plane distortion along 6 feet at the midspan diaphragm, though distortion appears to affect the full length between field splices (33' CS4). Beam 1 has minor impact damage in Span 2 and the remaining beams have some scrapes along the bottom flanges (25' CS2). The beams have scattered surface corrosion throughout, especially near the bridge ends and longitudinal joint, and on exterior beams (175' CS2).

Girders have surface rust scattered throughout, with heavier rust near the beam ends and longitudinal joint (Beam 16 at Abutment 4 shown).

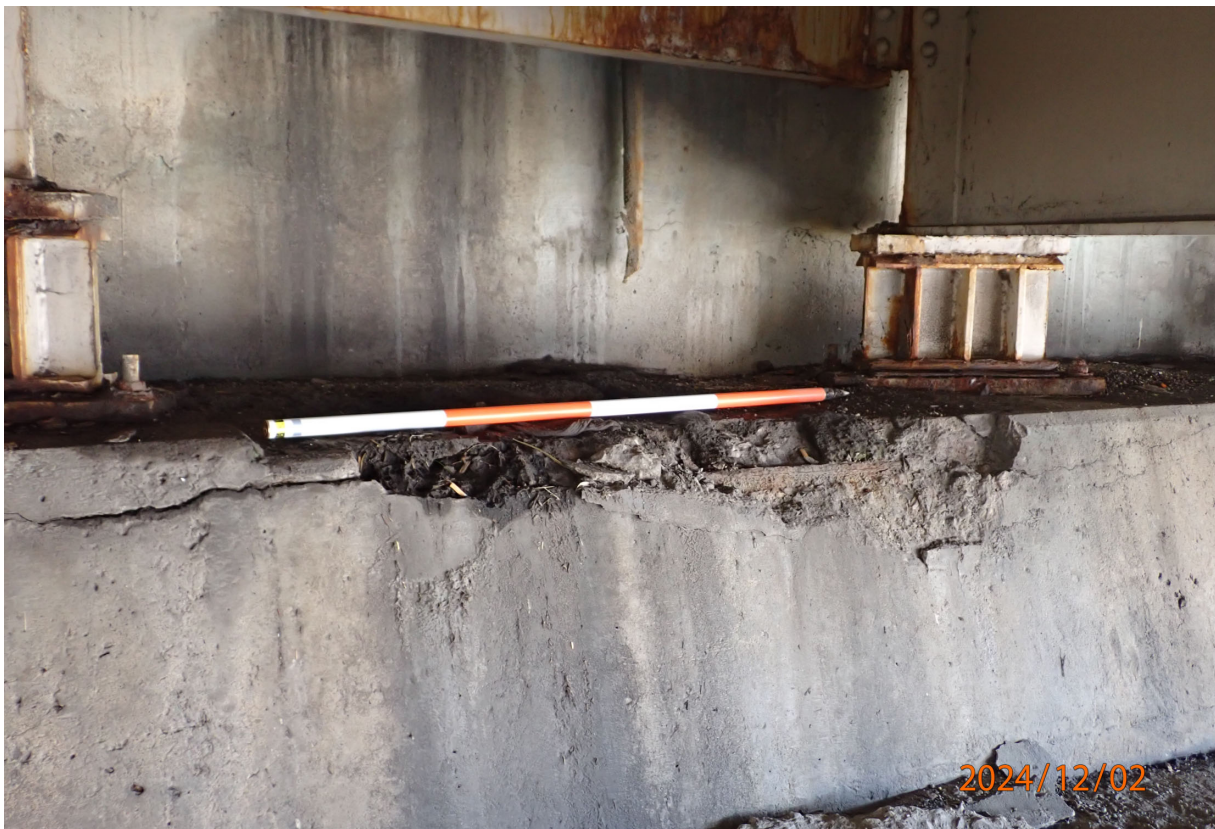
Abutment 4 cap has spalling with exposed rebar below Bay 19, 5' L x 1' T x 3" D.

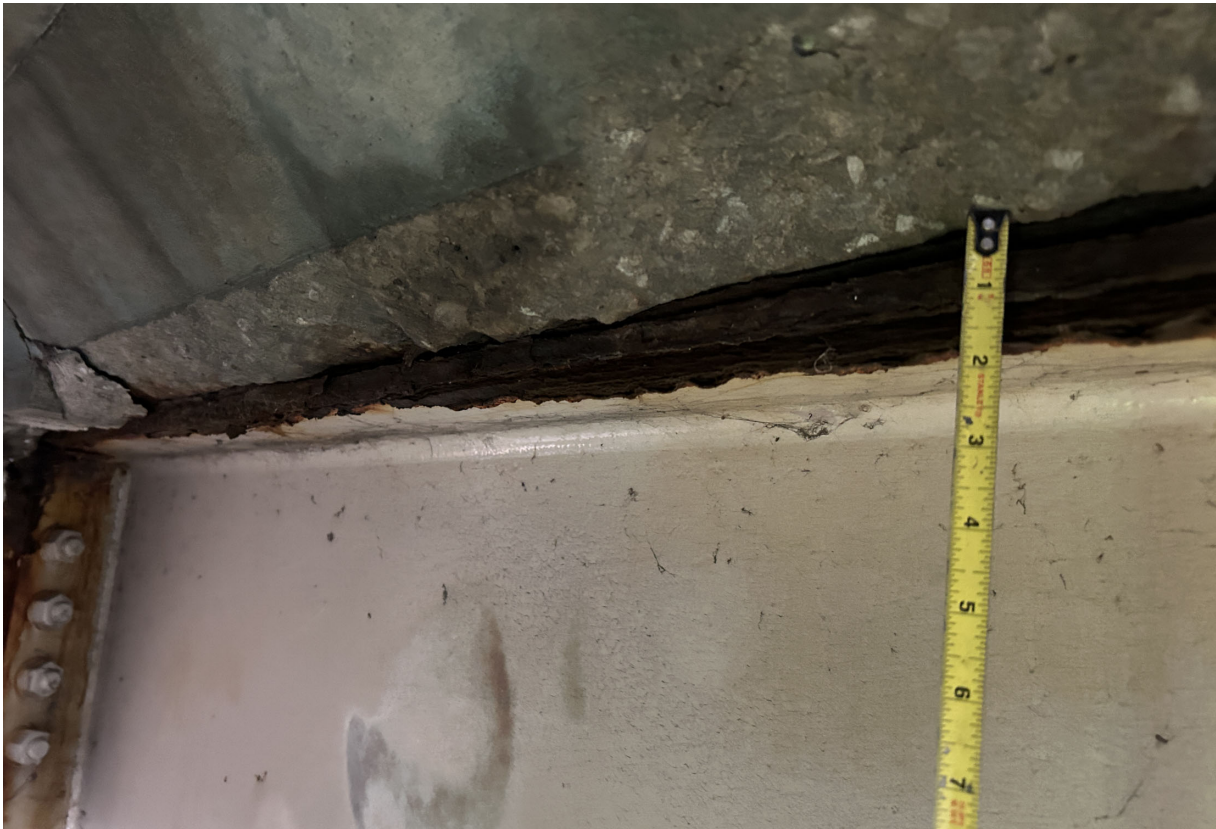
Beam 13 has flaking corrosion on the flanges in Spans 2 and 3 near Pier 3 and Abutment 4 (top flange at Abutment 4 shown).

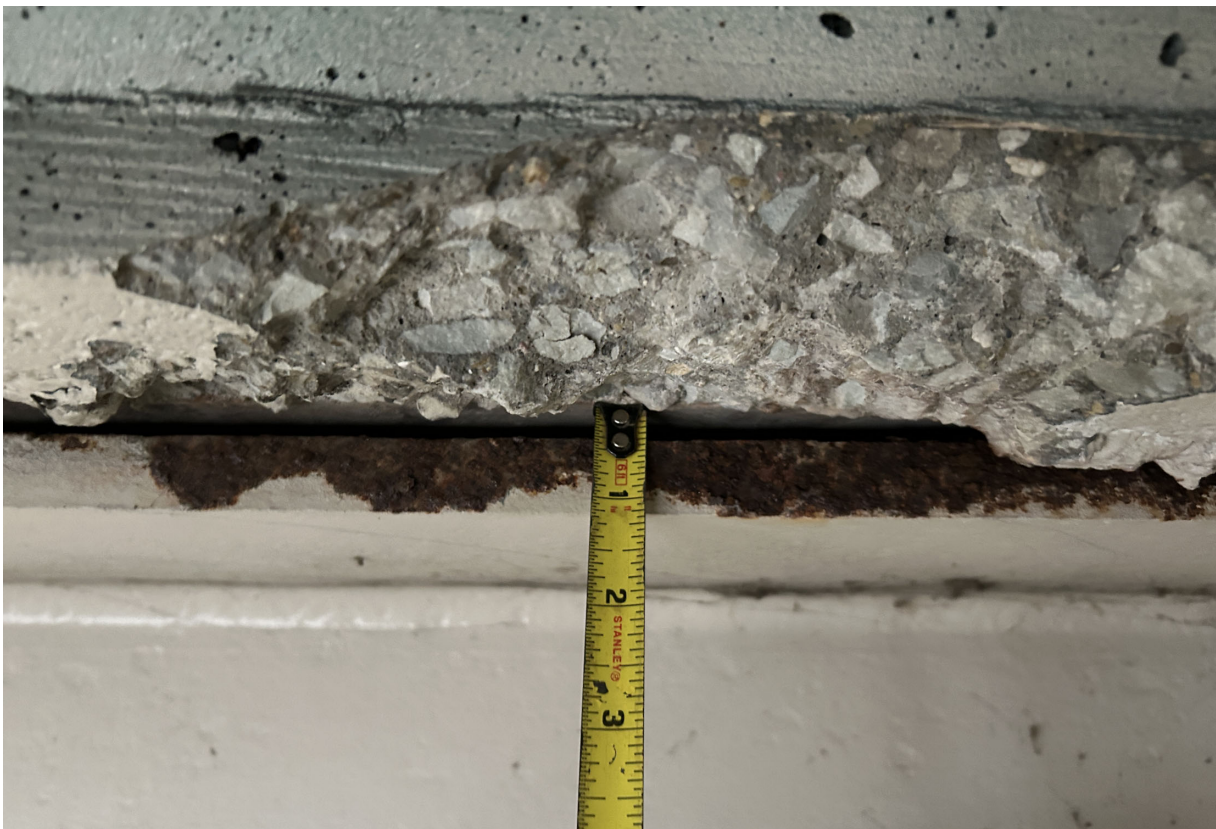
The deck moves independently from the beams at several locations, with gaps up to 3/8" between the deck and top flanges (Beam 16 at Abutment 4 shown).

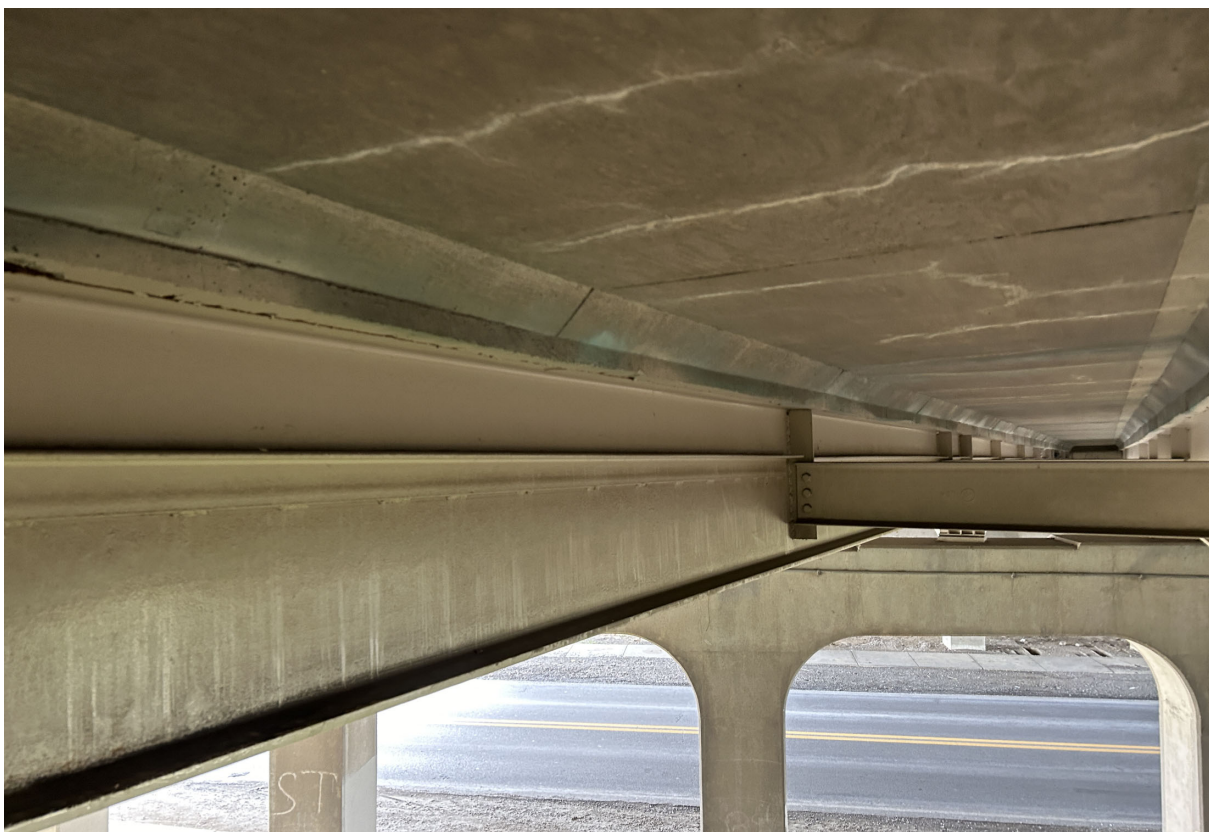
Bridge has potential CIF details (Beam 16 in Span 3 shown).

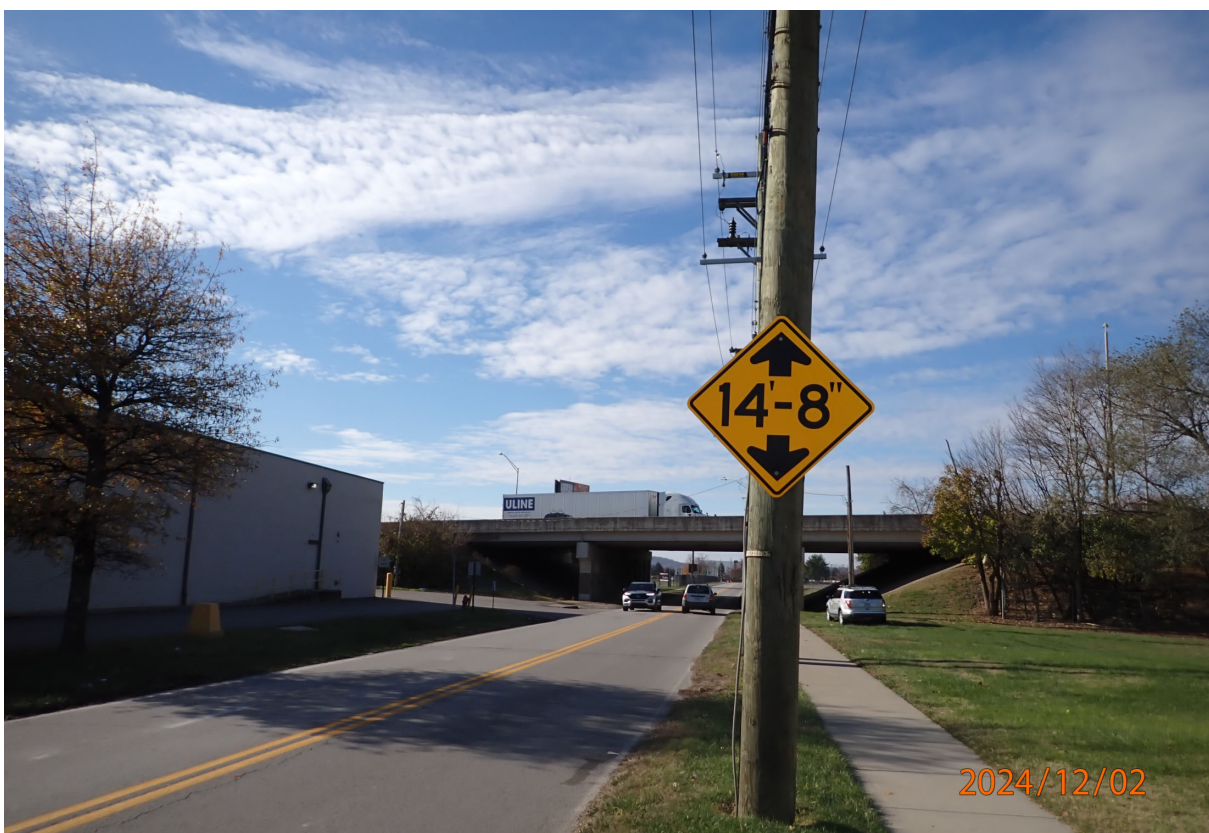
- BRIDGE IS REQUIRED TO BE POSTED AT THE FOLLOWING WEIGHT LIMITS: EV SINGLE – 16 TONS, EV TANDEM – 29 TONS, EV GROSS – 41 TONS.
- MINIMUM VERTICAL UNDER-CLEARANCE MEASURED AT 14'-11". SHOULD BE POSTED AT 14'-8".

East profile
Phillips Lane is posted for 14'-8" vertical clearance.

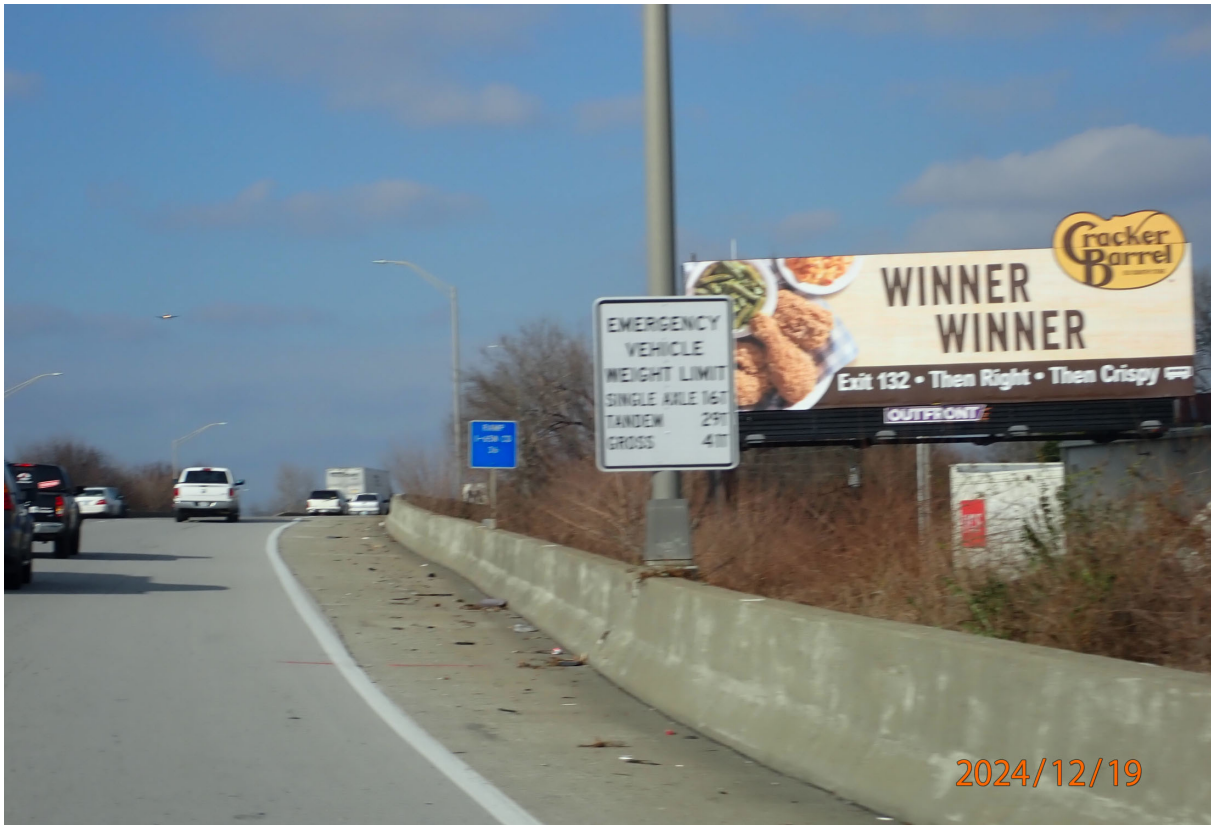
Looking north along I-65 NB towards Eastern Parkway (US 60A)
Correct EV weight limit sign is in place for NB traffic.

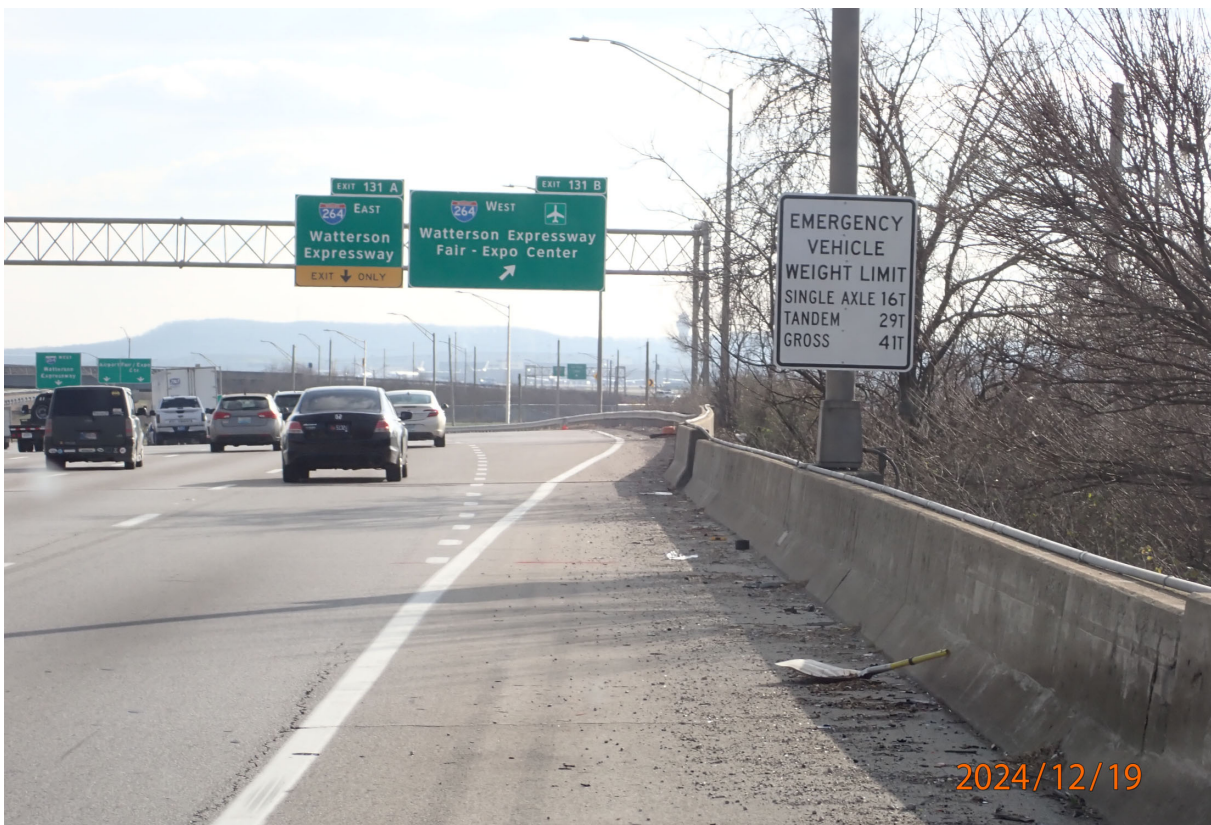
Looking south along I-65 SB towards I-264
Correct EV weight limit sign is in place for SB traffic.
