Bridge Inspection Report

056B00210N

12/02/2024

<u>IDENTIFICATION</u>			
Structure Num (8):	056B00210N		
NBI Number	056B00210N		
Structure Name:			
Location (9):	0.55 MI N OF I-264		
Carries (7):	I-65		
Type of Service (42A):	1 Highway		
Feature Crossed (6):	MANNING RD		
Type of Service (42B):	1 Highway		
Placecode (4):	Not Applicable		
County (3):	Jefferson (056)		
State (1):	21 Kentucky		
Admin Area:	Inventory		
District:	District 5		
Latitude (16):	38° 11' 51"		
Longitude (17):	85° 44' 2"		
Owner (22):	State Highway Agency		
Maint. Resp. (21):	State Highway Agency		
Year Built (27):	1957	Border State (98A):	Not Applicable (P)
Year Recon (106):	1985	Border Number (99):	
		% Responsibility (98B):

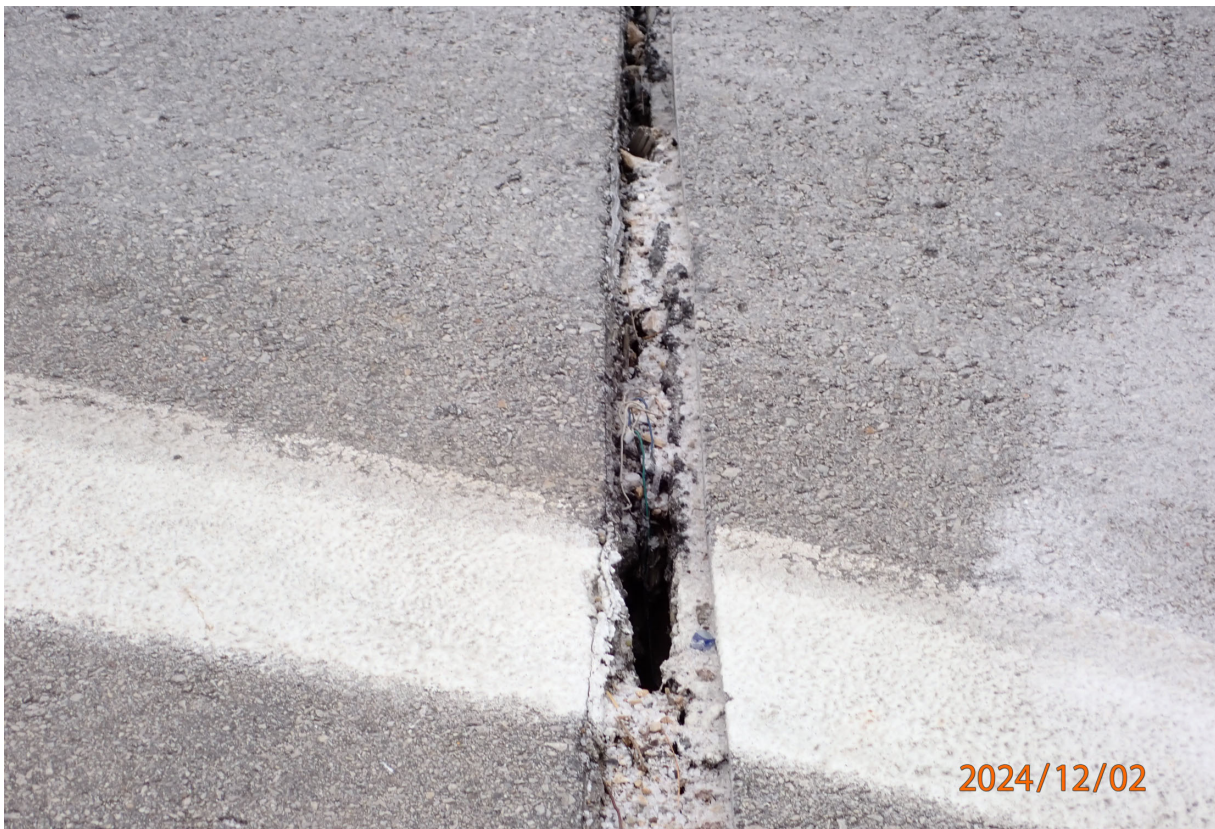
Asphalt plug joints are breaking up and/or missing throughout the traffic lanes, plus the full length of the SB Abutment 1 joint (214' CS4). The joints have debris in the shoulders with some partial depth cracks (46' CS3).

Asphalt plug joints are breaking up and/or missing throughout the traffic lanes (Abutment 1 at right NB edge line shown).

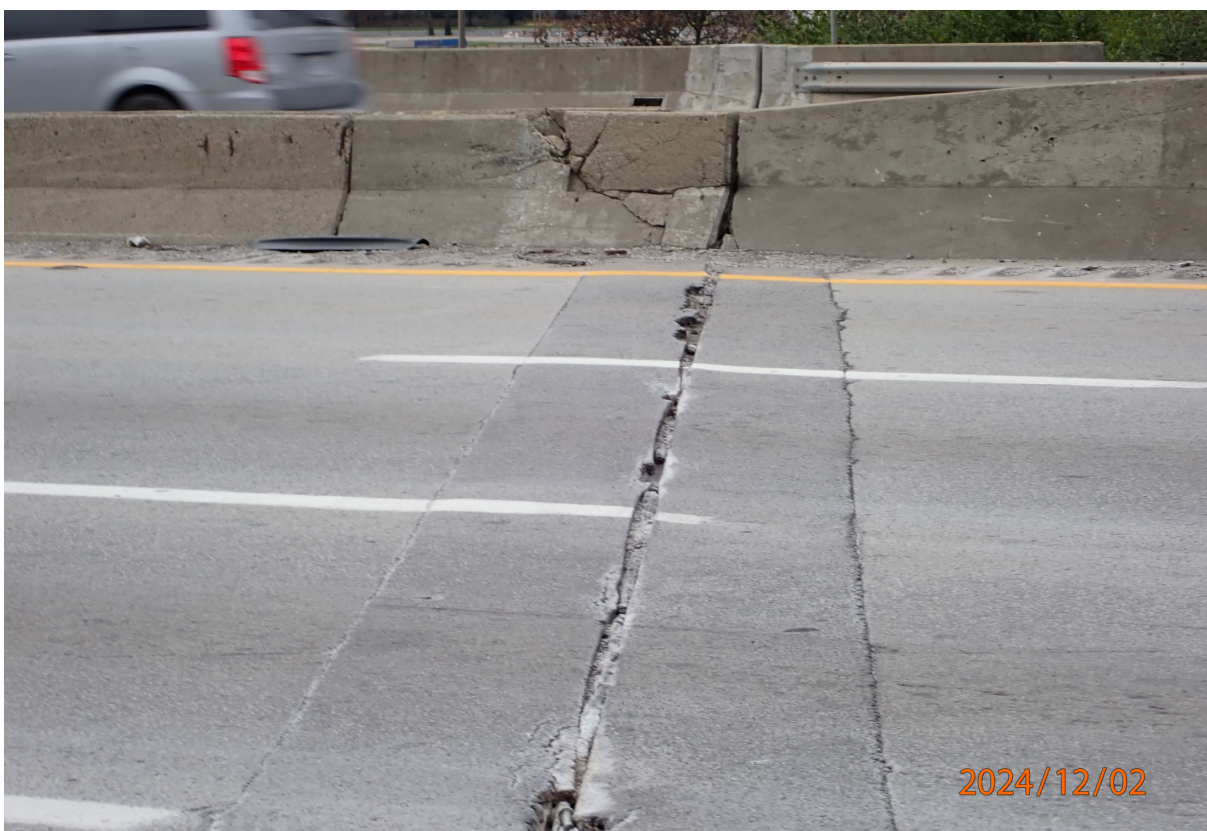
Median rails have numerous spalls with exposed rebar; spalling is more widespread on the NB rail (95' CS3). Median railing has a 5-foot-long diagonal fracture at the north end, with spalling with exposed rebar on both faces, plus an additional 4 feet of spalling on the west face (9' CS3). The east and west railings have moderate width vertical cracks and scattered small spalls (300 ft CS2).

Median railing has a 5-foot-long diagonal fracture at the north end, with spalling along both faces and exposed rebar on the west face. Note failed asphalt plug joint.

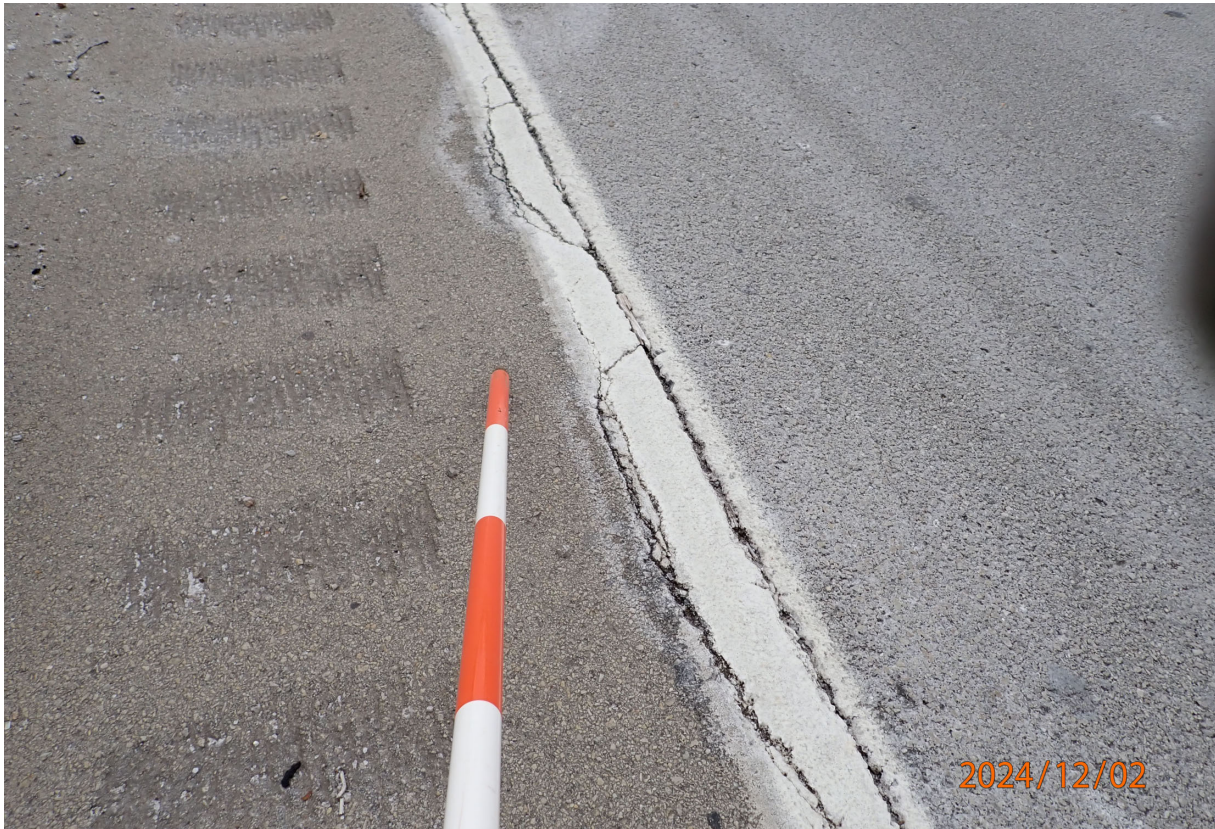
The bridge was overlaid with an asphalt waterproofing mix (a product by "Road Science") as part of the 2012 rehab project. Overlay has minor wearing in the traffic lanes, plus some 1-inch-wide spalls in the NB lanes in Span 1. There is also intermittent unsealed longitudinal cracking along the right NB edge line. The shoulders are lined with dirt and debris.

Overlay has intermittent unsealed longitudinal cracking along the right NB edge line.

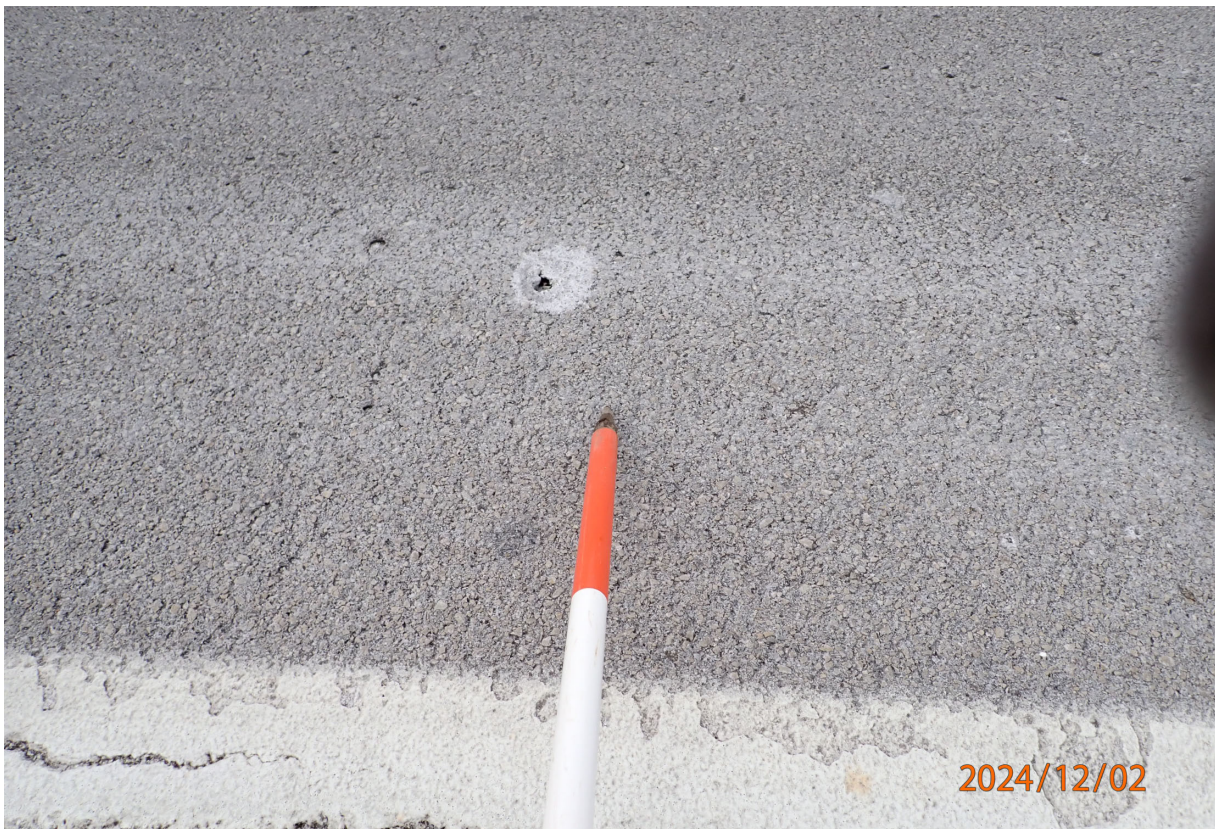
Overlay has minor wearing in the traffic lanes, plus some 1-inch-wide spalls in the NB lanes in Span 1.

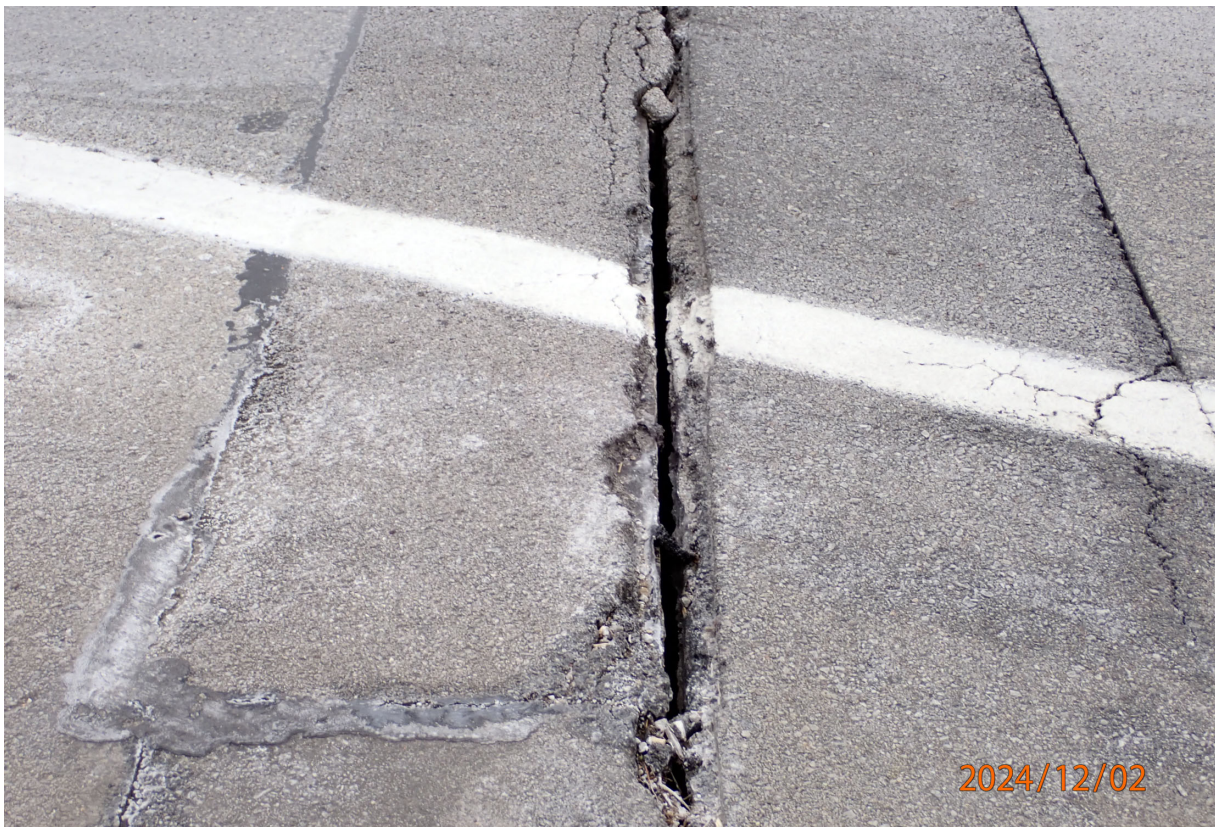
Asphalt plug joints are breaking up and/or missing throughout the traffic lanes, plus the full length of the SB Abutment 1 joint (right SB shoulder shown).

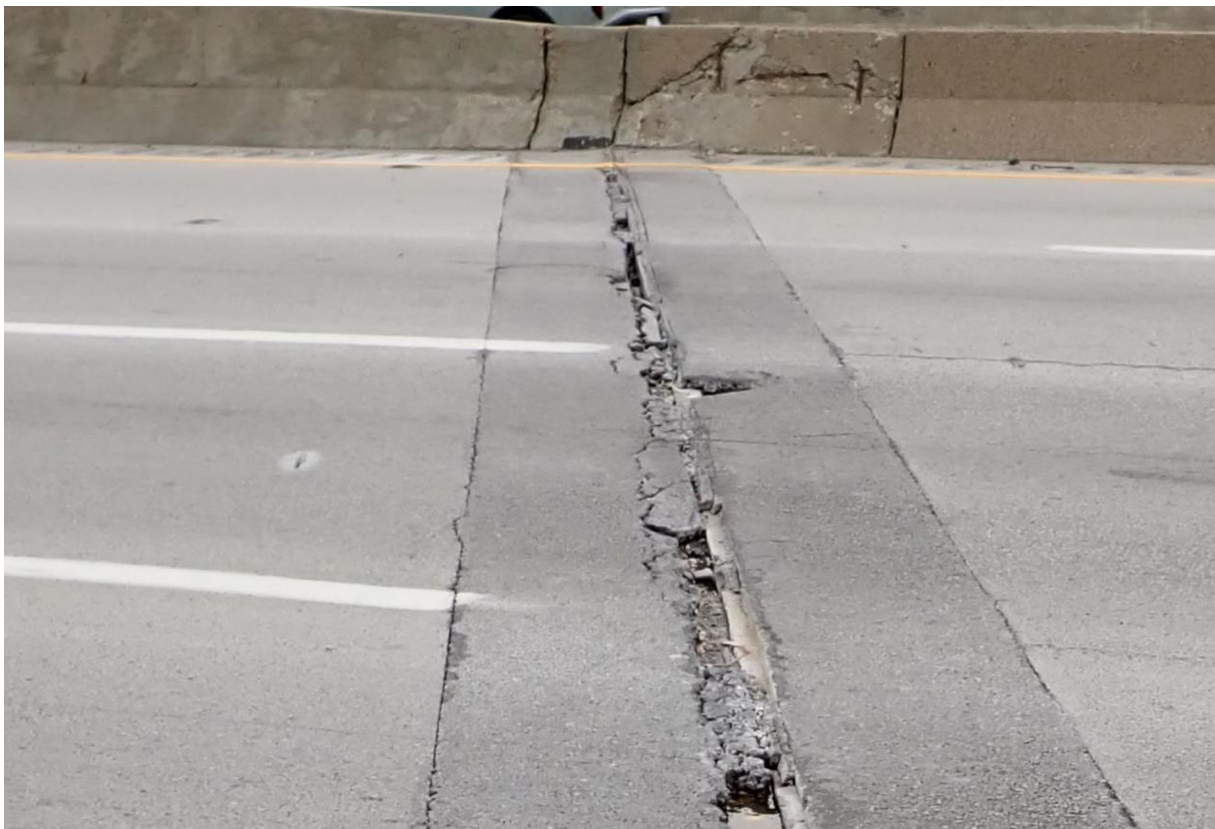
Asphalt plug joints are breaking up and/or missing throughout the traffic lanes (Abutment 4 joint shown). Note fracture in median barrier.

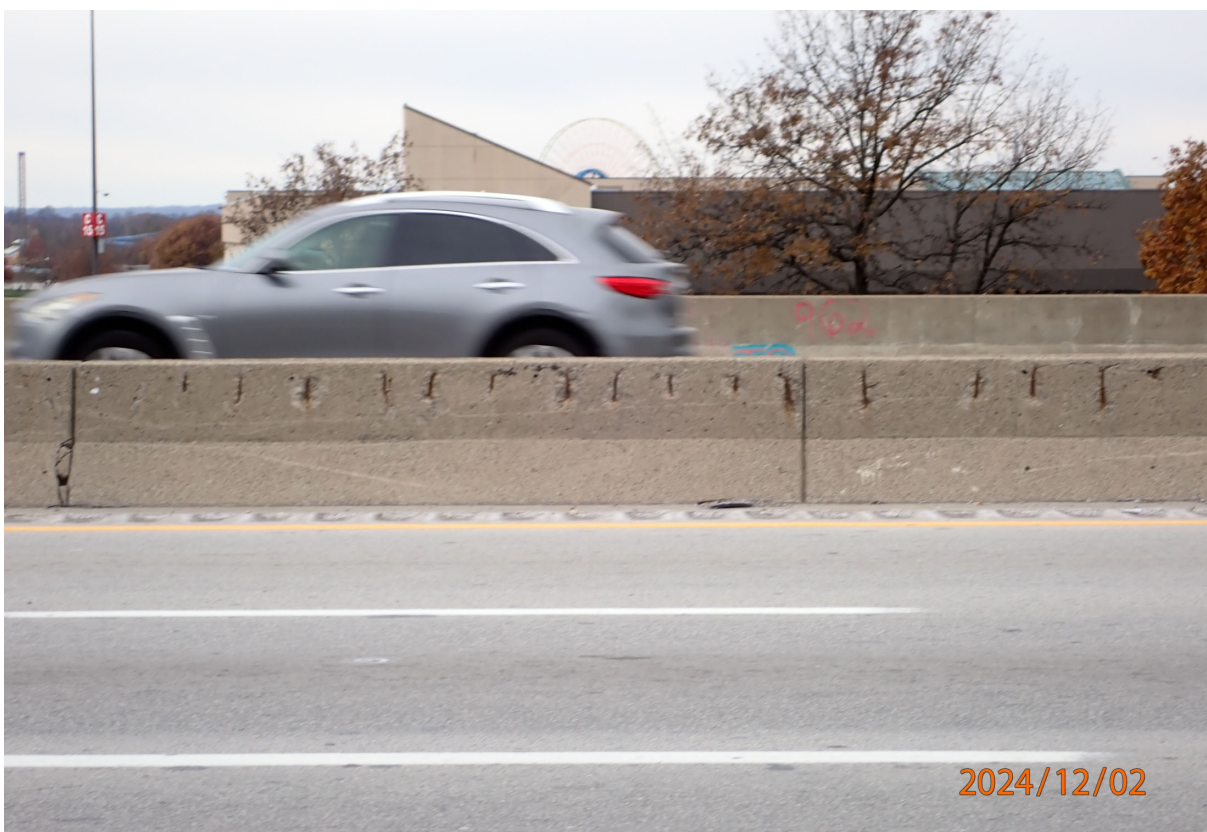
Median rails have numerous spalls with exposed rebar; spalling is more widespread on the NB rail.

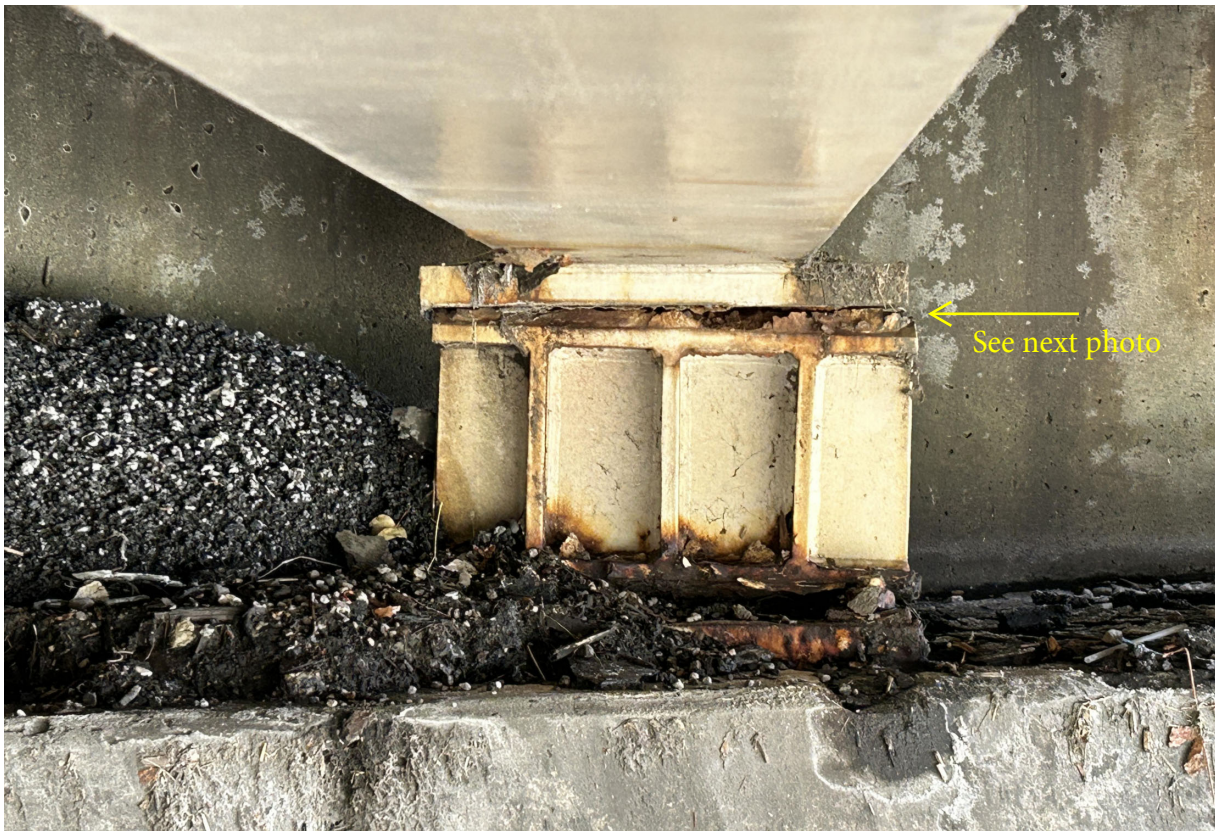
The movable bearings are located at the abutments and Pier 3. Abutment bearings have flaking corrosion and pack rust between the rocker and bearing plates; corrosion is heavier at exterior bearings and near the longitudinal joint. Several abutment bearings have gaps between the plates and rocker and/or below the masonry plates due to pack rust. Abutment bearings are expanded at 28° F (tolerable alignment, inconsistent with temperature). At Abutment 1-Beam 4, the rocker bearing is laterally rotated with an 11/16" gap between the sole plate and rocker on the west side only. No significant deficiencies noted on Pier 3 rocker bearings.

At Abutment 1-Beam 4, the rocker bearing is laterally rotated with an $11/16$ " gap between the sole plate and rocker on the west side only. Note asphalt piled on seat.

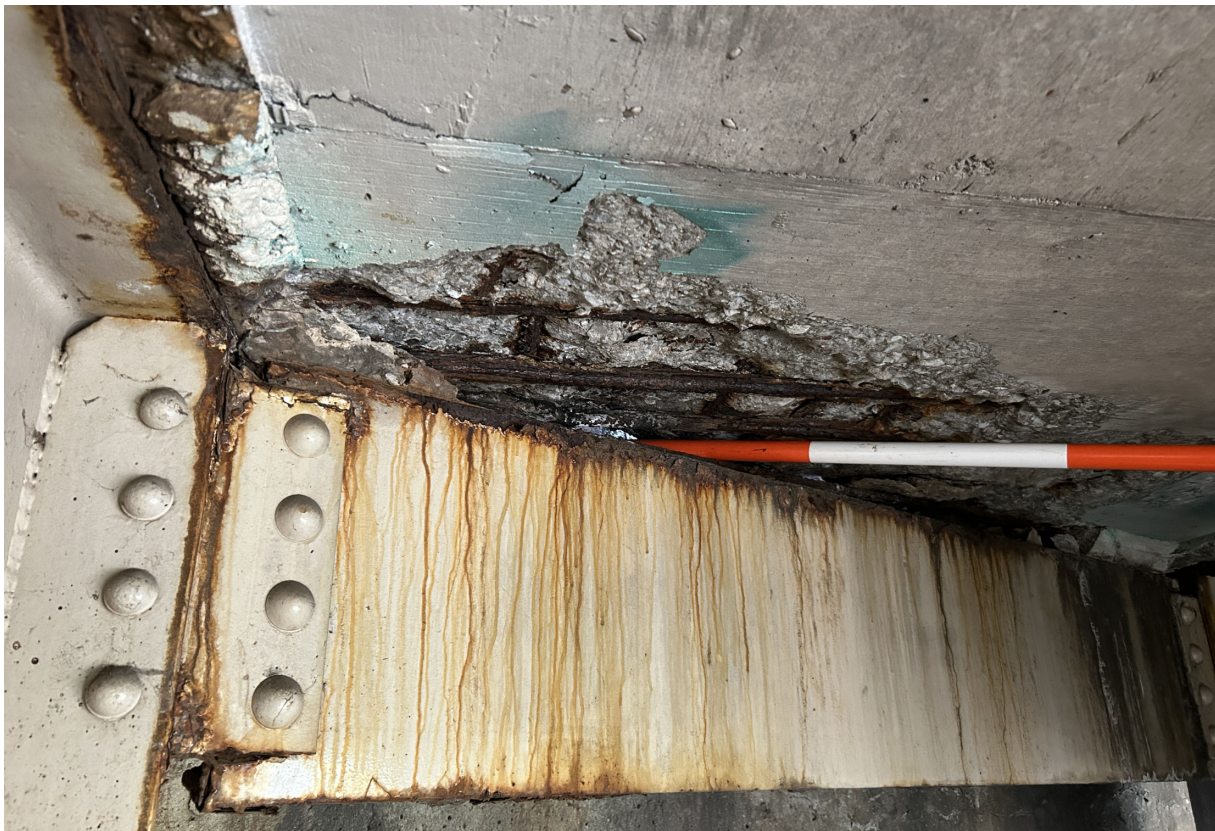
Bay 6 soffit has a 4' W x 2' L x 3" D spall at Abutment 1. Note daylight visible through failed joint.

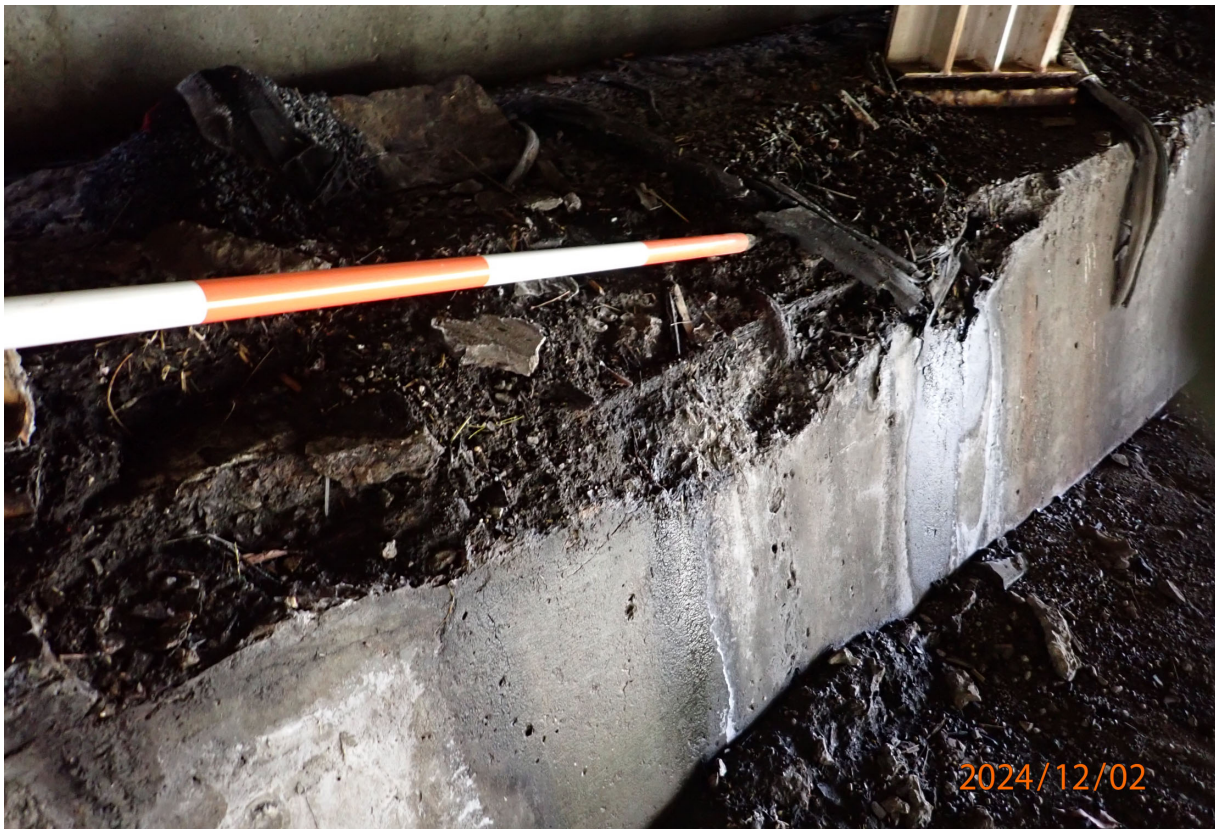
Abutment 1 cap has 6' L x 1' W x 9" H spalling with exposed rebar and adjacent wide cracking in Bay 8 (8' CS3). Abutment 1 cap also has intermittent wide horizontal cracking in the NB portion (17' CS3). Abutment 4 cap has spalls with exposed rebar at Beams 5 and 6, each roughly 4' L x 1' H x 7" D, with large delaminations and wide cracking below Beams 4-7 (20' CS3). Abutment 4 has wide horizontal cracking plus scaling in the cap and backwall from fires between Beams 13-15 (14' CS3). The backwalls have intermittent wide cracking and wide diagonal cracks with efflorescence at the ends (81' CS3). The abutments otherwise have scattered moderate cracks, plus intermittent sound patching on the backwalls. There are no deficiencies noted in the wingwalls.

Abutment 1 cap has 6' L x 1' W x 9" H spalling with exposed rebar in Bay 8.

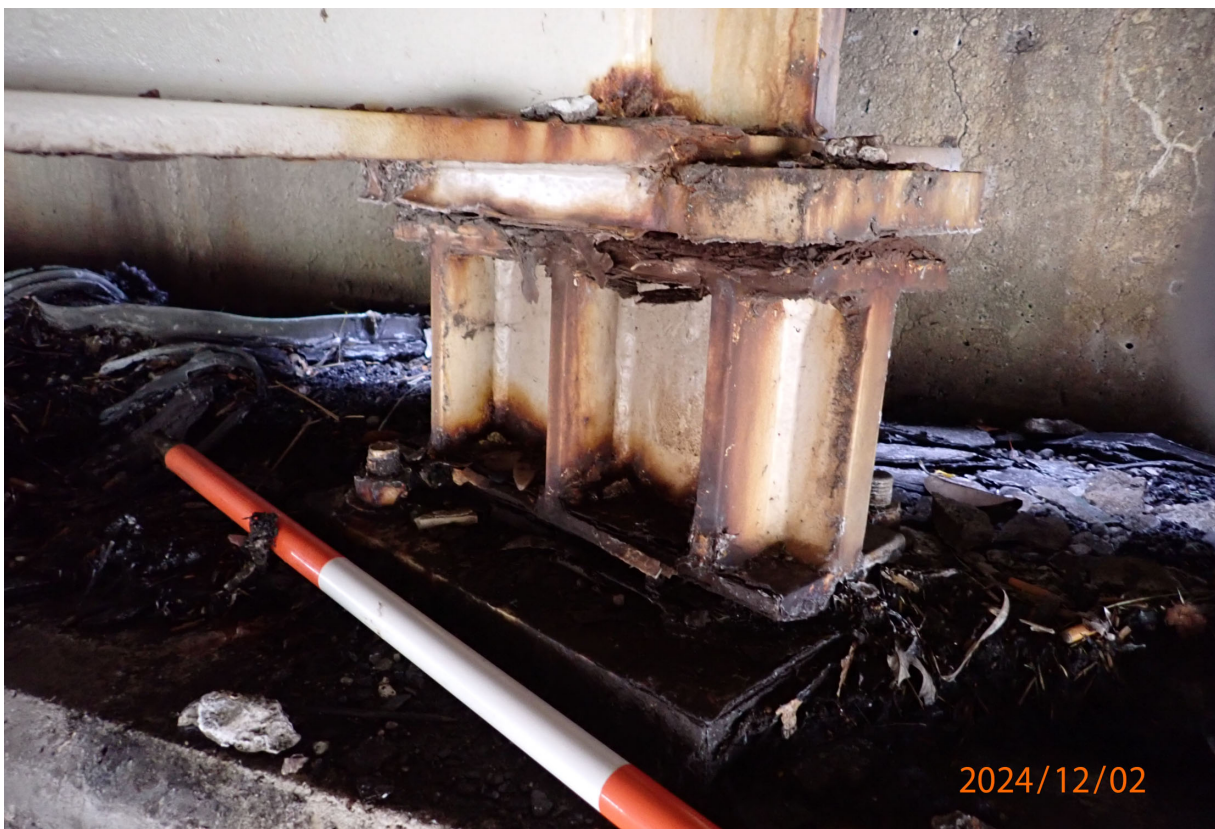
Abutment bearings have flaking corrosion and pack rust, primarily between the rockers and masonry plates, with heavier corrosion at the longitudinal joint and exterior beams (Beam 16 at Abutment 1 shown).

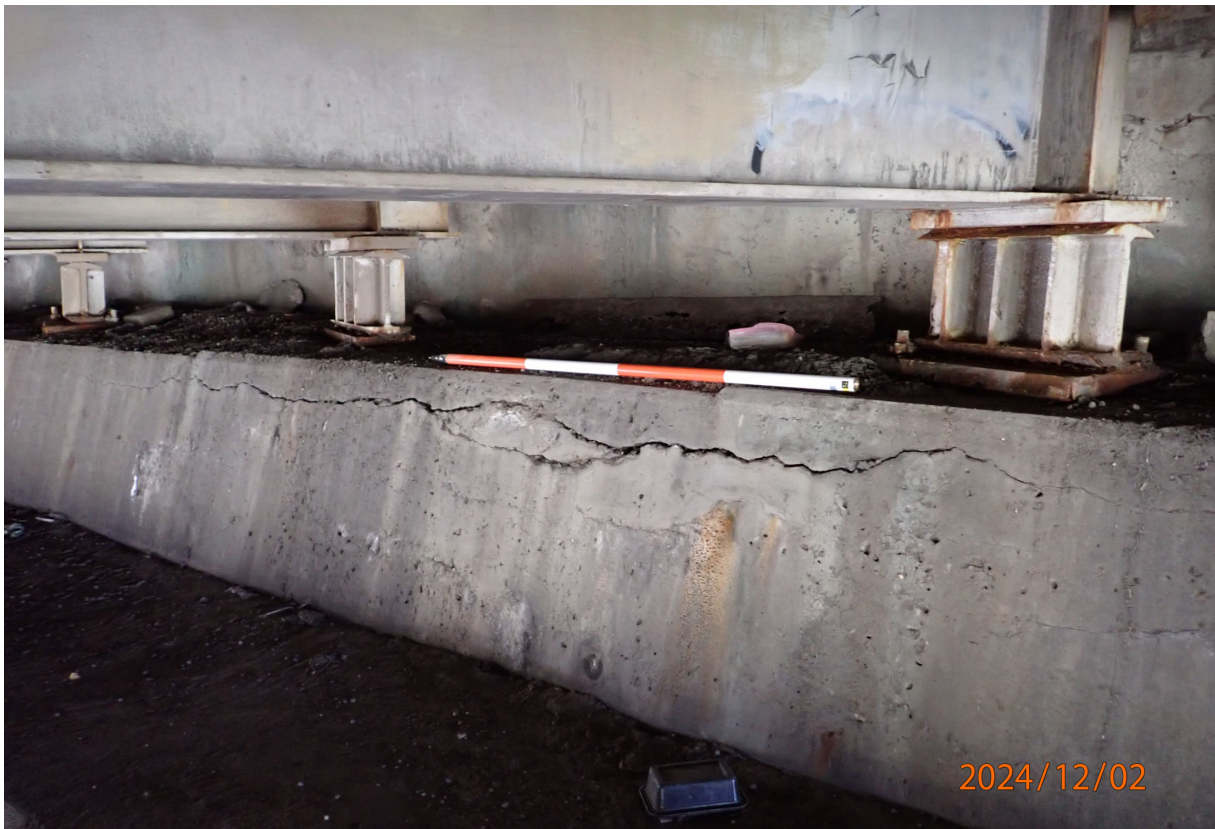
Abutment 1 has intermittent wide horizontal cracking in the NB portion.

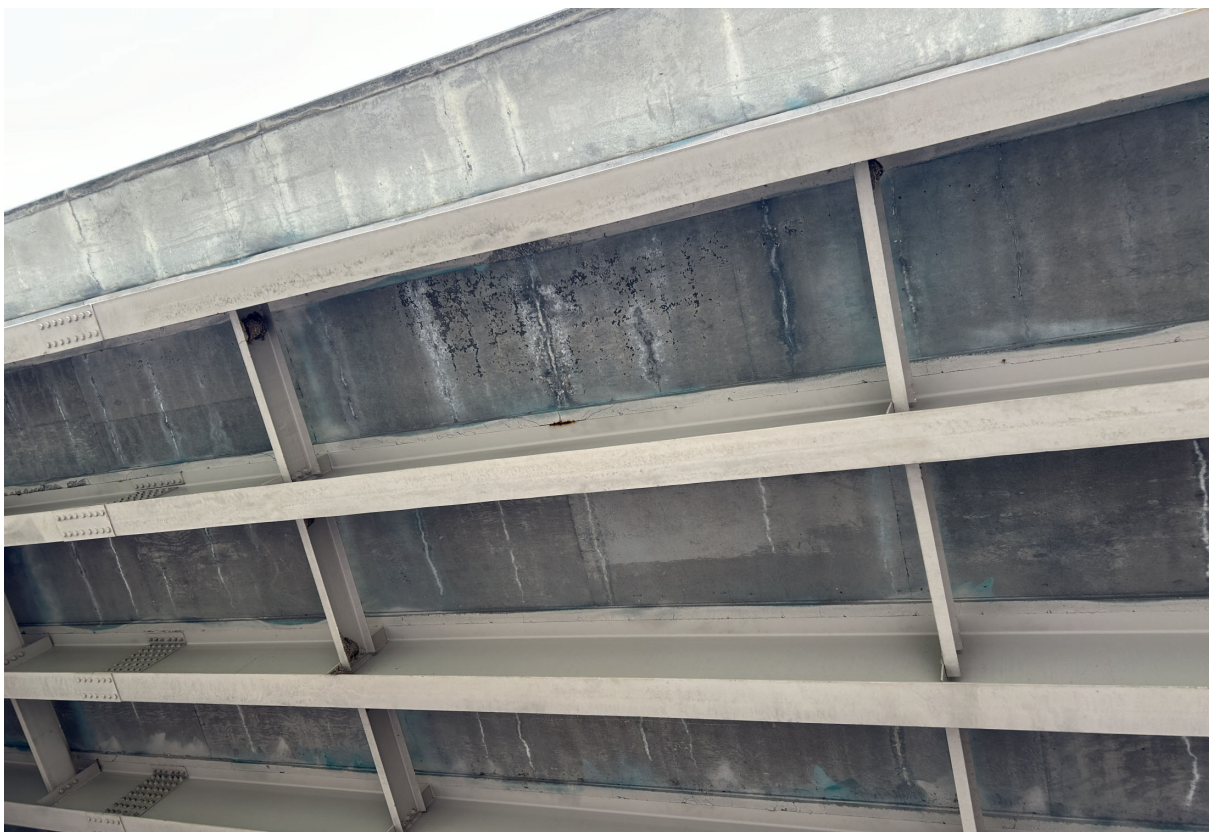
The top of deck cannot be visually inspected due to "Road Science" asphalt waterproofing mix overlay. Soffit has transverse cracking with efflorescence spaced at less than 3 feet throughout Spans 1 and 3, in exterior bays, and near the longitudinal joint. Cracking near longitudinal joint at Abutment 1 has an isolated area with heavy efflorescence (4 SF CS3). There is a local area of full depth deterioration in Span 2-Bay 1 at midspan (30 SF CS3). Soffit has spalling below the joints behind the end diaphragms with some exposed rebar, as well as spalling along the haunches (462 SF CS3). Bay 6 soffit has a 4' W x 2' L x 3" D spall with exposed rebar having section loss at Abutment 1 (8 SF CS3). Portions of the soffit are covered in soot from fires under the bridge near Abutment 4. The deck moves independently from the beams under heavy live load at Beams 2-8 at Abutment 1 and Beams 2, 4, 5, and 7 at Abutment 4; spalling is common along the haunches at these locations.

Soffit has transverse cracking, some with efflorescence; cracking is more closely spaced in the exterior bays and near the longitudinal joint. There is an isolated area of full depth deterioration in Span 2-Bay 1 at midspan (shown).

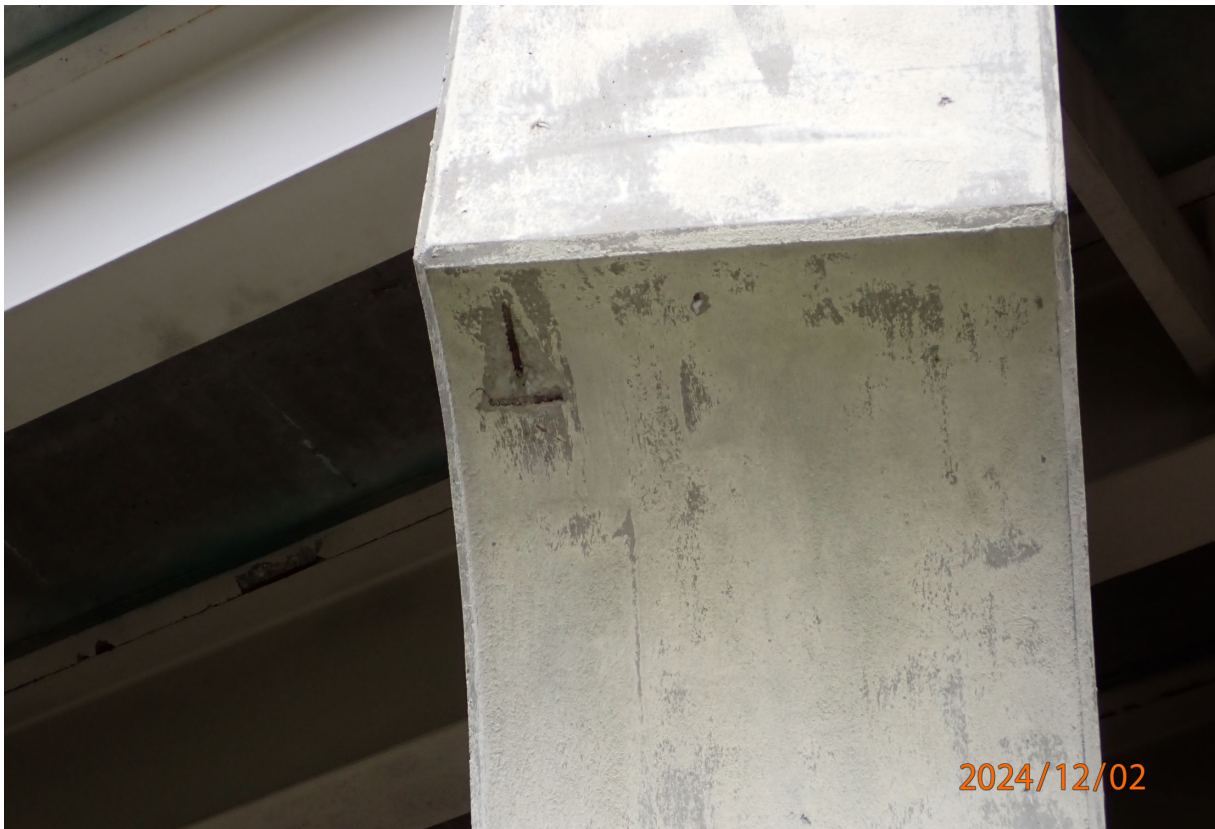
Pier 2 cap has a moderate crack at the west end about 1/3 of the cap depth from the bottom and extending into both the north and south faces, and a delamination in the east face adjacent to Column 5 (2' CS2). Pier 3 cap has an 8-inch-diameter spall with exposed rebar on the bottom face at the west end (1' CS3).

Pier 3 cap has an 8-inch-diameter spall with exposed rebar on the bottom face at the west end.

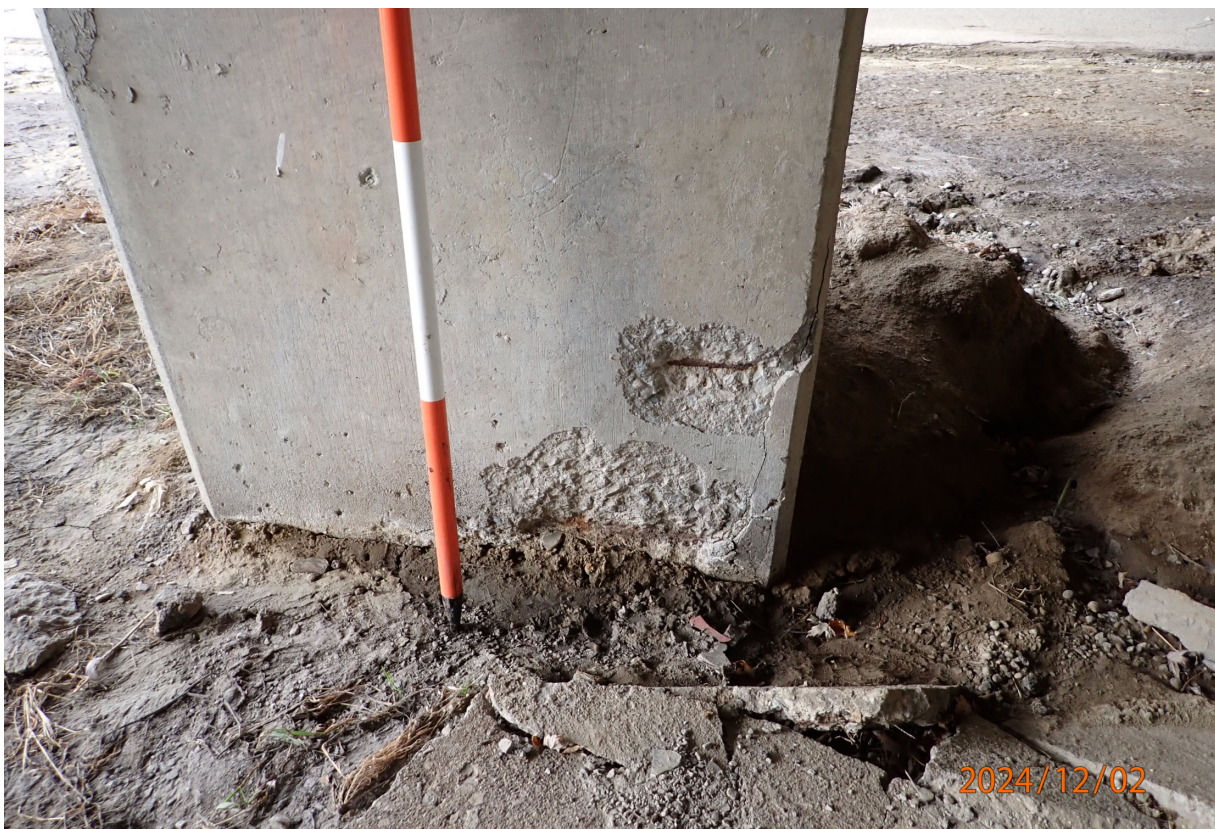
Pier 2-Column 3 has spalling with exposed rebar at the bottom of the south face, 1.5-foot-diameter by 1-inch-deep (1 CS3). A few columns have small spalls and moderate cracks (3 CS2).

Pier 2-Column 3 has spalling with exposed rebar at the bottom of the south face, 1.5-foot-diameter by 1-inch-deep.

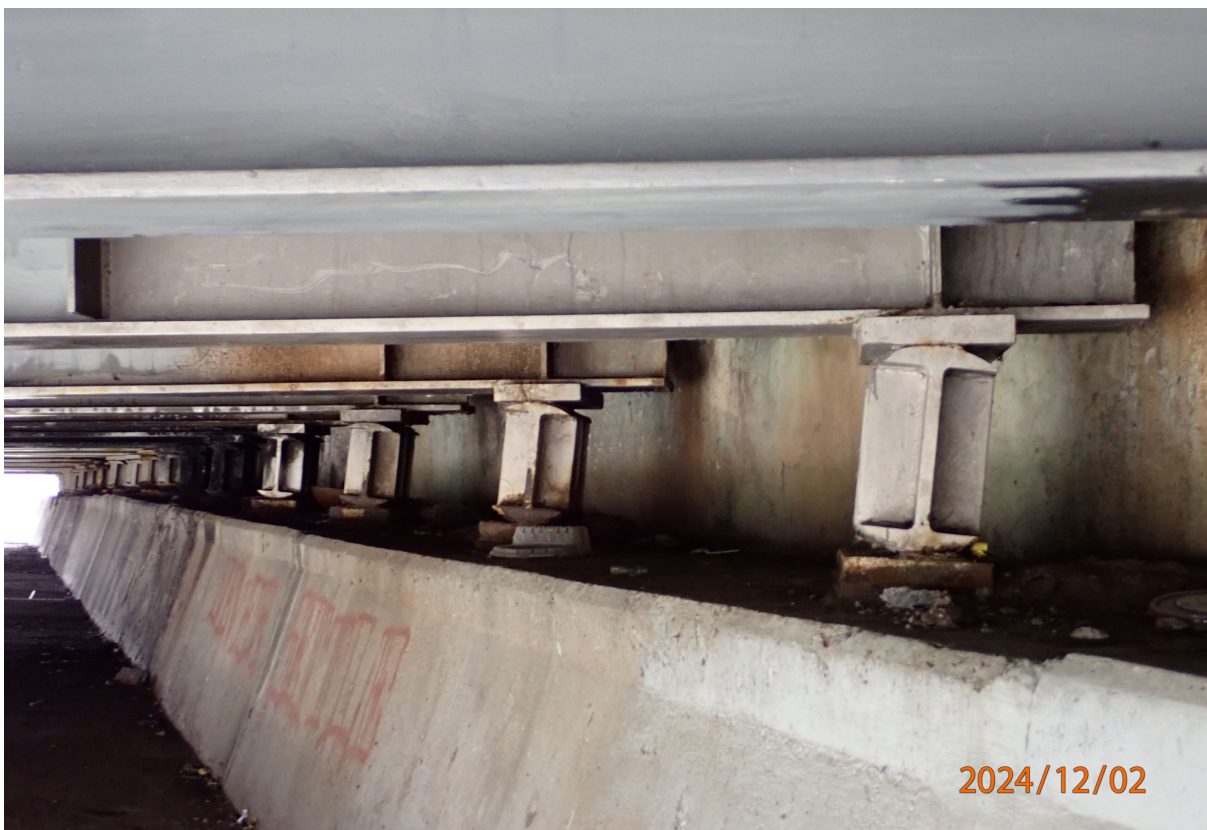
Abutment bearings are expanded at 28° F (tolerable alignment, inconsistent with temperature; looking west along Abutment 4 shown).

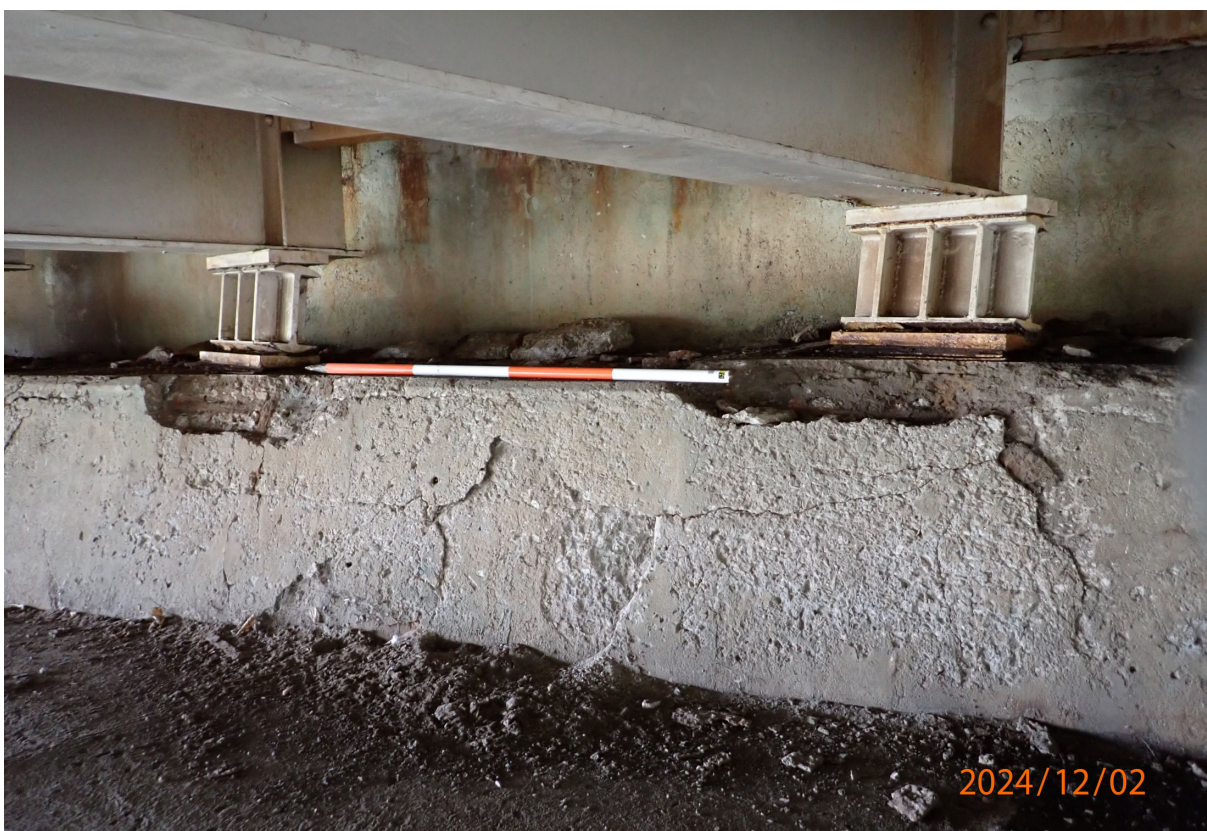
Abutment 4 cap has spalls with exposed rebar at Beams 5 and 6, each roughly 4' L x 1' H x 7" D. There are also large delaminations at this location.

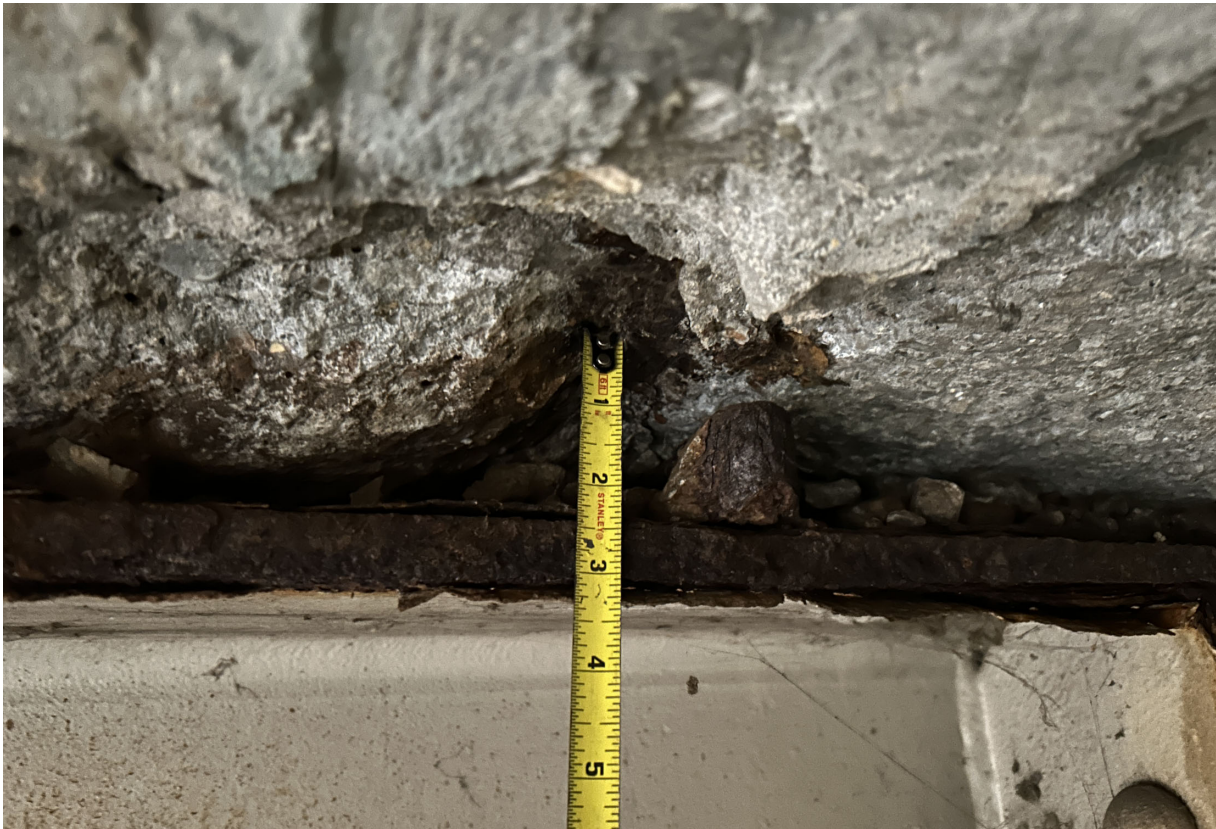
The deck moves independently from the beams at Beams 2-8 at Abutment 1 and Beams 2, 4, 5, & 7 at Abutment 4, with gaps typically up to 3/8 inch between the deck and top flanges. The gap above the Beam 7 top flange at Abutment 4 is up to 2.5 inches at a spalled portion of the haunch. Some beam ends have flaking corrosion, especially at Abutment 4 (110' CS3). The beams have surface corrosion scattered throughout, especially near the bridge ends, longitudinal joint, and exterior faces (300' CS2). There is soot from fires on Beams 12-20 at Abutment 4; Beam 17 has up to 3/4 inch distortion in the web. There are a few cracked tack welds at the top of the stiffeners visible near the abutments.

The deck moves independently from the beams at several locations, with gaps typically up to 3/8" between the deck and top flanges. Beam 7 at Abutment 4 has a 2.5" gap at a spalled portion of the haunch.

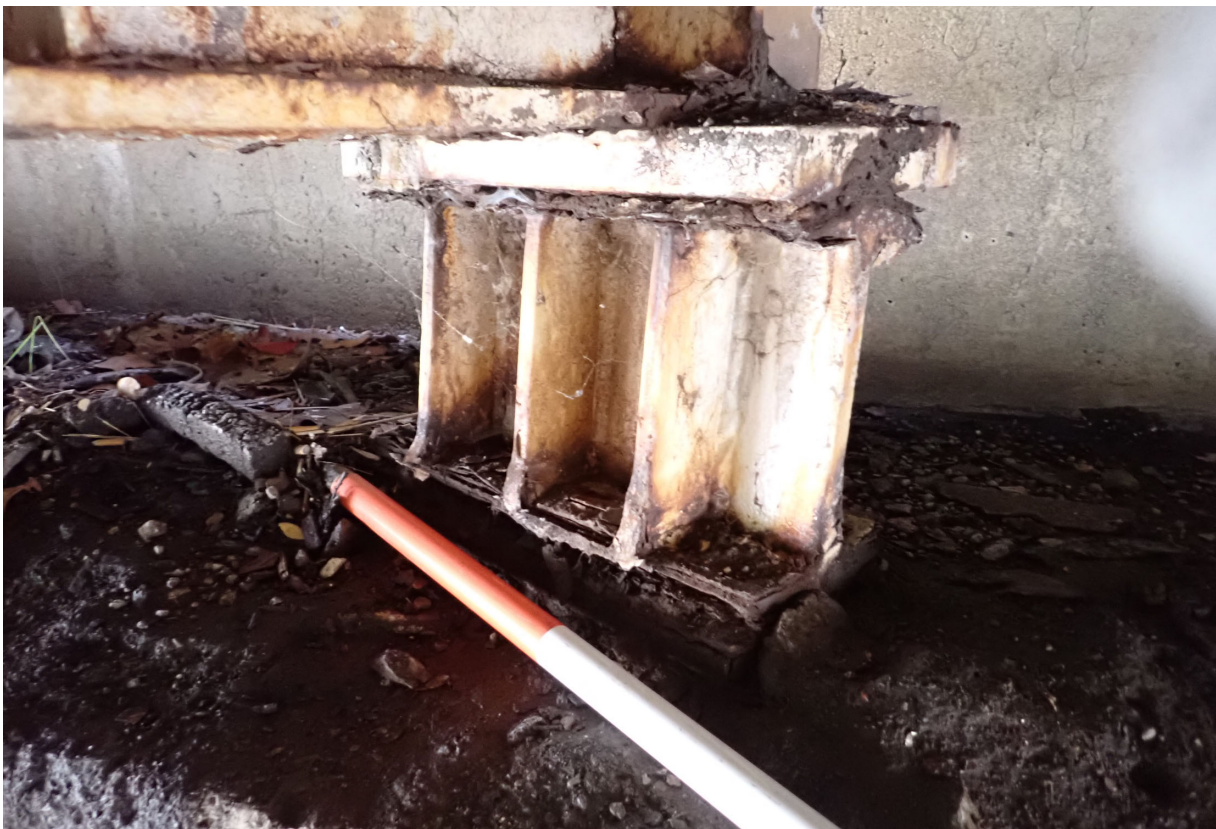
Abutment bearings have flaking corrosion and pack rust, primarily between the rockers and masonry plates, with heavier corrosion at the longitudinal joint and exterior beams (Beam 8 at Abutment 4 shown).

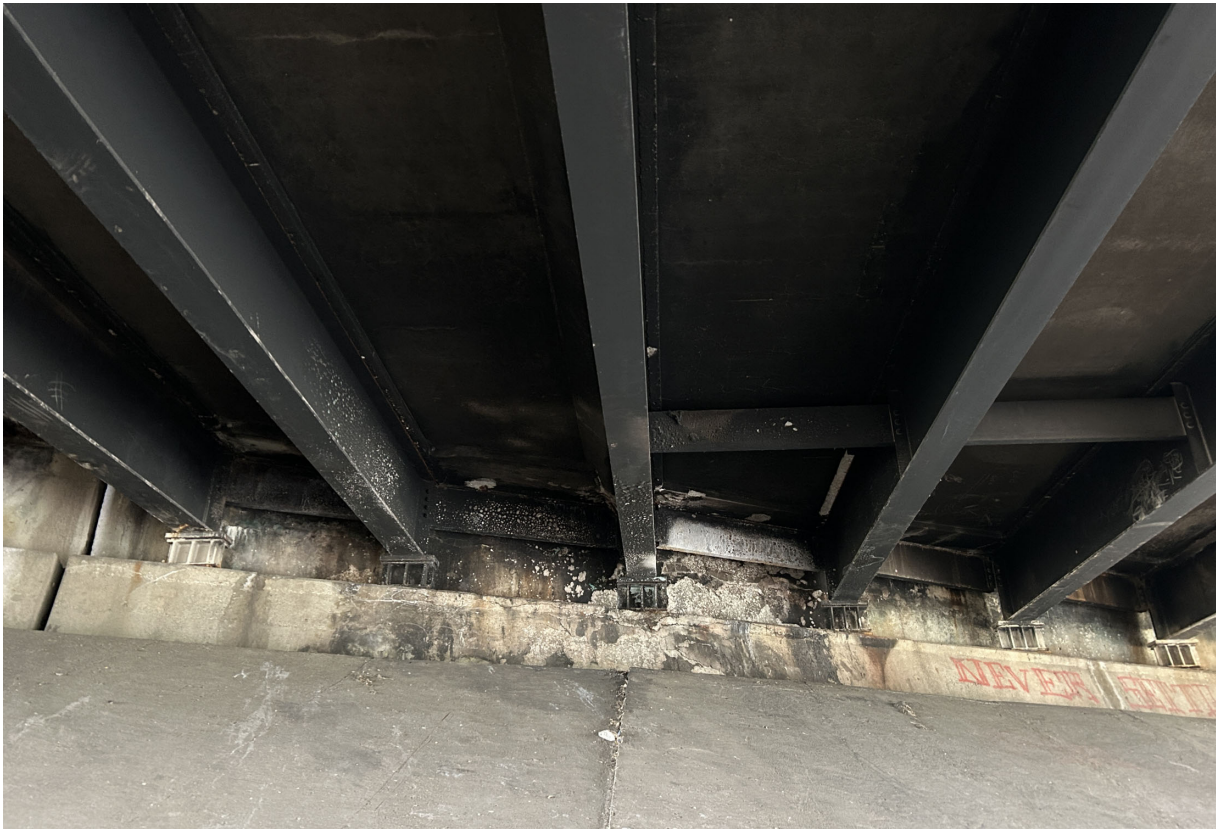
The majority of the paint is substantially effective and dulling, with areas of limited to no effectiveness near the abutments and longitudinal joint. There is soot from fires on Beams 12-20 at Abutment 4; some of these beams have paint bubbling and/or failure, especially Beam 15.

There is soot from fires on Beams 12-20 at Abutment 4.
