Bridge Inspection Report

056B00210N

12/02/2024

<u>IDENTIFICATION</u>			
Structure Num (8):	056B00210N		
NBI Number	056B00210N		
Structure Name:			
Location (9):	0.55 MI N OF I-264		
Carries (7):	I-65		
Type of Service (42A):	1 Highway		
Feature Crossed (6):	MANNING RD		
Type of Service (42B):	1 Highway		
Placecode (4):	Not Applicable		
County (3):	Jefferson (056)		
State (1):	21 Kentucky		
Admin Area:	Inventory		
District:	District 5		
Latitude (16):	38° 11' 51"		
Longitude (17):	85° 44' 2"		
Owner (22):	State Highway Agency		
Maint. Resp. (21):	State Highway Agency		
Year Built (27):	1957	Border State (98A):	Not Applicable (P)
Year Recon (106):	1985	Border Number (99):	
		% Responsibility (98B):

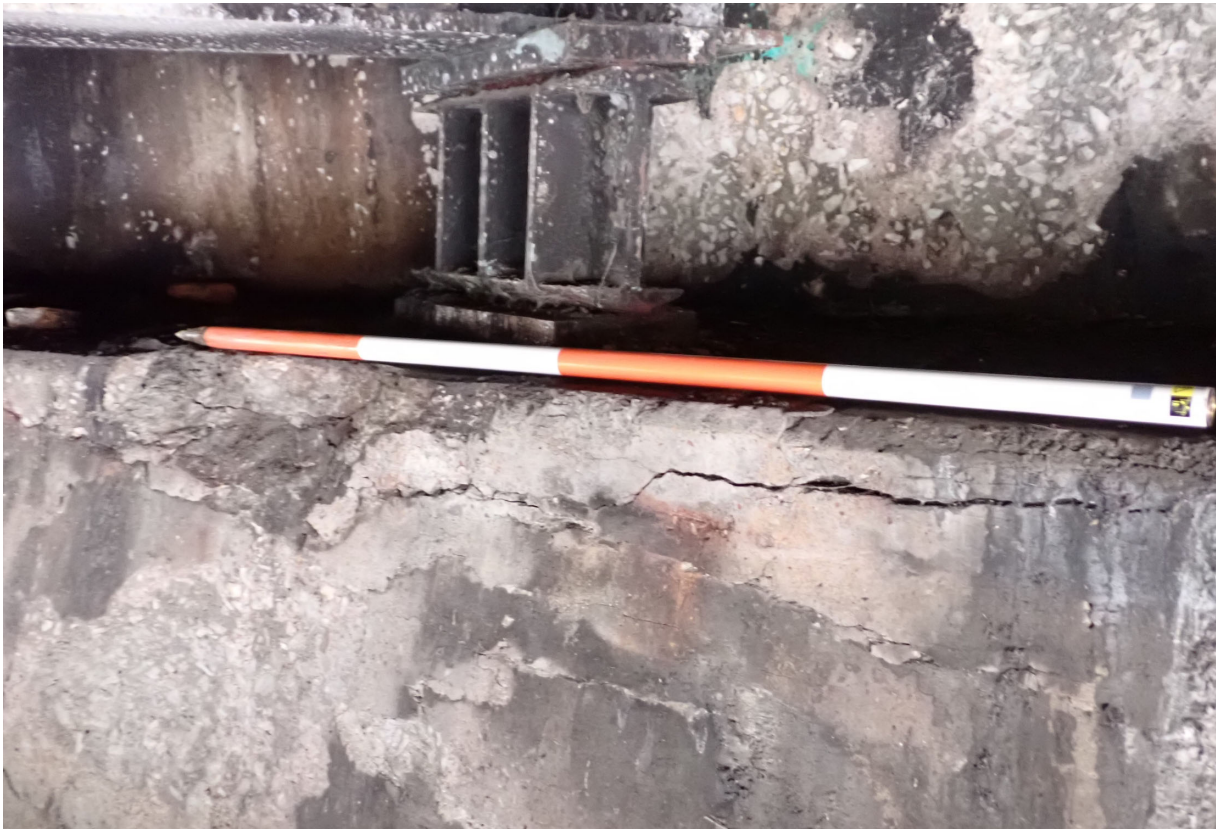
Abutment 4 has wide horizontal cracking plus scaling from fires between Beams 13 and 15 (cap at Beam 14 shown).

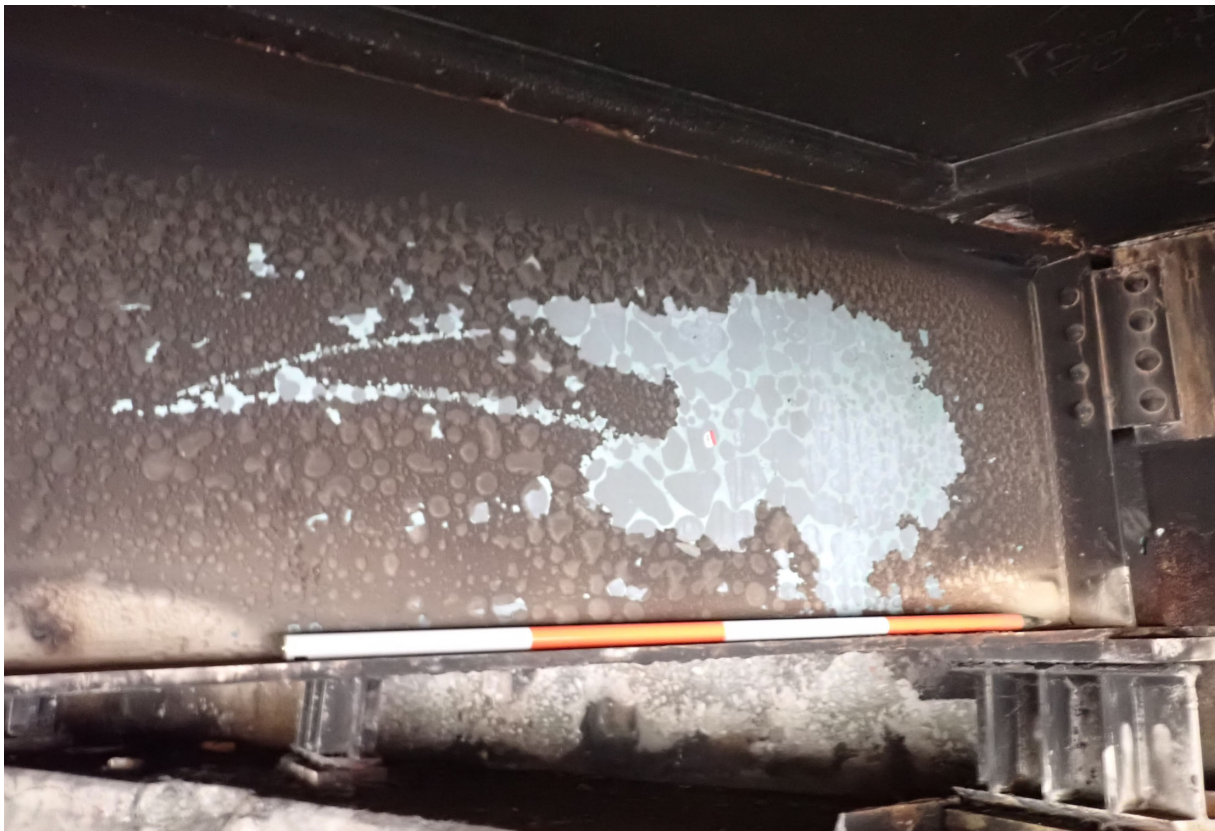
Paint bubbling and failure from fires at Beam 15

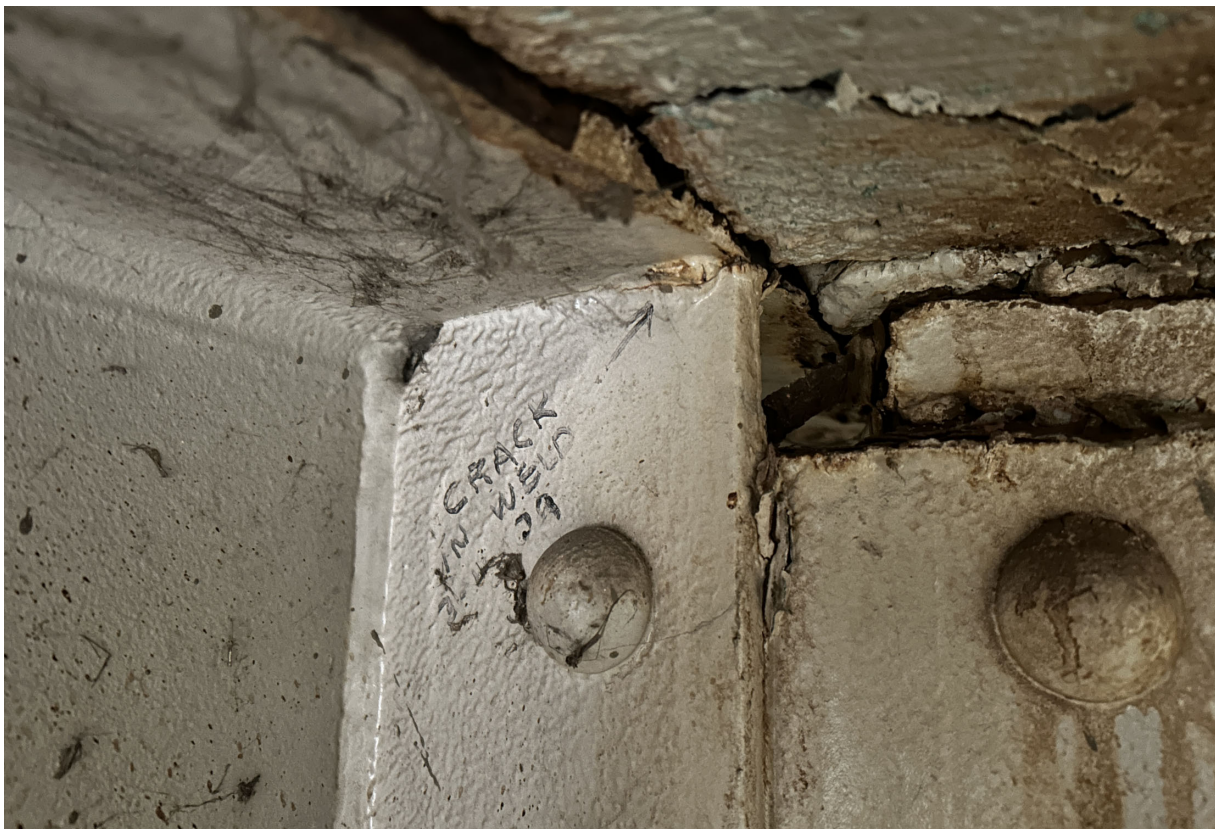
There are a few cracked tack welds at the top of the stiffeners visible near the abutments.
