KENTUCKY PUBLIC RIVERPORT CONSTRUCTION AND MAINTENANCE (KPRCM) APPLICATION

Barge Cell Revitalization – Phase II

Marine Solutions, Inc. (Marine Solutions) performed an inspection on the Paducah-McCracken County Riverport Authority Bulk Commodity Berth and General Cargo Berth from December 9 through December 13, 2024. The primary purpose of the inspection was to investigate the current condition of the mooring cells along the berthing line and provide a summary of recommended repairs to extend the service life of the facilities. The inspected structures included four mooring cells on the Bulk Commodity Berth (BCB) and five mooring cells on the General Cargo Berth (GCB). The inspection consisted of a below and above water examination of the cells, including the condition of the sheet piles, cell caps, and amount of aggregate fill material contained within the cell.

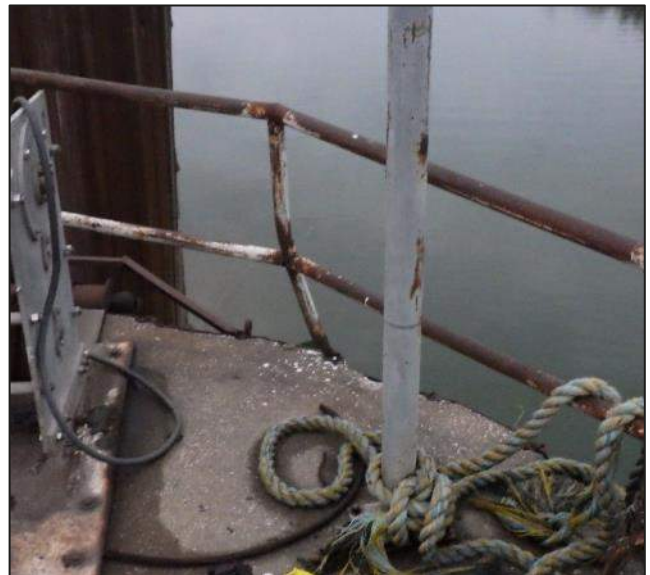
Photograph 8 View of impacted and damaged guardrail at Sheet 30.

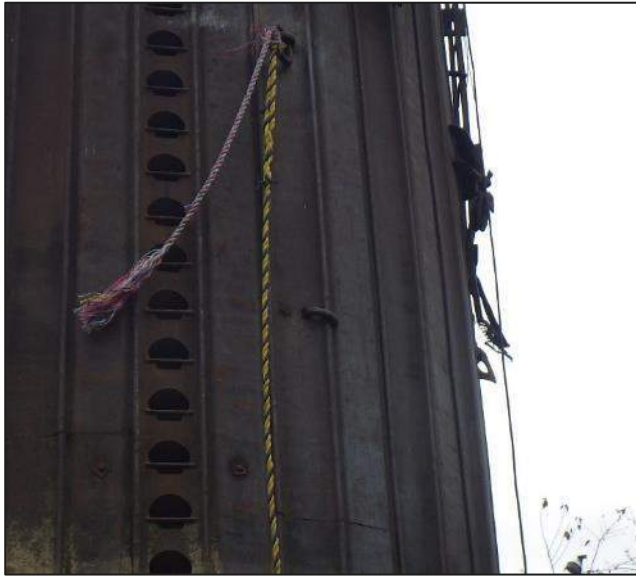
Photograph 9 View of broken U-bolt at Sheet 37.

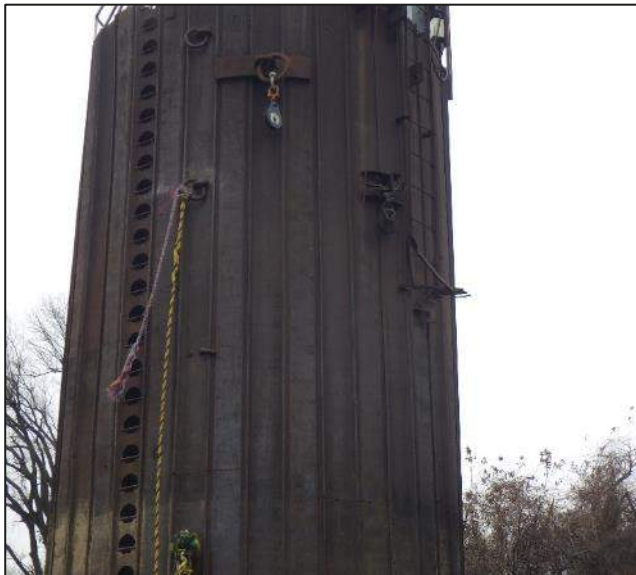
Photograph 11 View of impact damage and broken ladder at Sheet 30.

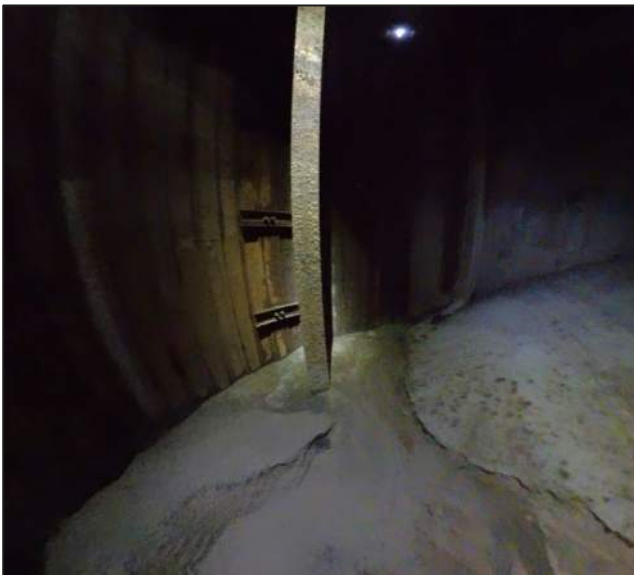
Photograph 7 View of lost ballast material inside cell.

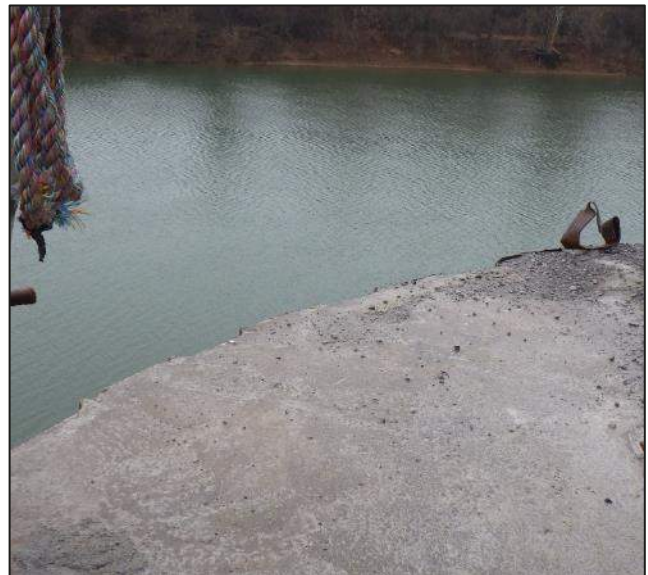
Photograph 8 View of missing guardrail on the channel side of the cell.

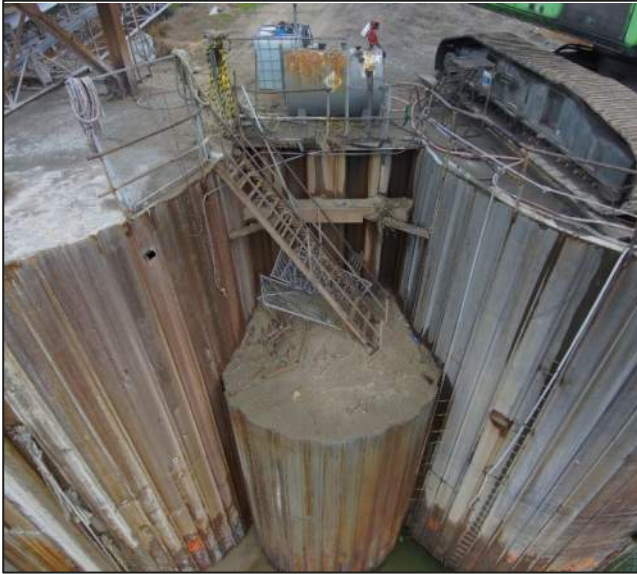
Photograph 13 View of damaged staircase centered at Sheet 56.

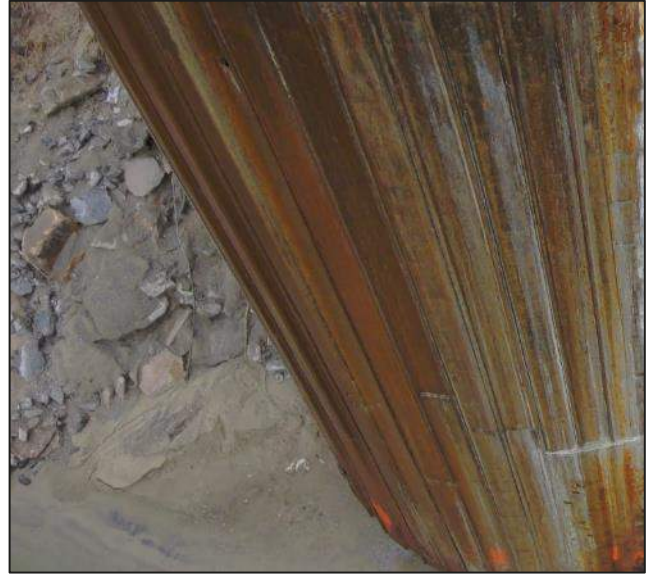
Photograph 14 View of isolated impact damage on Sheet 5 and Sheet 6.

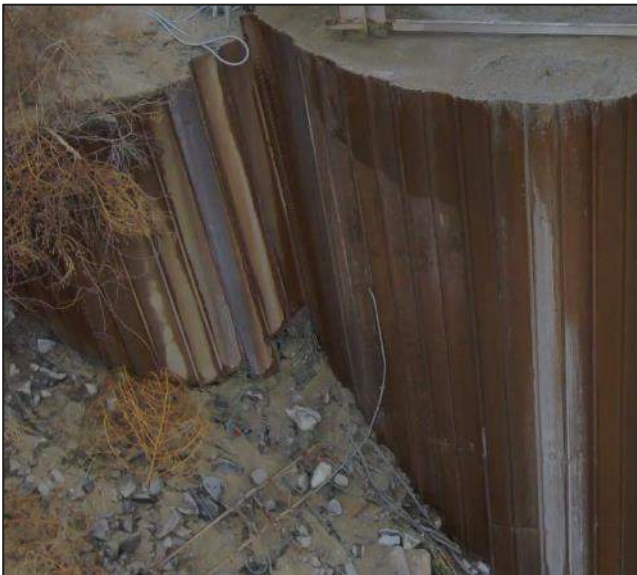
Photograph 15 View of erosion and undermining of the containment sheets attached to Sheet 31.

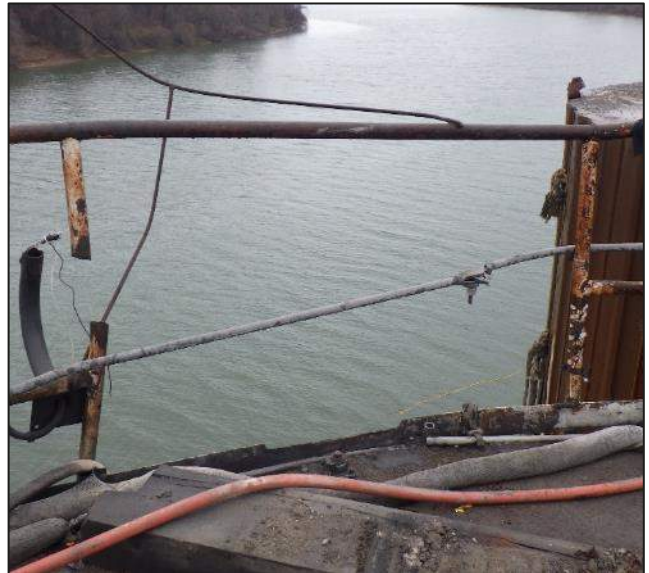
Photograph 8 View of broken guardrail.

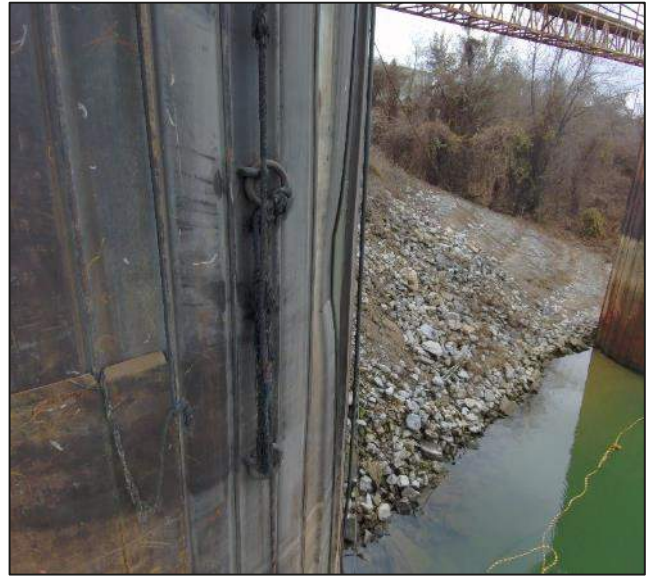
Photograph 10 View of impact damage at Sheet 67.

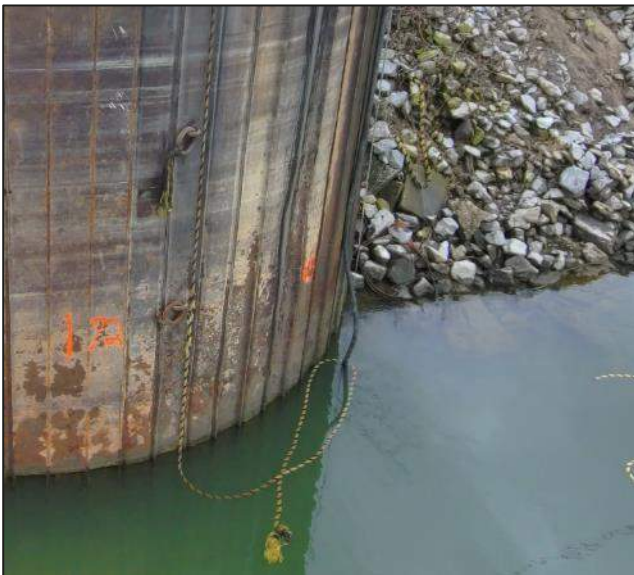
Photograph 11 View of impact damage at Sheet 66.

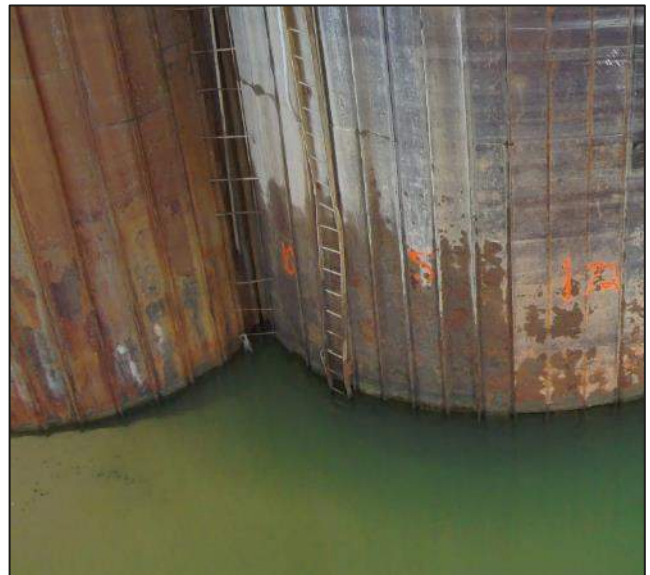
Photograph 12 View of ladder damage on Sheet 8.

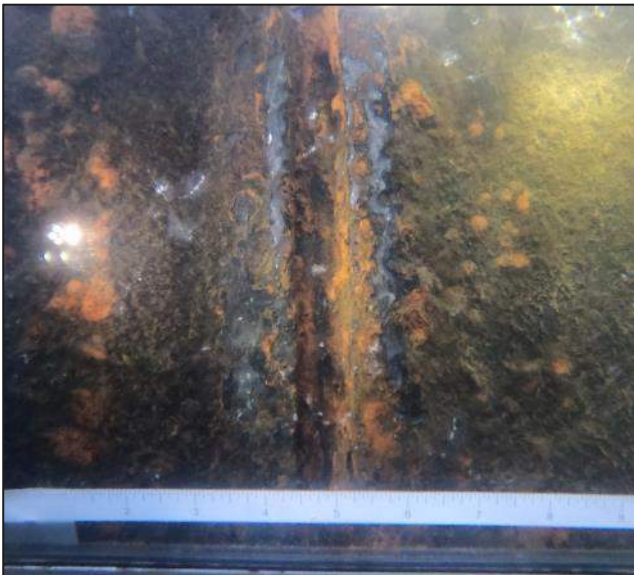
Photograph 15 View of split interlock between Sheet 72 and Sheet 1.

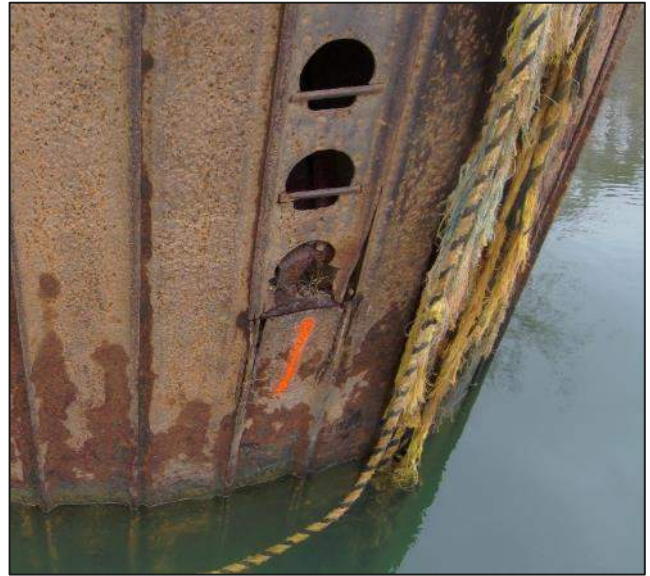
Photograph 6 View of split interlocks and the crack on the sheet ladder.

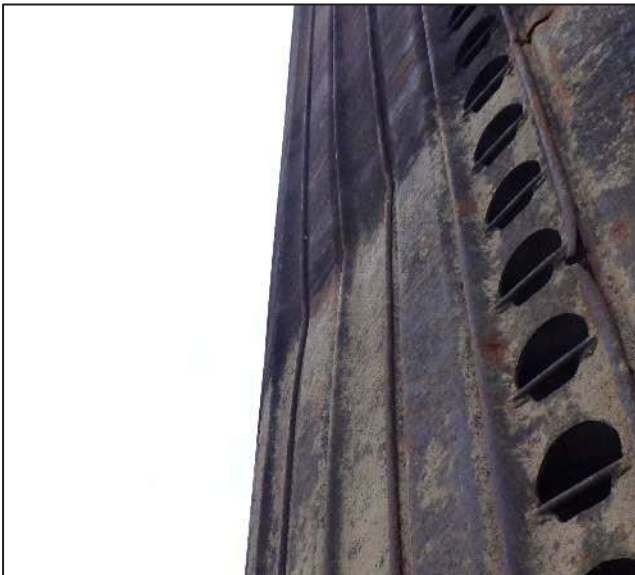
Photograph 7 View of impact damage on Sheet 3.

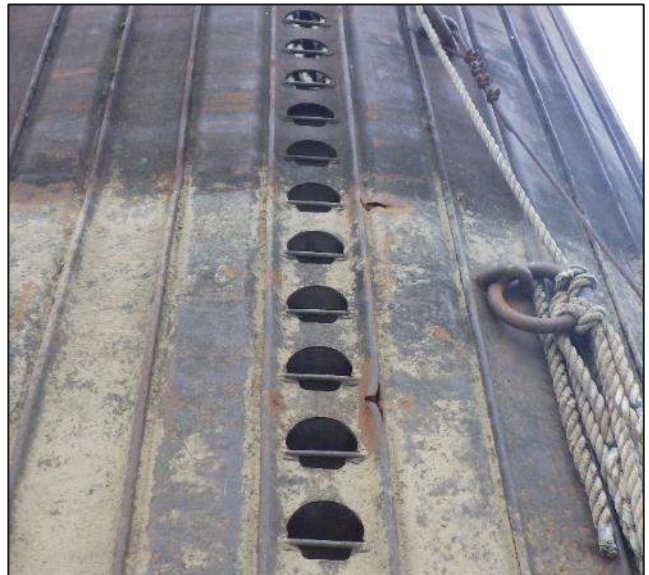
Photograph 8 View of splits on Sheet 1.

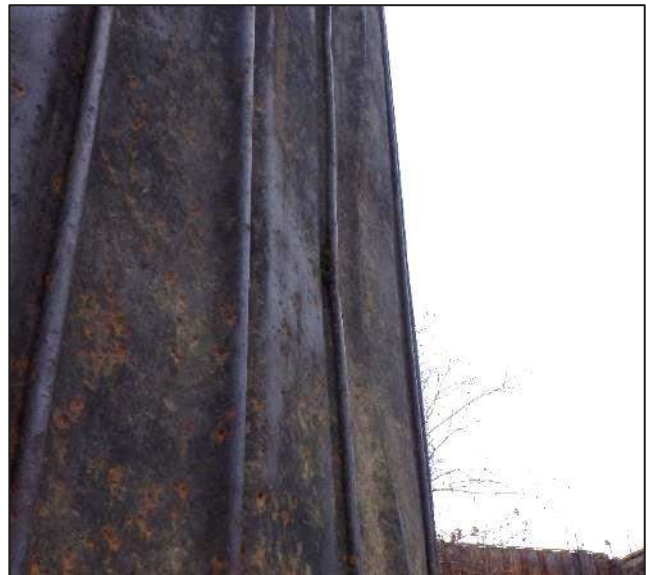
Photograph 8 View of impact damage at Sheet 47.

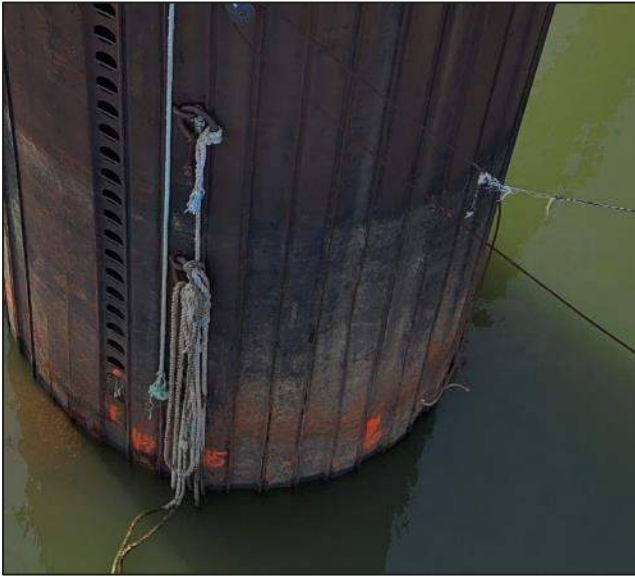
Photograph 9 View of impact damage on Sheet 43.

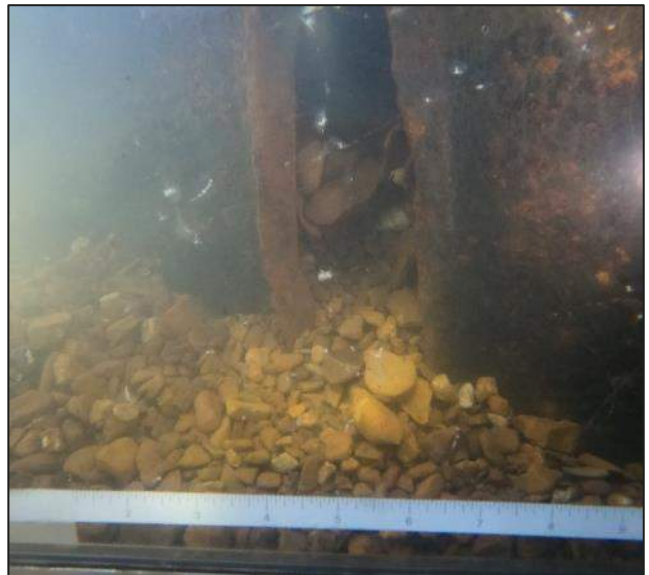
Photograph 12 Underwater view of split between Sheet 2 and Sheet 3.

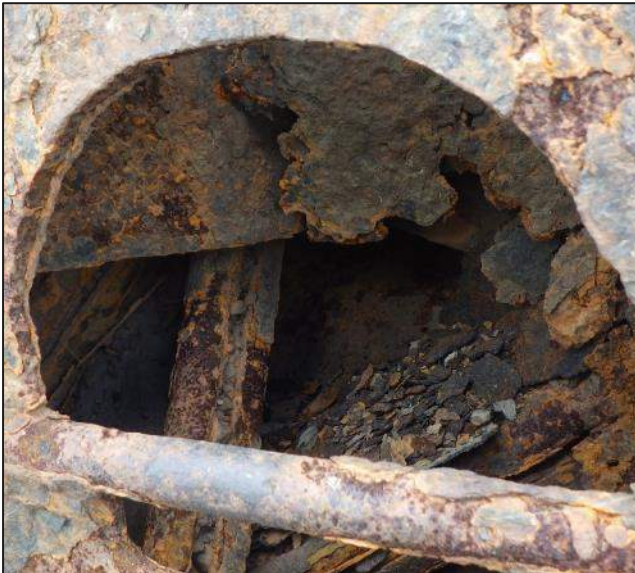
Photograph 7 View of split in pan sheet.

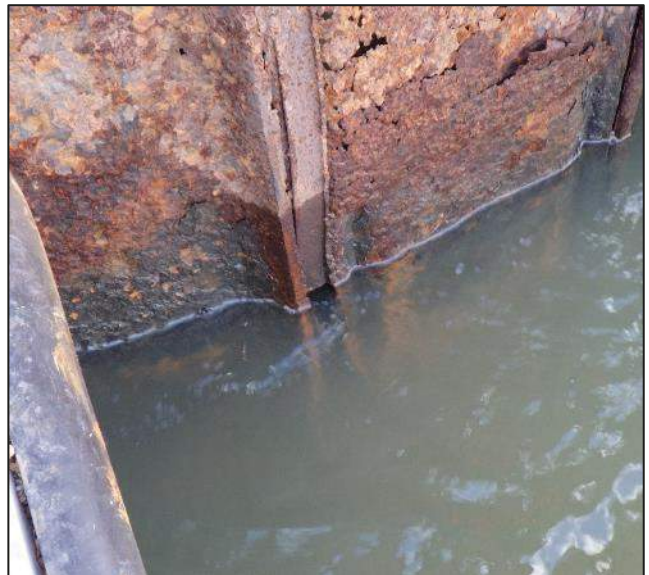
Photograph 8 View of split interlock between Sheet 2 and Sheet 3.

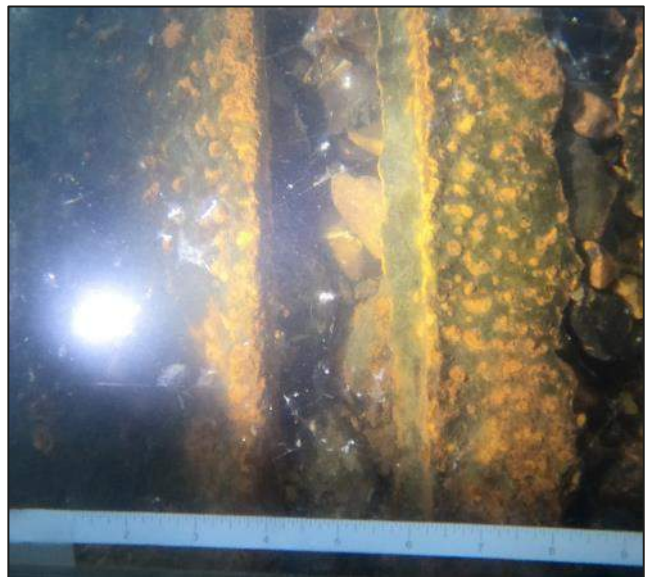
Photograph 12 Underwater view of split interlock between Sheet 2 and Sheet 3.

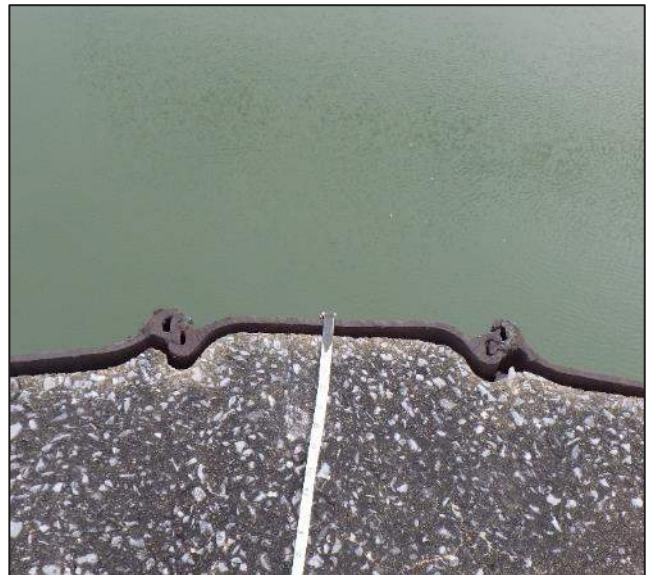
Photograph 8 View of the gap between the cap and the sheets at Sheet 10 through Sheet 12.

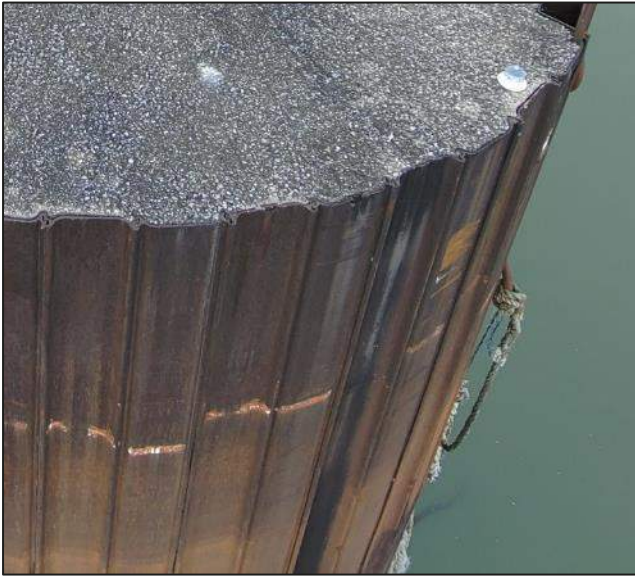
Photograph 9 View of impact damage on Sheet 5.

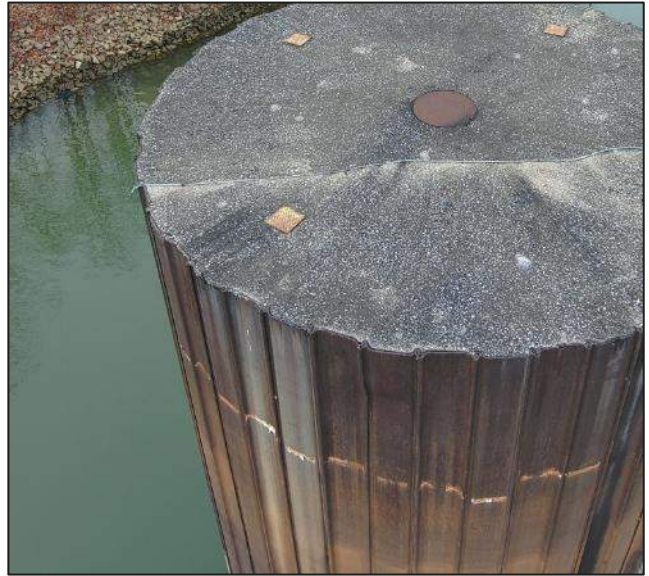
Photograph 10 View of impact damage on Sheet 10 through Sheet 12.
