**FROM:** Michael Carpenter, PE  
Director  
Division of Structural Design

**DATE:** December 20, 2023

**SUBJECT:** Pendleton County  
FD04 096 0177 005-010 P  
KY 177 Improvements  
Item No. 6-80258.00  
Mars No. 1632901P  
Geotechnical Overview

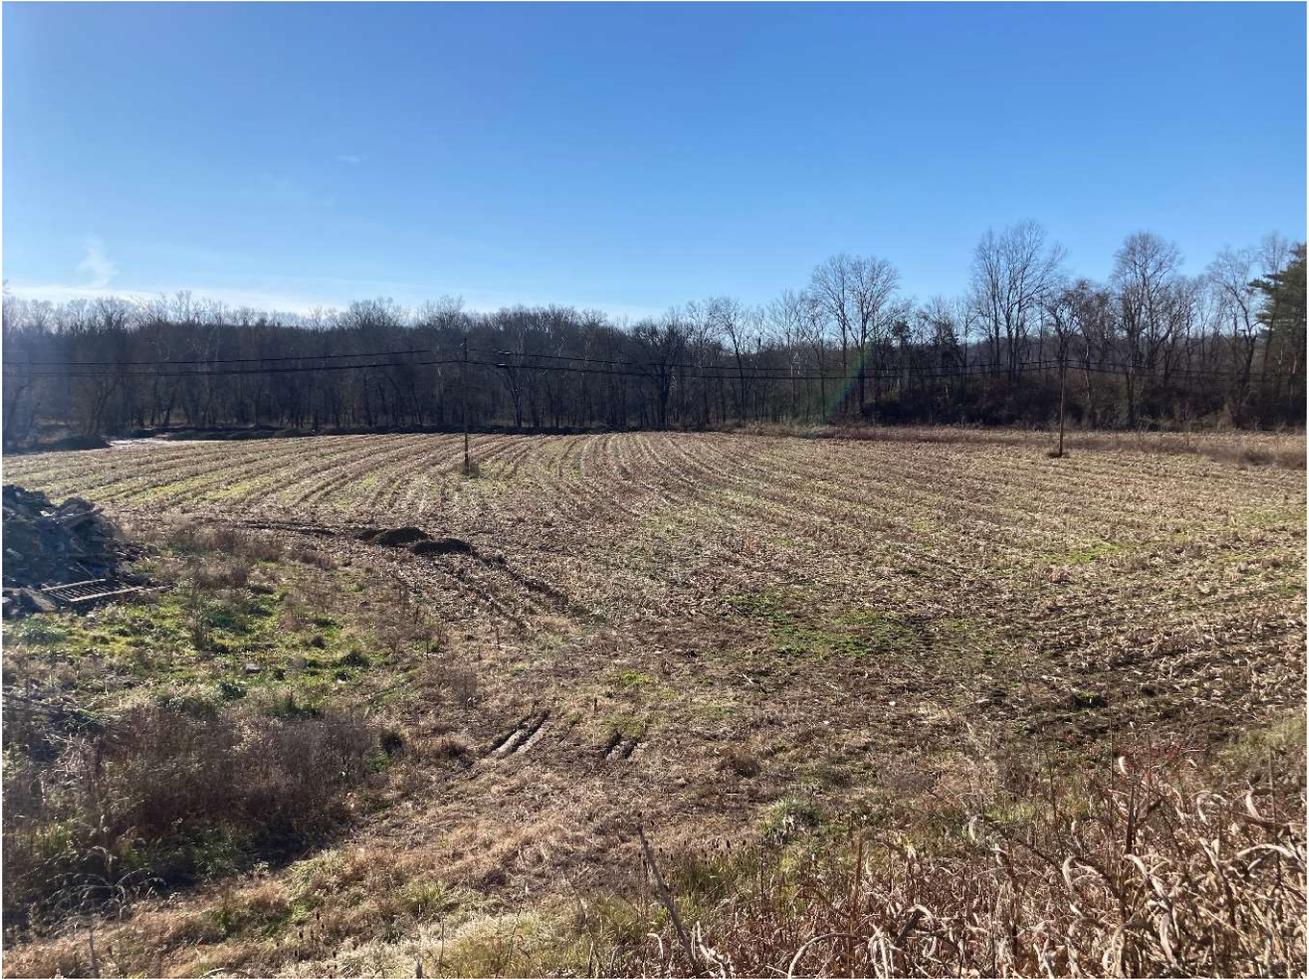
Licking River floodplain along KY 177, North of Butler.

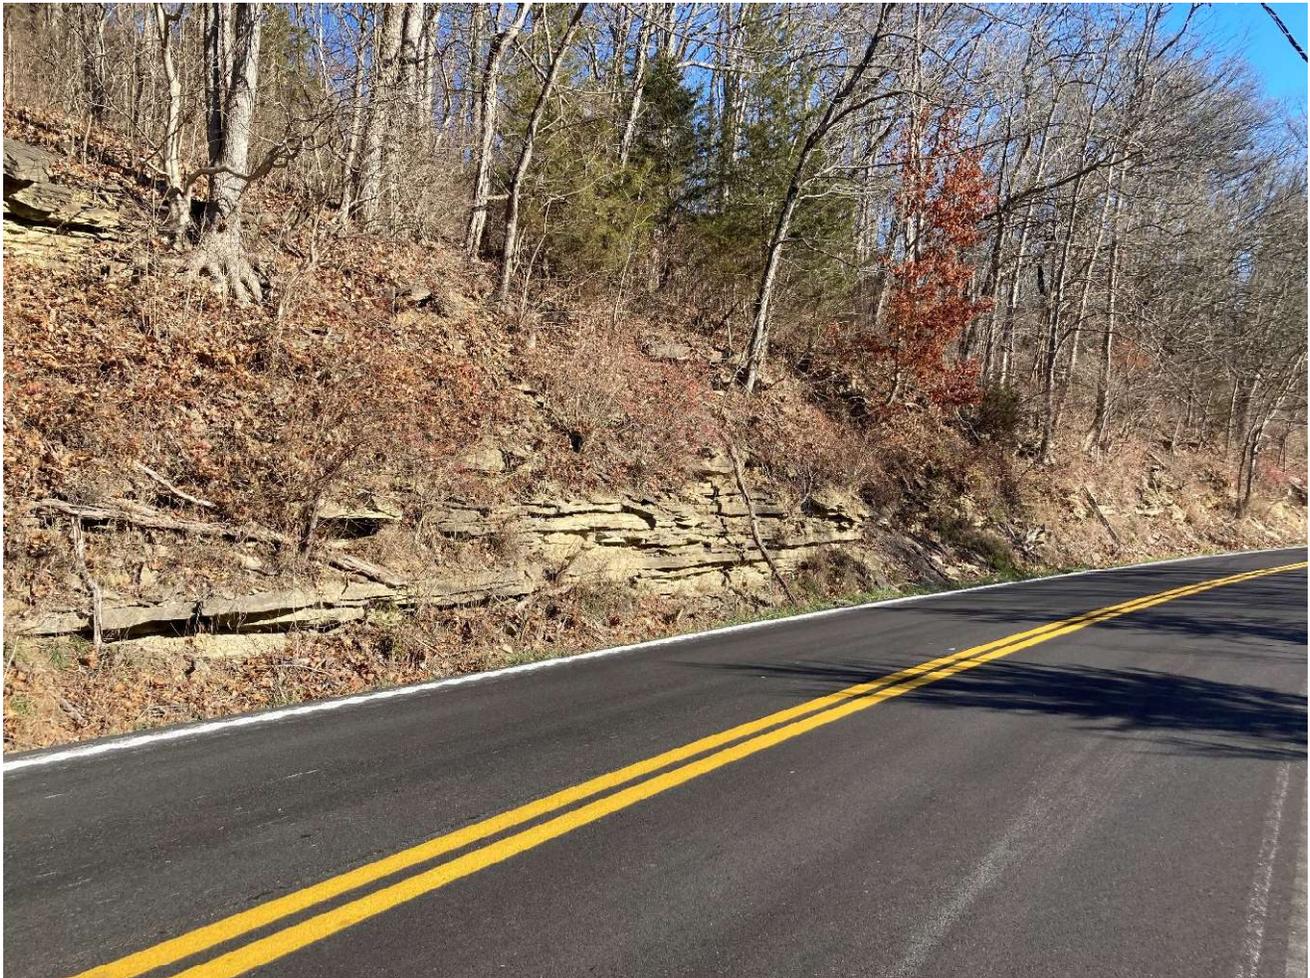
Fairview Formation exposure on KY 177 at mile point 5.75.

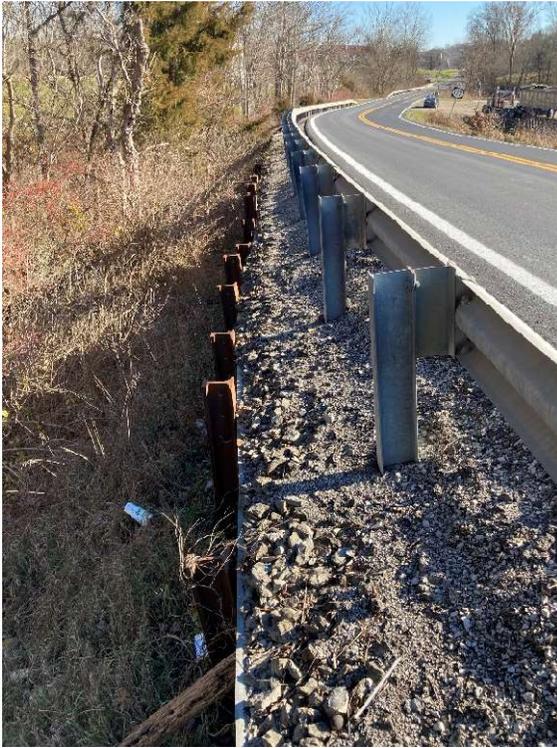
The entirety of the project area is notorious for cut and fill slope stability failures. The driving force behind these instabilities can be attributed to groundwater movement, poor rock mass quality, deep colluvium accumulations, primary and secondary structures of the river valley deposits, and the proximity to the Licking River and potential high water levels.

Slide repair on KY 177 mile point 4.45.

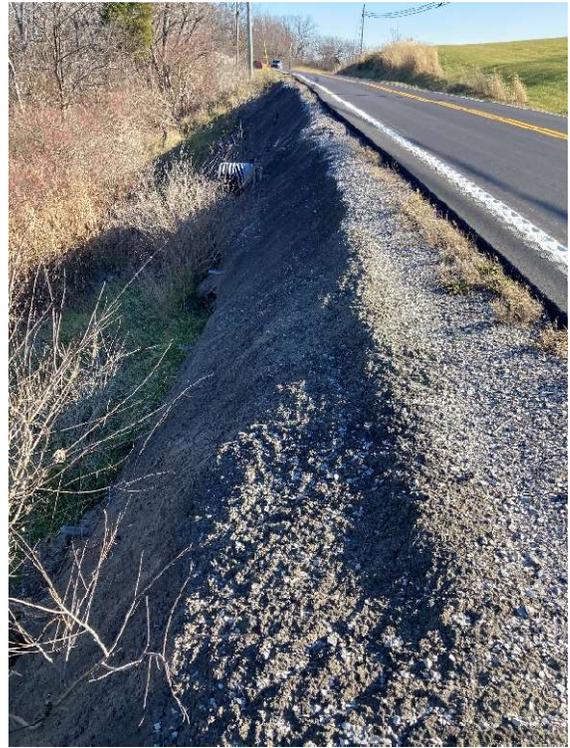
Slide repair on KY 177 mile point 6.55.

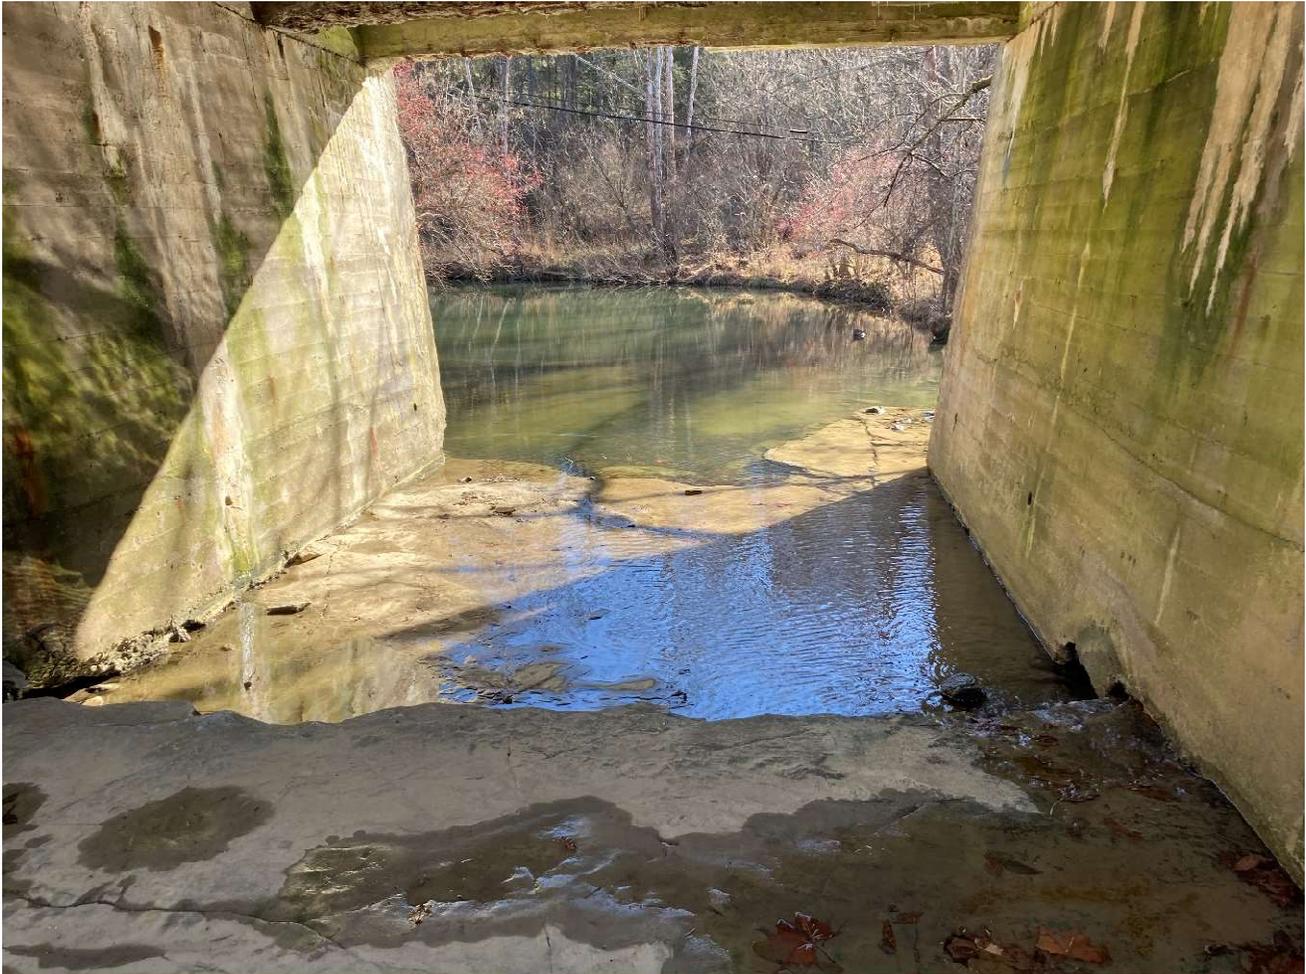
Bedrock exposed in stream bottom at KY 3185 bridge at mile point 2.3.

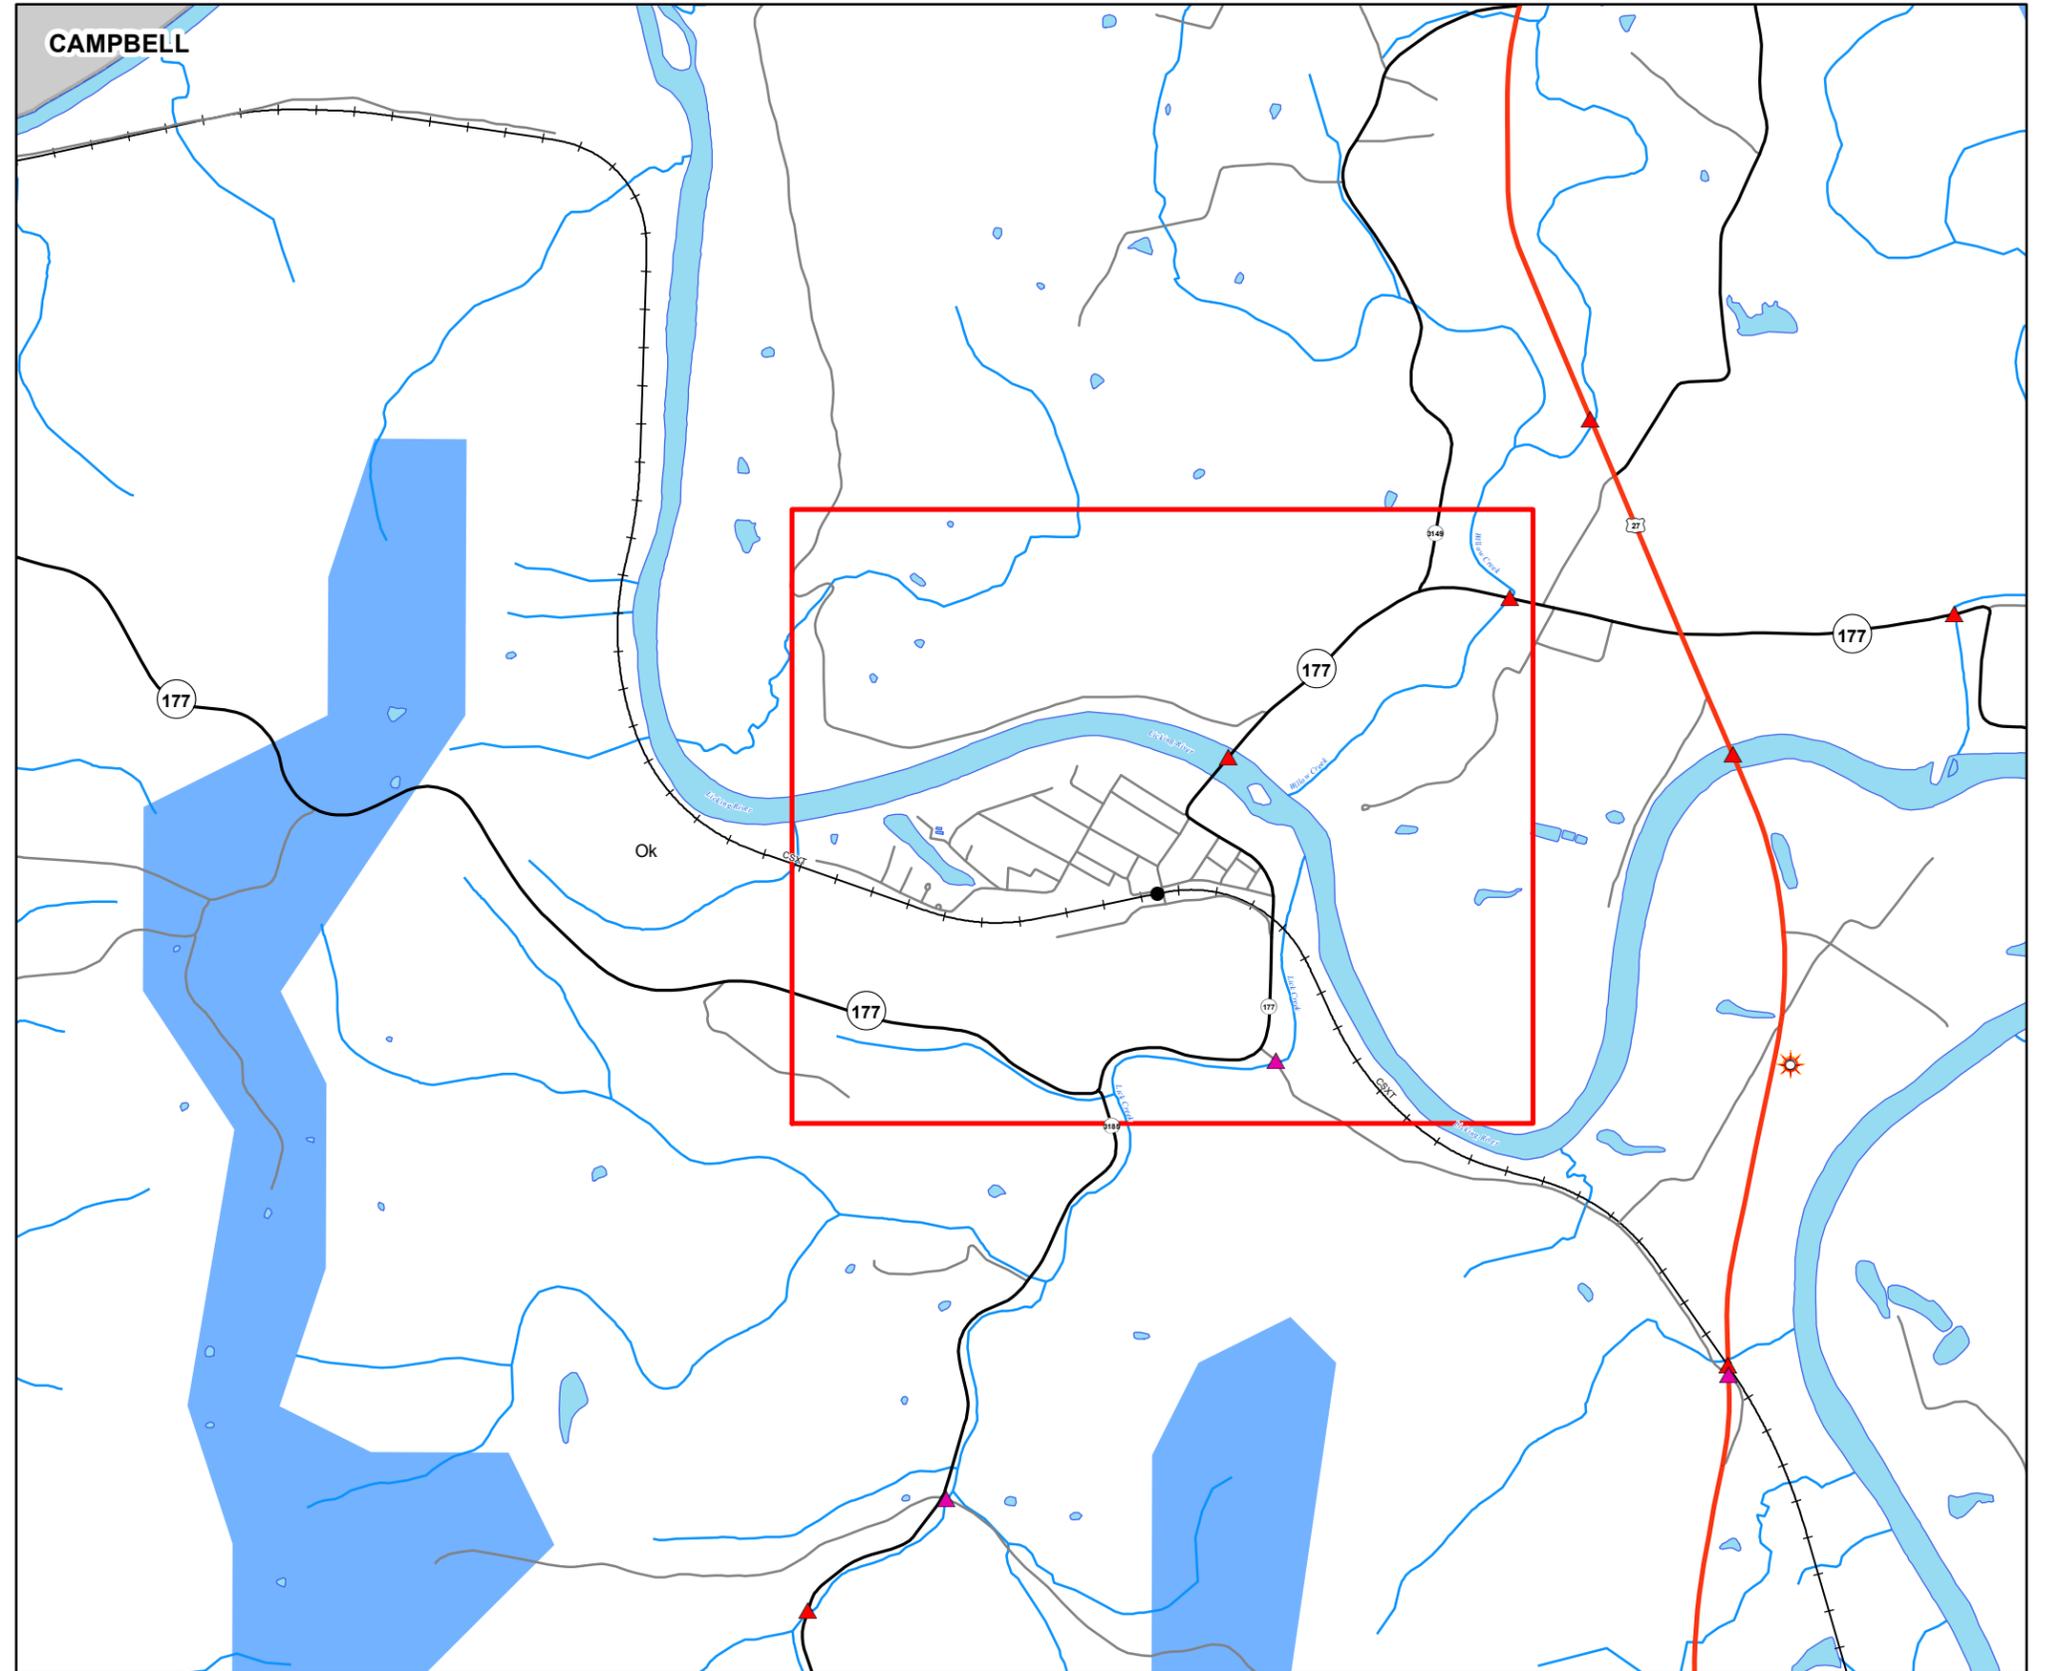
# Pendleton P-007-2023 - Karst Potential

The Fairview Formation is known to develop or have karst features such as solutioned cavities, sinkholes and springs. These features are not noted in the study area but may be encountered or exposed if constructing within this formation. Other than the Fairview Formation, the rest of the project lies within bedrock that is not in a karst risk location (Appendix D).

Geologic mapping and field observations does not indicate the presence of sinkholes (Appendix D). Any open sinkhole and/or solution cavities within the limits of construction, whether shown on the plans or not, that are not used for drainage purposes, shall be filled and/or capped in accordance with the current edition of Section 215 of the Standard Specifications for Road and Bridge Construction.
