# APPENDIX C

## RECURRING MAINTENANCE ISSUES

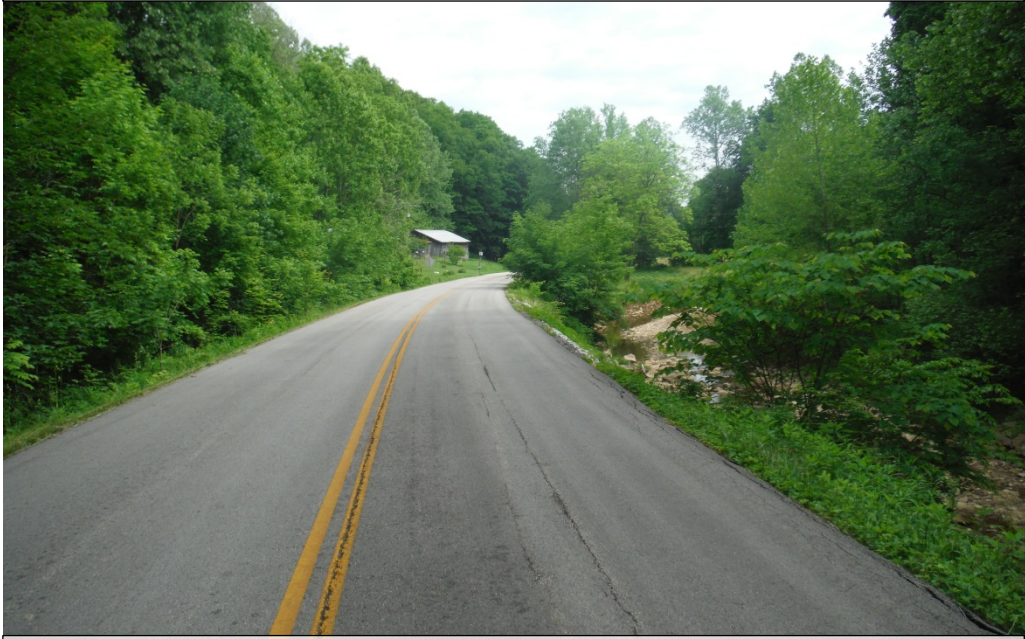
Location 9 (2): KY 377 MP 2.50 to MP 2.70

Slope/shoulder stability issues adjacent to the roadway at Buck Crawford Place at Indian Creek. 5/20/2015

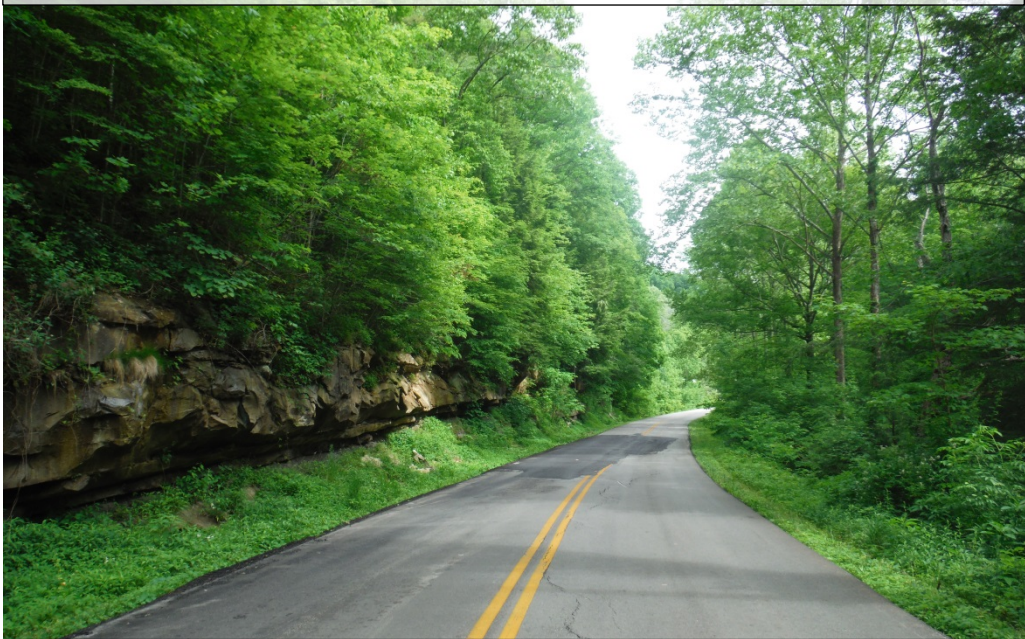
Location 9: KY 377 MP 2.50 to MP 2.70

Slope/shoulder stability issues adjacent to the roadway at Buck Crawford Place at Indian Creek. 5/20/2015

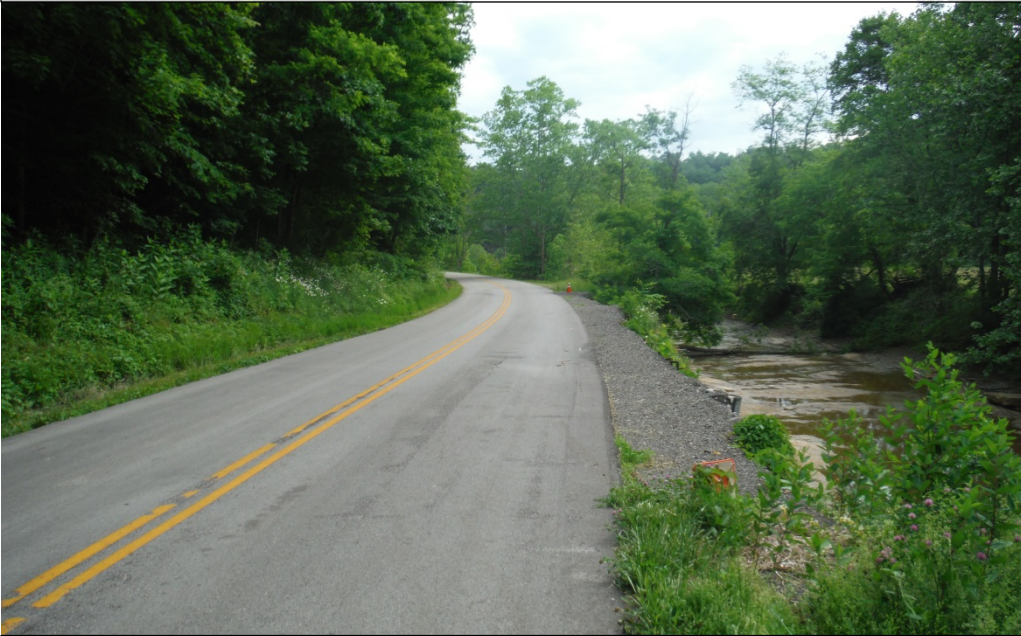
Location 8: KY 59 MP 3.40 to MP 3.45

Slope/shoulder stability issues adjacent to the roadway at Mike Thomas Place at Indian Creek.

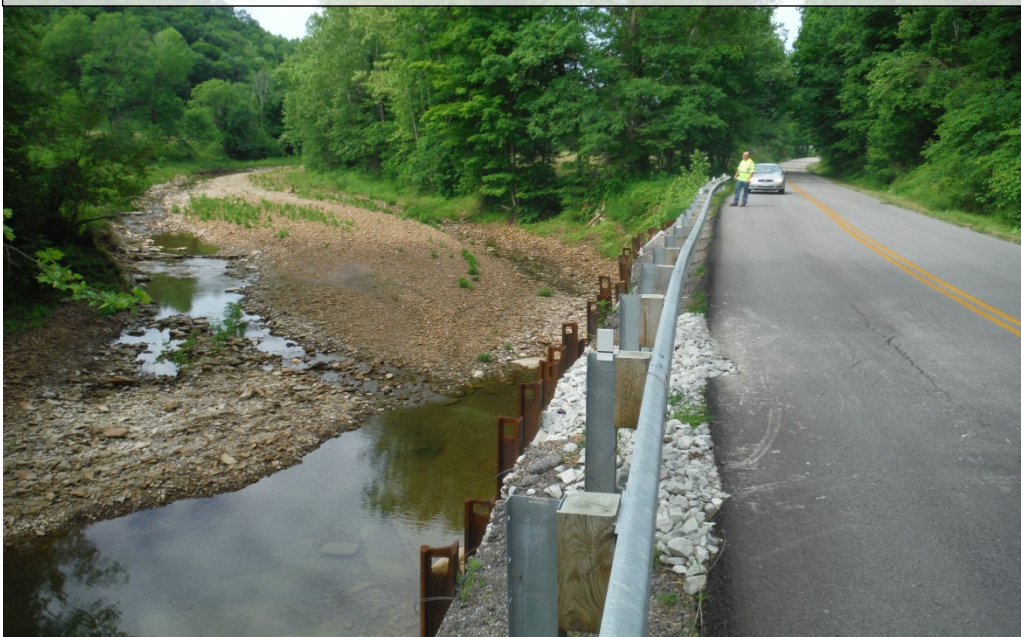
Location 7 (2) : KY 377 MP 4.45 to MP 4.50

Slope/shoulder stability issues adjacent to the roadway near Eddie Stamm Farm at Indian Creek.

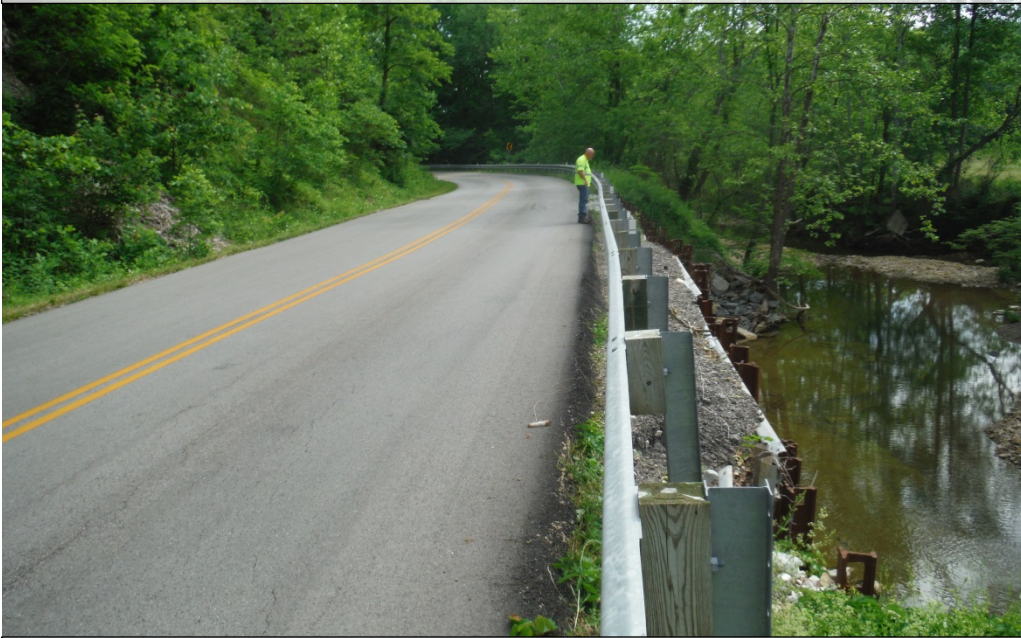
Location 7: KY 377 MP 4.45 to MP 4.50

Slope/shoulder stability issues adjacent to the roadway near Eddie Stamm Farm at Indian Creek. 5/29/2015

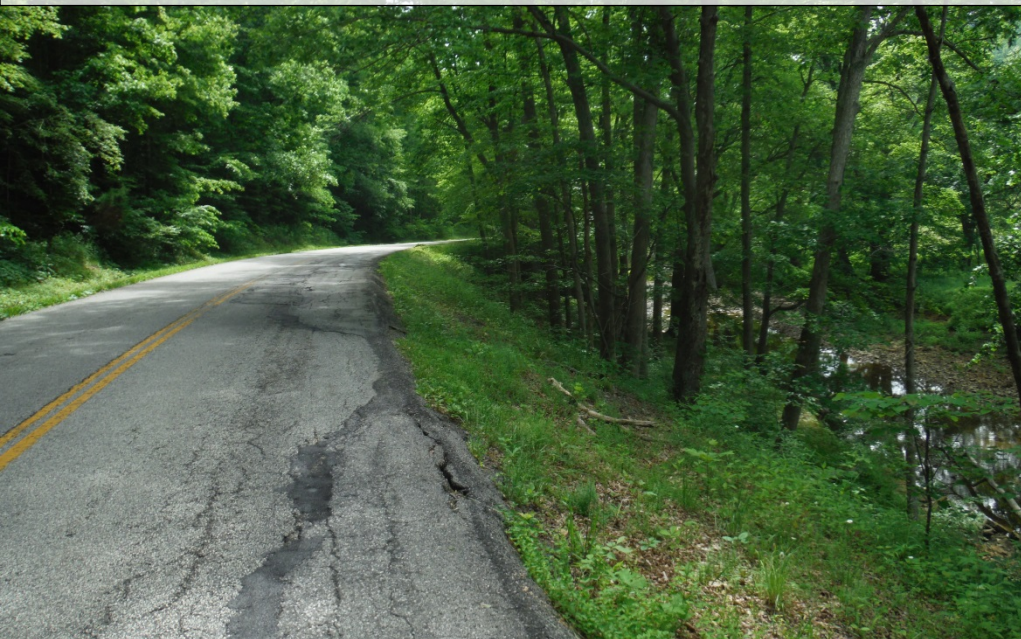
Location 6: KY 377 MP 7.15 to MP 7.35

Slope/shoulder stability issues adjacent to the roadway at Indian Creek. 5/29/2015

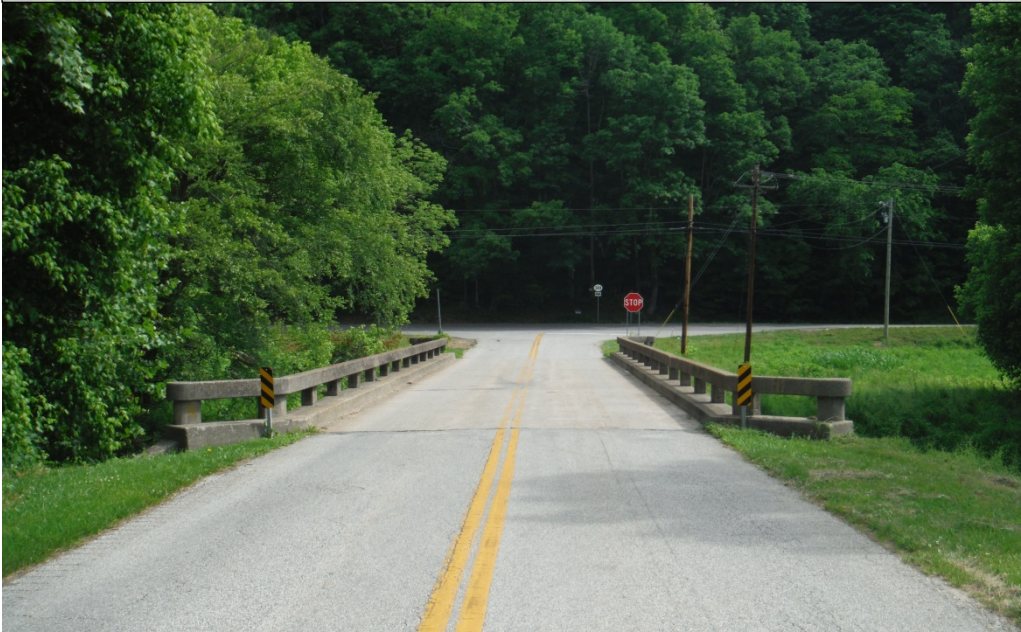
Location 5: KY 344 / KY 377 Intersection

Occasional flooding of the intersection requires KYTC maintenance crews to close the road until water recedes.

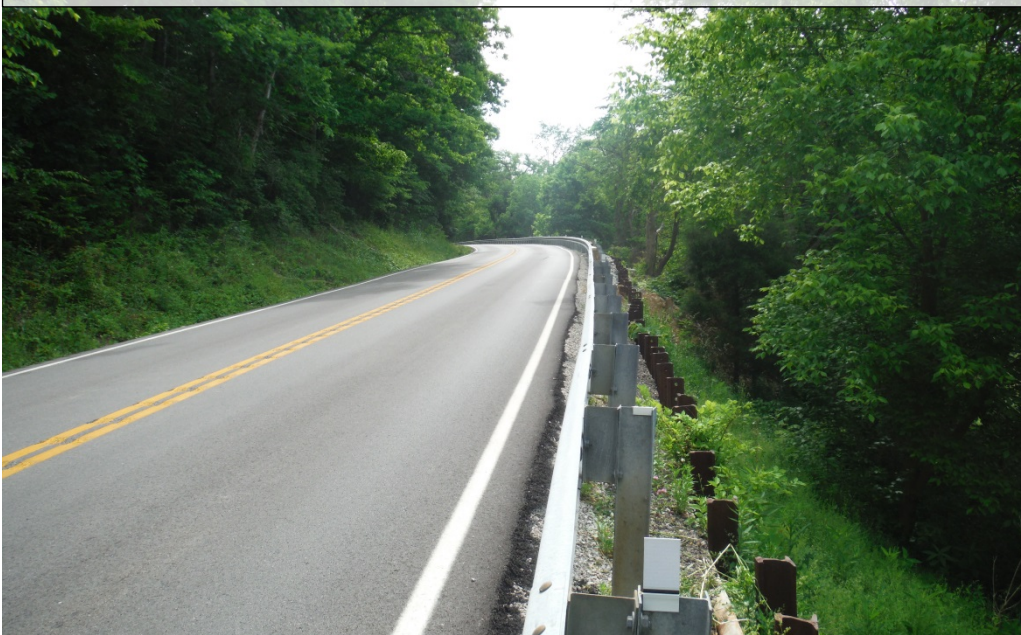
Location 4: KY 344 MP 14.30 to MP 14.40

Slope/shoulder stability issues adjacent to the roadway near Bob Thurman Curve at Kinniconick Creek.

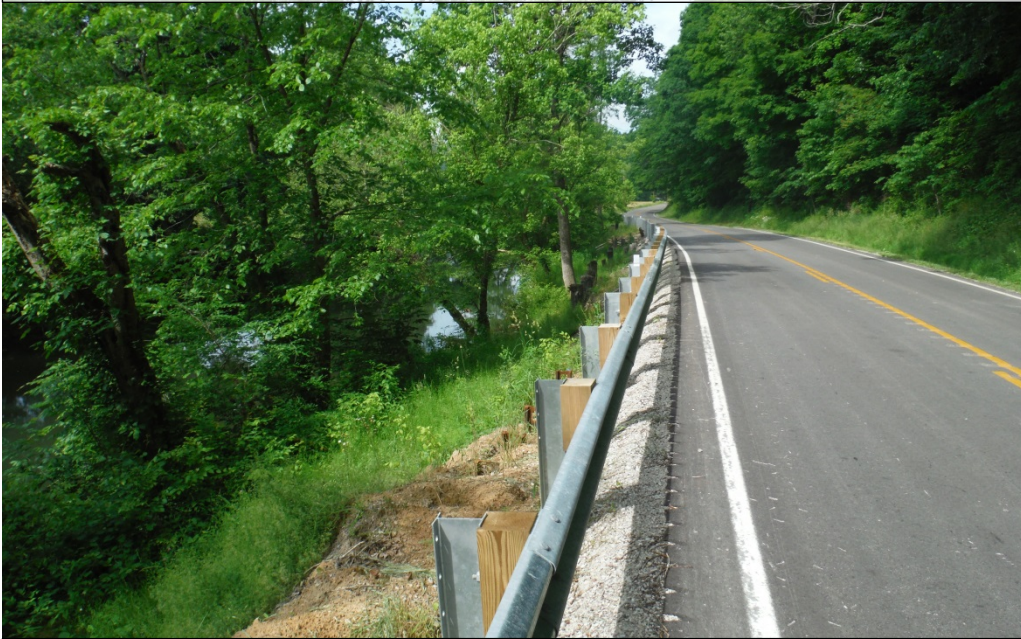
Location 3: KY 344 MP 15.70 to MP 15.90

Slope/shoulder stability issues adjacent to the roadway near “Beaver Pond” at Kinniconick Creek.

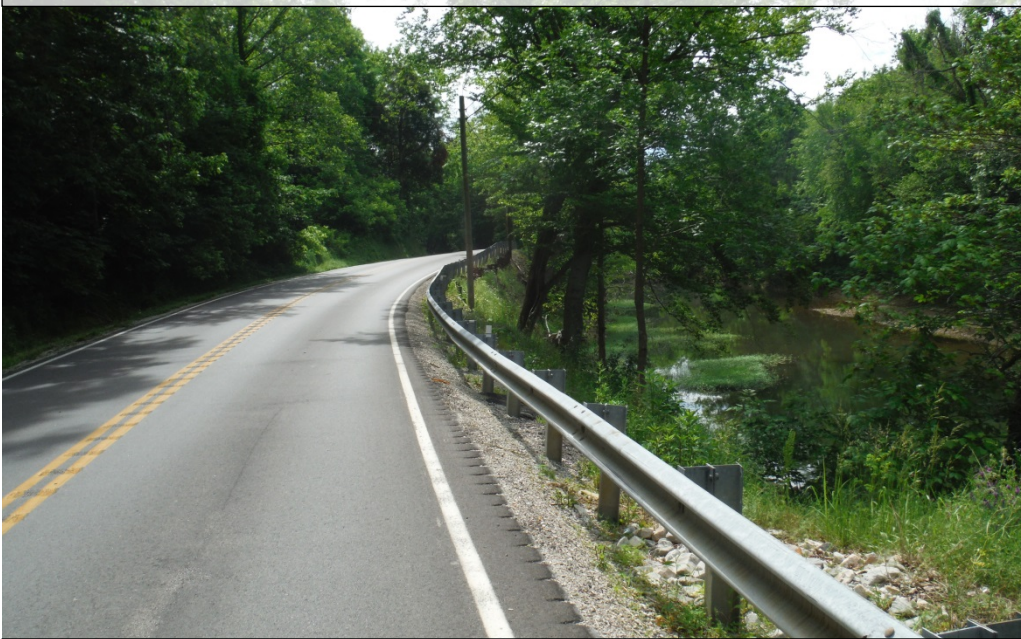
Location 2: KY 344 MP 18.10 to MP 18.20

Issues adjacent to the roadway near the Kinniconick Hotel at Kinniconick Creek.

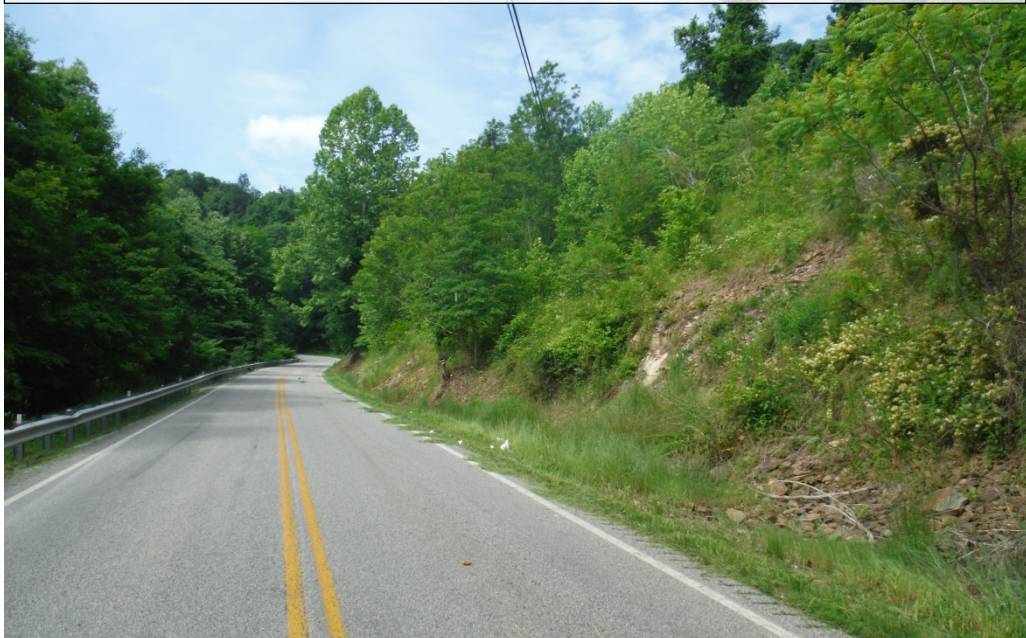
Location 1: KY 59 MP 21.8 to MP 23.50

Along the west slope of Vanceburg Hill, there are more problems with the uphill side falling into KY 59 than with the downhill side falling away from KY 59.
