MEMORANDUM

DATE: May 31, 2022

SUBJECT: Powell, Wolfe, & Menifee Counties
Red River Gorge/Daniel Boone National Forest
Transportation Planning Study
Mars # 1343807P
Geotechnical Overview Report

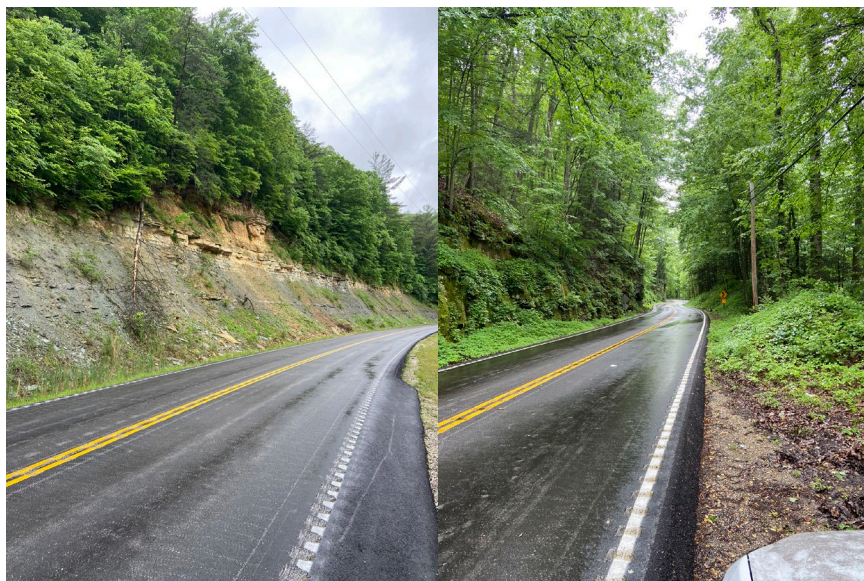
The intersection of KY-15 and KY-11 in Slade is located in the valley bottom where the Middle Fork of the Red River and Clear Branch Creek converge. Bearing East KY-15 follows Clear Branch Creek upstream and crosses the Mountain Parkway. The two-lane road once on the southern side of the Mountain Parkway exposes the Borden Formation in a road cut that provides horizontal space between the existing roadway and the parkway. At approximate mile point 1.3 KY-15 begins to drastically curve and wind to the top of Pine Ridge near the Wolfe County border. Two sharp curves are flanked by rock cuts on the south side and steep fills on the north side. KY-15 has recently been paved and no geotechnical concerns were noted. Due to the extreme curves site lines were limited.

Image 1: Rock cut Borden Formation, looking West, MP 2.7.
Image 2: Looking West, MP 0.7.

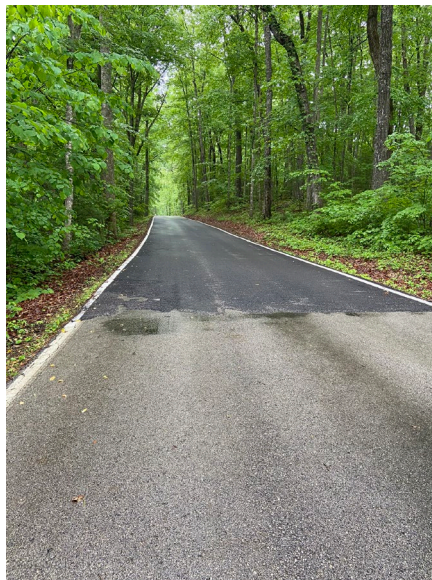
From Pine Ridge KY-715 winds its way on top of an unnamed ridge. The roadway is a narrow two-lane road that follows the top of the ridge with no cuts and a very shallow fills. In places, spot improvements have been made to the surface of the roadway where natural drainage may have impaired the roadway.

Image 3: KY-715, spot improvement, MP 7.4.

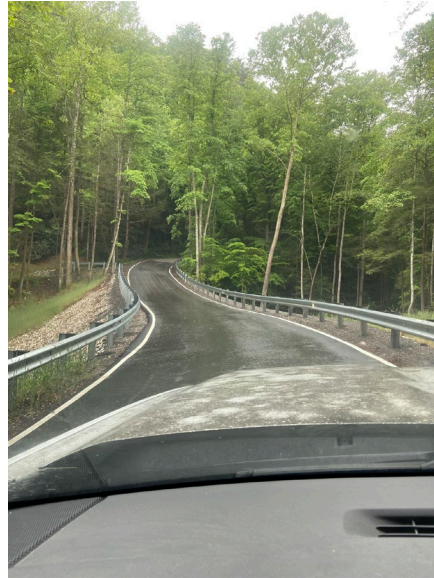
At approximate mile point 10.6 KY-715 begins its steep descent along the southern side of Swift Camp Creek until it reaches the intersection of the Red River and the Menifee County line. The road winds with the ridge flanks with several tall, steep, fills down the valley to Swift Camp Creek. Several slides have been previously corrected and other breaks in the pavement were noted.

Image 4: KY-715, looking South, road repair a drainage crossing, MP 11.1.

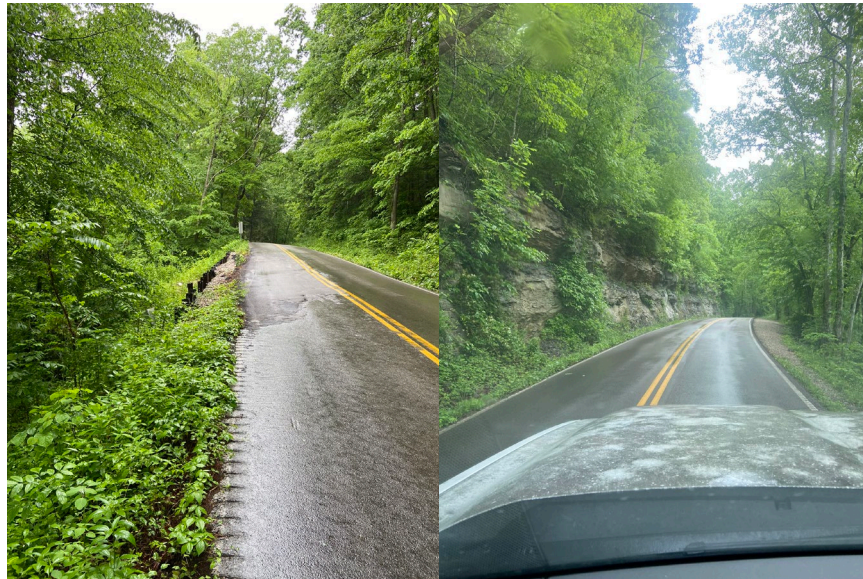
Once in the Red River valley bottom KY-715 follows the Red River until its intersection with KY-77. In places, road cuts were created to provide space between the roadway and the Red River. Several places displayed embankment instability and previous remediations using rails.

Image 5: KY-715, looking East, slide repair with rails, MP 2.2

Image 6: KY-715, looking East, rock cut exposing Borden and Slade formations.

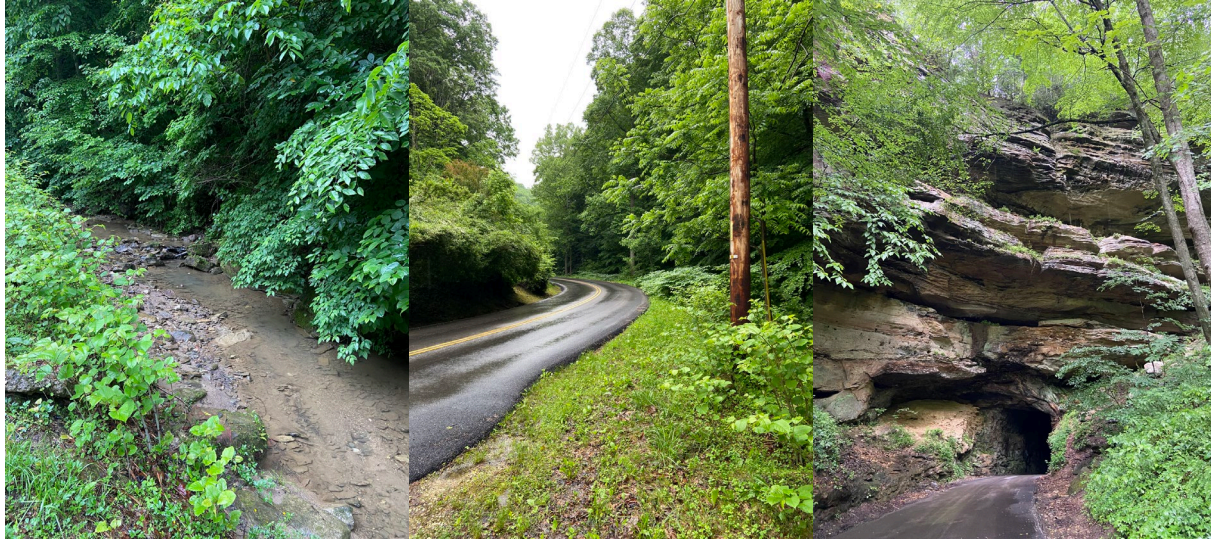
KY-77 begins in the valley bottom of the Middle Fork of the Red River and follows Moreland Branch Creek upstream, climbing in stratigraphic section until it reaches the 900-foot long Nada Tunnel at mile point 2.1. Moreland Branch is a small creek with a narrow valley. The roadway is a narrow two-lane road that follows the stream with several small crossings. No rock cuts were noted and very little fills were utilized because the roadway remains on the valley bottom.

Image 7: Moreland Branch.
Image 8: KY-77, looking East.
Image 9: Western entrance to Nada Tunnel

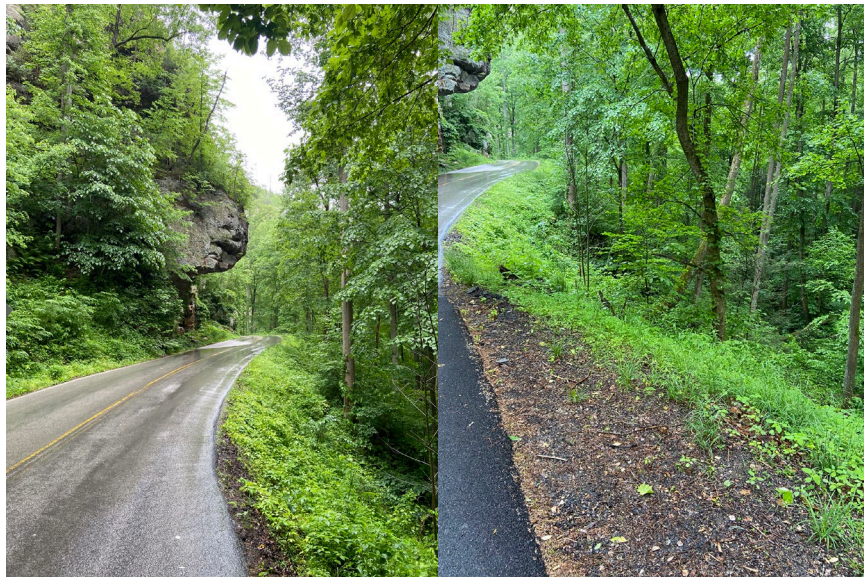
Once through the Nada Tunnel KY-77 descends down Grays Branch Creek until it intersects the Red River. The roadway is placed well above Grays Branch with rock cuts on the north side and steep embankments towards the valley bottom on the south side. Rock overhangs are present where differential weathering has occurred and roadway surface breaks are present in areas with steep fill slopes.

Image 10: Rock overhang exposed on Eastern side of Nada Tunnel.
Image 11: Steep fill slope towards Grays Branch on East side of Nada Tunnel.

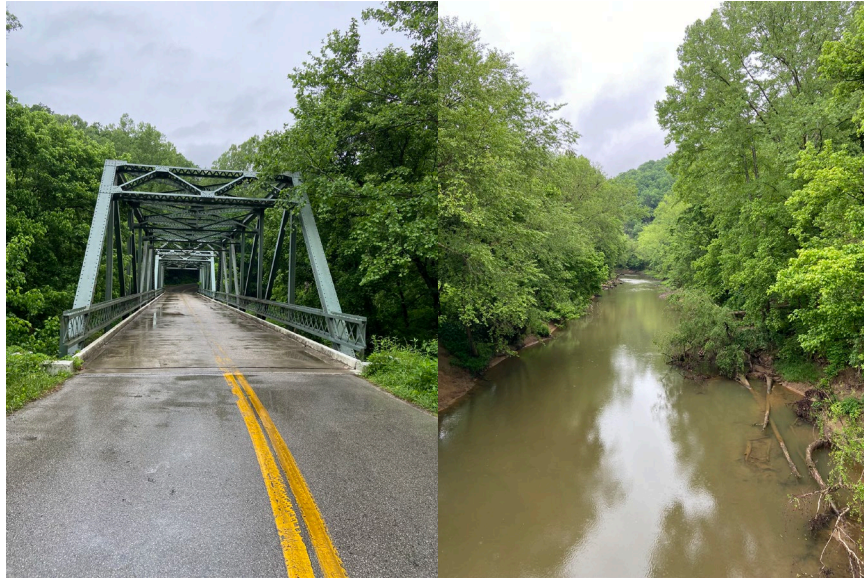
Image 12: Bridge over Red River, MP 4.3.

Image 13: Red River, MP 4.3.

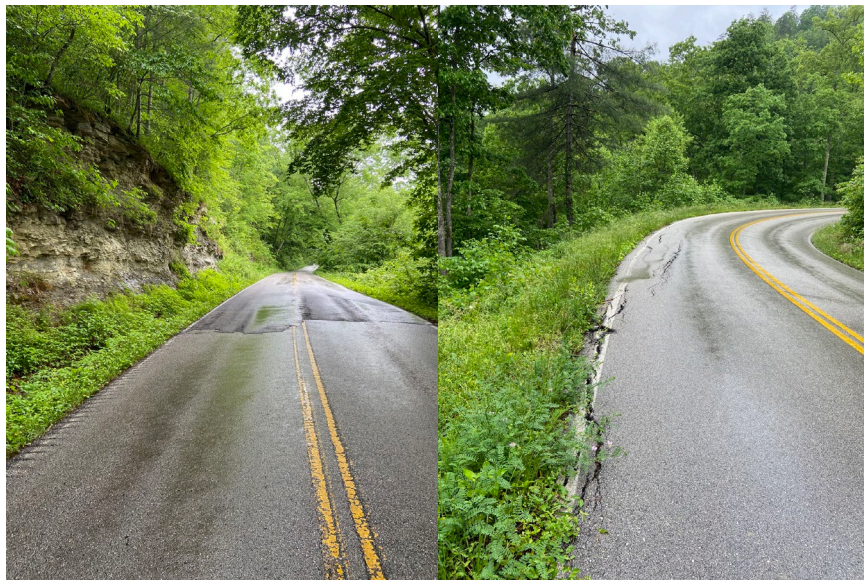
Similar to KY-715 along the Red River KY-77 is flanked by rock cuts on the north side and embankment fills slopes on the south side. The rock cuts exposed the Borden Formation. Several places in the roadway displayed cracks in the surface indicating fill instabilities. Repairs were noted in a few places.

Image 14: Rock cut exposing the Borden Formation with roadway surface repair, MP 0.3.

Image 15: Roadway surface cracks, Grays Branch side, MP 3.7.

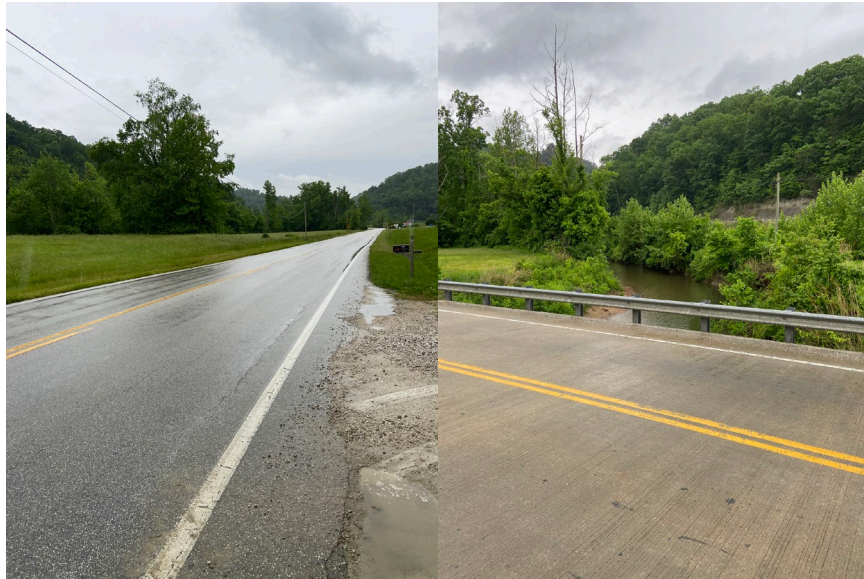
Image 16: KY-11, looking north along the Middle Fork of the Red River valley.

Image 17: Middle Fork of the Red River crossing.

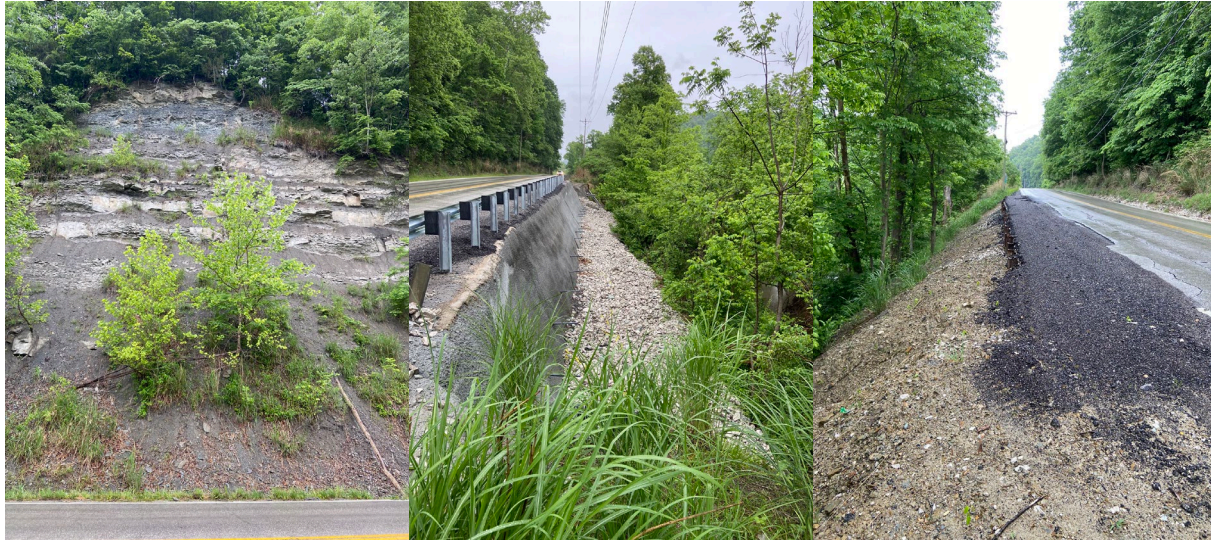
To provide space between KY-11 and the Middle Fork of the Red River, mile point 4.6, a large road cut was made exposing the Borden Formation. Differential weathering between interbedded siltstone and shale was observed. Two major landslide repairs were observed where two sections of the embankment were undercut by the stream. The slide at mile point 4.7 utilized quickcrete with horizontal drains indicating water movement along the cut slope also contributed to slope stability failures.

Image 18: Rock cut, exposing Borden Formation, KY-11 MP 4.6.

Image 19: Slide repair, quickcrete and horizontal drains, KY-11 MP 4.7.

Image 20: Slide repair, rails, KY-11 MP 5.0.
