**A
DATA
NEEDS
ANALYSIS
STUDY**

**Item 7-1116.00 Bridge Replacement on Herrington Lake,
KY 152 at Mercer/Garrard County line**

**Prepared By: Division of Planning & District 7
Kentucky Transportation Cabinet
June 6, 2011**

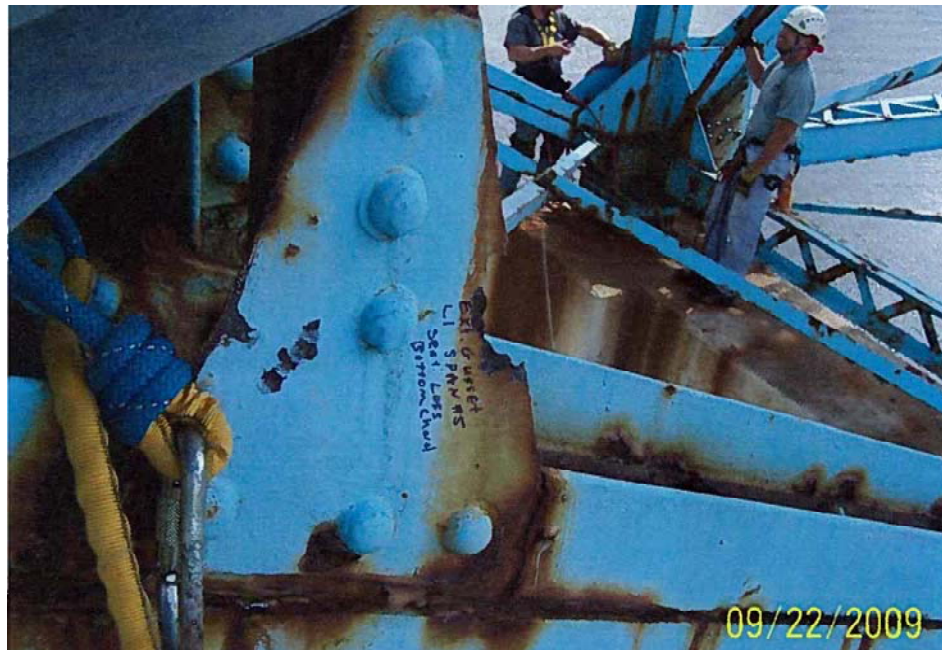
Figure 5: Structural condition of the bridge in 2009

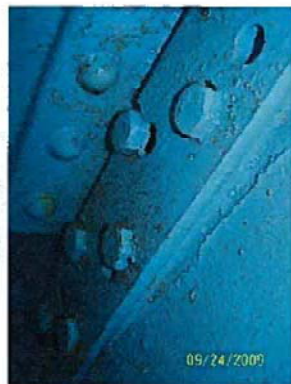
Typical view of previously rehabed diagonals. Having problems were the bolt holes had to be redrilled during the rehab.

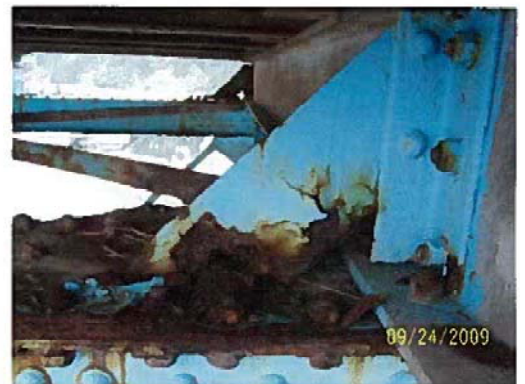
Typical view of floor beam bracing. Most have heavy section loss and some braces are completely gone or broken.

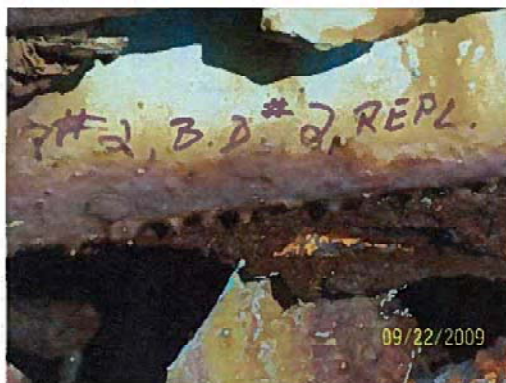
Close up view of bearing device #2 at Pier #2. Bearing device needs to be replaced.

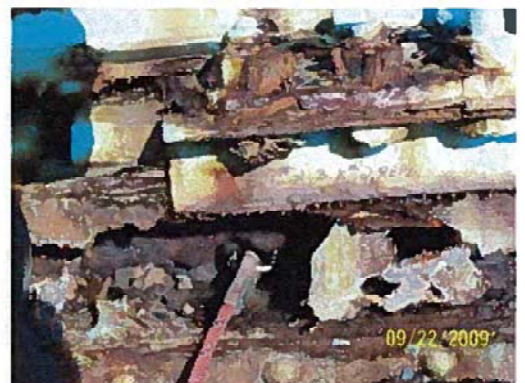
Exterior view of bearing device #2 at Pier #2. Bearing device needs to be replaced.

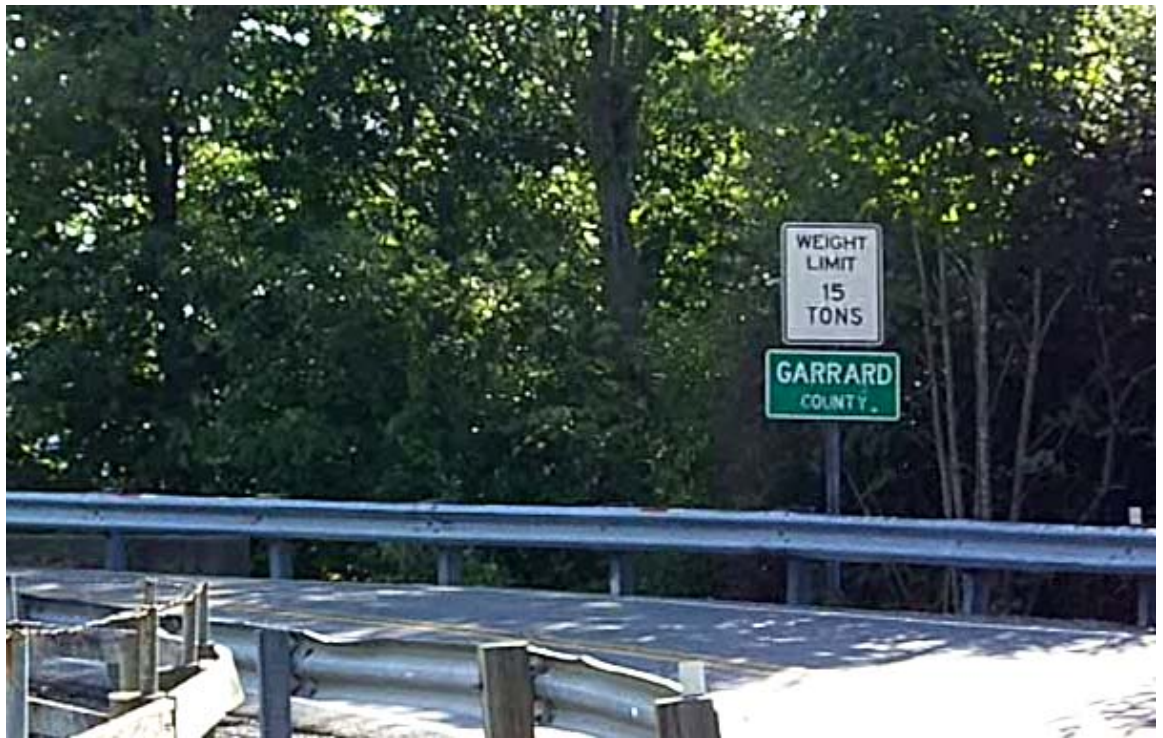
Due to the condition and changes in the weight carrying capacity of the bridge, the posted weight limit is 15T (see Figure 7). A memo was released on June 1, 2010 by District 7 Office to this effect (Appendix G).

Figure 7: Current posted weight limit on the bridge is 15T

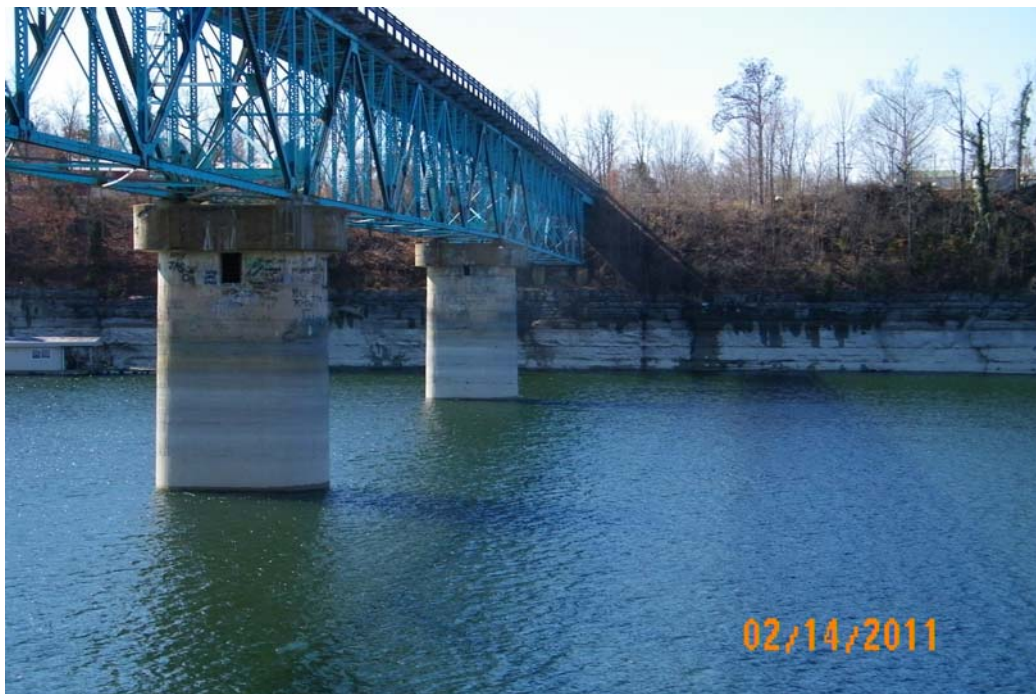
Pier 3 (front) Pier 2 (rear)

An article by F.C. Mahan from the *Kentucky Engineer* (year unknown - see appendix) supplied to this office by the District indicates that there have been some significant problems at Pier 2. Once the downstream dam was constructed and water began to back up around the piers it was noted that Pier 2 was actually rising and rotating. In the article Mahan states that the earliest inspection on record was in March of 1932 and that the top of Pier 2 was 1.33 feet higher than pier 3. (Mahan indicates that earlier records had been lost in a fire). Both were supposedly constructed to the same elevation. Mahan also states that "At the height of the movement the pier had risen approximately 30" and had tilted upstream and toward the Mercer County side approximately 12". This office does not have current information that indicates the elevation difference between the two piers.

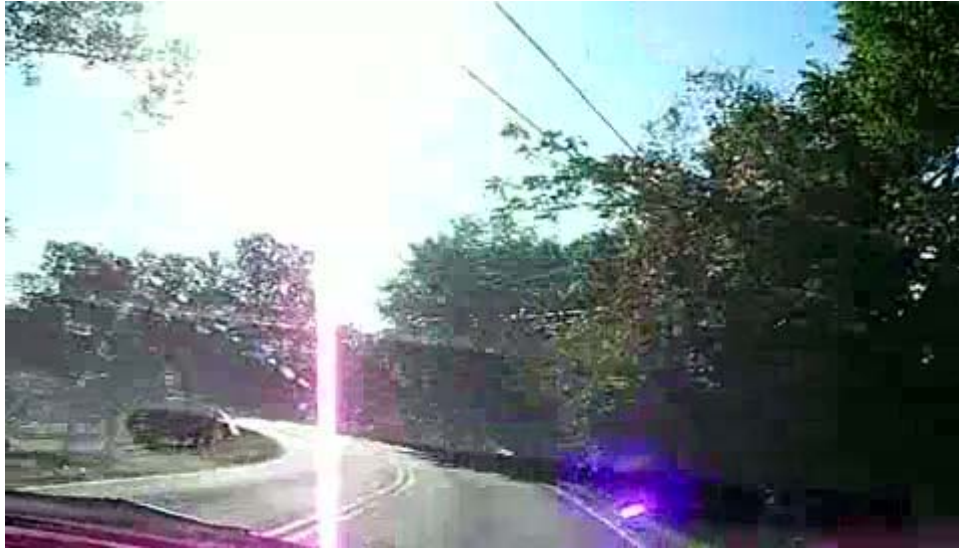
Sharp curve on KY 152 entering the bridge from west side – reason for some crashes

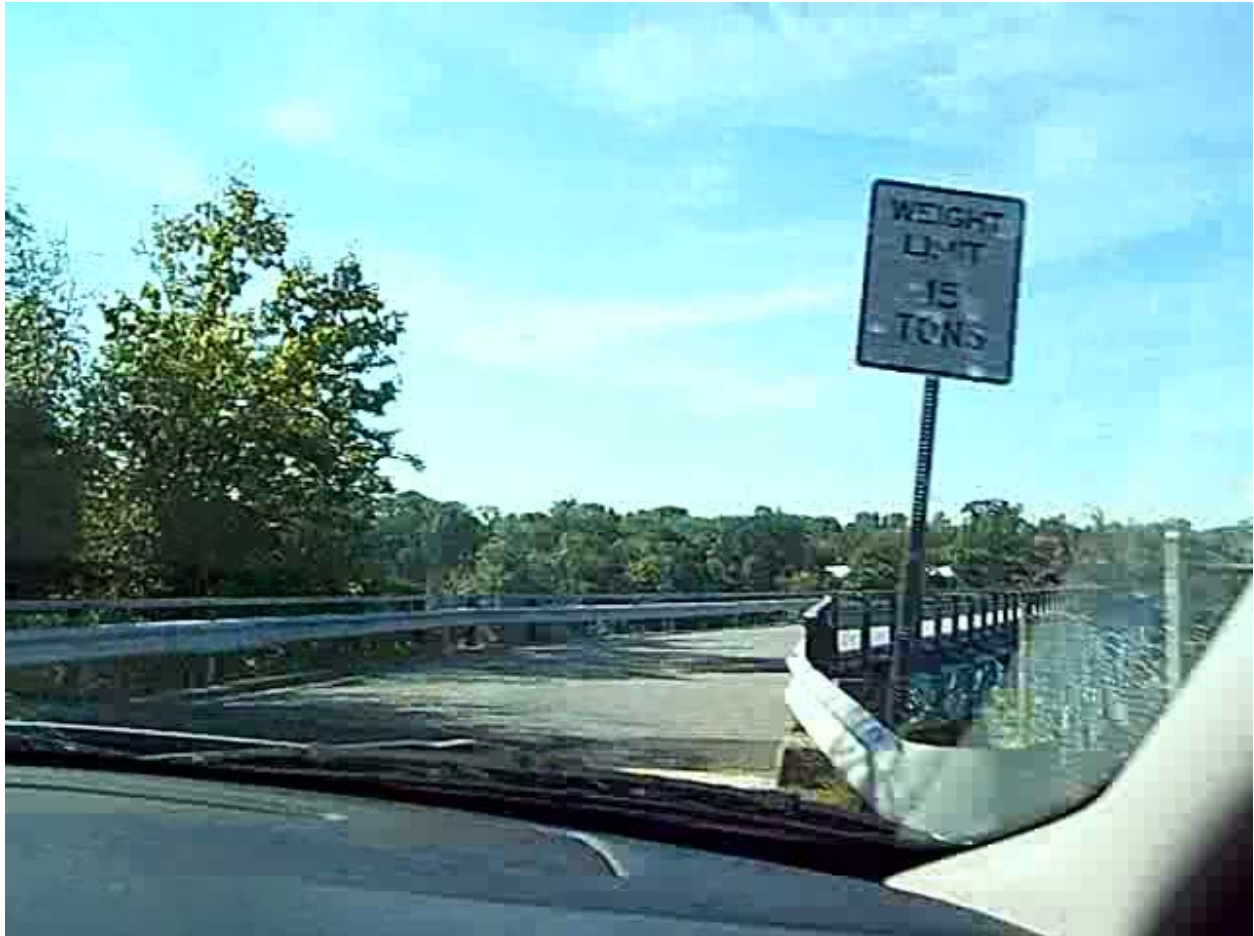
Crashes occurred at the curve to the bridge on the east side
