MEMORANDUM

DATE: January 13, 2017

**SUBJECT: Lincoln County
US-27 Corridor improvements from Somerset to Lexington
Halls Gap
Mile Point 11.169-15.881
Item # 8-167.00
Mars # 9011101D
Preliminary Geotechnical Assessment**

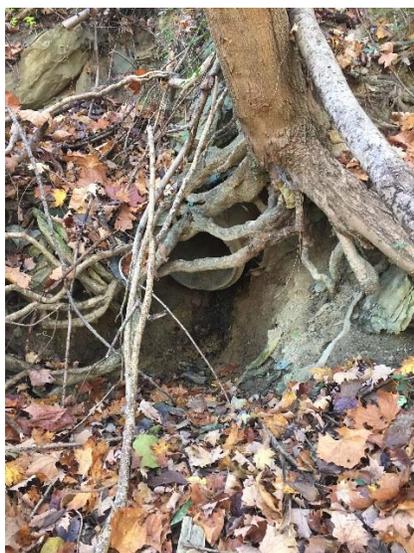
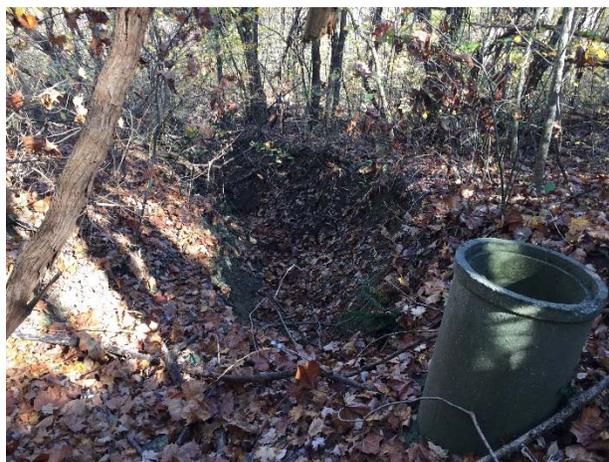
MP 12.3-13 – Existing embankments on the right side have been historically unstable. Current signs of stability problems are still present. Existing embankment slopes in this area are too steep. A more thorough investigation for a chosen alternate would be required but it is likely that it will be necessary to excavate the material in the over steepened areas to bedrock from the vicinity of the existing northbound driving lane down on a 1:1 slope and reconstruct with properly compacted embankment on a 2H:1V slope. A drainage blanket and embankment benching would be required. Any installed retaining structures (H-piles or railroad rails) would be removed as part of the reconstruction. It should be noted that two of the concrete pipes that were investigated at the toe of the slope in this area show signs of extreme erosion. Portions of these pipes have separated and dropped, including the headwalls. It is likely that these concrete pipe joints have separated in the fill and are causing water to directly enter the embankment. This causes further issues with slope stability. It is recommended that a camera is used to evaluate these pipes for further mitigation.

Failing concrete pipe

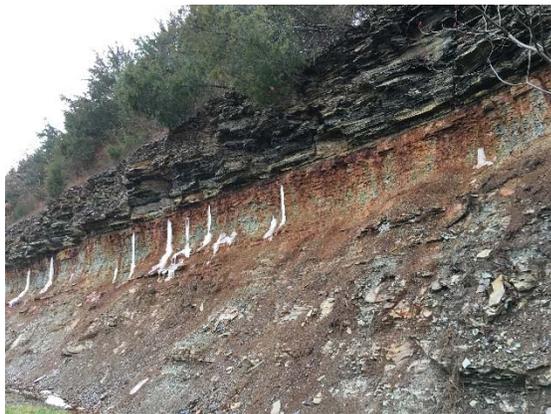
MP 13.9-14 – This existing cut contains the acid producing New Albany Shale Formation material (dark material at top of cut in picture). Cuts in this formation are typically over-excavated on a 2H:1V slope and capped with impervious control surface water from reacting with the pyrite in the shale.

New Albany Shale Formation

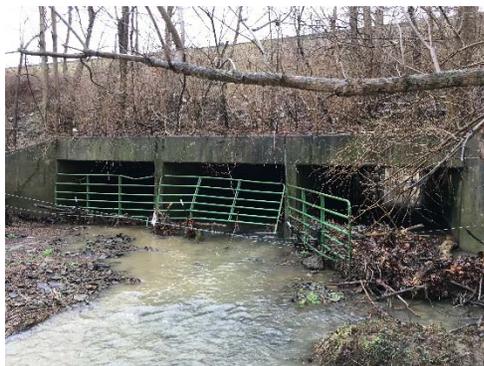
MP 15.7 – There is an existing triple barrel culvert at this location. The embankment on the left side has a dip in the guardrail that could indicate some previous slope instability. The base of that slope shows indication of being wet year around.

Existing Culvert
