## **Appendix F**

### **Renfro Dam**

# KYTC DAM ASSESSMENT STUDY – RENFRO DAM

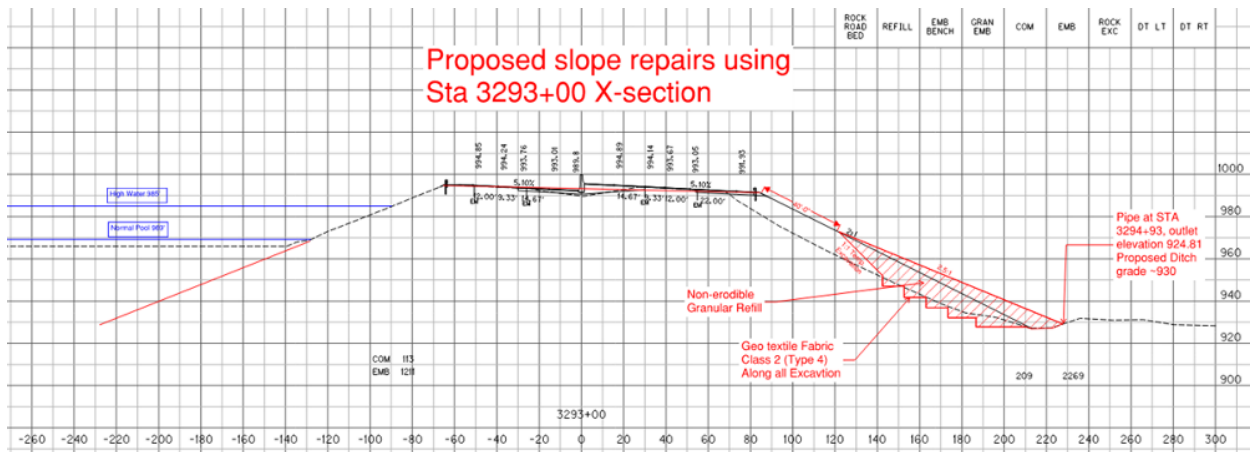
Cross Section for Slope Repair

| <ul style="list-style-type: none"><li>• Reports of shallow sliding prior to the 2001 modifications</li><li>• Bulge observed in the 2024 KDOW inspection</li></ul> | | <ul style="list-style-type: none"><li>• Wide (140' wide at the crest)</li><li>• 25' of freeboard at normal pool</li><li>• Successful intervention is almost certain</li></ul> | |

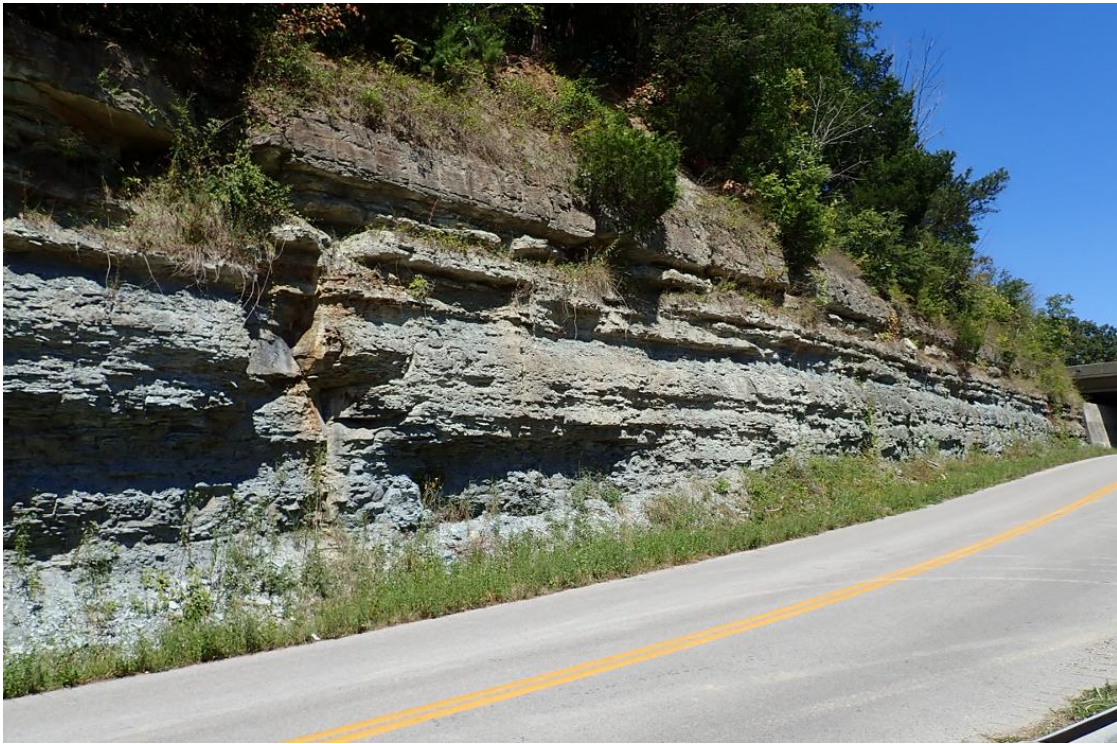
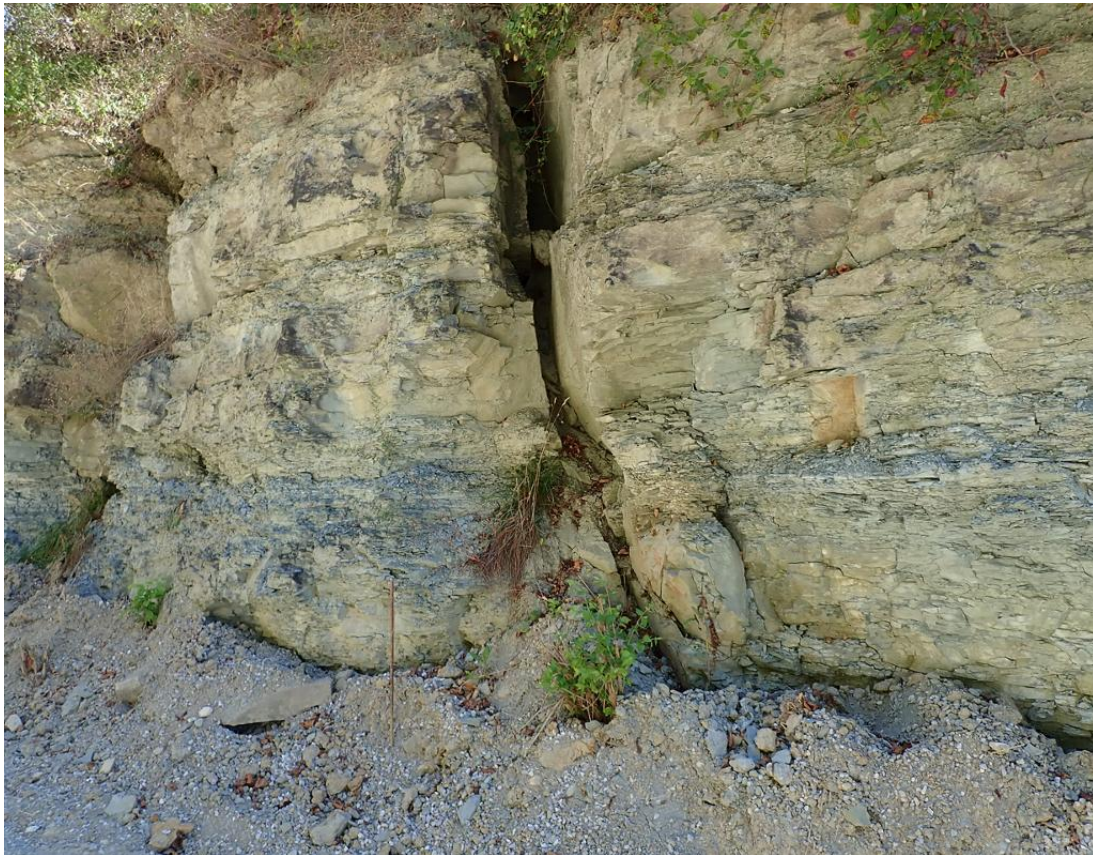
***Site Visit Photo***

| <ul style="list-style-type: none"> <li>The geologic map of Kentucky suggests we are in an area of moderate to high karst activity.</li> <li>Fissures and discontinuities were observed in the rock abutments in 2025 that could indicate weathering.</li> <li>There is a possible sinkhole above the reservoir, to the west of the dam. However, that sinkhole appears to be in a higher formation.</li> </ul> | | <ul style="list-style-type: none"> <li>The foundation rock is siltstones with some fracturing. No indication of soluble limestones.</li> <li>The geologic map of Kentucky suggests we are in an area of moderate to high karst activity. However, when you zoom into the dam site, it appears that the karstic rock formations are above the elevations of the dam.</li> <li>There are no sinkholes at the dam mapped on the KGS lidar survey</li> <li>No karst features were observed in the 2025 inspection</li> </ul> | |

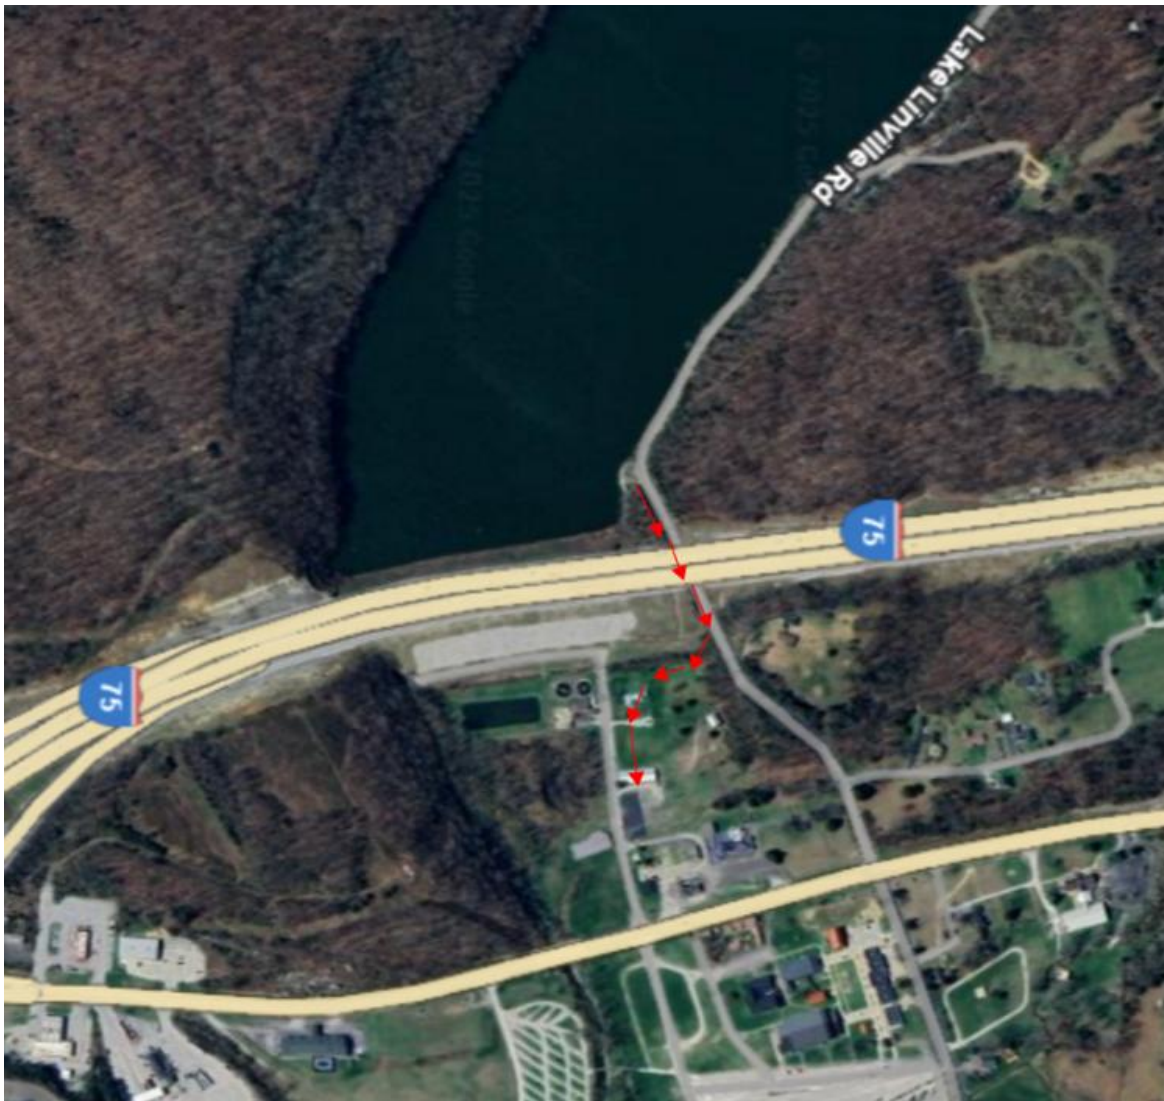
*Auxiliary Spillway Estimated Flow Path*

through Lake Linville Road underpass. The water levels continue to rise and overtop the dam crest. The median barrier wall fails to retain the water. No plausible effort is made to raise the crest of the dam. The overtopping flows begin to erode the downstream slope of the dam embankment. The flow causes head cutting, which progresses backward across the width of the dam crest. The dam is breached when the crest erosion reaches the upstream pool. The resulting flows scour downward through the dam embankment, releasing the reservoir.

| More Likely (Adverse) Factors | | Less Likely (Favorable) Factors |
|---|---|---|
| <ul style="list-style-type: none"> <li>• <b>The morning glory spillway is prone to clogging from floating debris</b></li> <li>• <b>There are large trees on the lake shore near the morning glory spillway</b></li> <li>• <b>The dam does not currently convey the PMP and it overtops at 1e-5</b></li> <li>• The debris boom is damaged</li> <li>• <b>Median barrier wall was not designed as a flood wall</b></li> <li>• The stormwater in the sag of the road flows in a 24" pipe that discharges on the downstream face.</li> </ul> | | <ul style="list-style-type: none"> <li>• The median barrier wall is robust, it is a continuous concrete wall across the entire dam crest.</li> <li>• The lowest elevation of the median barrier wall is 998.5', the PMP event is 995.3' (3' of freeboard)</li> <li>• Estimated 4-5' of water on the barrier wall for up to one day. Without looking at the details of the wall design, we feel that the wall can support that. There will be water discharging from the storm water system.</li> <li>• No evidence of debris in the 2024 inspection videos within the tunnel</li> <li>• <b>Wide crest (140')</b></li> <li>• <b>The crest is paved in an erosion resistant material</b></li> </ul> |
| Failure Likelihood | FL3 | The probability of overtopping is 1e-5. We are also accounting for the performance of the median barrier wall. |

| Risk Assessment | Category | Notes |
|---|---|---|
| Studies and Investigations | Study the hydraulics and flow path, further evaluate the roads ability to resist erosion, verify the rock conditions in the underpass. | |

The work recommended for Renfro Dam is to modify Lake Linville Road underpass to perform as an auxiliary spillway and/or modify the median crash barrier.

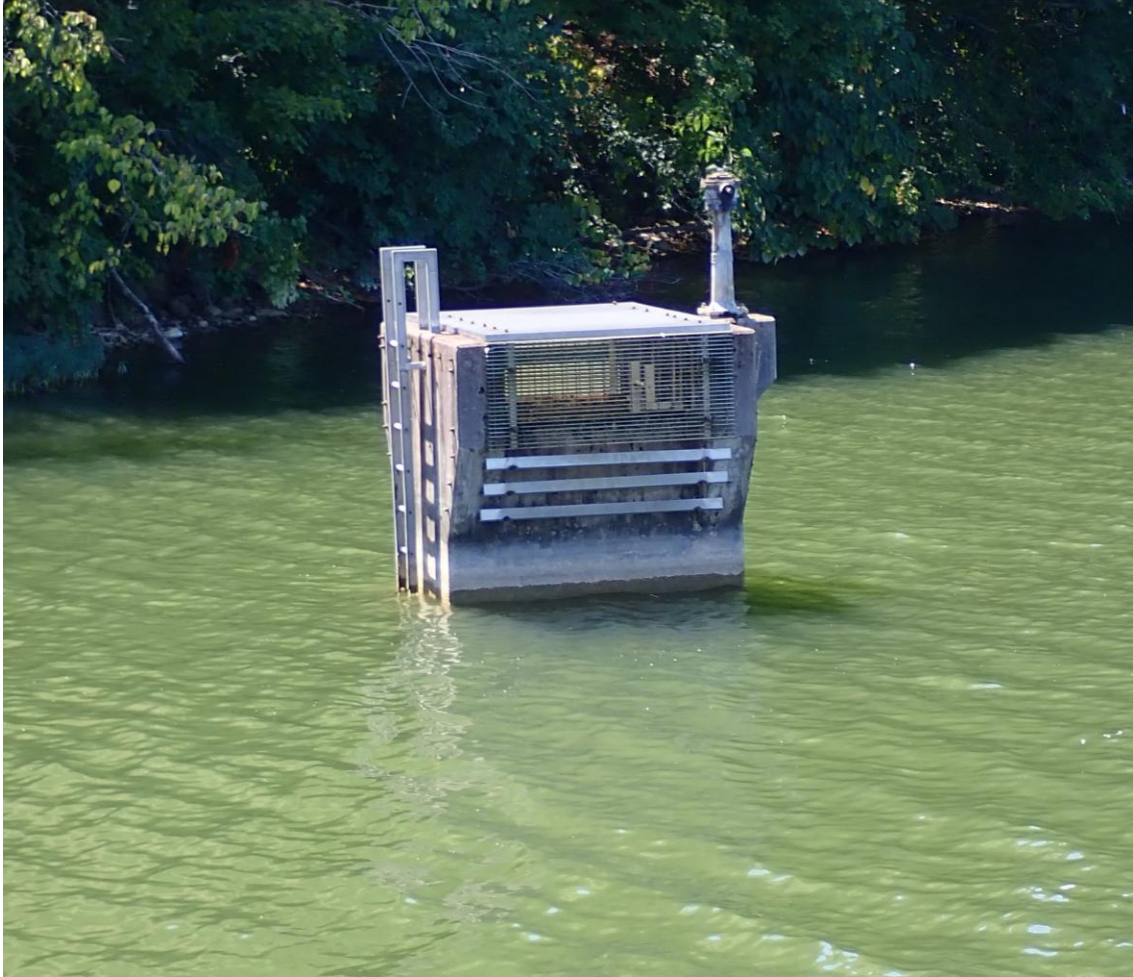
***Site Visit Photo***

| The valve is opened during annual operation. Due to continued corrosion, the valve is unable to be closed. Attempt to close the inlet is unsuccessful. The dam does not fail but the lake is slowly drained through the 24" cast iron low level drawdown pipe. | | | |
| <ul style="list-style-type: none"><li>Age of cast iron valve system (beyond service life)</li><li>The inlet and the valve are submerged in the lake, on the outside of the riser structure</li><li>Inspections have identified corrosion deterioration of the drawdown components</li></ul> | | <ul style="list-style-type: none"><li>The flow is limited by the 24" pipe</li><li>The system is operated every year</li><li>The flow discharges into the 11' diameter tunnel.</li><li>The 24" pipe is inside the 4'x6' conduit and backfilled with concrete.</li><li>Intervention is more feasible because it is possible to bulkhead the outlet inside the riser structure</li></ul> | |
| Failure Likelihood | FL6 | We estimate a 1-10% chance each year when the system is operated/inspected. We have a long stem that has potential for damage. | |

| Maintenance and Monitoring | Replace the slide gate, implement recommendations from 2024 inspections. | |
| Design and Modifications | Replace low level drawdown system. | |

| Recommendations – Renfro Dam | | | | | | | | |
|---|---|---|---|---|---|---|---|---|
| R - REPAIR LLD | Implement repairs identified in the 2024 low level inspection, replace the slide gate if necessary. | O&M | 0 | 6 | Yes | 100K-1M | Intermediate | 6 |
