Subject: Bridge Closure
Warren County
Old Richardsville Road (CR 1350 at MP 0.261) over Barren River

114C00011N -- Steel Truss Notes

March 2018

Typical Defects Throughout Truss

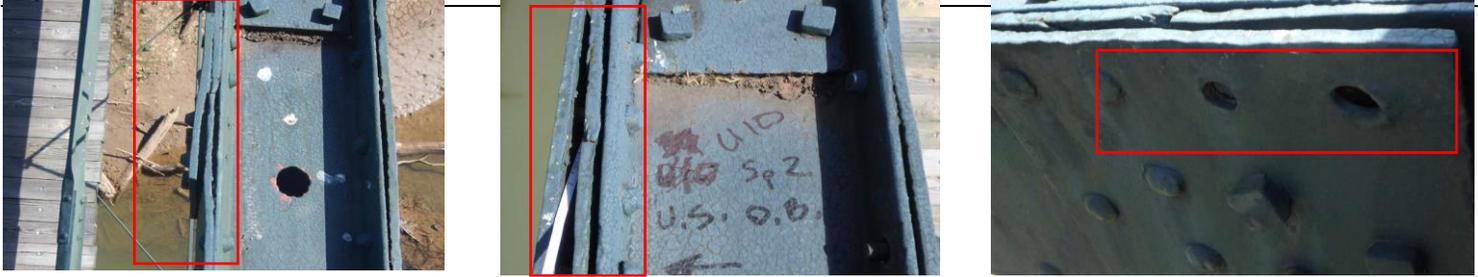
Typical Condition to all Splice Plates of Top Chord - Swelling Pack Rust between Interface of Splice Plate and Exterior Chord Plate has lead to distortion and failure of rivets.

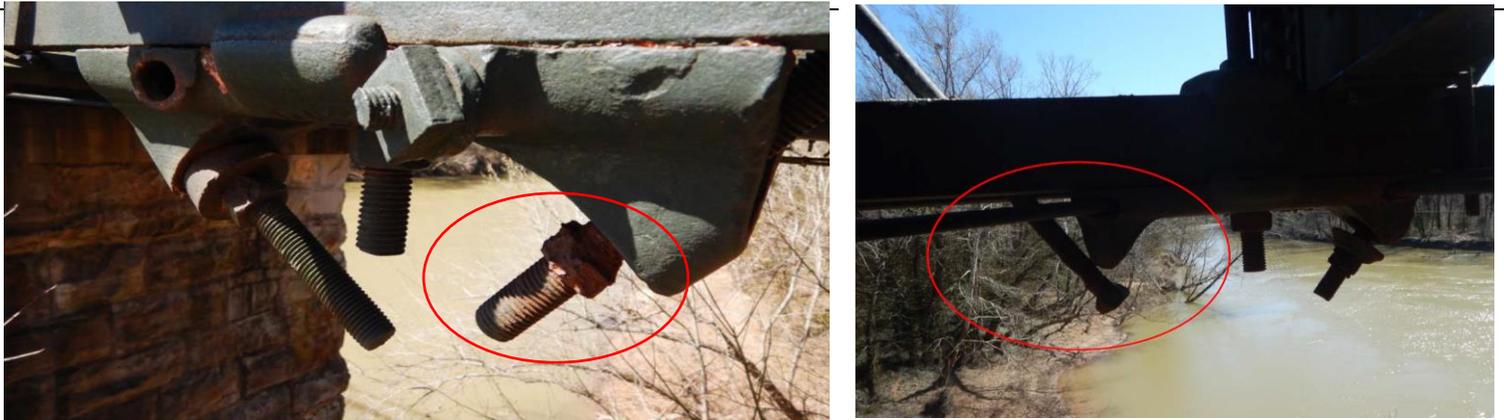
The cast iron, crescent shaped bushings on some diagonal tension counters at the lower chord connections have badly deteriorated along with the nuts that hold the counters in place. Several locations are completely missing the bushings. See [Media Tab "Tension Counter Nut Corrosion"](#) for a catalogue of this defect.

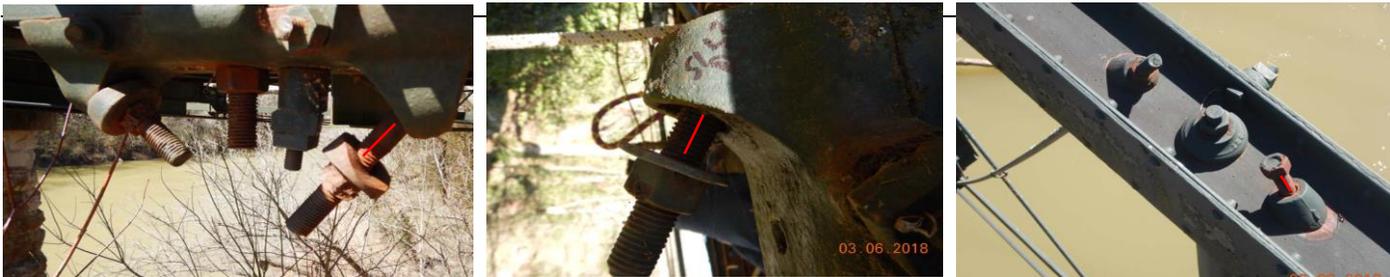
Multiple diagonal tension counters are loose and do not come under tension during live load, resulting force distribution of live load is not evenly dispersed throughout trusses.

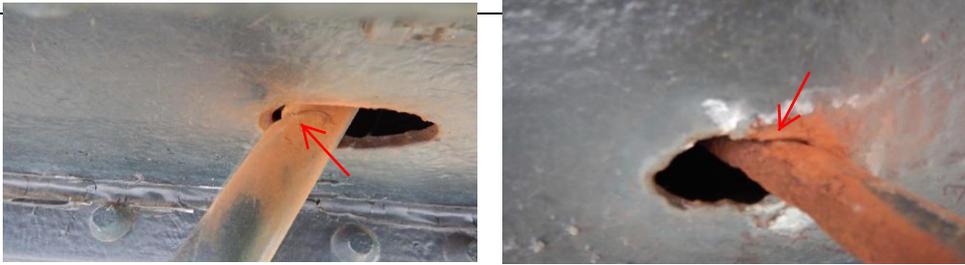
Grooving of Tension Counter at protrusion of Lower Channel of Top Chord Build Up member is widespread throughout the structure

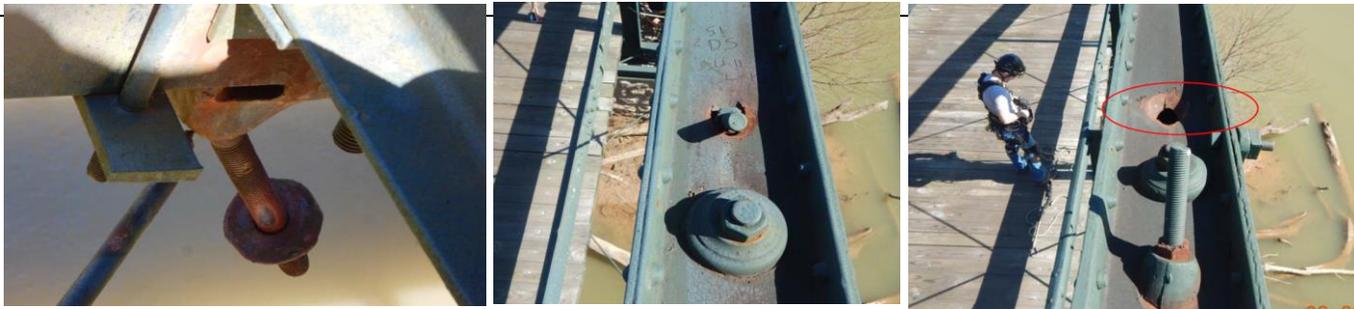
There are multiple instances of Tension Counter Failure. Failure of Tension Counter listed in this table is categorized by failure at member connection Top or Bottom Chord. Typical mode of Failure at Top Chord locations is described as pull through of counter end washer and nut from Top Chord Channel Component. Typical Mode of Failure at Lower Chord locations is described by separation of Tension Counter from Lower Chord Mounting Hardware. See [Media Tab "Tension Counter Failure Summary"](#).

Failure of Tension Counter listed in this table is categorized by failure at member connection Top or Bottom Chord. Typical mode of Failure at Top Chord locations is described as pull through of counter end washer and nut from Top Chord Channel Component. Typical Mode of Failure at Lower Chord locations is described by separation of Tension Counter from Lower Chord Mounting Hardware.
