Structure Inventory and Appraisal Sheet (English Units)

Bridge Key: 13164 Agency ID: 111B00054N SR: 19.7 SD/FO: SD

State 1: 21 Kentucky Struc Num 8: 111B00054N
 Facility Carried 7: KY-1585 Location 9: .3MI. N OF HWY. 272 JCT.
 Rte.(On/Under)5A: Route On Structure Rte. Signing Prefix 5B: 3 State Hwy
 Level of Service 5C: 1 Mainline Rte. Number 5D: 01585
 Directional Suffix 5E: 0 N/A (NBI) % Responsibility: Unknown
 SHD District 2: District 1 County Code 3: Trigg (111)
 Place Code 4: FIPS 0000 Mile Post 11: 4.870 mi
 Feature Intersected 6SINKING FORK
 Latitude 16: 36d 49' 26" Longitude 17: 087d 42' 25"
 Border Bridge Code 98: Unknown (P)
 Border Bridge Number 99

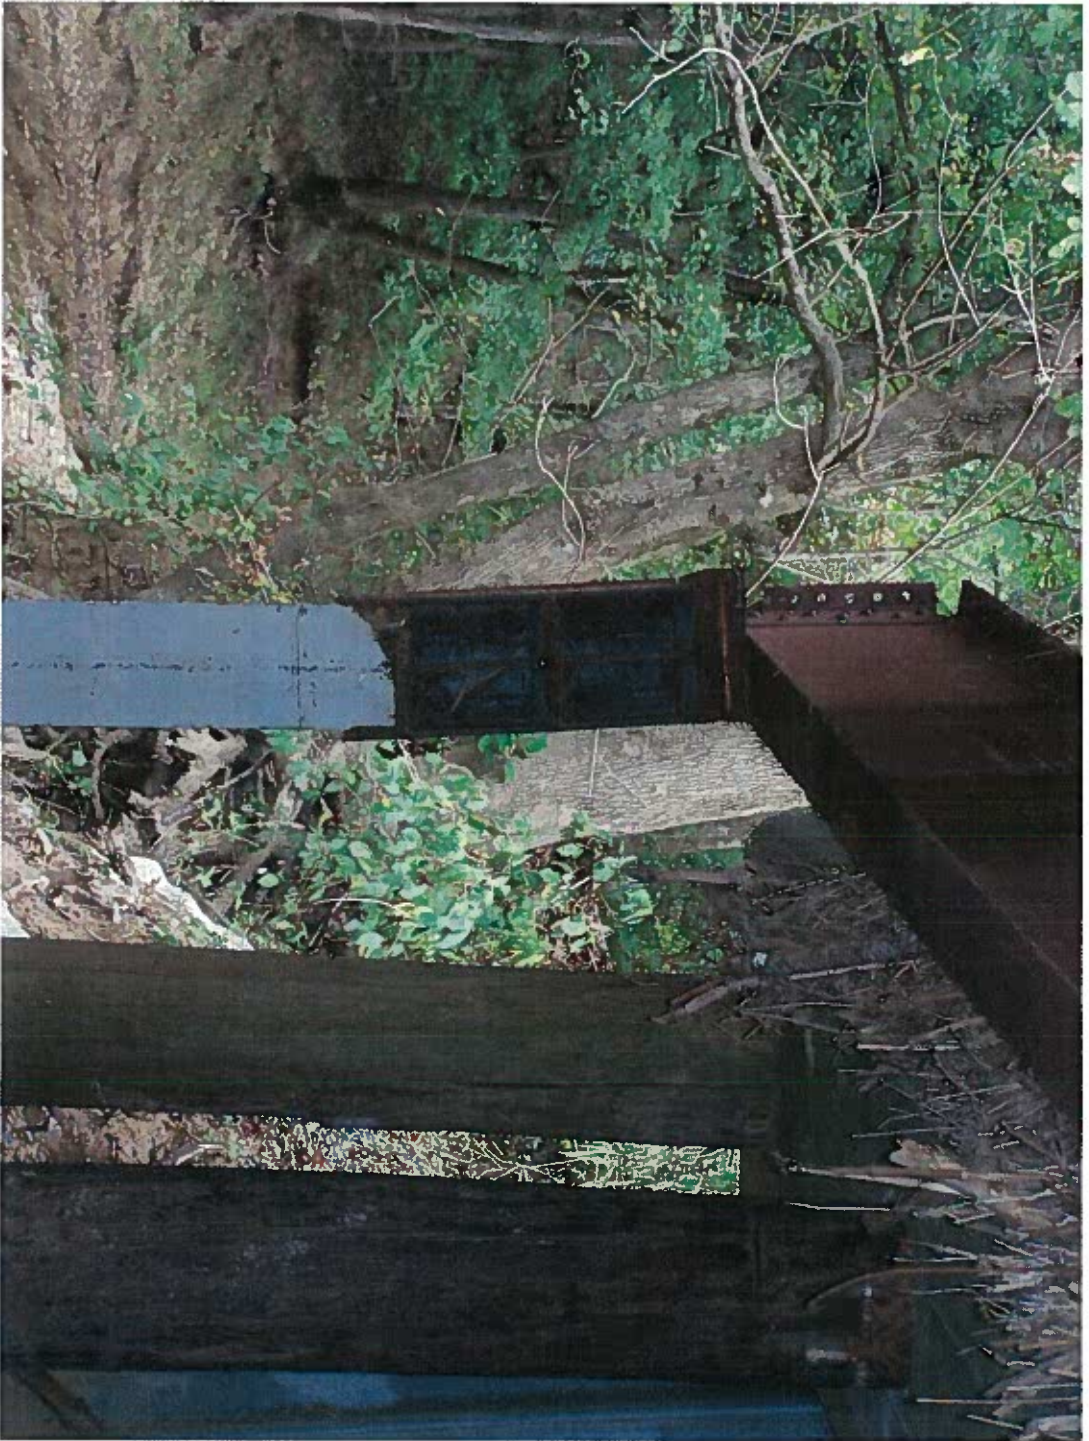
Bent 2, uspsream side
false bent support

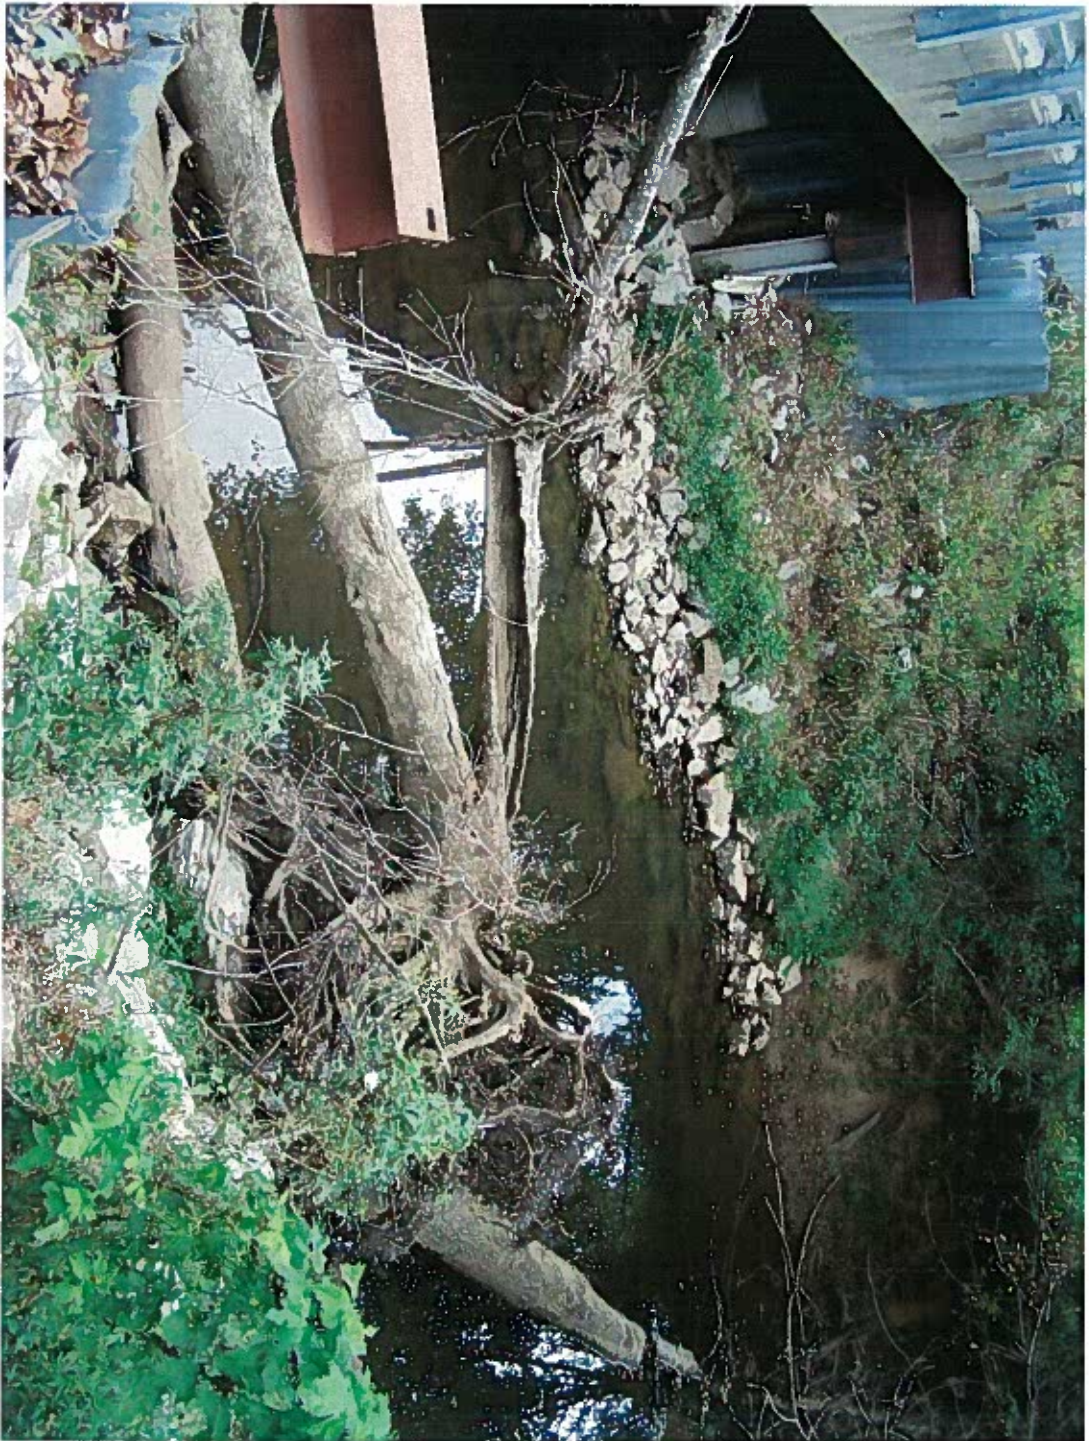
Drift
