IDENTIFICATION			
Bridge ID (8):	018B00080N	MAP BRIDGE	District Number: 1
Route Carried (7):	KY-893		County (3): 35 Calloway
Mile Point:	22.92		Feature Intersected (6): MCCULLOUGH FORK
Location (9):	4.0 MI EAST OF JCT US 641		Road Name: STATE LINE RD E
Structure Description:	21.98 Foot - Single Span Prestressed concrete Box Beam or Girders - Multiple

RTIC Bridge Inspection Report

018-B00080N
04-28-2009

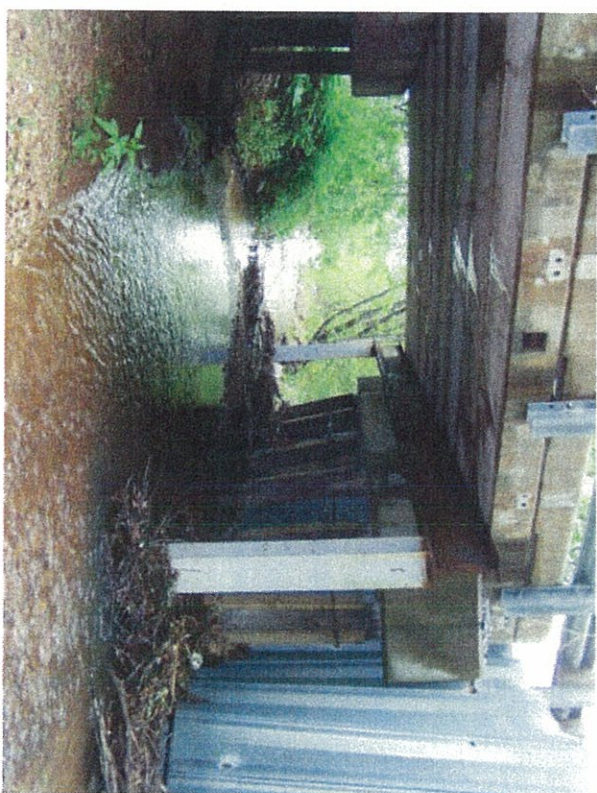
False bent in place at bent 2 due to heavy rotation of bent, piles are severely out of line.

Bent 2, False bent in place.

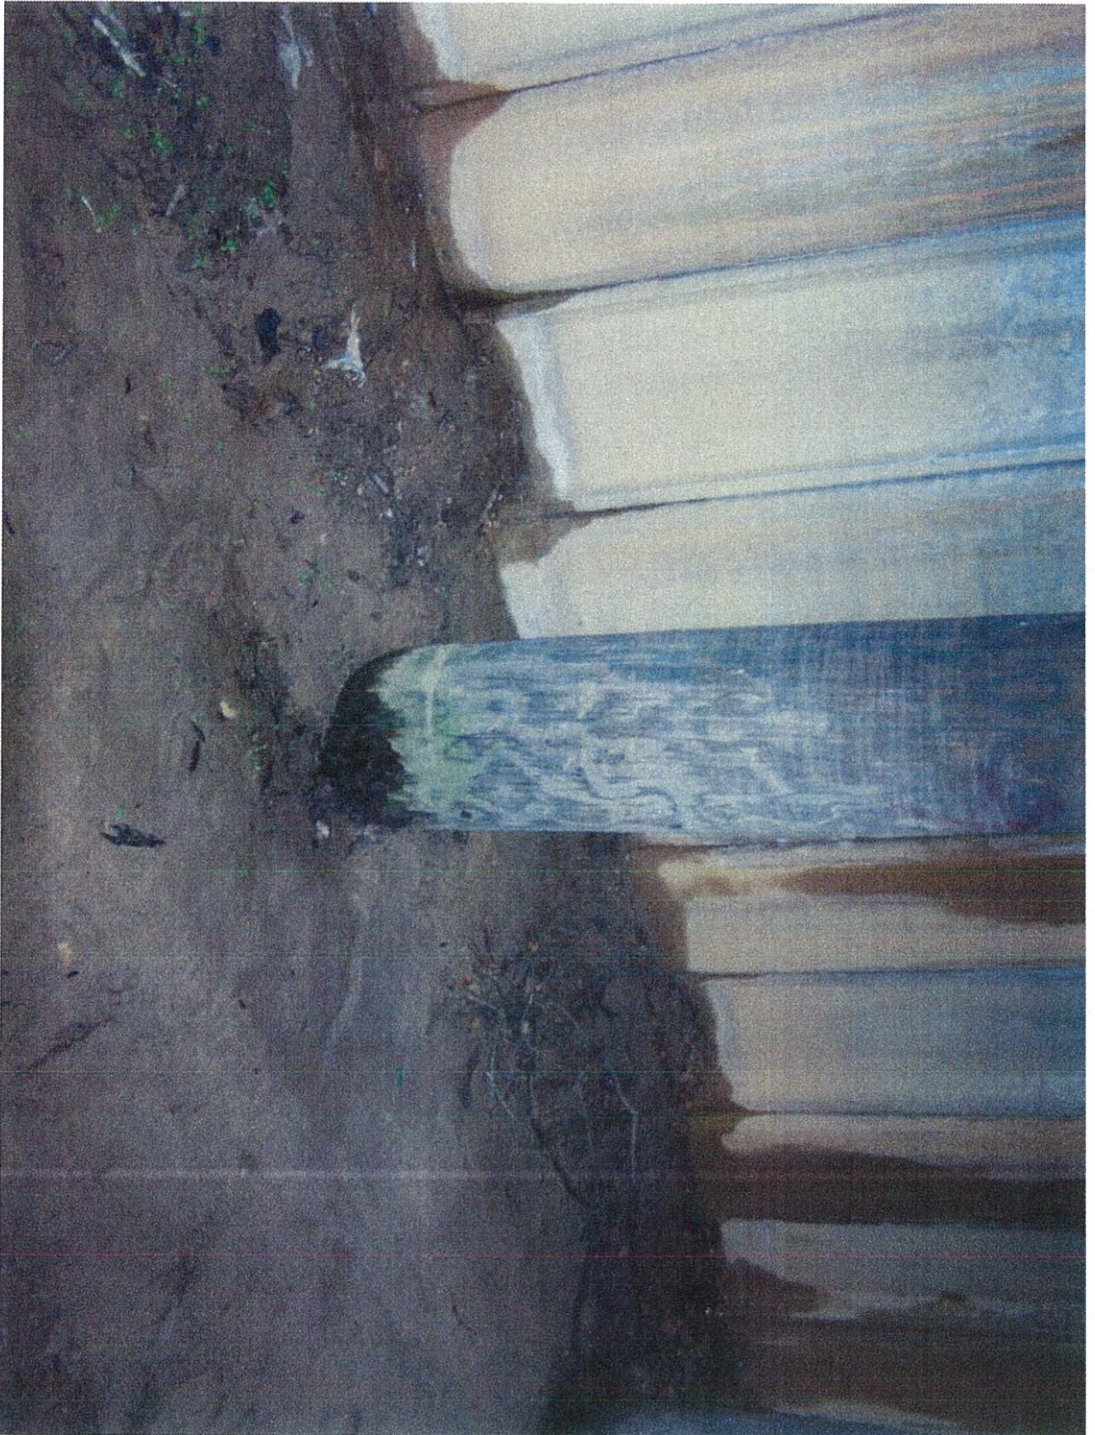
Timber pile typical
