COLLINS ENGINEERS^{INC}

UNDERWATER BRIDGE INSPECTION REPORT

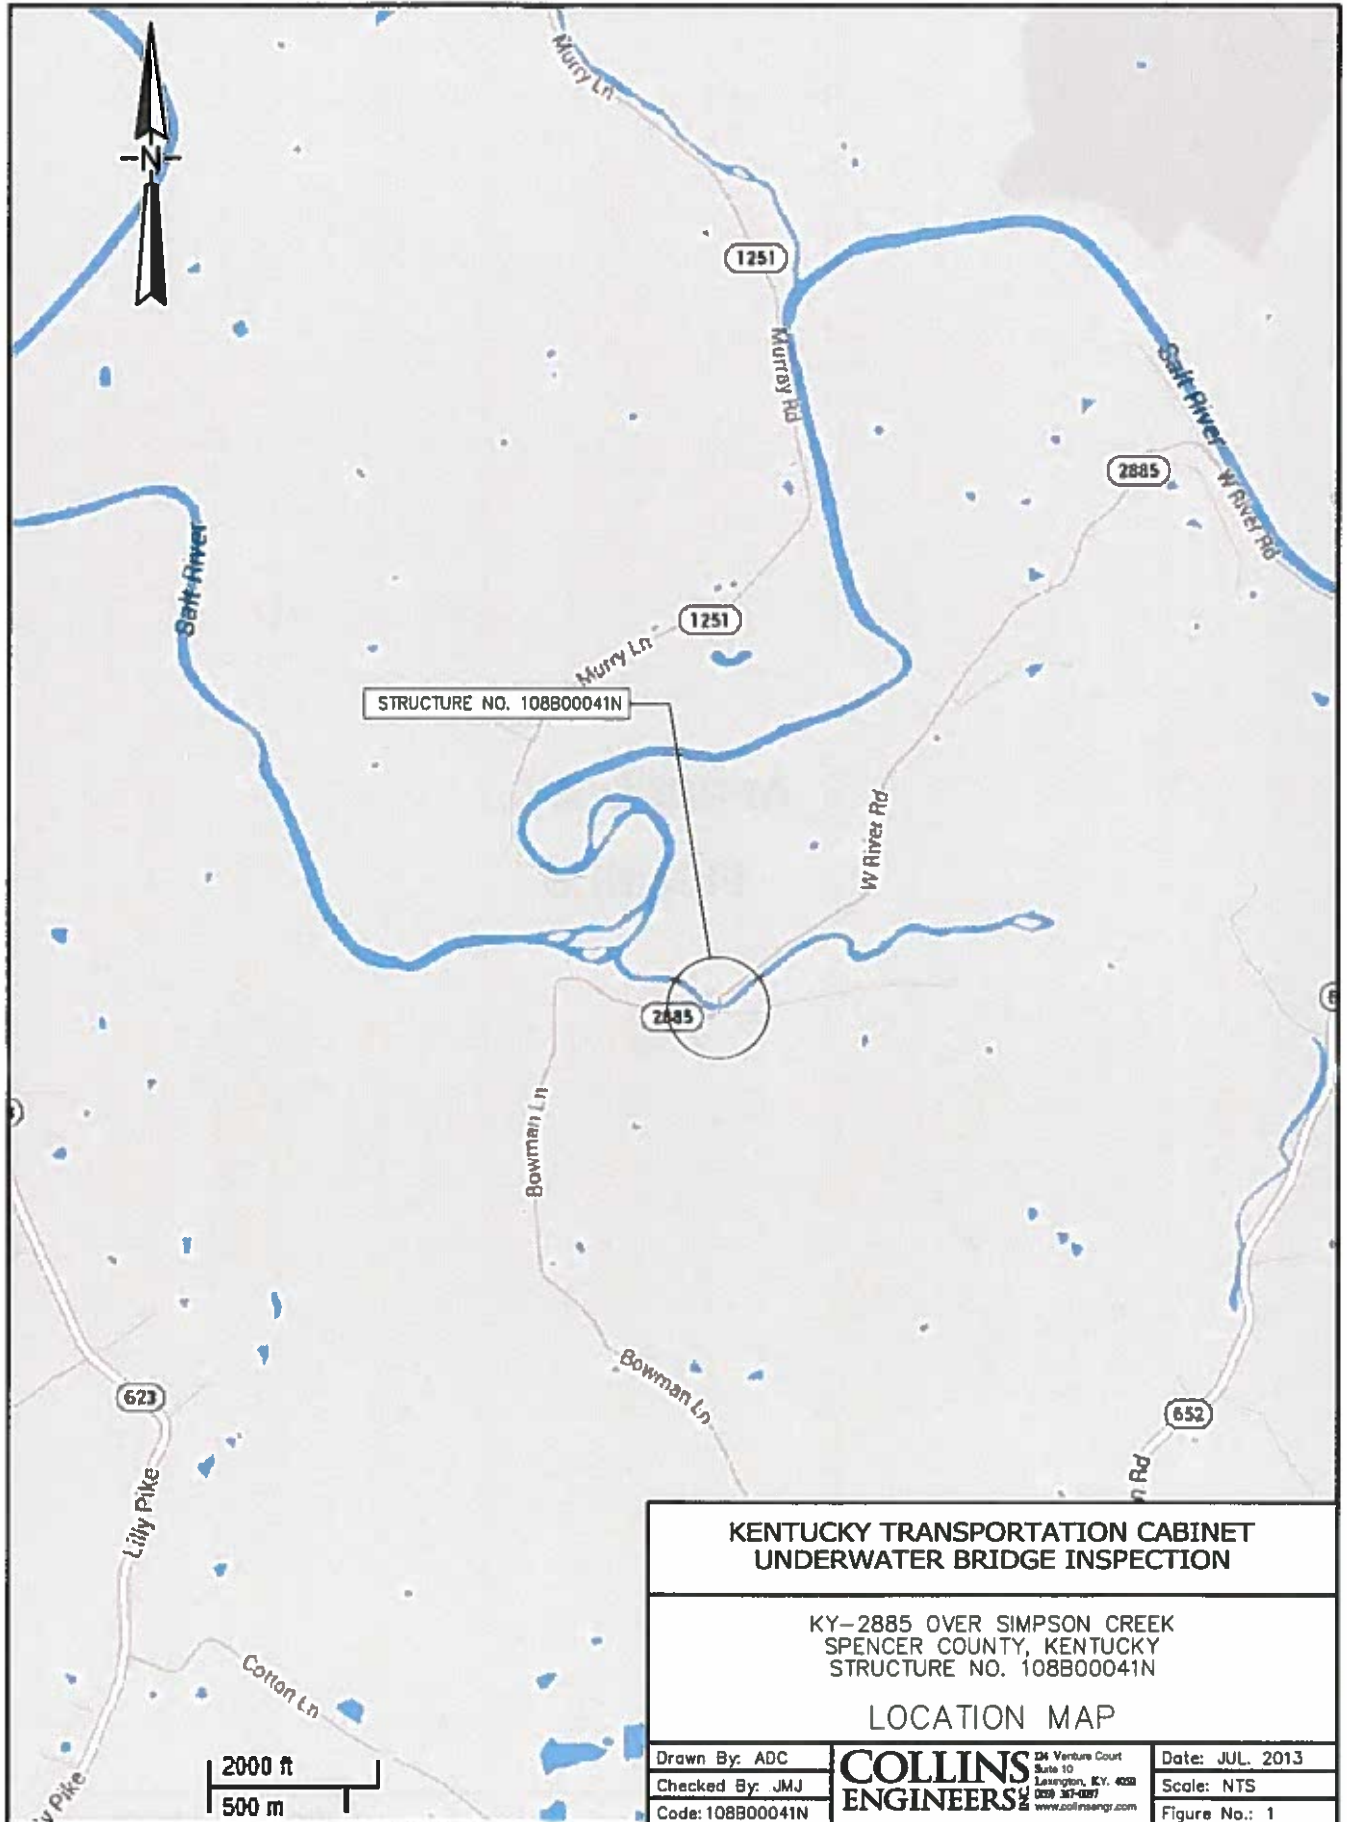
**KENTUCKY TRANSPORTATION CABINET
UNDERWATER BRIDGE INSPECTION**

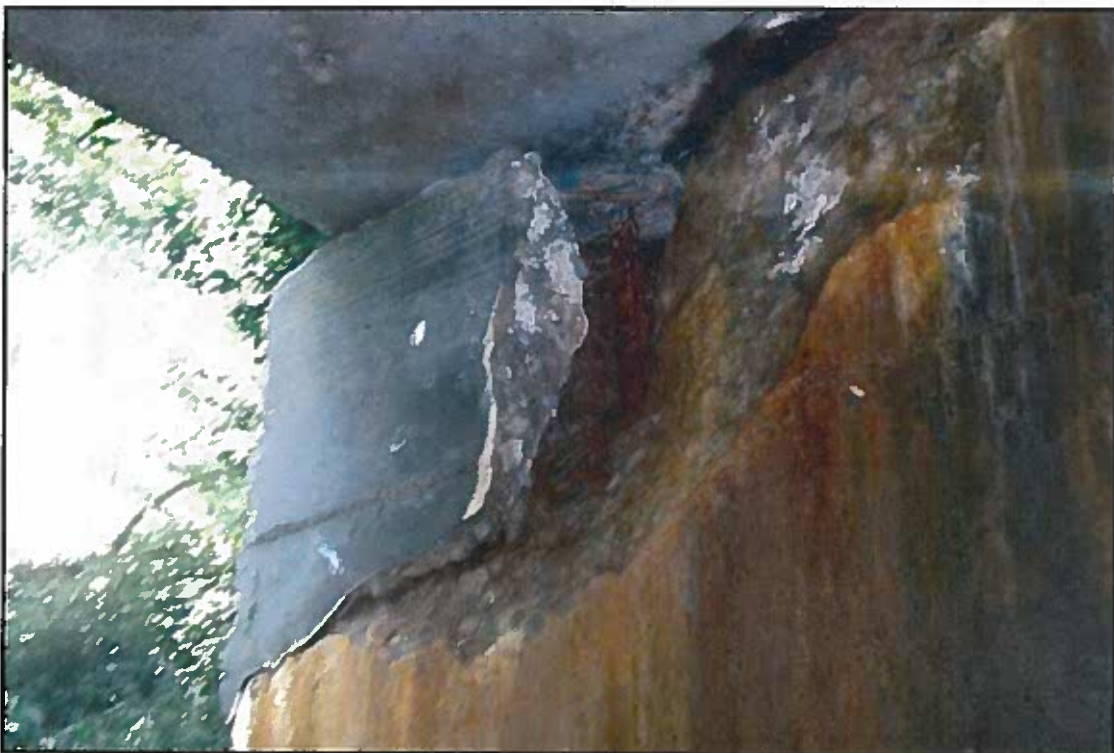
Photograph No. 10: View of Failed Concrete Repair at Upstream Corner of Abutment 1, Looking South.

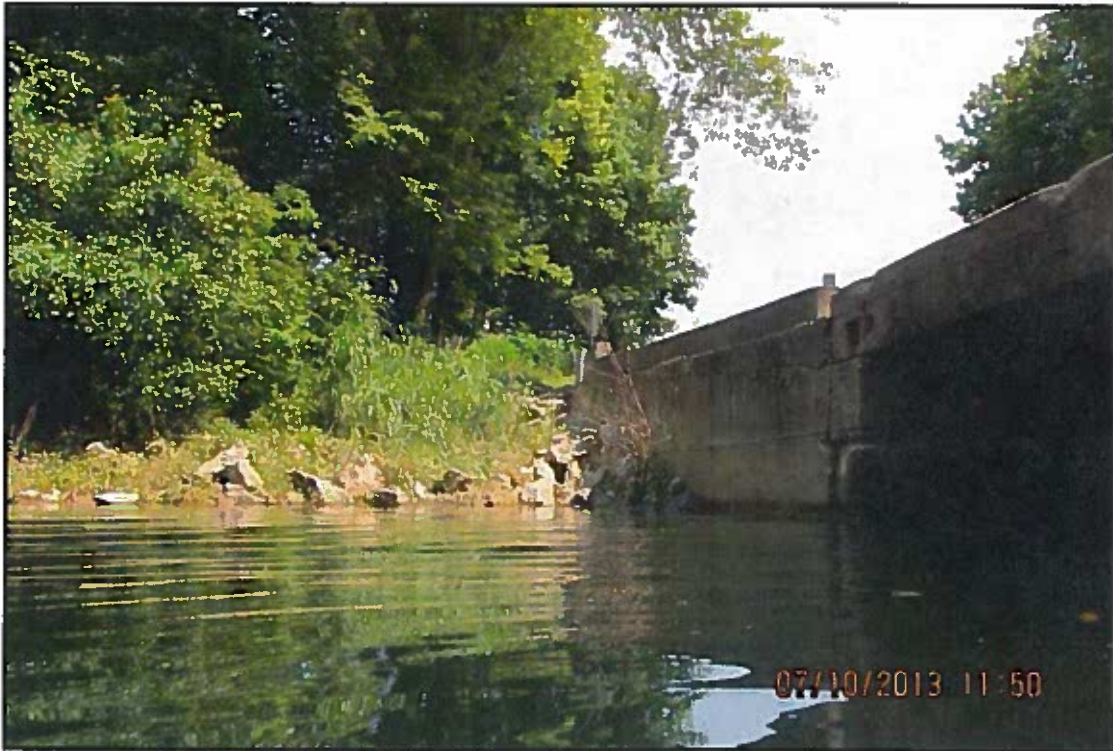
Photograph No. 13: View of West Wingwall of Abutment 2, Looking Northeast.

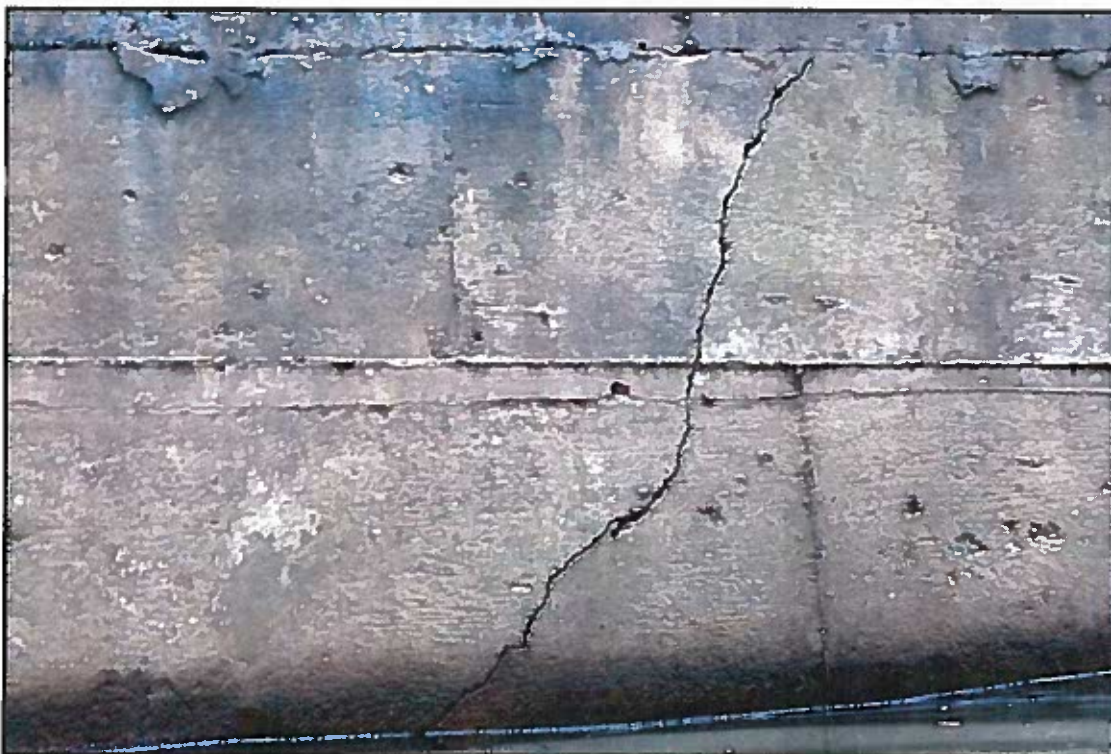
Photograph No. 14: View of Shear Crack above the Water Line on East Wingwall of Abutment 2, Looking West.

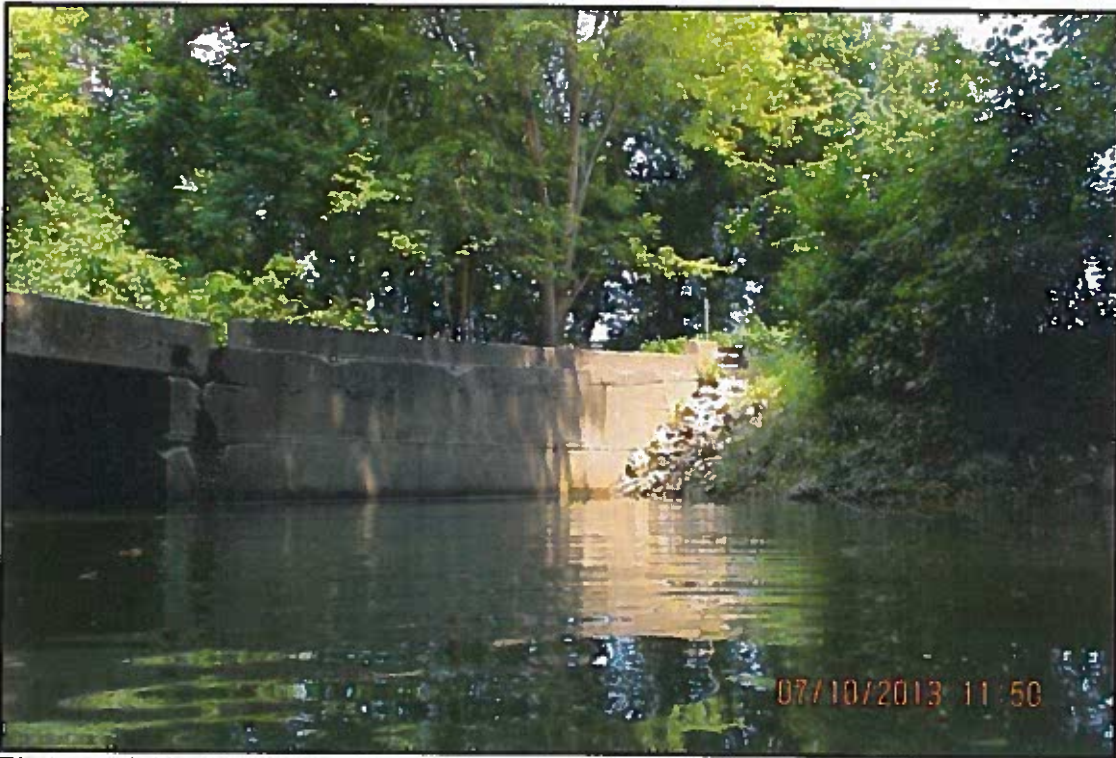
Photograph No. 11: View of East Wingwall of Abutment 2, Looking Northwest.

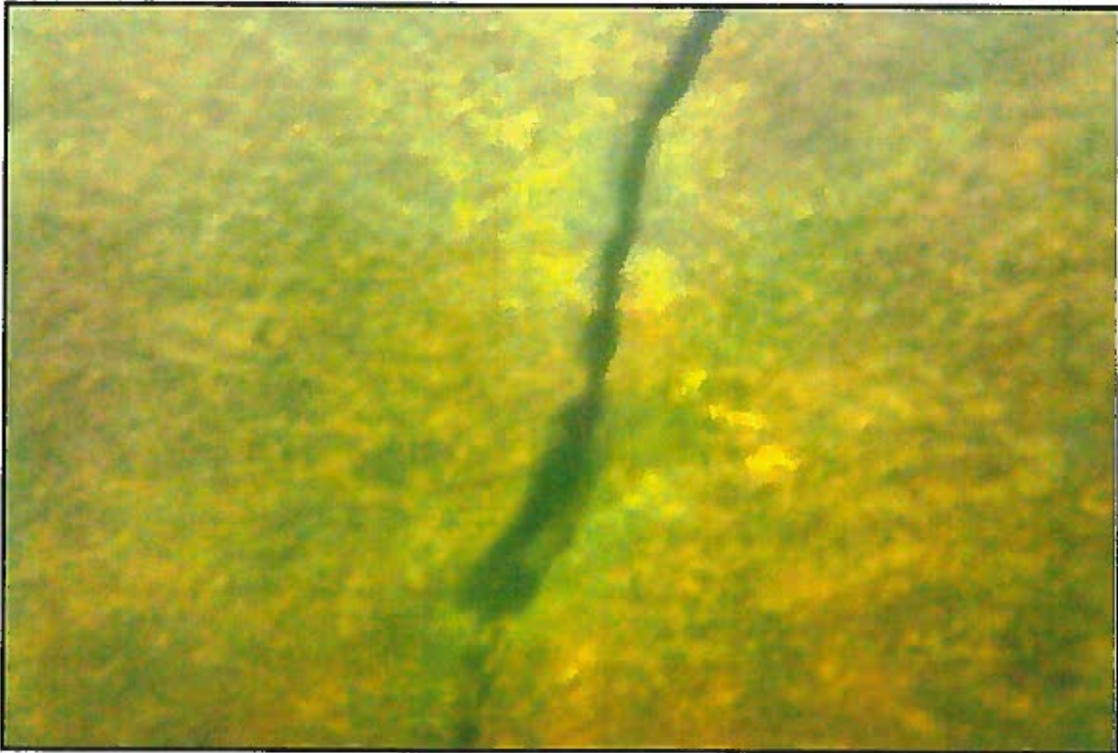
Photograph No. 15: View of Shear Crack below the Water Line on East Wingwall of Abutment 2, Looking West.

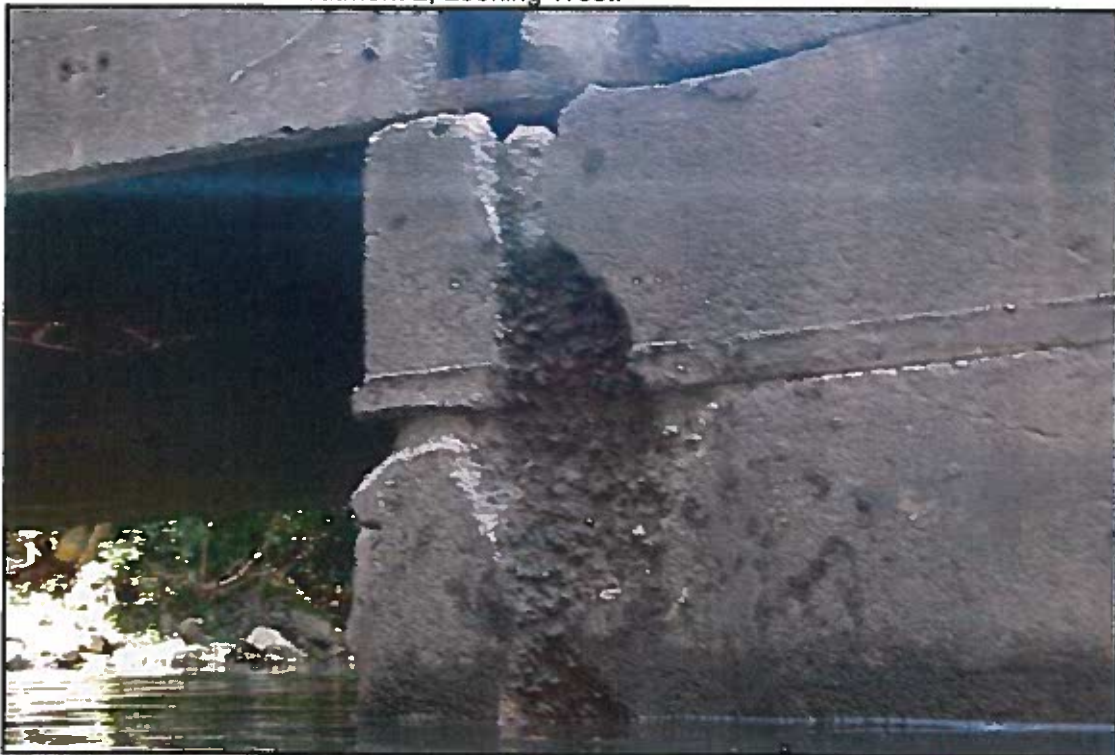
Photograph No. 16: View of Spall on East Wingwall of Abutment 2, Looking Southwest.

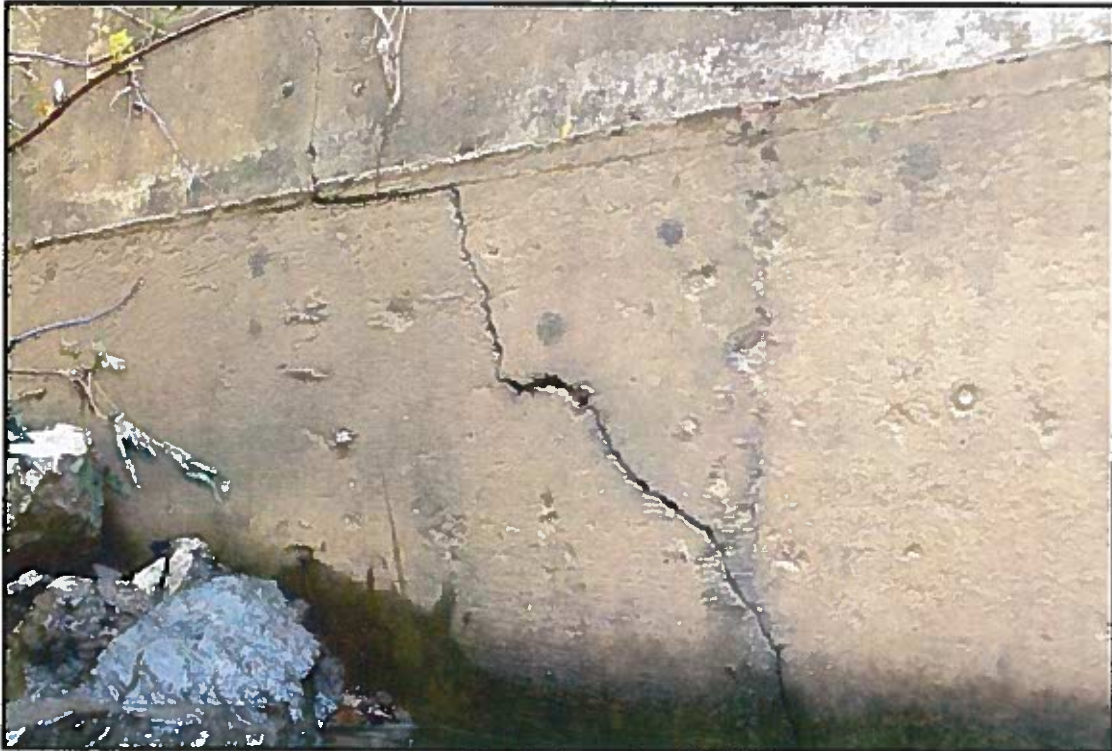
Photograph No. 17: View of Shear Crack above the Water Line on West Wingwall of Abutment 2, Looking East.

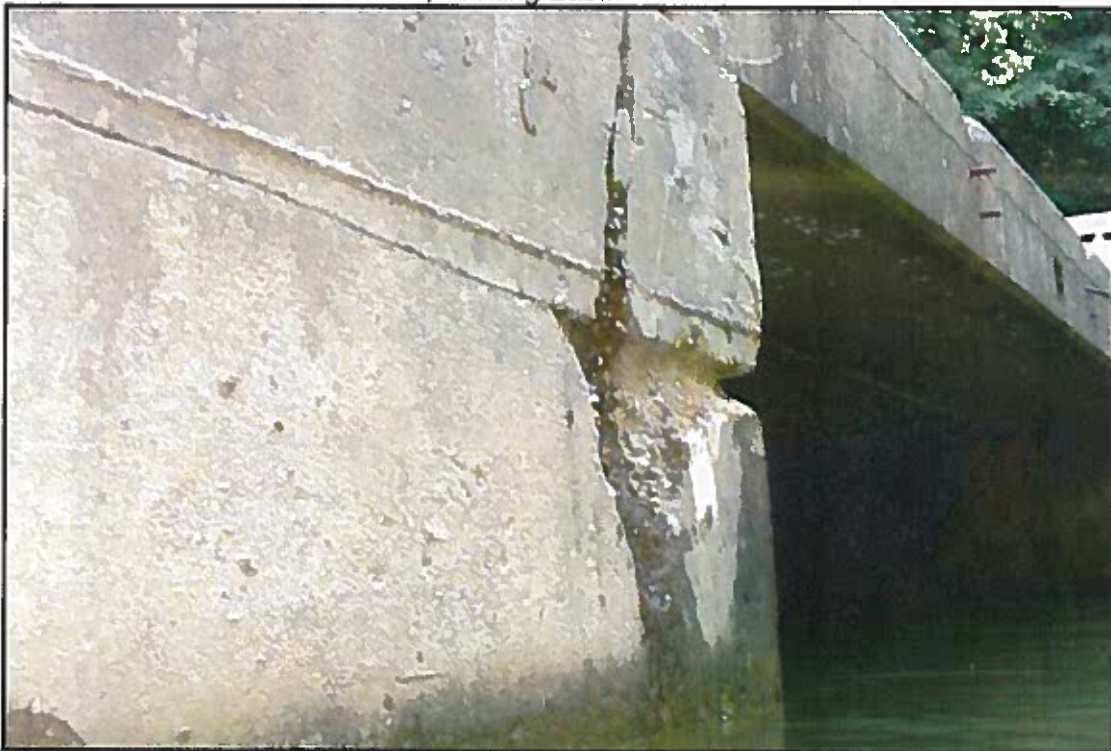
Photograph No. 18: View of Spall on West Wingwall of Abutment 2, Looking Southeast.
