Inspection Report with SI&A Data

Structure Description: 305.12 Foot - 3 Span Steel continuous Stringer/Multi-beam or Girder

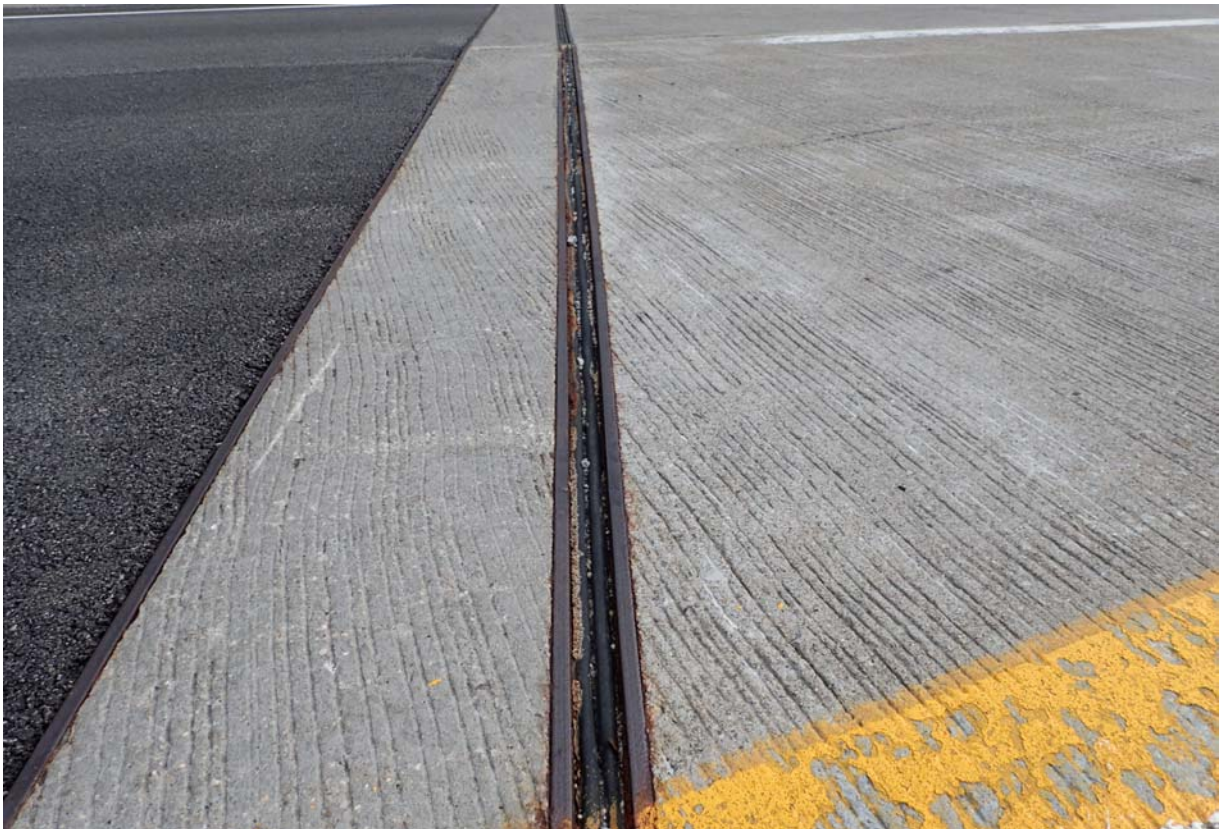
Typical view of the transverse joint at abutment 1; it is partially full of debris, and has some adhesion failures.

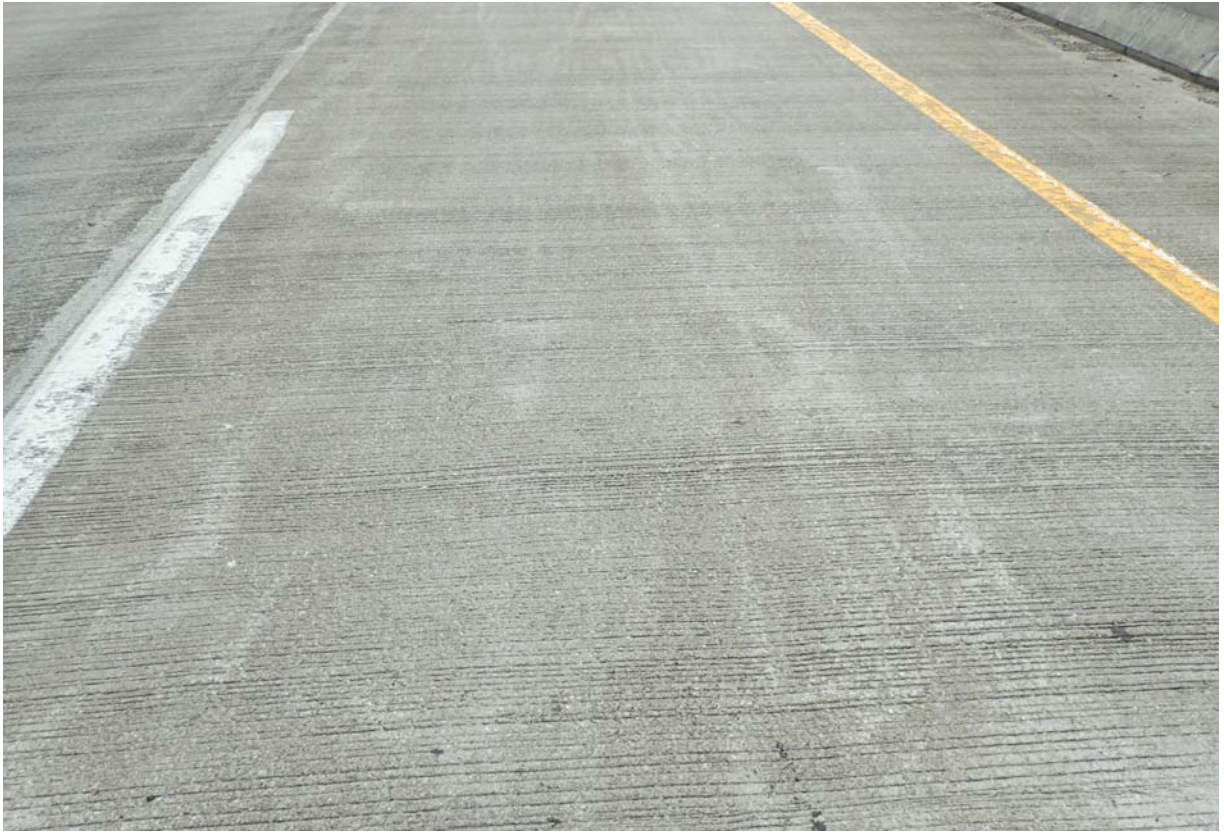
Typical view of the wearing surface near abutment 1.

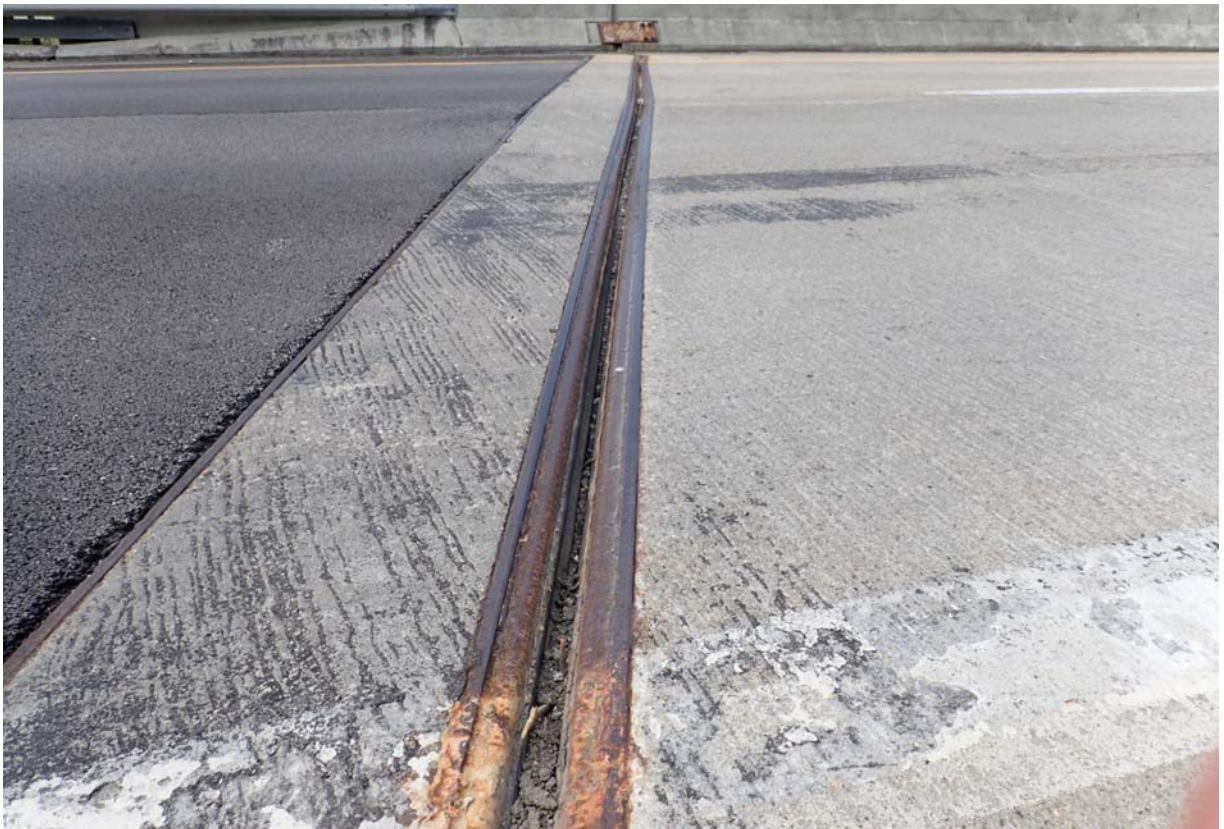
View of the transverse joint at abutment 4. It is mostly full of dirt and debris.

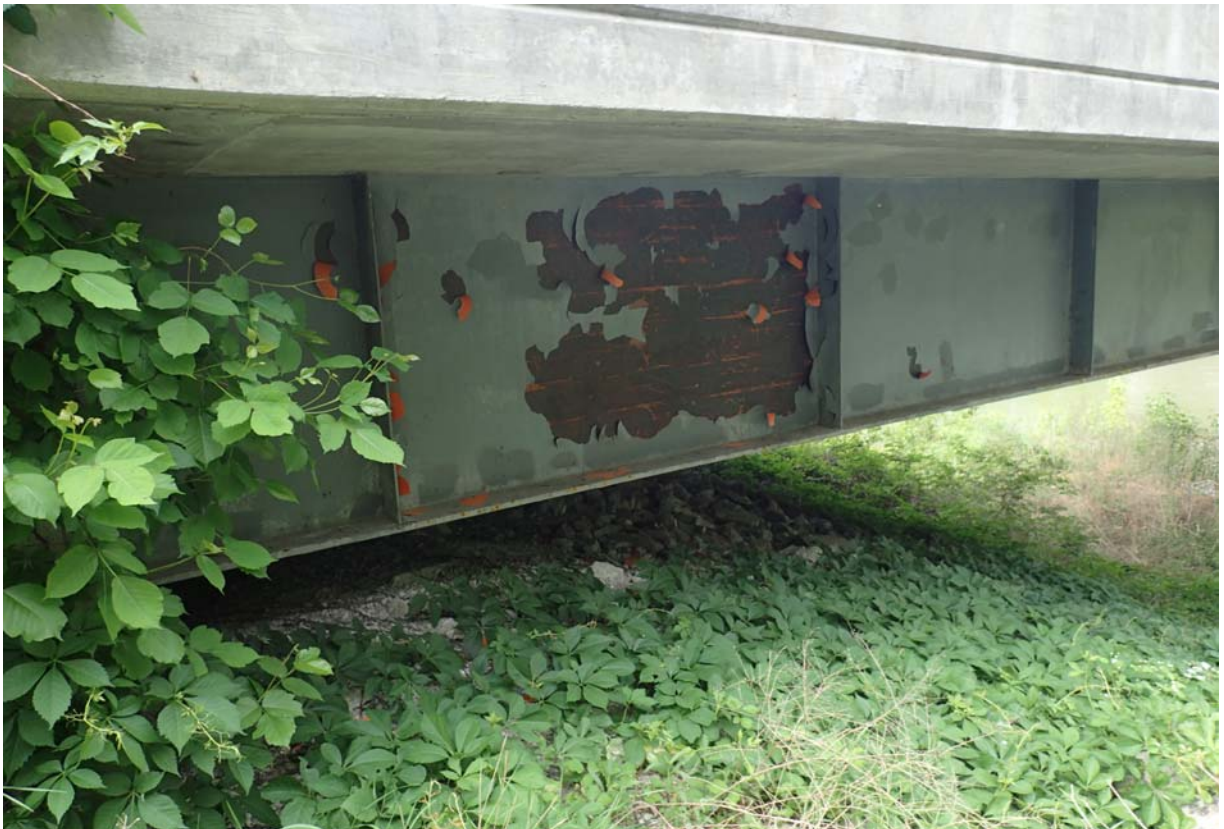
Large area of paint failure on the exterior face of the downstream girder near abutment 4.

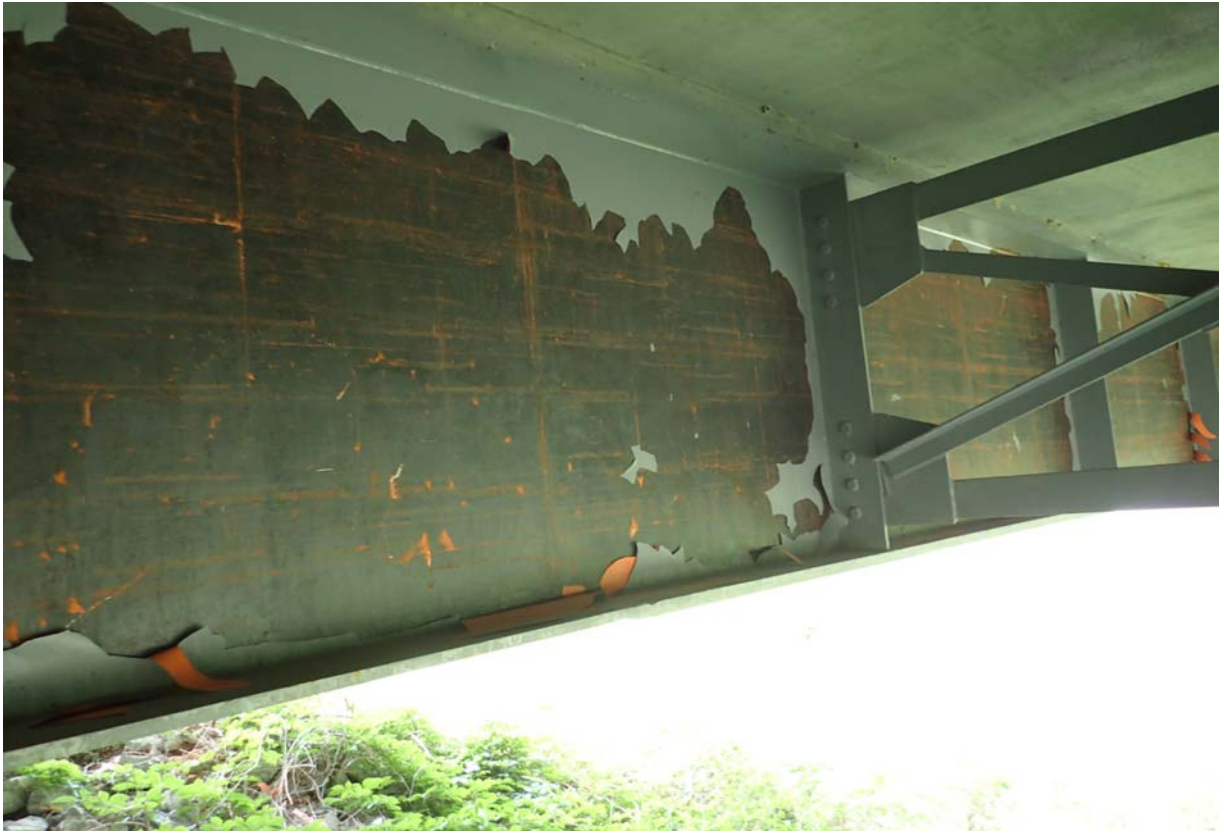
Large area of paint failure on the downstream face of girder 3 from upstream near abutment 4.

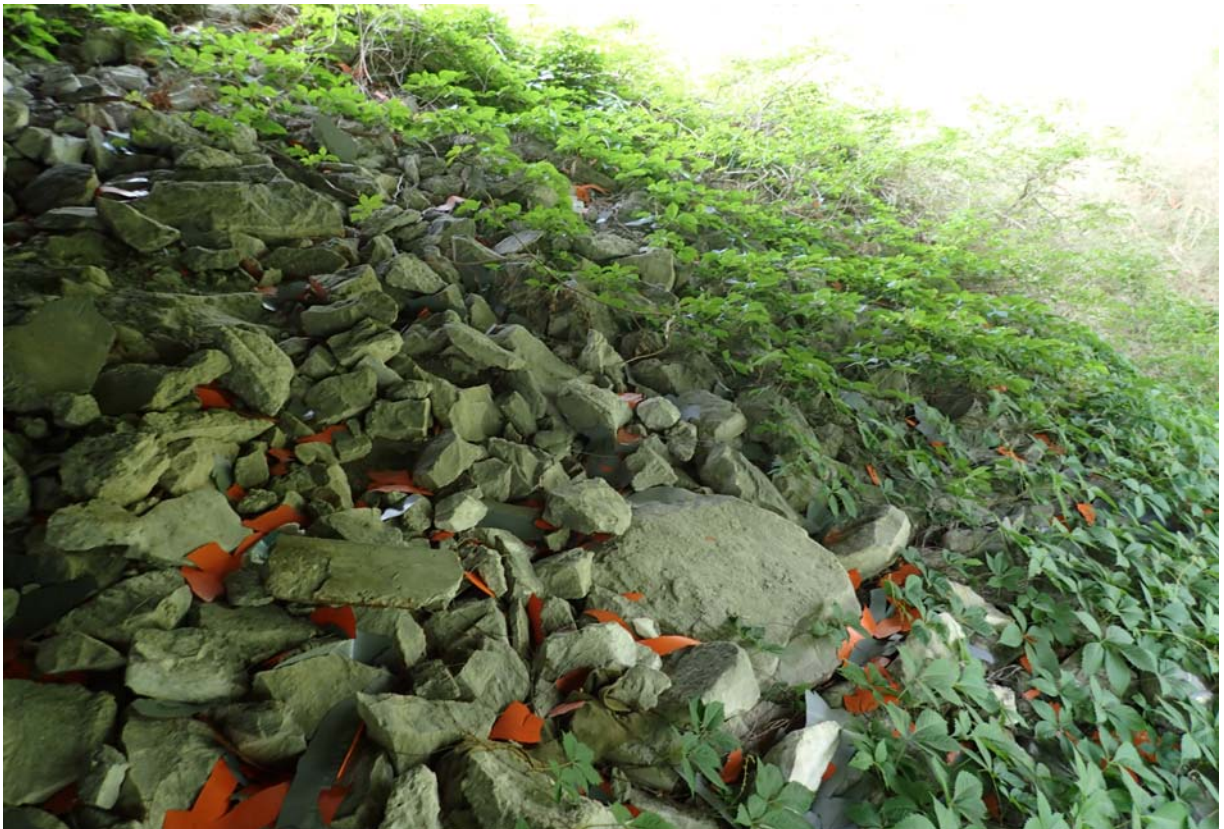
View of paint lying on the ground near abutment 4.

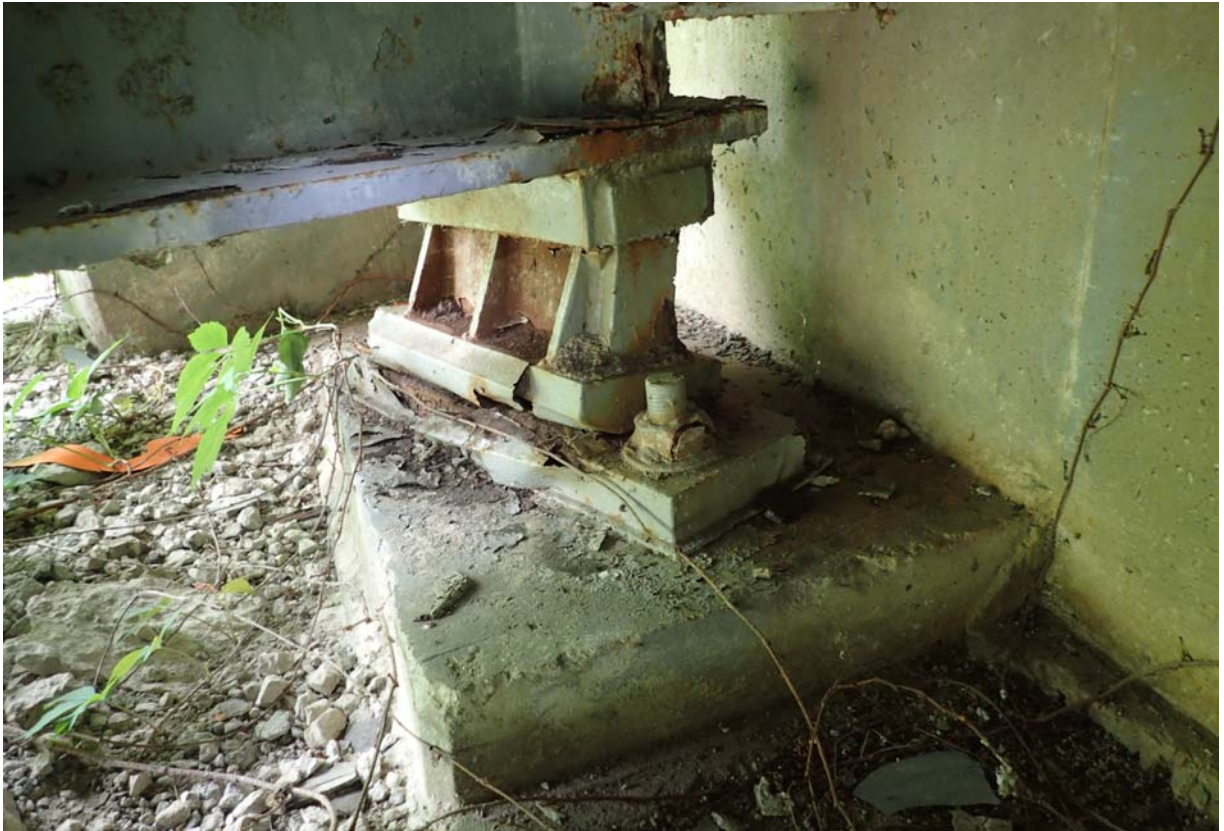
Downstream bearing at abutment 4; Flaking paint with some minor to moderate corrosion.

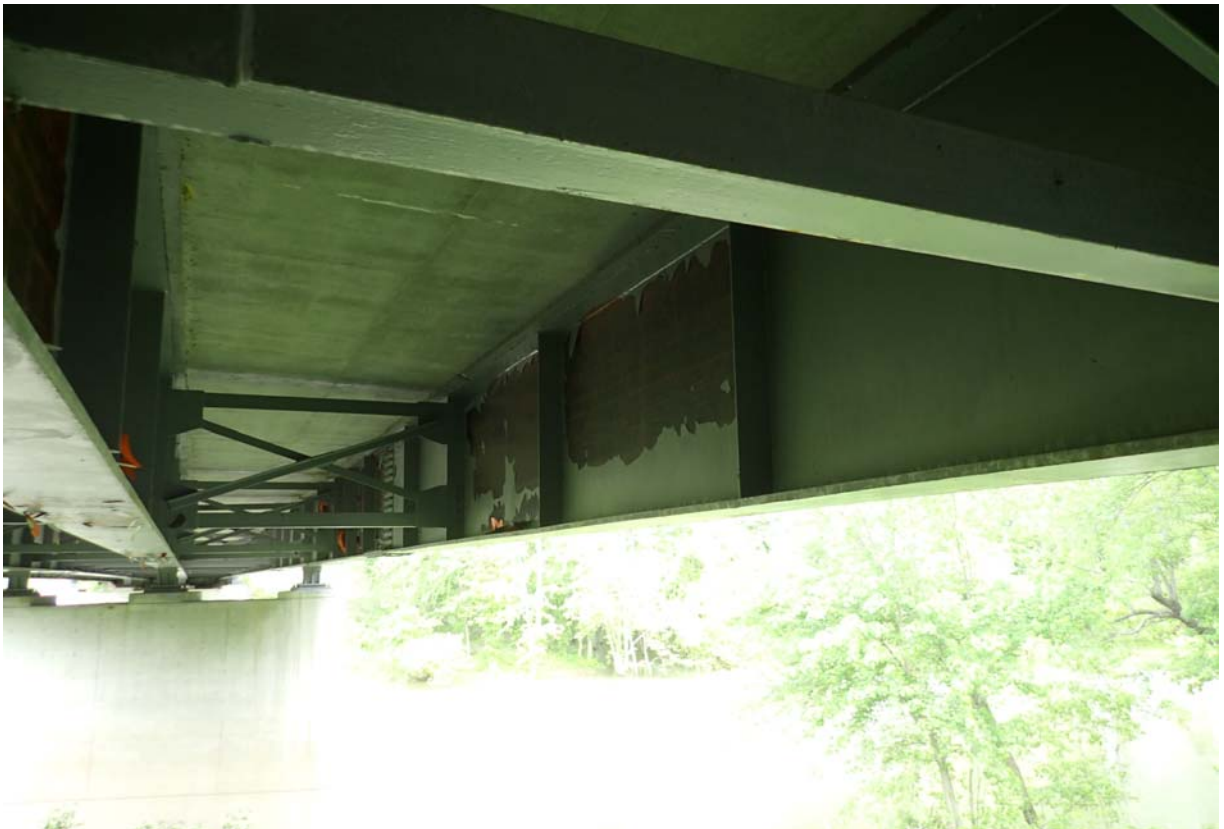
Large areas of paint failure on the upstream face of the downstream girder in span 3.

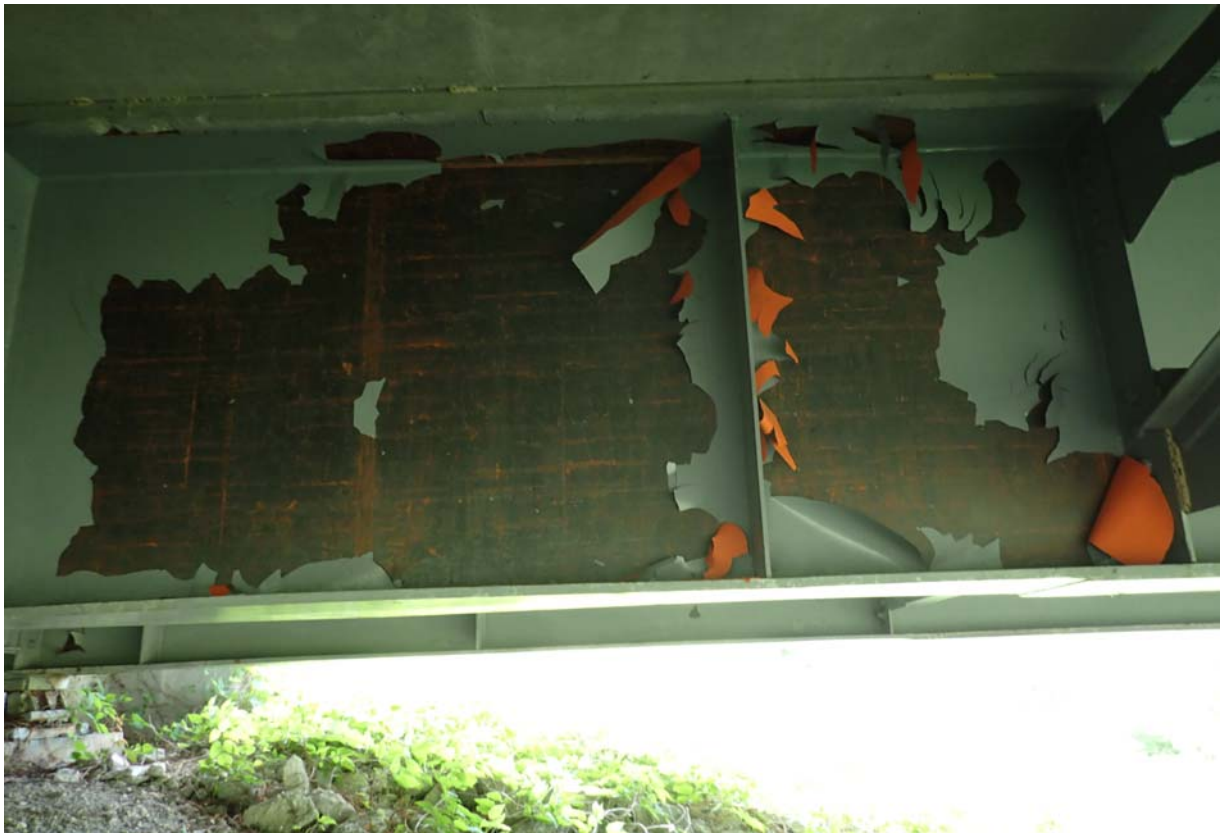
Large areas of paint failure on the downstream face of girder 2 in span 3.

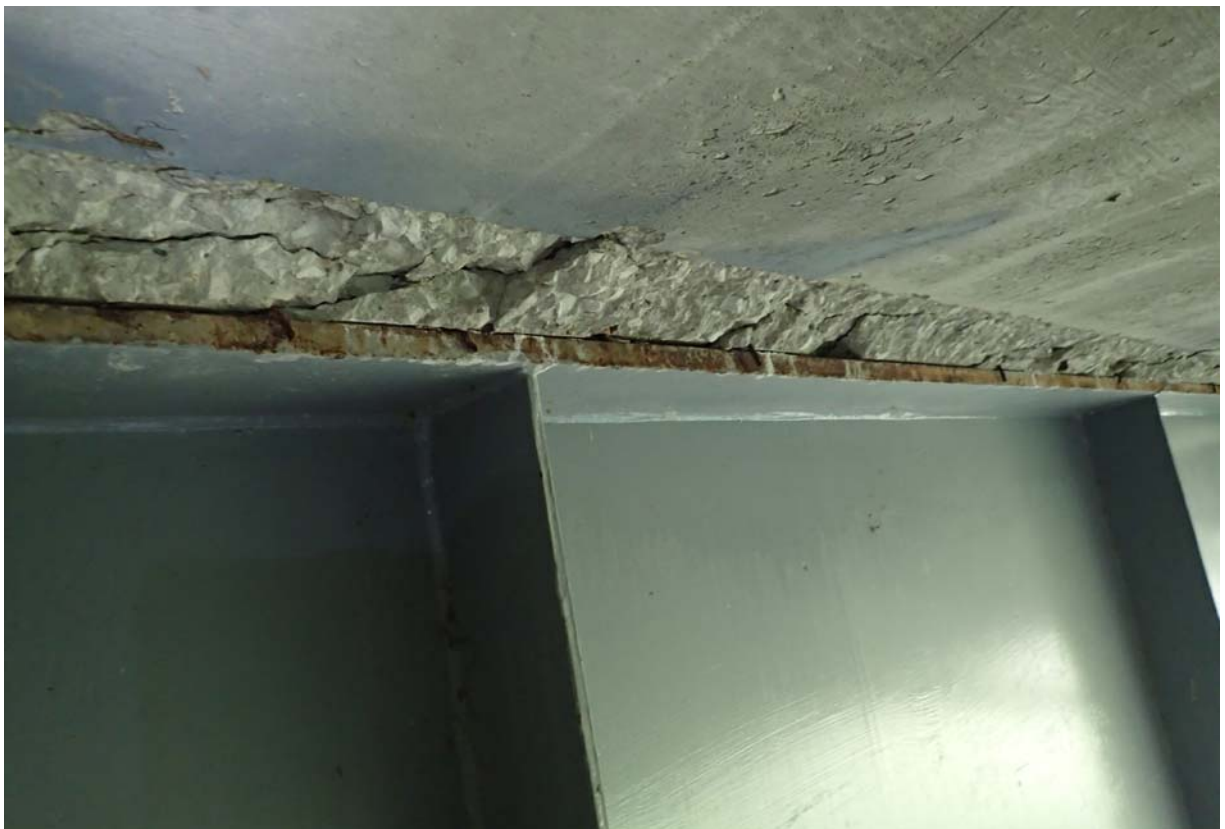
Moderate spalling along the fillet on the top interior flange on the upstream girder at abutment 4.

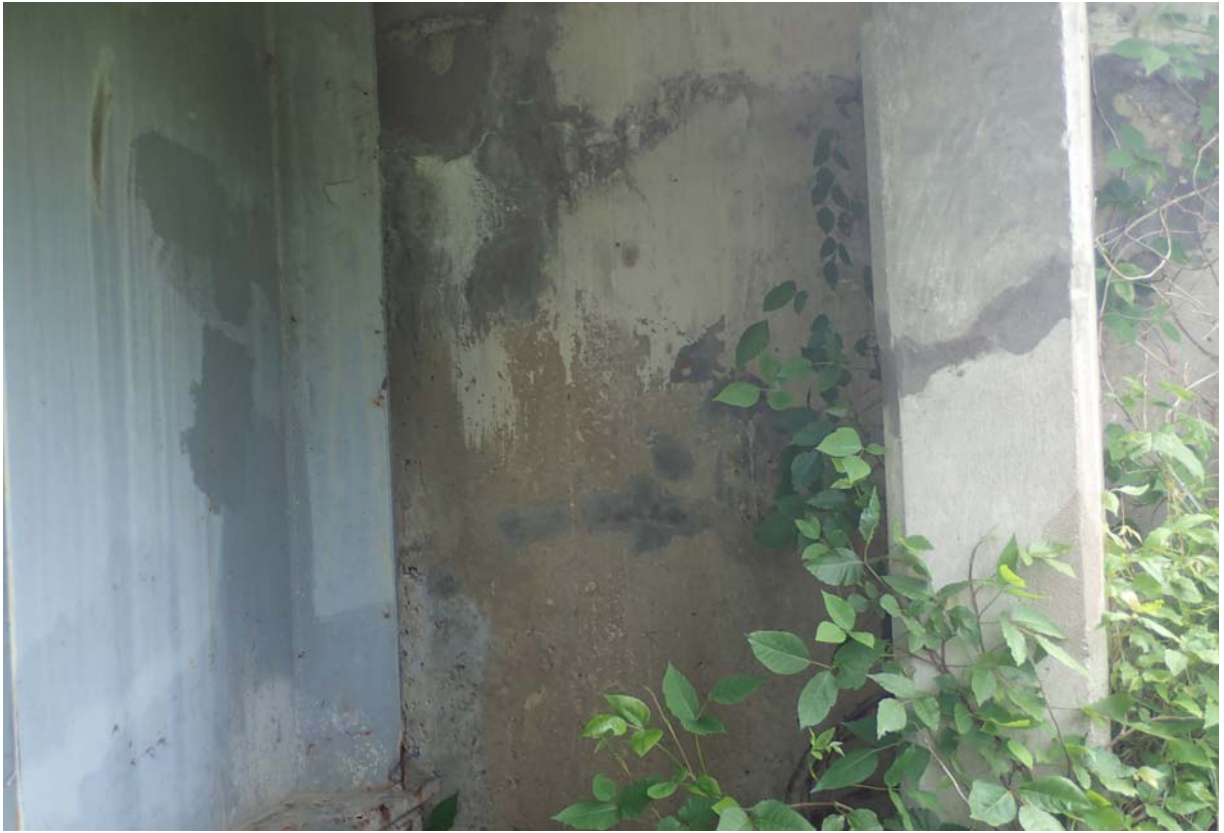
View of minor cracking with efflorescence in the upstream backwall of abutment 4.

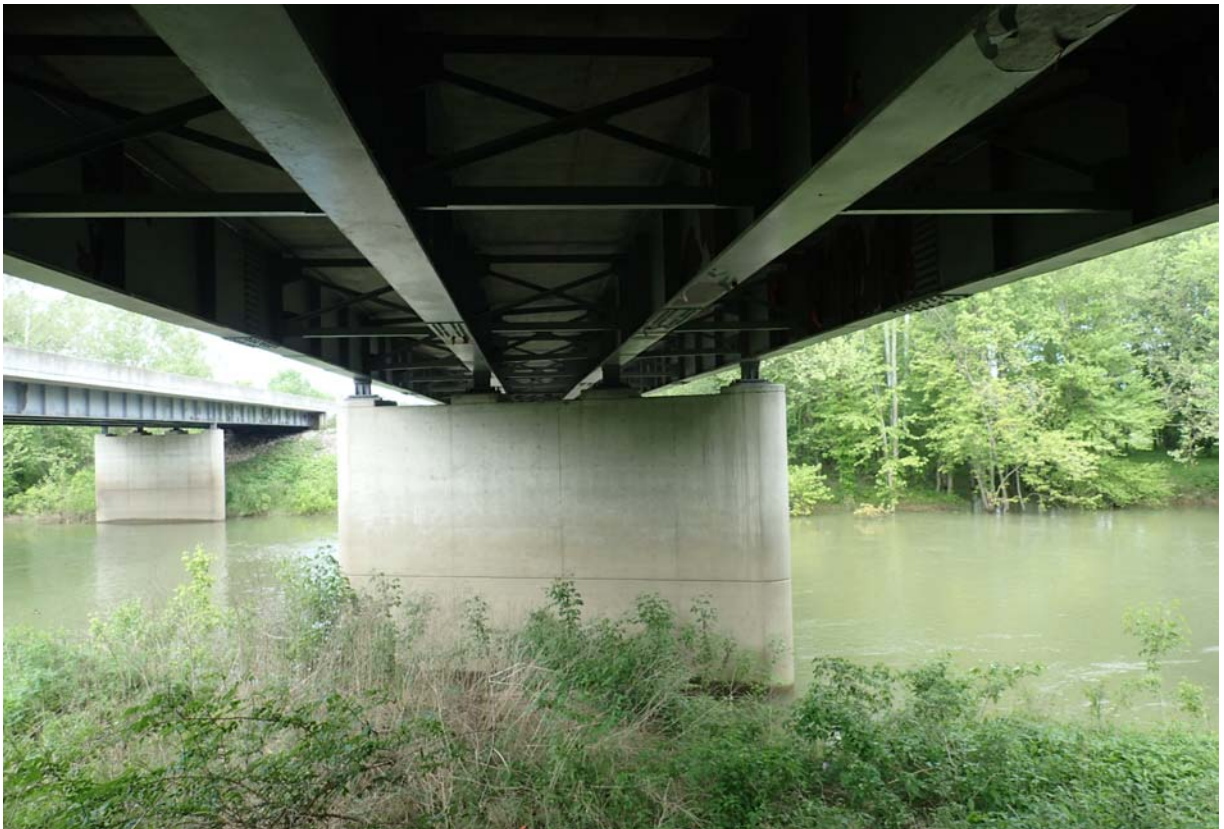
Typical view of span 3 and pier 3.

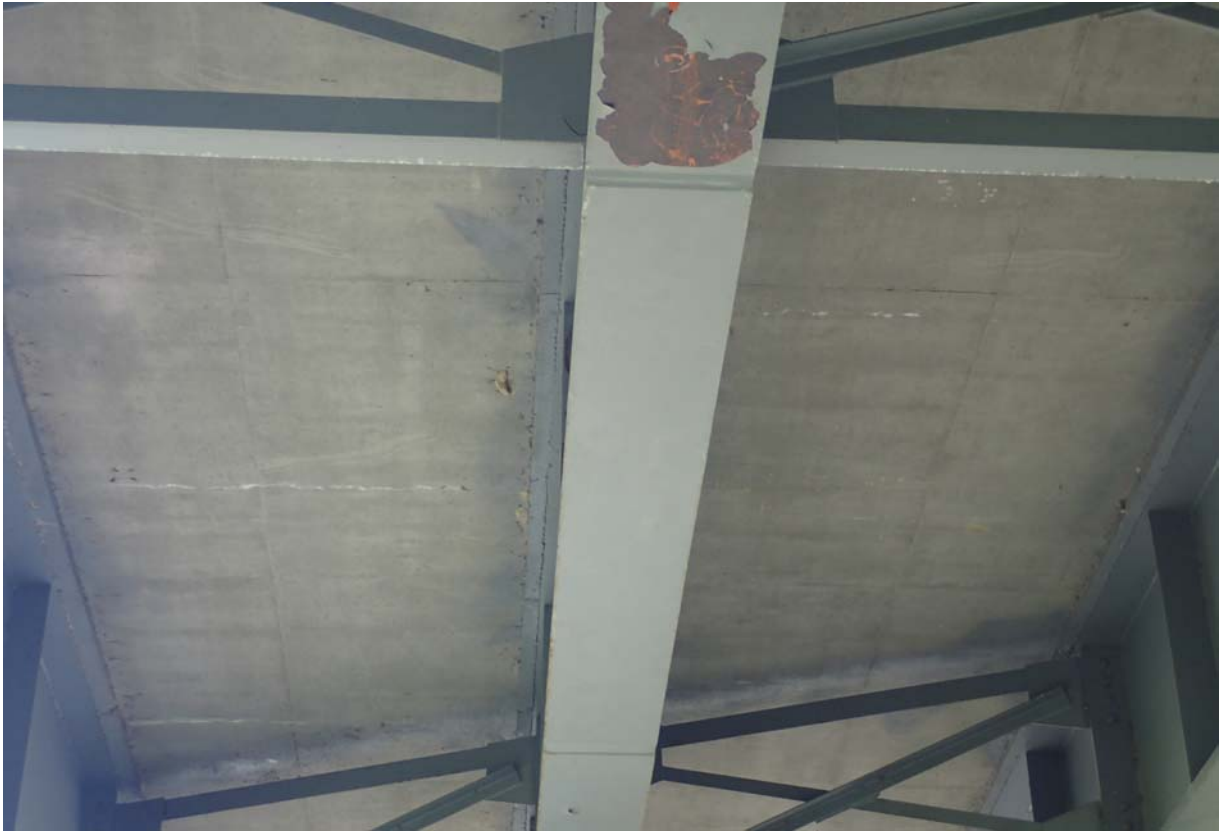
View of minor cracking with efflorescence in the deck underside at pier 3.

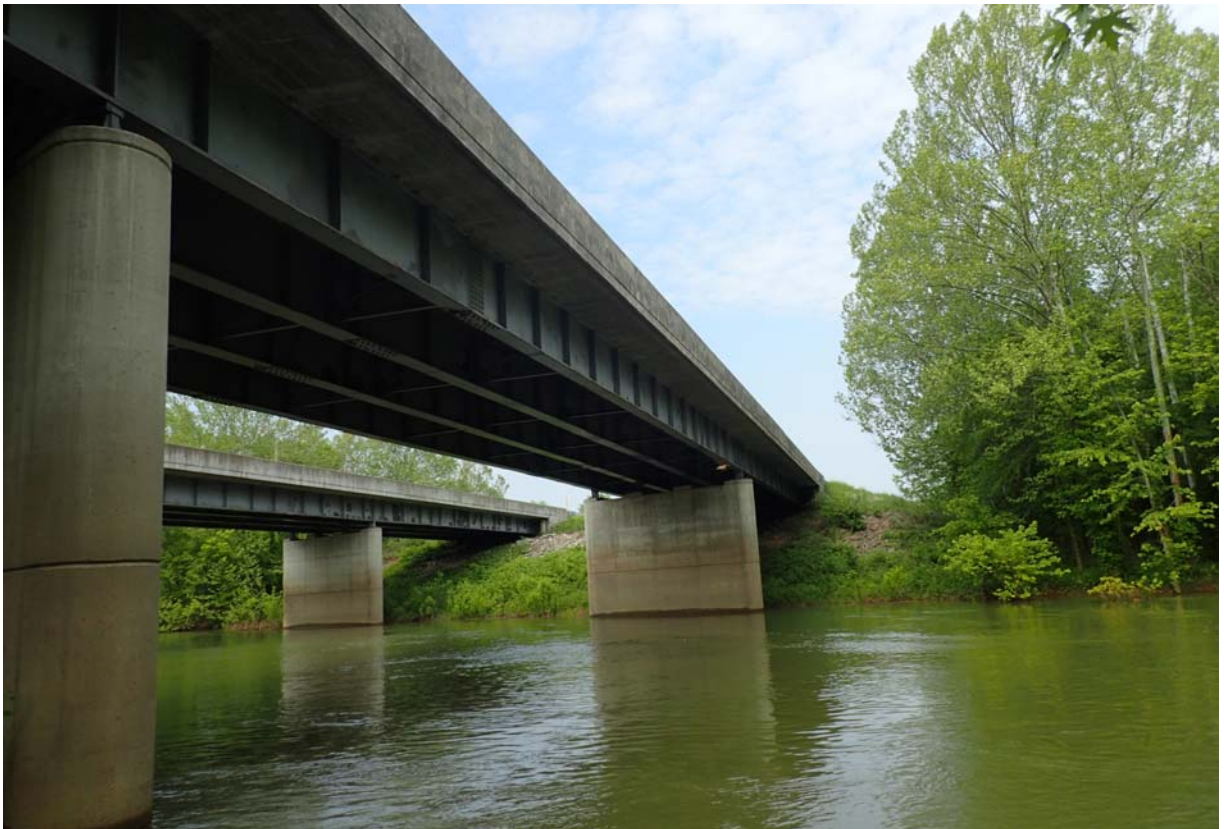
Typical view of span 2 and pier 2 from downstream.

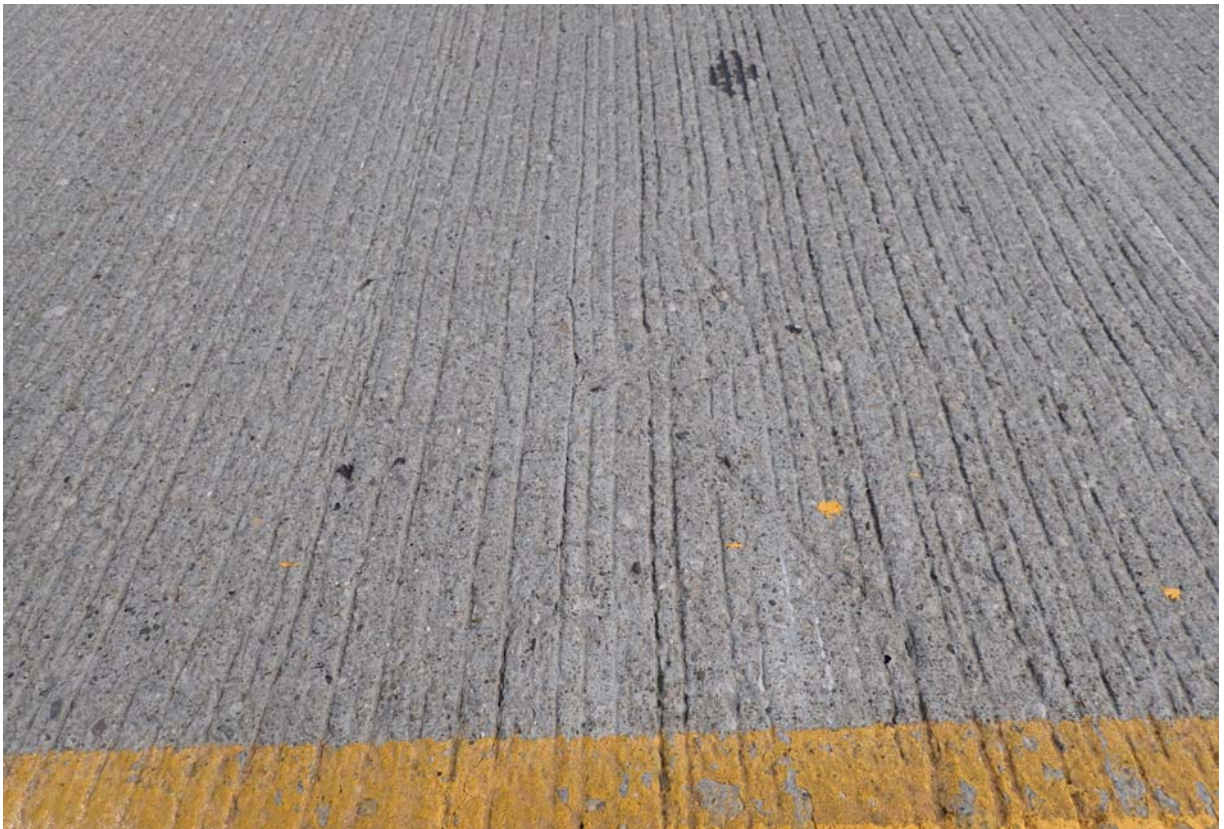
View of minor sized transverse cracking in the wearing surface near pier 2.

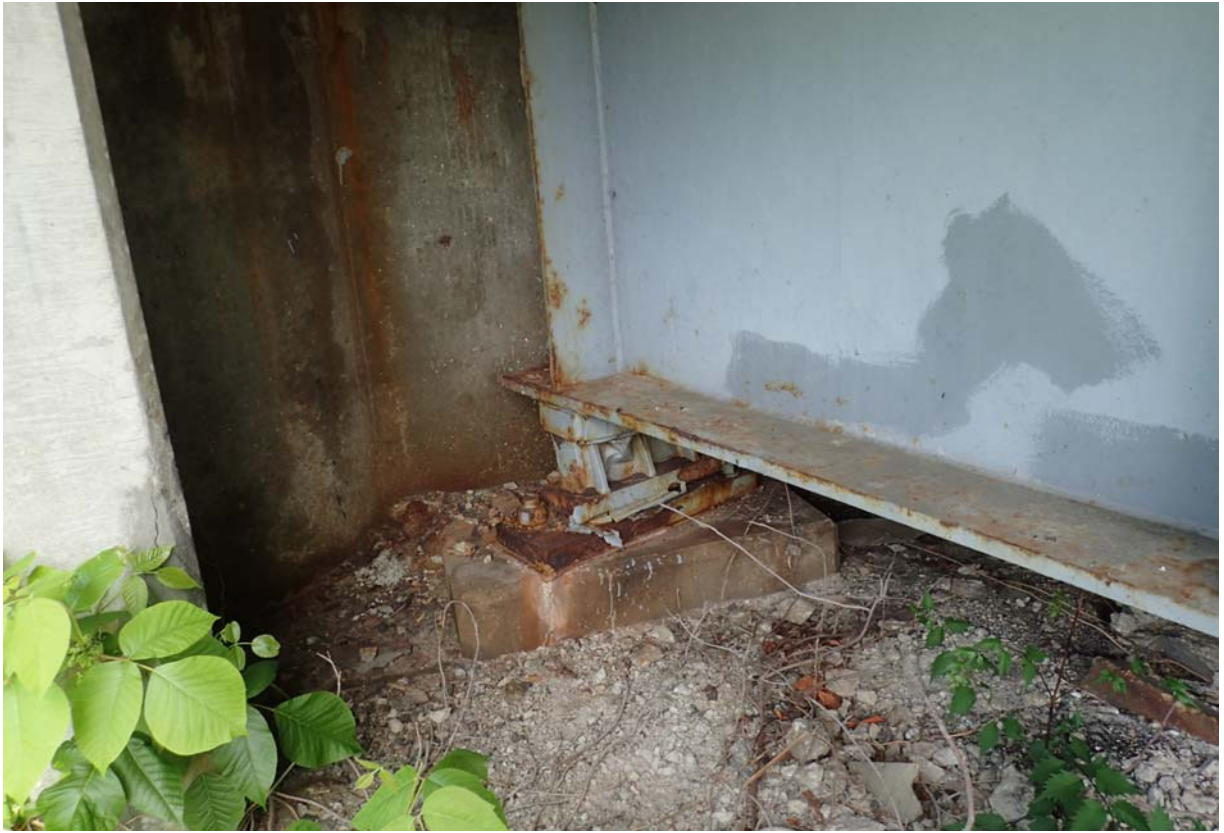
Upstream bearing at abutment 1; flaking paint and moderate corrosion.

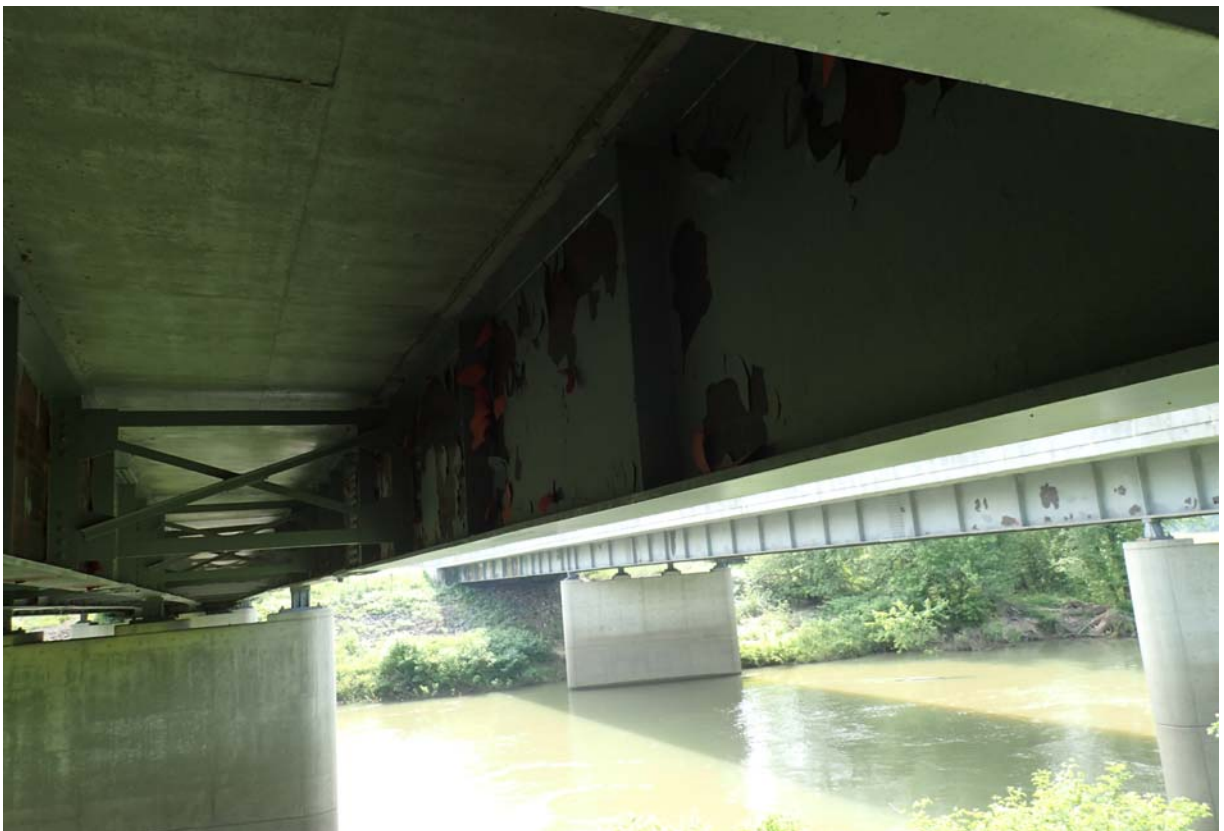
View of several large areas of paint failure on the downstream face of the upstream girder in span 1.

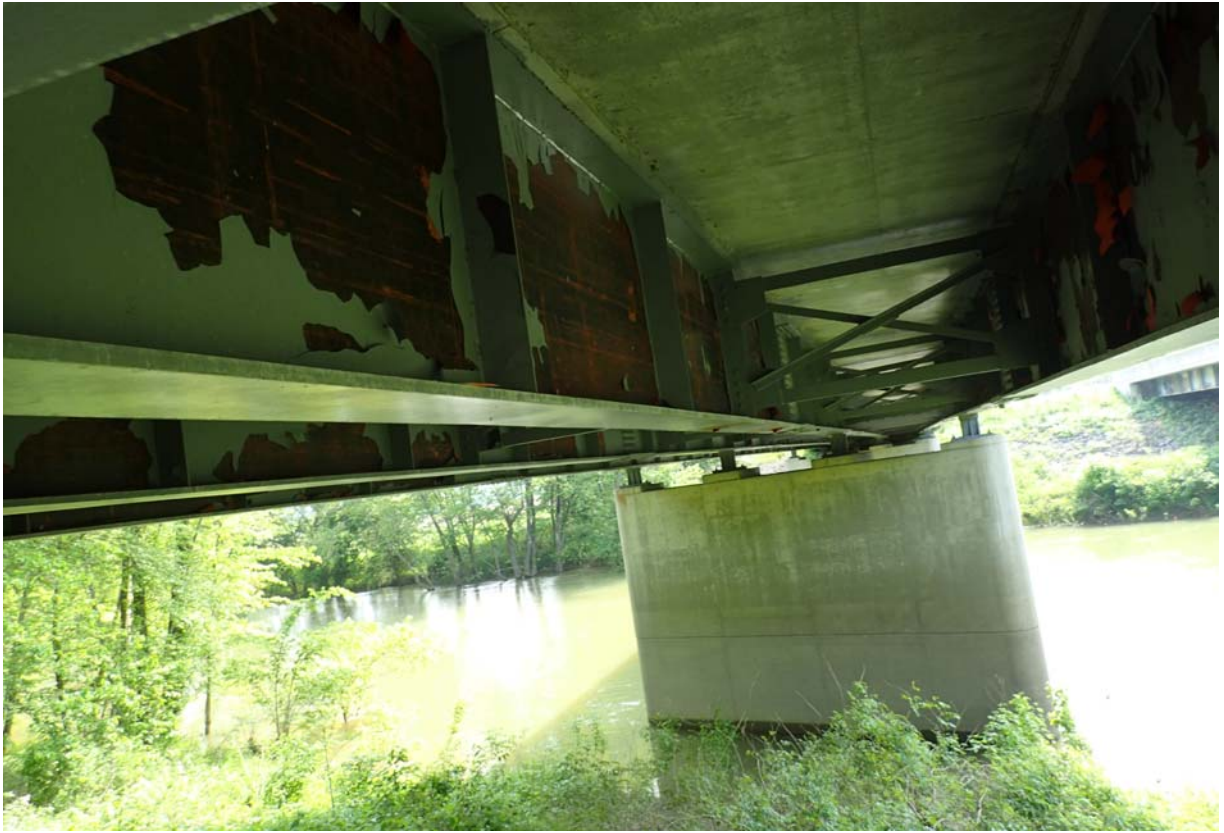
View of several large areas of paint failure on the upstream face of girder 2 from upstream in span 1.

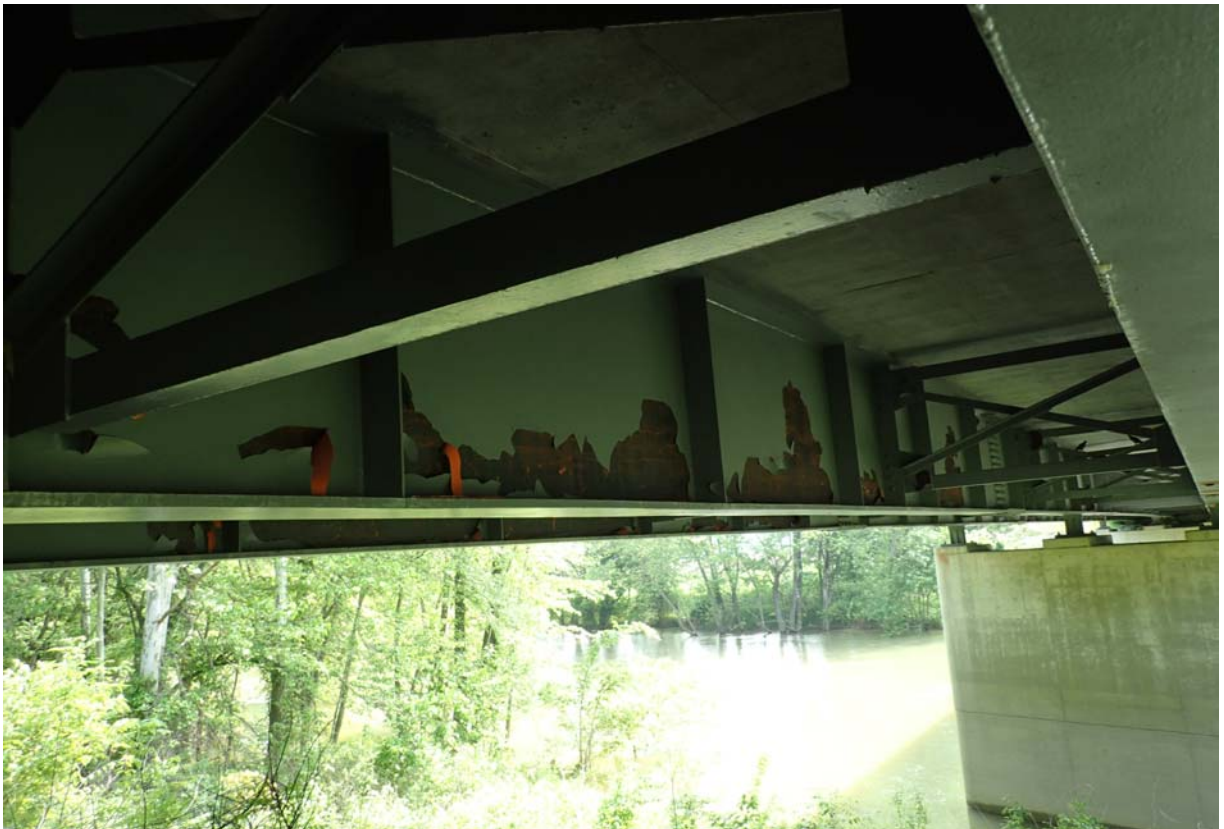
View of several large areas of paint failure on the upstream face of girder 3 from upstream in span 1.

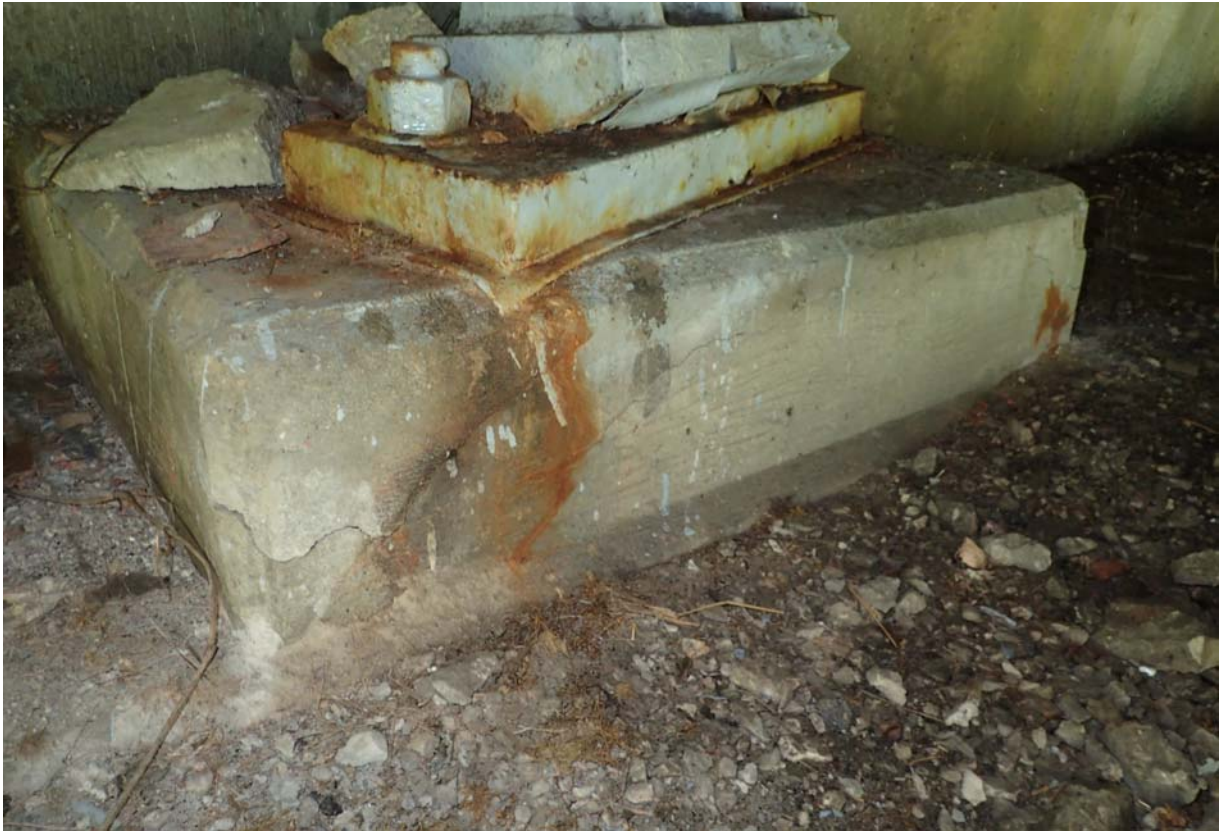
View of some minor cracking of pedestal 2 from upstream at abutment 1.

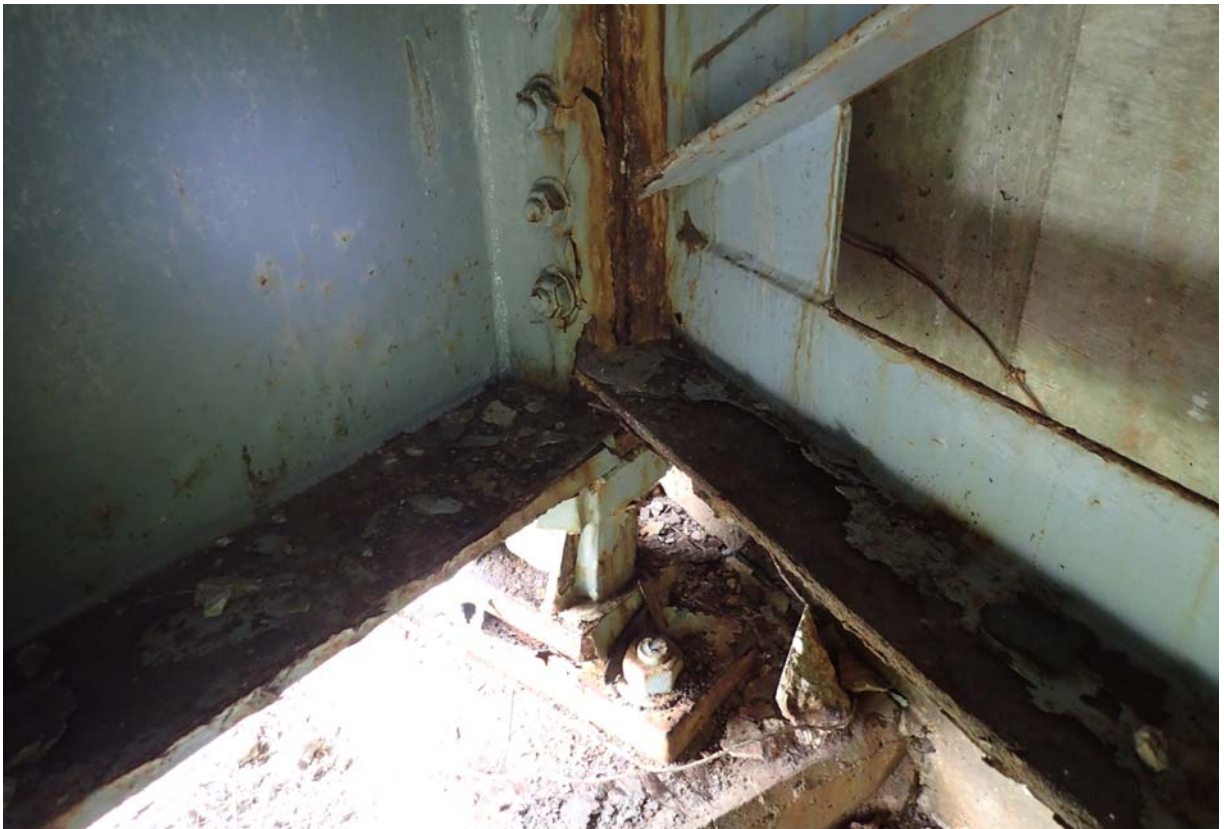
View of flaking paint and moderate corrosion at the end of the upstream girder at abutment 1.

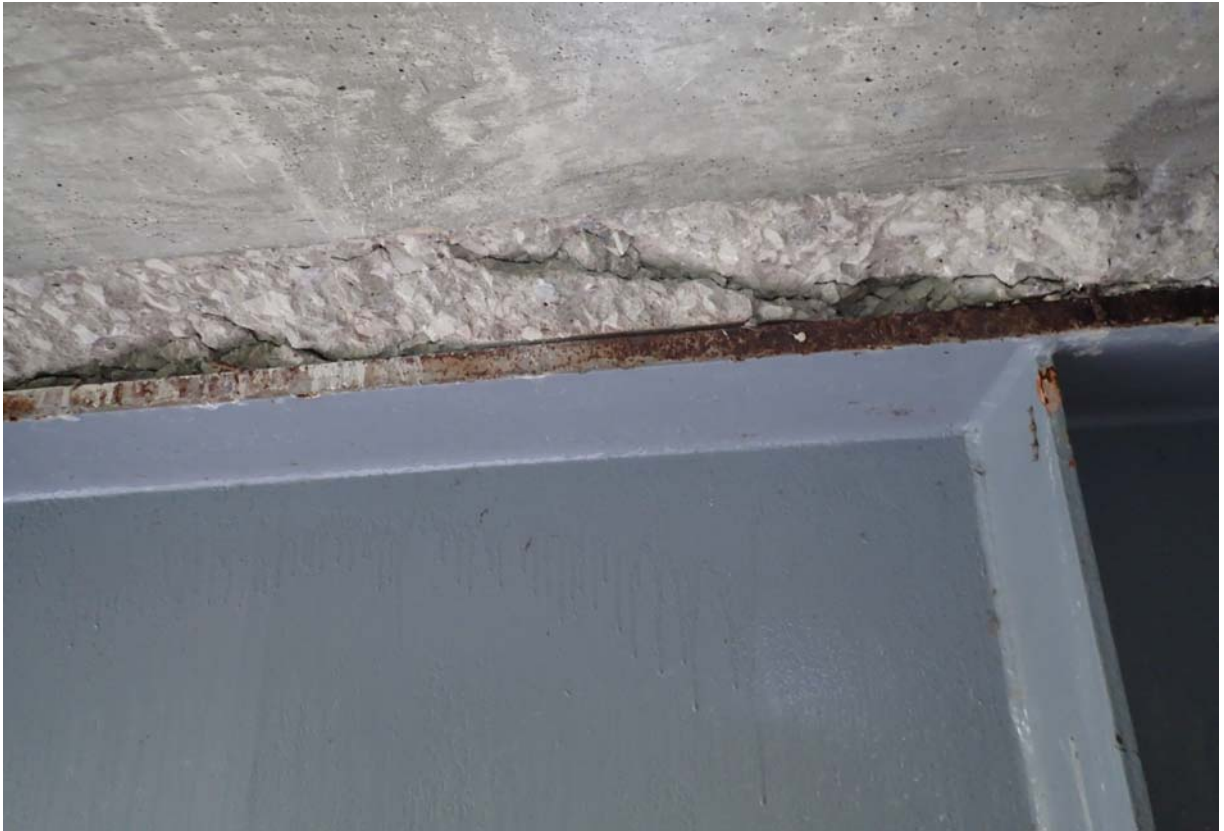
View of moderate cracking and spalling of the fillet above the upstream girder in span 1.
