Inspection Report with SI&A Data

Structure Description: 305.12 Foot - 3 Span Steel continuous Stringer/Multi-beam or Girder

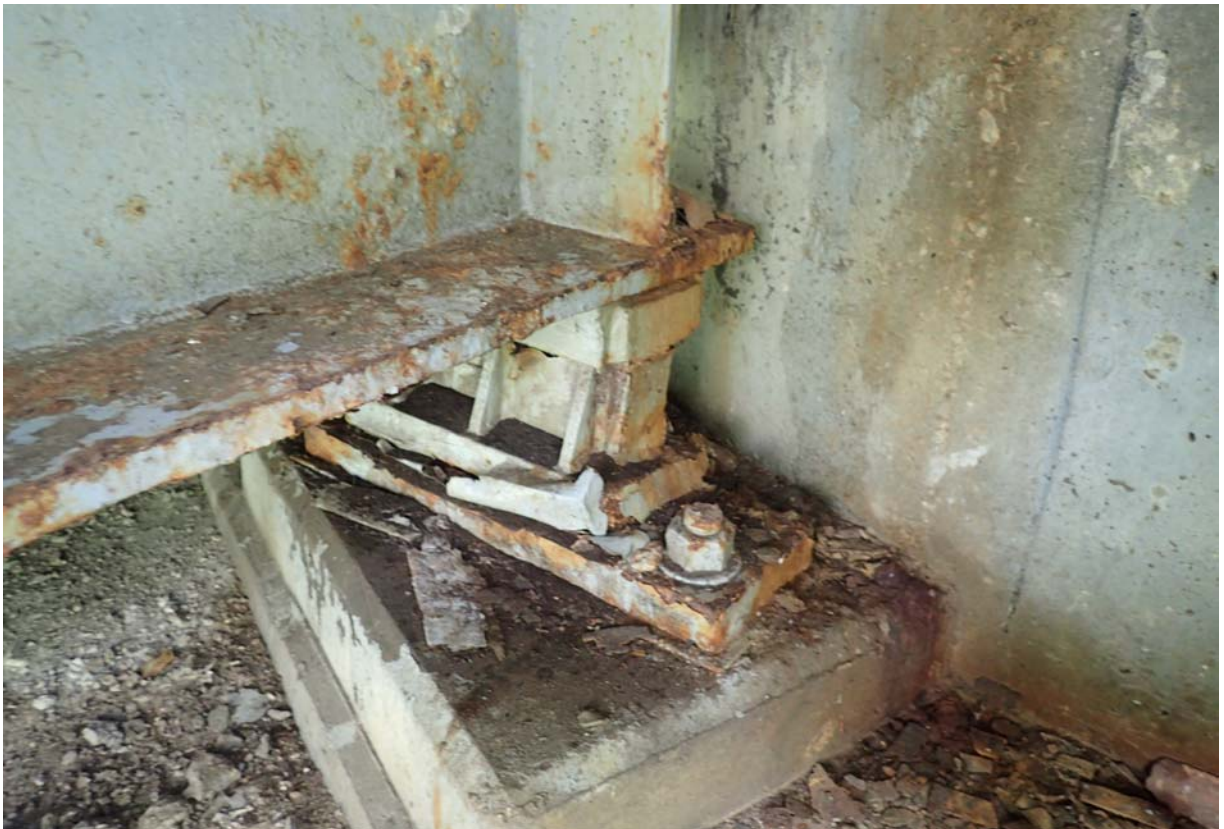
View of the downstream bearing at abutment 1.

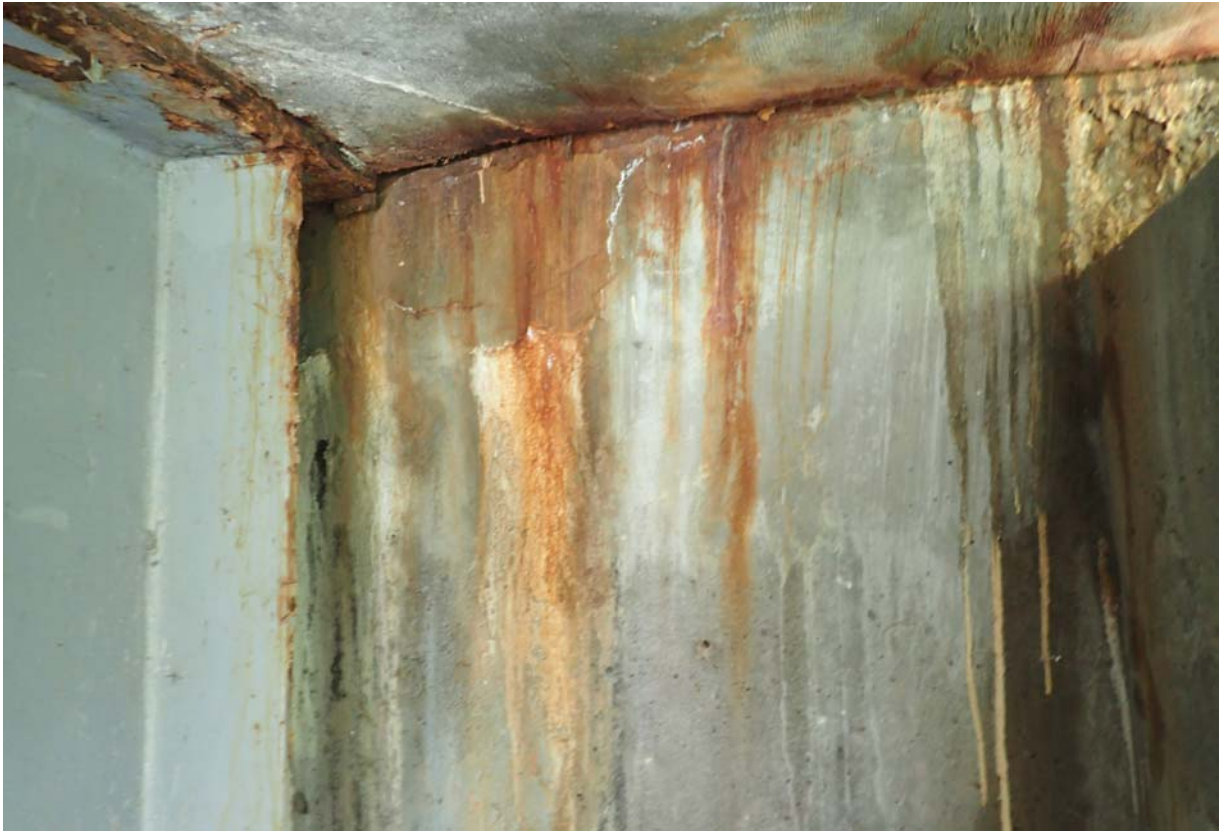
View of minor cracking with efflorescence along the downstream backwall of abutment 1.

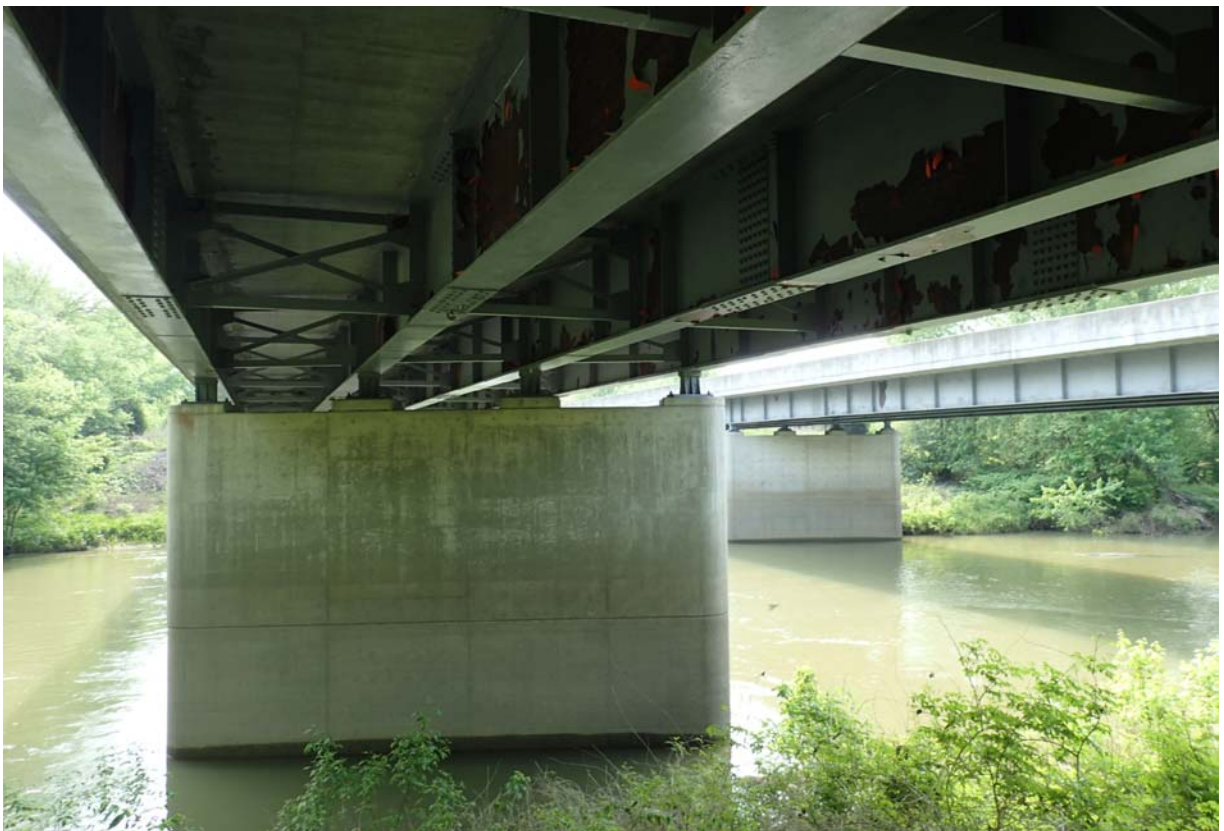
Typical view of span 1 and pier 2.
