Inspection Report with SI&A Data

Structure Description: 424.87 Foot - 3 Span Steel continuous Stringer/Multi-beam or Girder

7 Facility Carried: I-64

9 Location: EBL 2.4 MI W OF KY32 NTRC

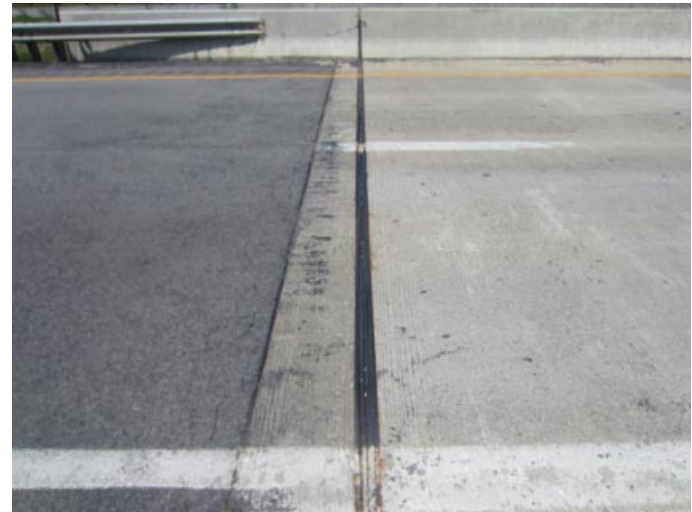
Over abutment #1 is a compression seal expansion. The expansion seal is in good condition. However it has dropped down approximately ?? in most of the left lane and the edges have small gaps along the riser bars with gravel getting down in. The steel riser bars have a few nicks from snow plows. The joint measured at centerline is 2?; however the top flange of left outside beam is tight against the headwall restricting any expansion. The current temperature is 75 degrees.

Looking left over compression
seal expansion over abutment #1

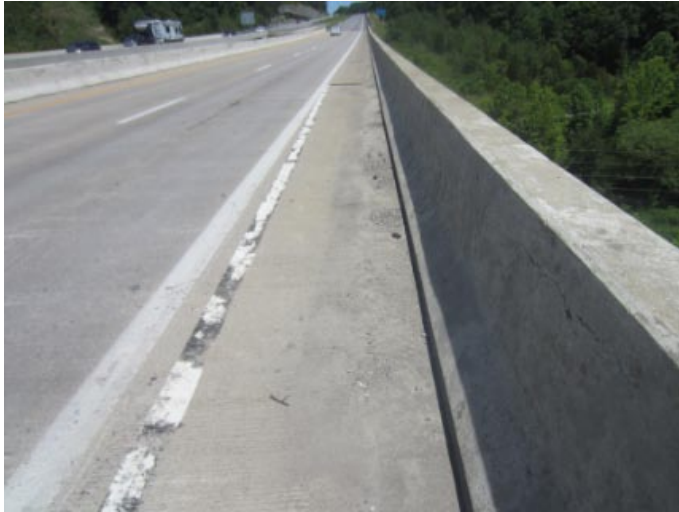
This bridge has scuppers and downspouts along the right side only. The downspouts are very rusty with section loss. On top there is some debris lying along the inside faces of parapets and a little in the scuppers; one has a small amount of grass growing.

Looking east along inside face of right parapet showing debris

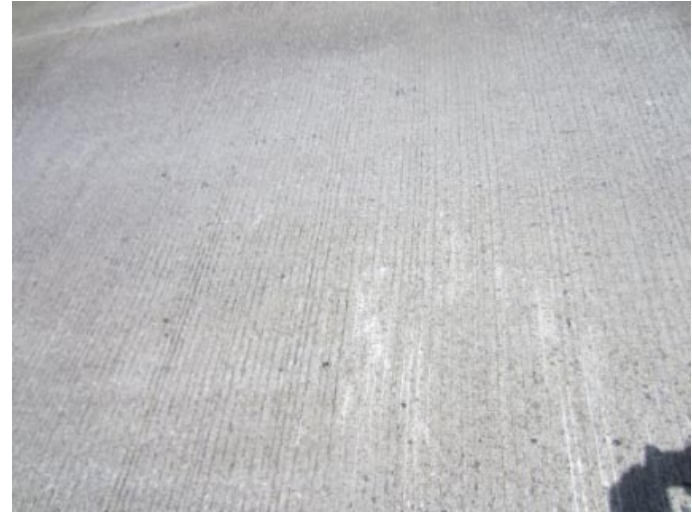
Cement seeping up through the concrete wearing surface

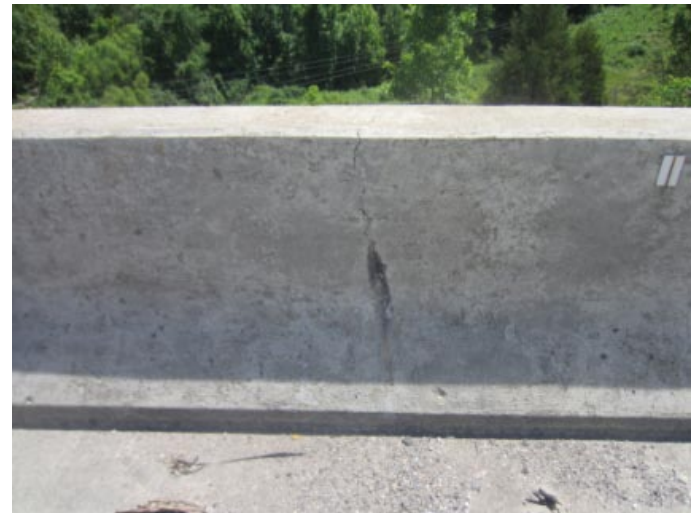
331: Re Conc Bridge Railing									
Units	Total Qty	Qty. St. 1	% in 1	Qty. St. 2	% in 2	Qty. St. 3	% in 3	Qty. St. 4	% in 4
FT	890	885	99%	5	1%	0	0%	0	0%
<p>The concrete parapets along both sides have wide spread shallow pop out type spalls along the inside faces and top surfaces. Both sides have the usual vertical cracks scattered here and there along the inside and outside faces found in this type railing. The east end of right side railing has a long section where the vertical cracks are worse and are spaced 2' to 3' apart. The inside face of left side has a few scrapes from traffic; minor. They have been sealed and the sealant along left side is still in fairly good condition; much is now missing from right side along inside face.</p>

Vertical cracks in right side parapet; typical

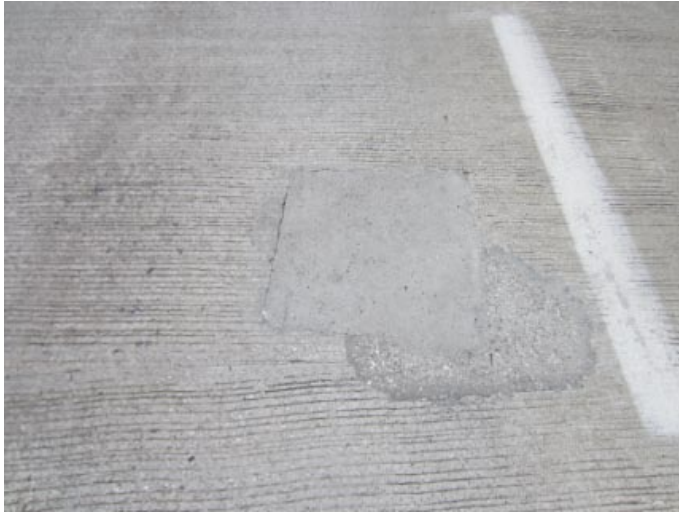
2' x 2' patched area in wearing surface in right lane

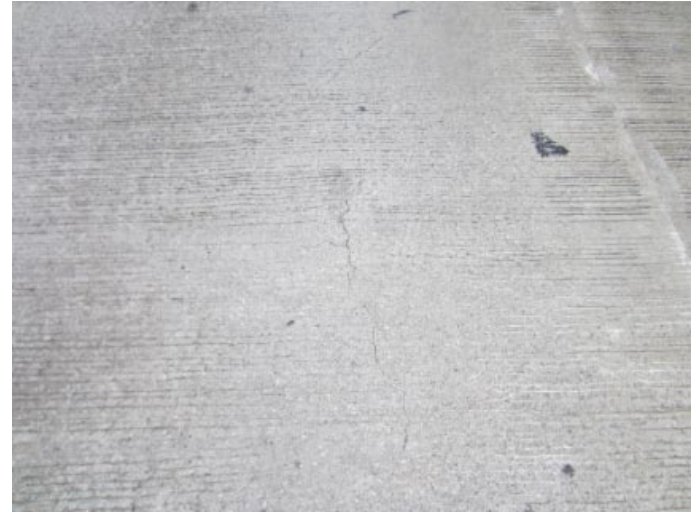
Longitudinal and random cracking in right lane

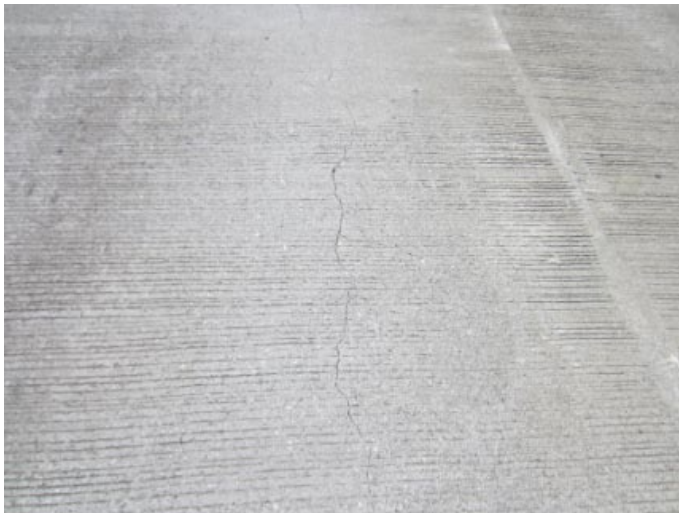
Long longitudinal cracks in right lane

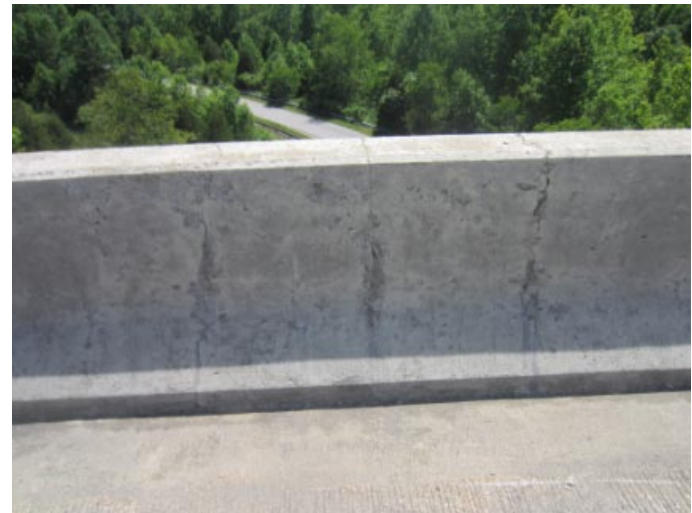
Vertical cracking in right parapet in east half of bridge

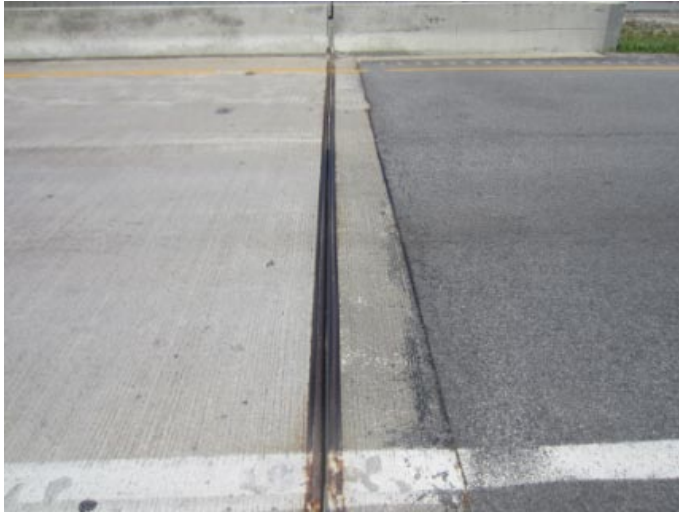
This bridge has a strip seal expansion joint at east end over abutment #4. It is still basically in good condition. The seal in left lane has dropped down approximately ?? in areas. Joint measured at centerline 1?; however the top flanges of all the beams are tight against the backwall which would restrict any expansion. The temperature is 75 degrees.

Looking left across strip seal
expansion joint over abutment
#4

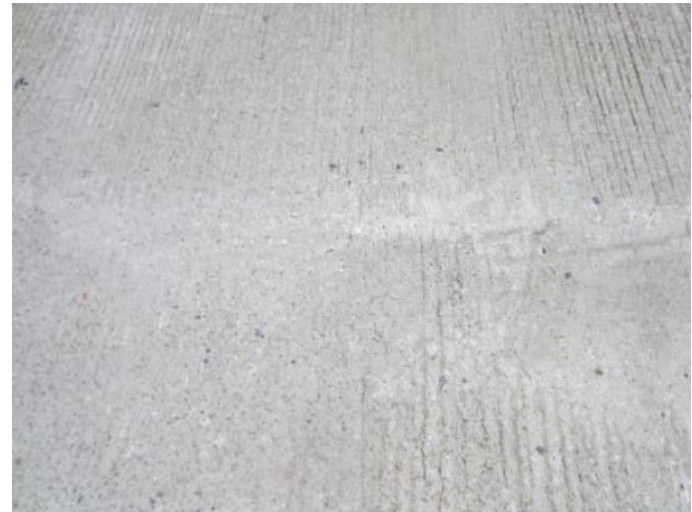
Random cracking in left lane at
east end of deck

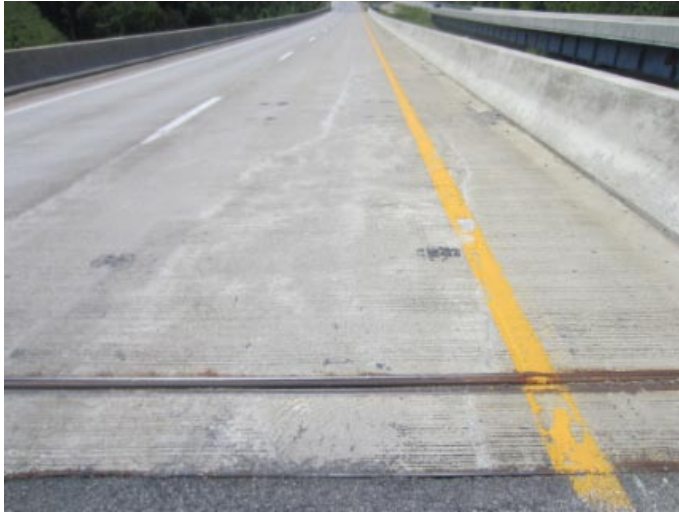
Long patched area in w.s. in left lane at east end of deck

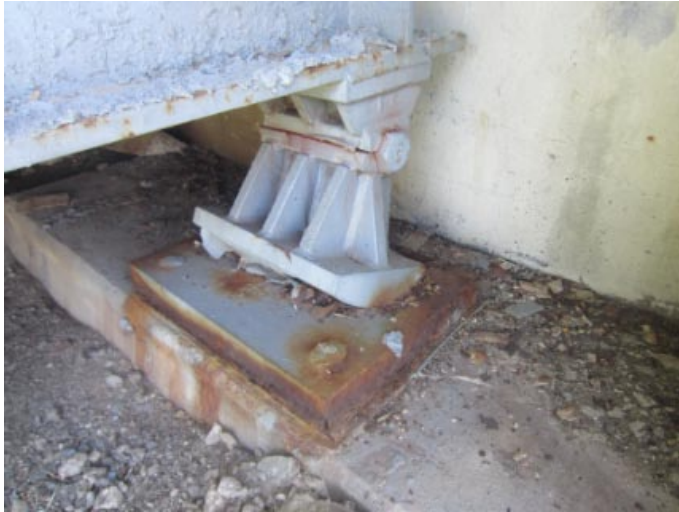
Over abutment #1 all rockers are tilted toward backwall to max; the three right rockers may have very slight room for movement yet. Since the left outside beam is tight against backwall there is no more space for expansion over abutment one. The base plates under the two interior rockers are 100% rusted with some flaking rust and section loss; 2nd from left is the worse. Over abutment #4 all four rockers are tilted back toward backwall 30 degrees. All beams over this abutment is tight against backwall restricting any further movement.

Left outside rocker over
abutment #1

Generated by erichmond on 06/18/2014. Rockers over abutments need reset.

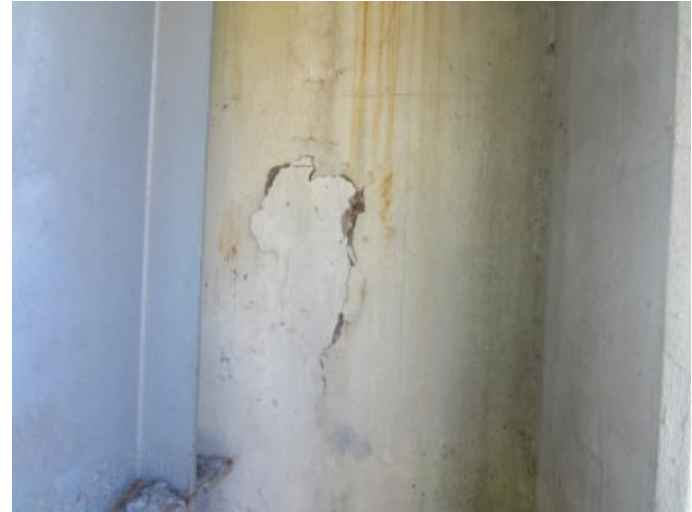
This bridge is built on a lot of fill. Since bridge was built both abutments have settled and tilted in. Only approximately 1? of abutment #1 can be seen. Abutment #1 backwall has a 1? cracked delaminated area near the left end and a vertical spall with rebar exposed next to 2nd beam from left. There are other areas of surface cracking with slight delamination and cracking throughout the backwall. The face of abutment #4 has some spalling in front of the three left rockers; minor rebar is exposed in two of these spalled areas. Abutment #4 backwall has a vertical spall with rebar exposed near the right end next to outside beam.

Abutment #1 backwall next to
left end

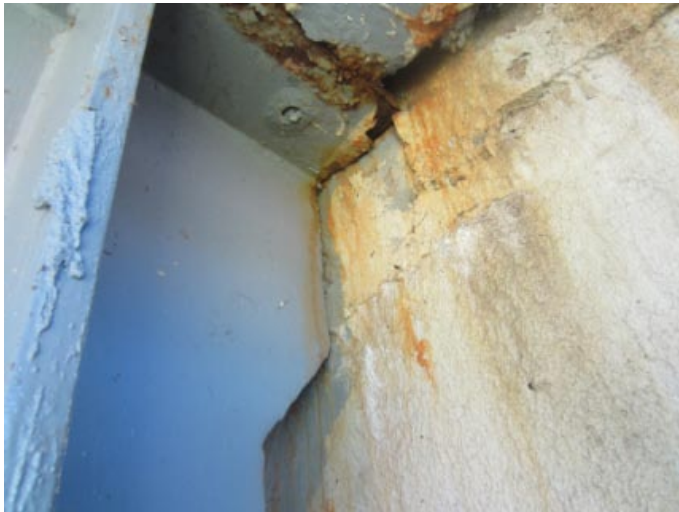
Left outside beam top flange
tight against backwall at
abutment #1

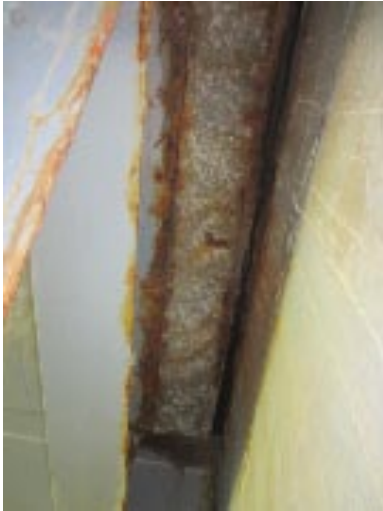
3' section of end of deck at
abutment #1 has broken off lying
on seat

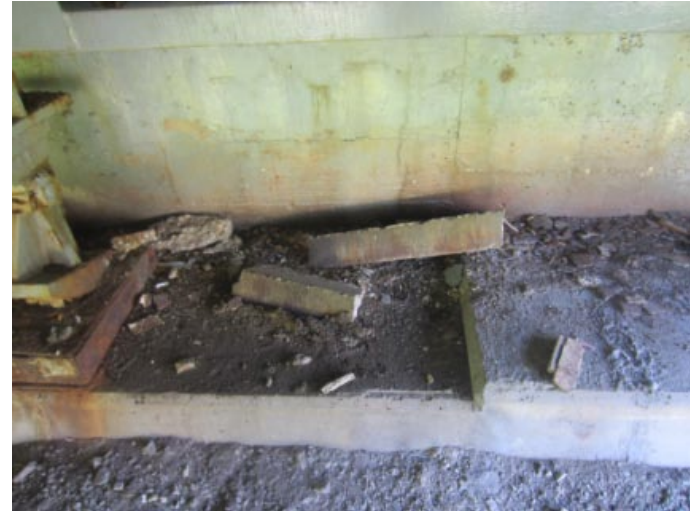
End of deck broken lying on
abutment #1

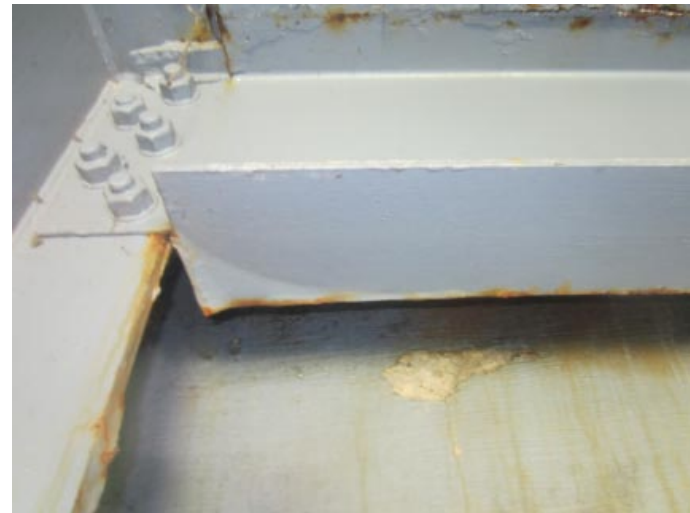
End diaphragm over abutment
#1 slightly bent; very minor

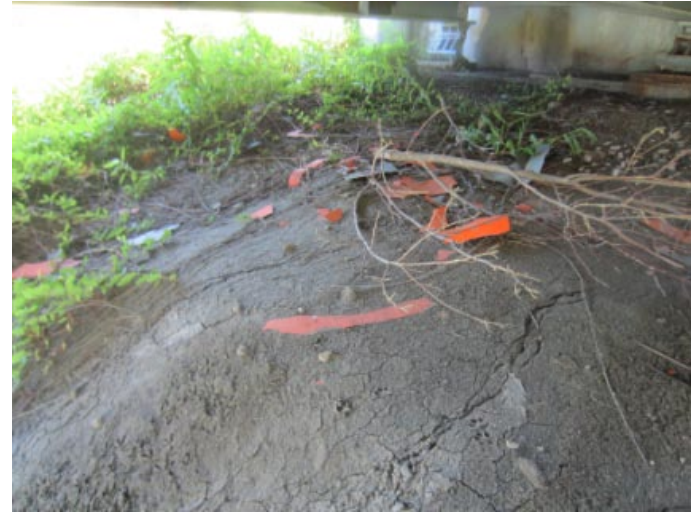
The superstructure is made up of four large steel girders with vertical stiffeners. There are crossframes throughout the bridge between all the beams. Between the two center beams is lower lateral bracing. There are large areas where the paint is flaking off the beams to bare steel along the webs but the flaking is not as bad as the twin L-bridge. There are isolated areas where rust is starting to appear along the outer edges of the bottom flanges. This is a very high bridge and this inspection is only from the ground looking up; I also used binoculars. However, any small cracks or broken welds could easily be missed. At west end over abutment the top flange of left outside beam is tight against the backwall and all are tight at east end which would restrict expansion.

Paint flaked off beams lying on ground in front of abutment #1

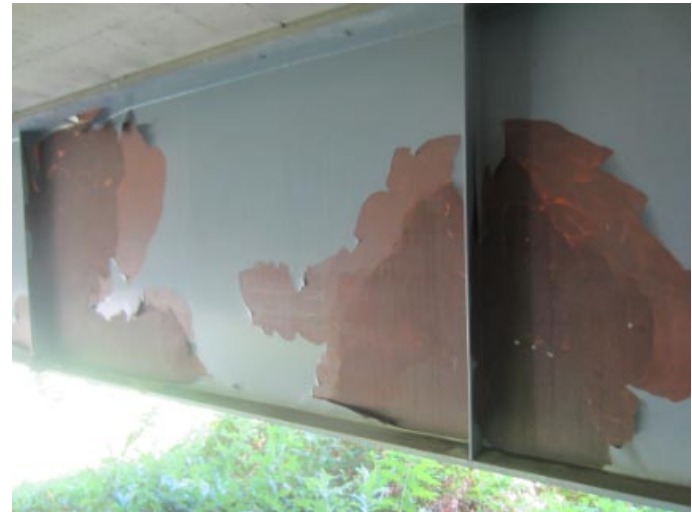
Paint flaked off inside face of right outside beam next to abutment #1

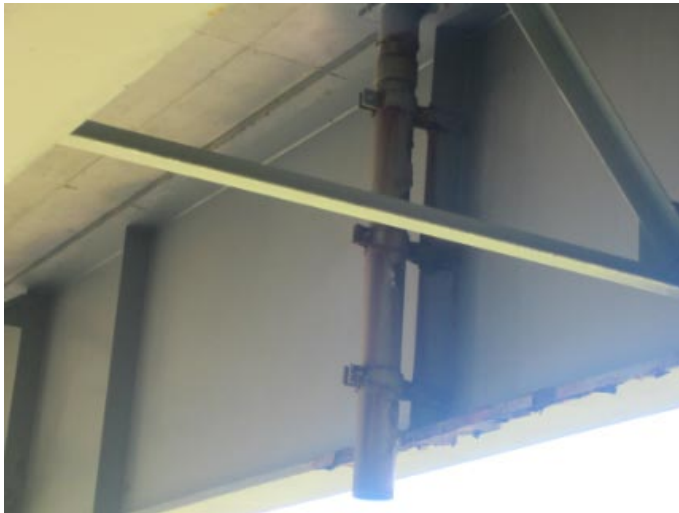
Downspout along right side
rusting

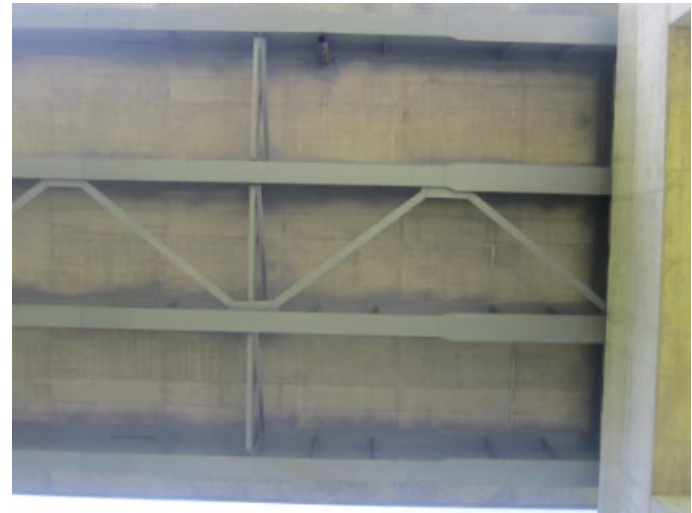
Transverse cracks in deck in span
#1 next to pier

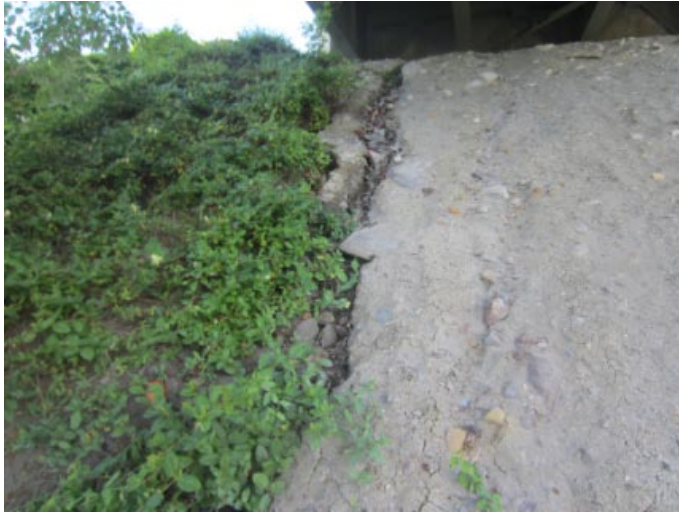
Gully washing out along left side of slope protection next to abutment #4

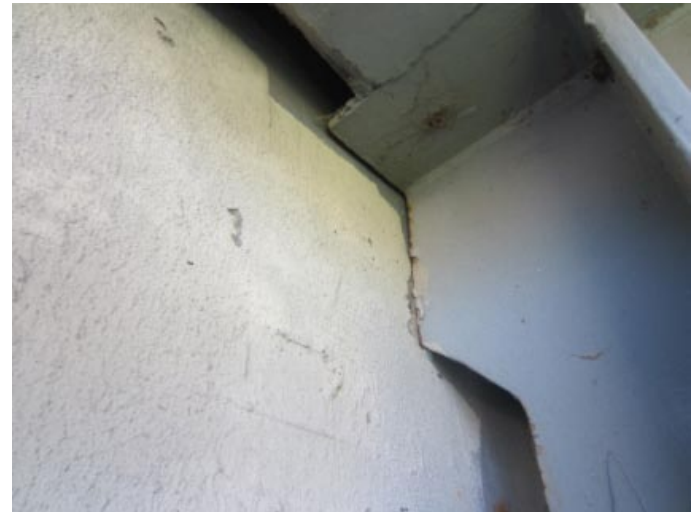
Left outside beam tight against abutment #4 backwall

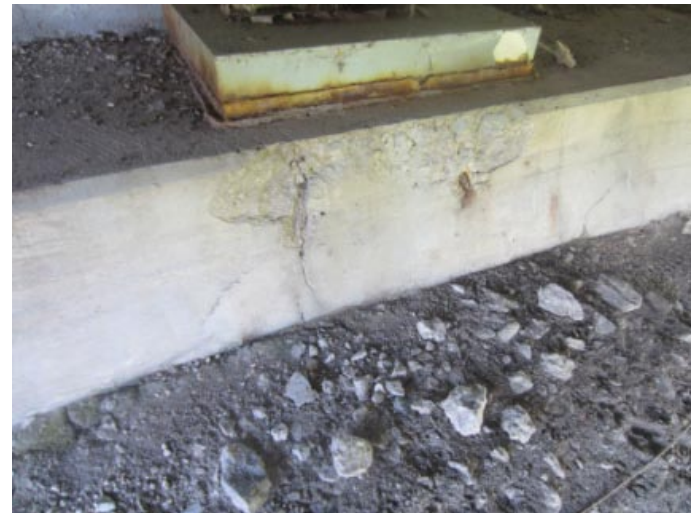
Face of abutment #4 spalling
under 2nd rocker from left

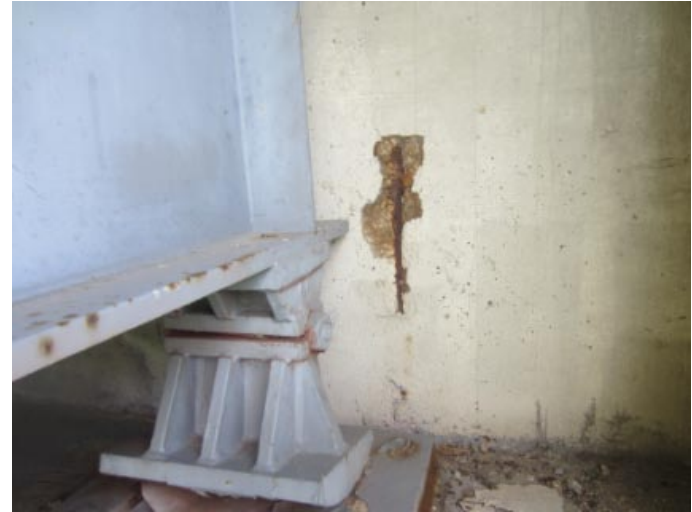
Vertical spall in #4 backwall at right end

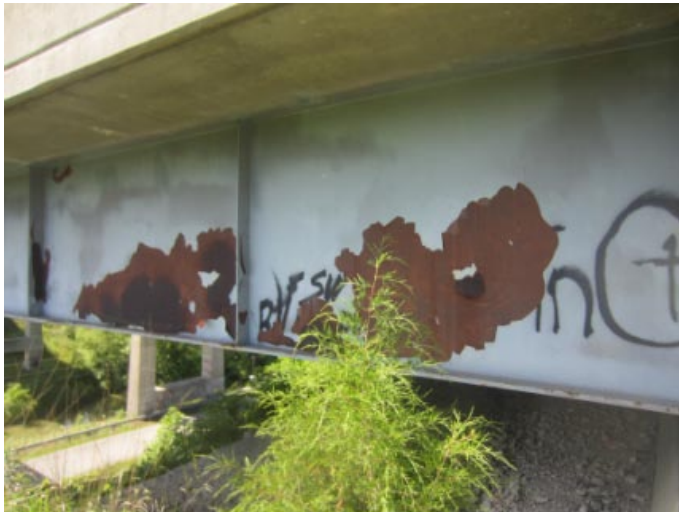
Paint flaking off outside face of right outside beam in span #3

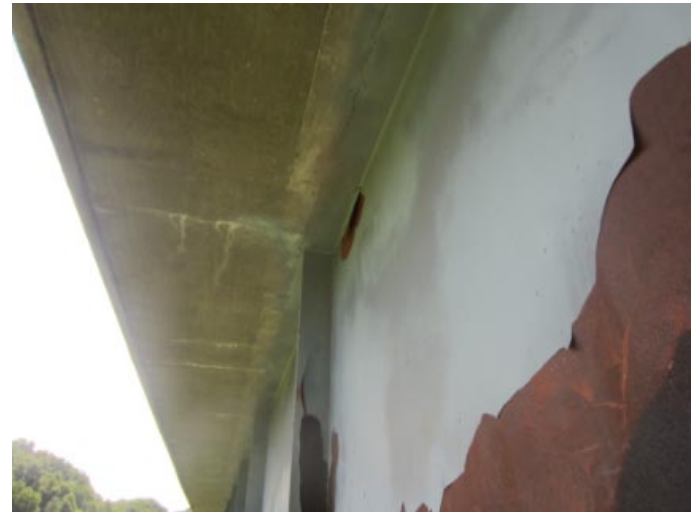
Lower outside edges of deck have transverse cracks with seepage
