Inspection Report with SI&A Data

Structure Description: 70.87 Foot - 2 Span Steel Stringer/Multi-beam or Girder

7 Facility Carried: CR1240 McINTIRE RD

6A Feature Intersected: FLEMING CREEK

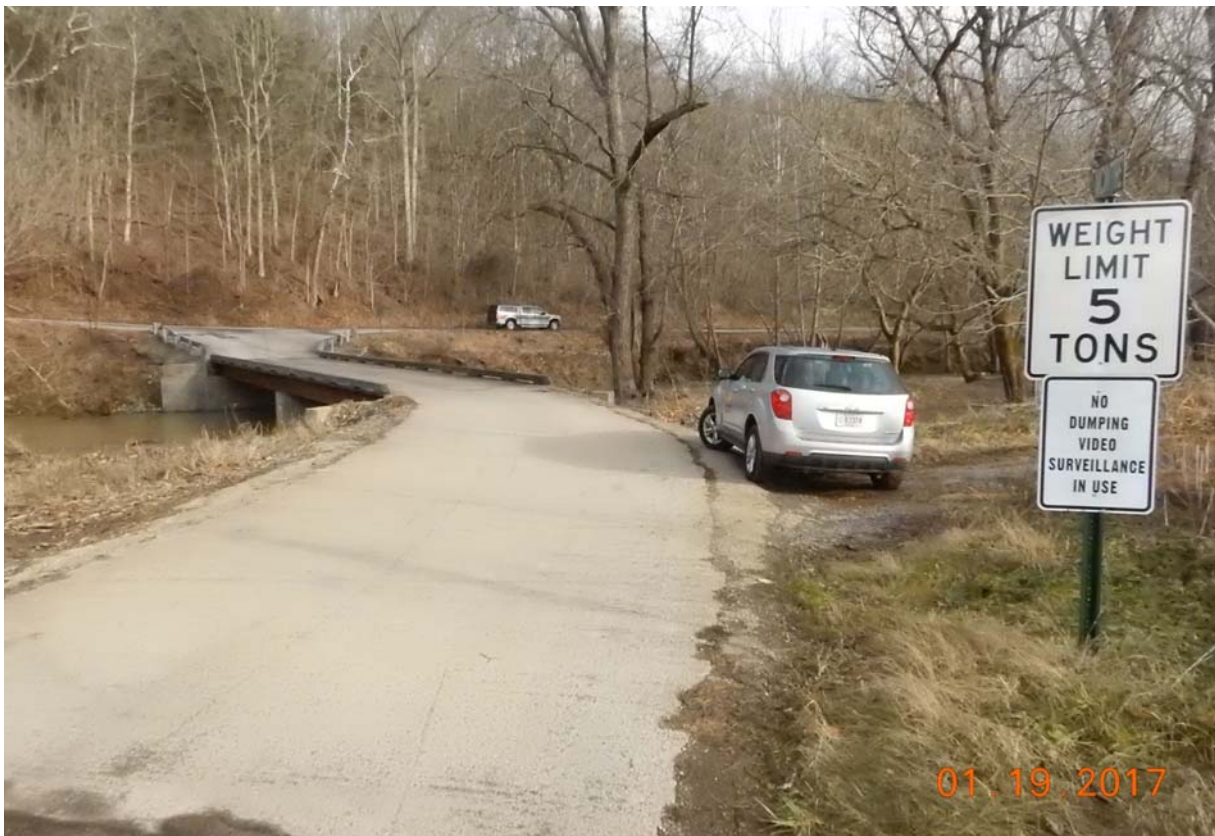
View of bridge from the east approach. Note the 5 ton posting sign is in place.

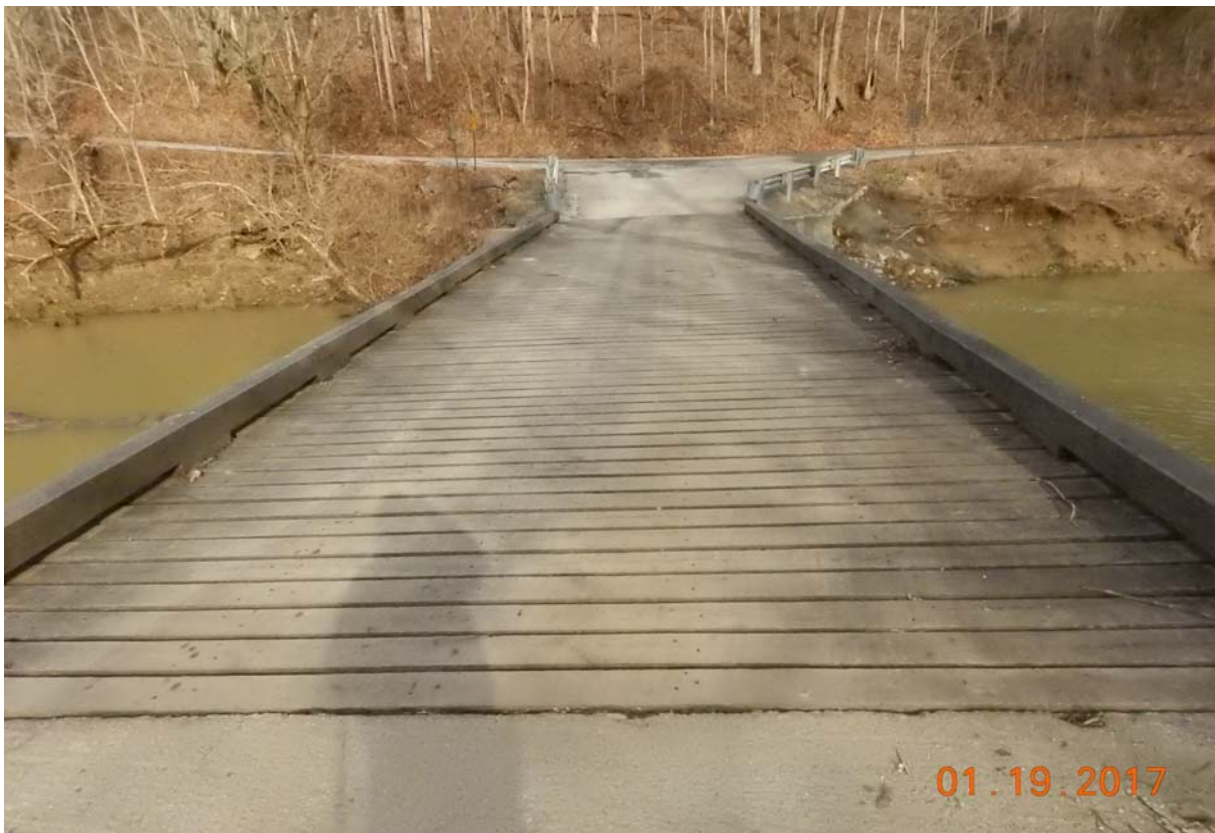
View of the timber wearing surface.

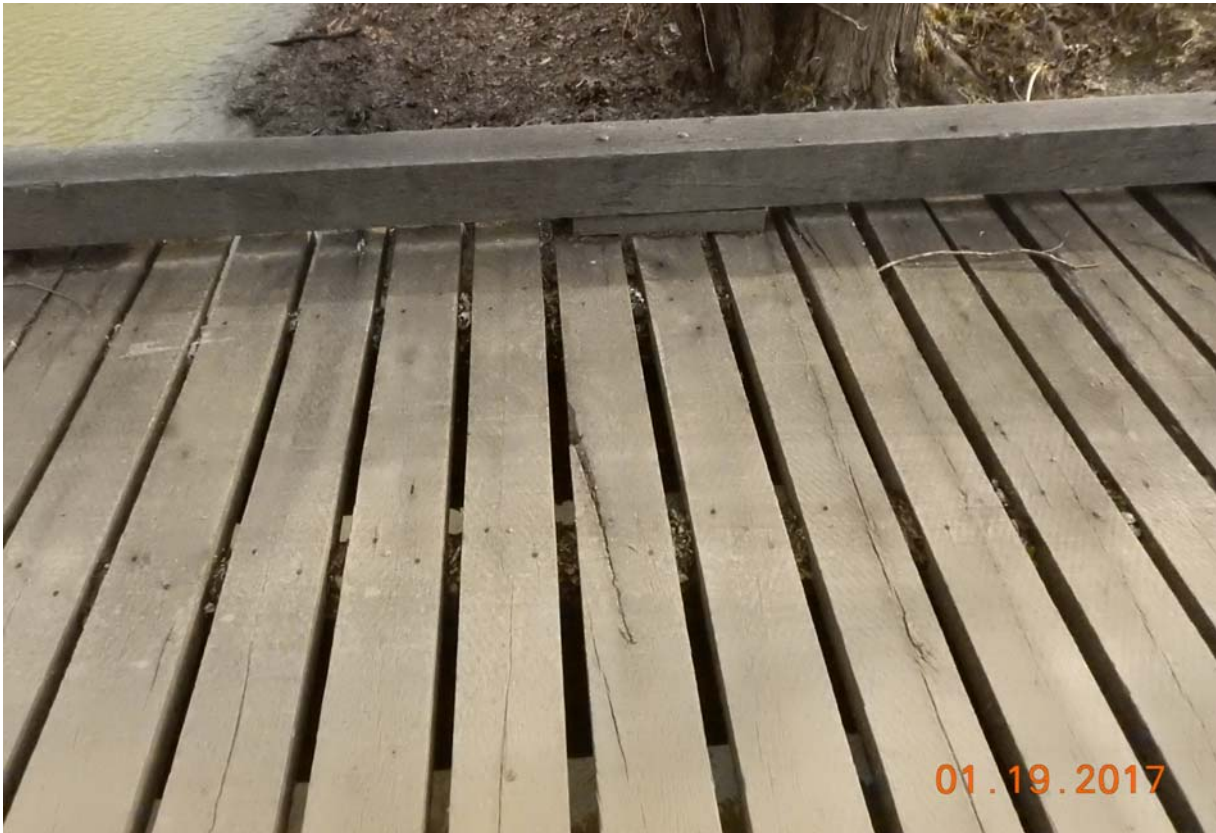
View of an area of minor splitting near the east end along the upstream wheel path.

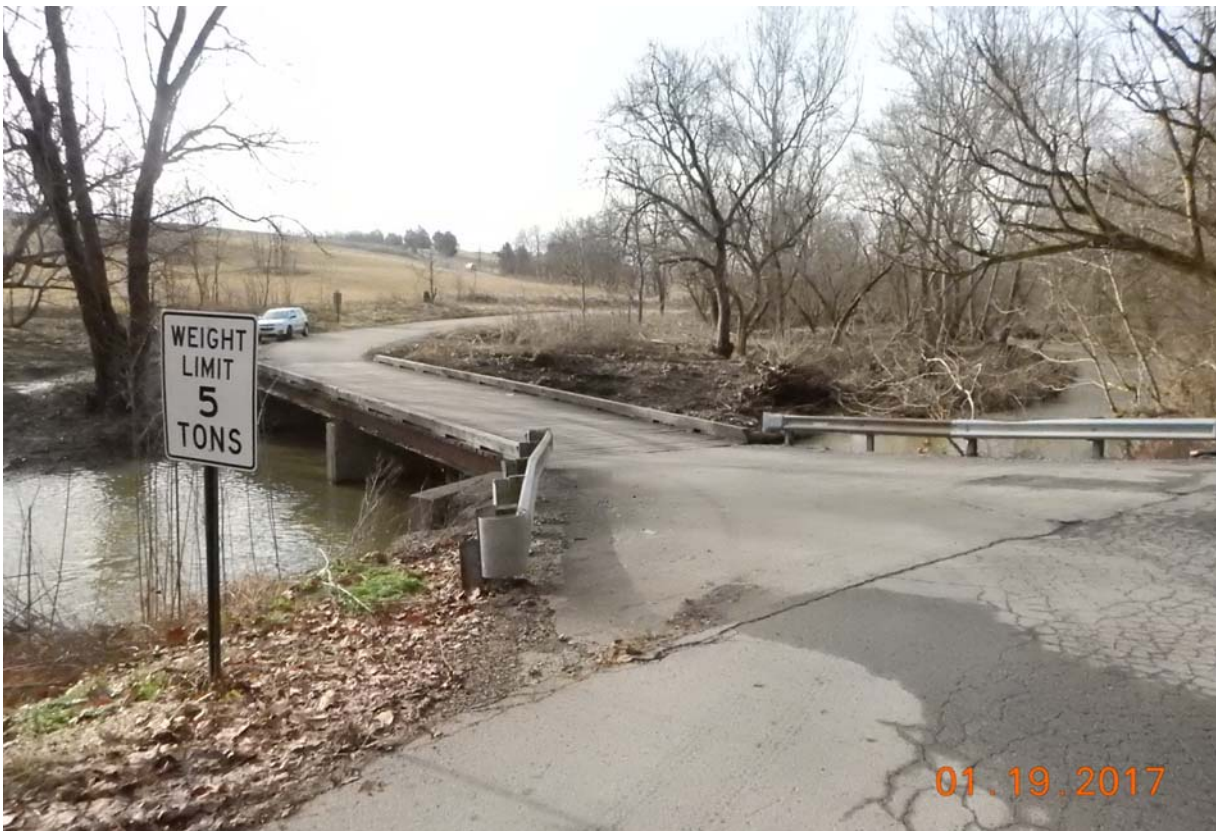
View of bridge from the west approach. Note the 5 ton posting sign is in place.

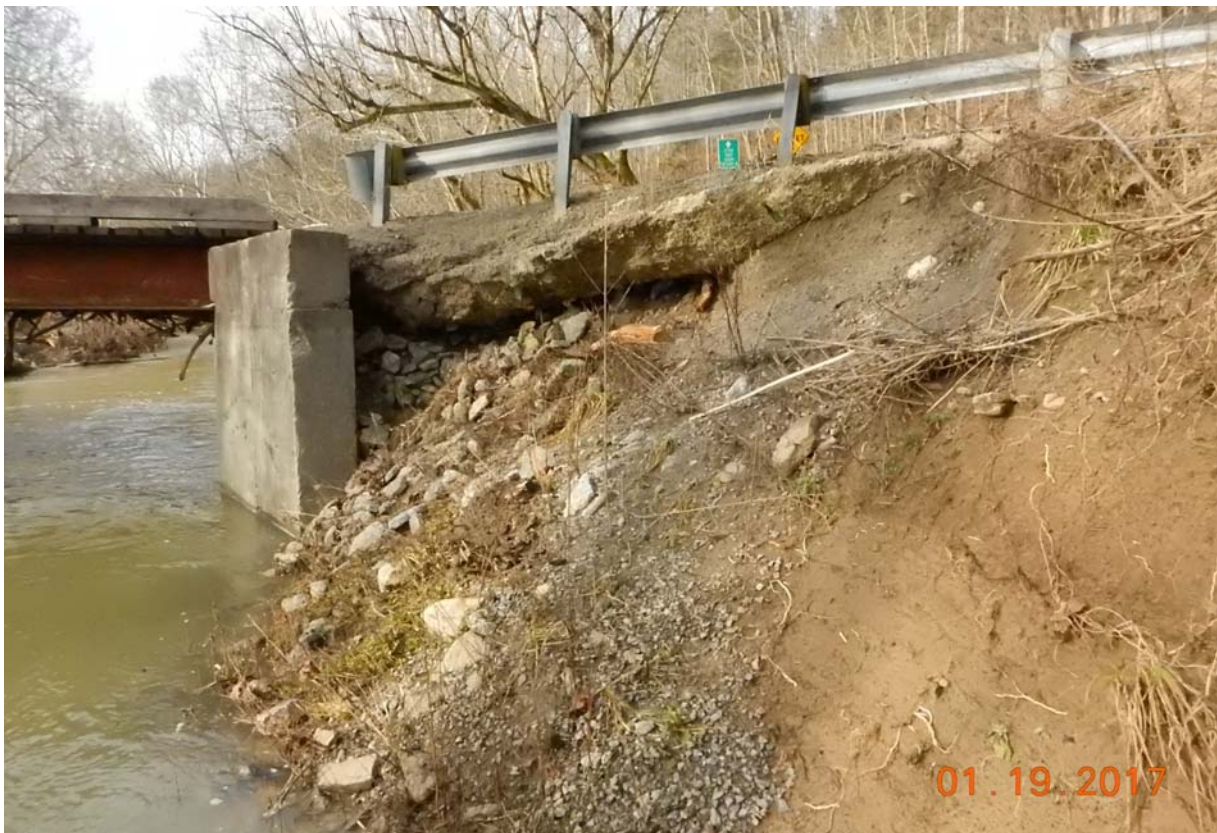
View of embankment erosion along the upstream embankment of the west abutment.

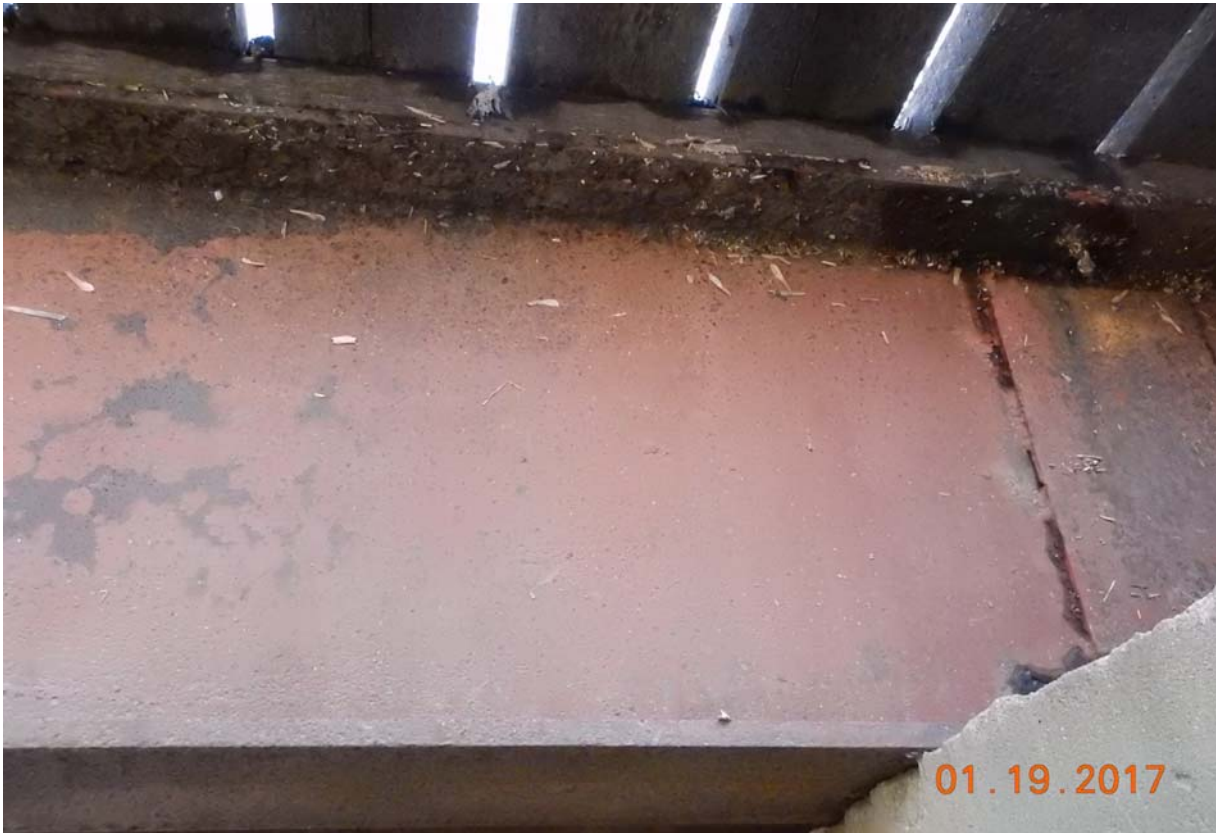
View of areas of minor pitting along the top flange of the downstream exterior beam at the east abutment.

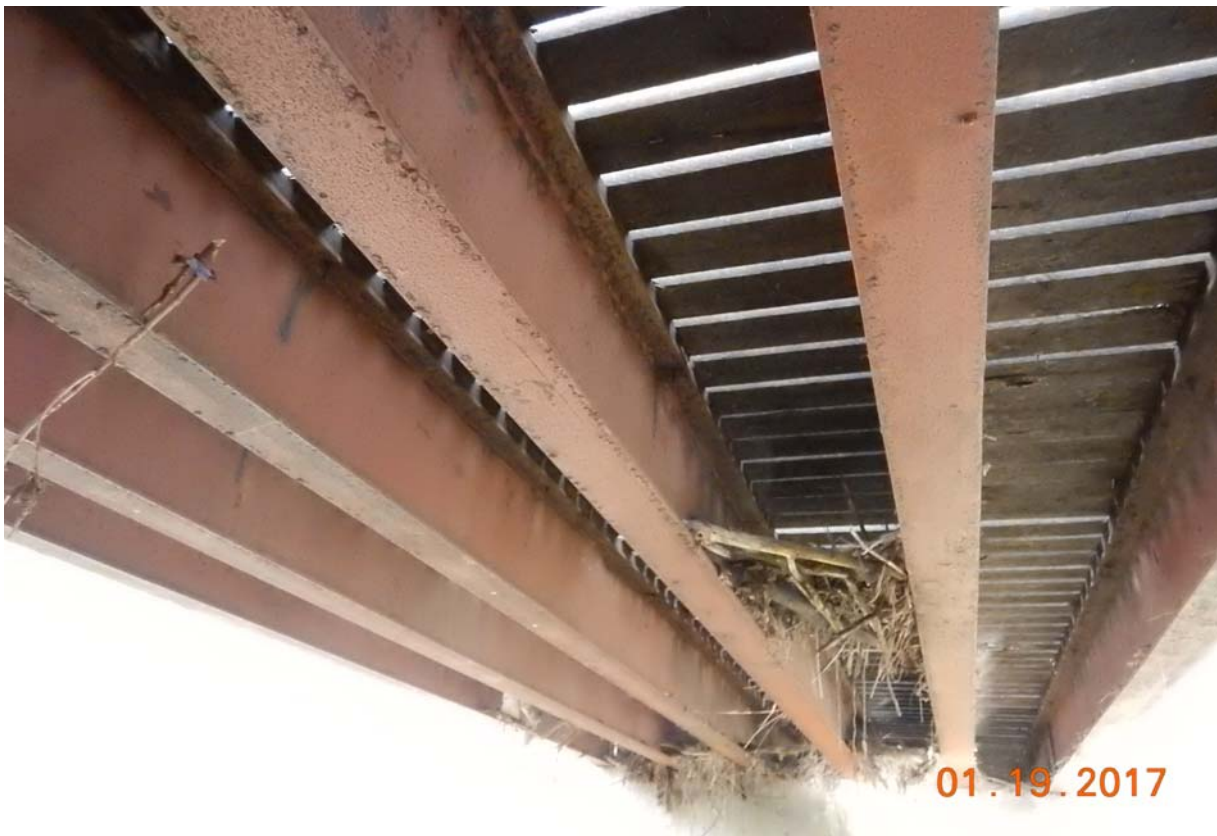
View of the underside of the east span. Note the debris lodged between the beams.

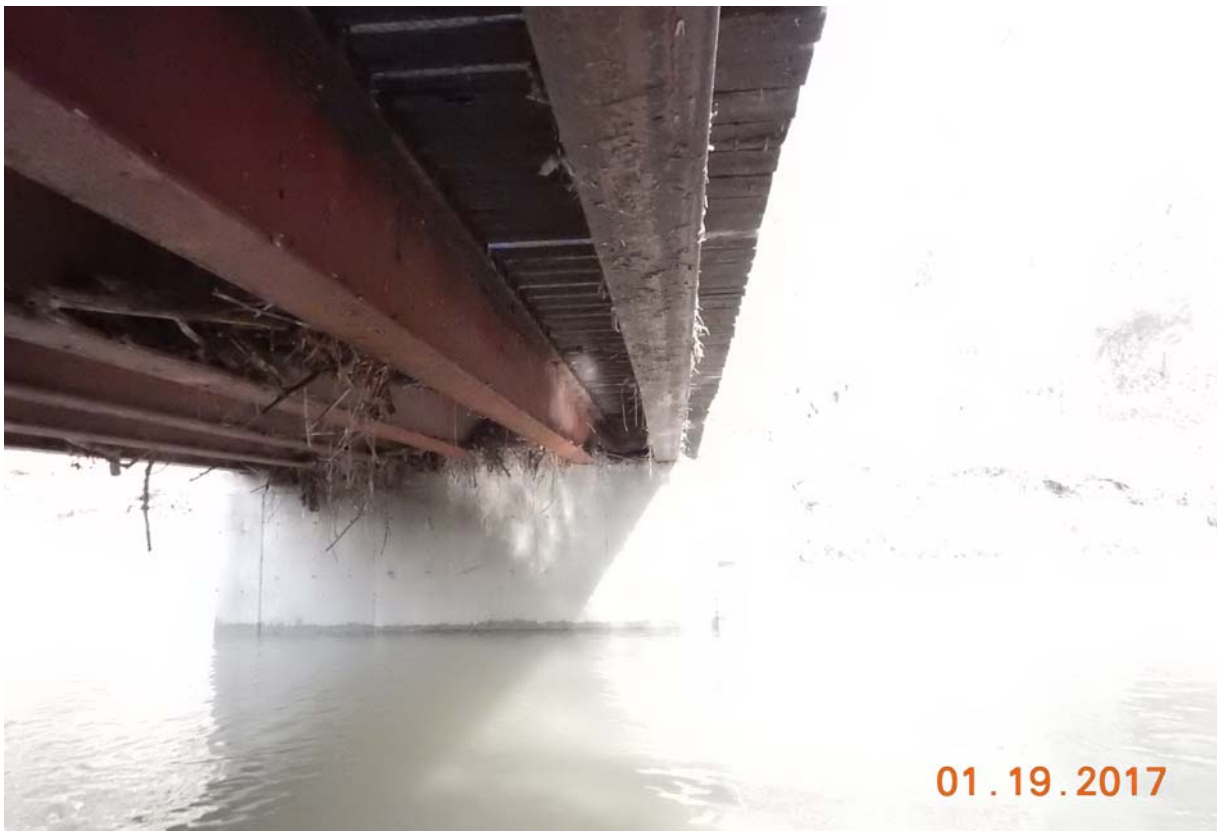
View sighting along the upstream exterior beam of the east span. Note when sighting along the beam the beam appears to be wavy.
