Inspection Report with SI&A Data

Structure Description: 36.09 Foot - Single Span Concrete Tee Beam

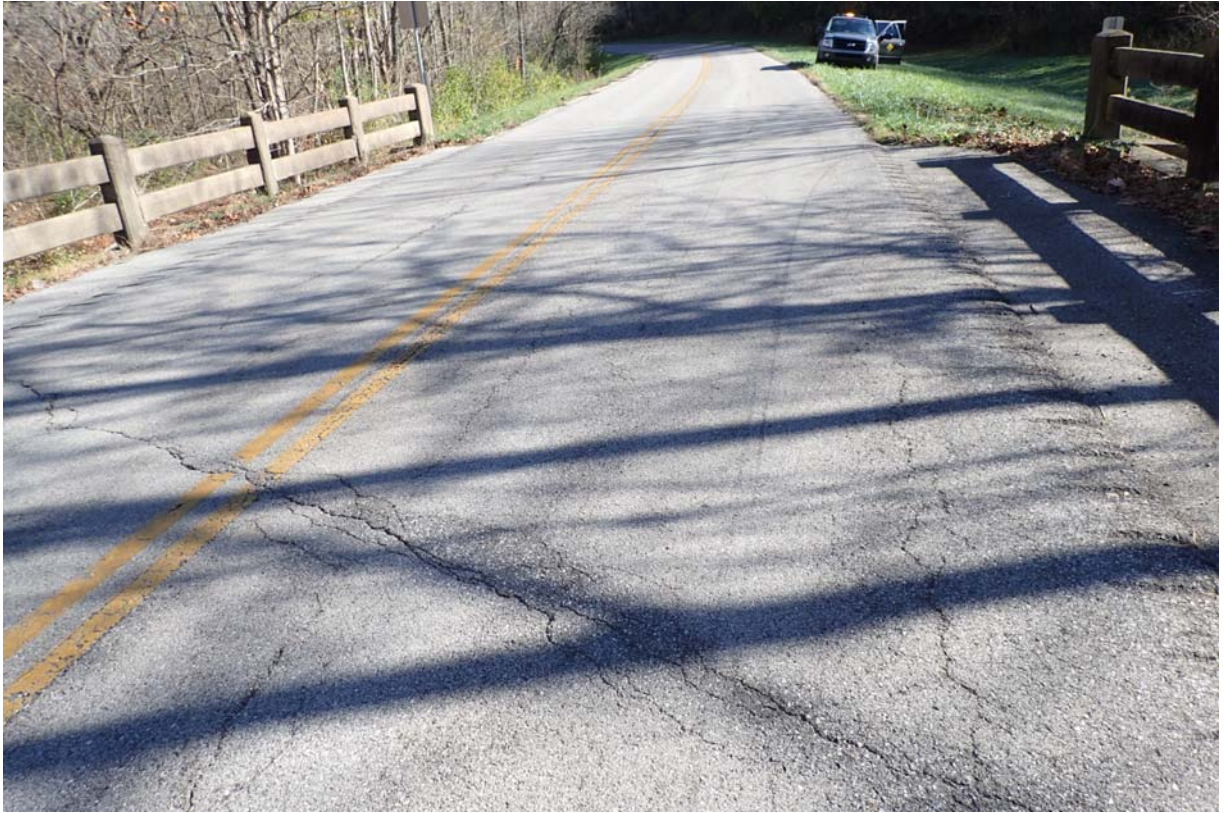
Typical view of the asphalt wearing surface. Notice the moderate sized transverse cracking at the end of the bridge and the moderate sized longitudinal cracking in the driving lanes.

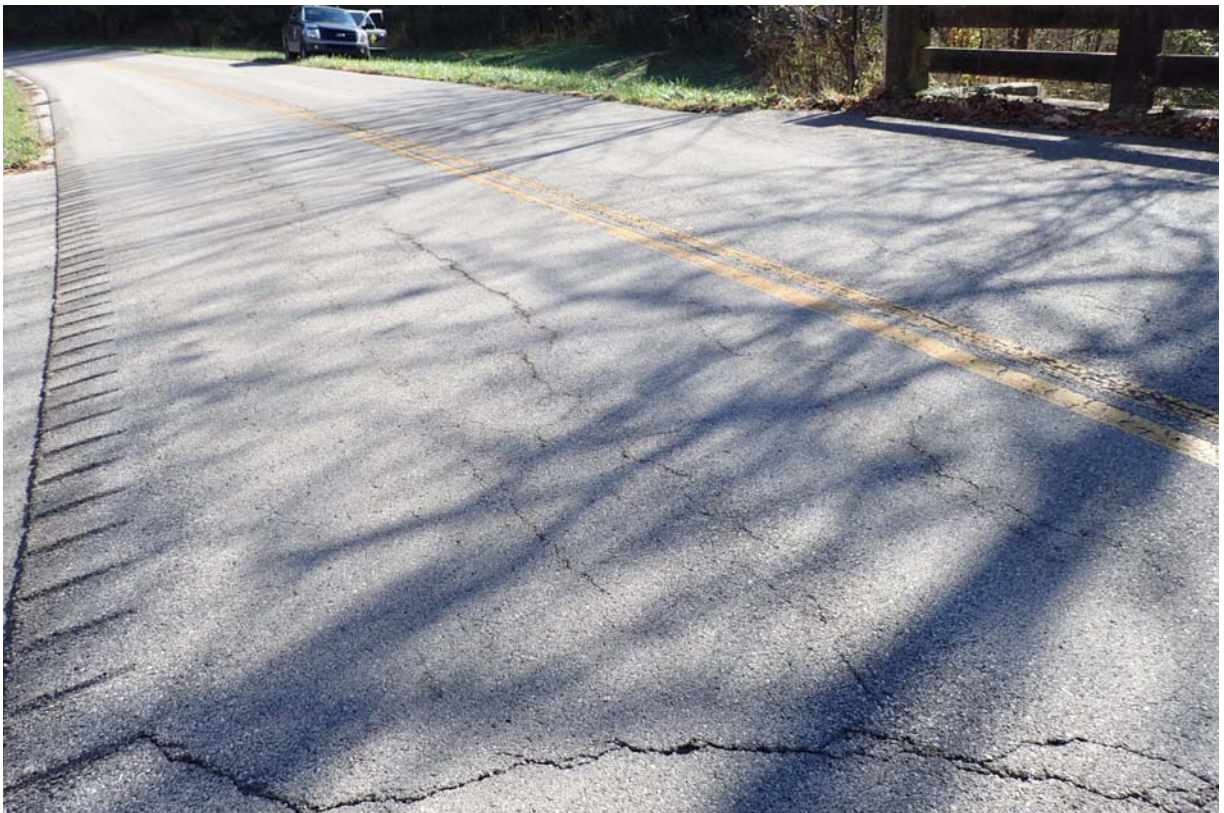
Typical view of the asphalt wearing surface. Notice the moderate sized transverse cracking at the end of the bridge and the moderate sized longitudinal cracking in the driving lanes.

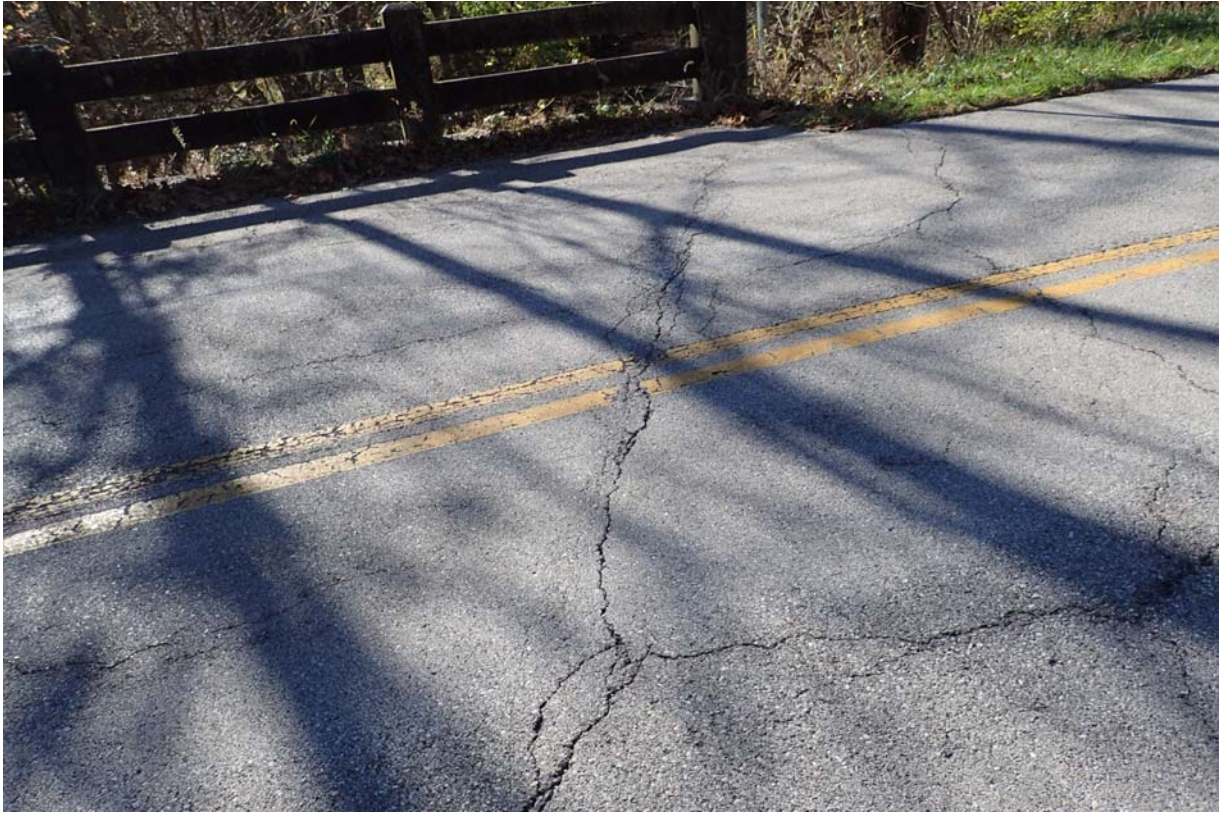
Typical view of moderate sized transverse cracking in the asphalt wearing surface over abutment 1.

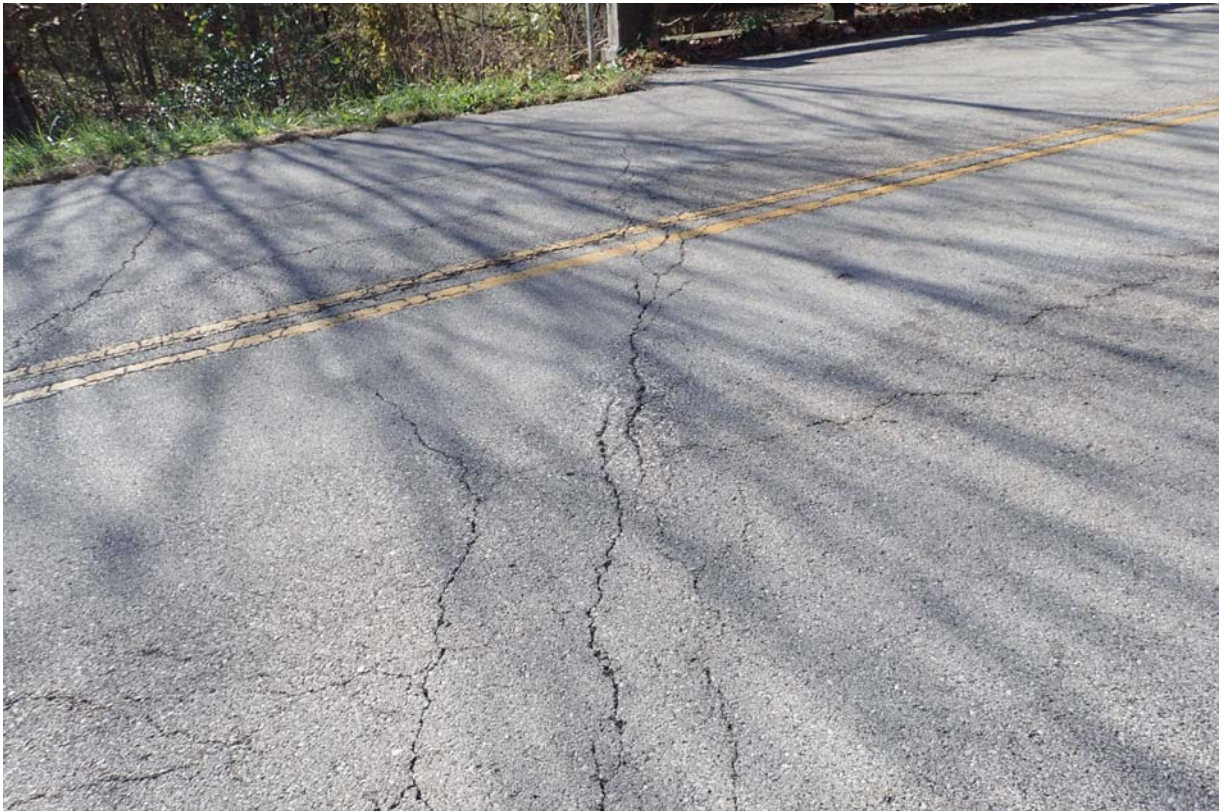
Typical view of moderate sized transverse cracking in the asphalt wearing surface over abutment 2.

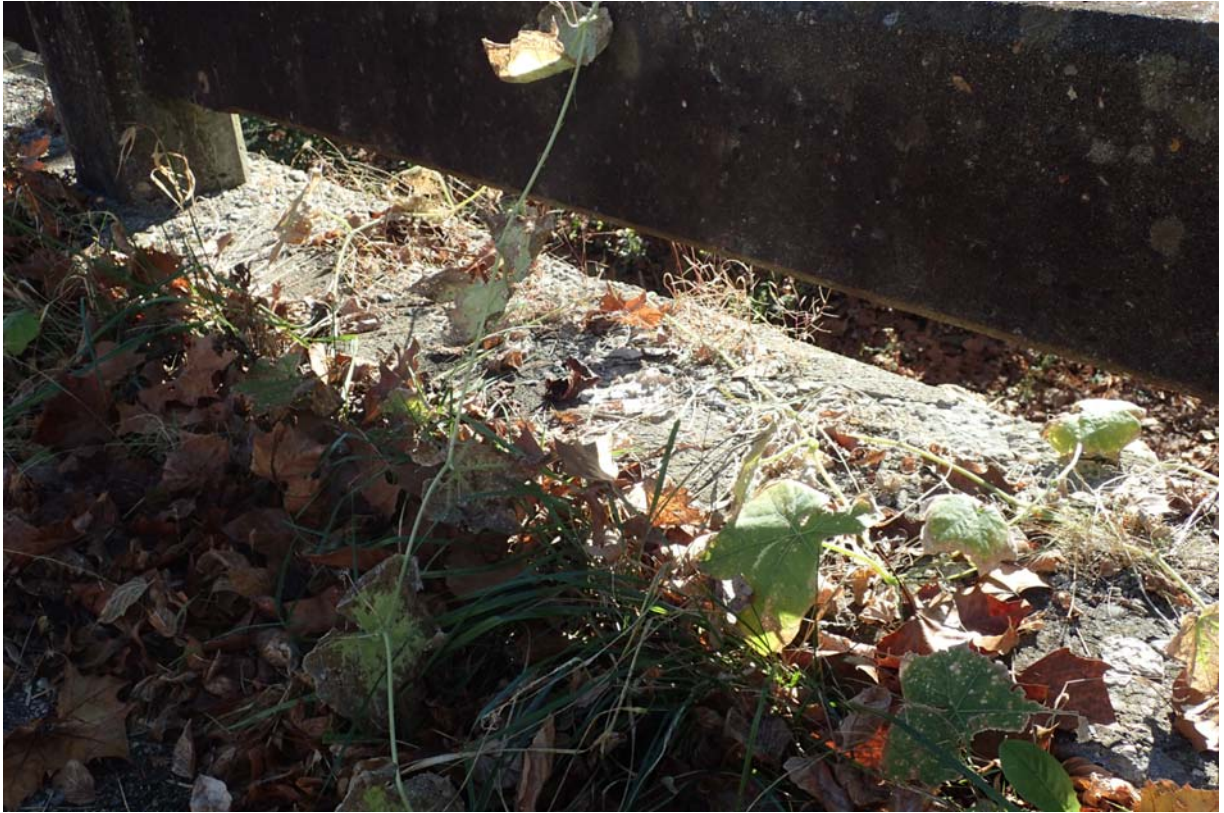
Moderate scaling/spalling along the top of the upstream curb near abutment 1.

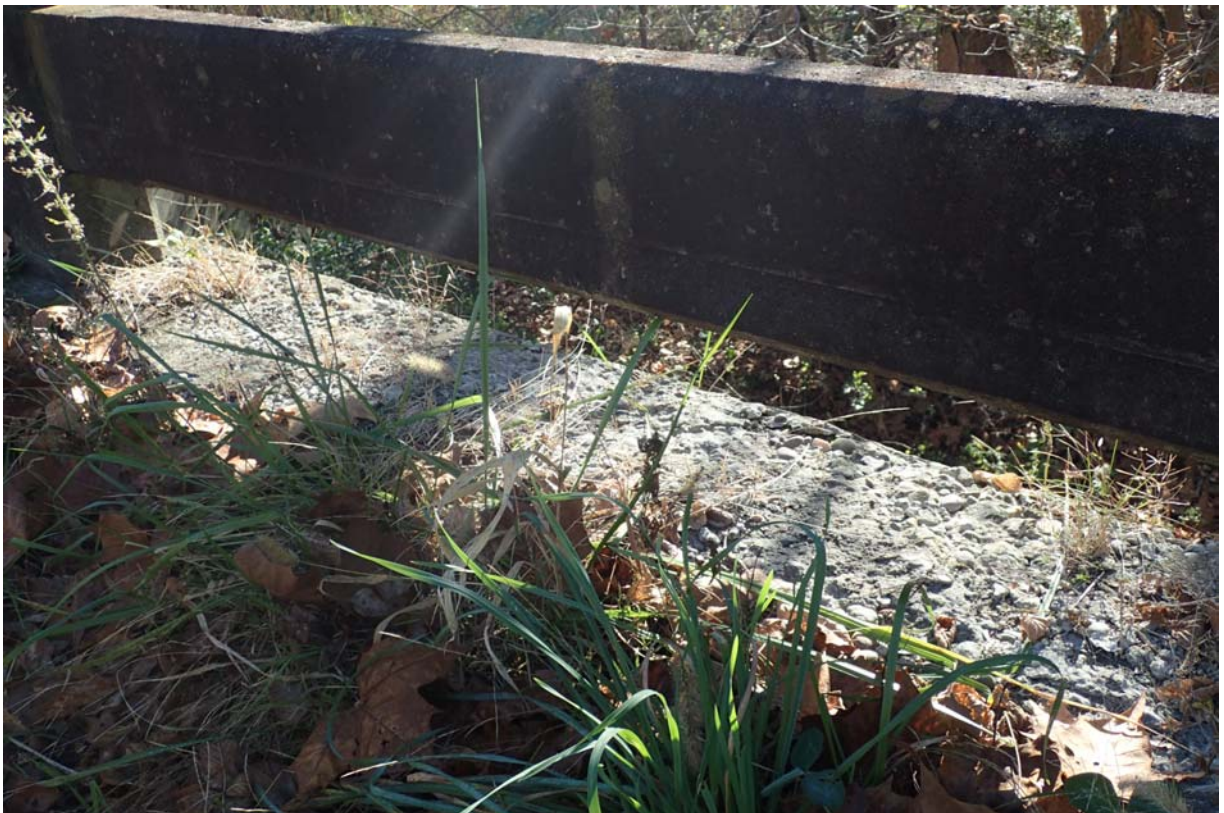
Moderate scaling/spalling along the top of the upstream curb near midlength.

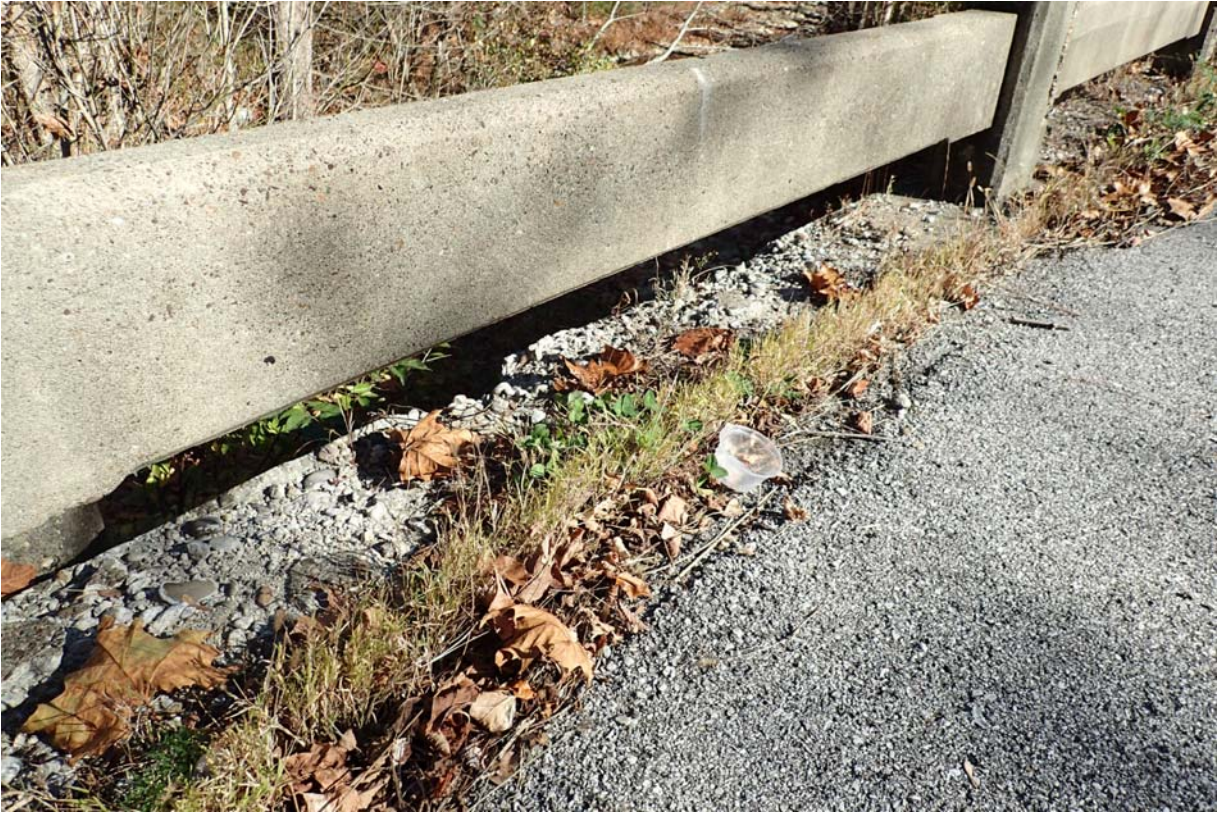
Moderate scaling/spalling along the top of the downstream curb near abutment 1.

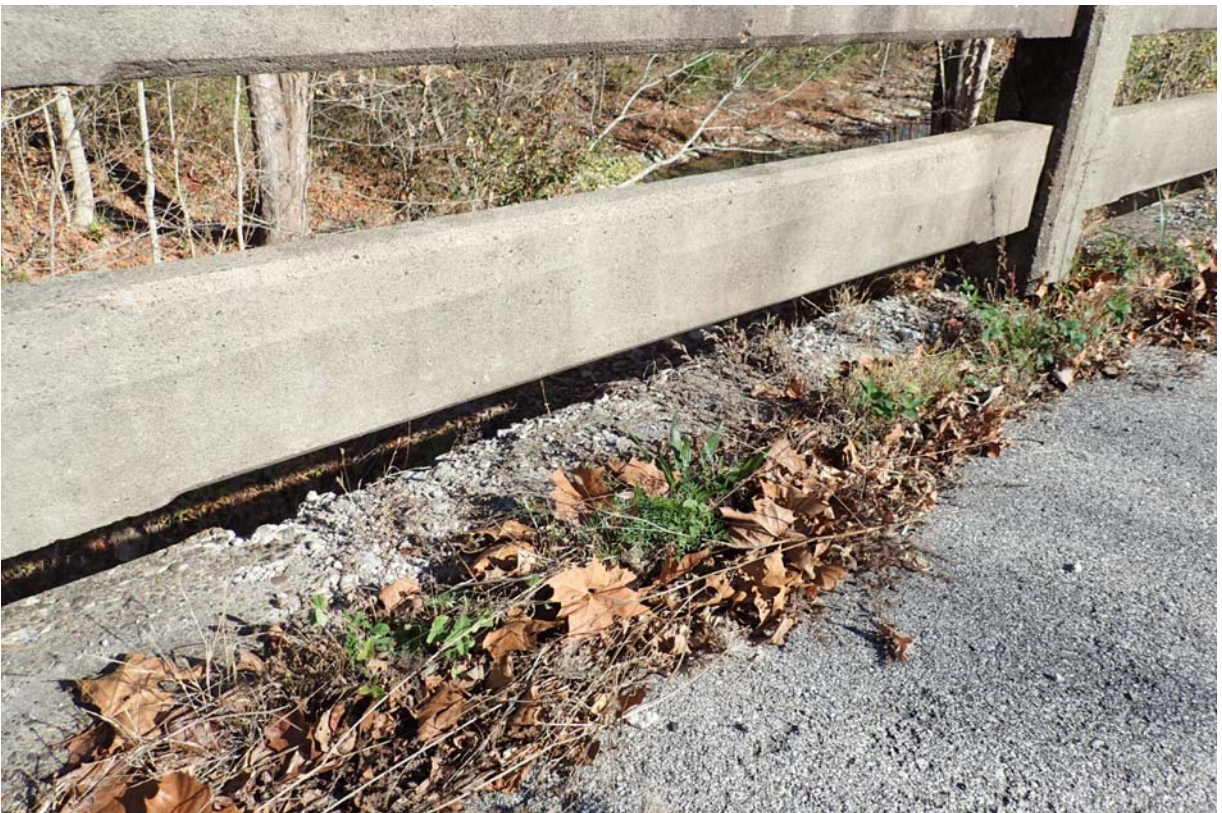
Moderate scaling/spalling along the top of the downstream curb near midspan.

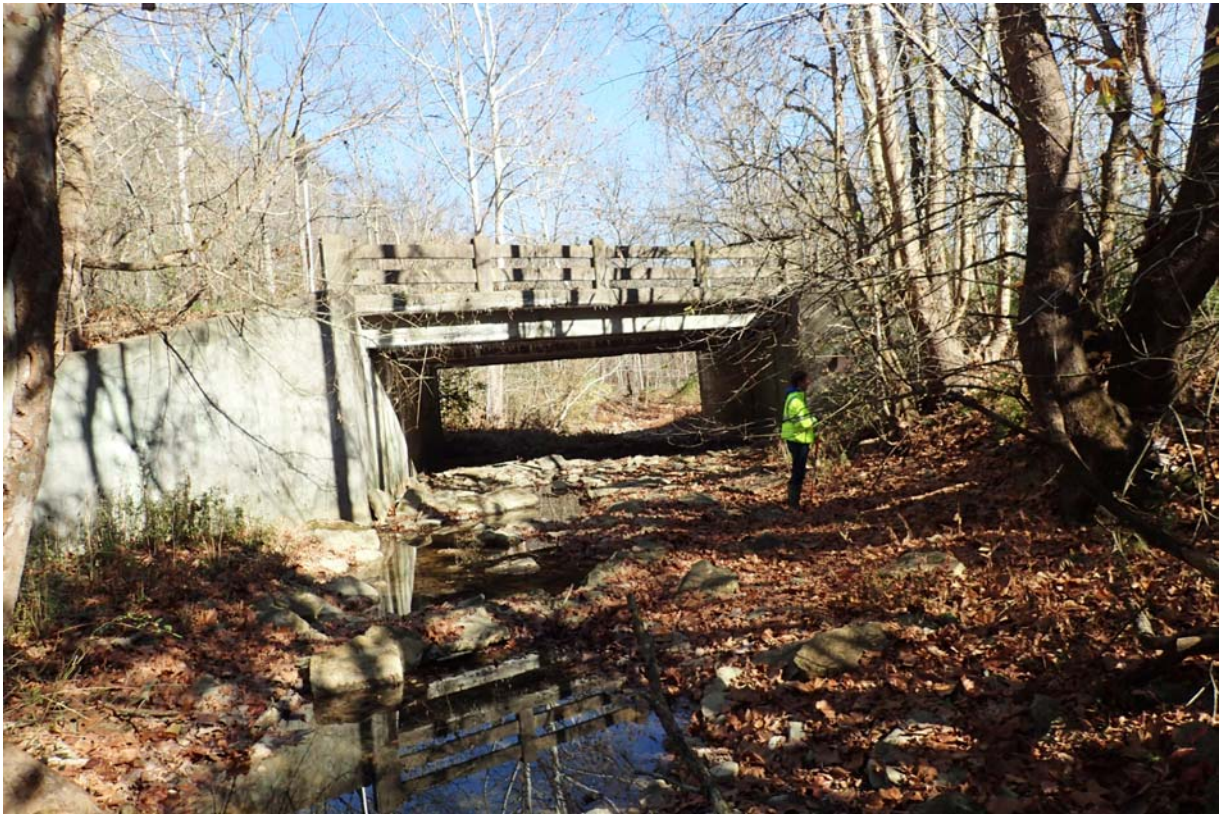
Typical upstream view.

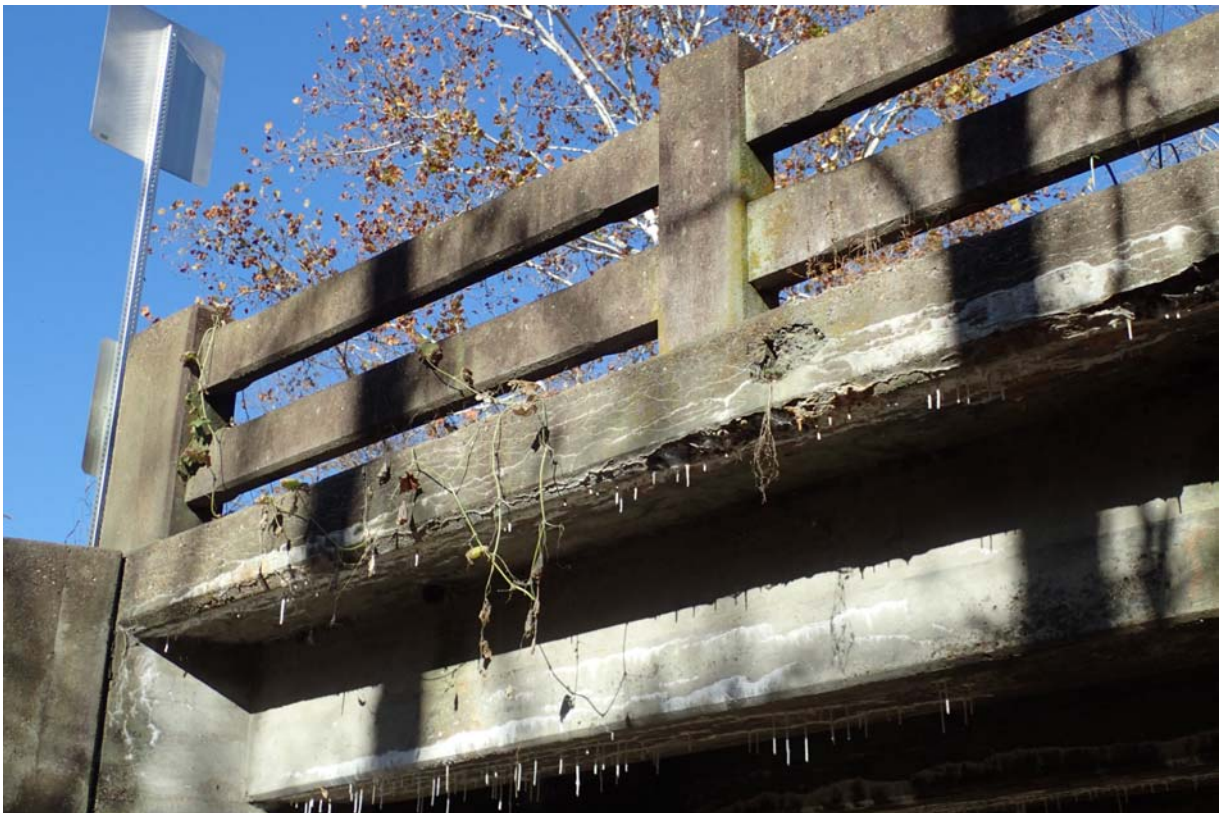
Heavy intensity of minor sized cracking with efflorescence and areas of moderate spalling in the upstream deck overhang near abutment 1.

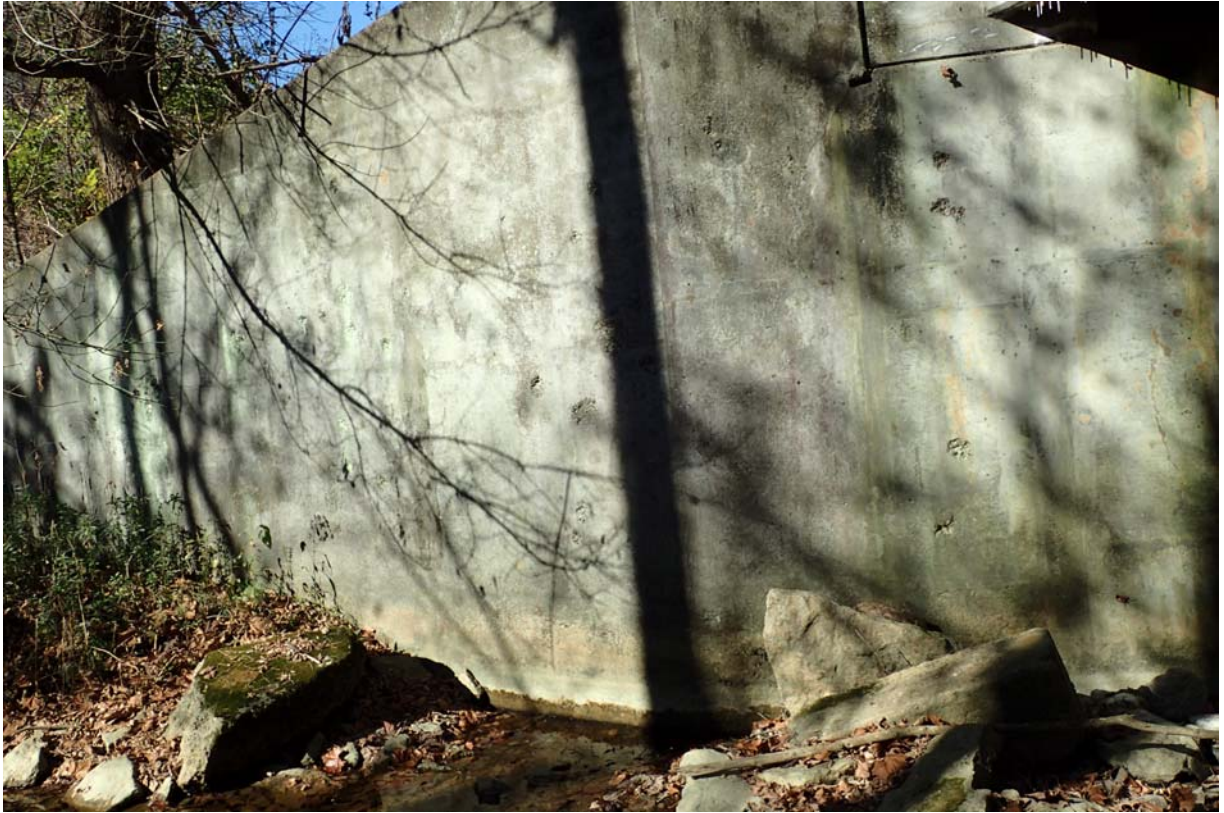
Several minor sized spalls at the upstream end of abutment 1.

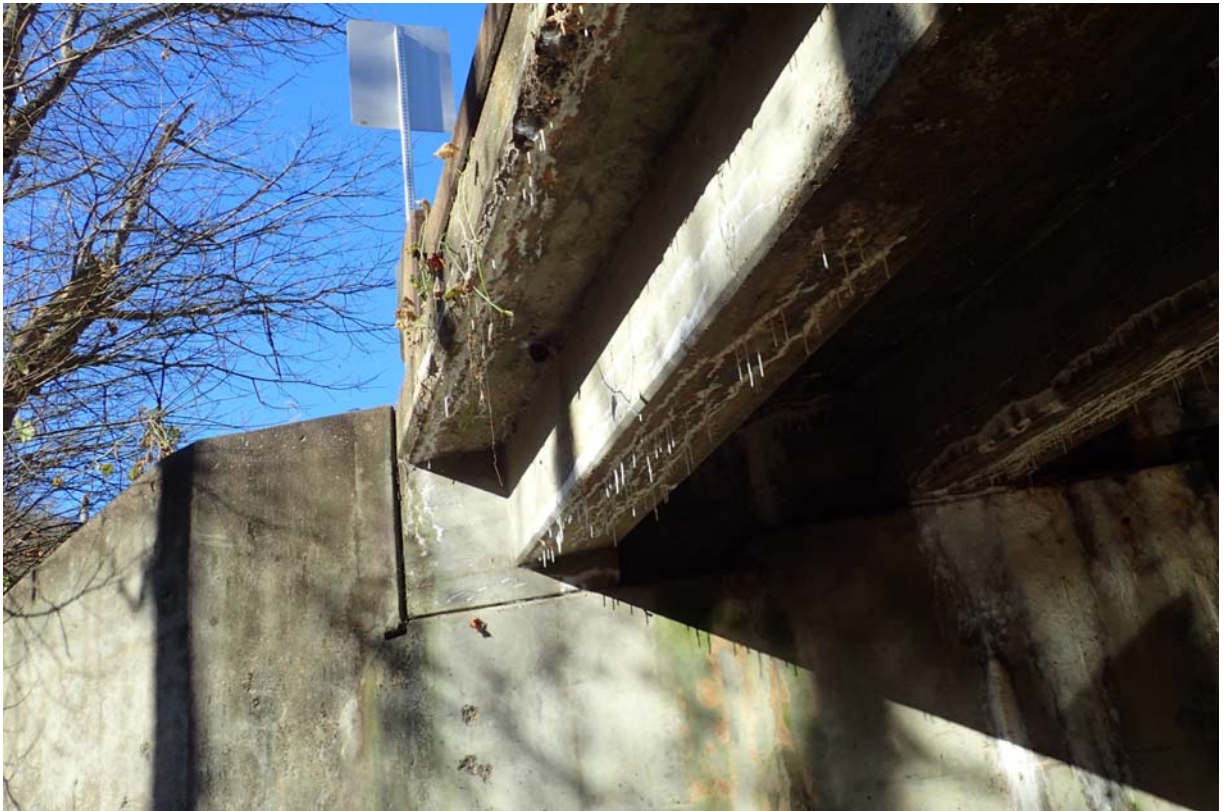
Typical view of minor sized cracking with efflorescence of heavy intensity in the upstream beam (beam 1) near abutment 1.

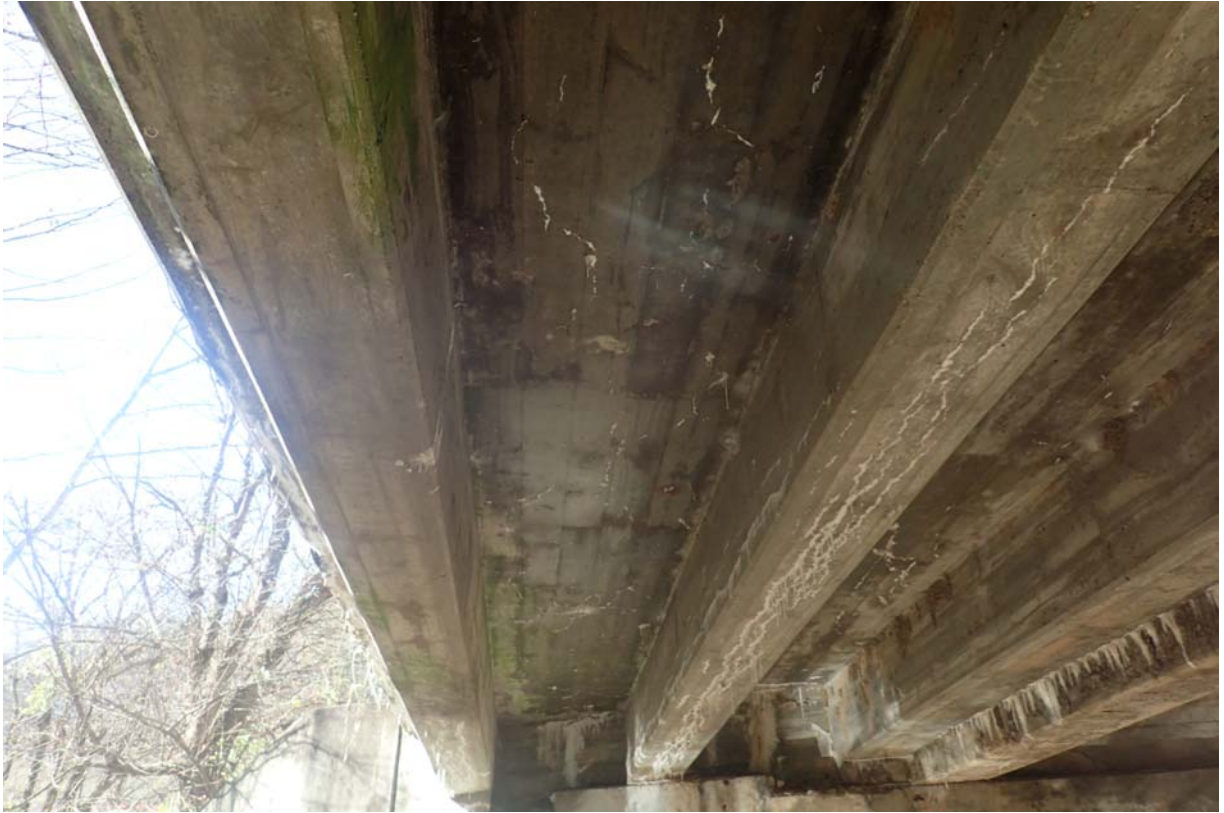
View of dark discoloration with scattered minor sized cracks with efflorescence in the deck underside between beams 1 and 2 from upstream.

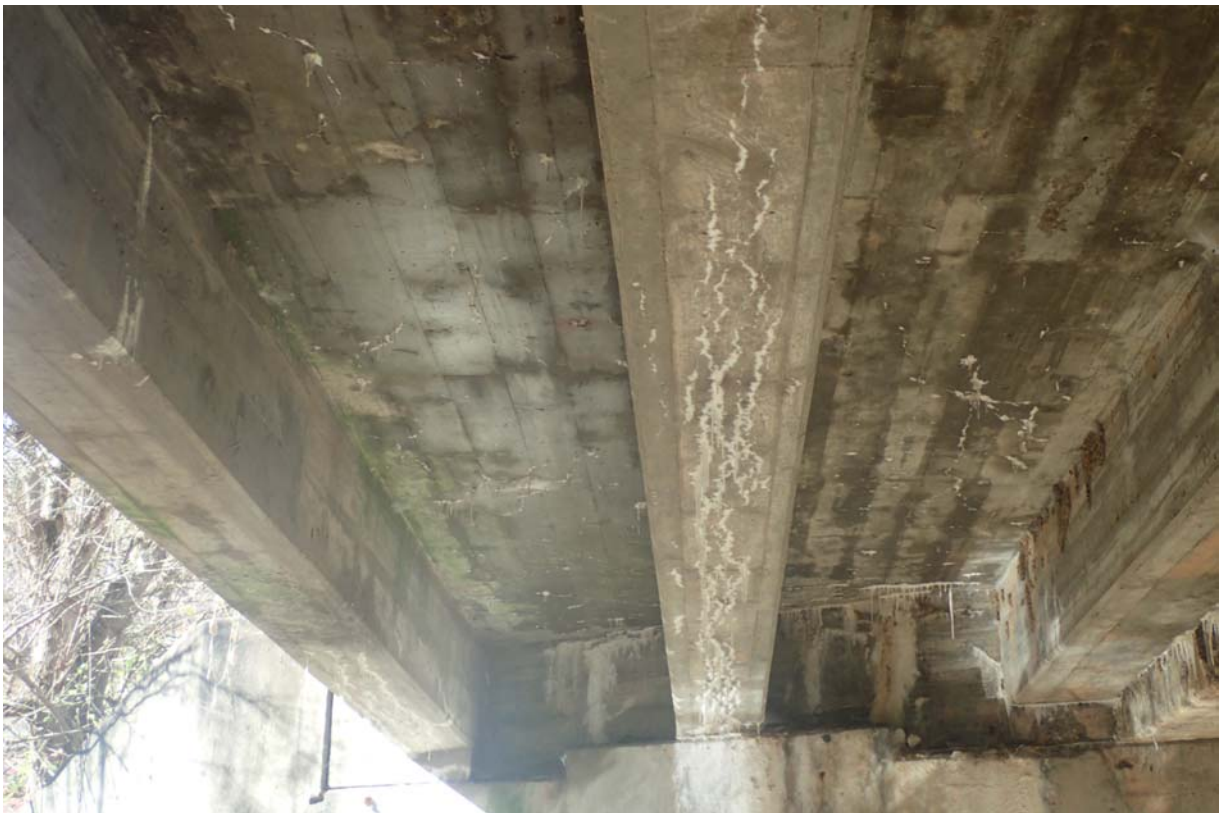
Typical view of beam 2 from upstream. Notice the heavy intensity of minor sized cracking.

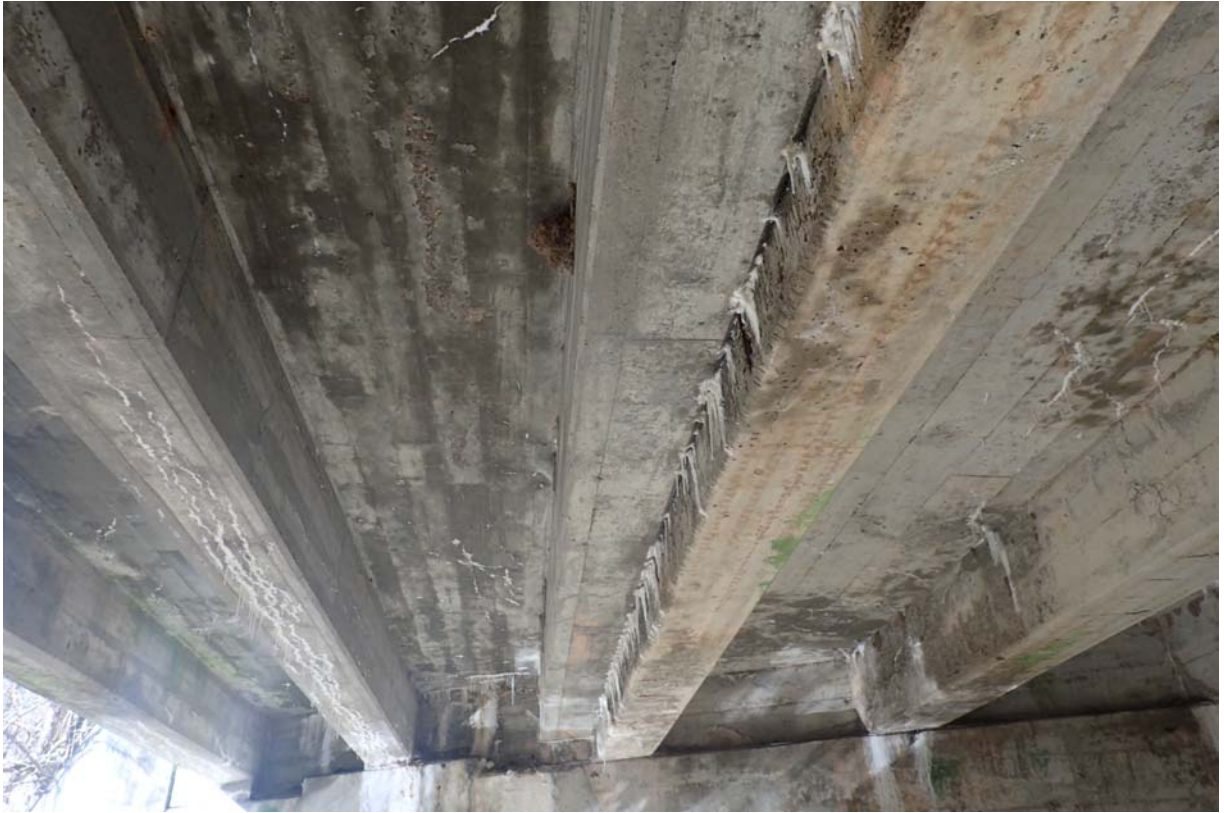
View of dark discoloration with scattered minor sized cracks with efflorescence in the deck underside between beams 2 and 3 from upstream.

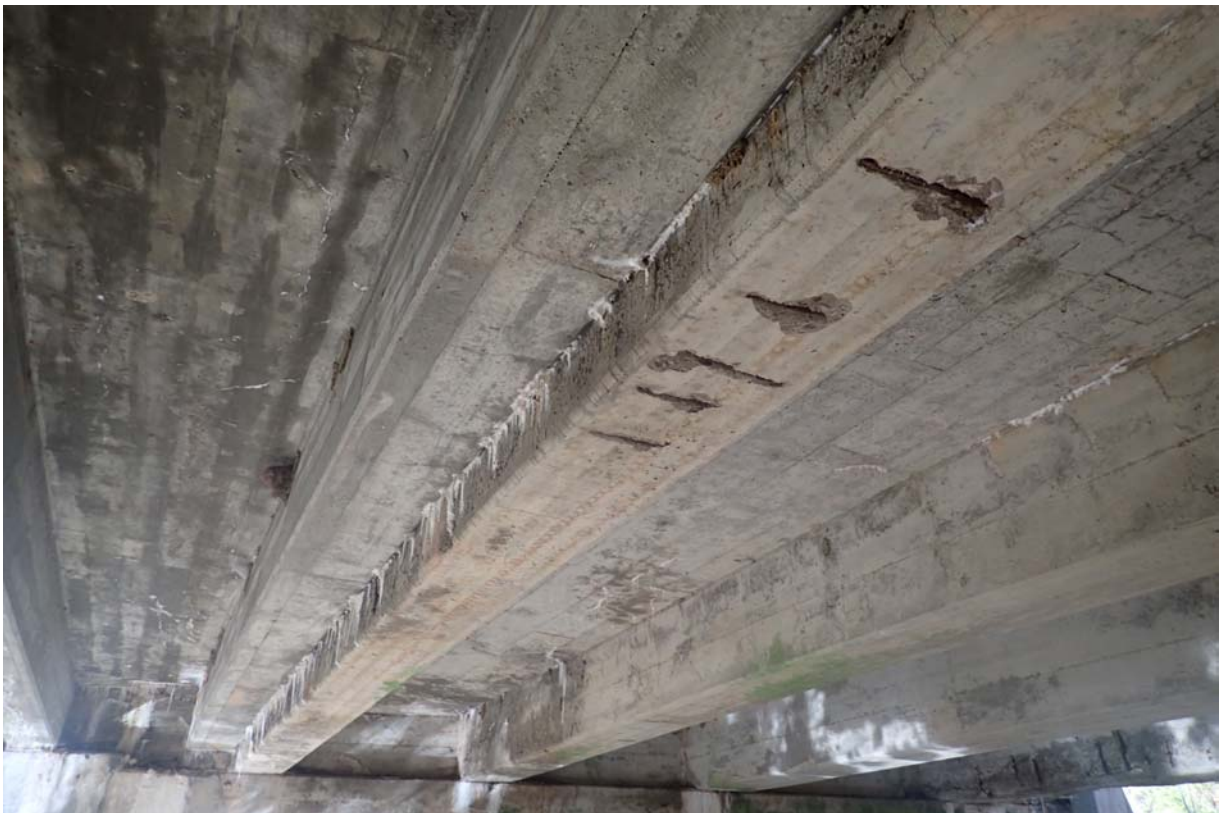
Typical view of beams 3 and 4 from upstream. Notice the several shallow spalls with exposed steel in the underside of beam 4 from upstream near abutment 2.

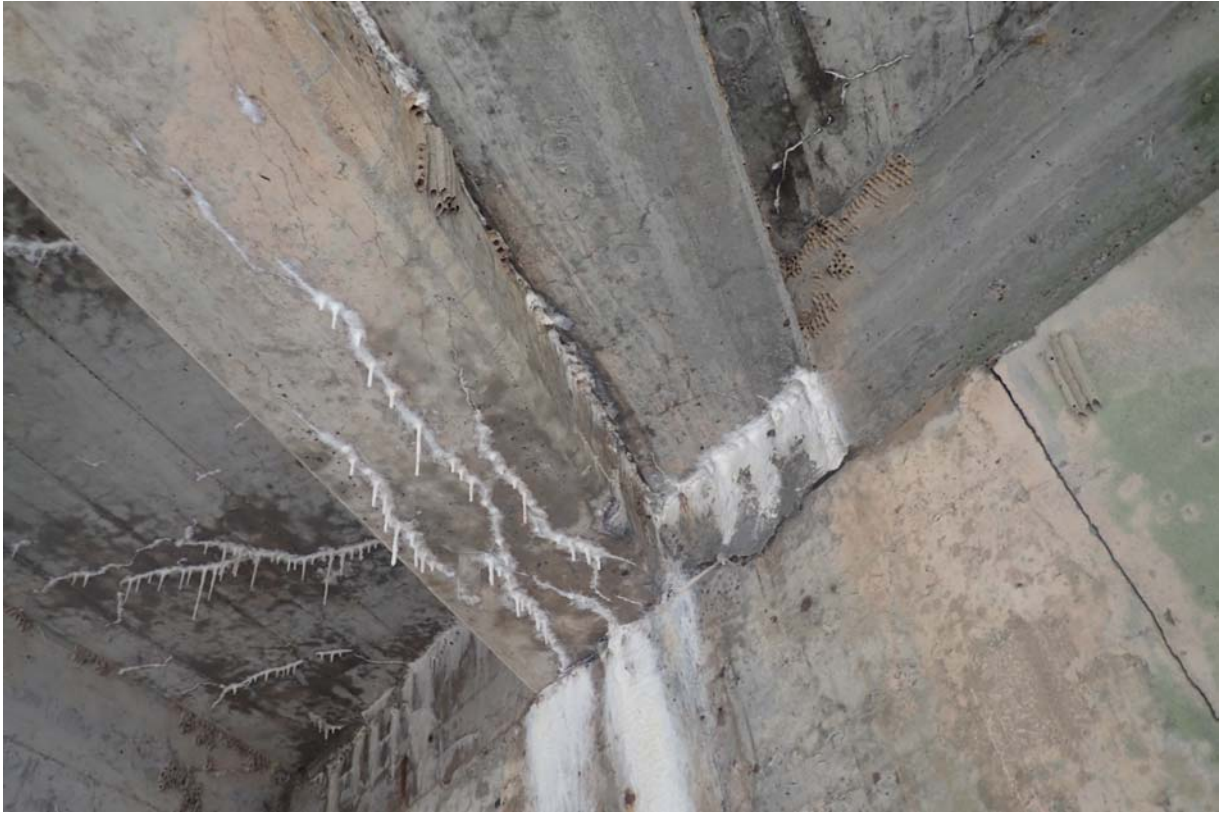
Heavy intensity of minor sized cracking with efflorescence at the end of beam 4 at abutment 2.

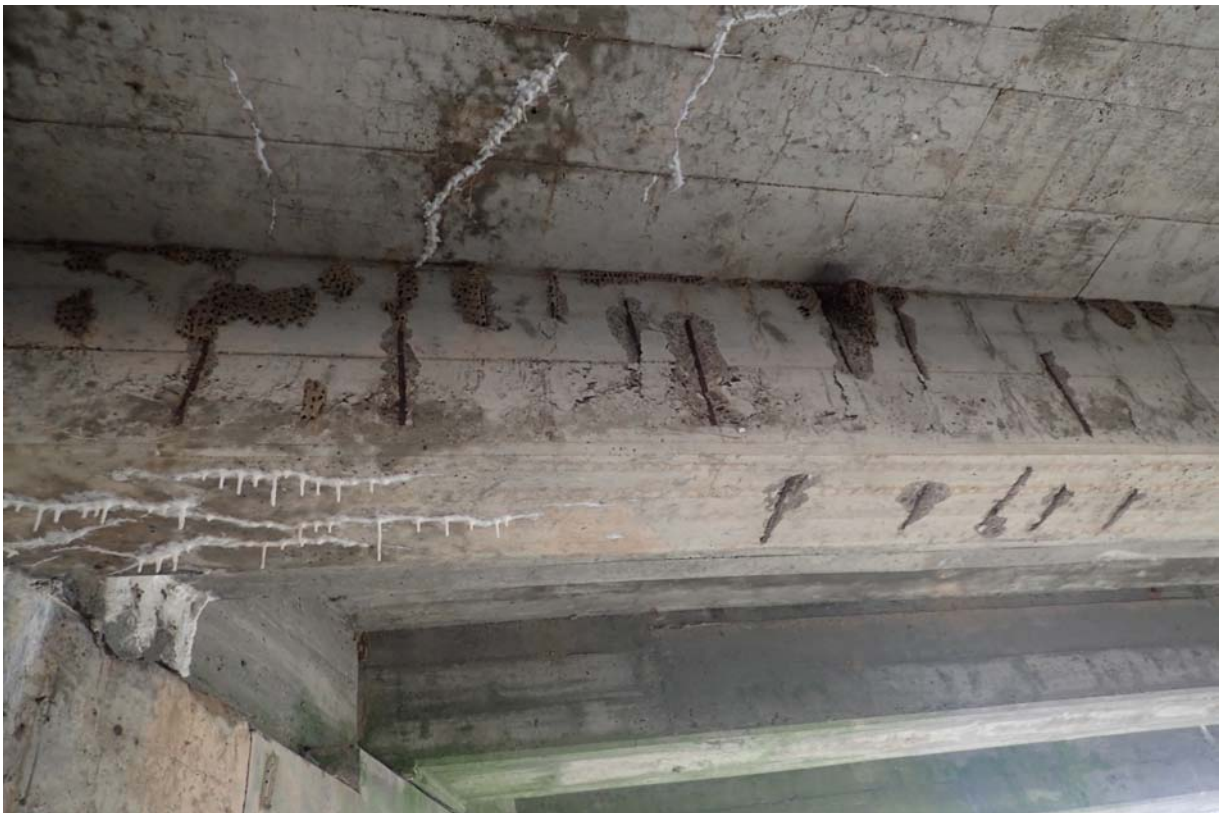
View of the downstream face of beam 4 from upstream near abutment 2. Notice the several shallow spalls with exposed steel.

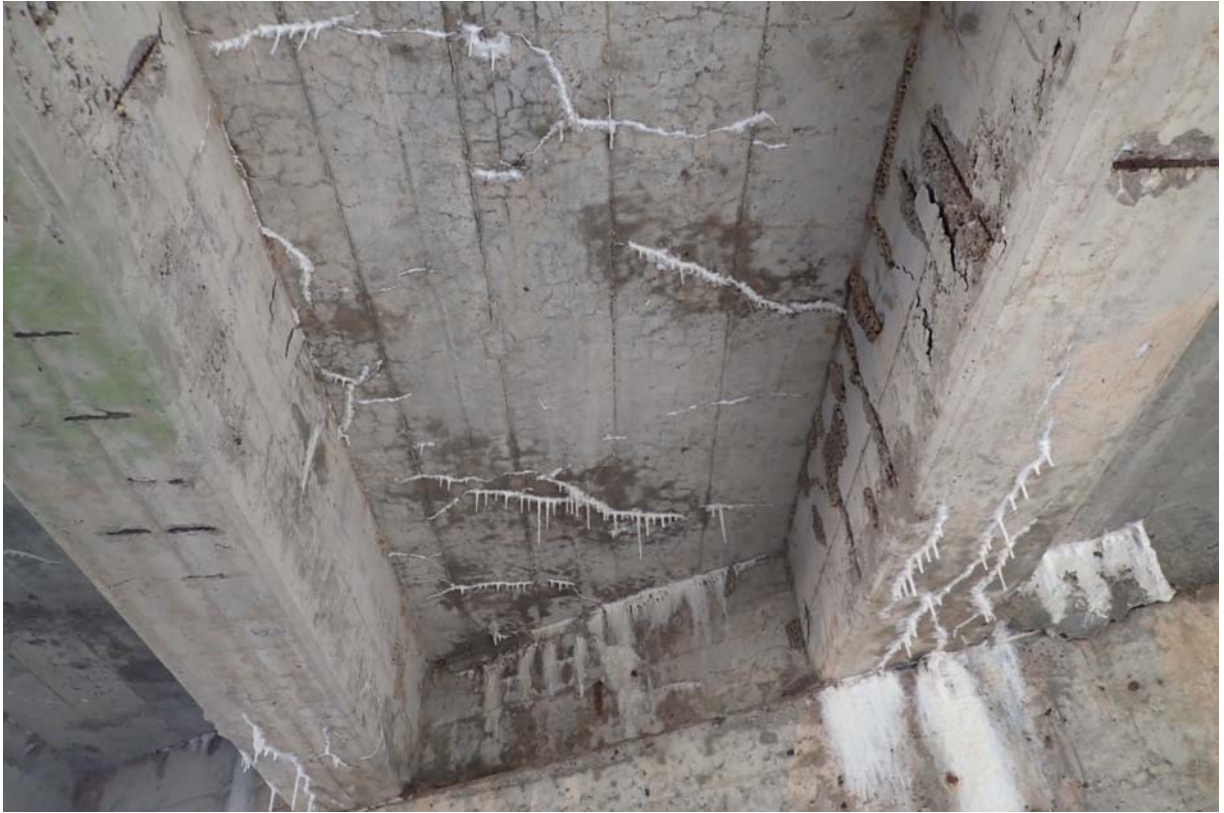
View of the deck underside with moderate to heavy intensity of cracking with efflorescence and discoloration between beams 4 and 5 from upstream near abutment 2.

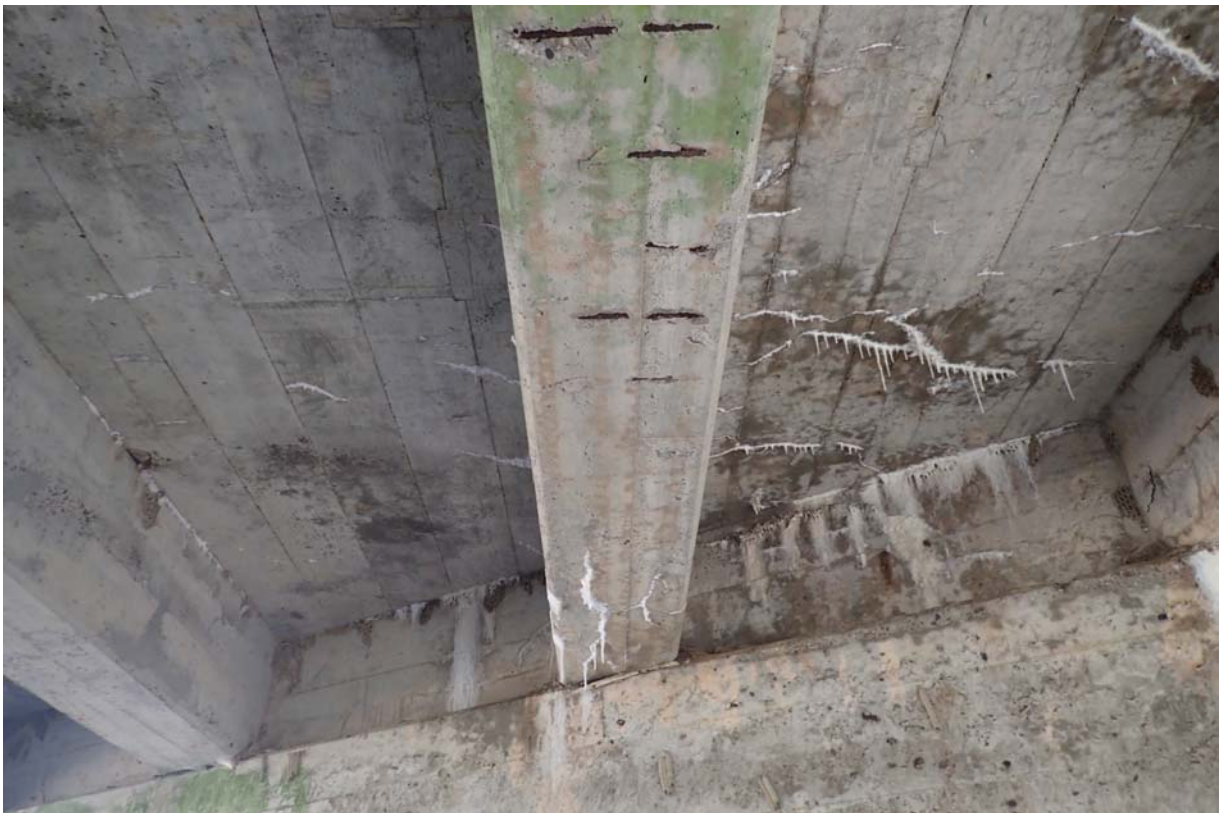
View of moderate intensity cracking with efflorescence and shallow spalling with exposed steel in the underside of beam 5 near abutment 2.

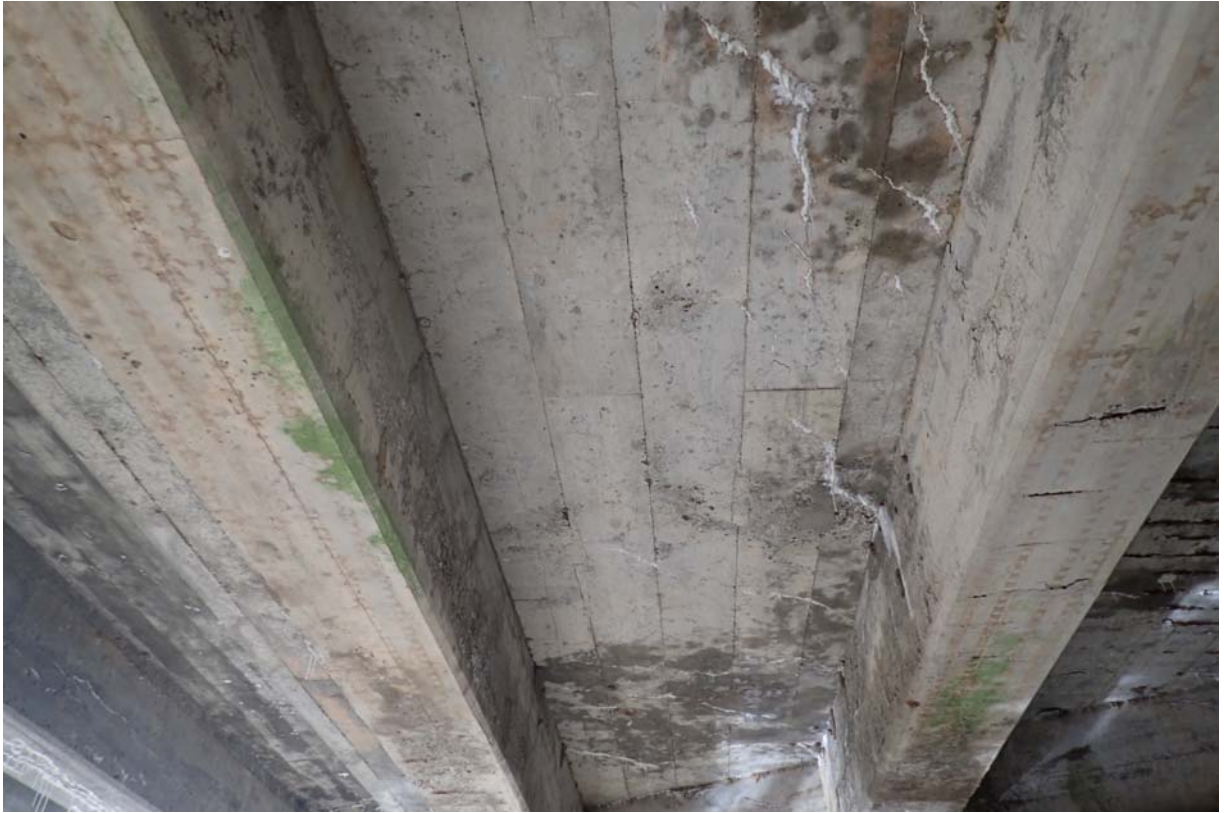
Typical view of the deck underside between beams 4 and 5 from upstream. Photo taken from midspan looking toward abutment 1.

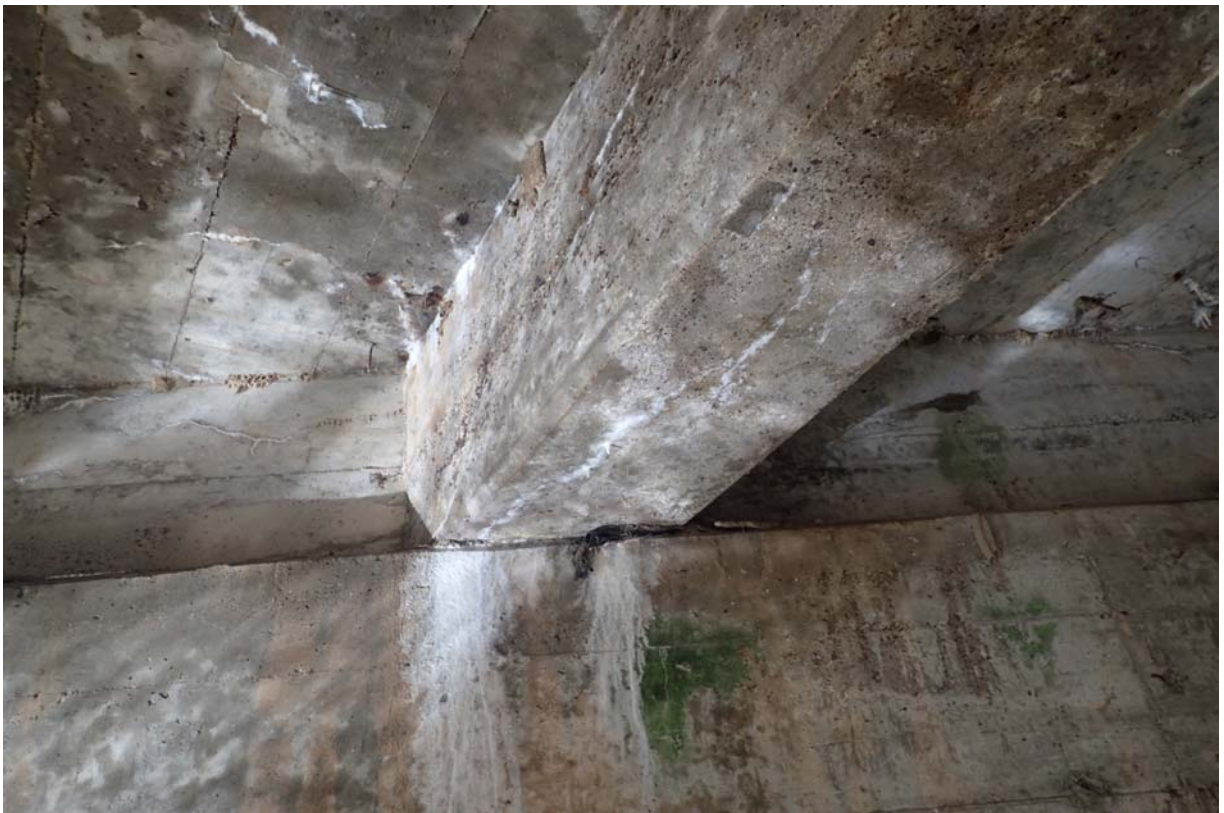
Moderate intensity of minor sized cracking with efflorescence in beam 5 at abutment 1.
