Inspection Report with SI&A Data

Structure Description: 36.09 Foot - Single Span Concrete Tee Beam

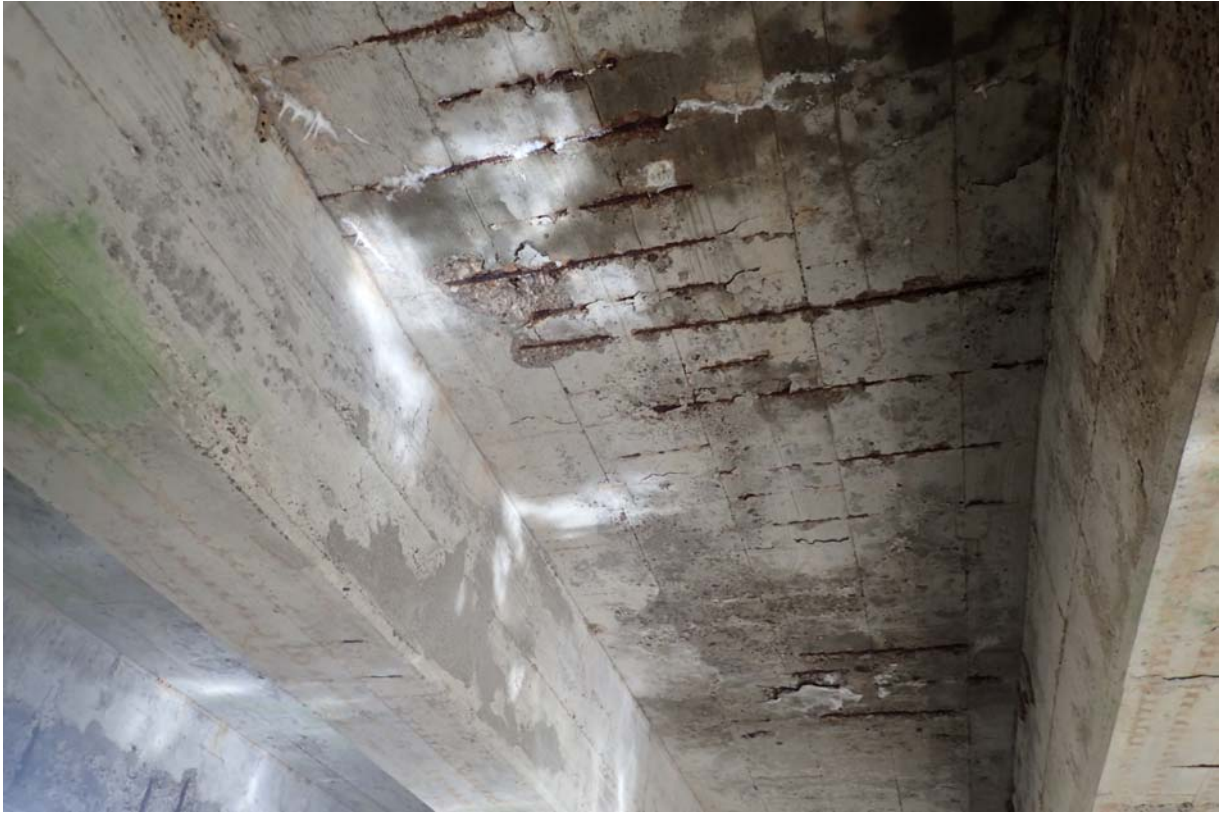
Shallow spalling with exposed steel in the deck underside between beams 5 and 6 from upstream. Photo taken from abutment 1 looking toward midspan.

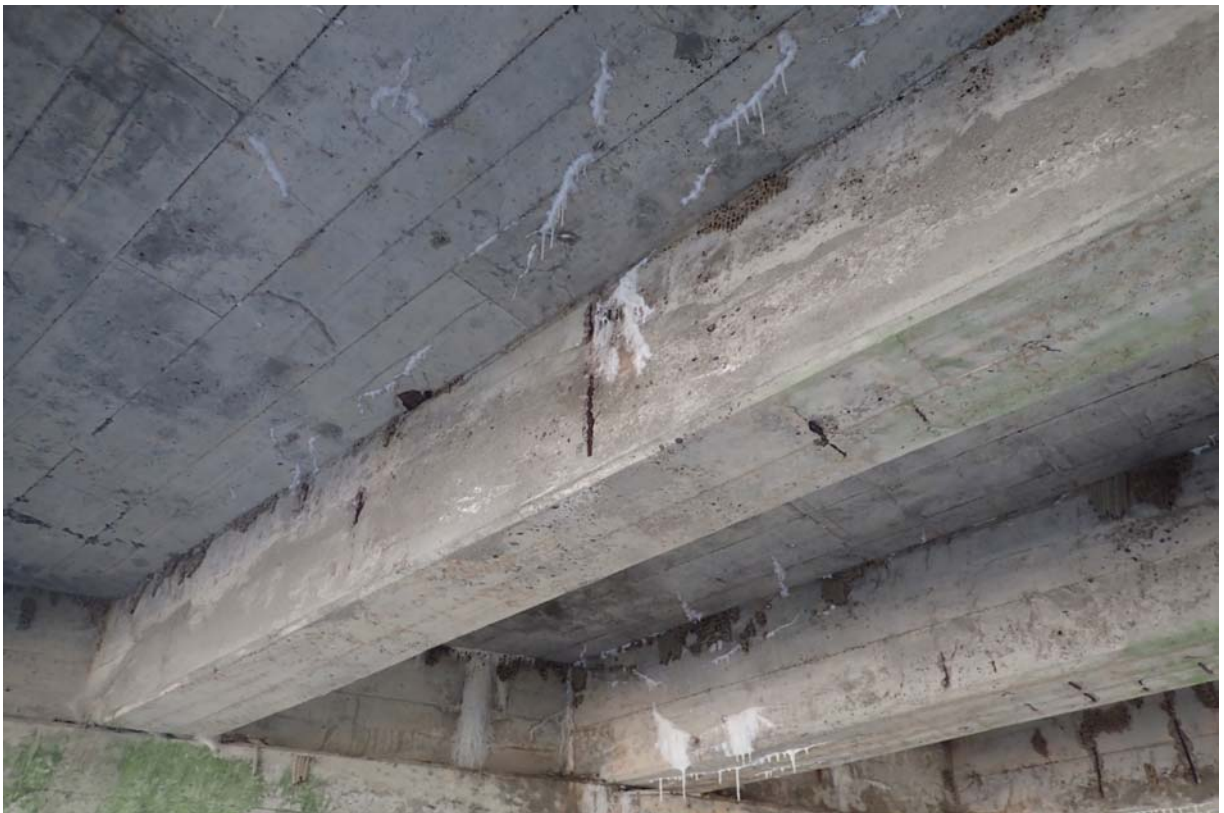
View of beam 6 near abutment 2. Notice the shallow spalls with exposed steel.

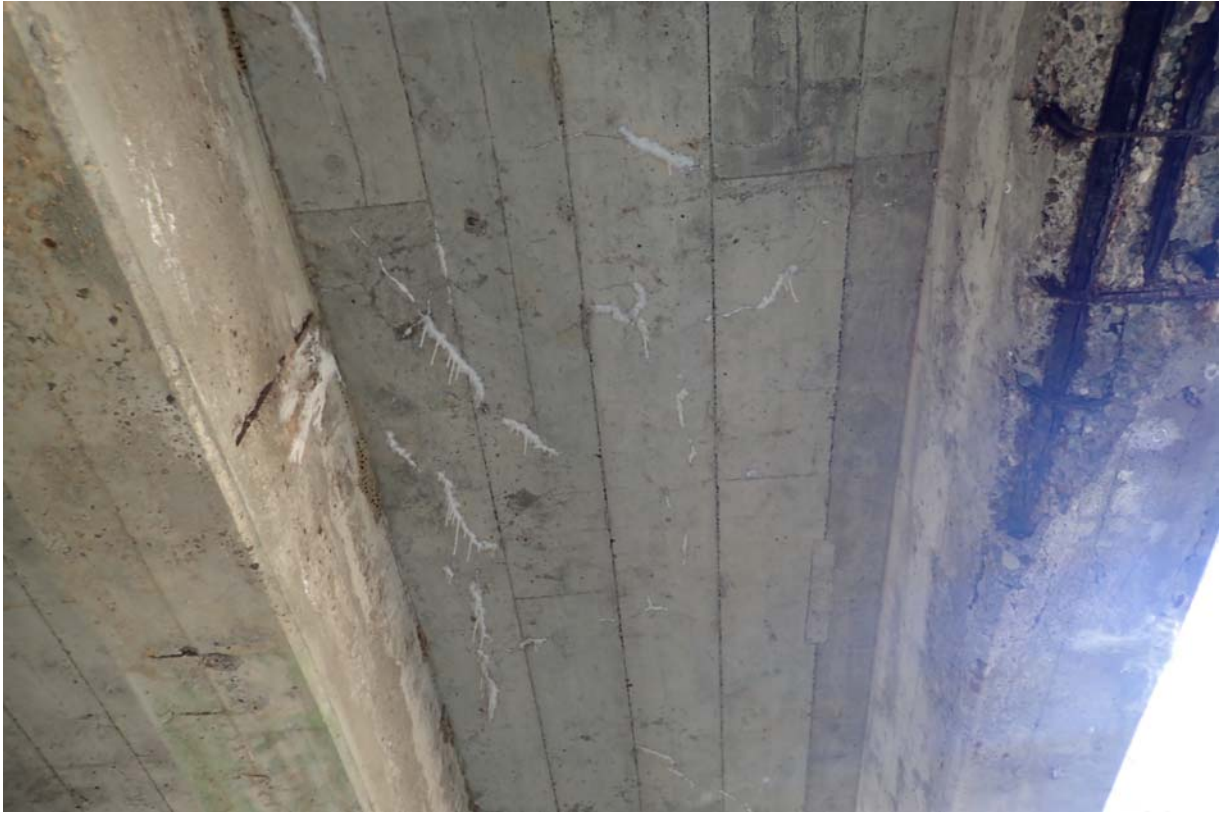
View of minor cracking with efflorescence in the deck underside between beams 6 and 7 from upstream.

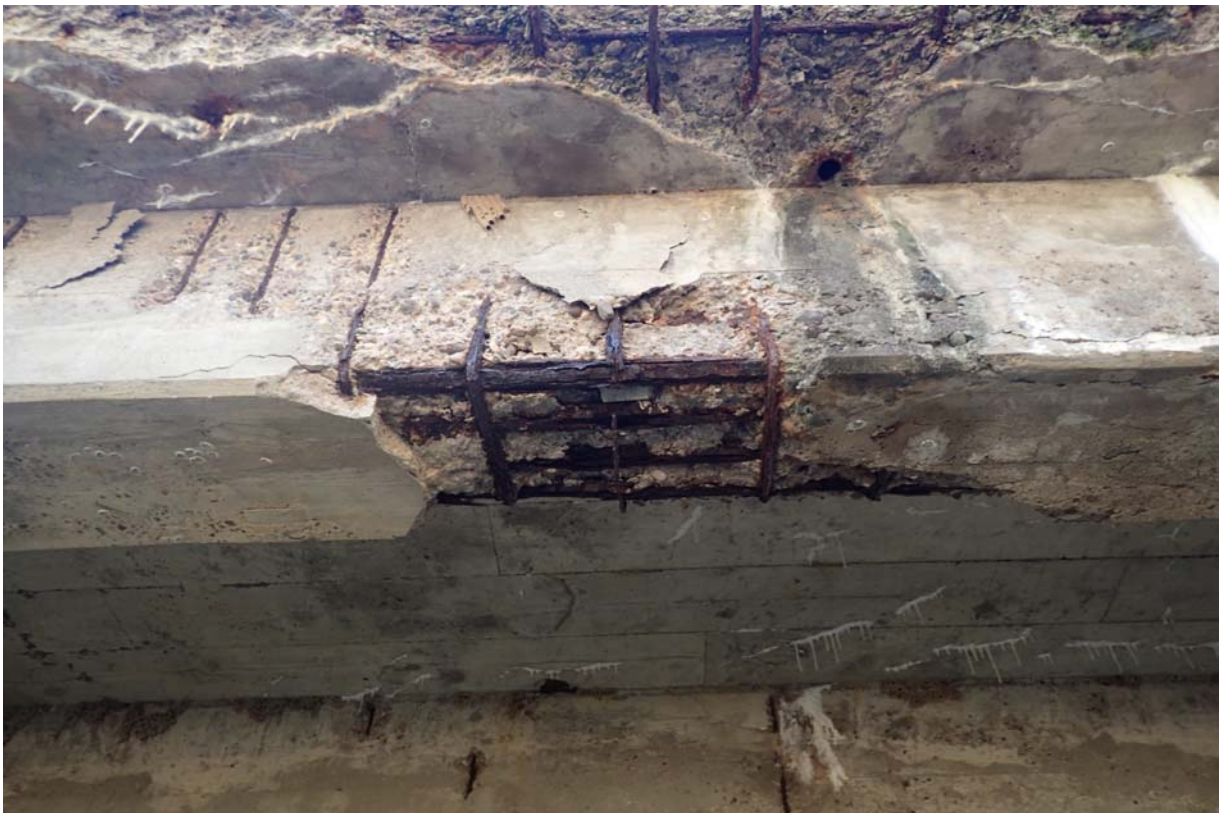
Heavy spalling with exposed steel in the downstream exterior girder below the deck drain near abutment 2. Notice the heavy corrosion of the steel reinforcement.

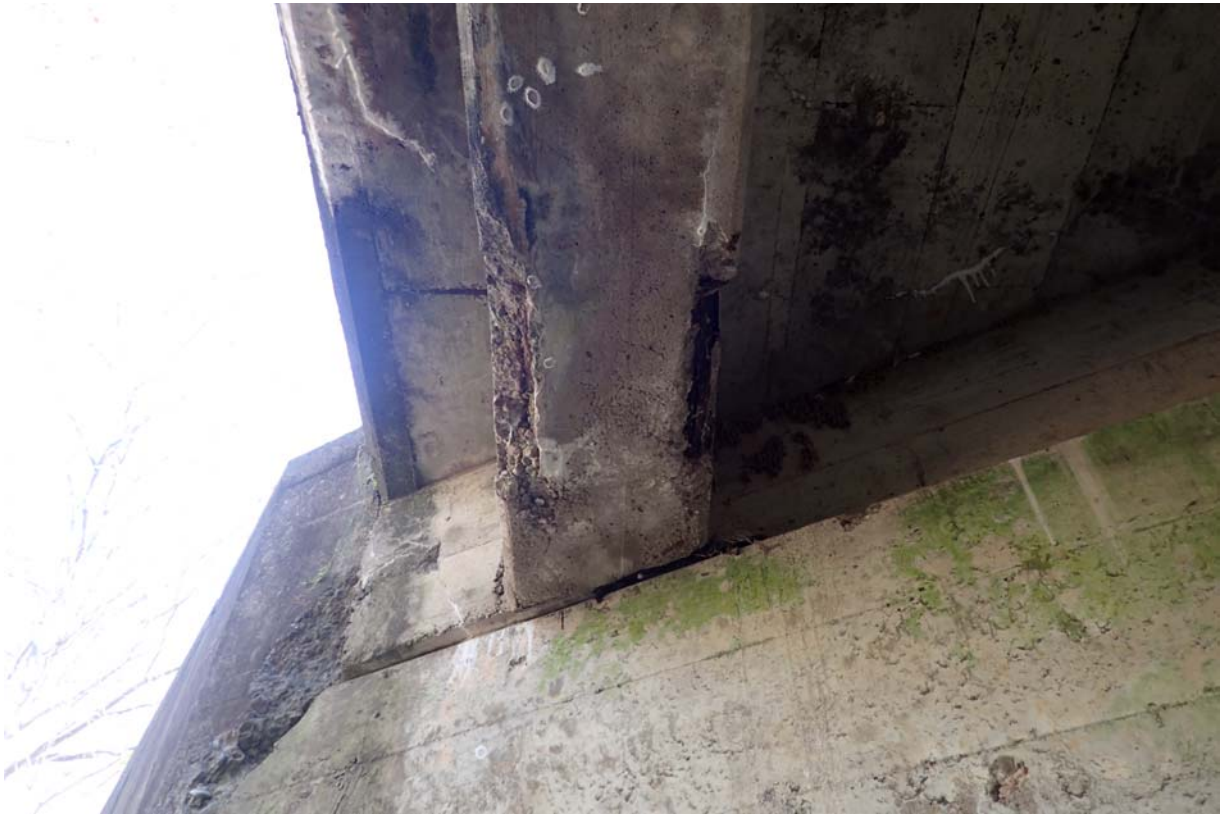
Moderate spalling with exposed steel in the downstream girder at abutment 2.

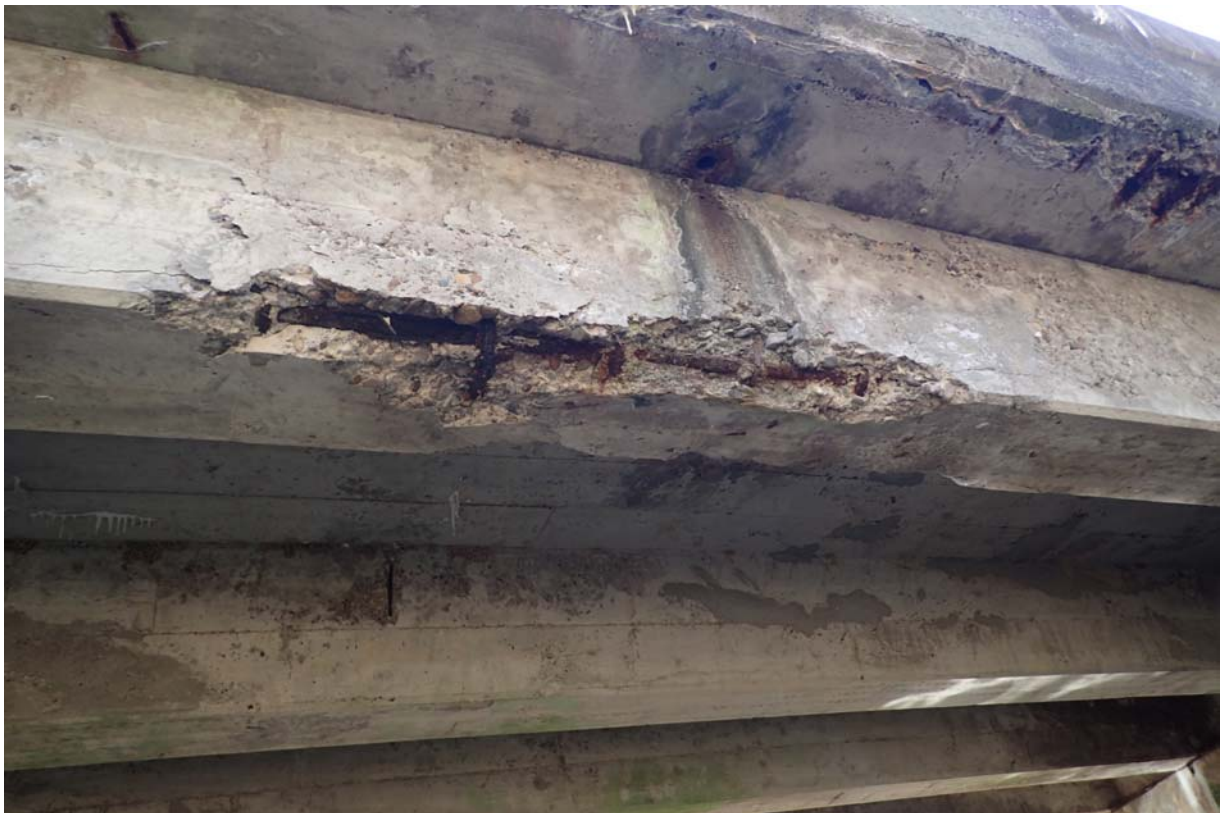
Heavy spalling with exposed steel in the downstream exterior girder below the deck drain near midspan. Notice the heavy corrosion of the steel reinforcement.

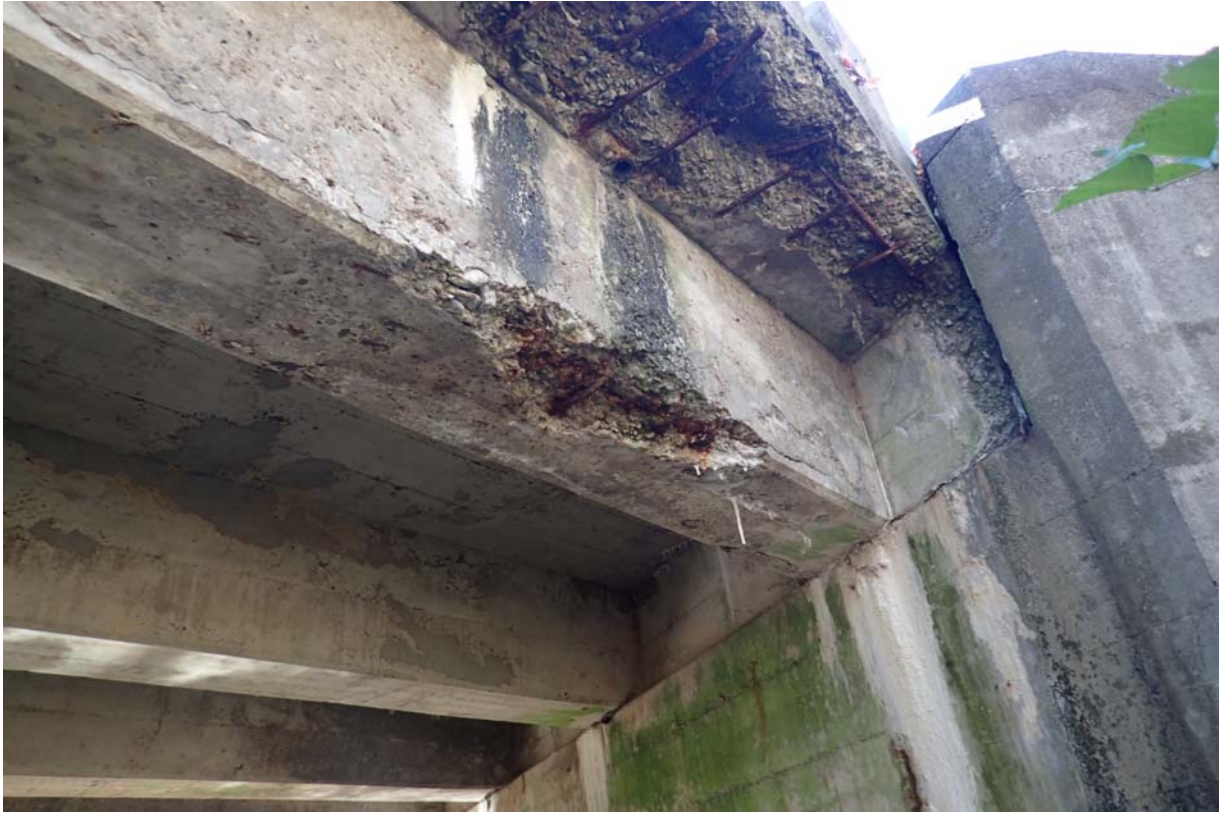
Heavy spalling with exposed steel in the downstream beam near abutment 1.

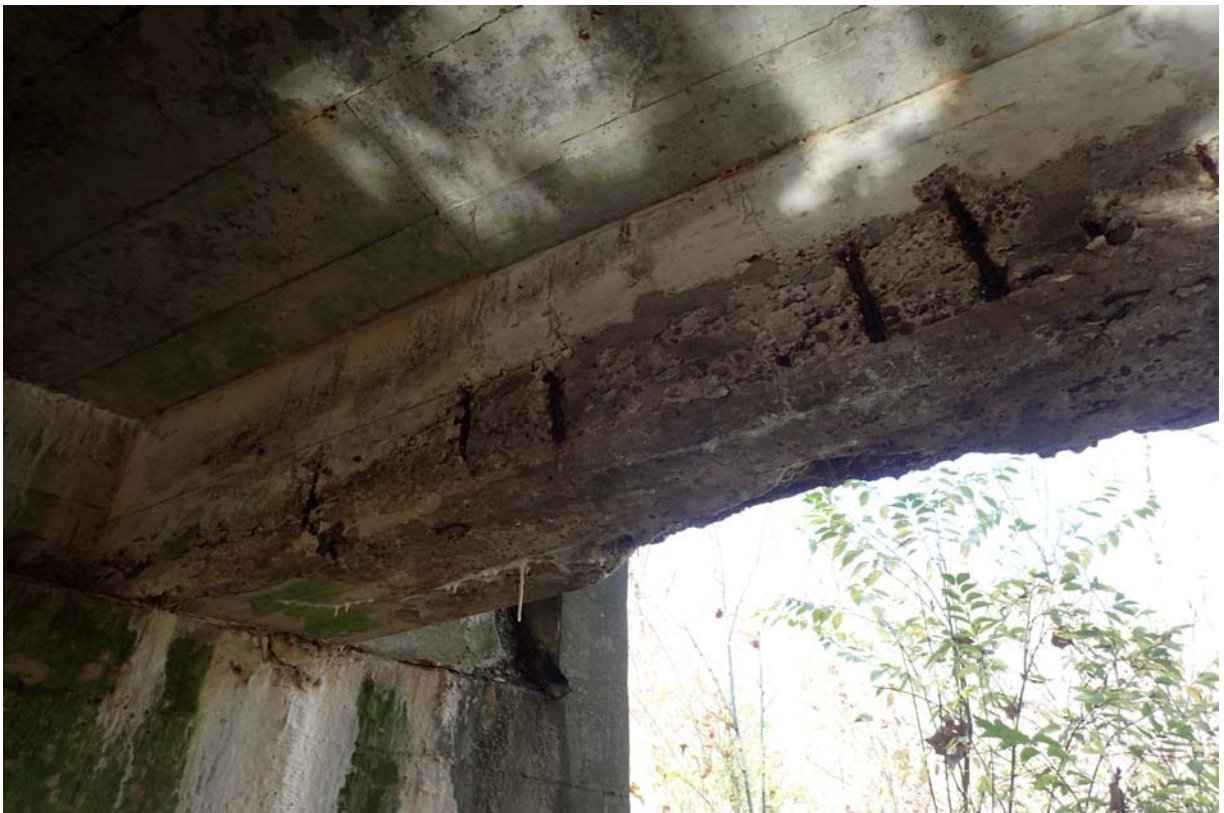
Several shallow spalls with exposed steel along the interior face of the downstream beam near abutment 1.

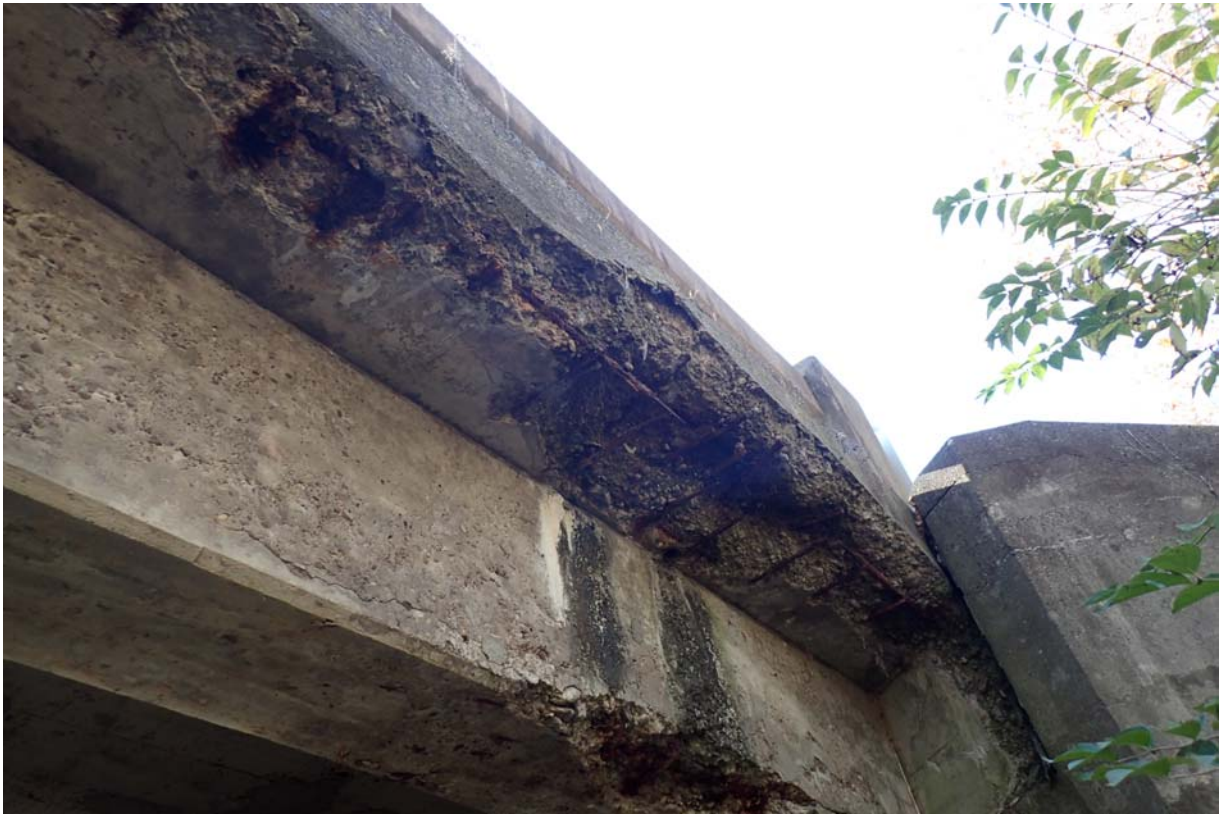
Heavy spalling with exposed steel in the downstream deck overhang near abutment 1.

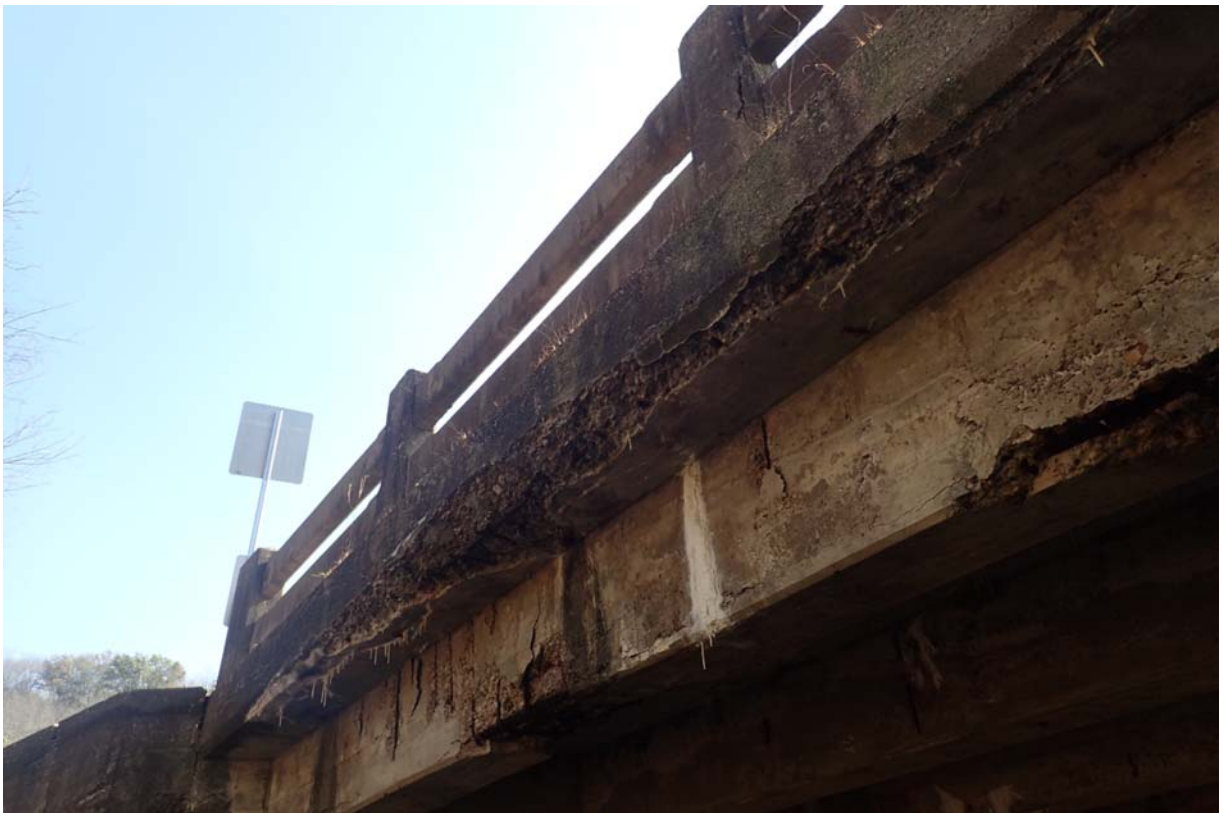
Heavy cracking and spalling in downstream deck overhang, extending from near abutment 2 to near midspan.

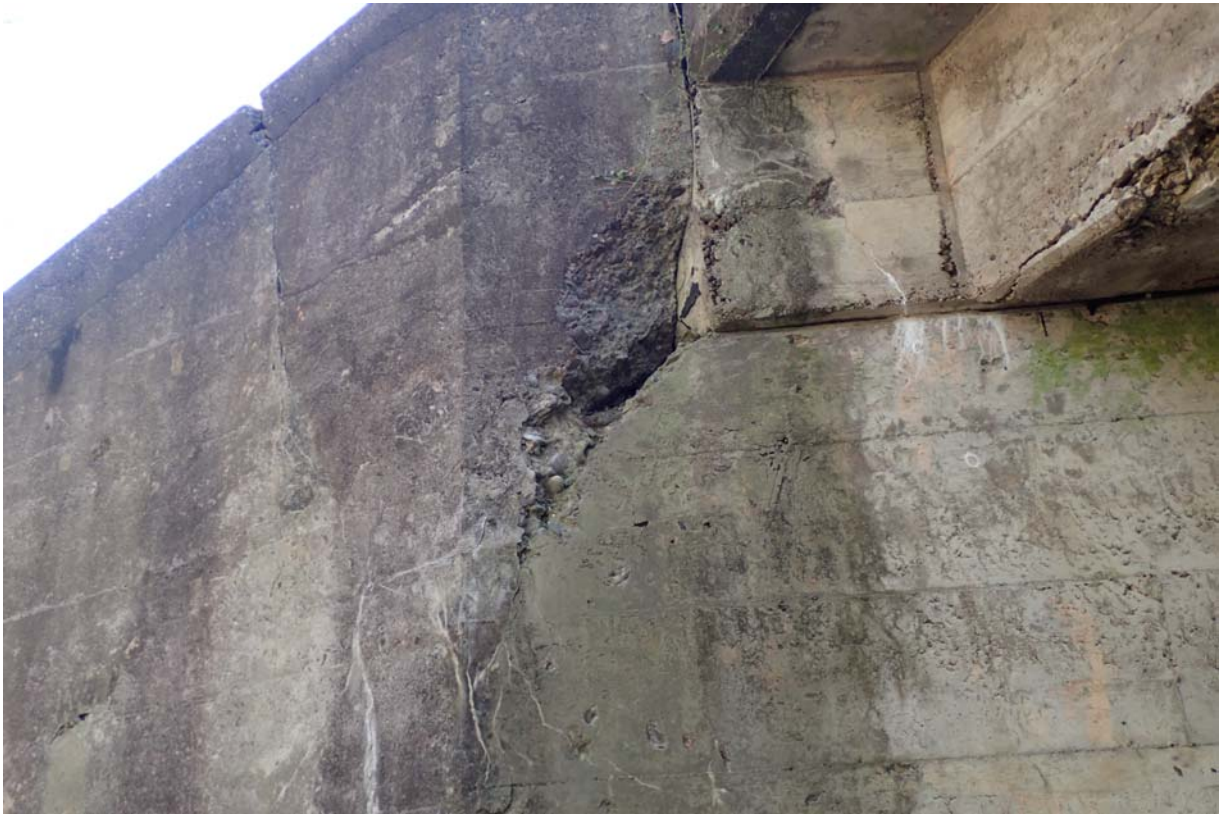
Fairly large deep spall in abutment 2 near the wingwall connection adjacent to the downstream end of the diaphragm

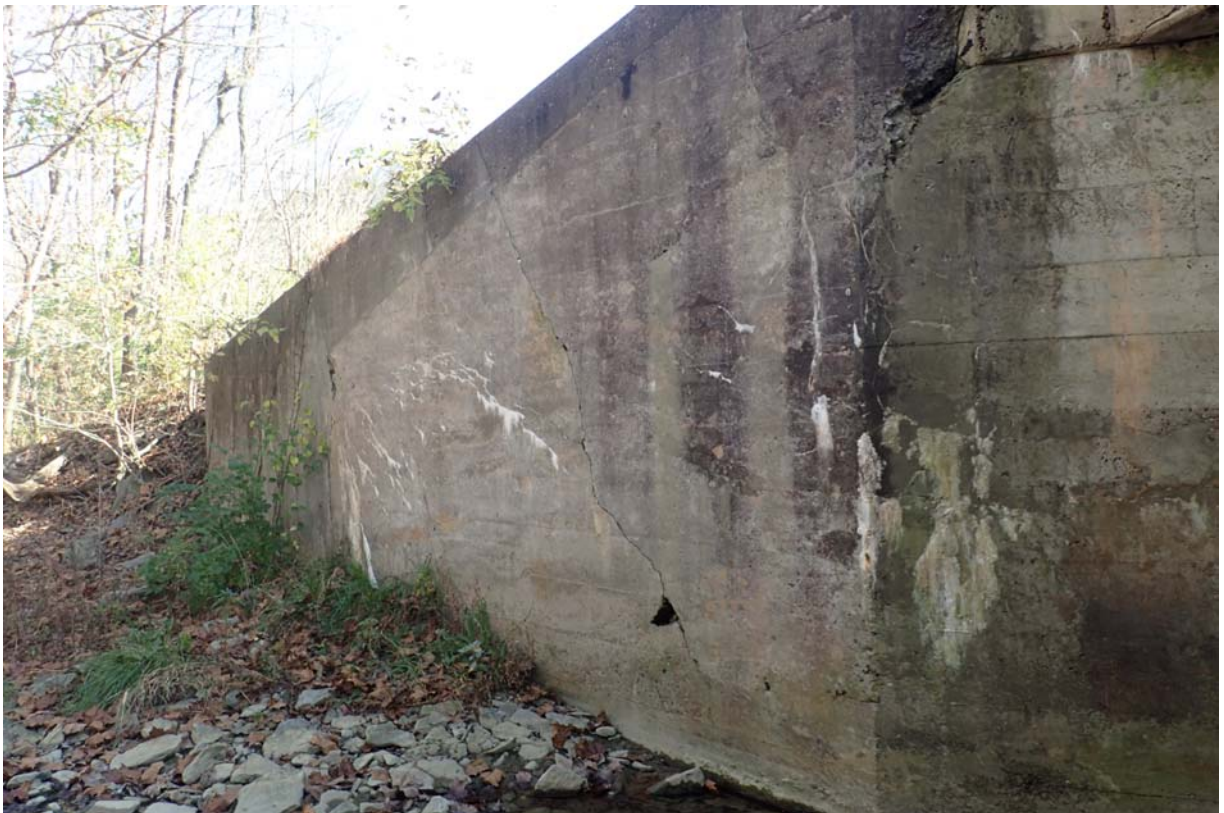
View of abutment 2s downstream wingwall. There are 2 full height vertical cracks and an area of minor sized cracking with efflorescence of heavy intensity.

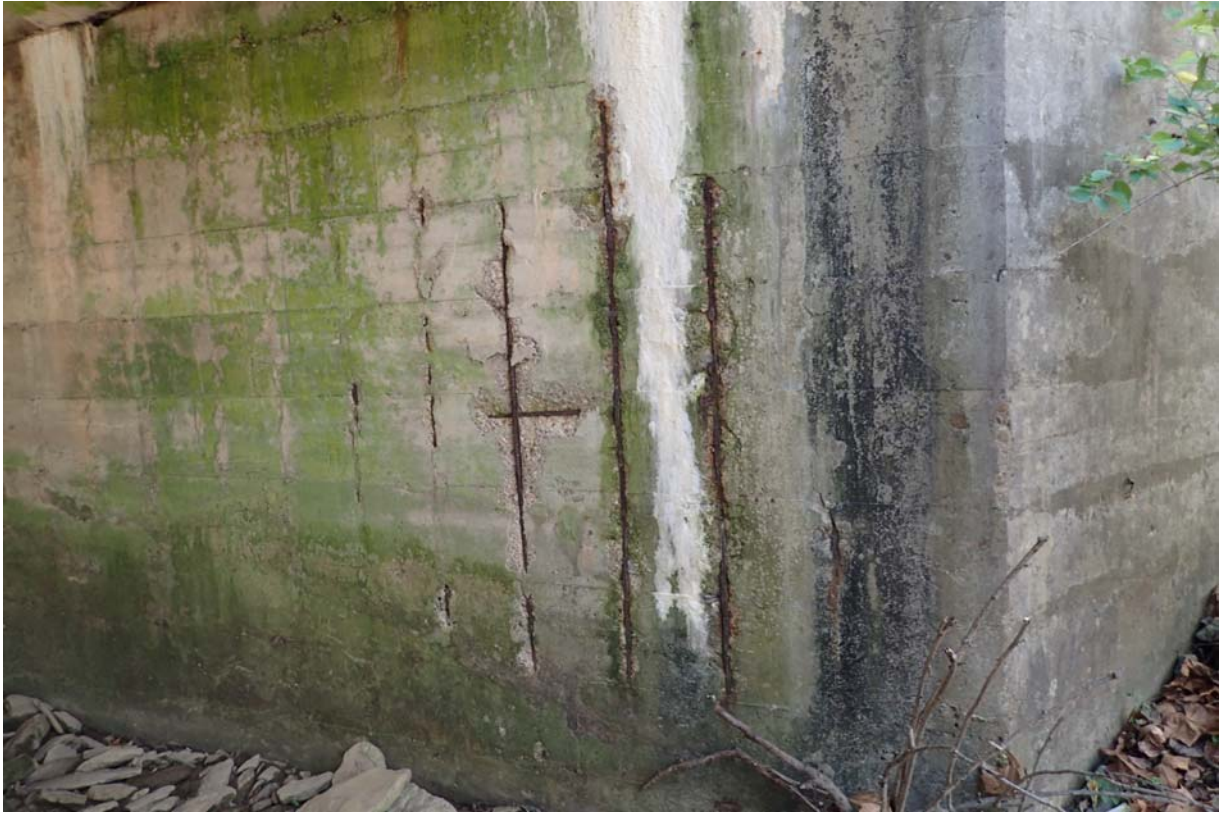
Shallow spalling with exposed steel at the downstream end of abutment 1.

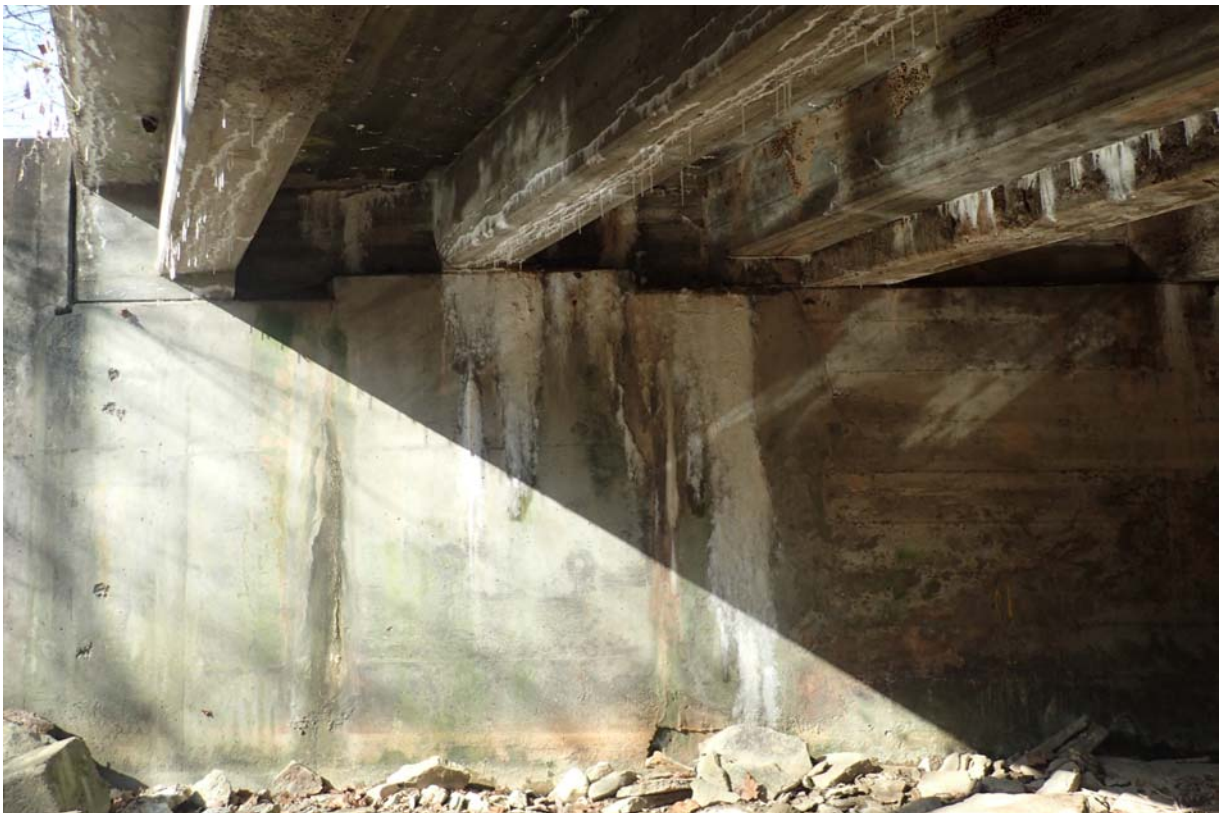
Heavy seepage at the seats of the upstream beams at abutment 1.
