## Inspection Report with SI&A Data

**Structure Description:** 390.09 Foot - 3 Span Steel continuous Stringer/Multi-beam or Girder

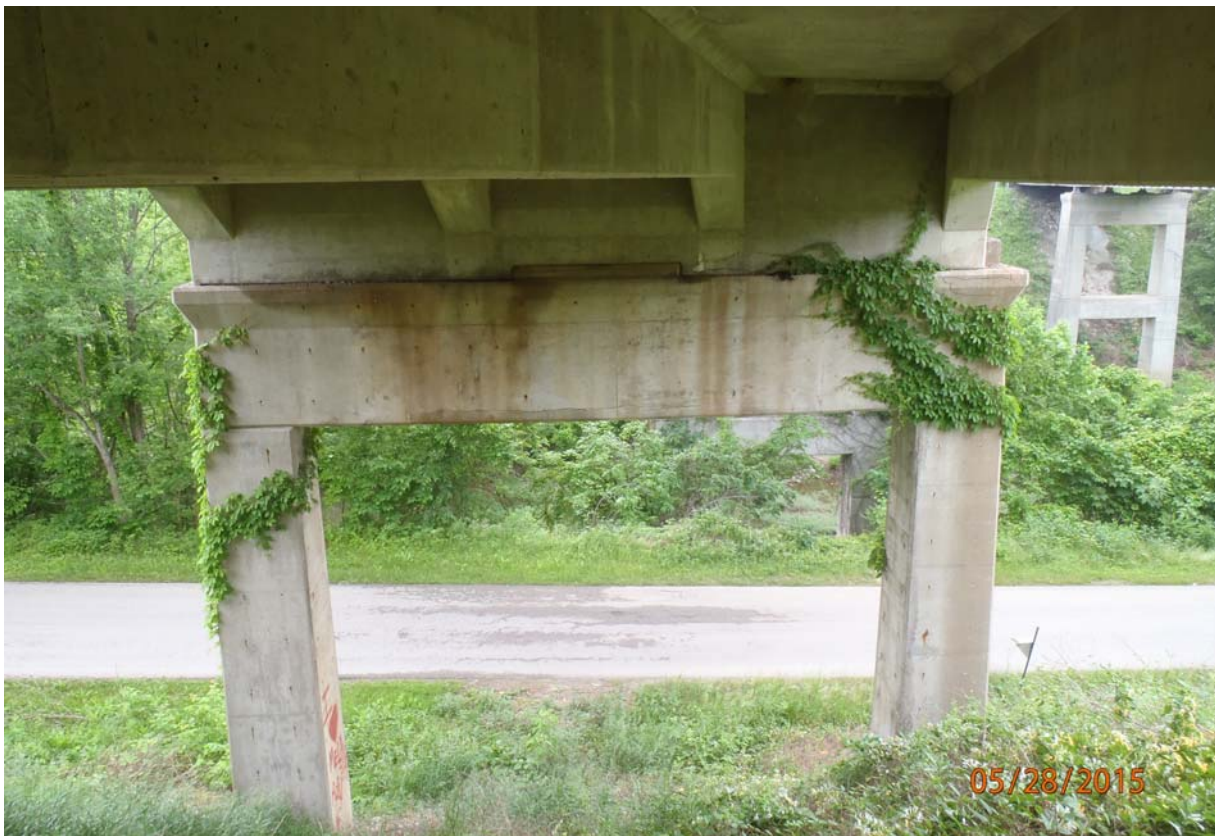
Elevation view of the west face of pier 2 (#s start at the west abutment and account for both piers and abutments). Note the vegetation growth and horizontal cracking in the pier cap and diaphragm. The cracking in the diaphragm is under beams 2, 3 and 4.

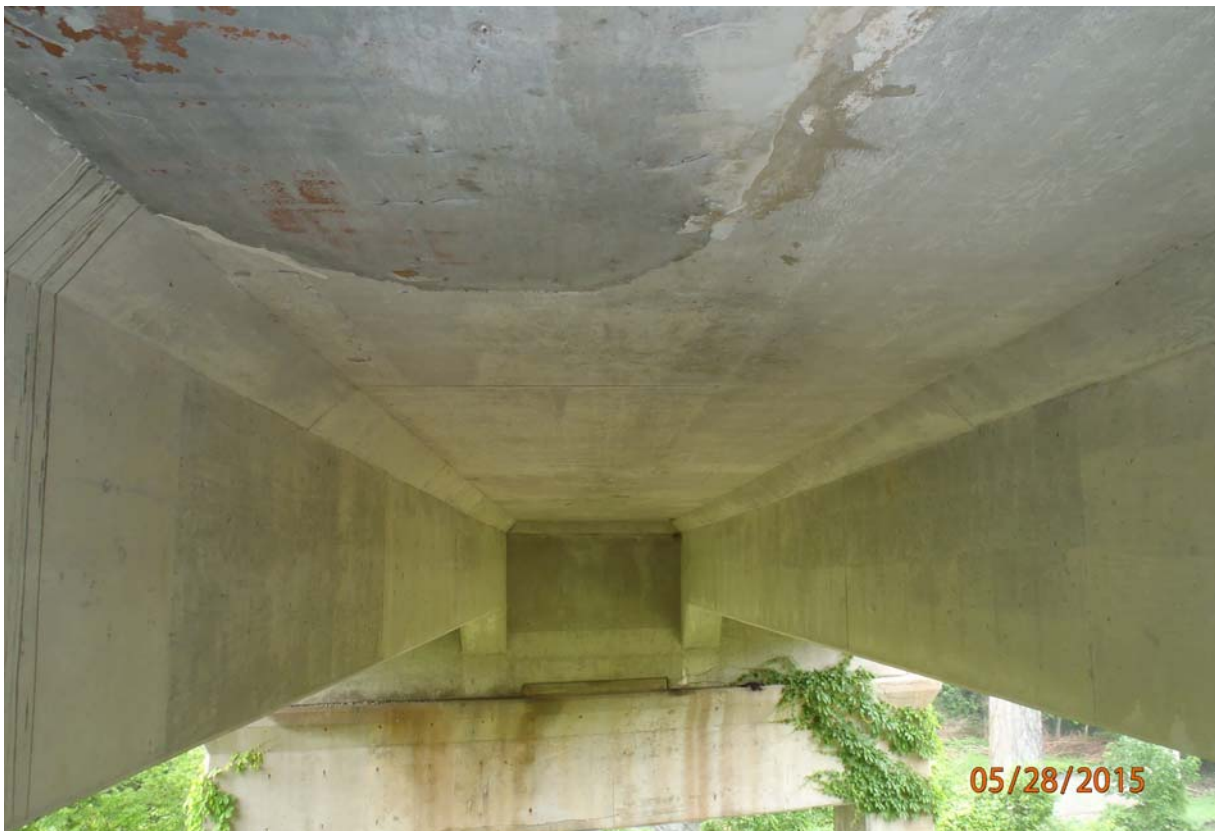
Looking towards pier 2 at the underside of the deck between beams 2 & 3 of span 1. Note the minor pop-outs and spalls with no reinforcing exposed throughout the deck underside in span 1.

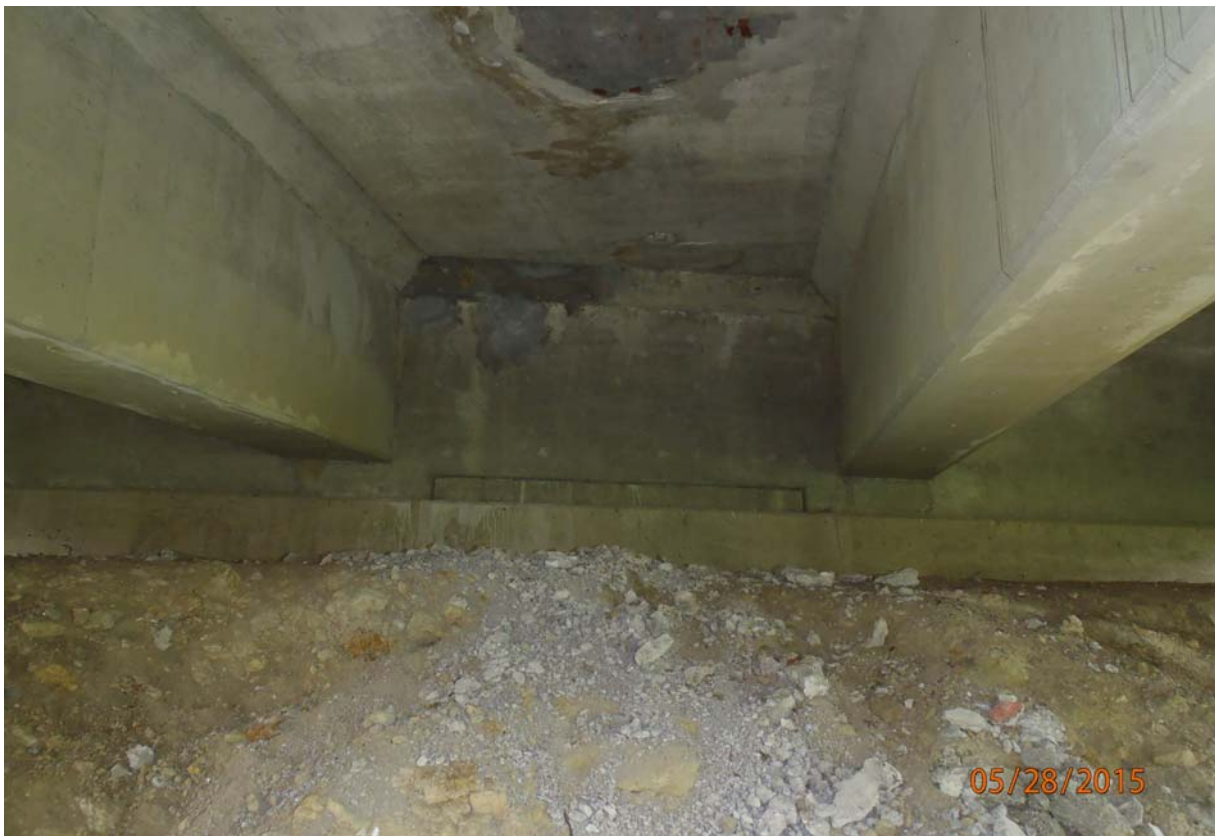
Looking at the west abutment (abutment 1) between beams 2 & 3.

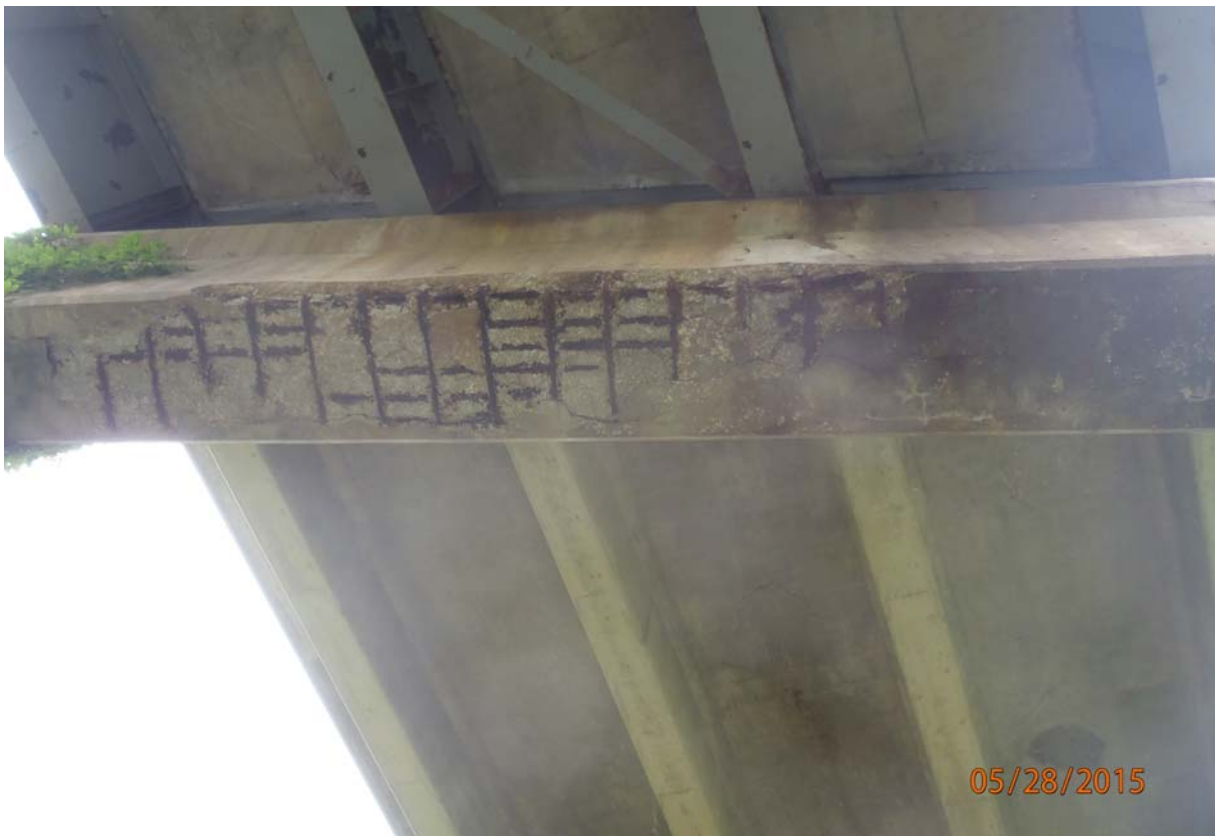
Looking up at the underside of the pier cap of pier 1. Note the heavily rusted and corroding (w/ section loss) exposed reinforcing steel. There is a deck joint directly above this pier (between the steel girder span and reinforced concrete girder span). The plans called for 2 rows of 6 #11Bar.

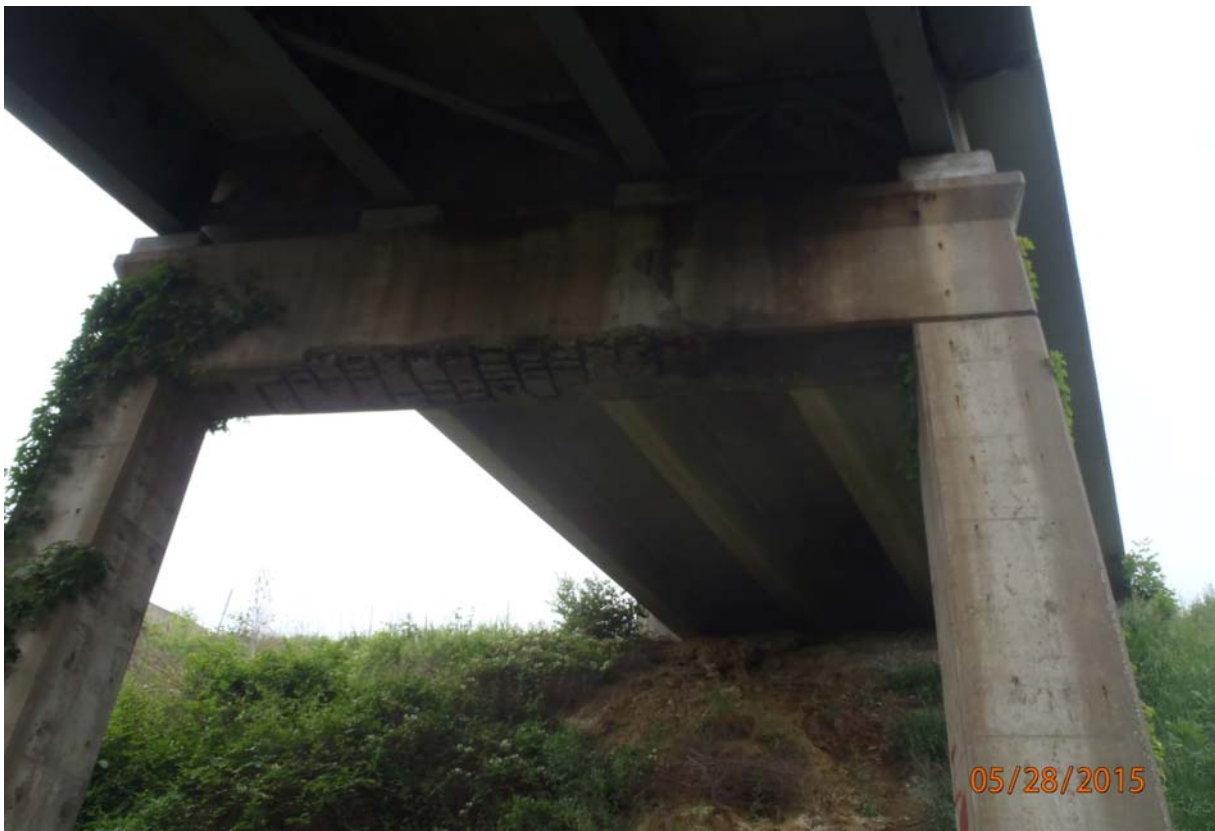
Elevation view of the east face of pier 2. Note the exposed rusting/corroding reinforcing steel in the pier and heavy rust staining on the pier cap see above photo for more info. Note 1 area with exposed rusting/corroding exposed vertical reinforcing steel in the east face of the cap. Some reinforcing steel is exposed in the deck underside in span 2 near pier 2. This pier cap needs to be cleaned and patched.

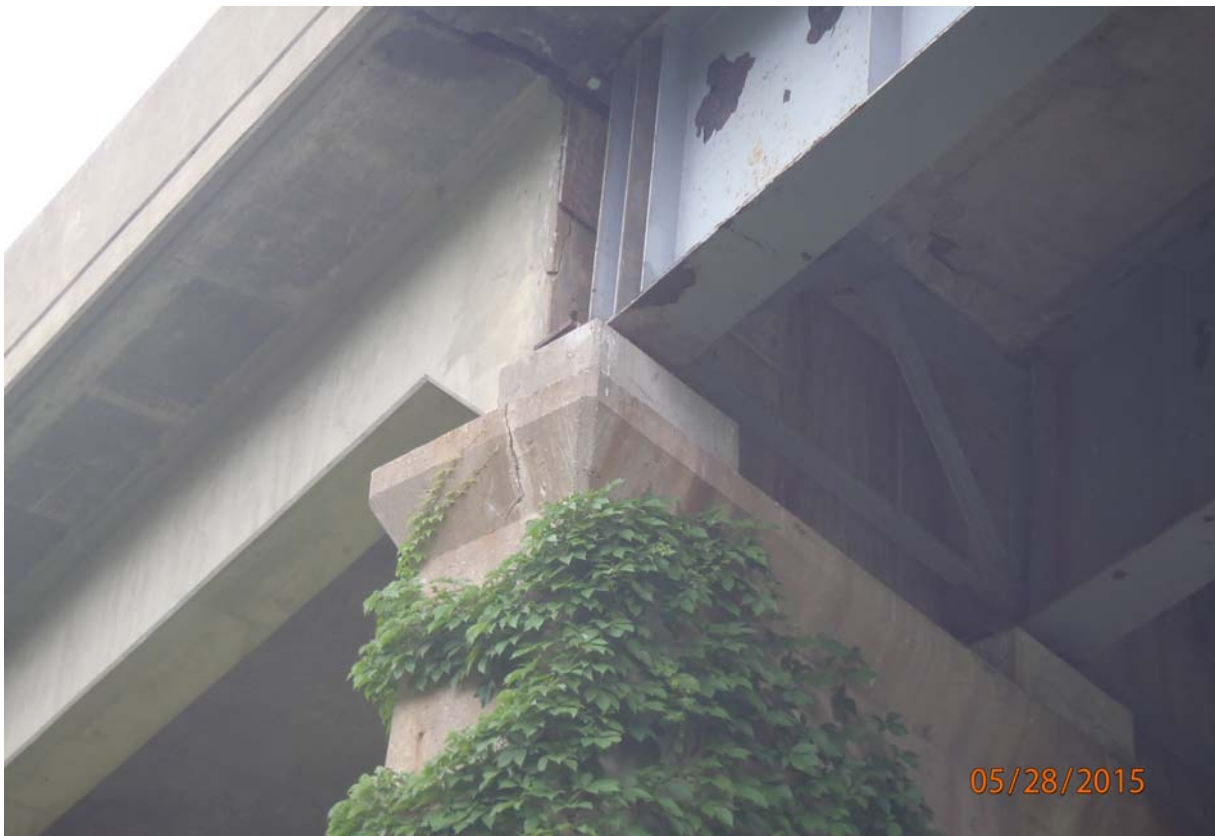
Looking up at beam 4 (#s from upstream to downstream). Note the vertical cracking @ the beam back-face and vertical crack in the exterior face of the pier cap under the bearing of beam 4.

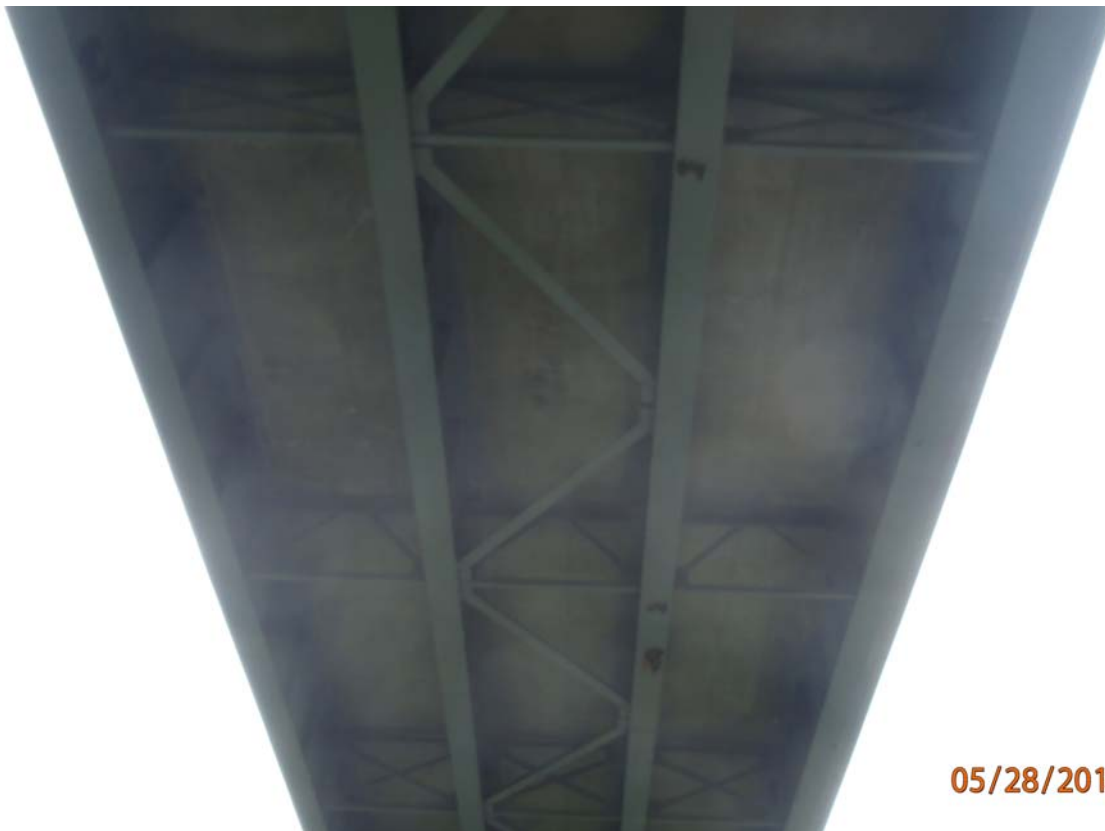
Looking up at the underside of span 2. Note the transverse cracks with efflorescence on the deck underside throughout the span; these cracks are more dominant near mid-span; there is evidence of water staining near midspan on the deck underside. **5/16**

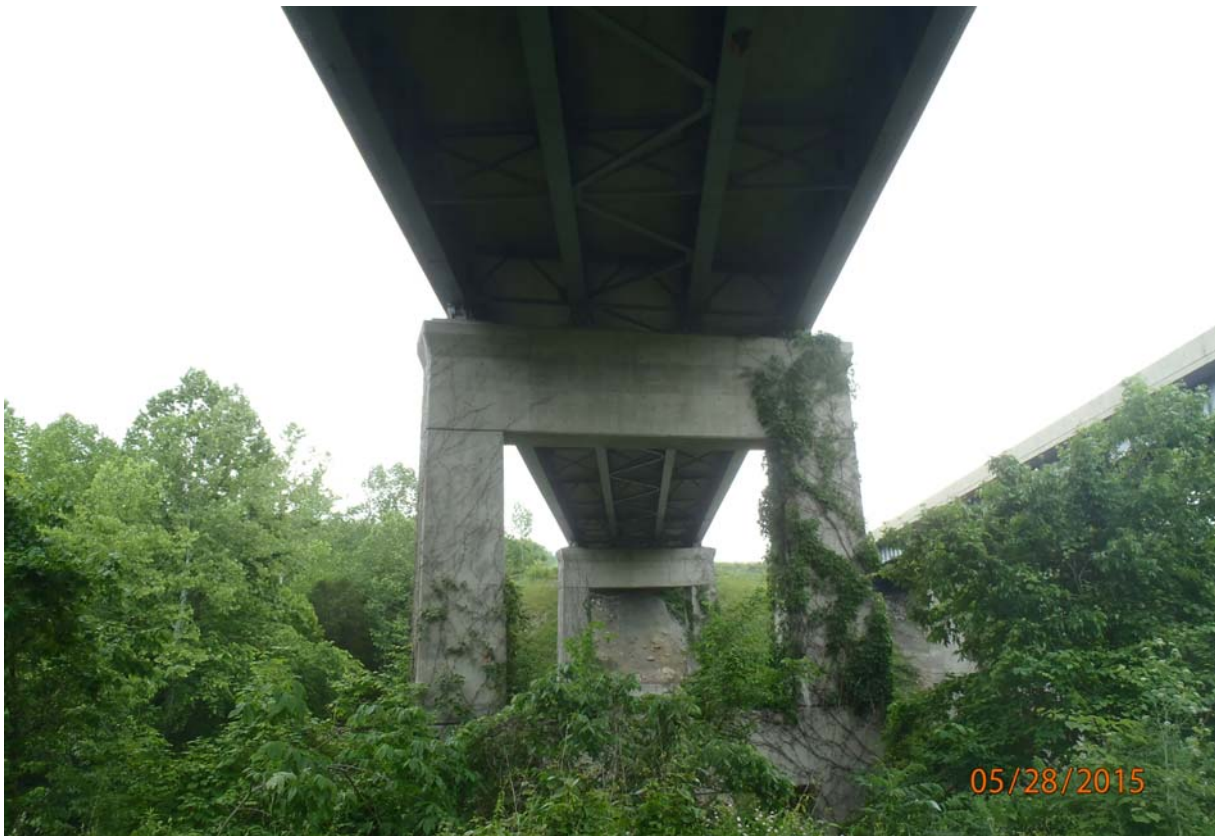
Elevation view of the west face of pier 3. Note the heavy vegetation growth.

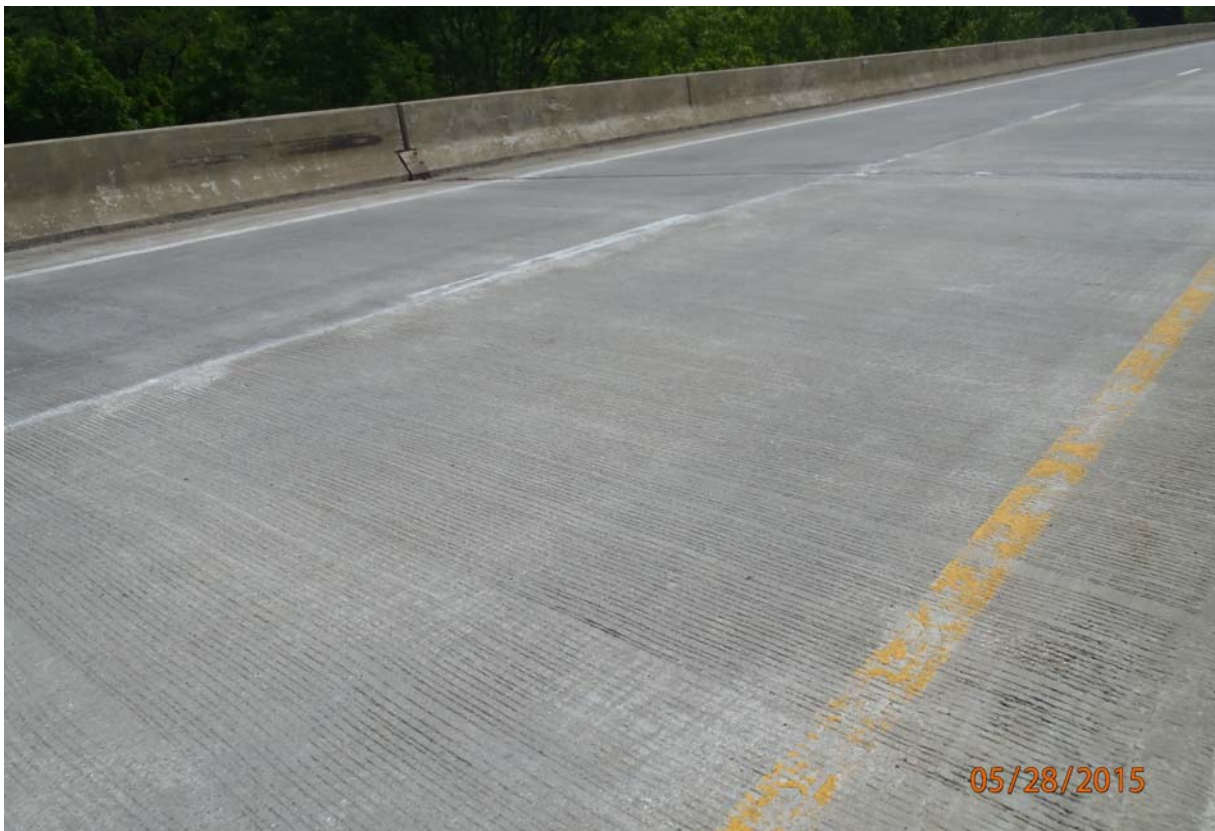
Looking down at the typical condition of the deck/driving surface. Note the deck has recently been overlaid. Note the scaling of the masonry coating on the face of the barrier wall (this is typical along many locations of the wall).

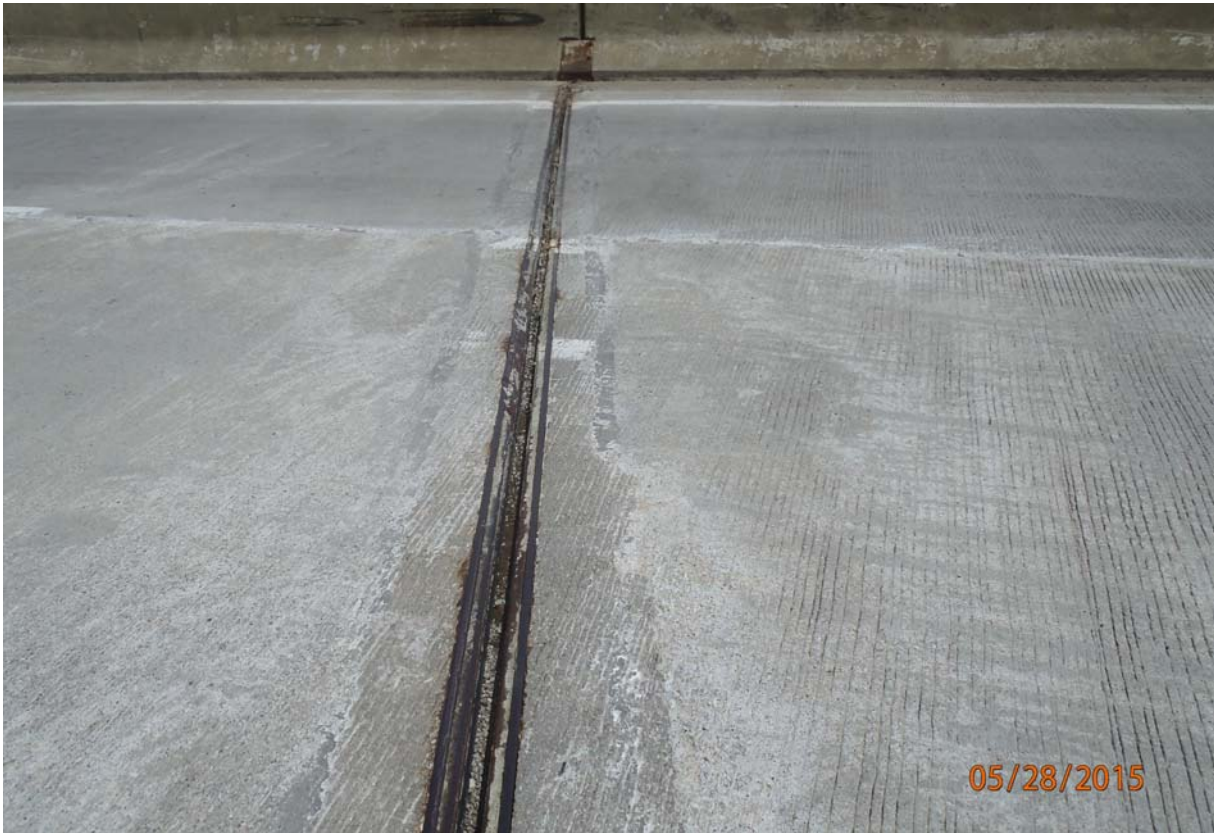
View of the joint over pier 2. Note the joint was recently replaced; only minor amounts of debris are trapped in the joint at this time.

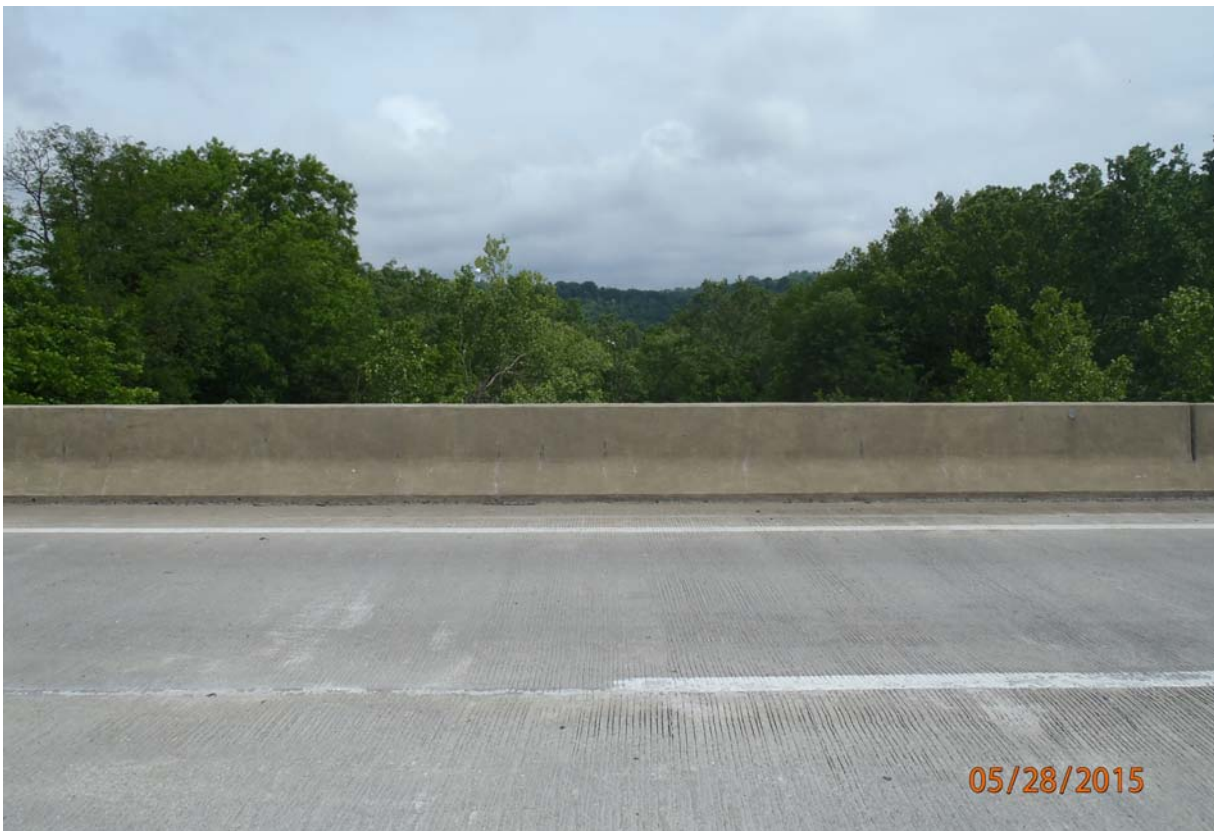
View of the upstream barrier wall. Note minor vertical cracking in the face of the barrier wall along the entire length of wall and many areas of scaling of the masonry coating on the face of the barrier wall.

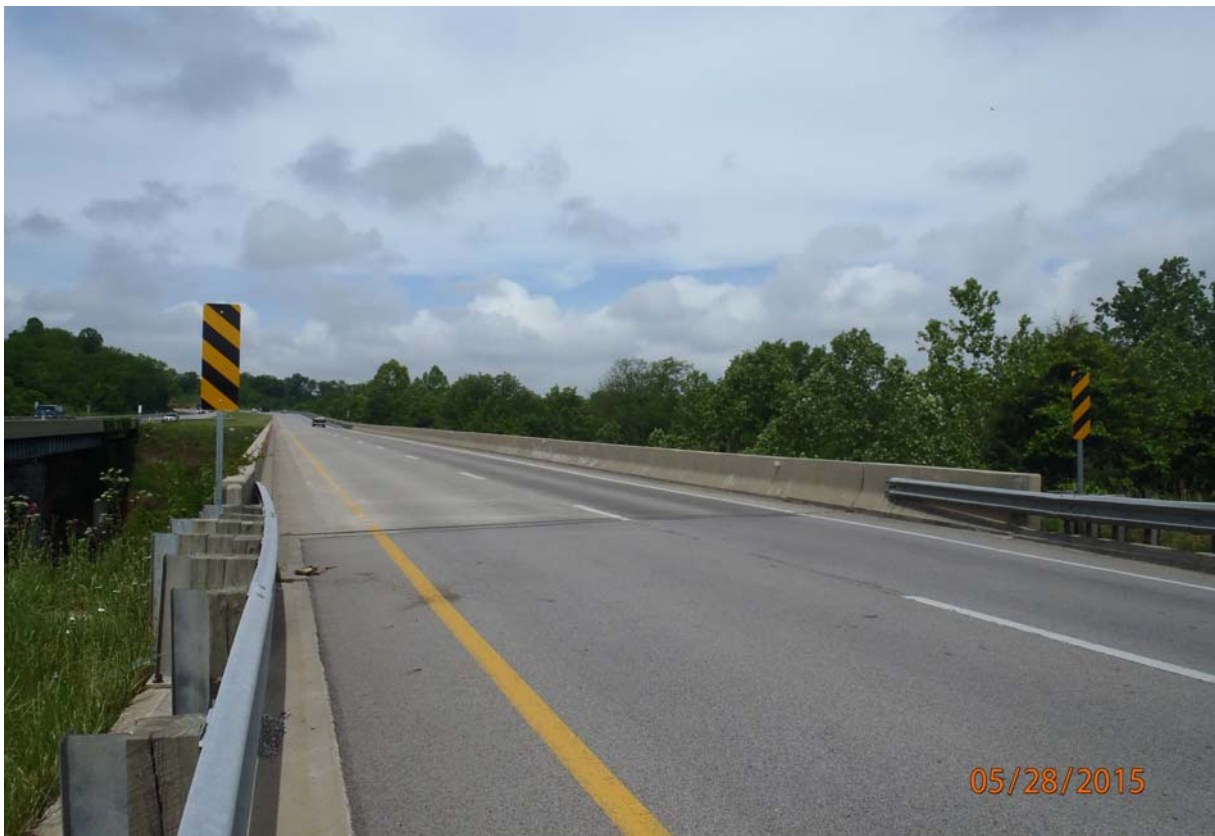
Endview from the east approach.

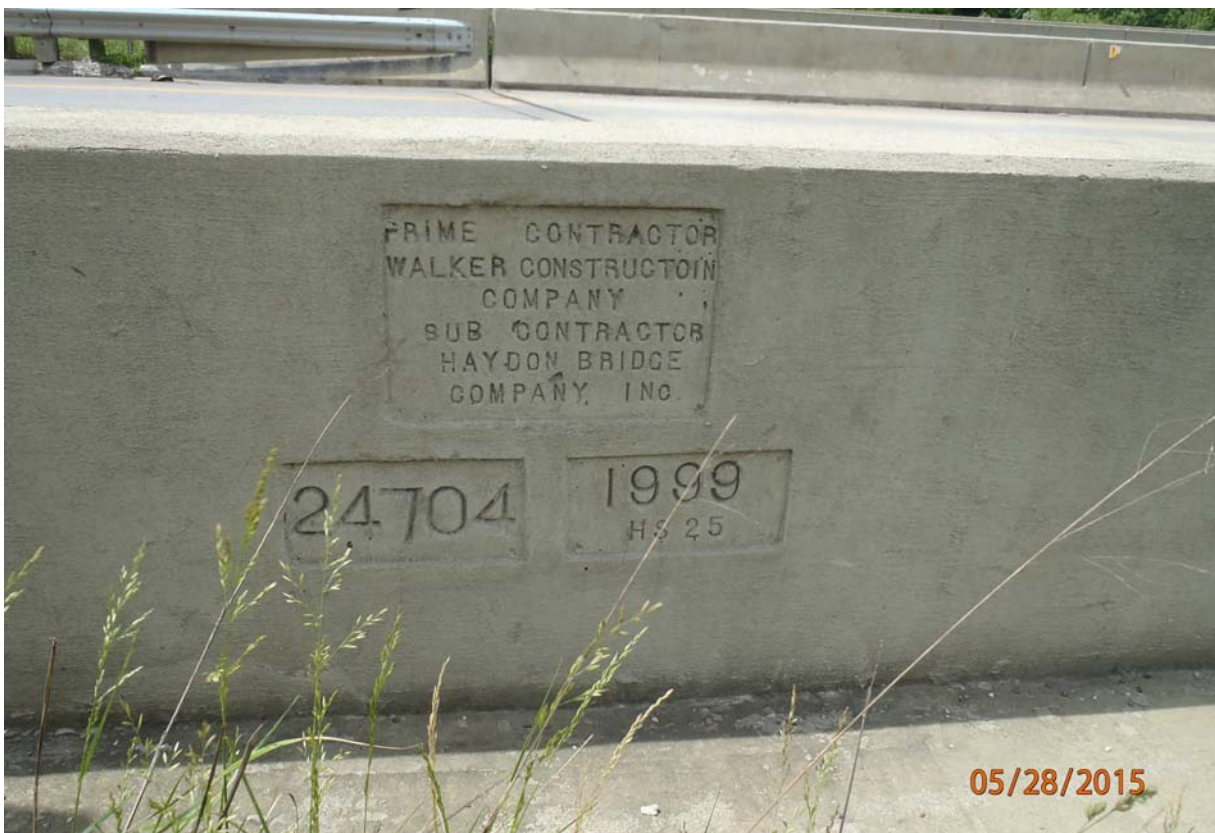
Bridge stamp of the deck replacement in 1999.

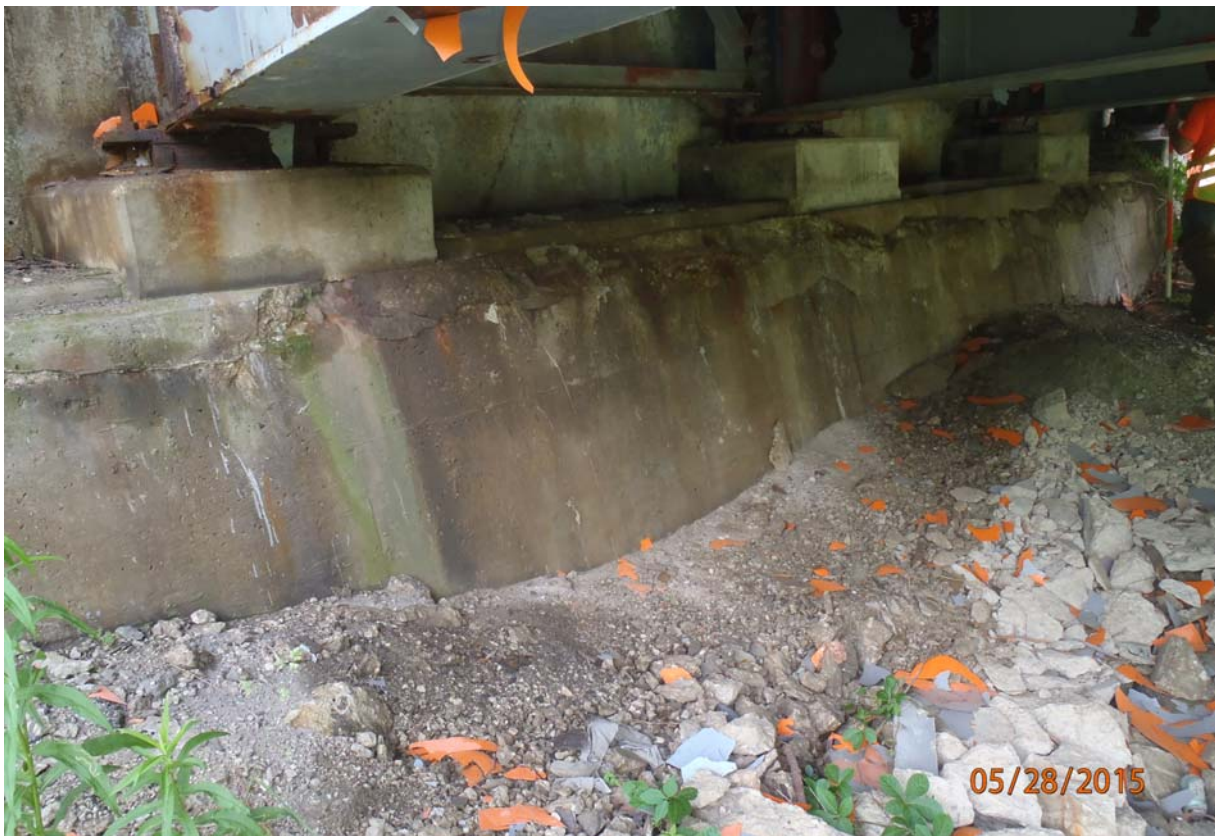
Elevation view of the east abutment (abutment 5). Note the heavy rust staining, horizontal cracking, efflorescence and spalling/delimitation along the abutment seat with rusting/active corrosion of the reinforcing steel. The joint has recently been replaced at this abutment and the abutment needs to be patched.

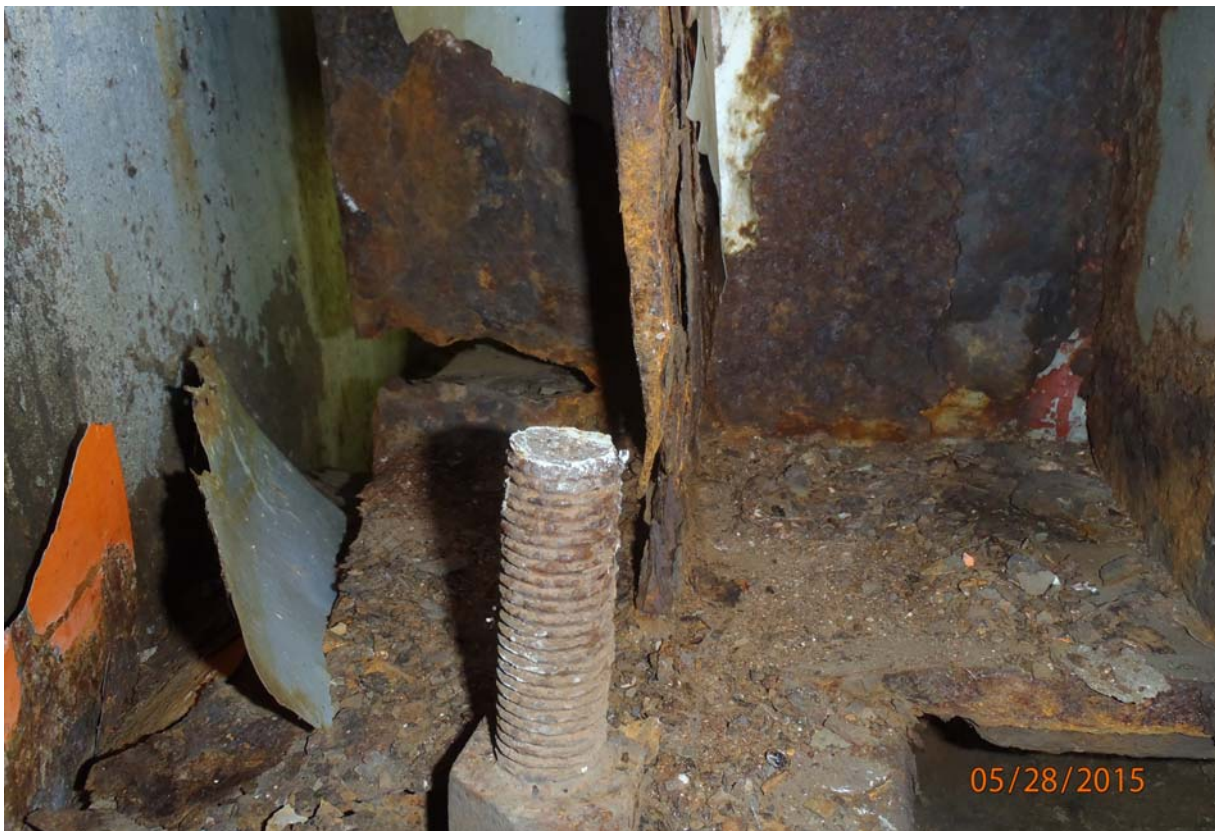
Looking at the upstream face of beam 1 @ abutment 5. Note the 6 5/8" long crack in the web near the bottom flange extending from the beam end towards the 1st vertical stiffener; this crack initiated from a corrosion hole. Note the bottom flange is heavily corroded and thinner @ the bearing location (up to 1/8" section loss).

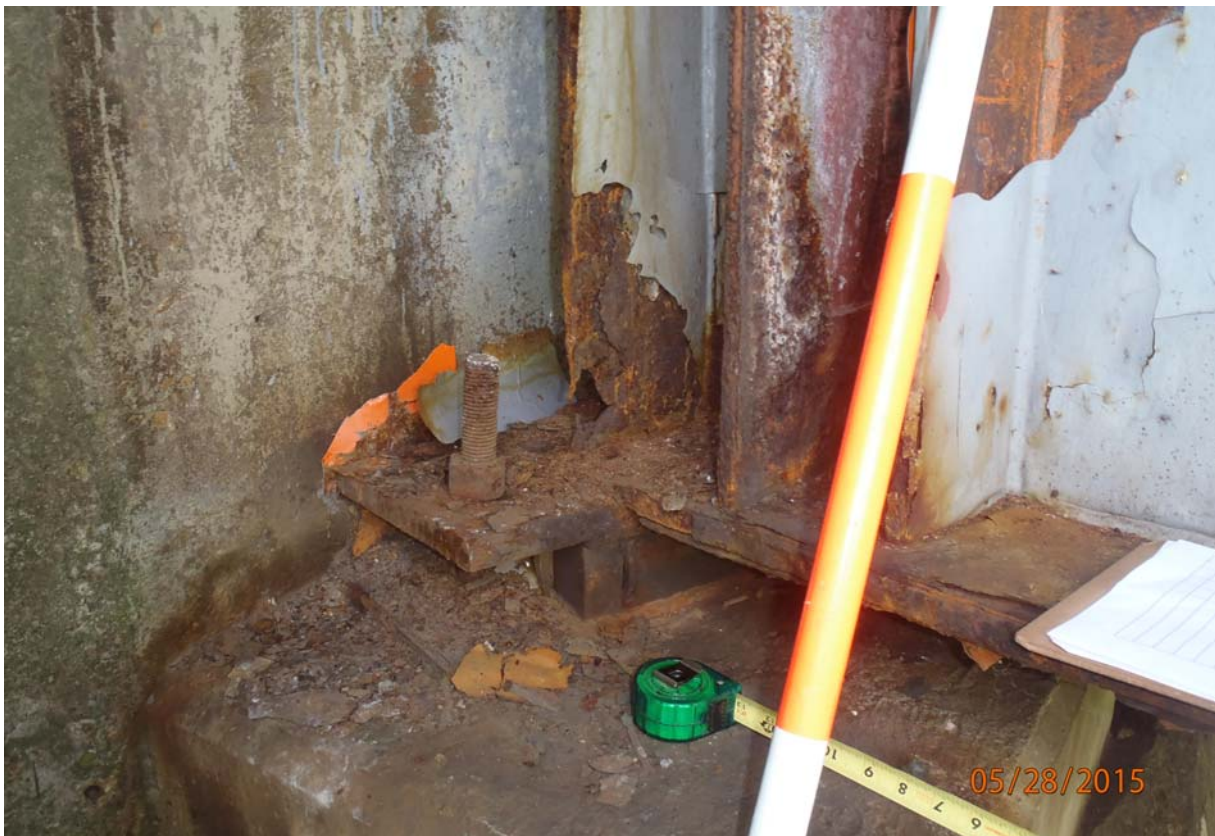
Looking at the upstream face of beam 1 @ abutment 5. Note the 6" in 1st vertical stiffener @ the bearing; it is believed that this crack initiated from a 1.5" dia. corrosion hole in the stiffener. It appears that the beam web past the bearing is bowing slightly towards downstream.

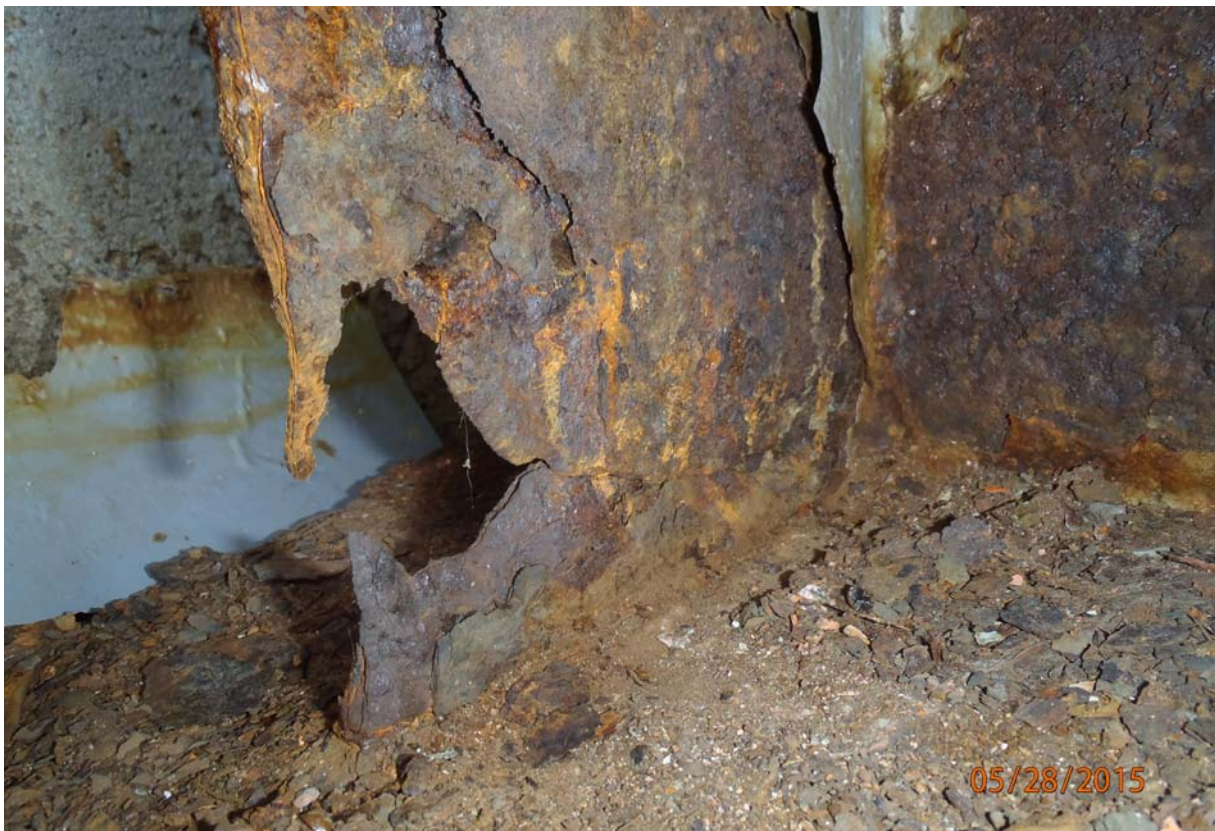
Close up of above noted crack; see above photo for notes.

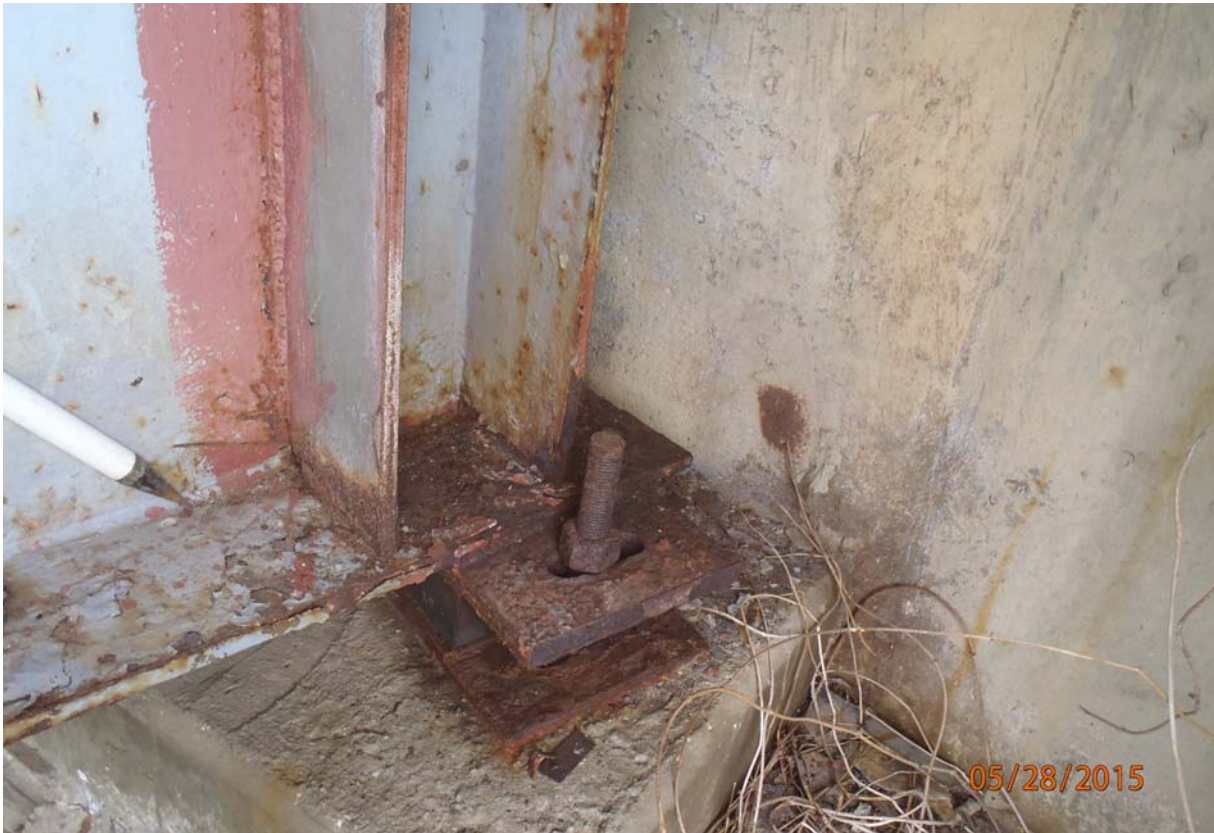
Downstream face of beam 4 @ abutment 5.

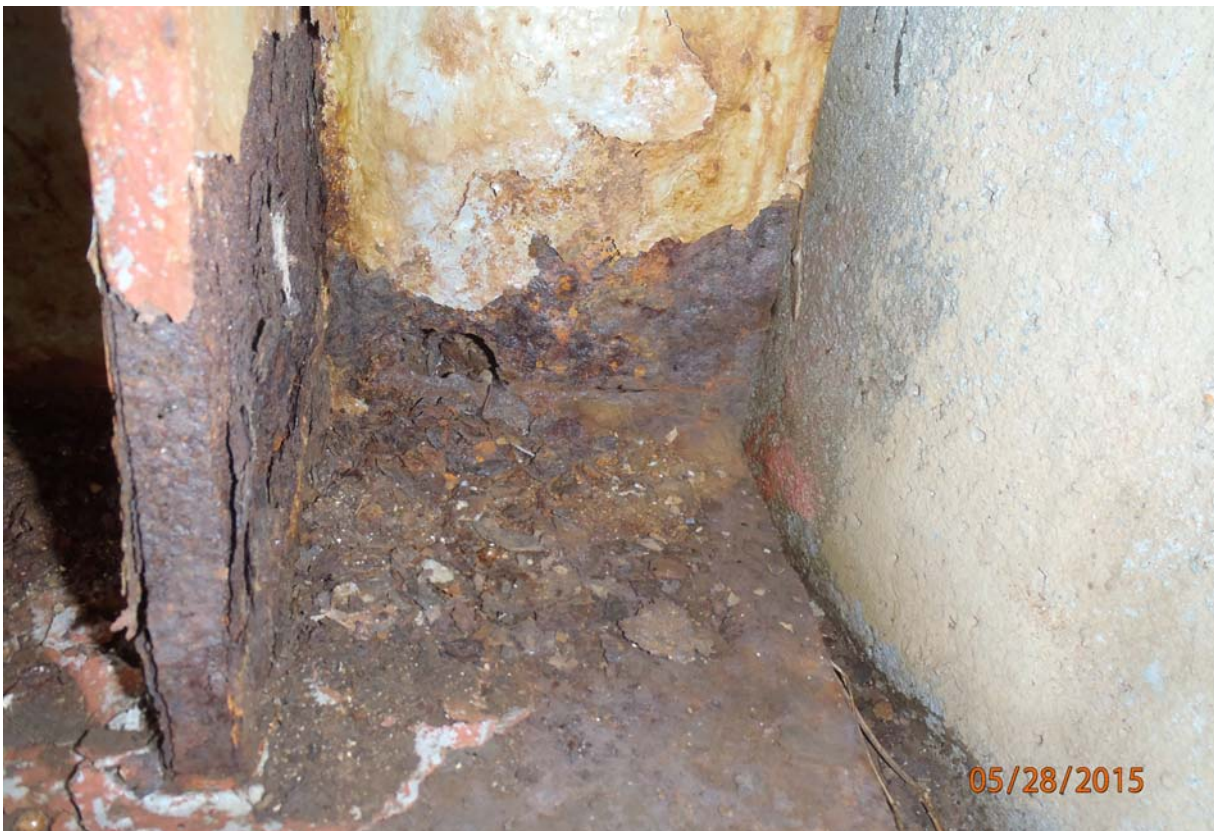
5 1/4" long crack in the web of beam 4 @ abutment 5 near the bottom flange extending from the end of the beam towards the 1st vertical stiffener. It appears this crack initiated from a corrosion hole. It appears that the web of the beam in this location is bowing slightly. **11/16**

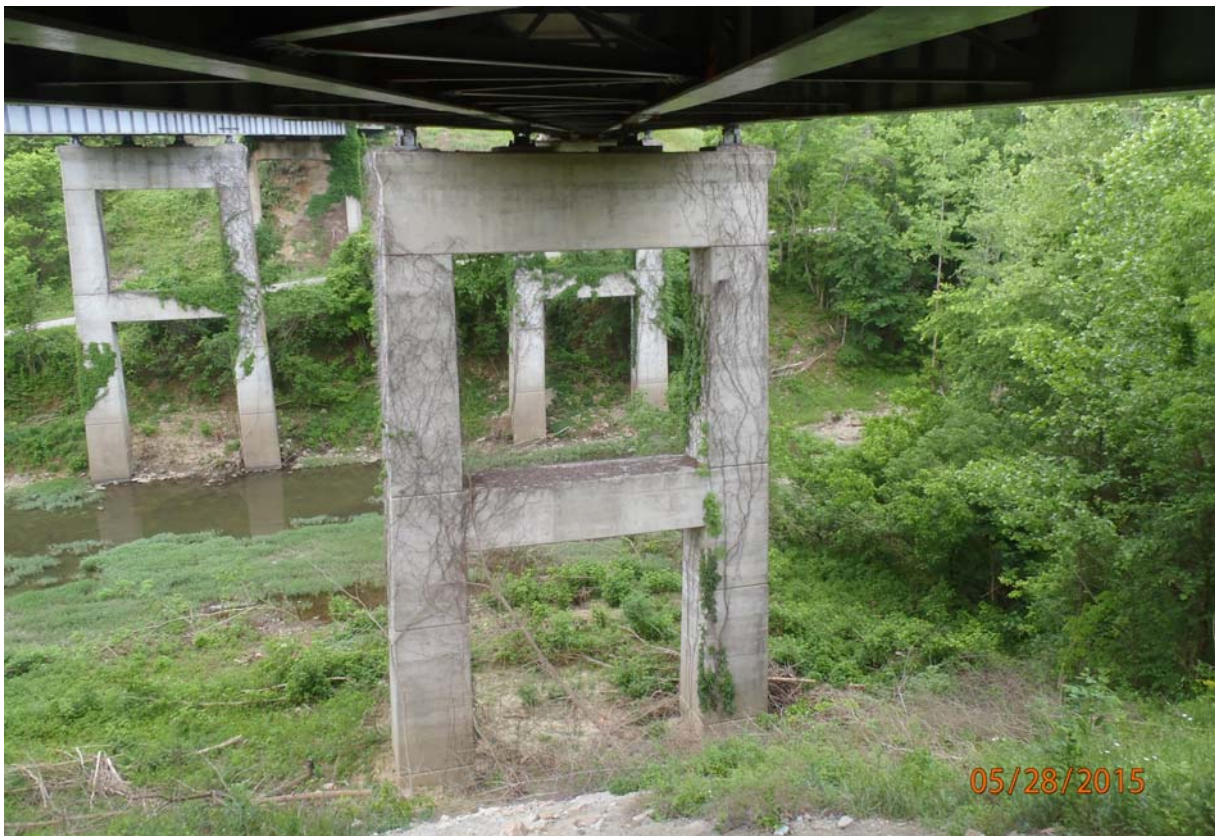
Elevation view of the east face of pier 4. Note the vegetation growth.

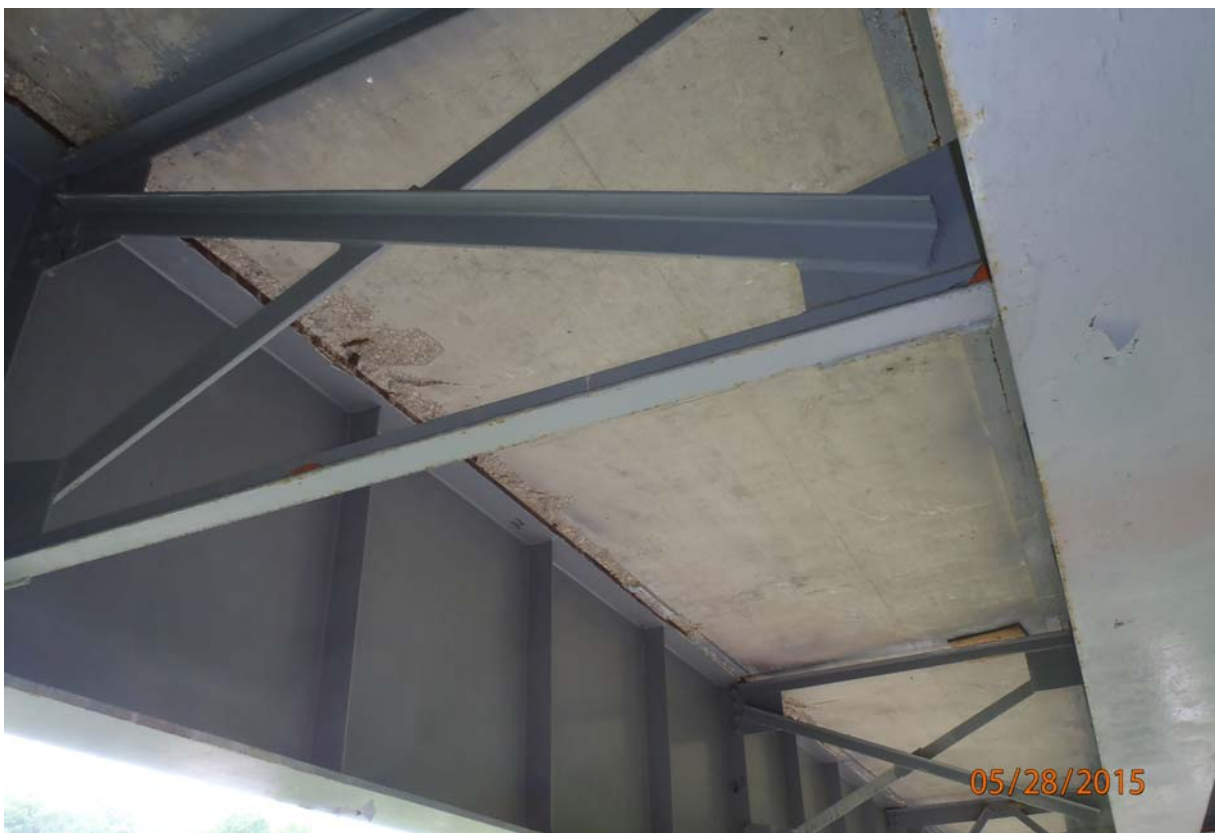
Looking up between beams 3 & 4 in span 4. Note the spalls with exposed reinforcing along the top flange of beam 4.

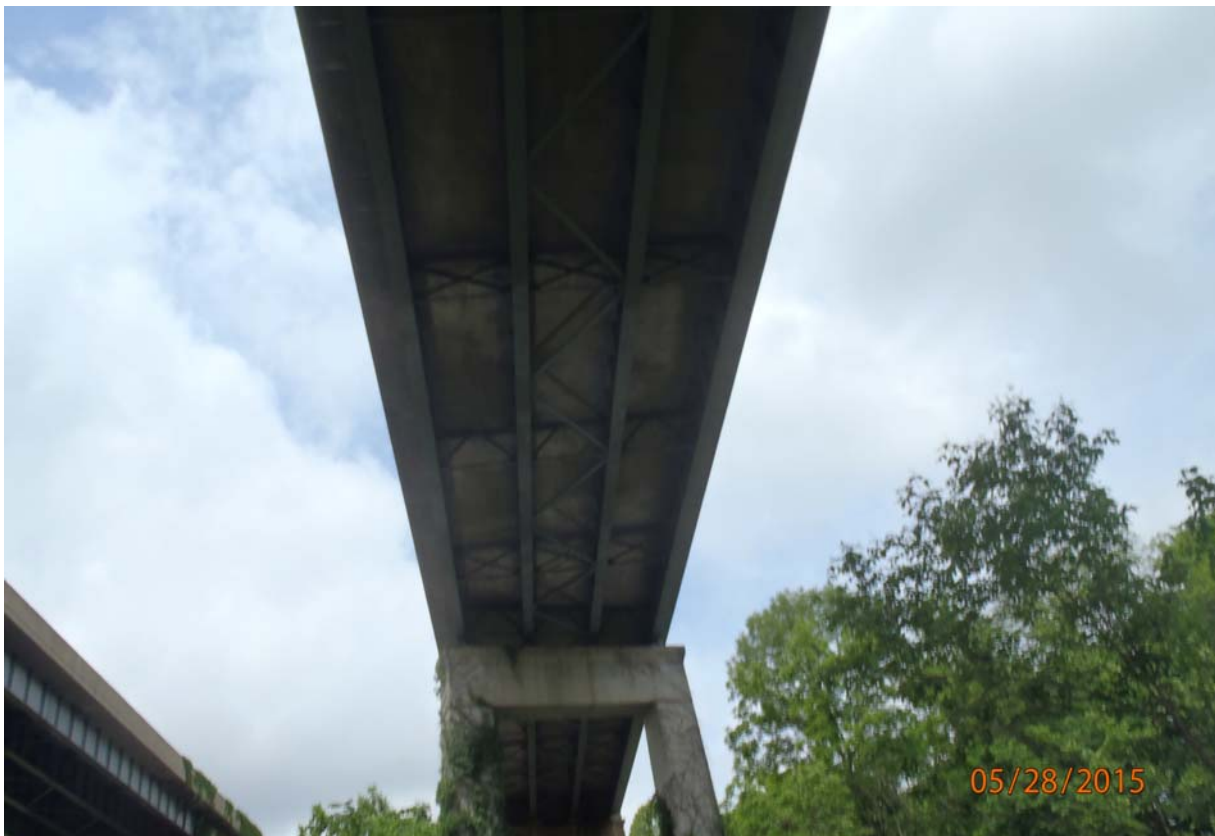
Looking up @ the underside of span 3.
