## Inspection Report with SI&A Data

**Structure Description:** 390.09 Foot - 3 Span Steel continuous Stringer/Multi-beam or Girder

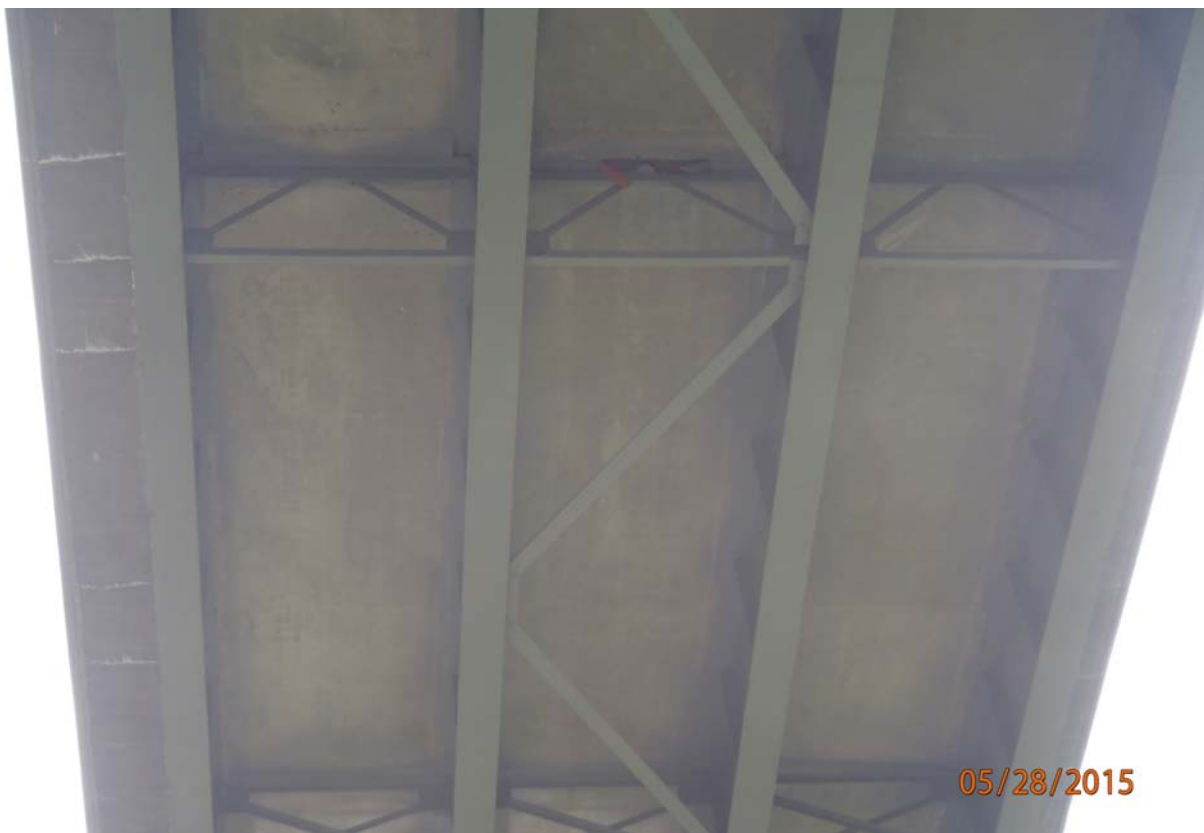
Looking up @ the underside of the superstructure in span 3. Note the transverse cracking with efflorescence on the underside of the downstream overhang.

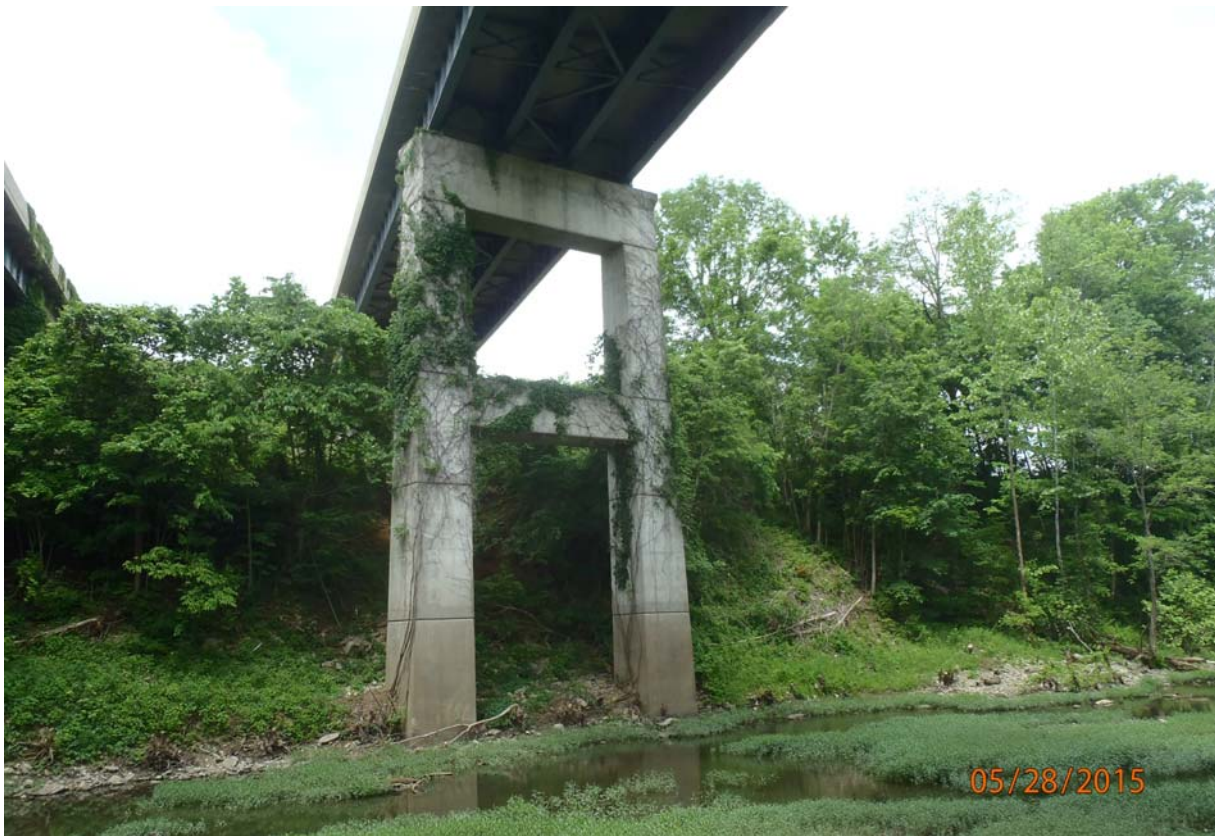
Elevation view of the east face of pier 3. Note water staining on the pier columns and heavy vegetation grown.

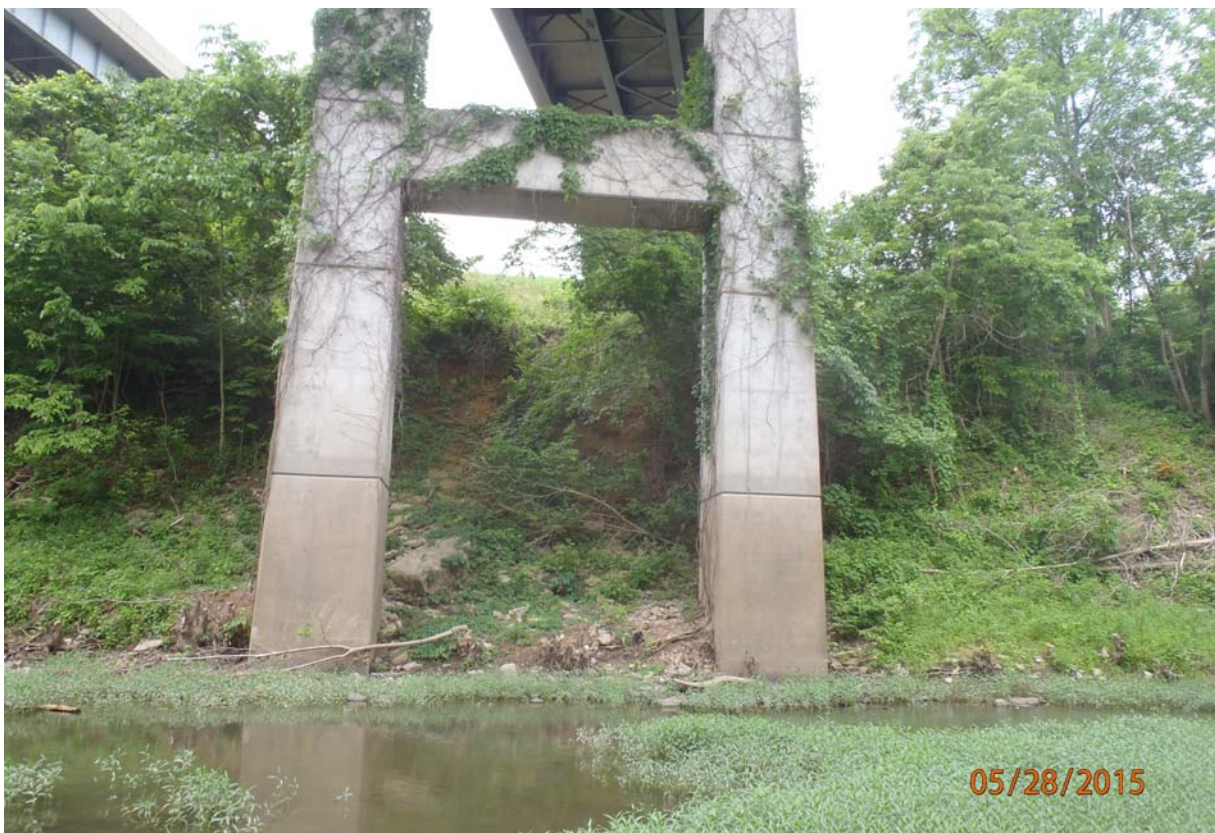
View of the east face of pier 3. Note the water staining and light wearing of the concrete surface from the normal stream level.
