## Inspection Report with SI&A Data

**Structure Description:** 390.09 Foot - 3 Span Steel continuous Stringer/Multi-beam or Girder

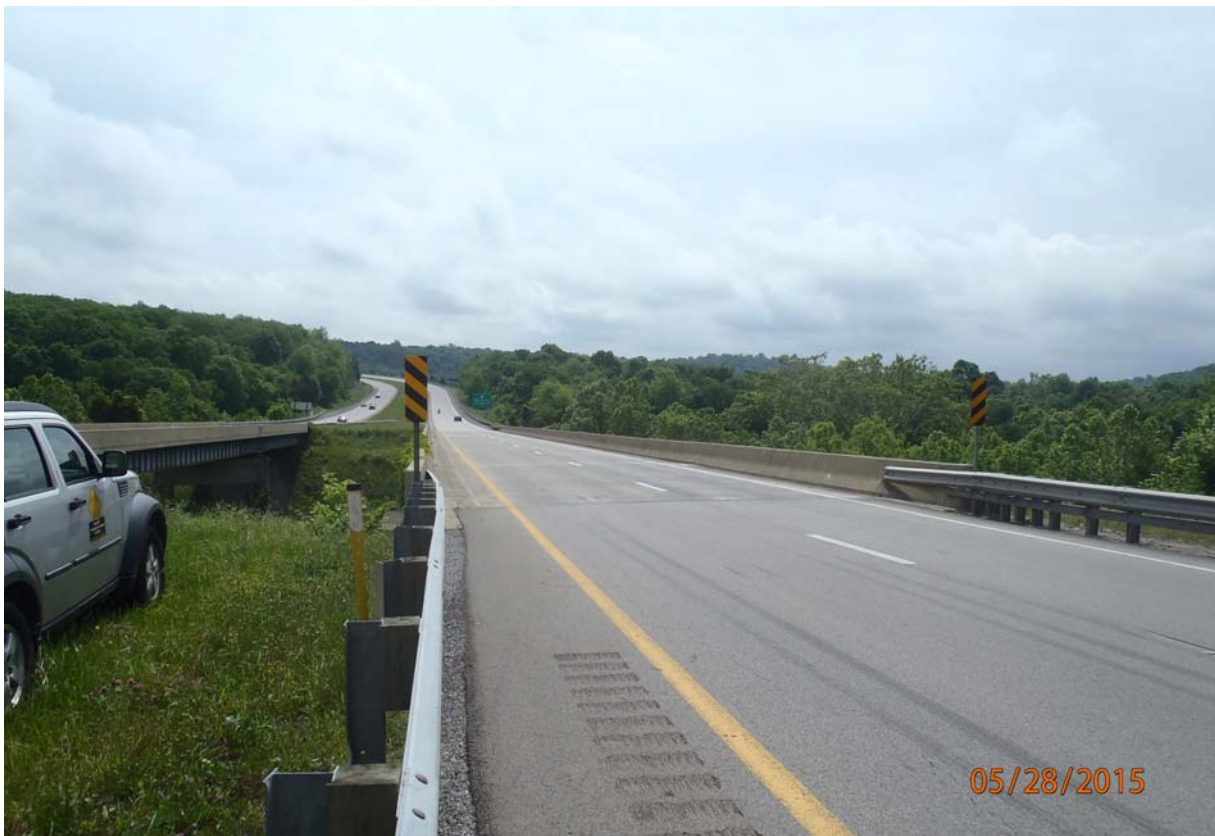
End view from the west approach.

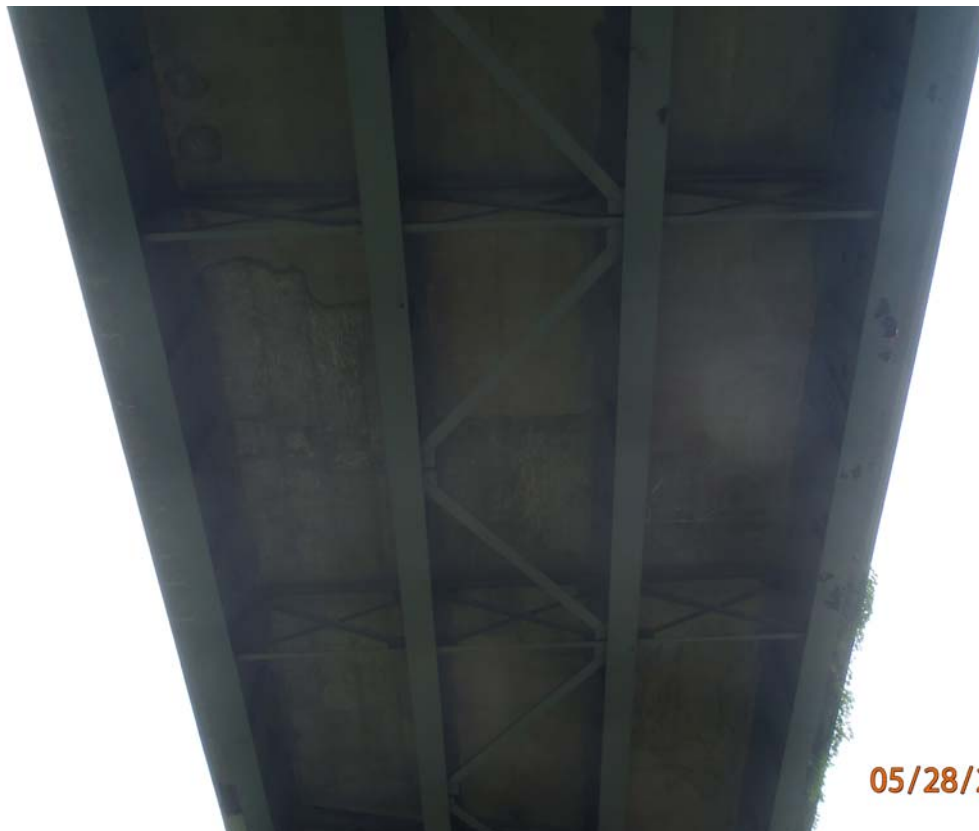
Looking up at the underside of span 2. Note the transverse cracks with efflorescence on the deck underside throughout the span; these cracks are more dominant near mid-span; there is evidence of water staining near mid-span on the deck underside. Note the areas of patching on the deck underside.

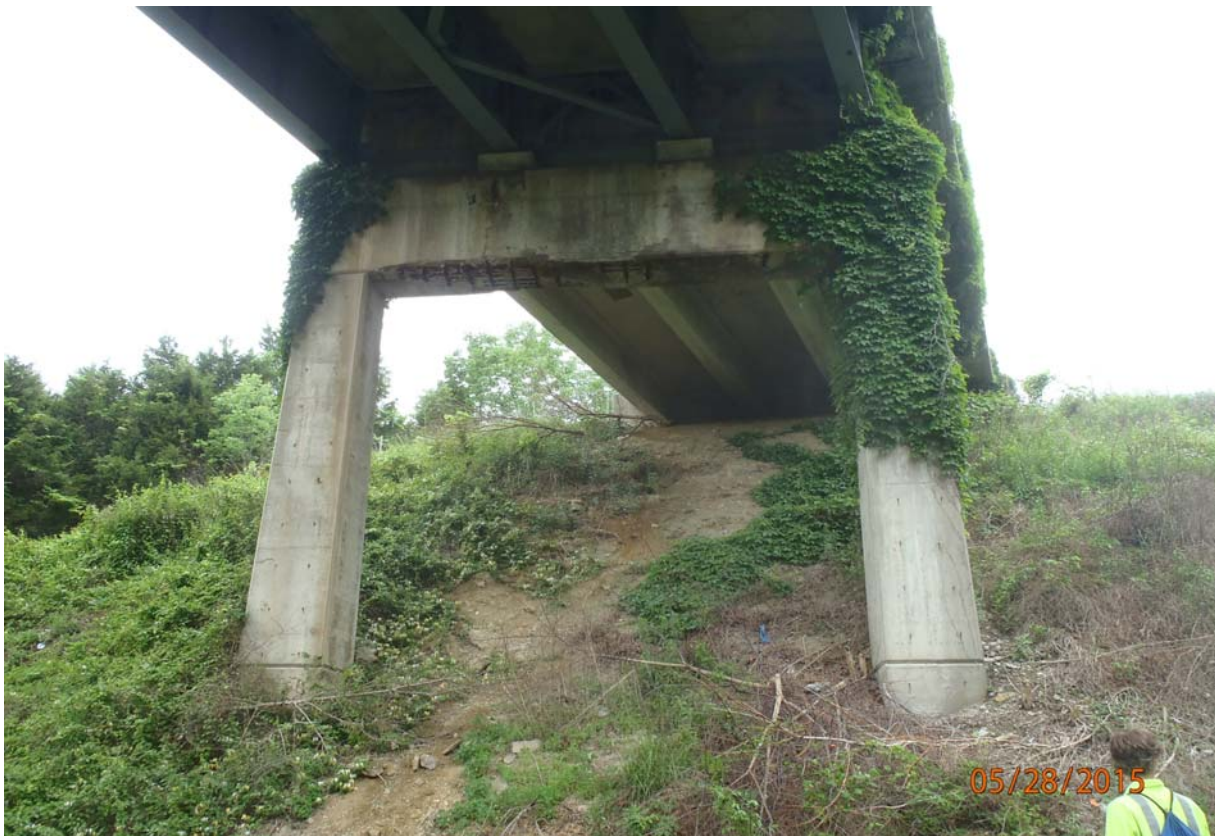
Elevation view of the east face of pier 2. Note the exposed rusting/corroding reinforcing steel in the pier and heavy rust staining on the pier cap see below photo for more info. Note 1 area with exposed rusting/corroding exposed vertical reinforcing steel in the east face of the cap (under beam 3 bearing). This pier cap needs to be cleaned and patched.

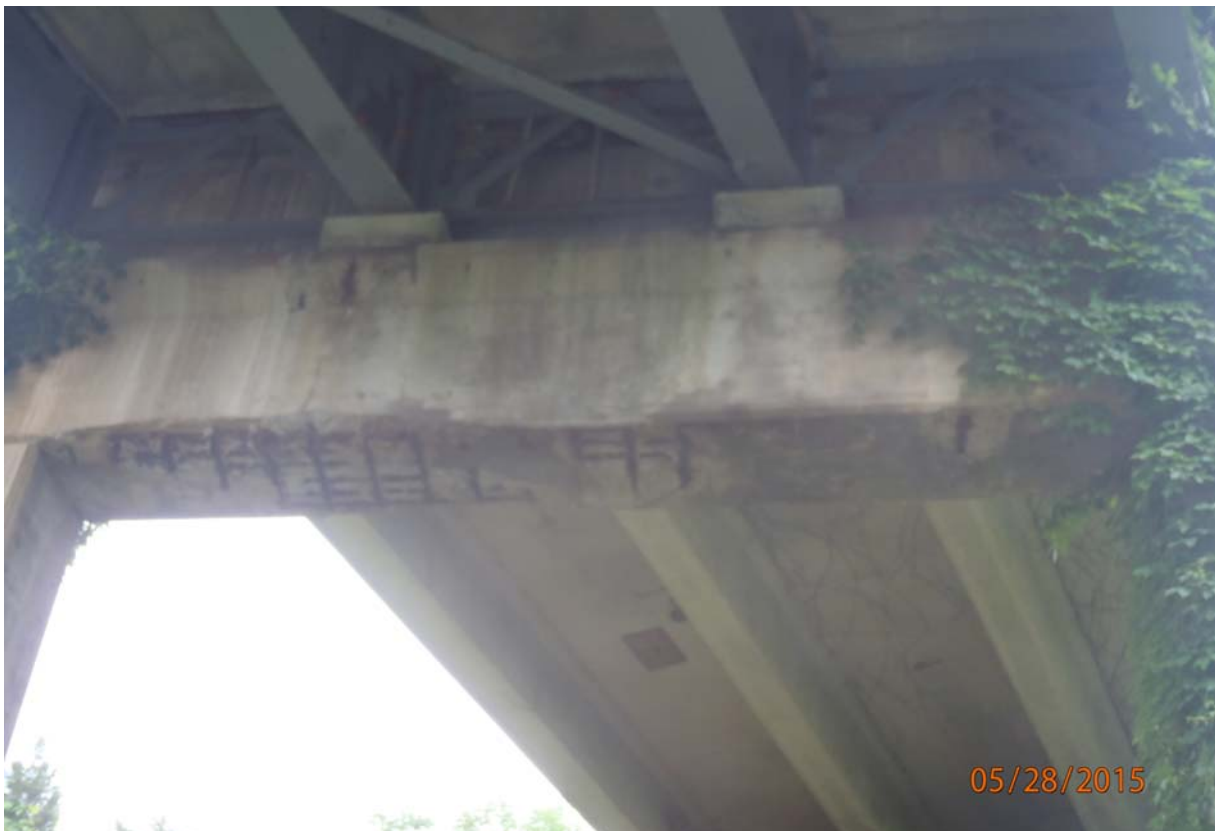
Looking up at the underside of the pier cap of pier 1. Note the heavily rusted and corroding (w/ section loss) exposed reinforcing steel. There is a deck joint directly above this pier (between the steel girder span and reinforced concrete girder span). The plans called for 2 rows of 6 #11 Bar. **4/19**

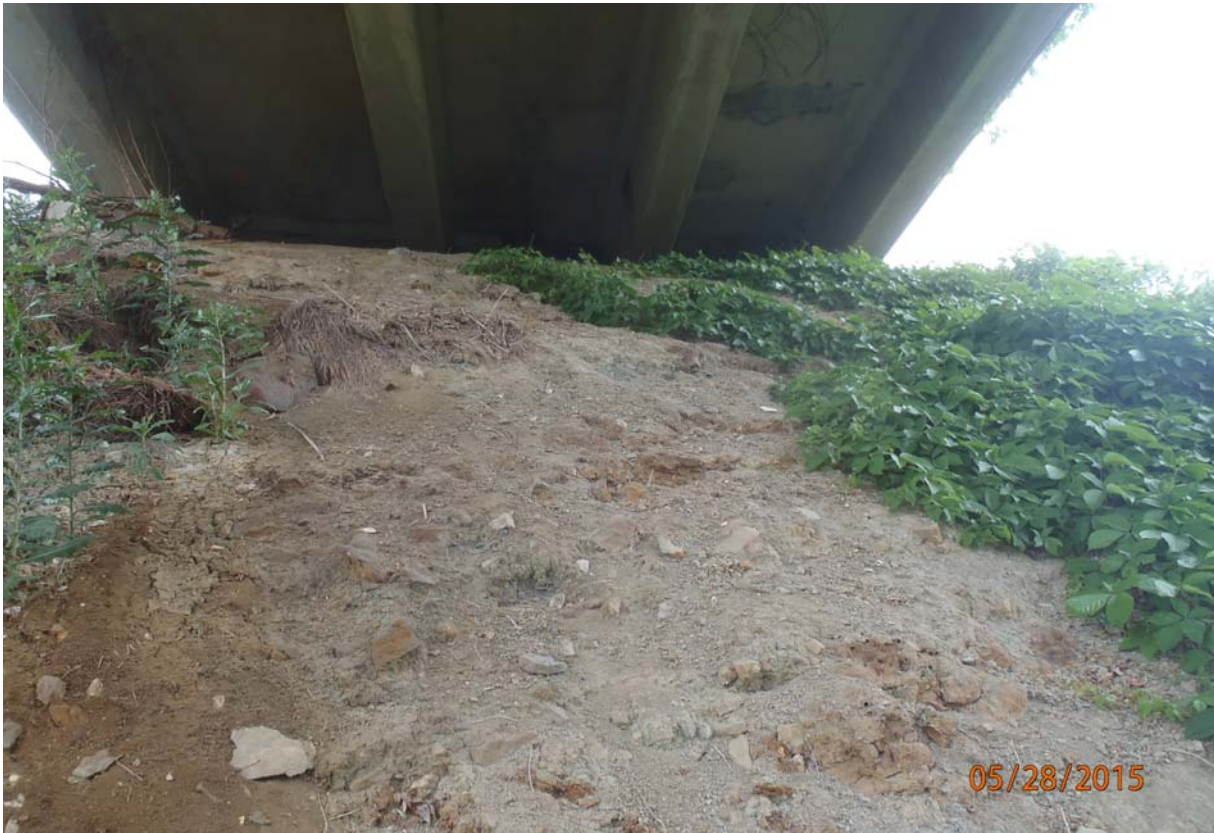
Looking at the embankment in-front of the west abutment. Note the minor erosion.

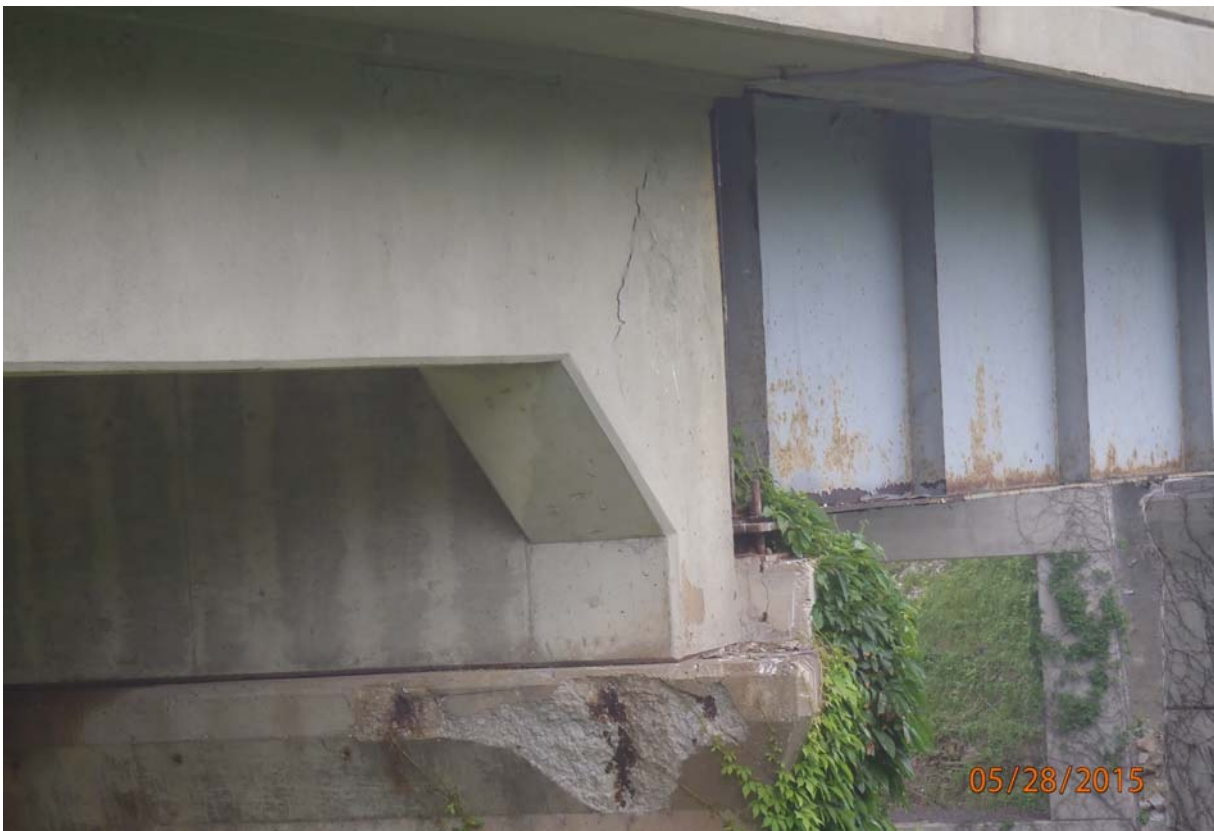
Exterior downstream beam @ pier 2. Note the 5'x2' spall with exposed rusting/corroding steel in the pier cap under the bearing of beam 4. Note the beam has an area above the bearing has light scaling and the start of light delimitation.

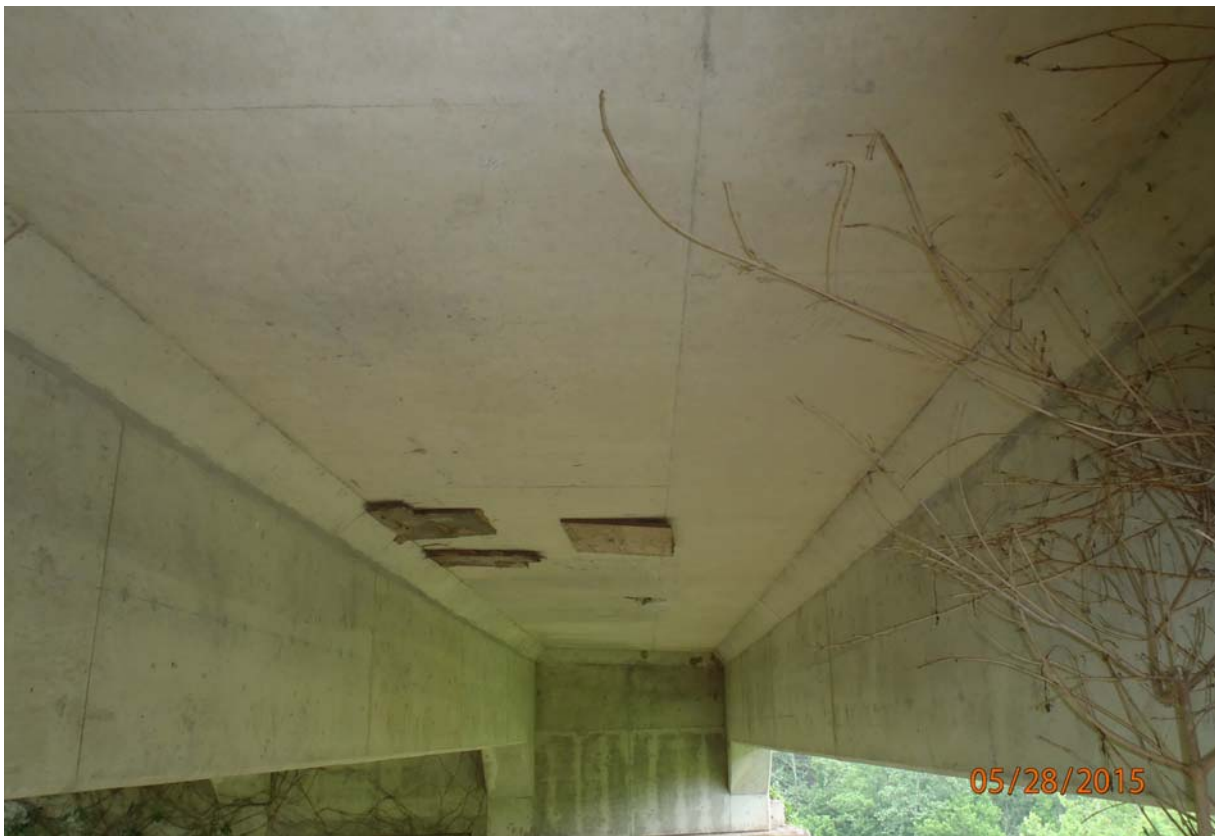
Looking up at the underside of the deck in span 1 between beams 3 & 4. Note the plywood forms still in place, minor vertical cracking in the concrete beams, minor map cracking on the underside of the bridge deck near abutment 1 and light scaling of concrete on the deck underside.

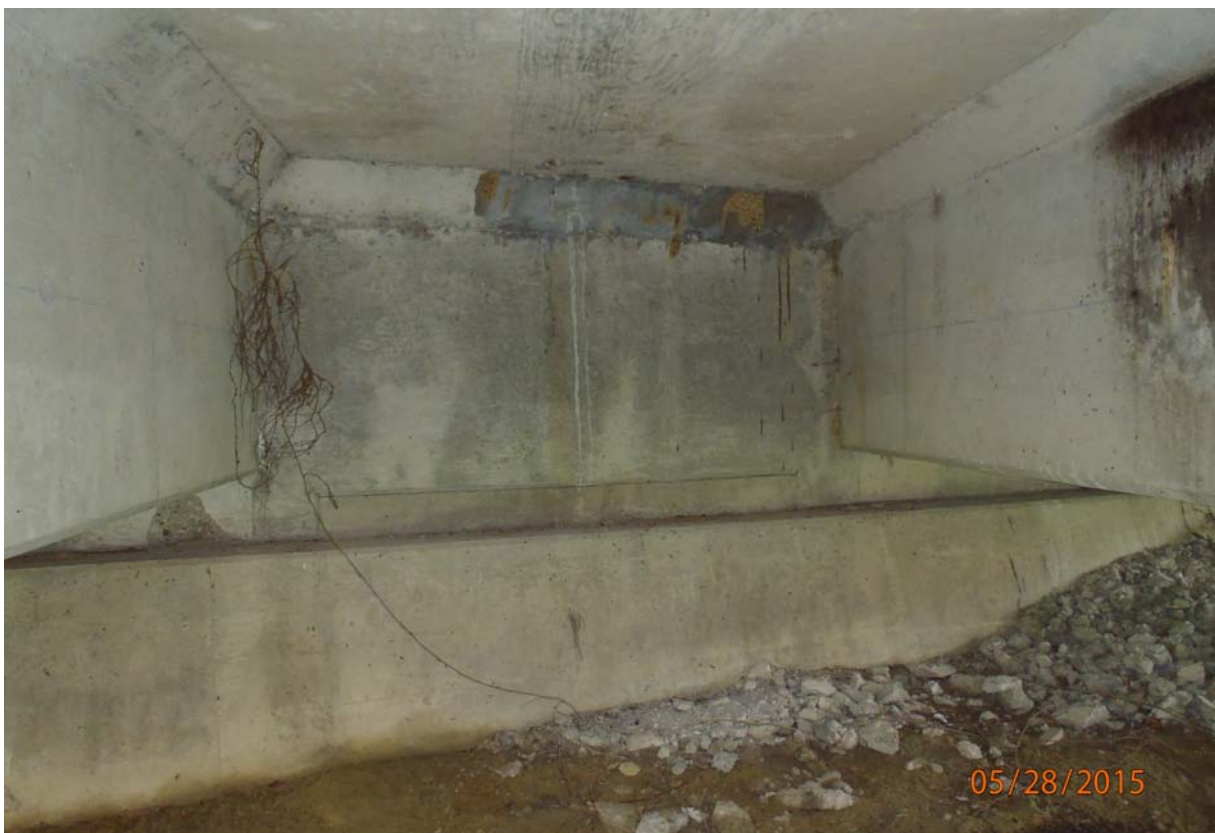
View of the abutment and diaphragm between beams 2 & 3 @ abutment 1.

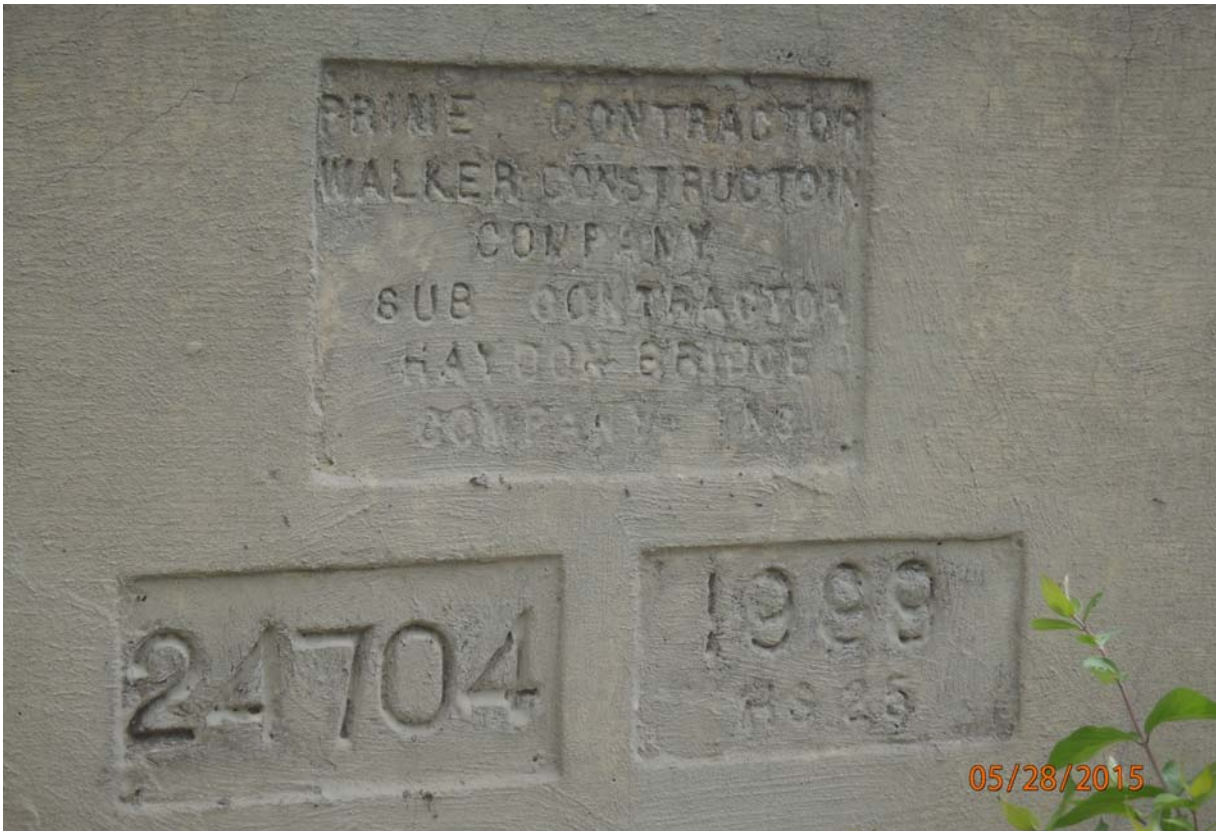
Bridge stamp from the deck replacement.

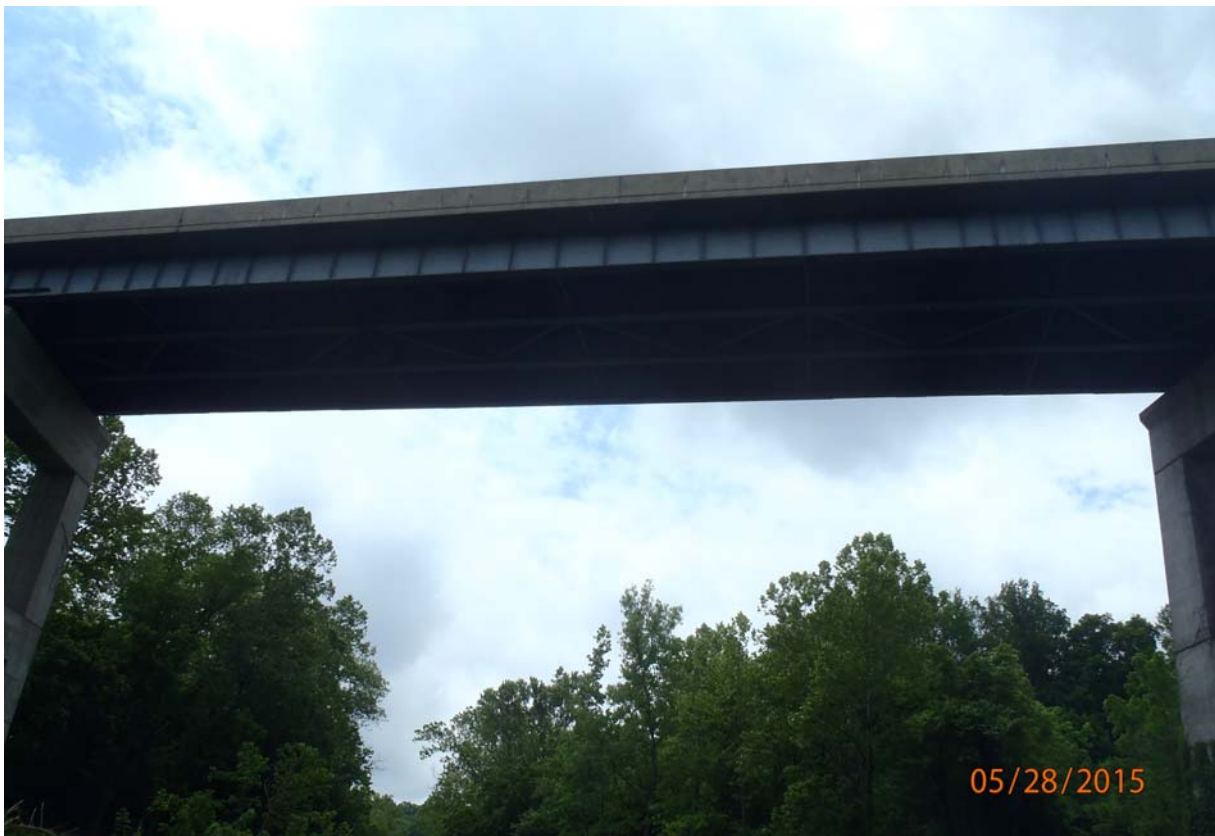
Elevation view of span 3 from upstream.

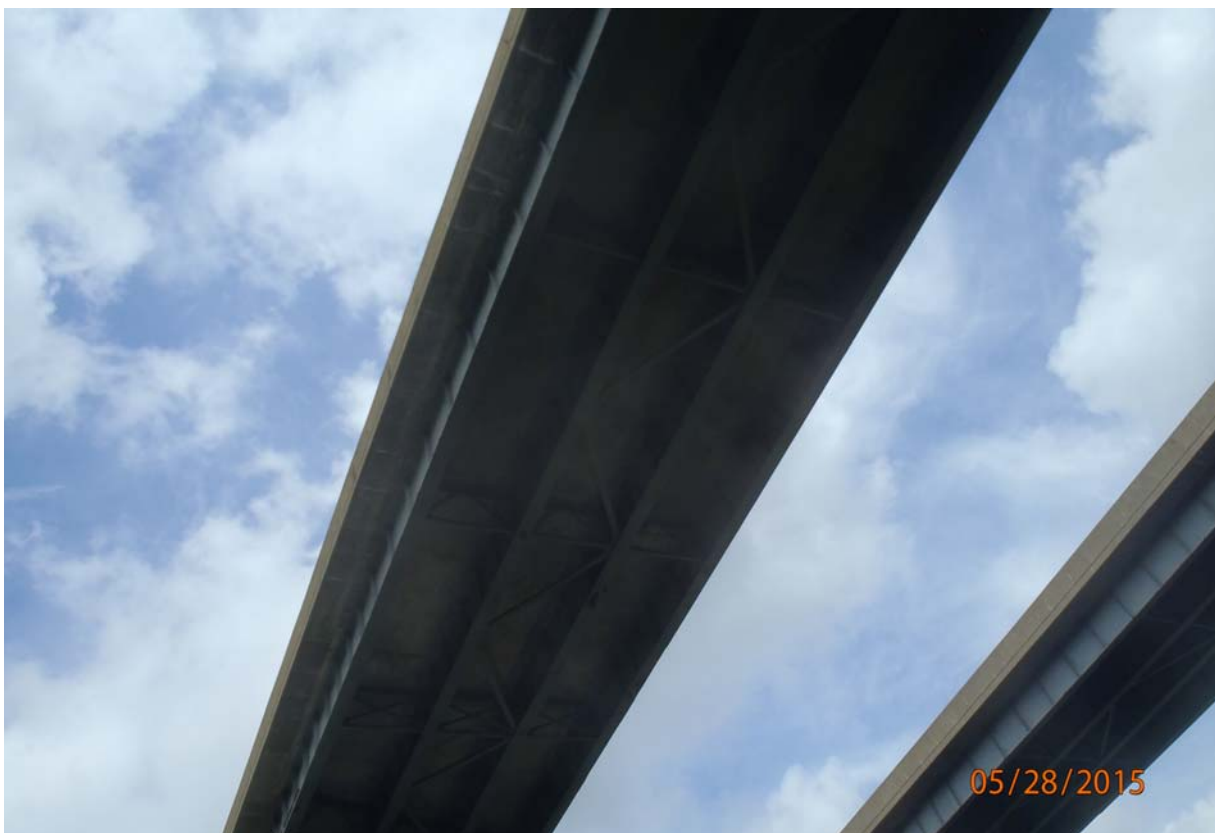
View of the underside of span 3. Note the transverse cracks with efflorescence on the underside of the downstream overhang.

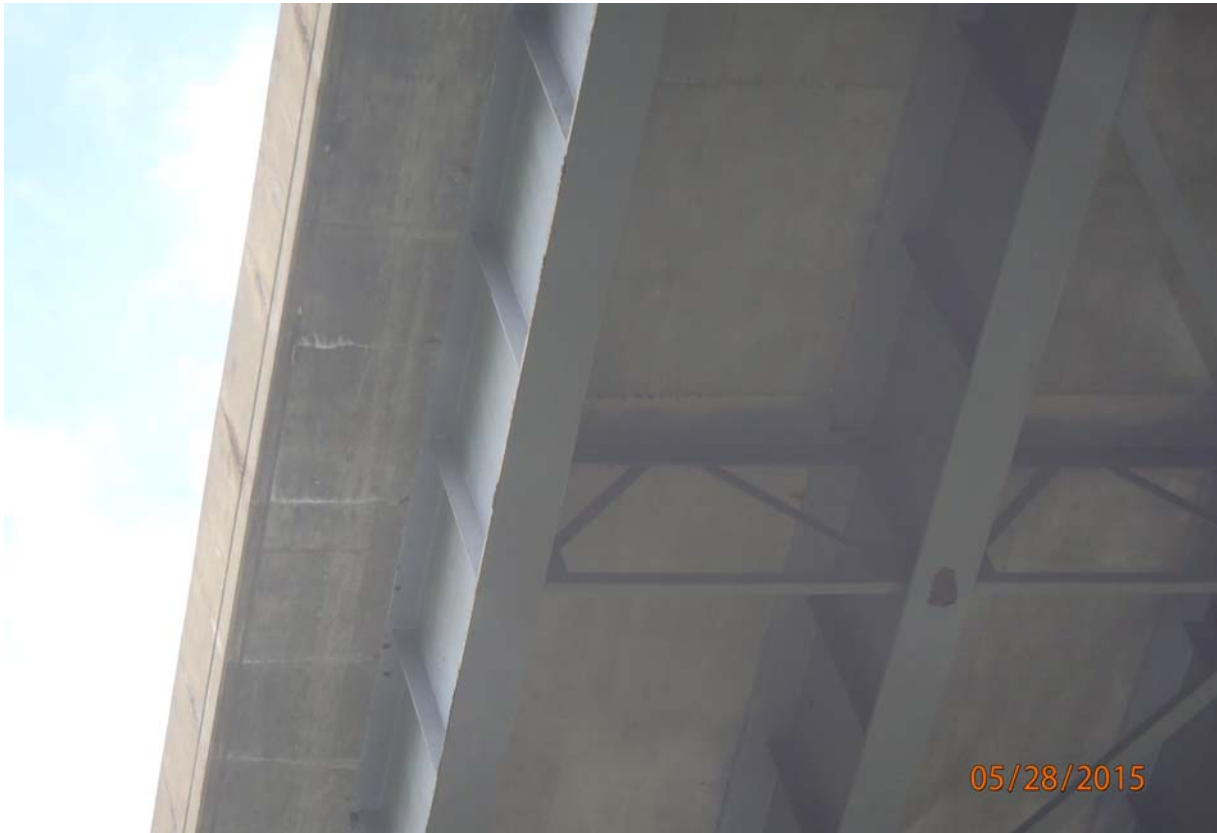
Close-up of the above photo.

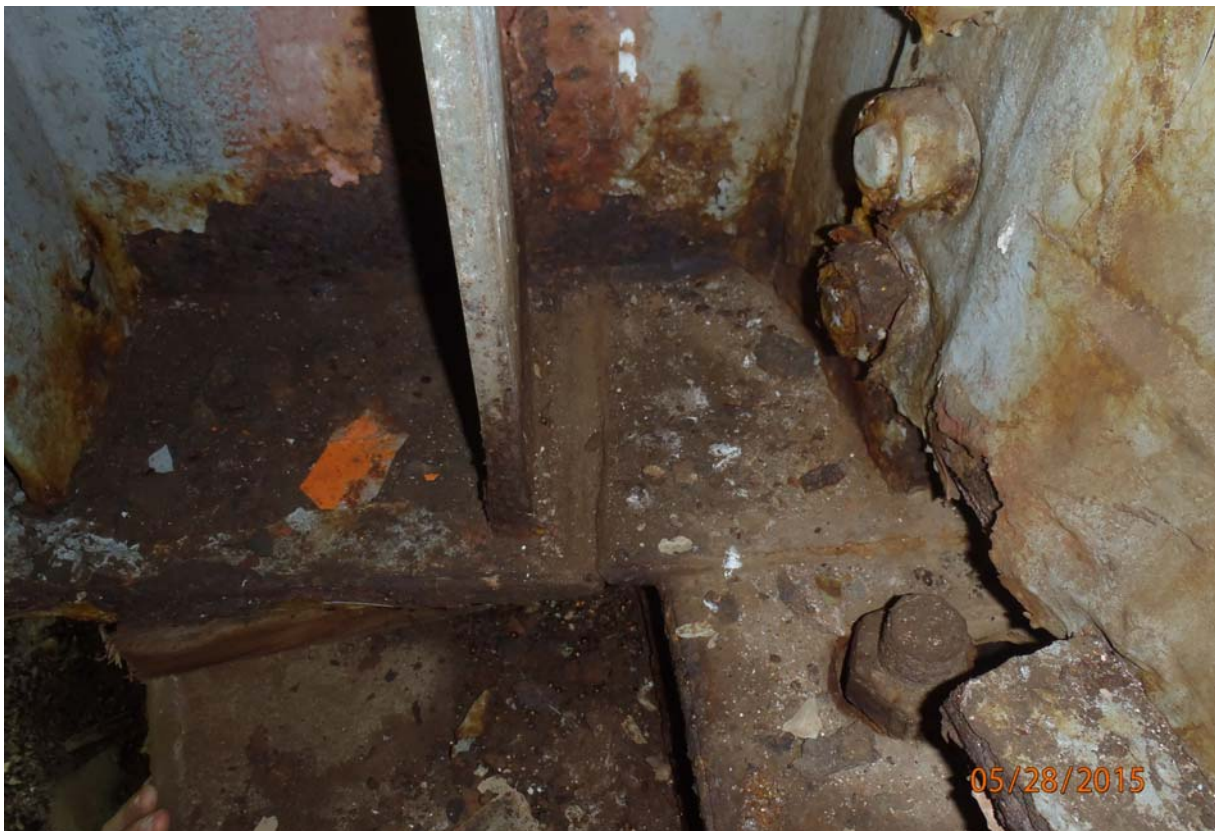
View of the cracking through the lower flange of beam 3 @ the bearing of abutment 5. This crack extends the entire length of the bottom flange. This photo is looking at the downstream face of the beam's bottom flange.

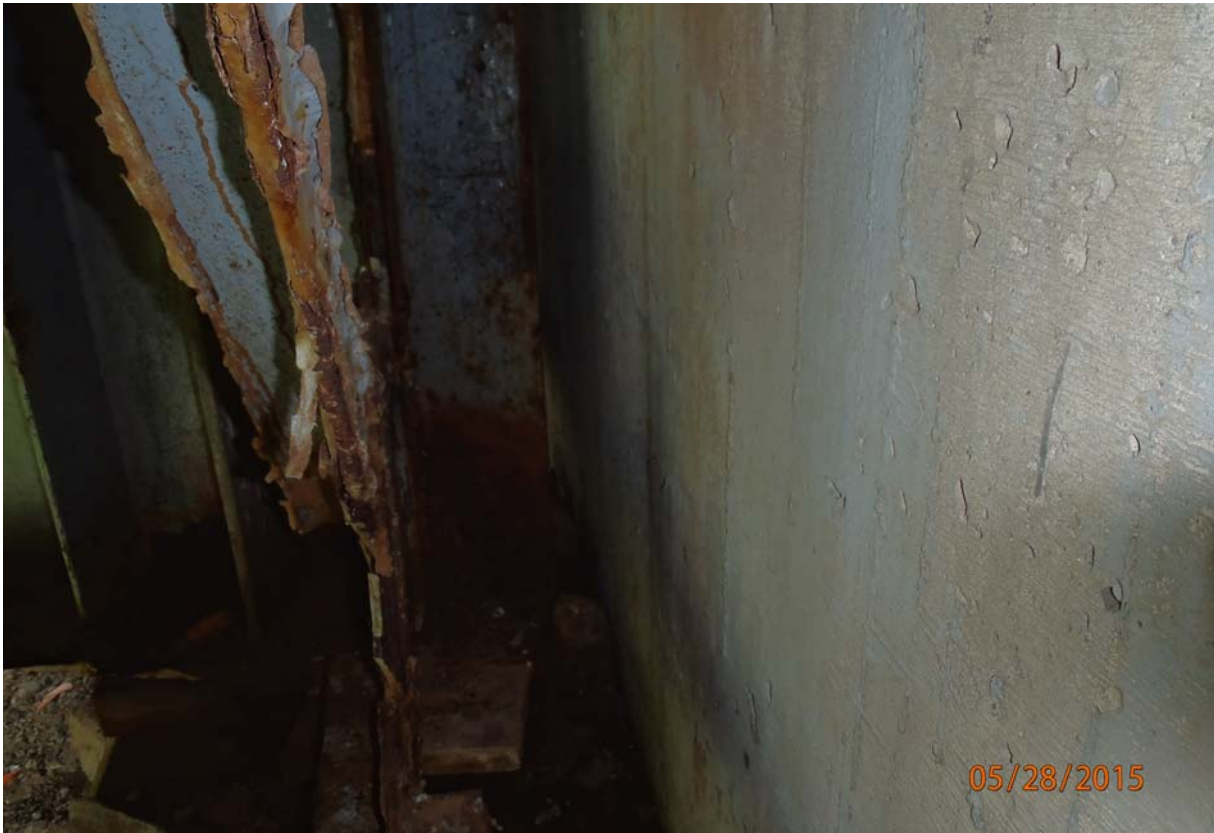
Looking at the beam web past the bearing @ abutment 5. Note the heavy active surface corrosion, light pitting (up to 1/8" section loss), crack in the beam web extending approximately 6" long from the back of the beam along the weld between the web and bottom flange and it appears that beam web is locally bowing/buckling @ this location.

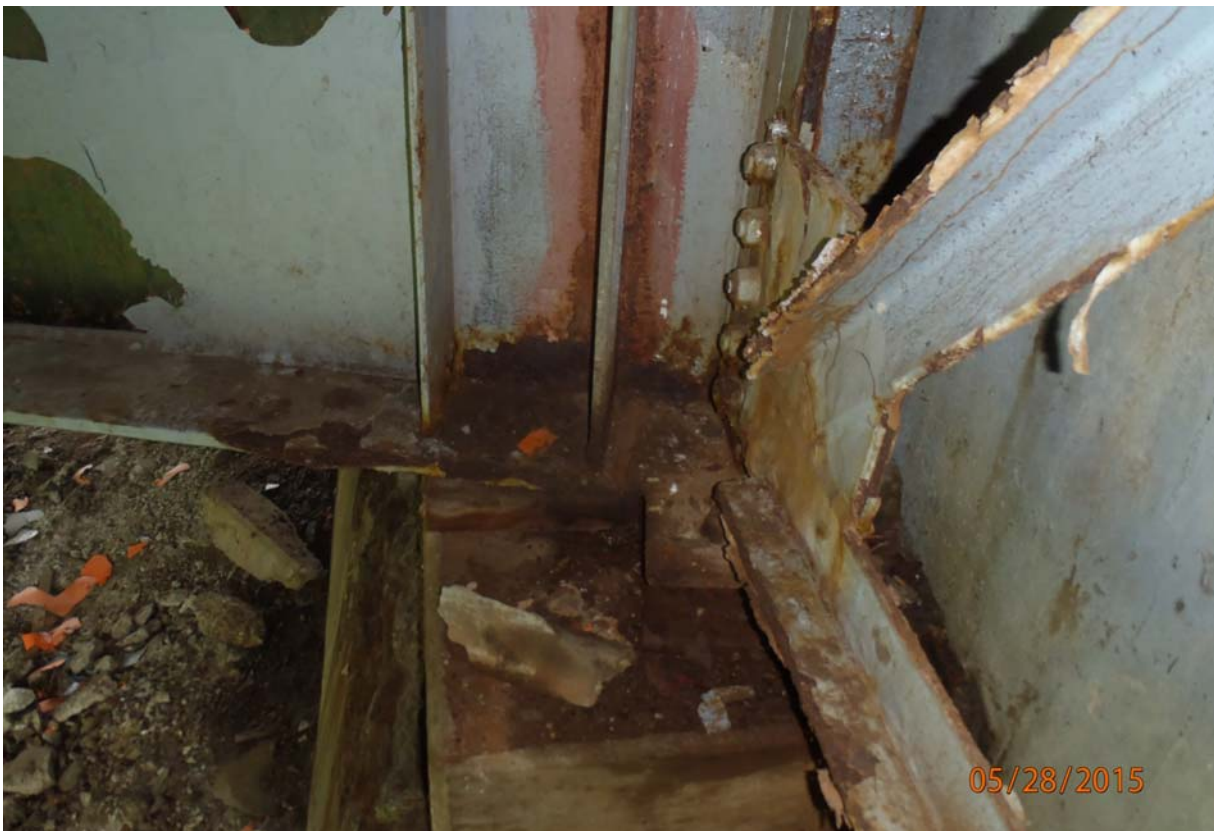
Zoomed out view of the above 2 noted photos.

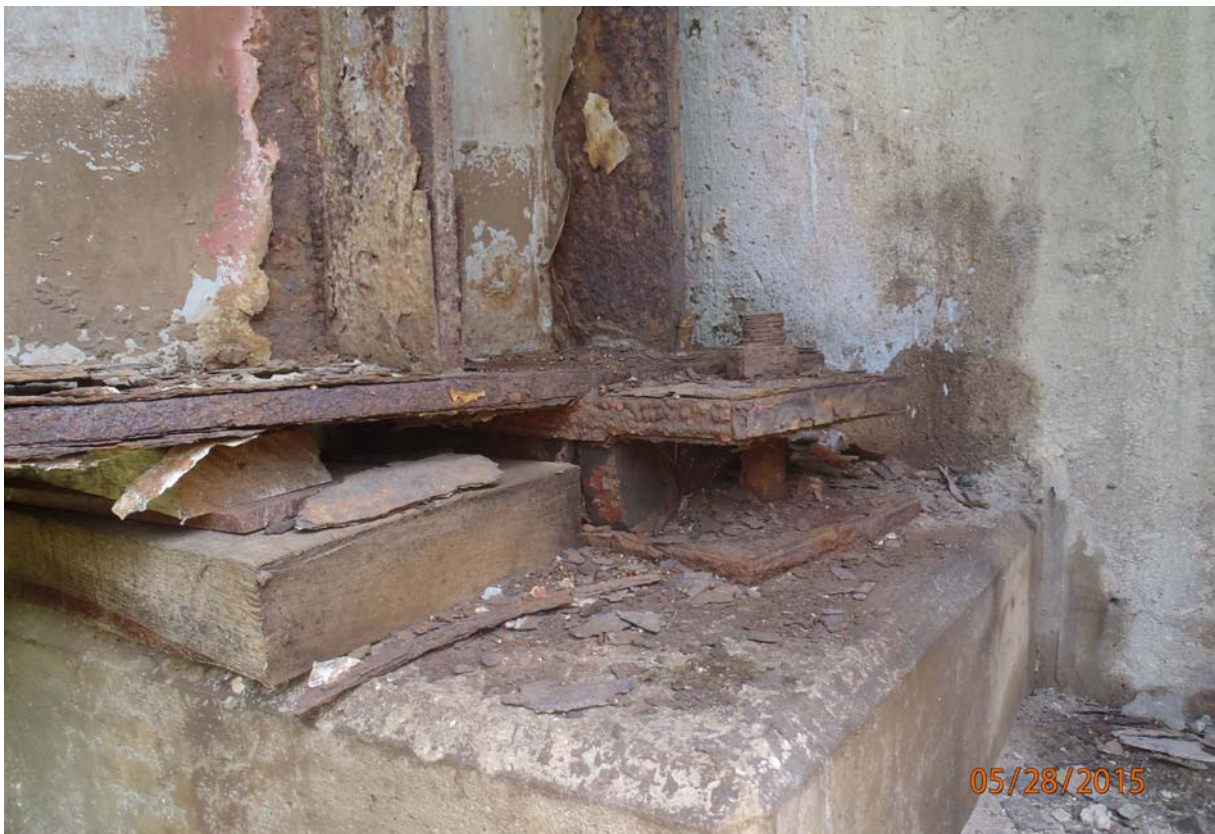
View of the bearing and beam end of beam 3 @ abutment 5. Note the heavy active corrosion and section loss at this location.

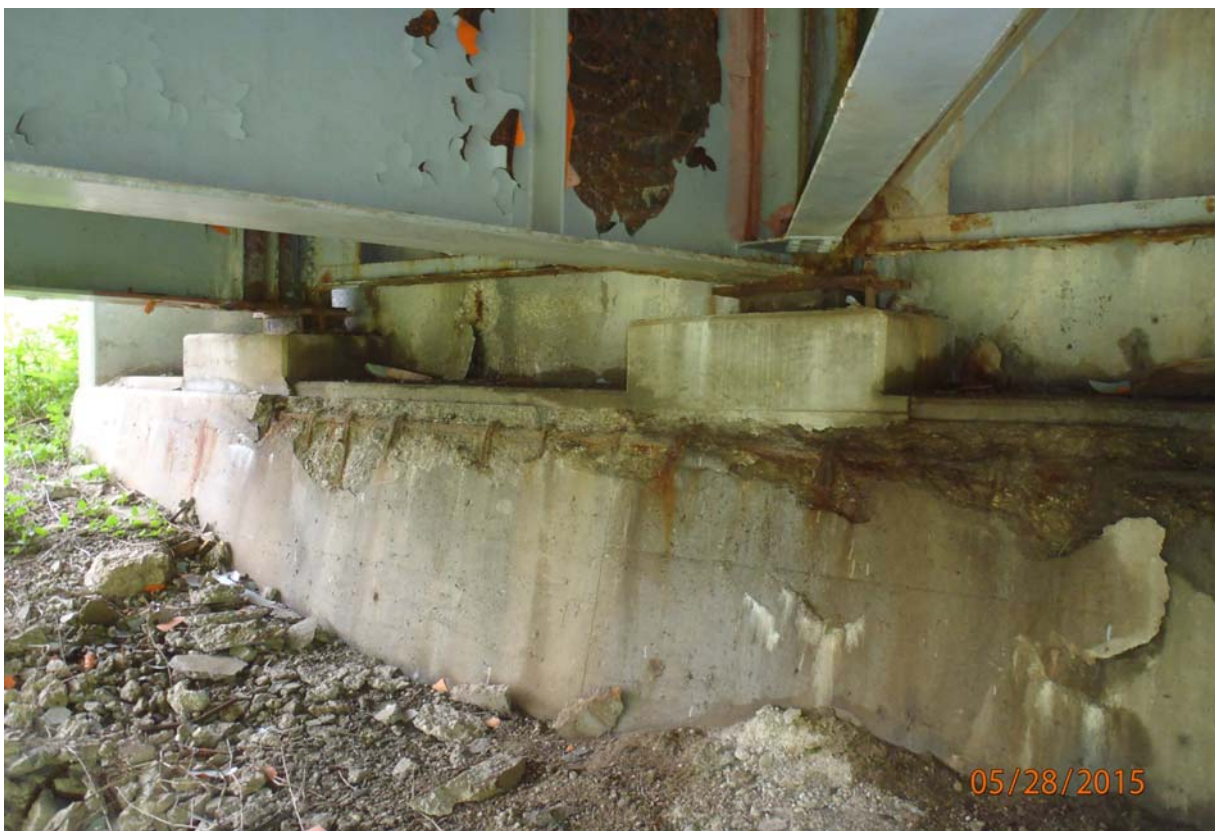
View of the abutment face between beams 1 & 2 of abutment 5. Note the heavy spalls and delimitations with exposed rusting/actively corroding reinforcing steel in the abutment face.

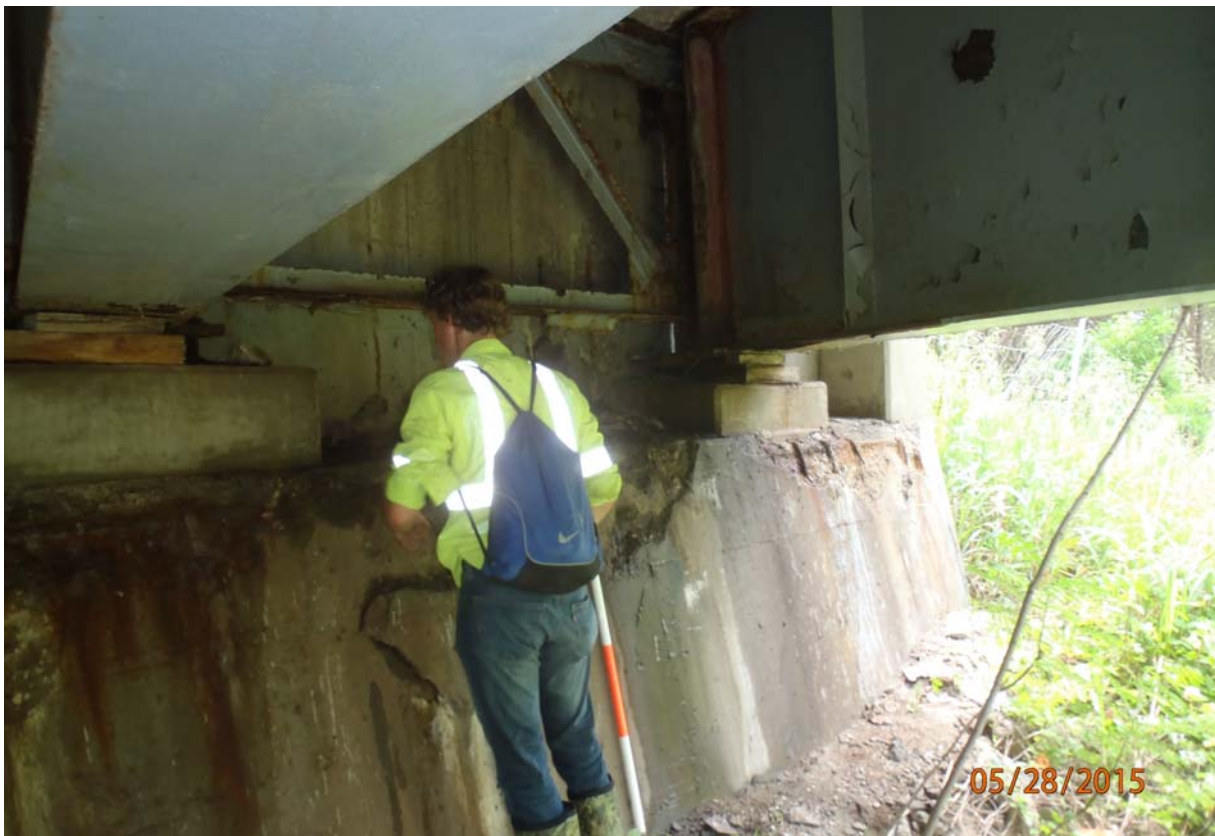
View of inspection of the bearing of beam 3 @ abutment 5.

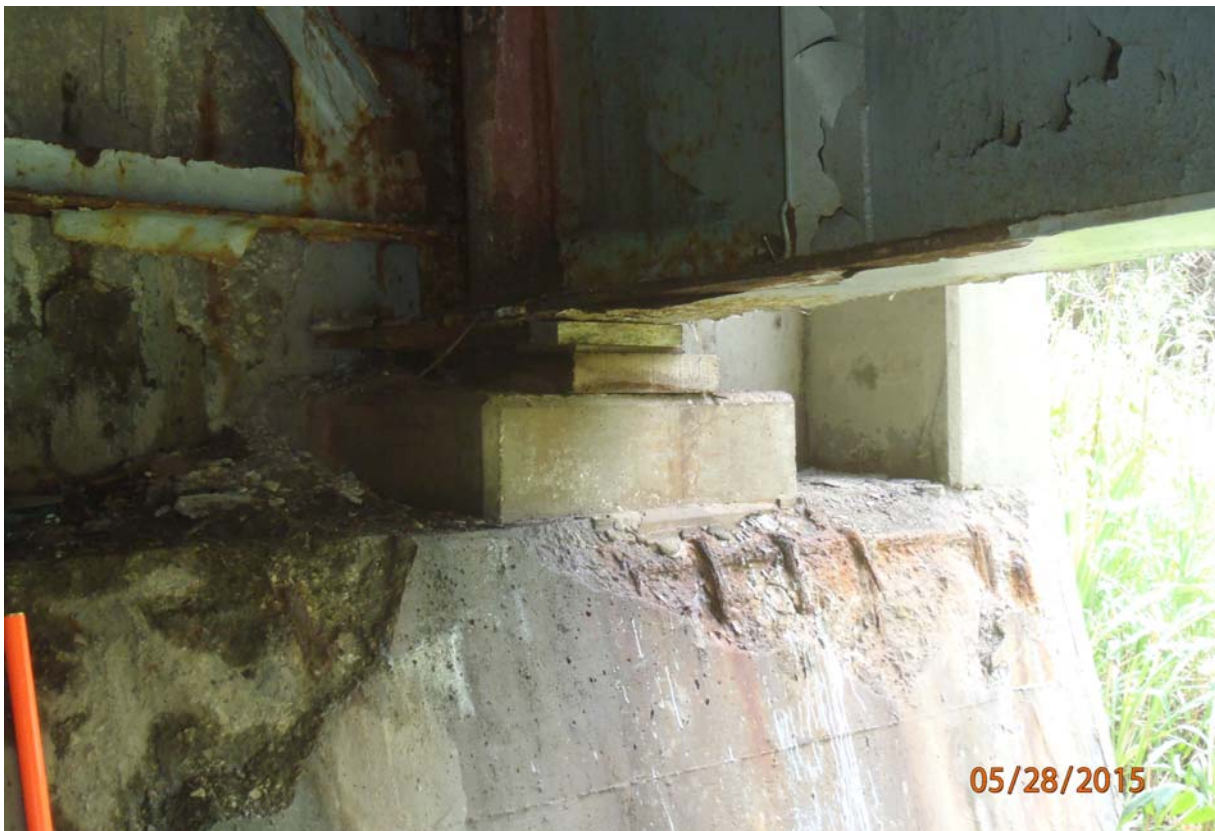
View of wooden blocks placed under the bearing of beam 4. Note the section loss of the beam at the bearing and exposed rusting and actively corroding reinforcing steel of the abutment face. **15/19**

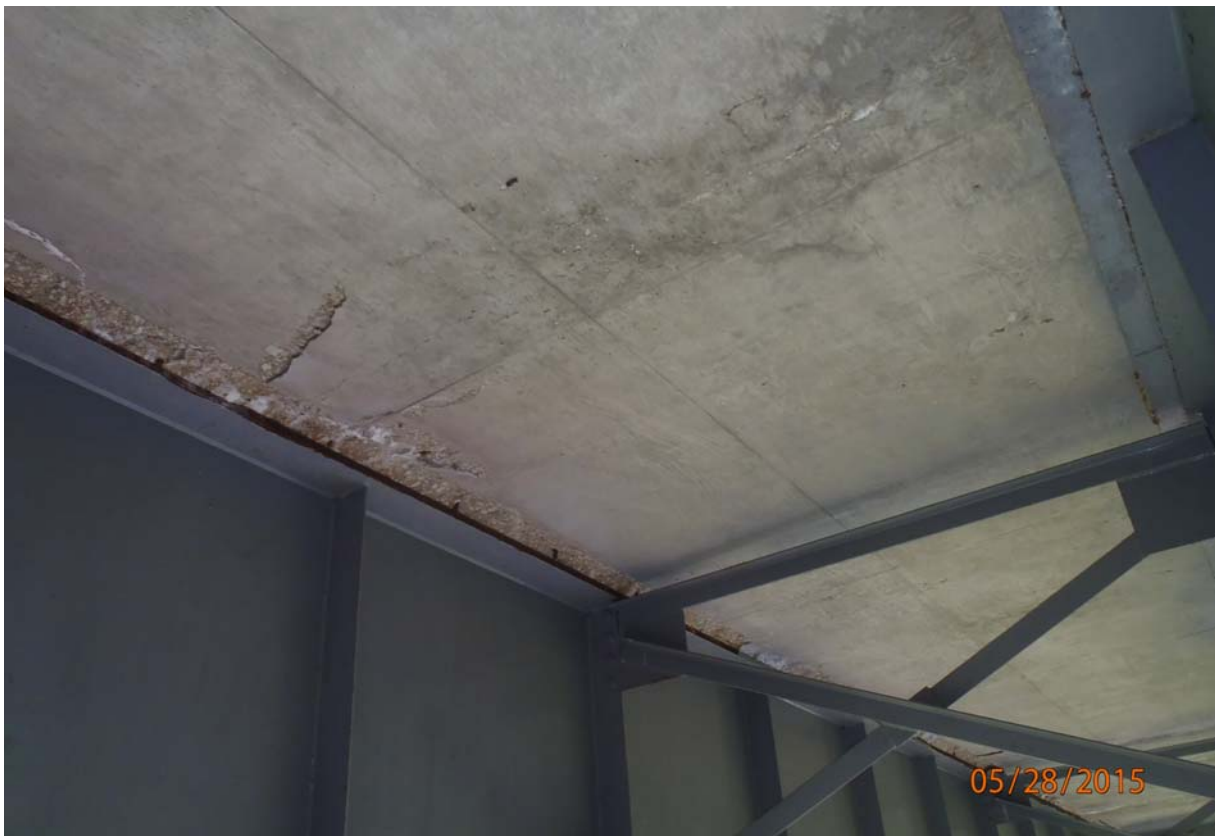
Looking up between beams 3 & 4 in span 4. Note the spalls with exposed reinforcing along the top flange of beam 4.

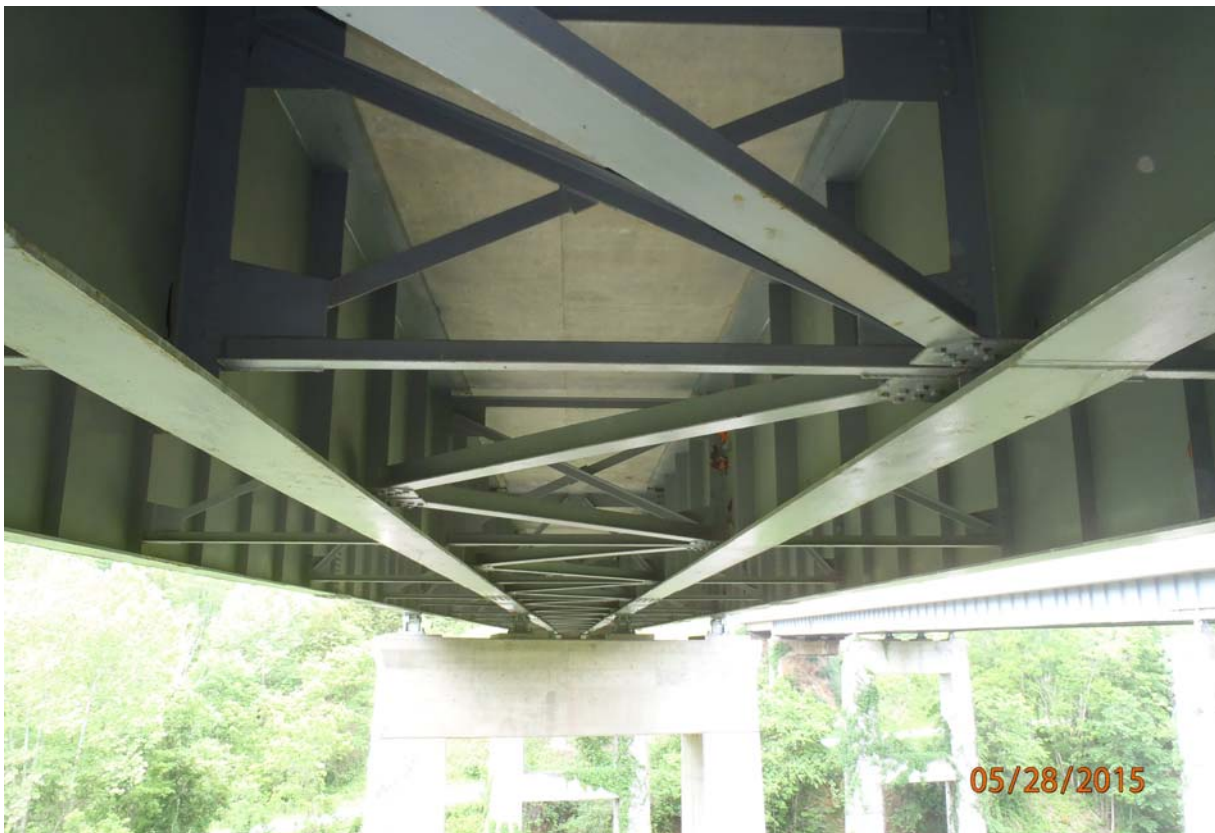
view of the underside of the superstructure in span 4.

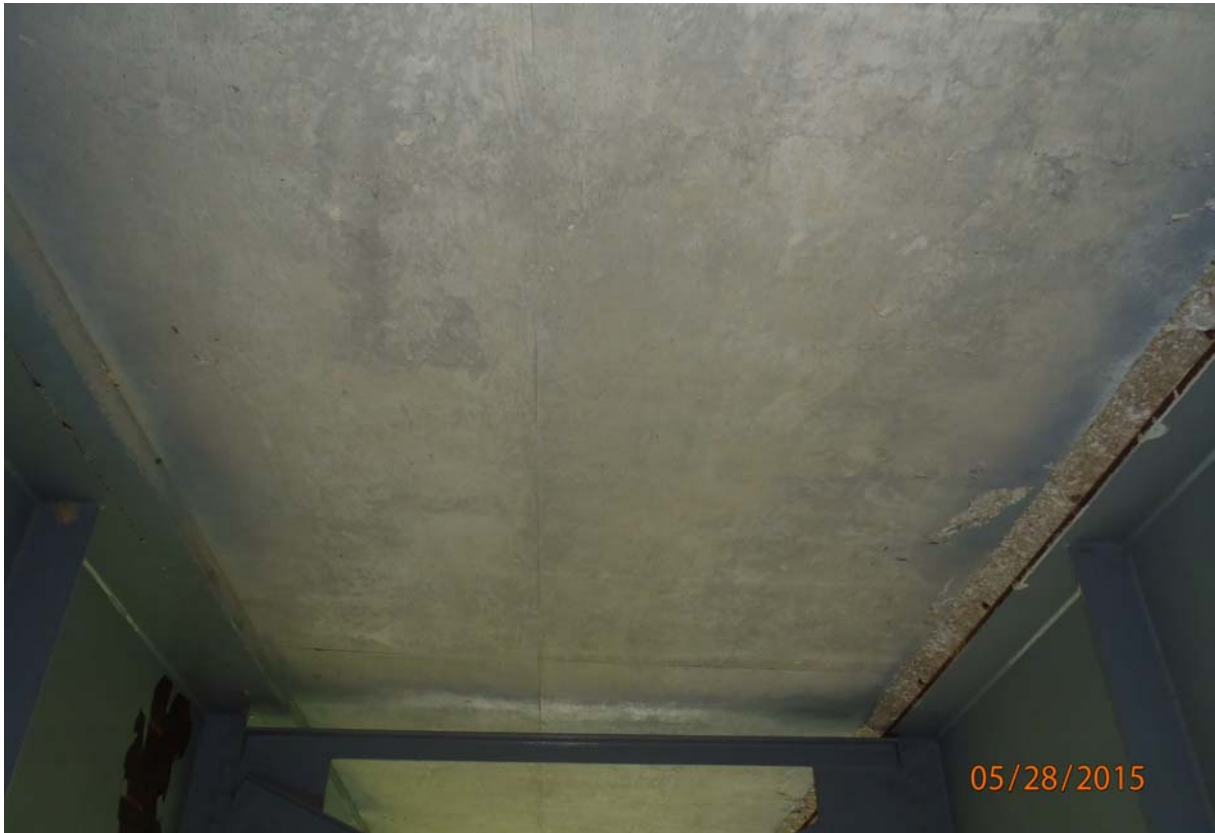
Looking up between beams 1 & 2 in span 4. Note the spalls with exposed reinforcing along the top flange of beam 4.
