## Inspection Report with SI&A Data

**Structure Description:** 390.09 Foot - 3 Span Steel continuous Stringer/Multi-beam or Girder

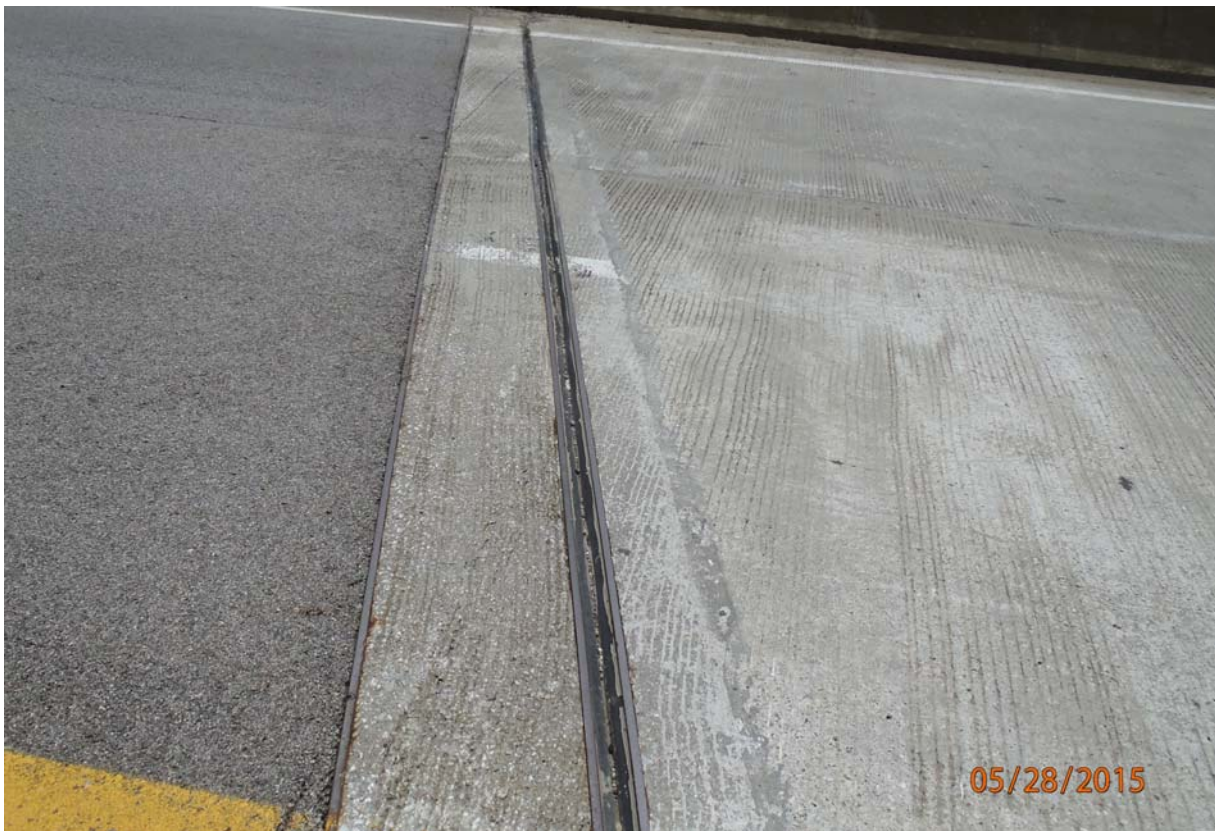
View of the deck joint at abutment 5.

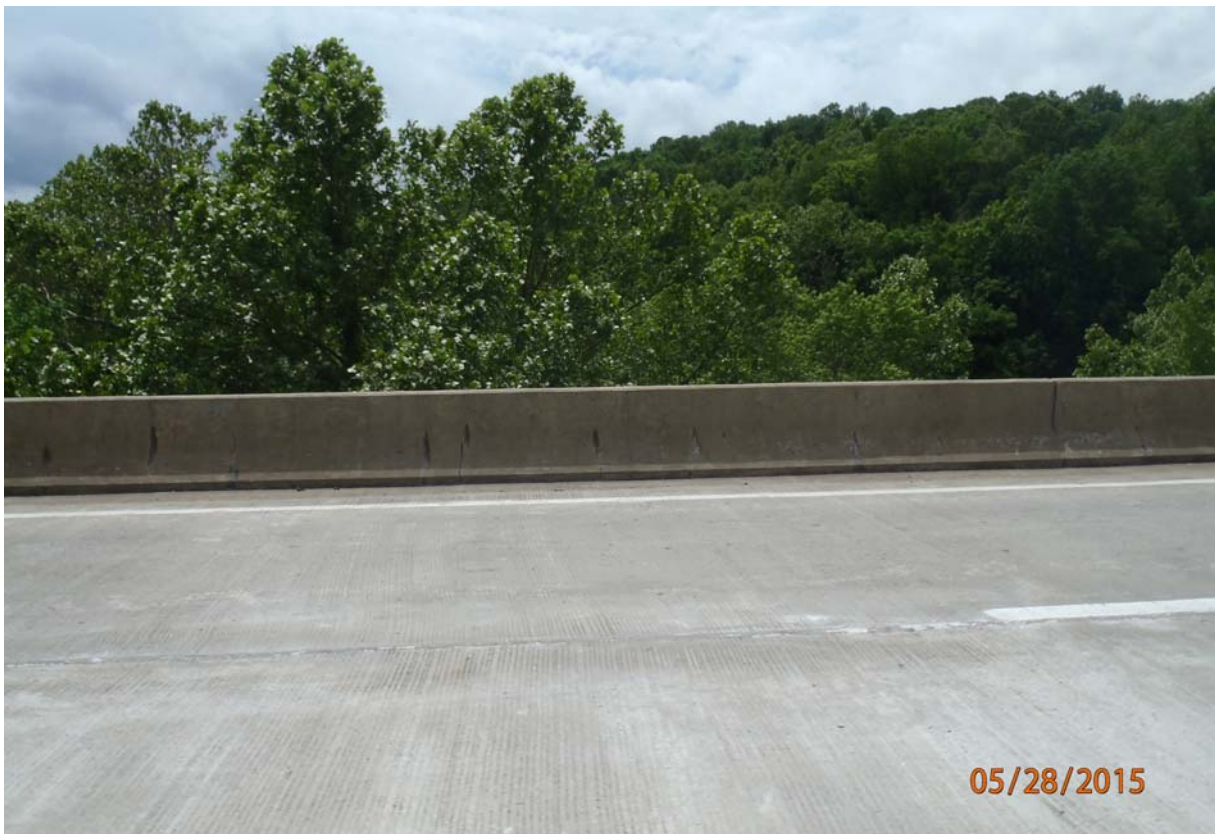
View of the downstream barrier wall. Note minor vertical cracking in the face of the barrier wall along the entire length of wall and many areas of scaling of the masonry coating on the face of the barrier wall.

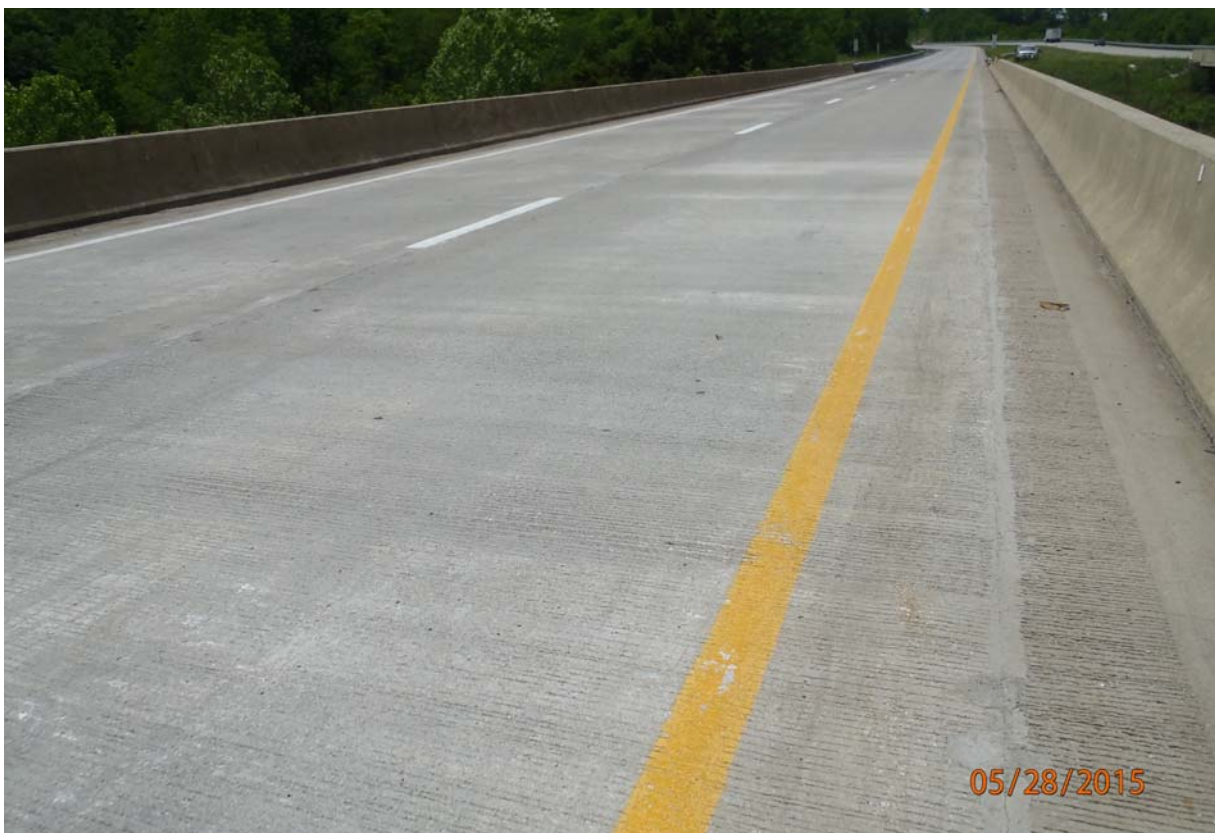
Typical view of the bridge deck.

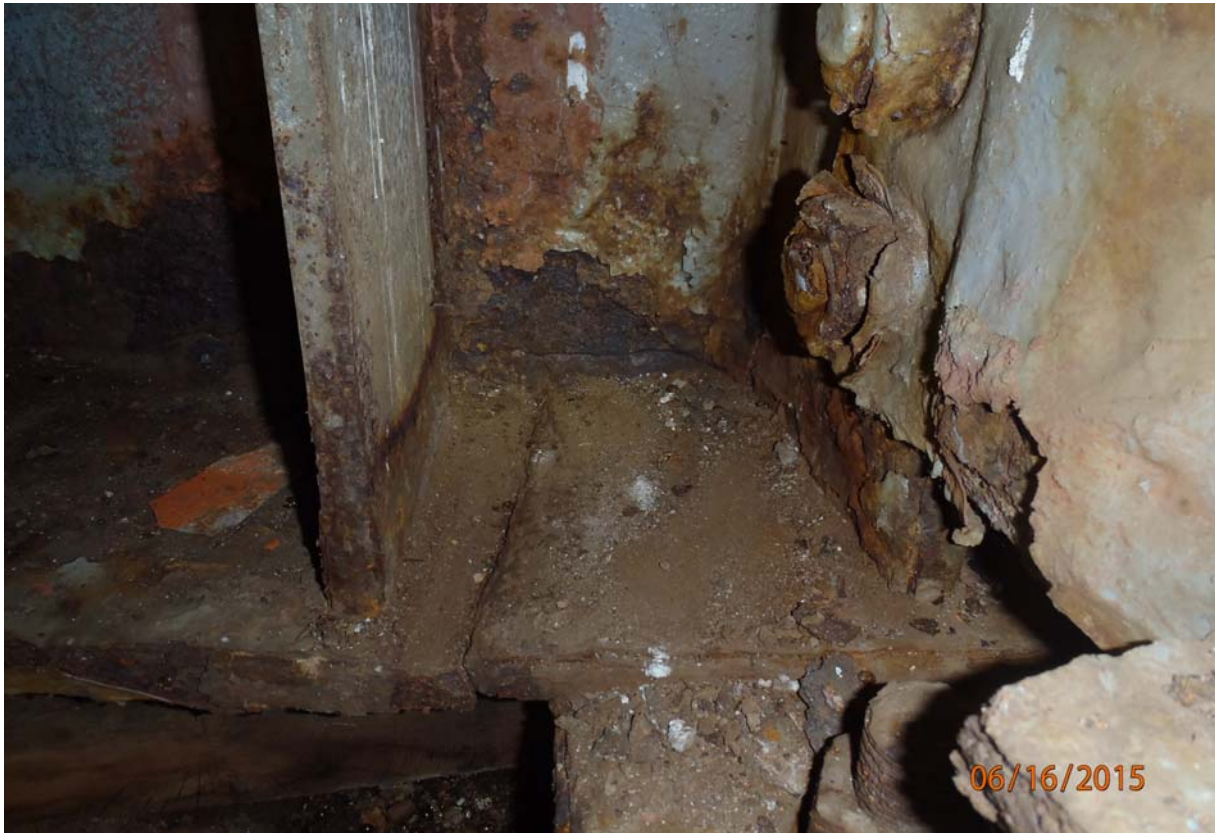
Correction/update to page 13/19 of the Standard Inspection Photos dated 5/28/2015.

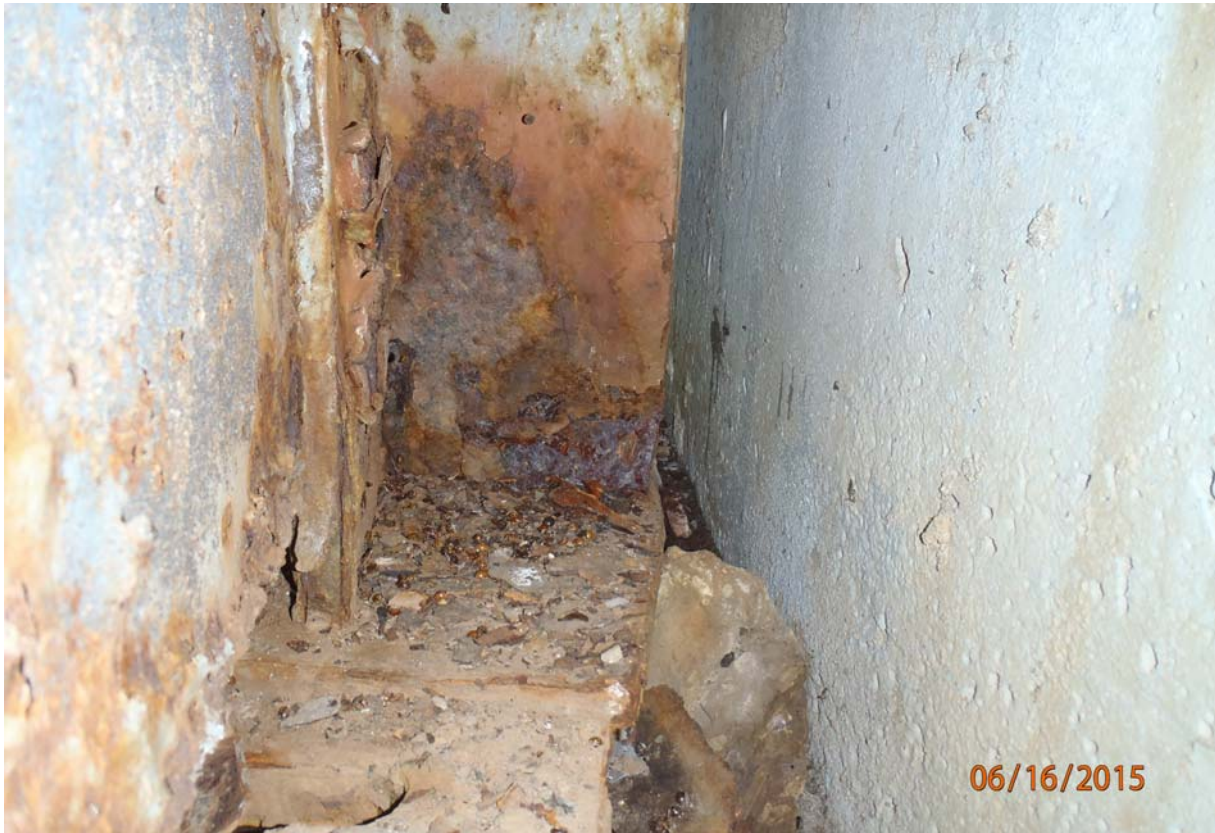
View of the beam end located behind the first vertical stiffener (stiffeners # east to west) of beam 3 @ abutment 5. See the above photo on page 1 for notes.
