Inspection Report with SI&A Data

Structure Description: 339.9 Foot - 3 Span Steel continuous Stringer/Multi-beam or Girder

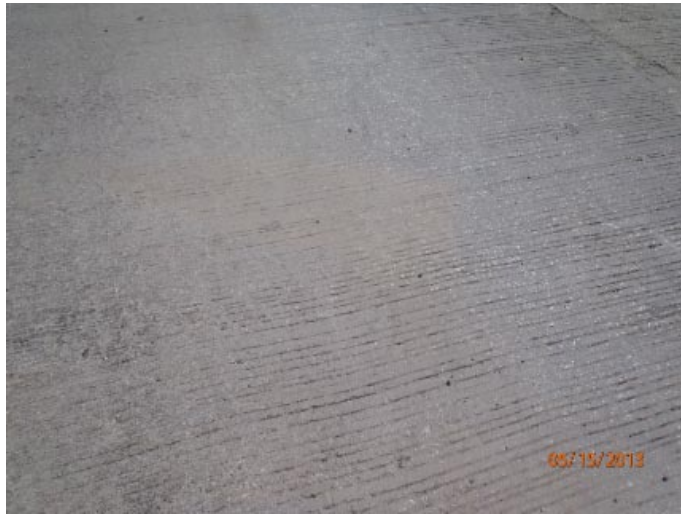
Typical view of the wearing surface.

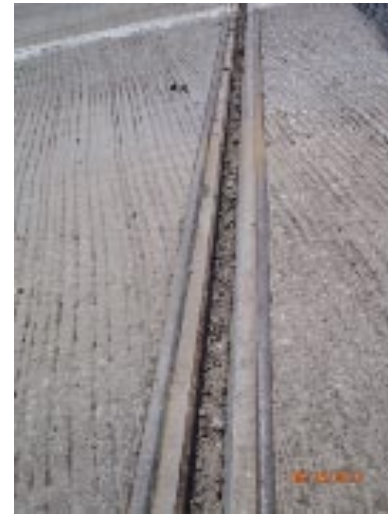
View of the expansion joint at abutment 1. It is partially full of dirt and debris.

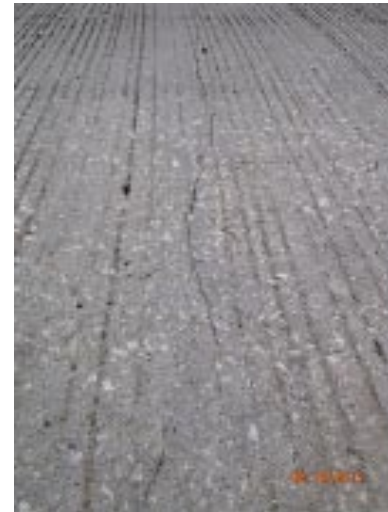
View of light transverse cracking in the right lane in span 2.

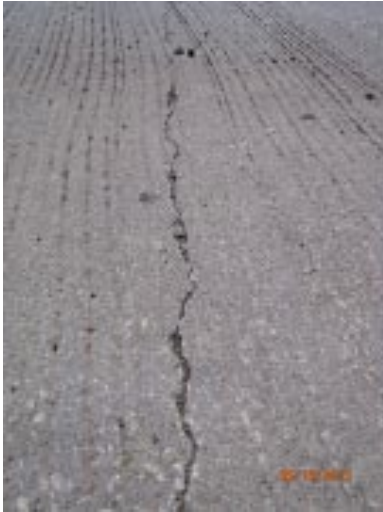
View of transverse cracking that is beginning to open up in the right lane near midspan in span 2.

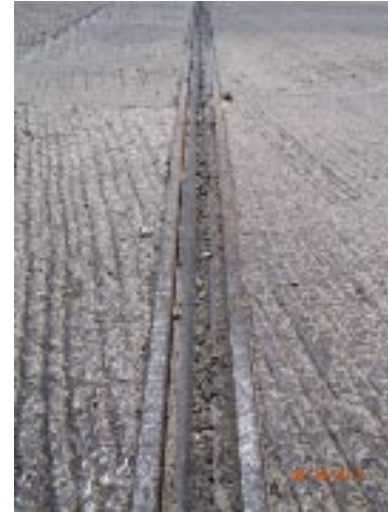
View of the transverse joint at abutment 4. It is partially full of dirt and debris.

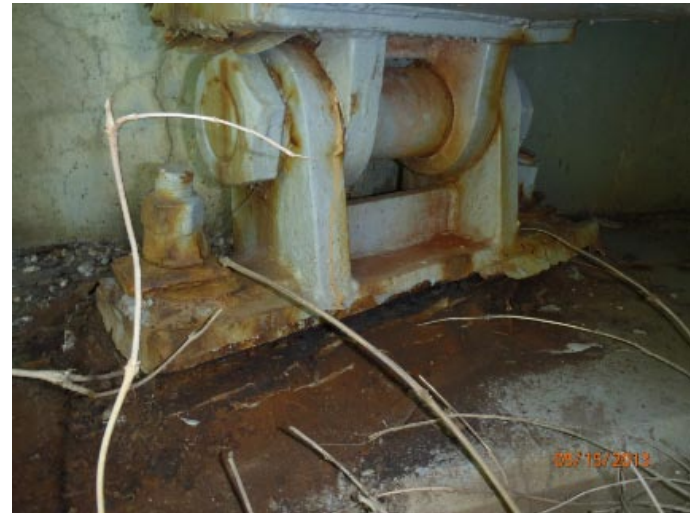
View of the north bearing at abutment 4. It has flaking paint and moderate corrosion of the masonry plate.

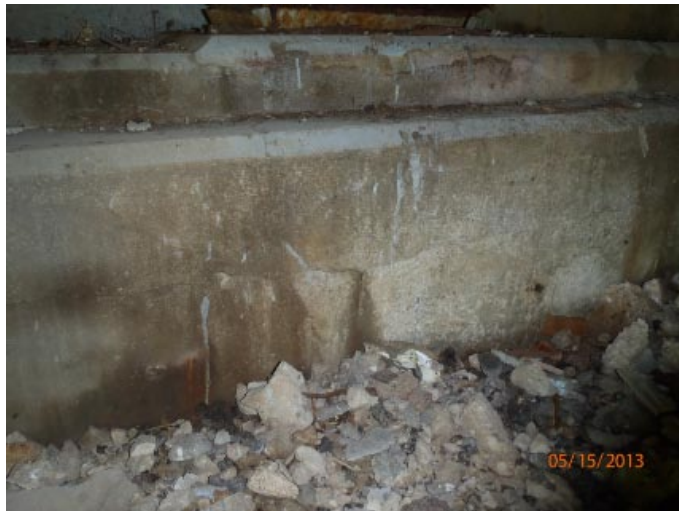
View of light cracking in abutment 4's breast wall below bearing 3 from the south.

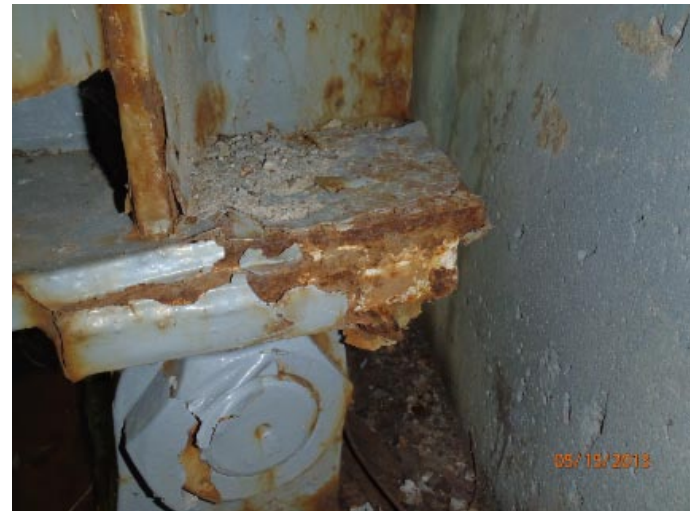
View of moderate rusting and corrosion at the end of the bottom flange of the north beam at abutment 4.

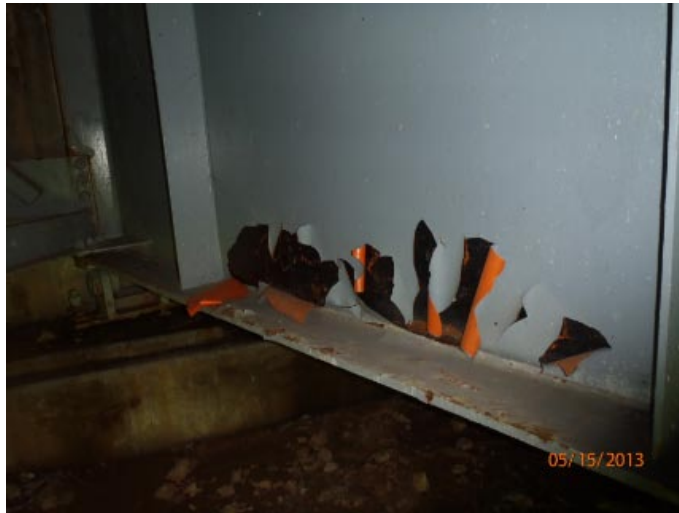
View of flaking paint along the north face of beam 3's web.

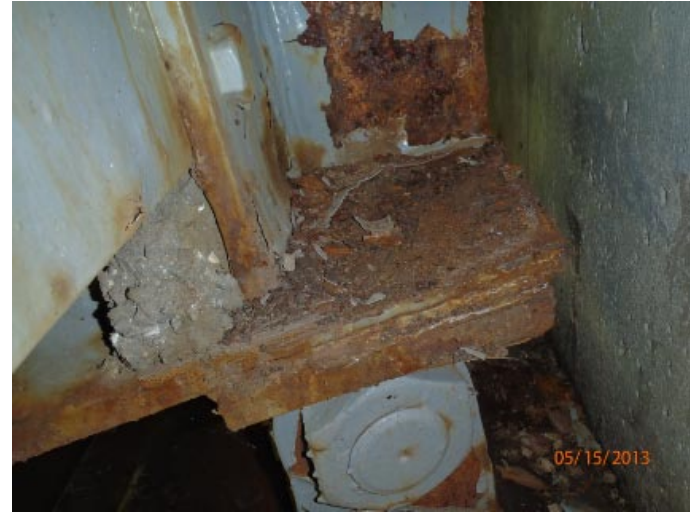
View of moderate rusting and corrosion at the end of beam 2 from the south at abutment 4.

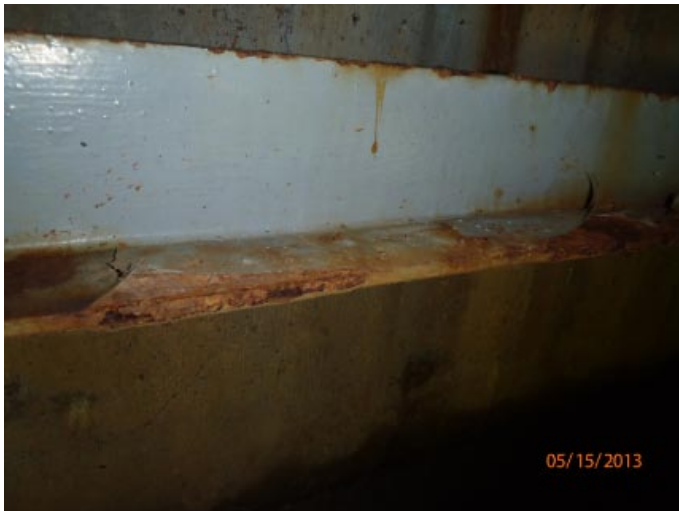
View of some moderate rusting and corrosion of the steel diaphragm between beams 1 and 2 from the south at abutment 4.

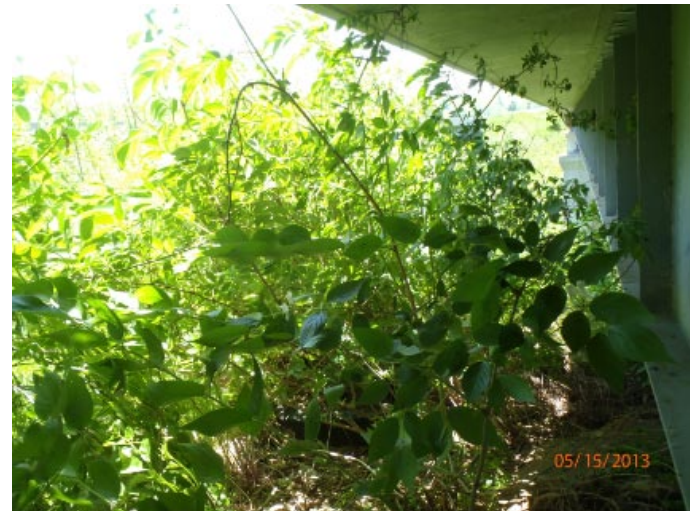
View of vegetation growth at the south end of span 3.

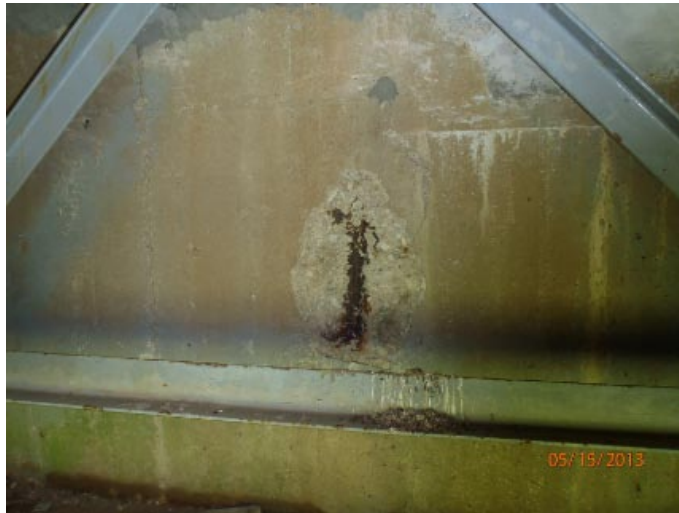
View of a moderate sized shallow spall with exposed steel in the backwall of abutment 1 between beams 3 and 4 from the south.

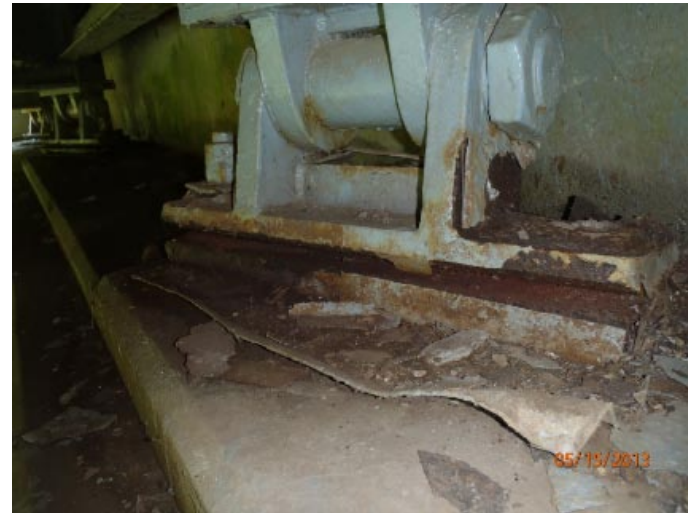
View of bearing 3 at abutment 1. Notice the north anchor bolt is missing.

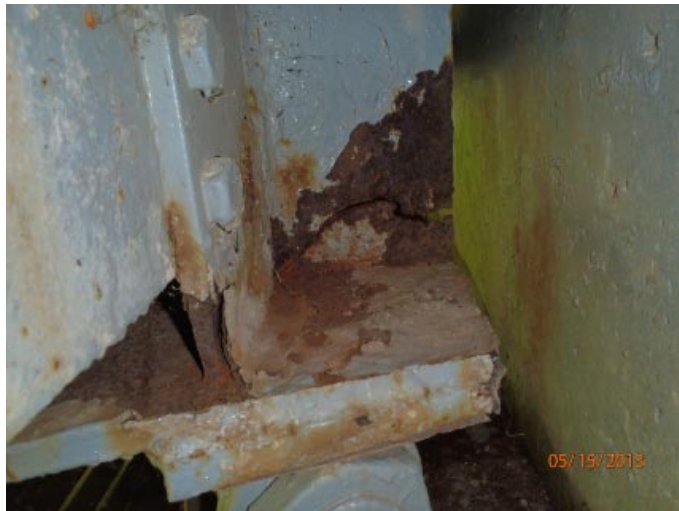
View of the previously noted crack in the web of beam 3 from the south at abutment 1. This crack is at the end of the web and stops at the bottom of the vertical stiffener.

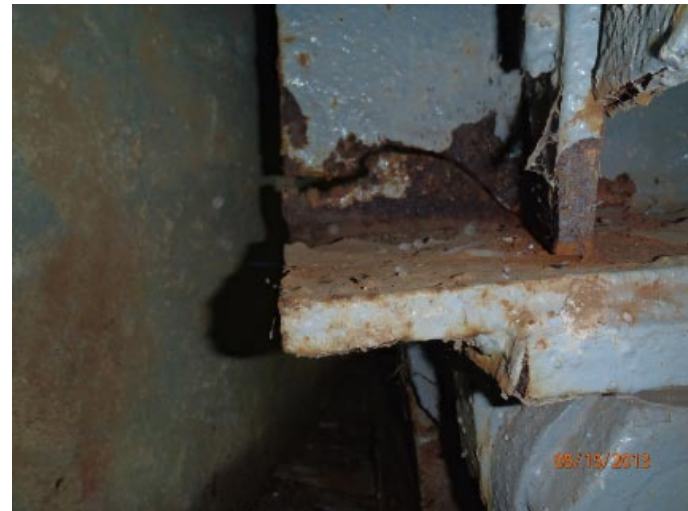
View of the previously noted crack in the web of beam 3 from the south at abutment 1. This crack is at the end of the web and stops at the bottom of the vertical stiffener.

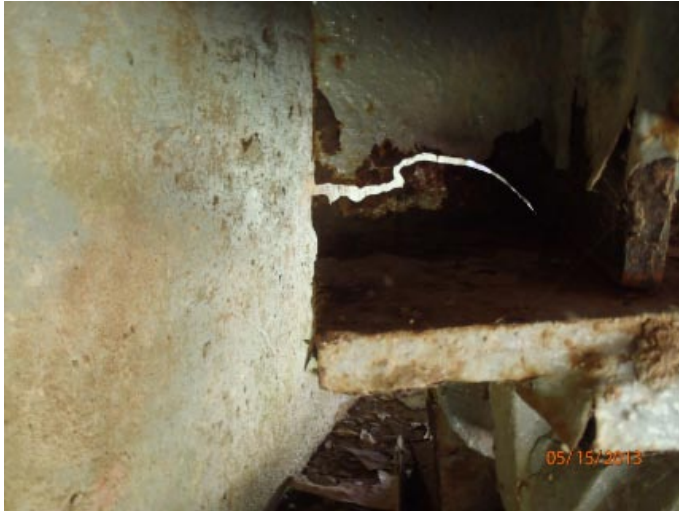
View of the previously noted crack in the web of beam 3 from the south at abutment 1. This crack is at the end of the web and stops at the bottom of the vertical stiffener.

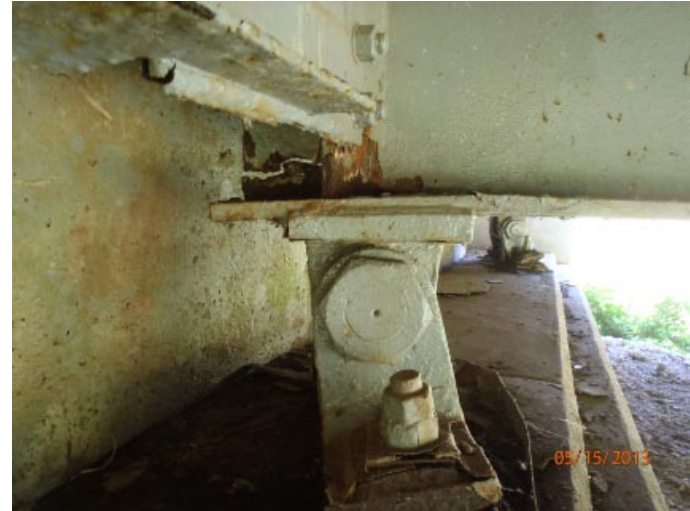
View of beam 3 from the south at abutment 1. Notice the bottom flange bending downward toward the backwall.

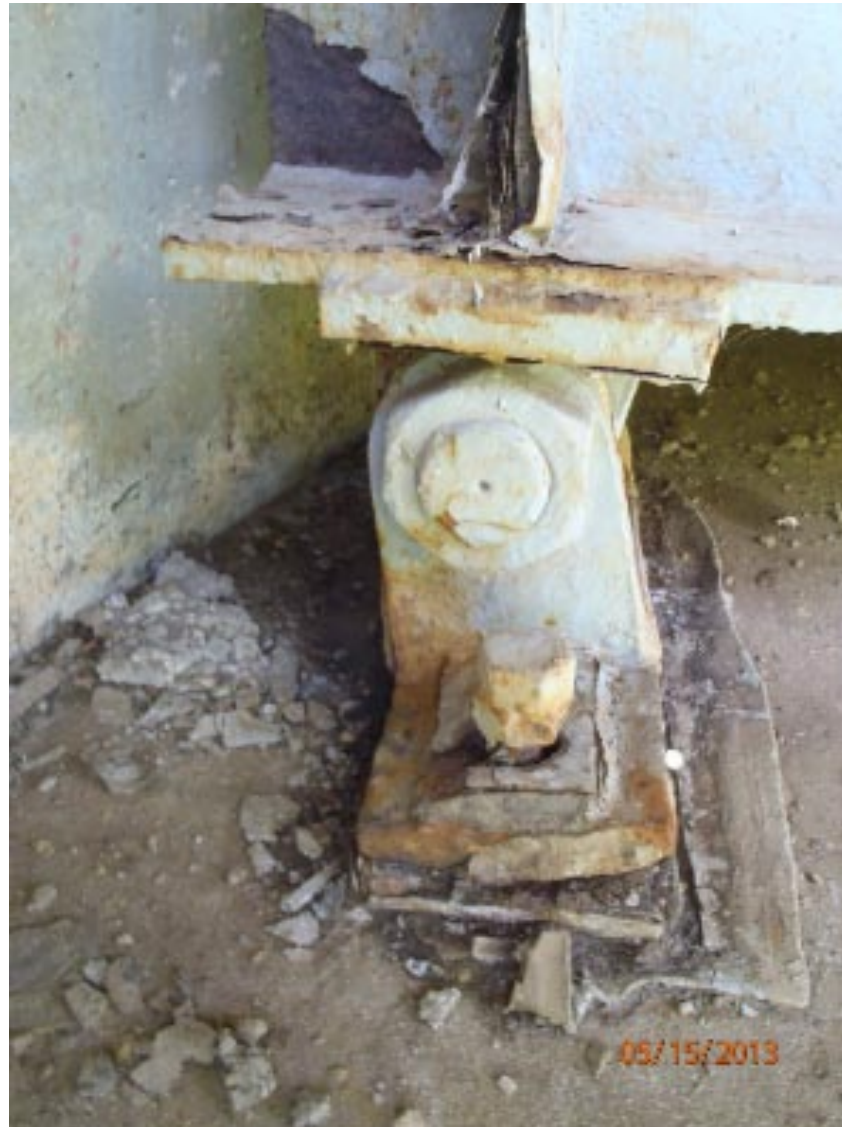
View of the south bearing at abutment
1. Notice the pack rust at the bottom
of the vertical stiffener.
