Inspection Report with SI&A Data

Structure Description: 766.08 Foot - 5 Span Prestressed concrete continuous Stringer/Multi-beam or Girder

7 Facility Carried: US-62

6A Feature Intersected: LAWRENCE CREEK

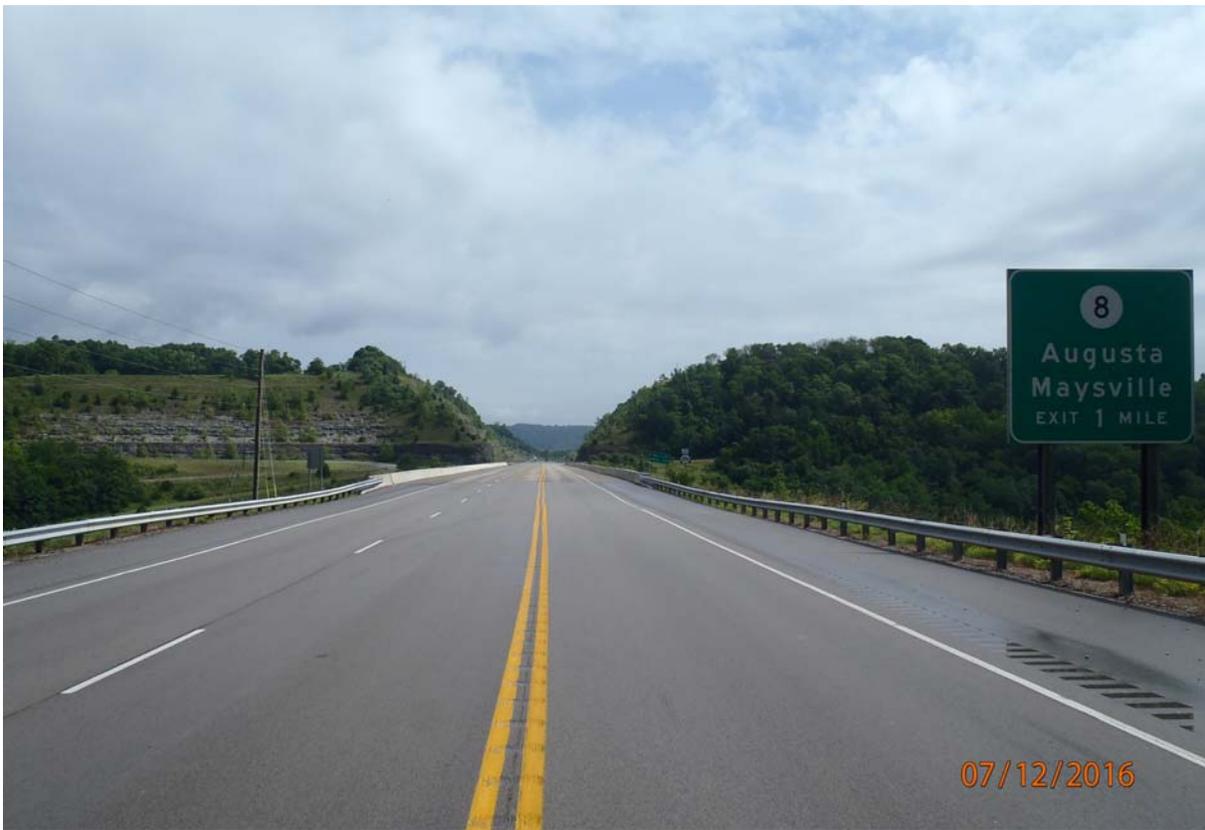
End view looking from the south approach to abutment 1.

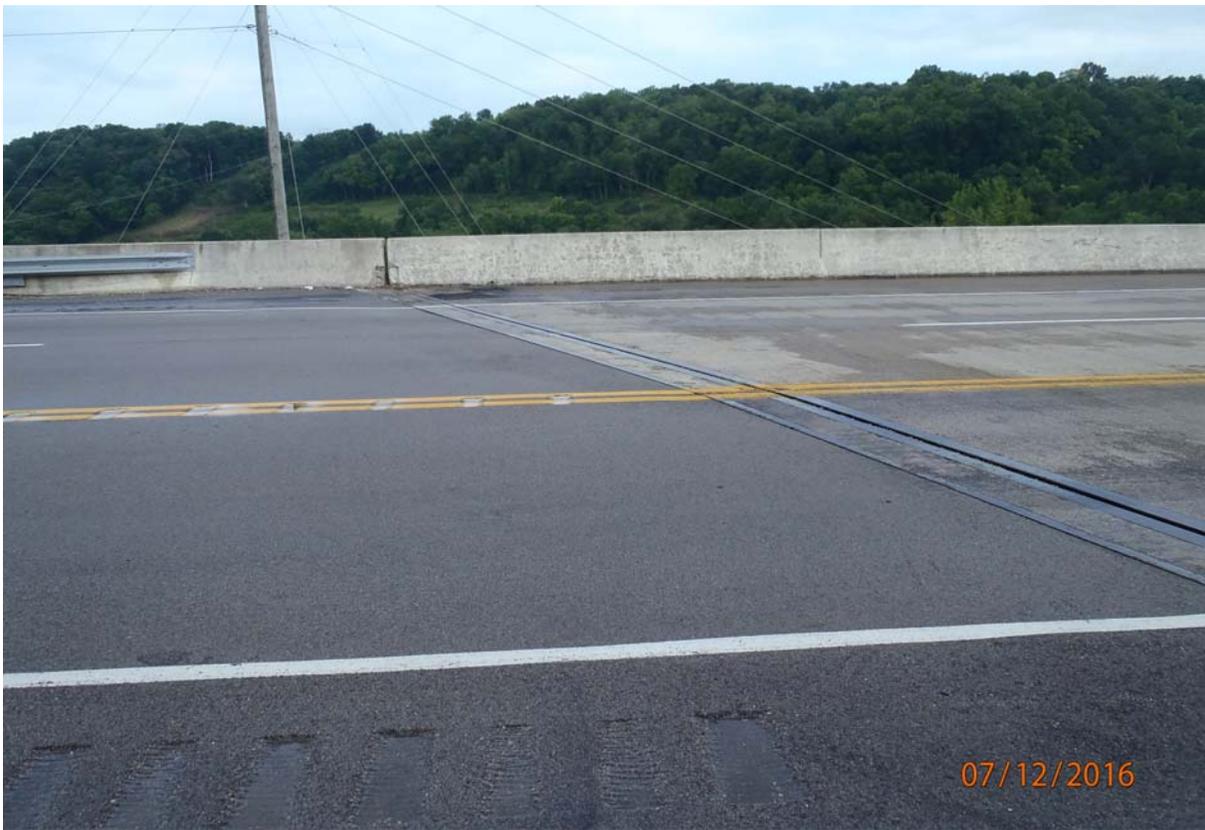
View of the south approach/transition.
Note this approach has settled severely in the past; it was recently repaired during a roadway asphalt overlay project.

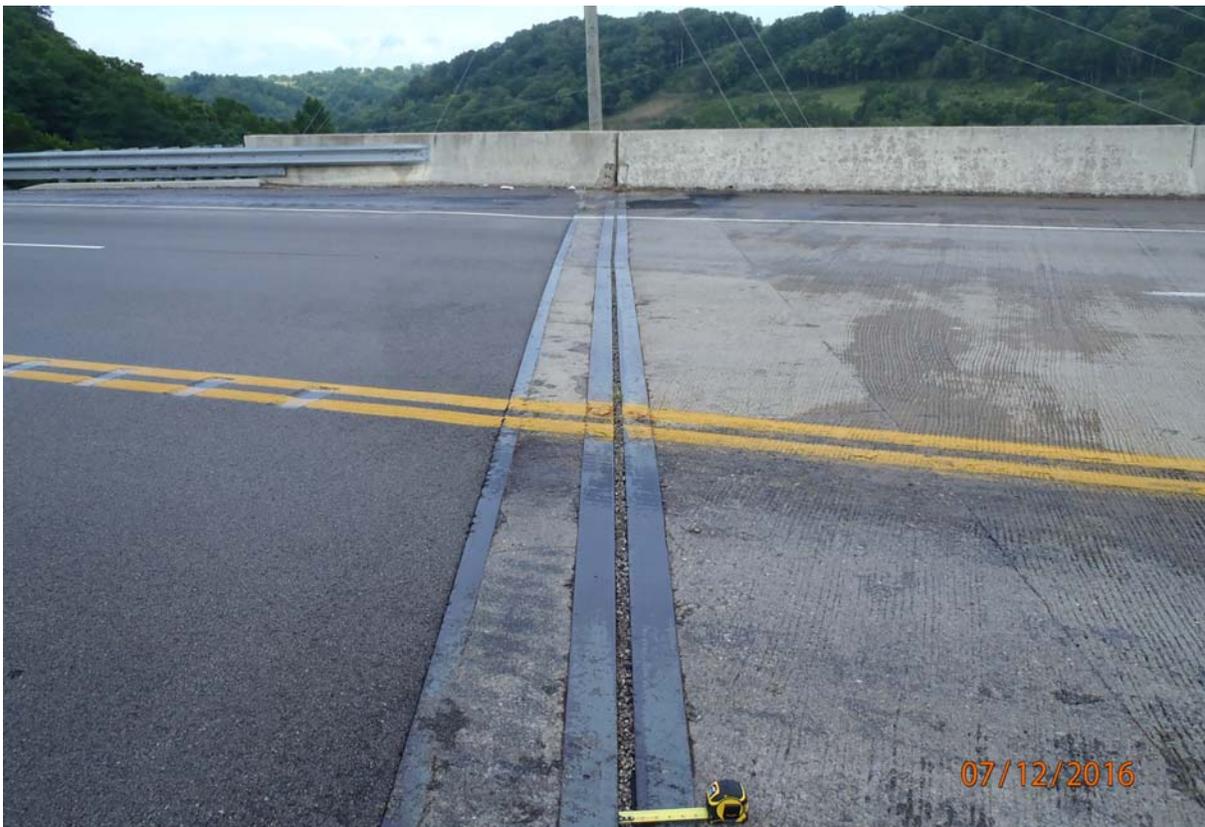
View looking down and along the deck joint of abutment 1.
Note the joint is full of debris and compressed/closed past the anticipated/tolerable limits.

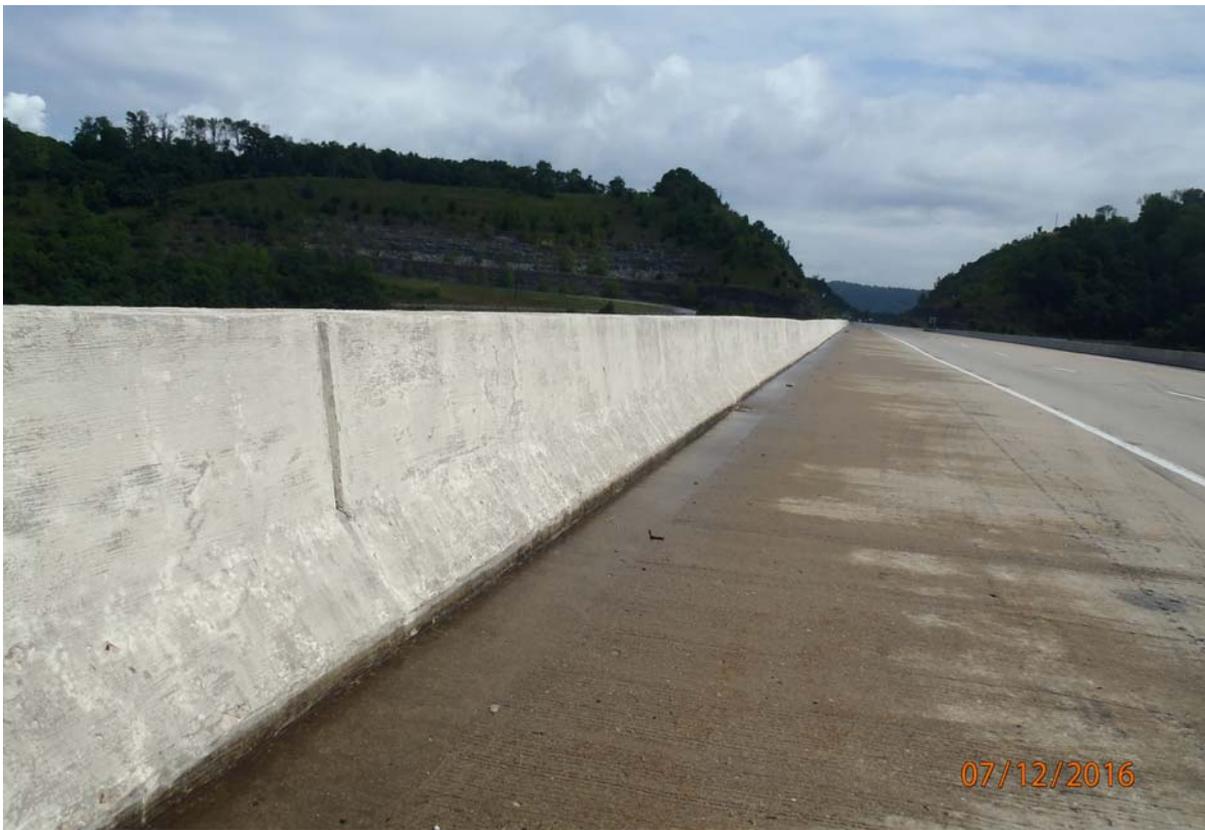
View along the downstream barrier wall (typical).
Note the minor vertical cracking throughout, minor spalling (with no exposed reinforcing steel) at isolated locations throughout, and minor impact damage at random/isolated locations.

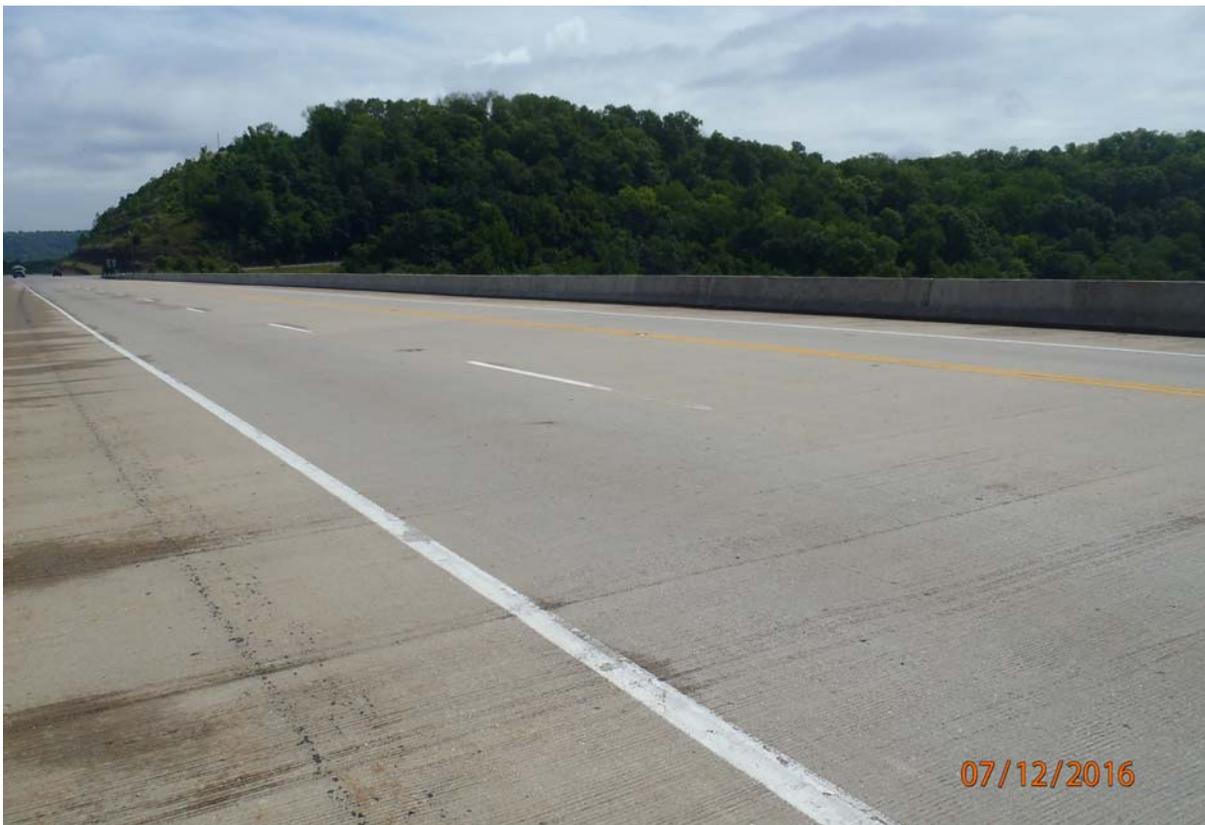
Typical view of the deck.
Note minor there are minor to moderate transverse and longitudinal cracks throughout.

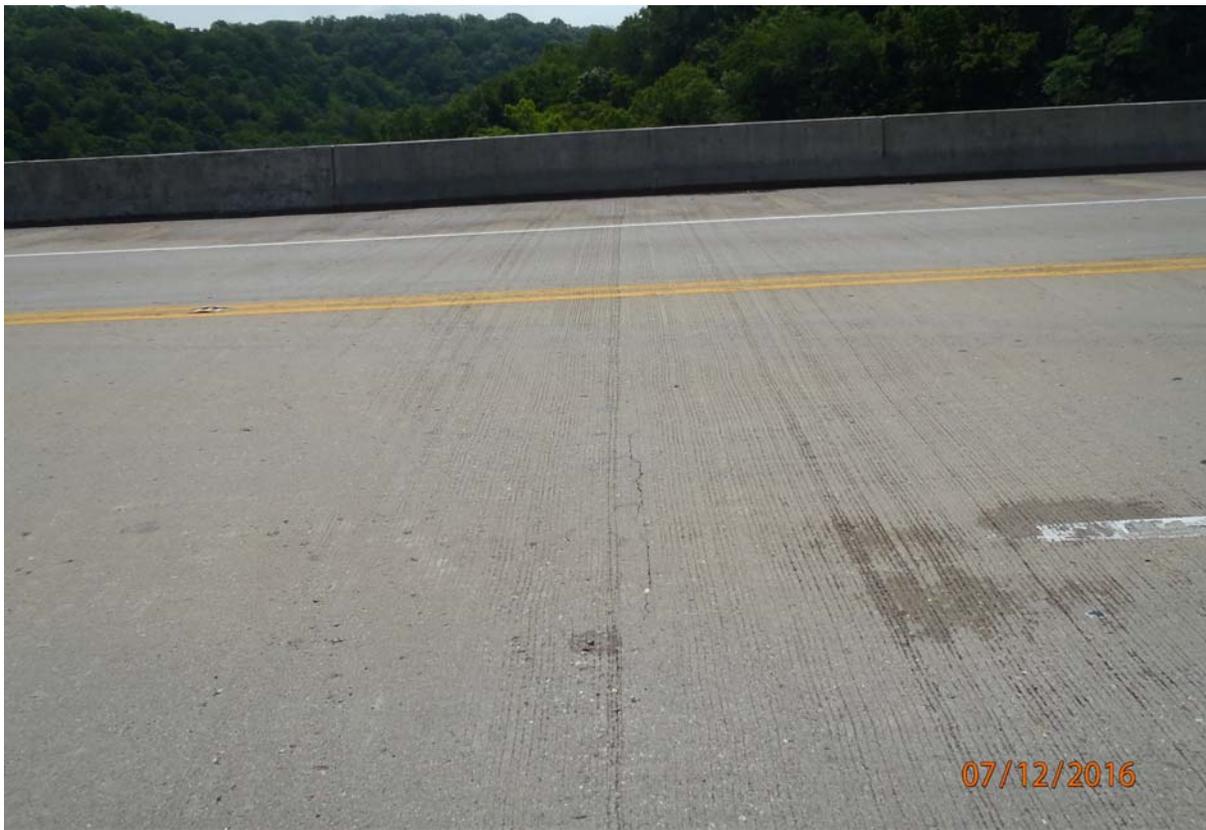
View of transverse cracking in the deck over at one line of the beam ends over pier 2.

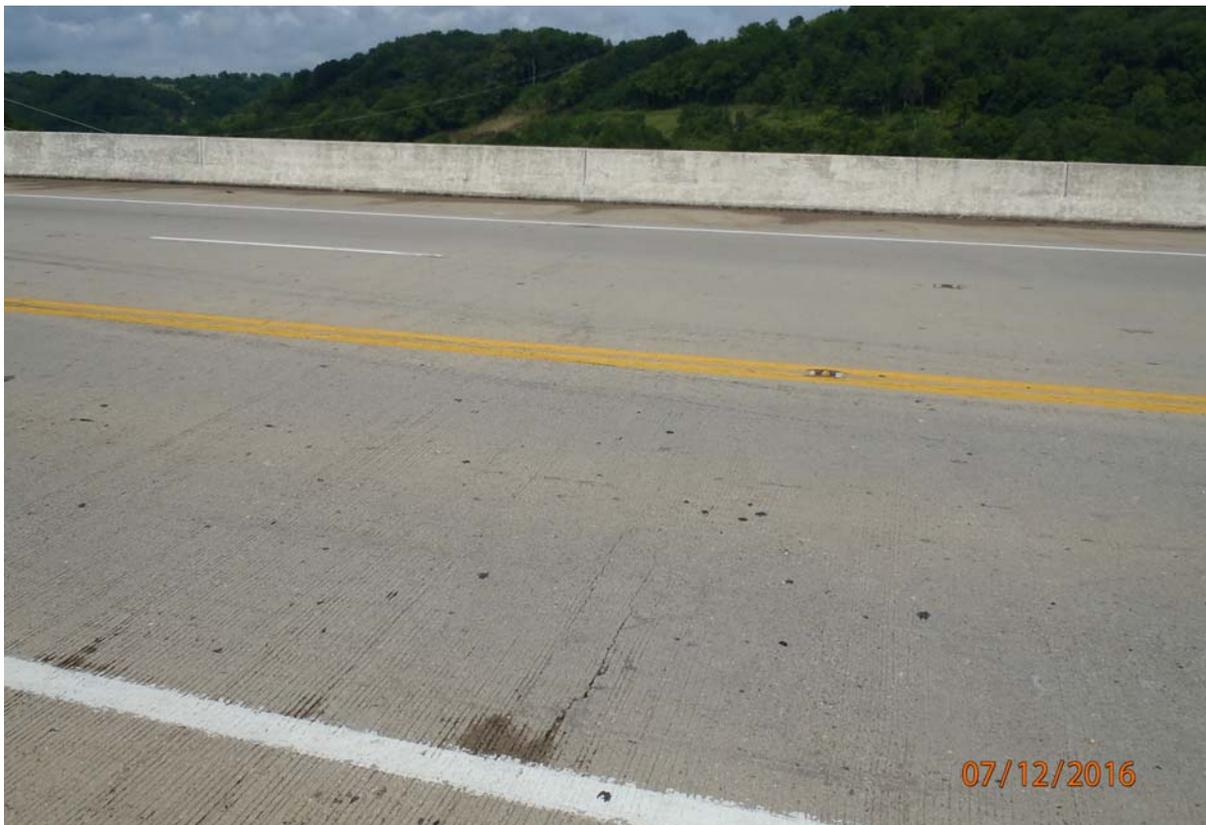
If you look closely, you can see the deck transverse cracking present at all of the interior beam ends over pier 2; note the cracking is aligned with the bridge skew.

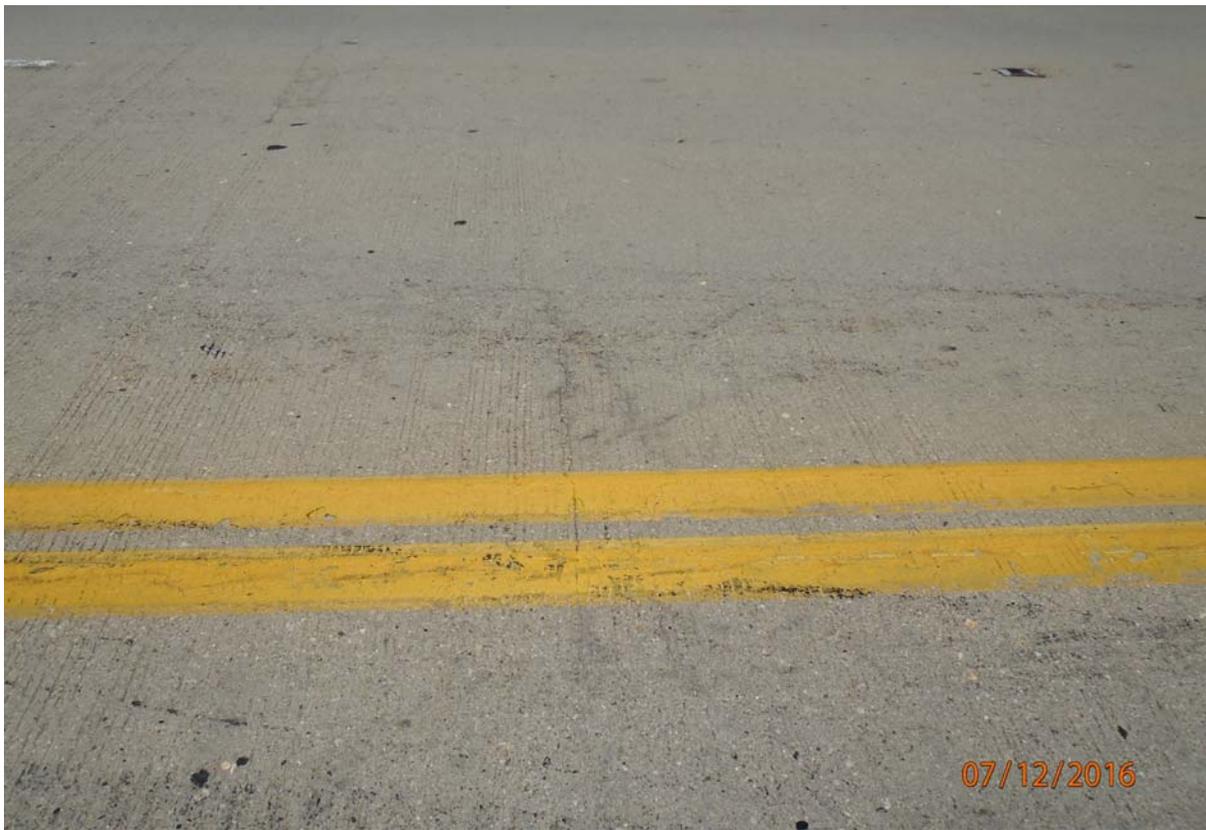
Close-up of transverse cracking noted in the bottom photo of page 10. Note this location is located at the beam ends over pier 2 of beamline 3.

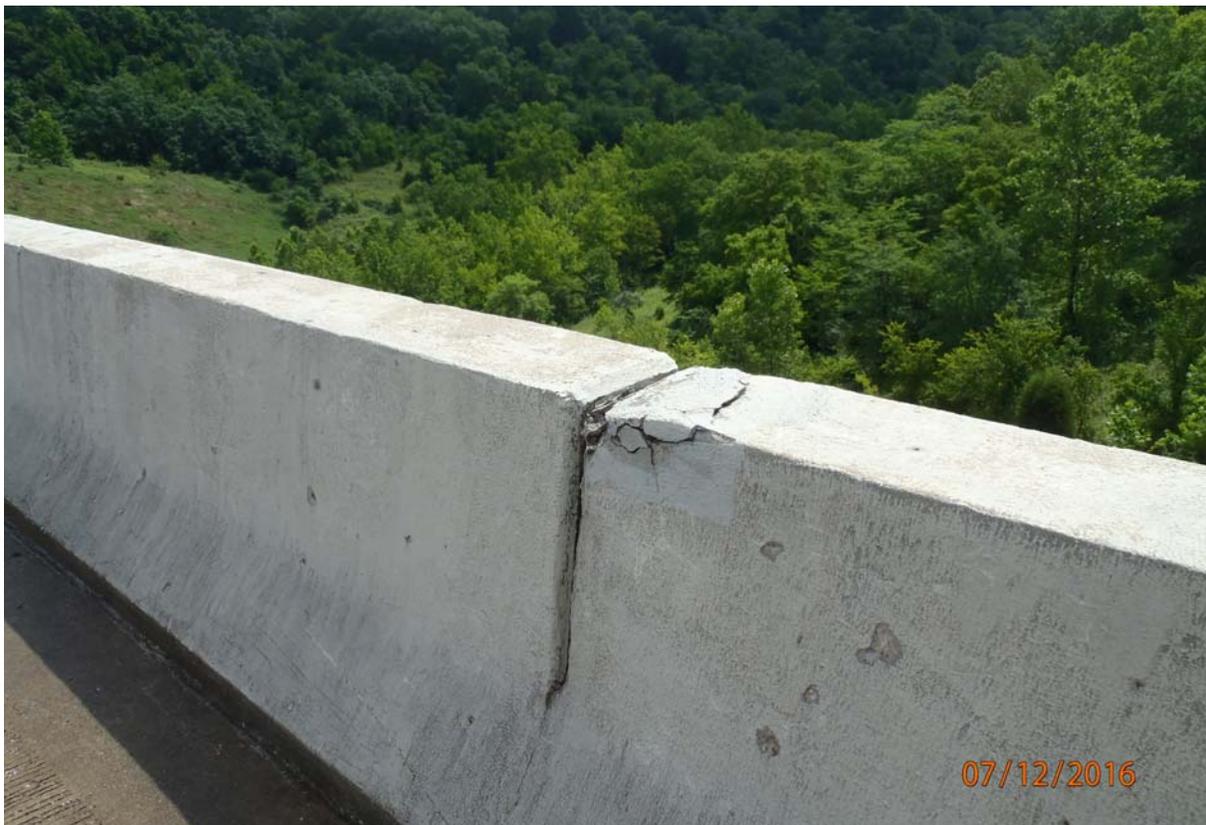
View of minor spall on the top of the upstream barrier wall located at the first drain from abutment 1 in span 1.

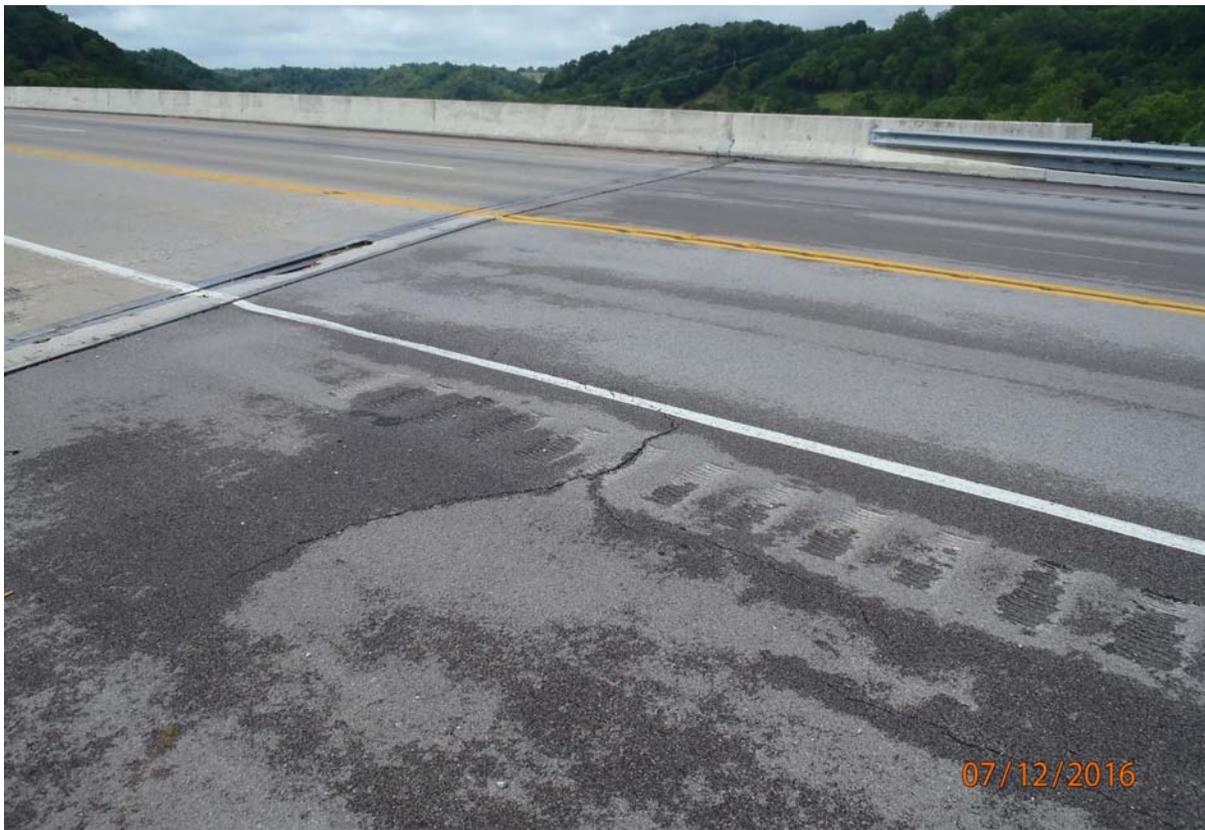
View of the north approach/transition.

Note the asphalt cracking present in the northbound lane and shoulder; an indication of continuing settlement.

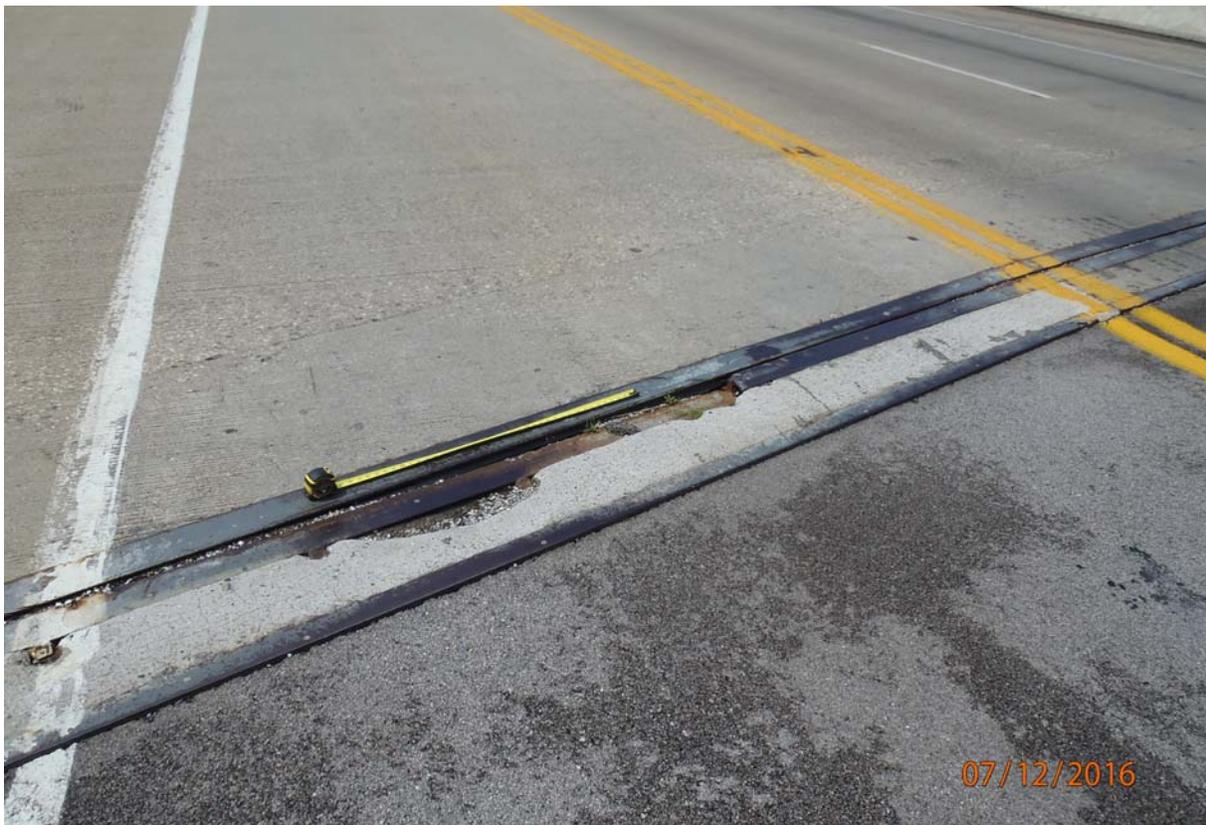
View of snowplow damage to joint at abutment 6, in the northbound lane.

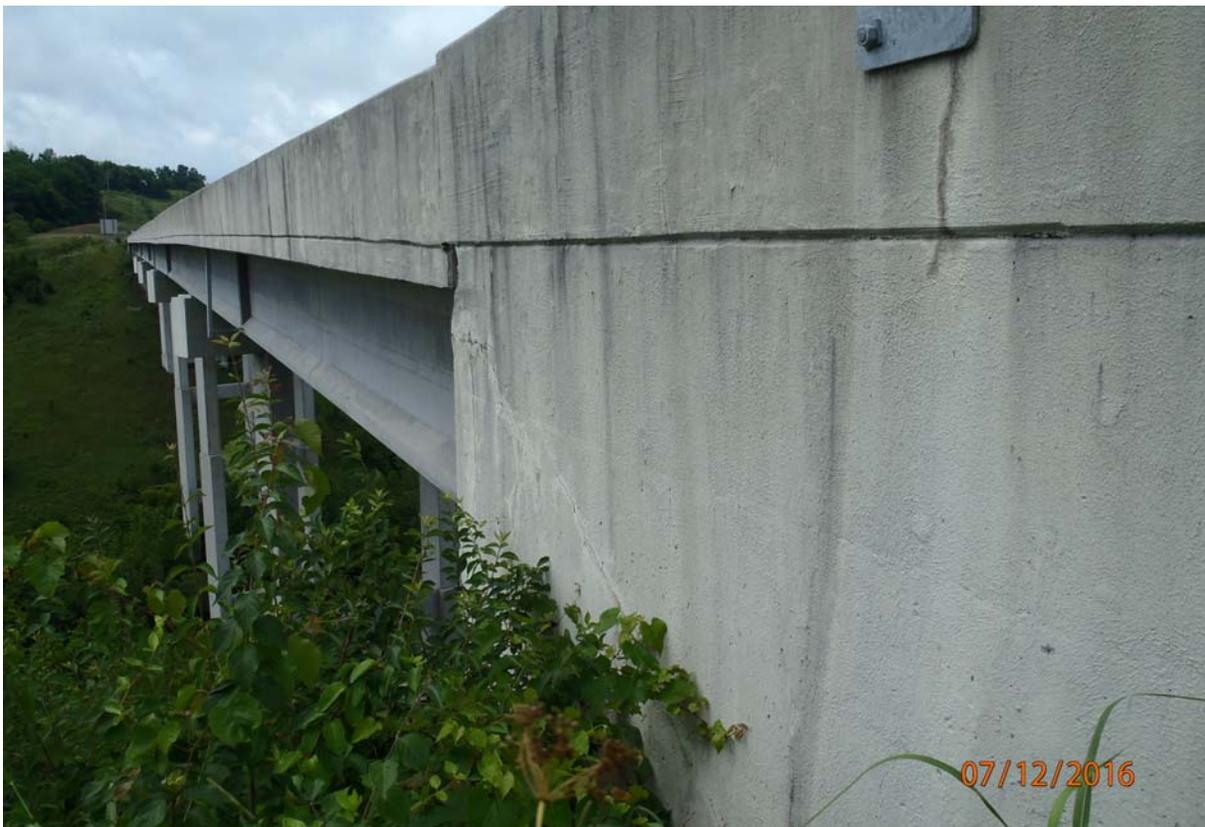
View along the upstream face of the upstream beam (beam 1) looking from abutment 6. Note the shear cracking in the wingwall (Wingwall D per plans). The shear cracks are up to **19/75** 0.023" wide with efflorescence staining.

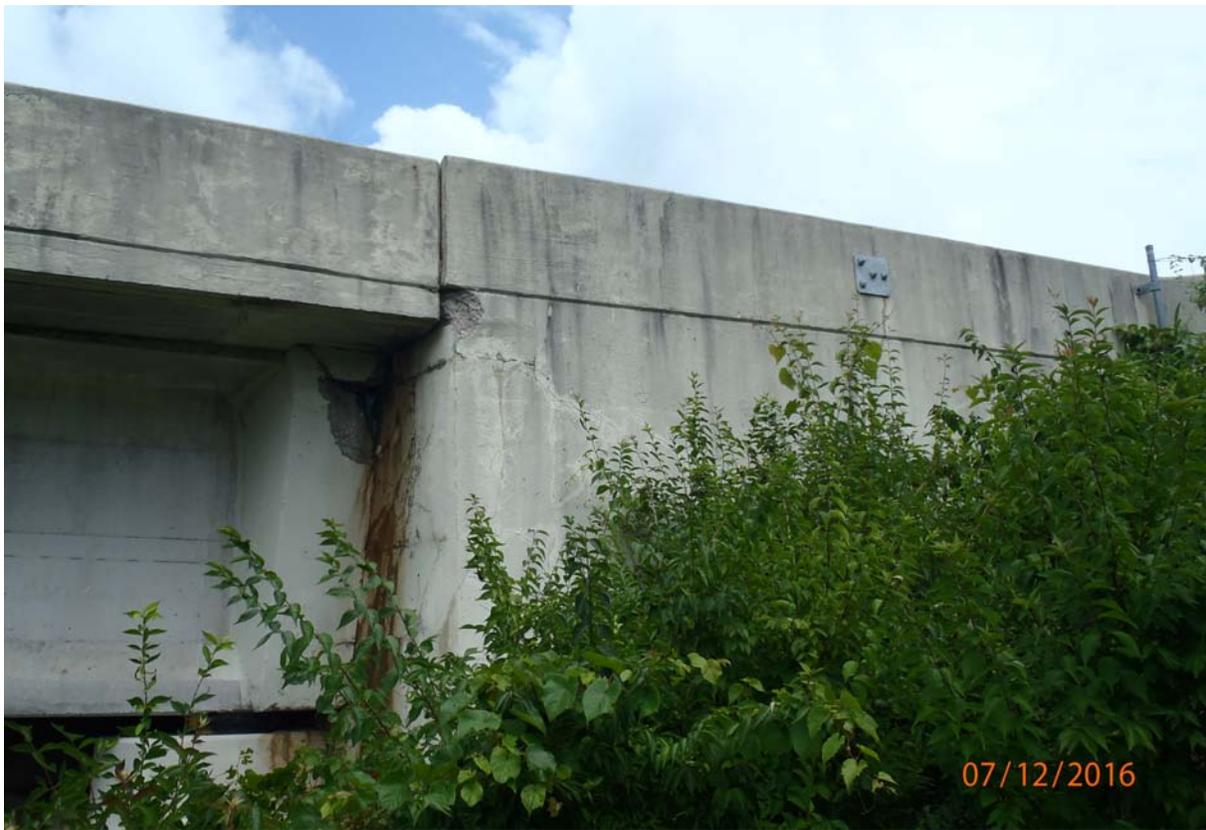
View of the upstream face of beam 1 at abutment 6.
Note the heavy cracking and staining of/on the abutment back-wall, spalling of the diaphragm,
and the cracking/spalling of the wingwall.

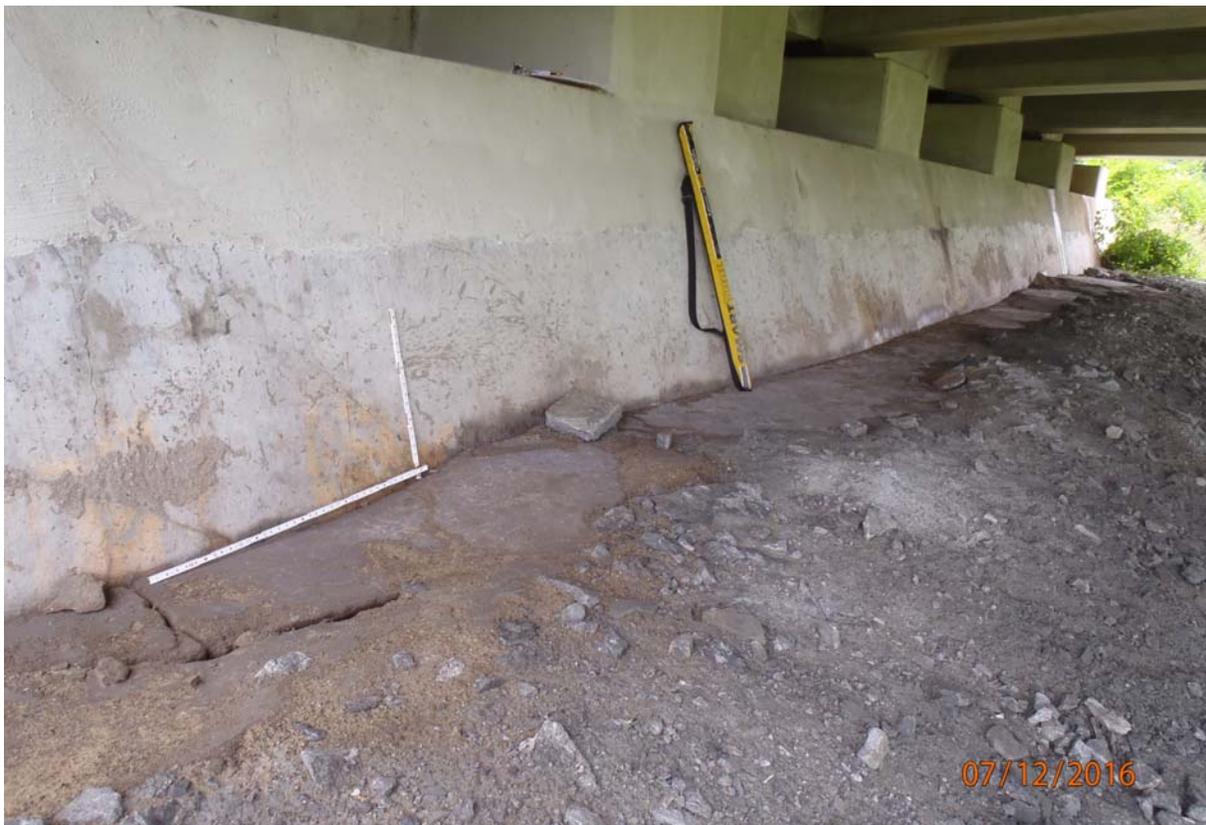
View along the face of abutment 6. Note at some point in the past heavy erosion was present exposing many of the piles at this abutment thus flow-able-fill was placed in the voided areas; the cracking and settlement of the flow-able-fill finished surface indicates that settlement is continuing.

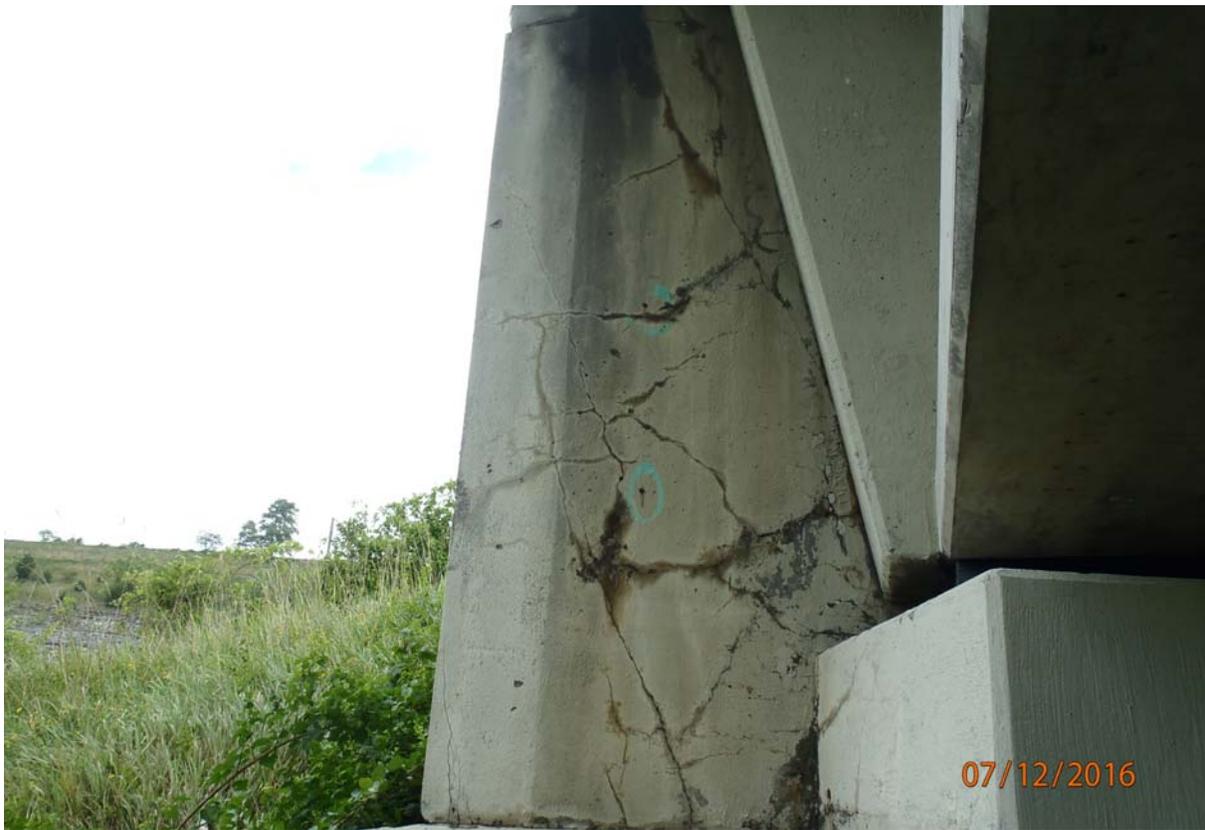
View of the back-wall downstream of beam 6.

Note the heavy cracking up to 0.02" wide with efflorescence and rust staining. Note the green circles and PK nails - the below level reading was recorded at this location.

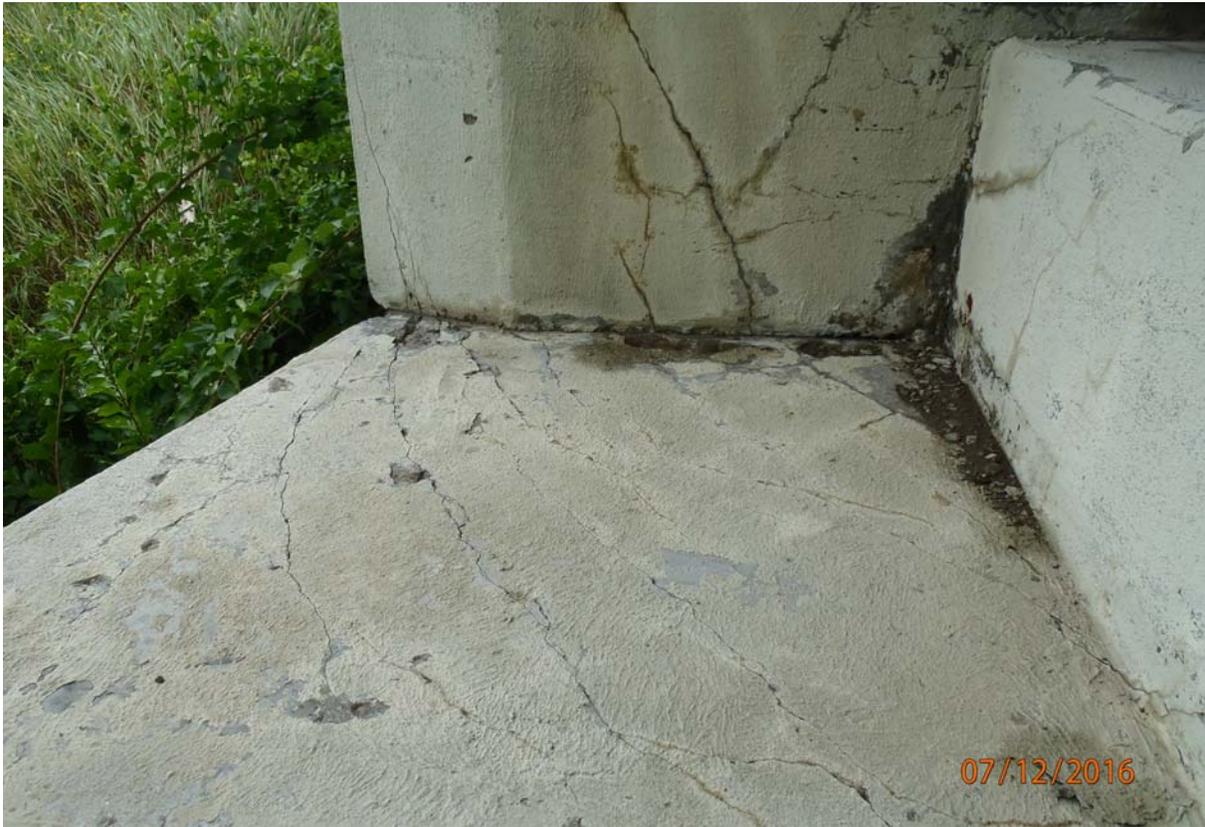
View of cracking present on the abutment seat downstream of beam 6.
Note the cracking widths are up to 0.06" wide.

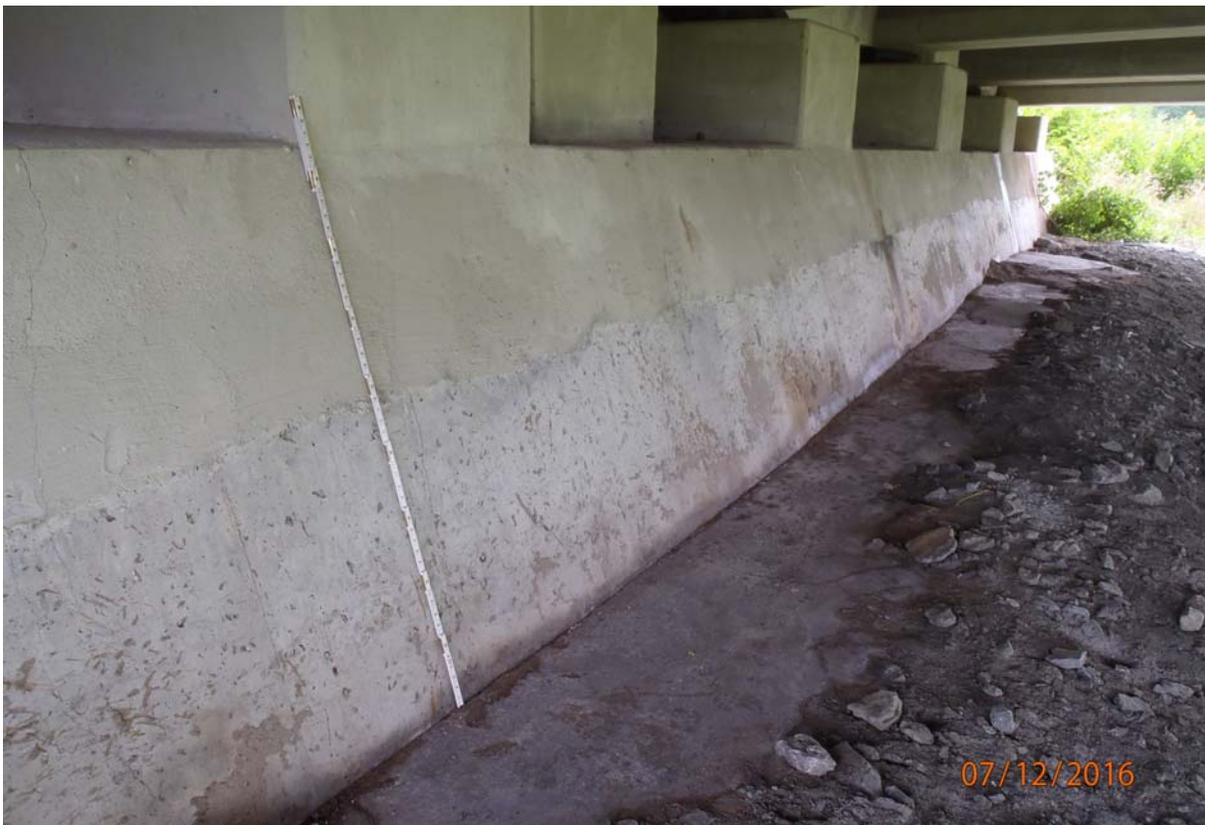
View of 2'-5" of vertical difference between the constructed height of the fill along abutment 6.
Note photos dated back to 1997 indicate that the fill was approximately to/near the masonry coating line.

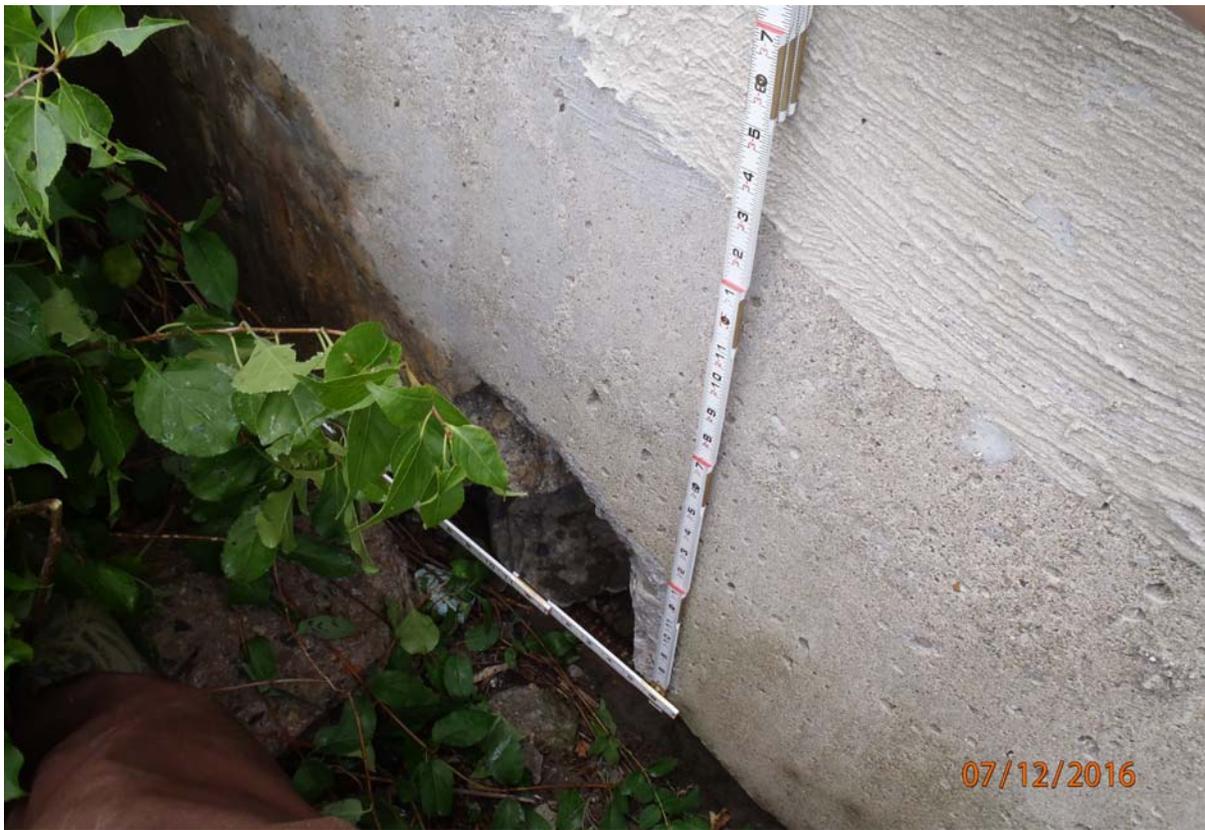
View of a spall and void under the downstream side of the pile cap of abutment 6. Note no piles are exposed but reinforcing steel is without any measureable section loss.

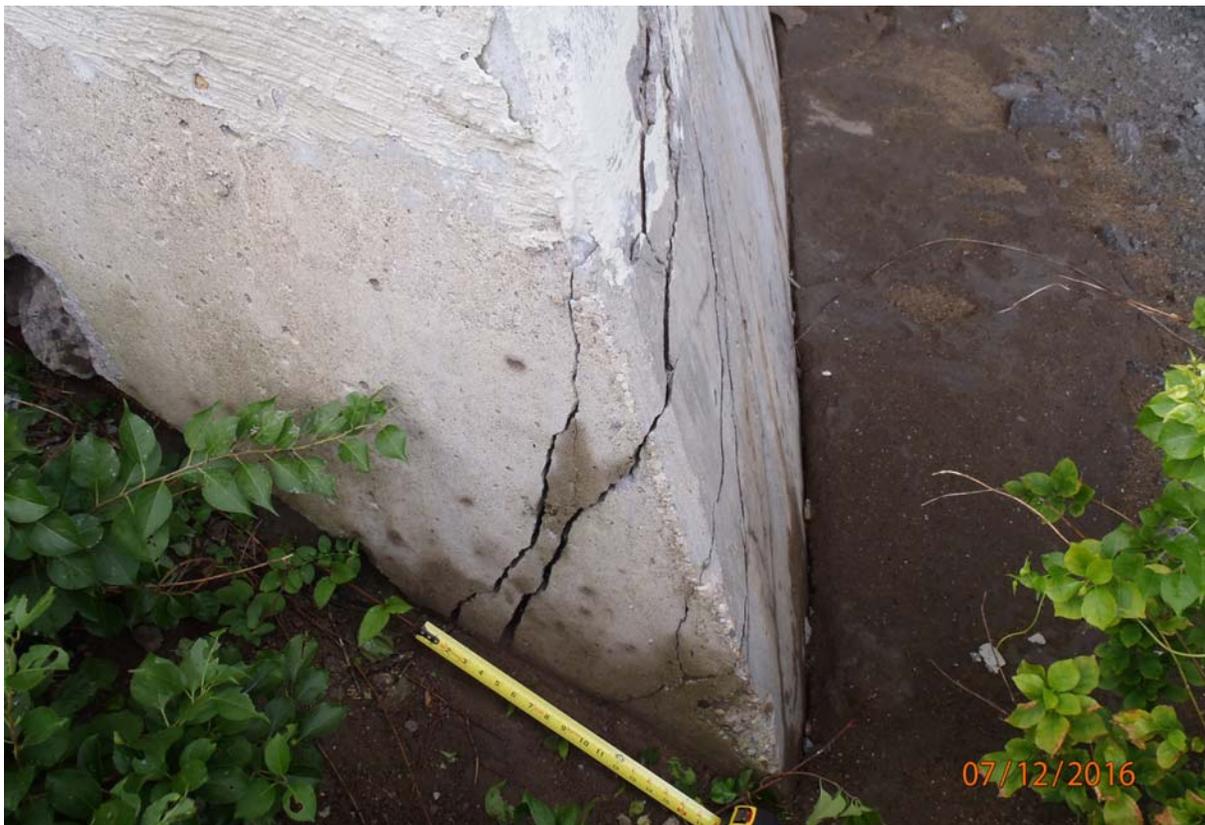
View of heavy cracking present at the downstream corning of the pile cap of abutment 6. Note the cracking is up to 1/2" wide.

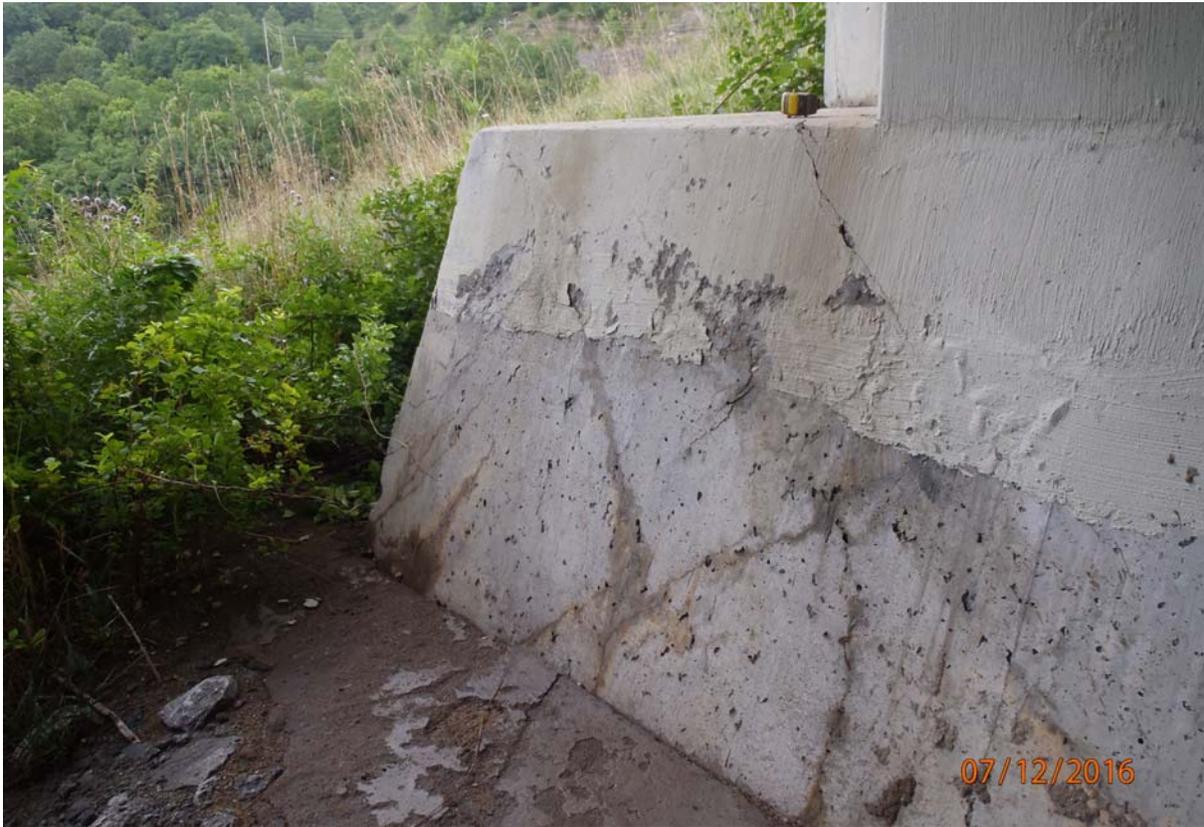
View of the face of the pile cap under and downstream of beam 6.
Note the heavy cracking with rust staining; the cracks are up to 0.02" wide at this location.

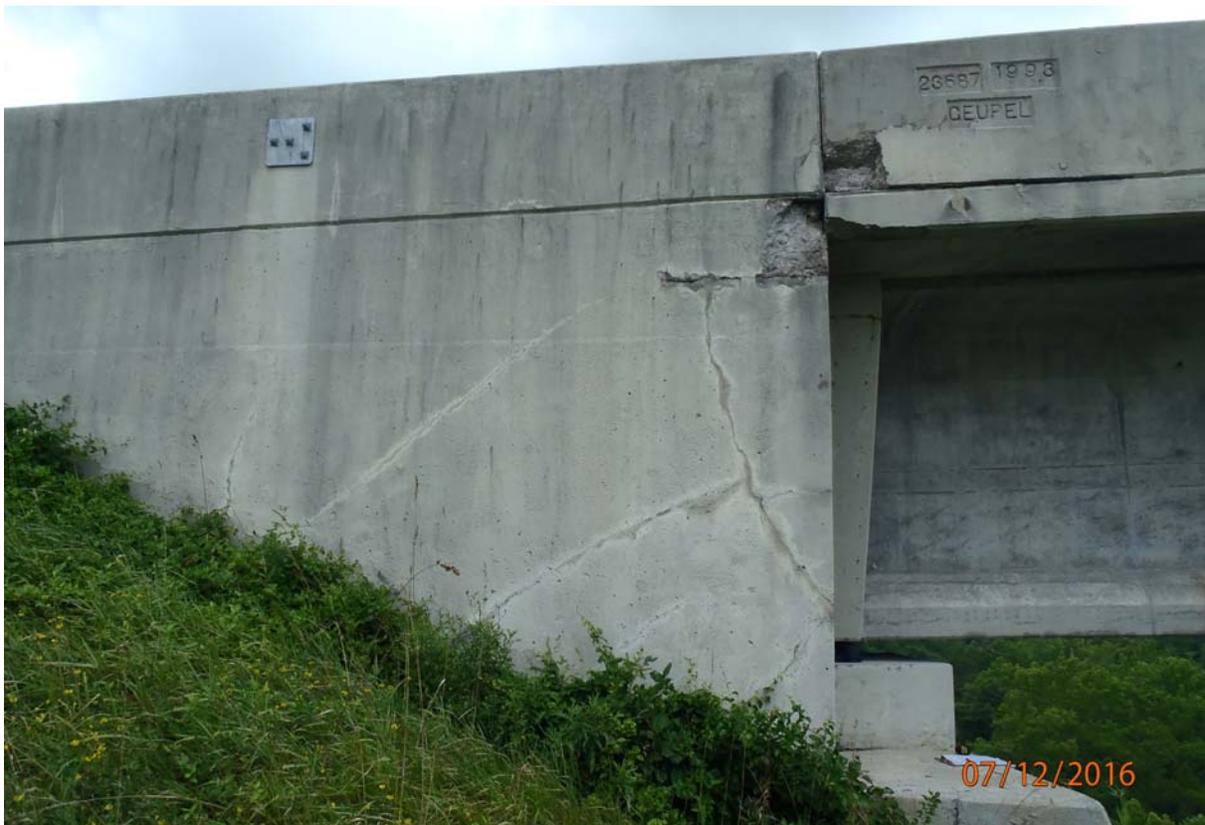
View of the downstream wingwall of abutment 6 (Wingwall C per plans).
Note the spalling of the barrier wall, spalling of the wingwall, and shear cracking with efflorescence and rust staining up to 0.023" wide.

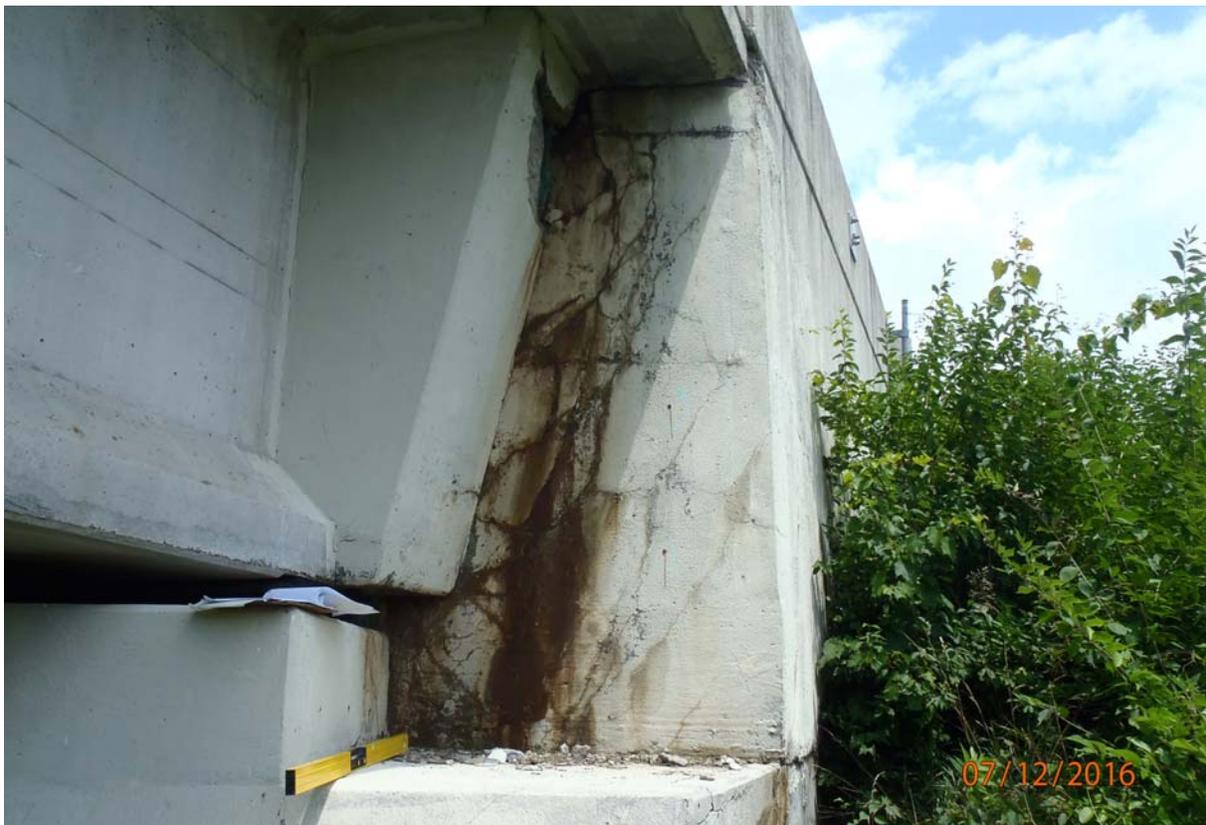
View of the back-wall upstream of beam 1.

Note the heavy cracking up to 0.03" wide with efflorescence and rust staining.
Note the green circles and PK nails - the below level reading was recorded at this location.
