Inspection Report with SI&A Data

Structure Description: 766.08 Foot - 5 Span Prestressed concrete continuous Stringer/Multi-beam or Girder

7 Facility Carried: US-62

6A Feature Intersected: LAWRENCE CREEK

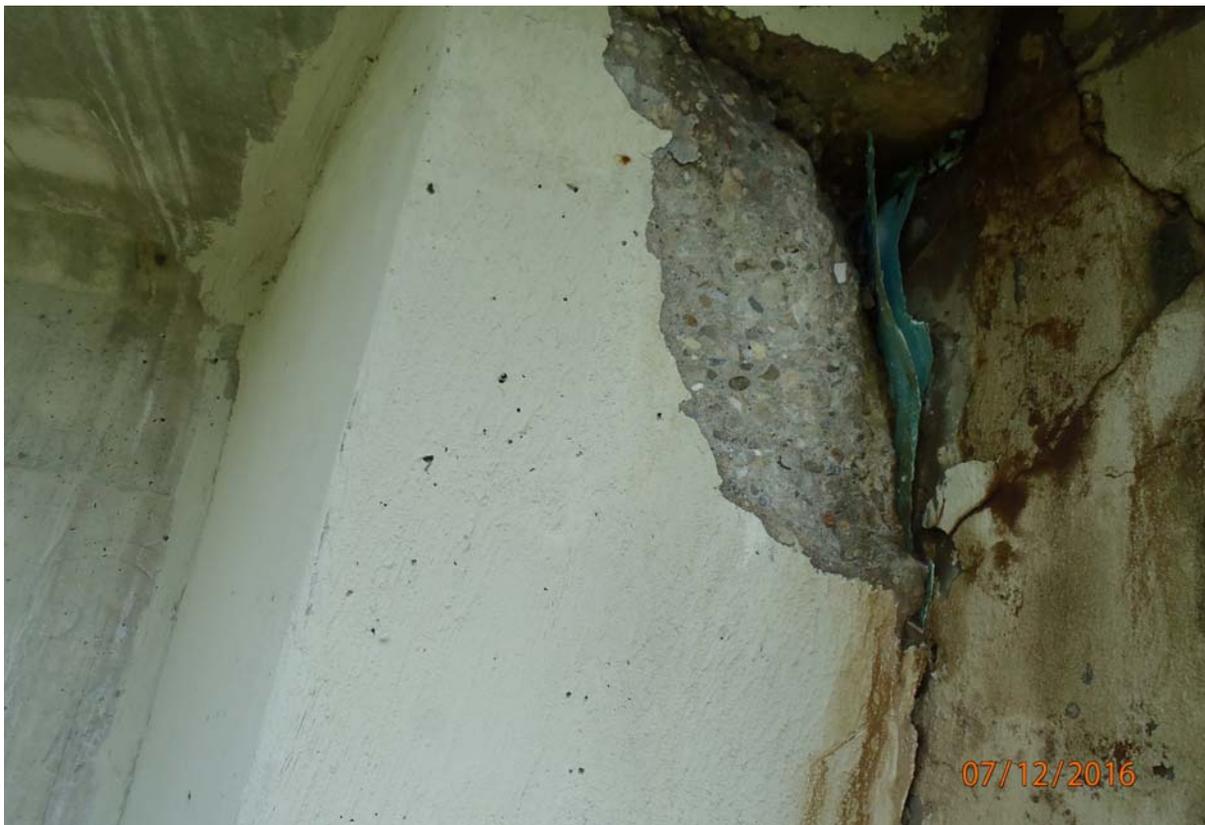
View of diaphragm and back wall spalling located upstream of beam 1. Note the diaphragm spall is approximately 20" tall with no exposed reinforcing steel.

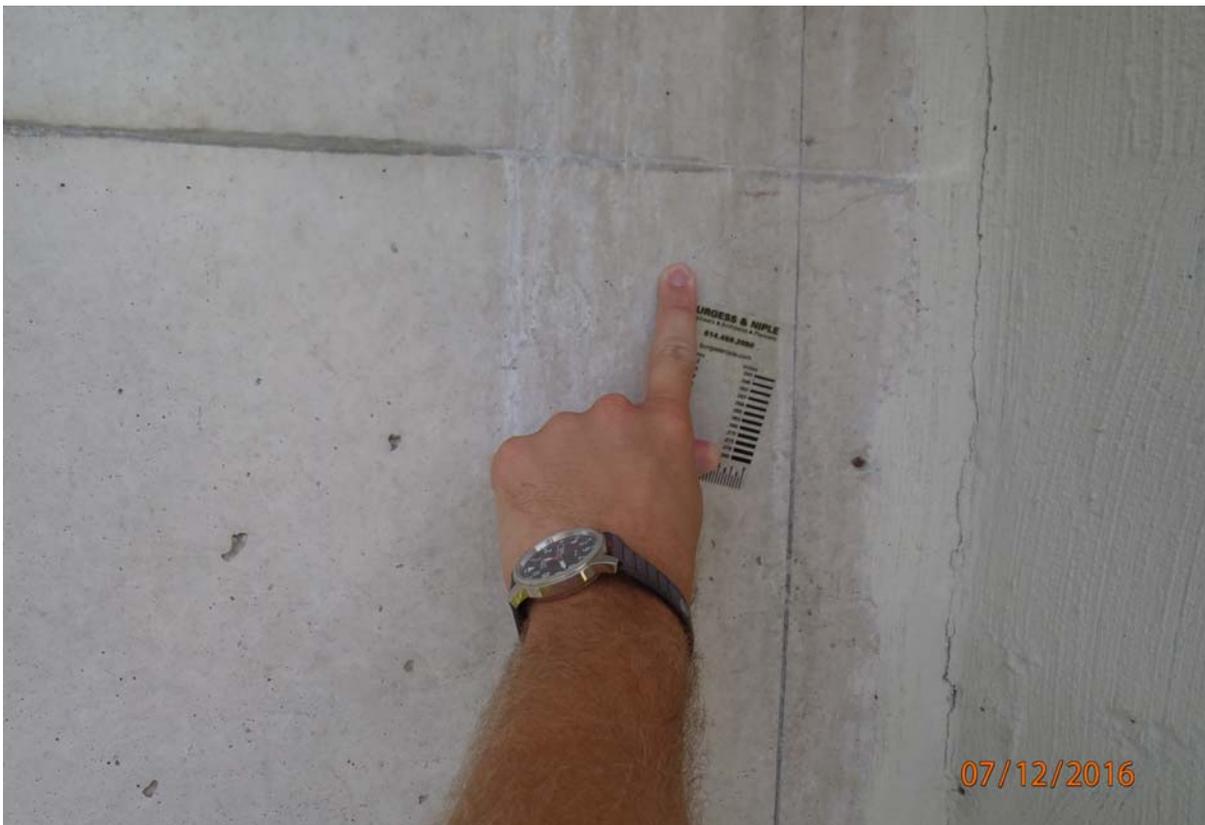
View of very minor longitudinal/diagonal cracks in the exterior face of beam 1 (3 cracks in total) extending from the diaphragm into span 5 approximately 15" from the face of the diaphragm; the cracks are up to 0.002" wide.

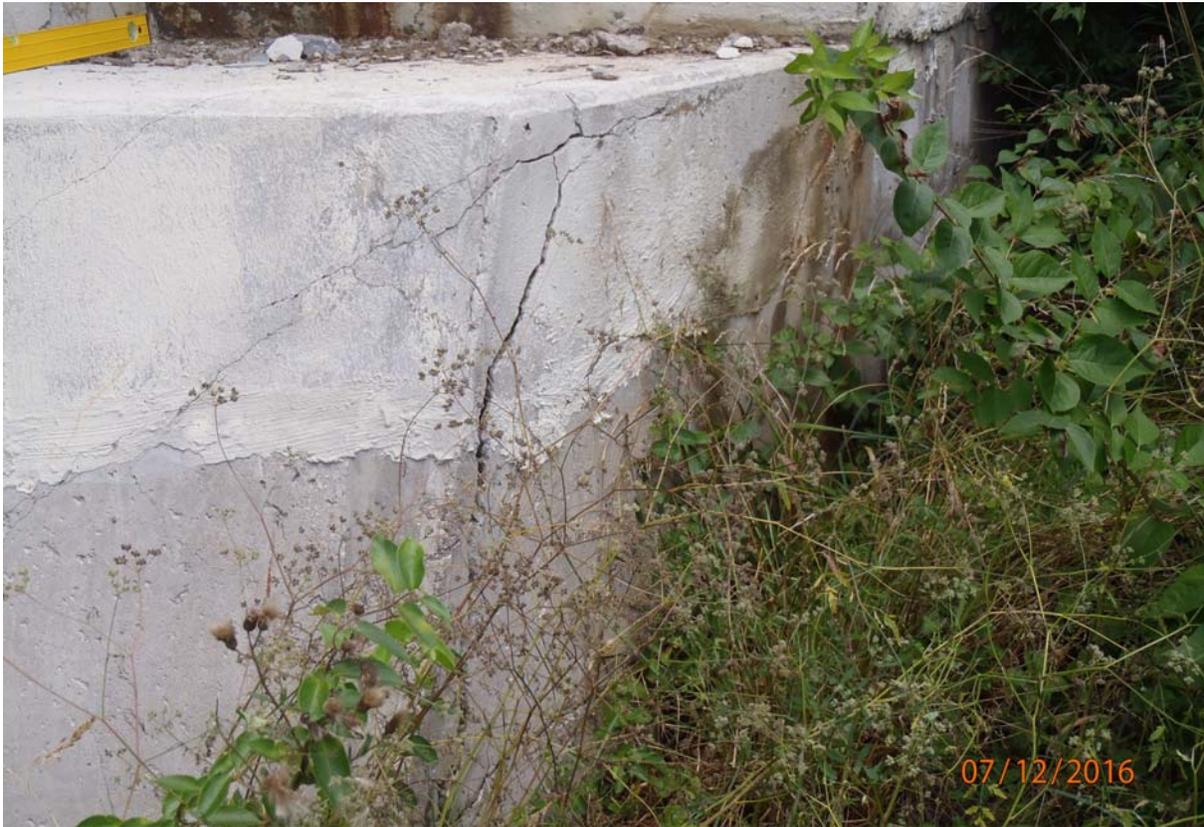
View of cracking present at the upstream corning of the pile cap of abutment 6.
Note the cracking is up to 2" wide near the base of the pile cap with exposed reinforcing steel
without section loss.

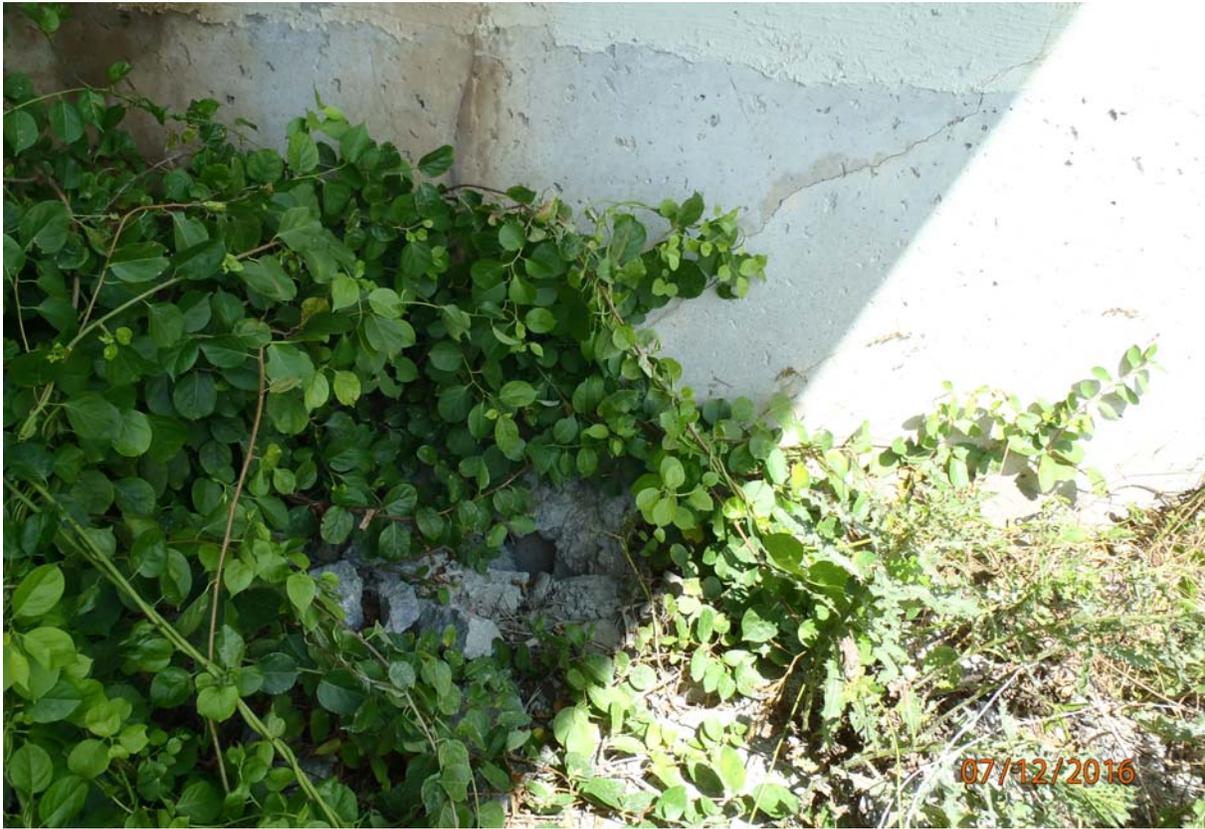
View of small void under the pile cap upstream of beam 1; no piles where exposed/detected.

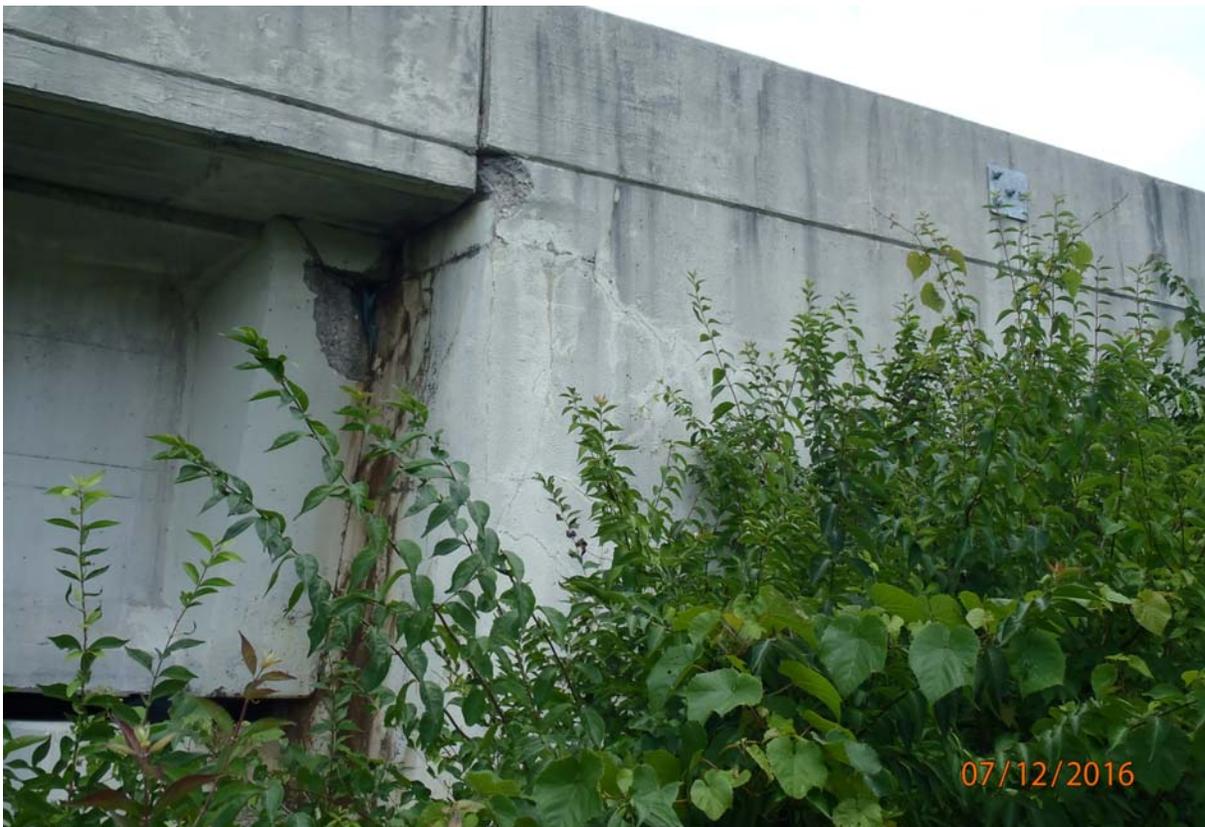
View of the upstream wingwall of abutment 6 (Wingwall D per plans). Note the spalling of the wingwall/back-wall, cracking of the back-wall, and shear cracking with efflorescence up to 0.023" wide.

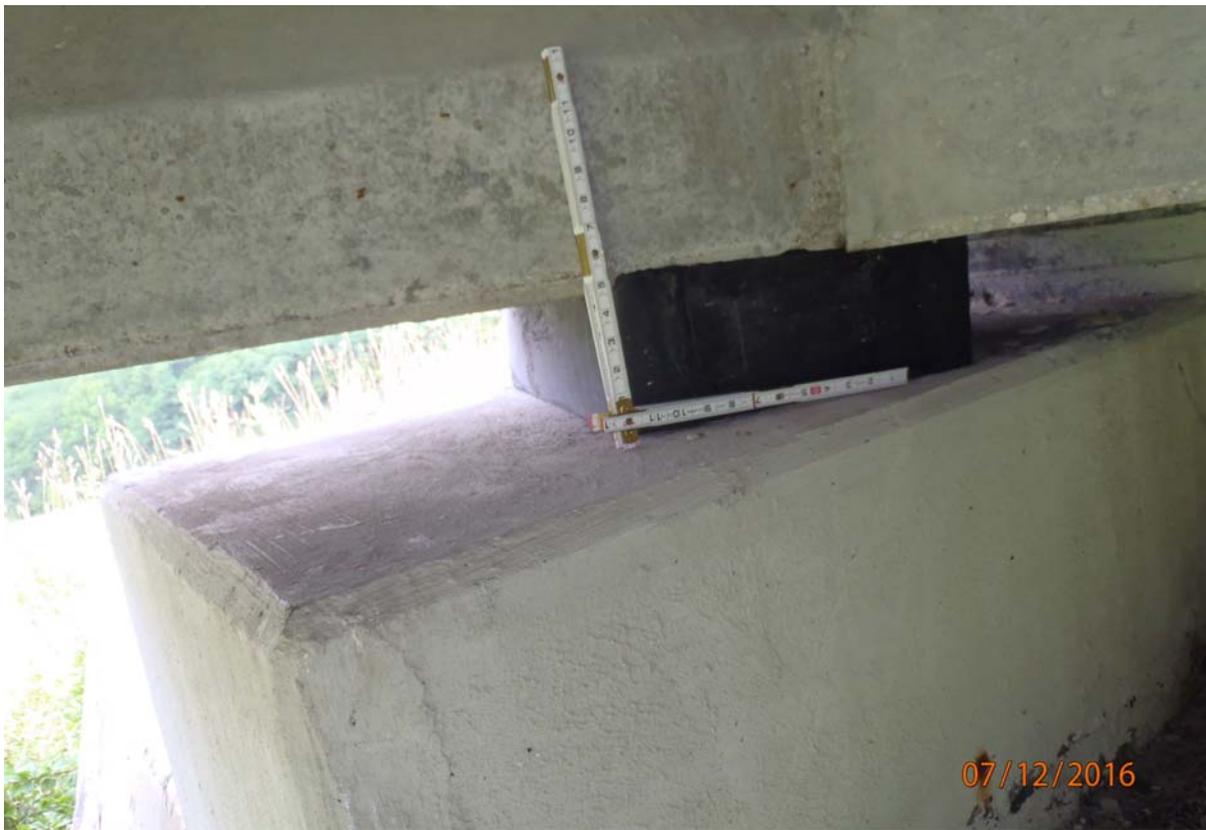
View of the bearing pad under beam 6 at abutment 6.
Note the deformation and cracking.

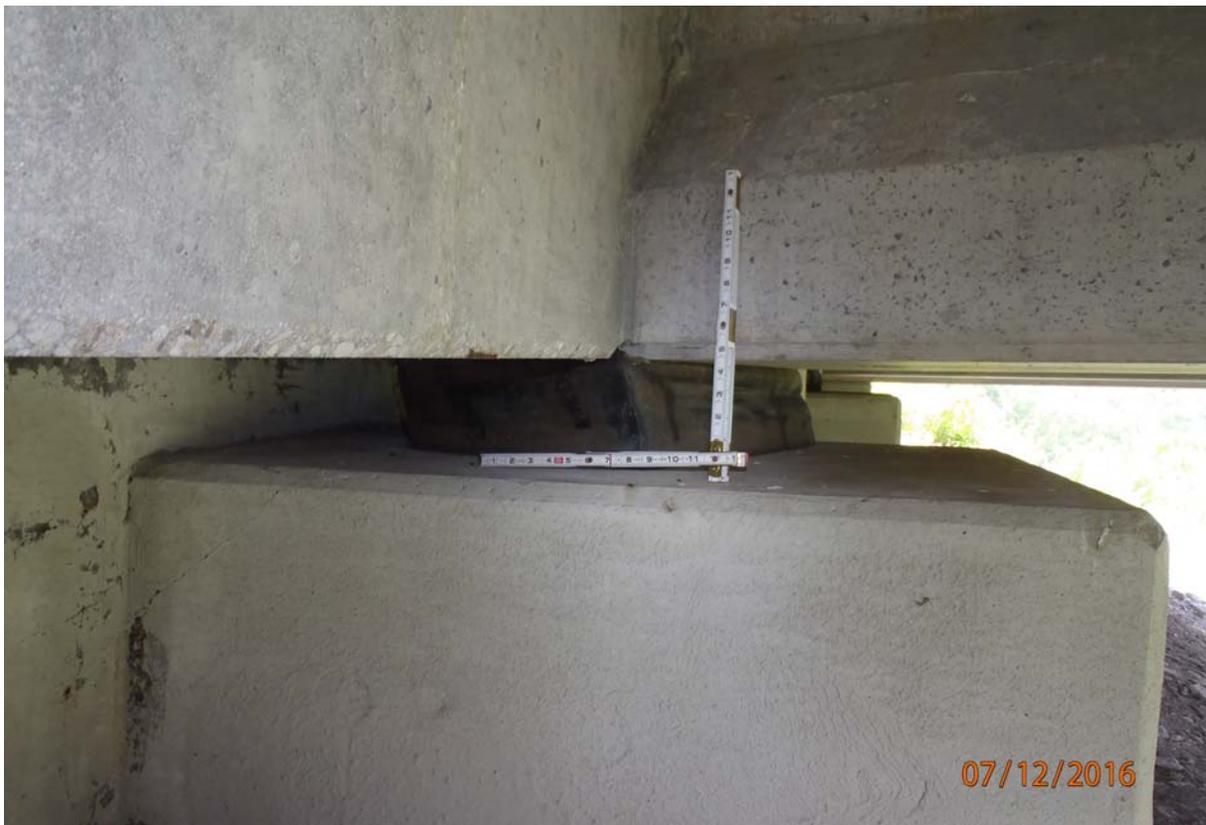
View of the bearing pad under beam 5 at abutment 6.
Note the deformation and cracking.

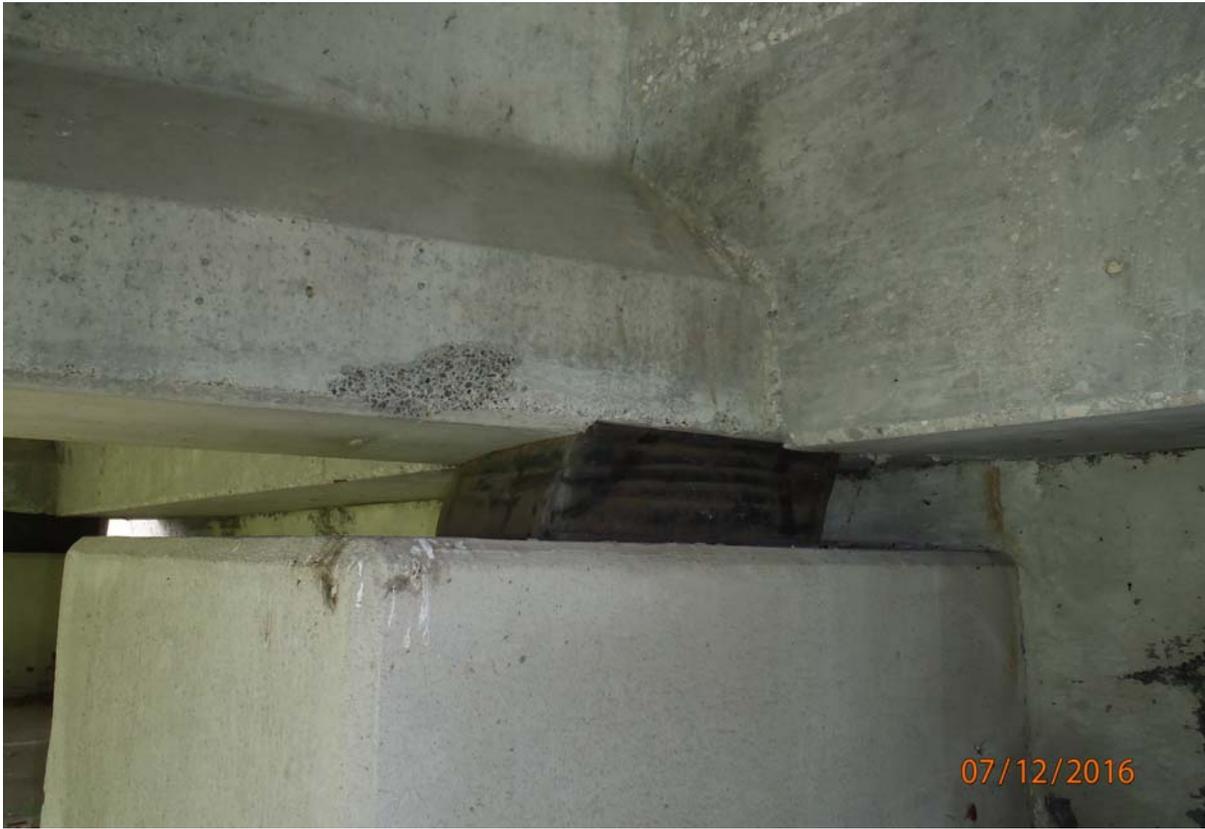
View of the bearing pad under beam 5 at abutment 6.
Note the deformation and cracking.

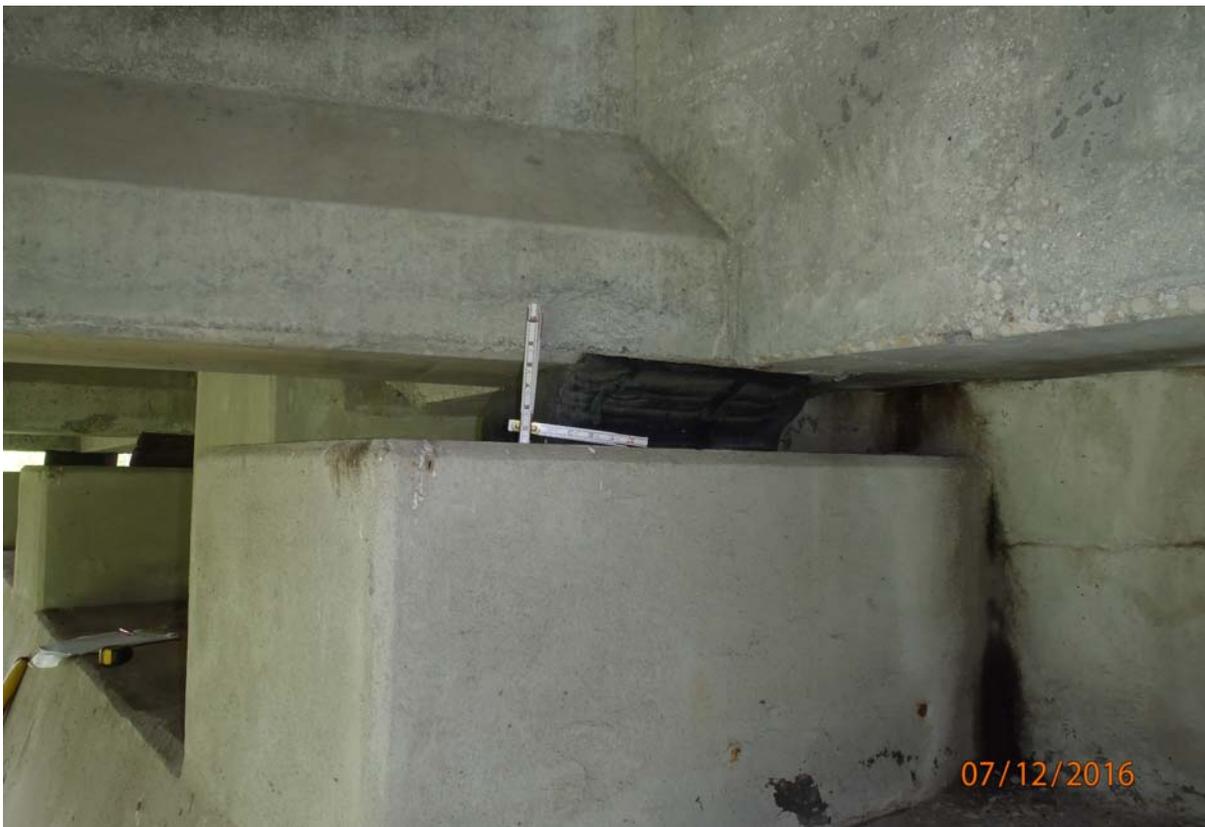
View of the bearing pad under beam 4 at abutment 6.
Note the deformation and cracking.

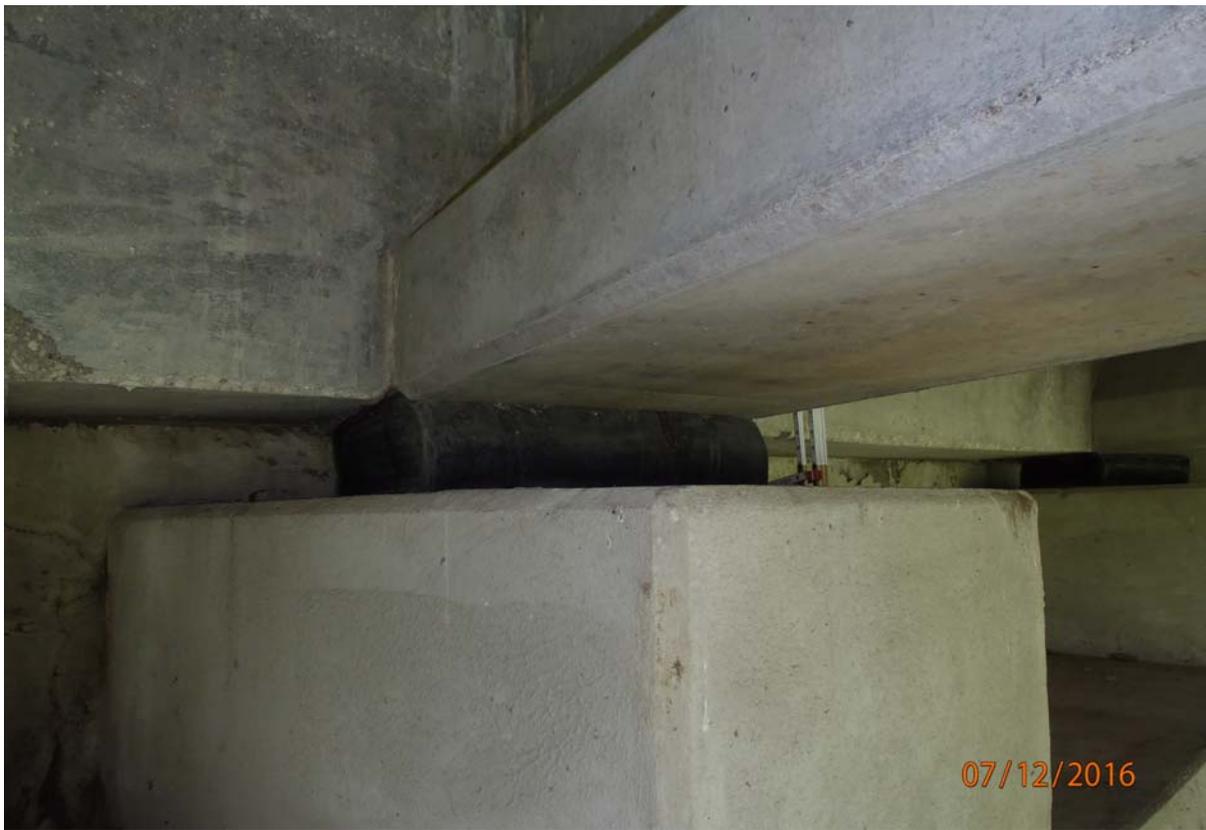
View of the bearing pad under beam 4 at abutment 6.
Note the deformation and cracking.

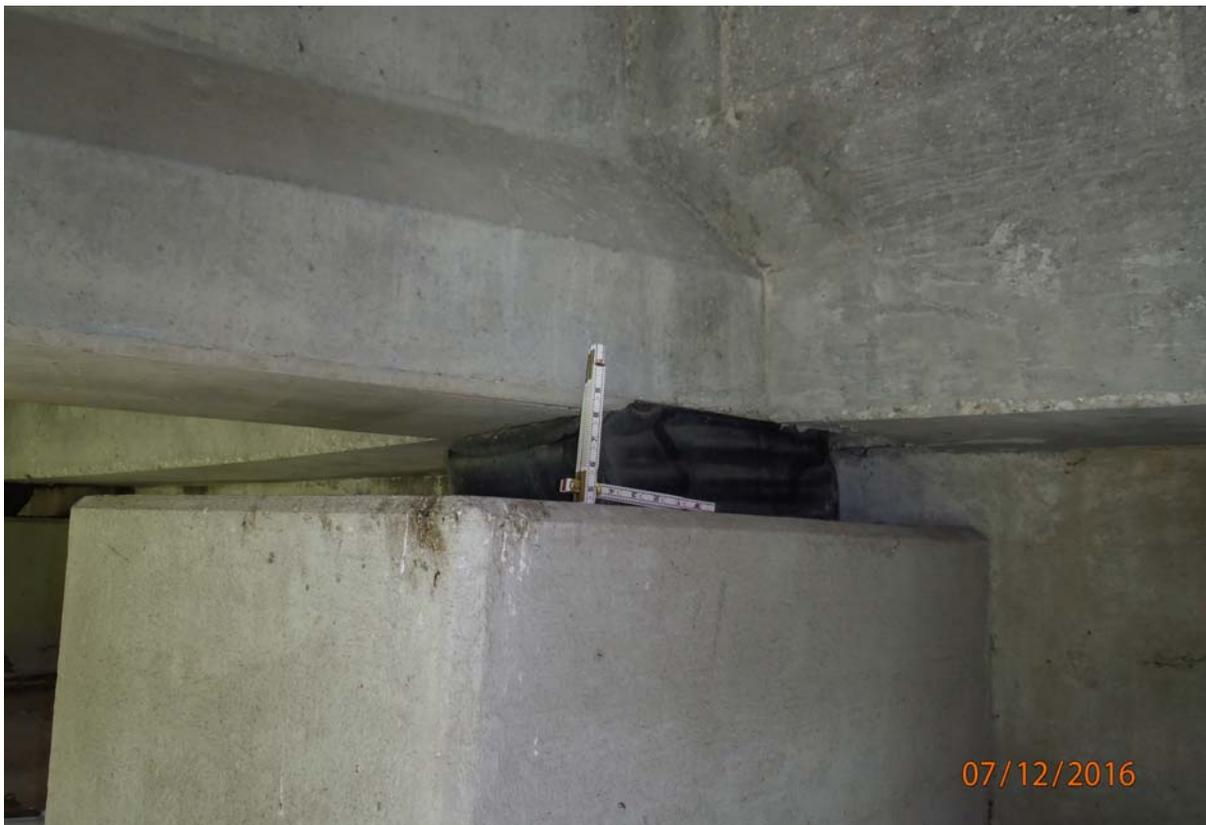
View of the bearing pad under beam 3 at abutment 6.
Note the deformation and cracking.

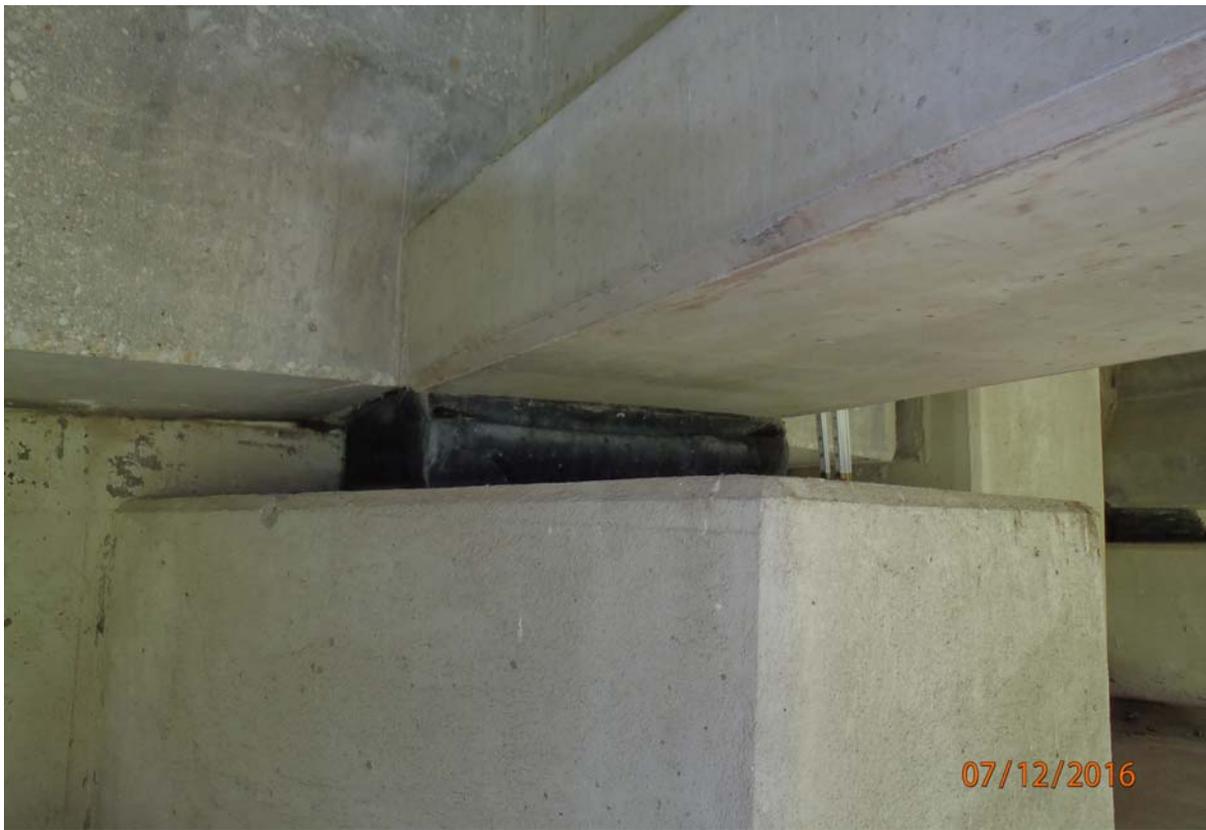
View of the bearing pad under beam 3 at abutment 6.
Note the deformation and cracking.

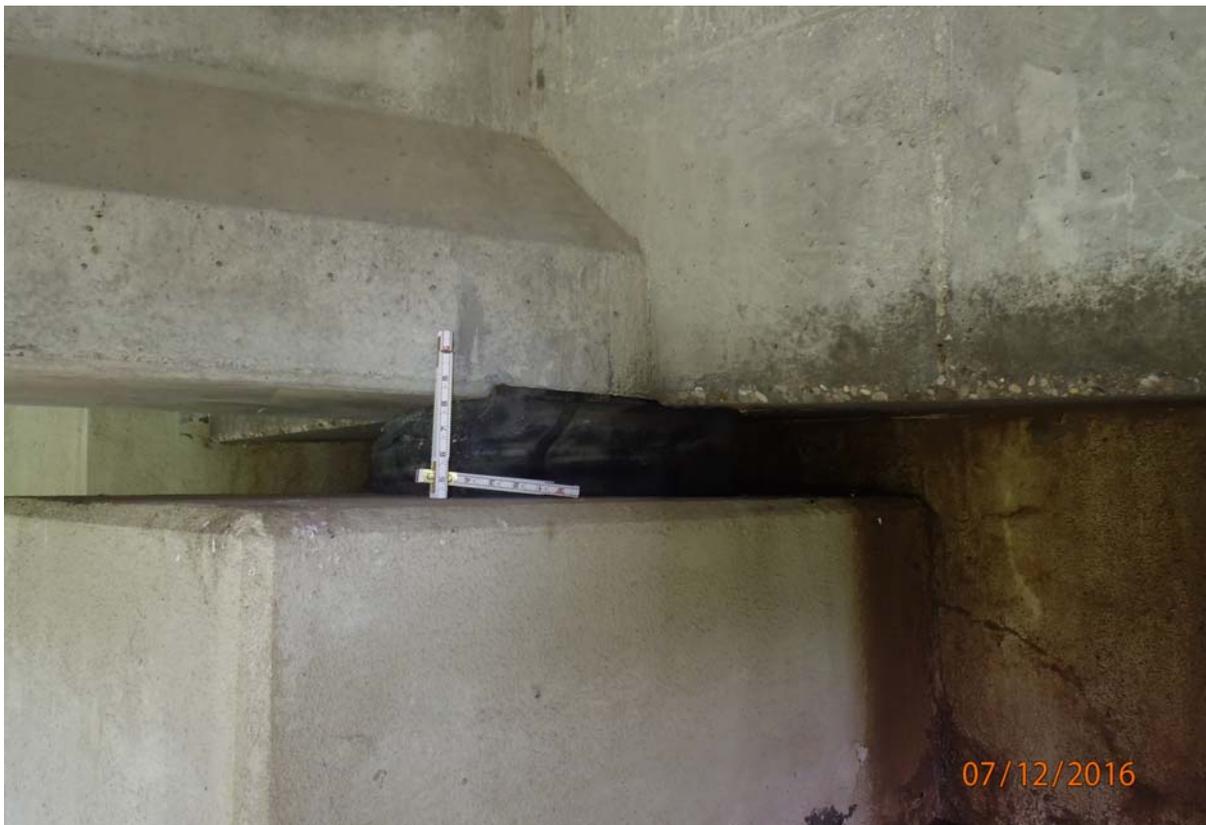
View of the bearing pad under beam 2 at abutment 6.
Note the deformation and cracking.

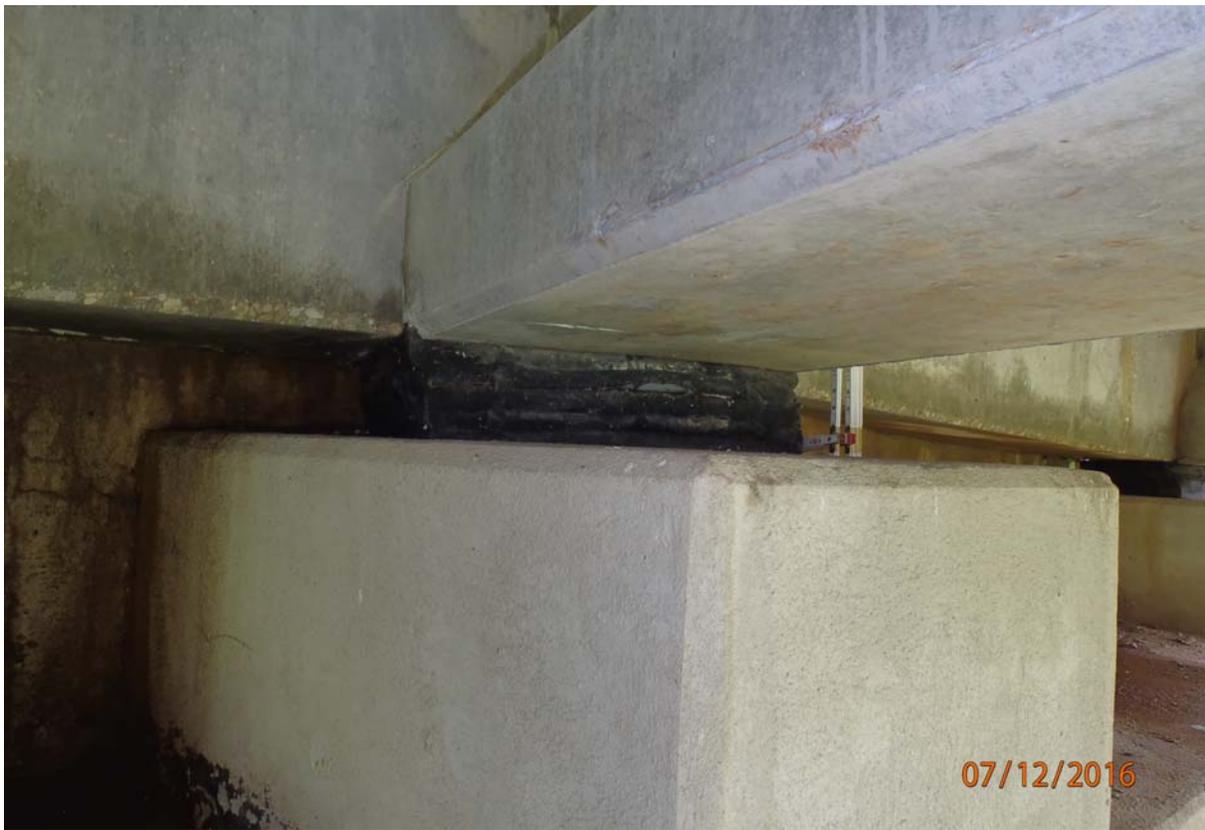
View of the bearing pad under beam 2 at abutment 6.
Note the deformation and cracking.

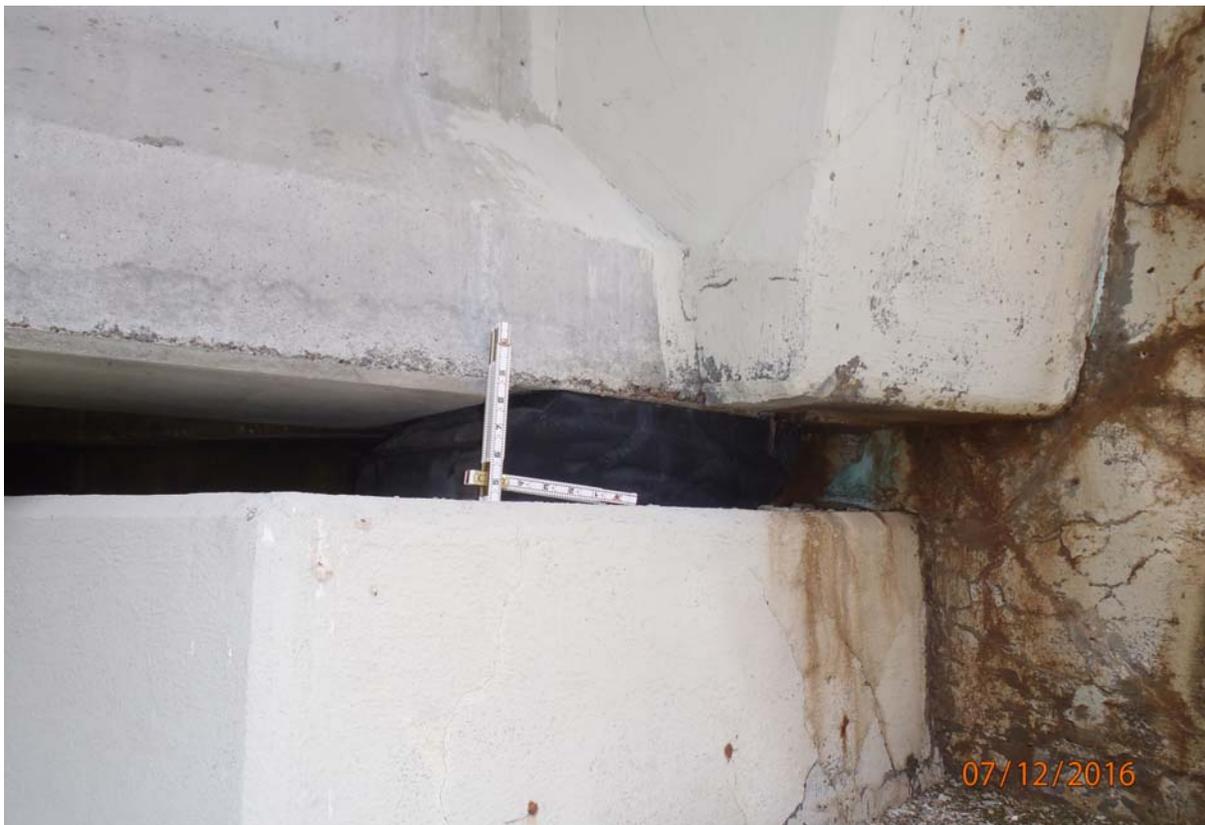
View of the bearing pad under beam 1 at abutment 6.
Note the deformation and cracking.

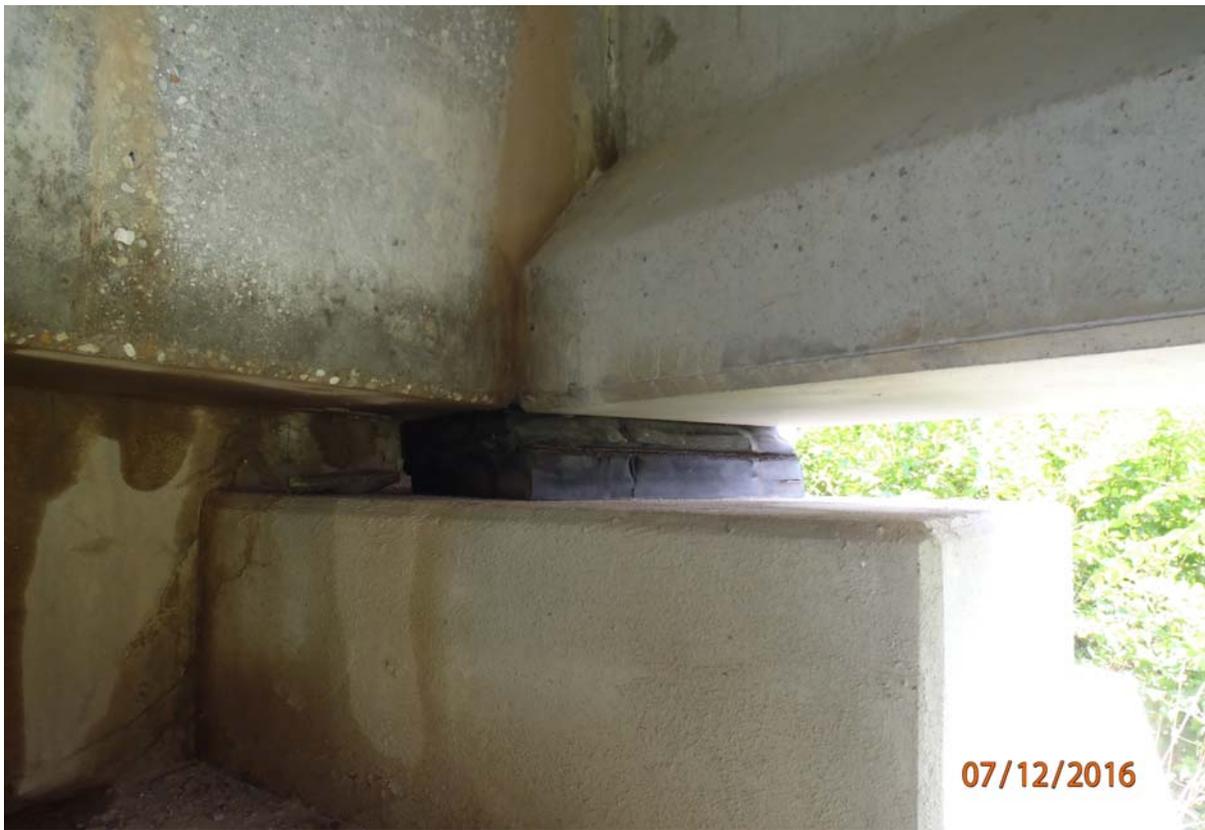
View of the bearing pad under beam 1 at abutment 6.
Note the deformation and cracking.

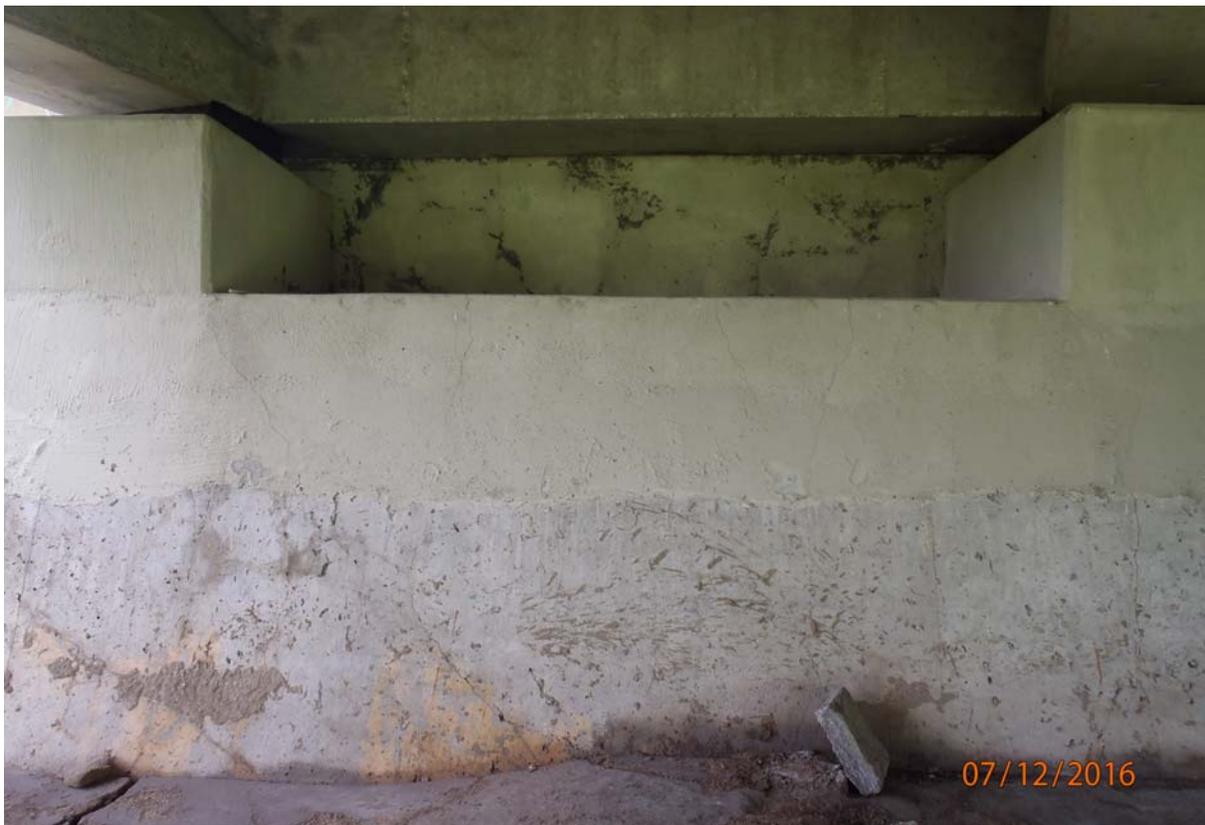
View of vertical and diagonal cracking in the back-wall and abutment face between beams 5 and 6 at abutment 6. Note the cracks in the abutment face are up to 0.023" wide, and some with rust staining.

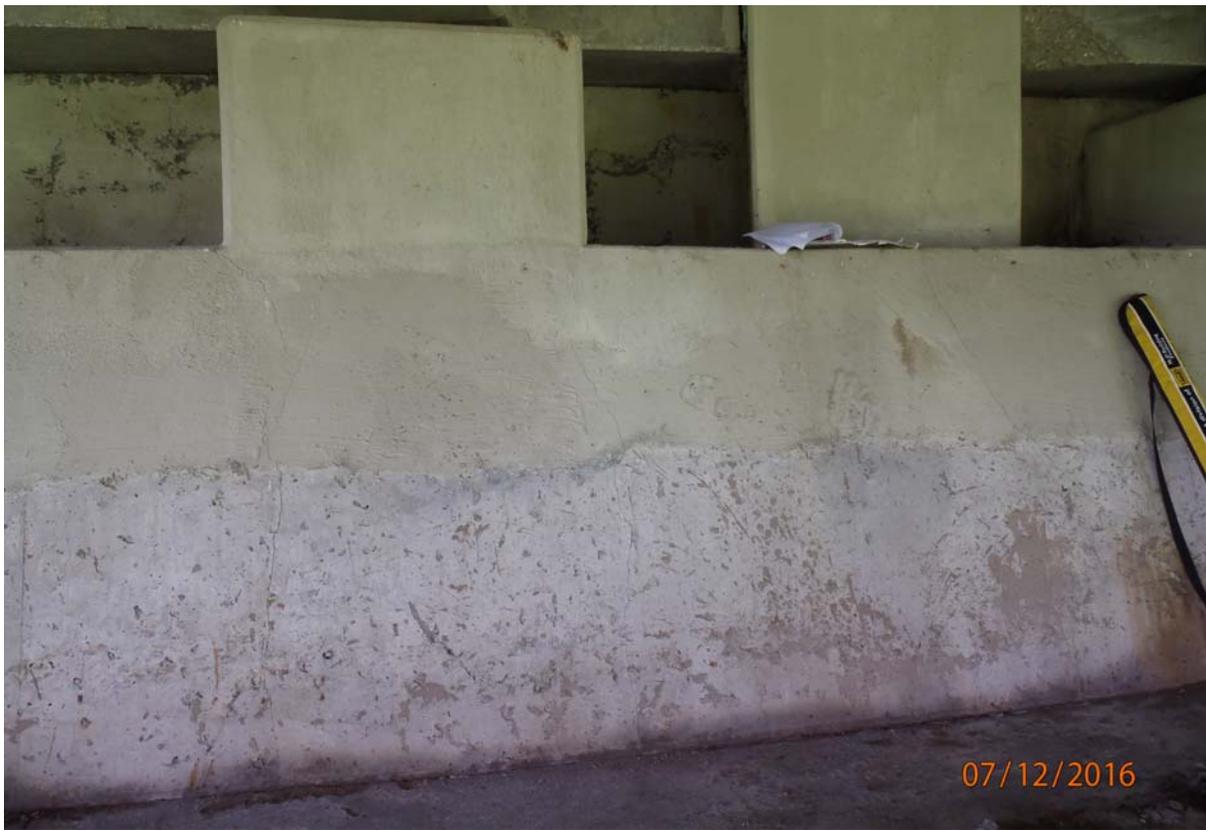
View of vertical cracking in the face of abutment 6 under and between beams 4 and 5; up to 0.05" wide under beam 5 and up to 0.03" wide between beams 4 and 5.

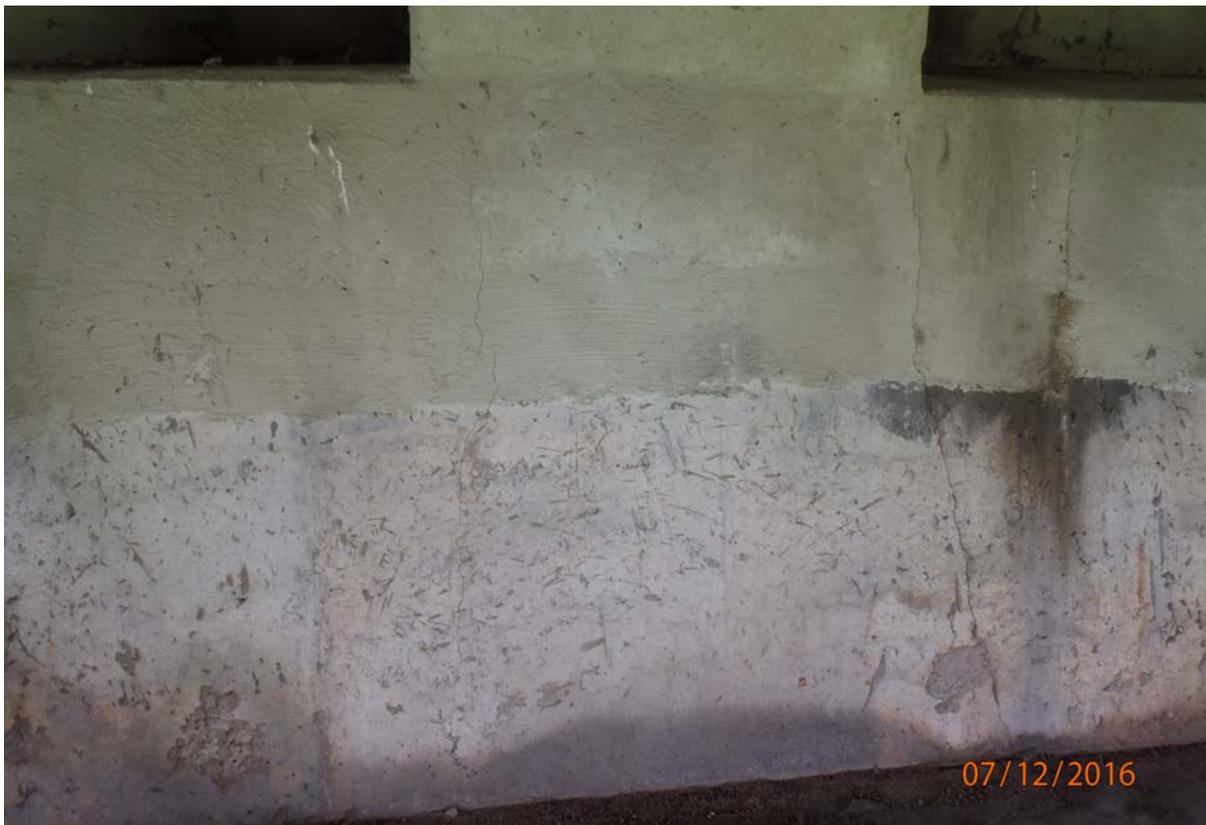
View of vertical cracking in the face of abutment 6 up to 0.026" wide under beam 4.

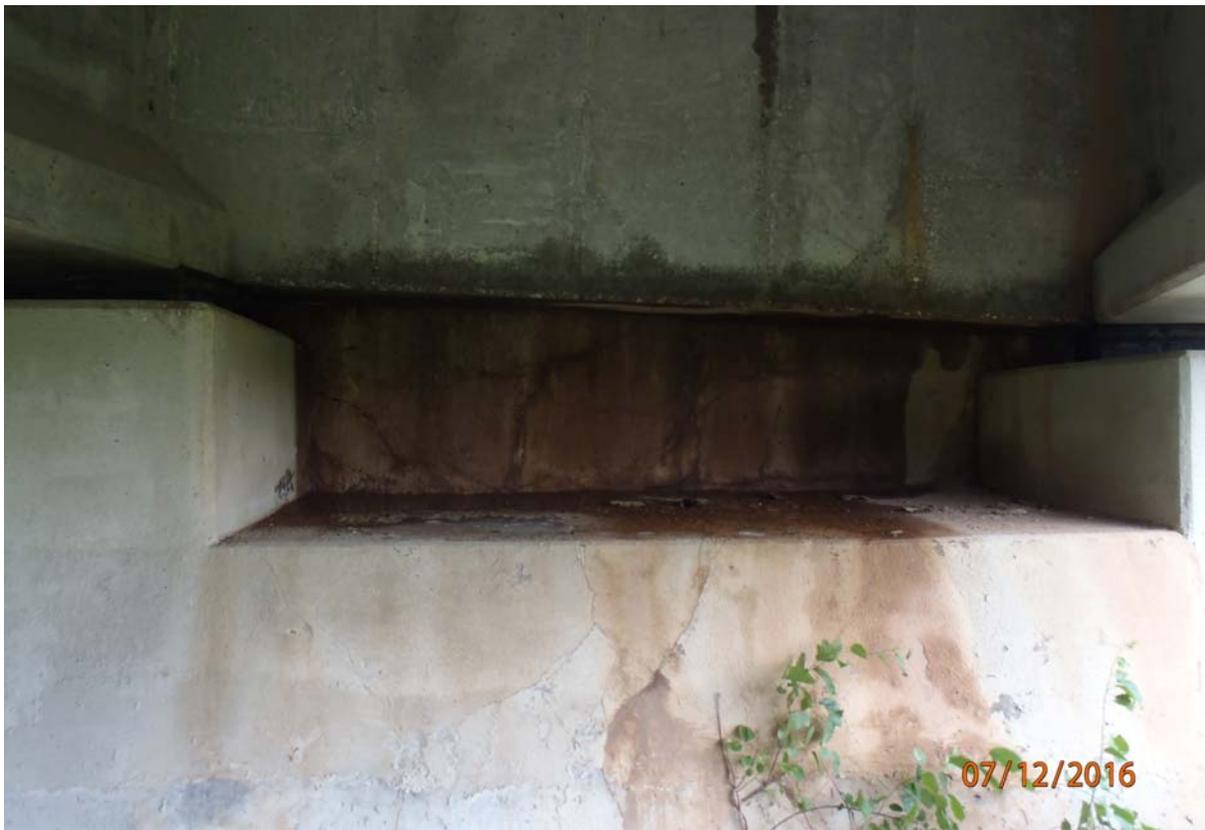
View of cracking under beam 1, upstream of beam 1, and downstream of beam 1 in the face of abutment 6.

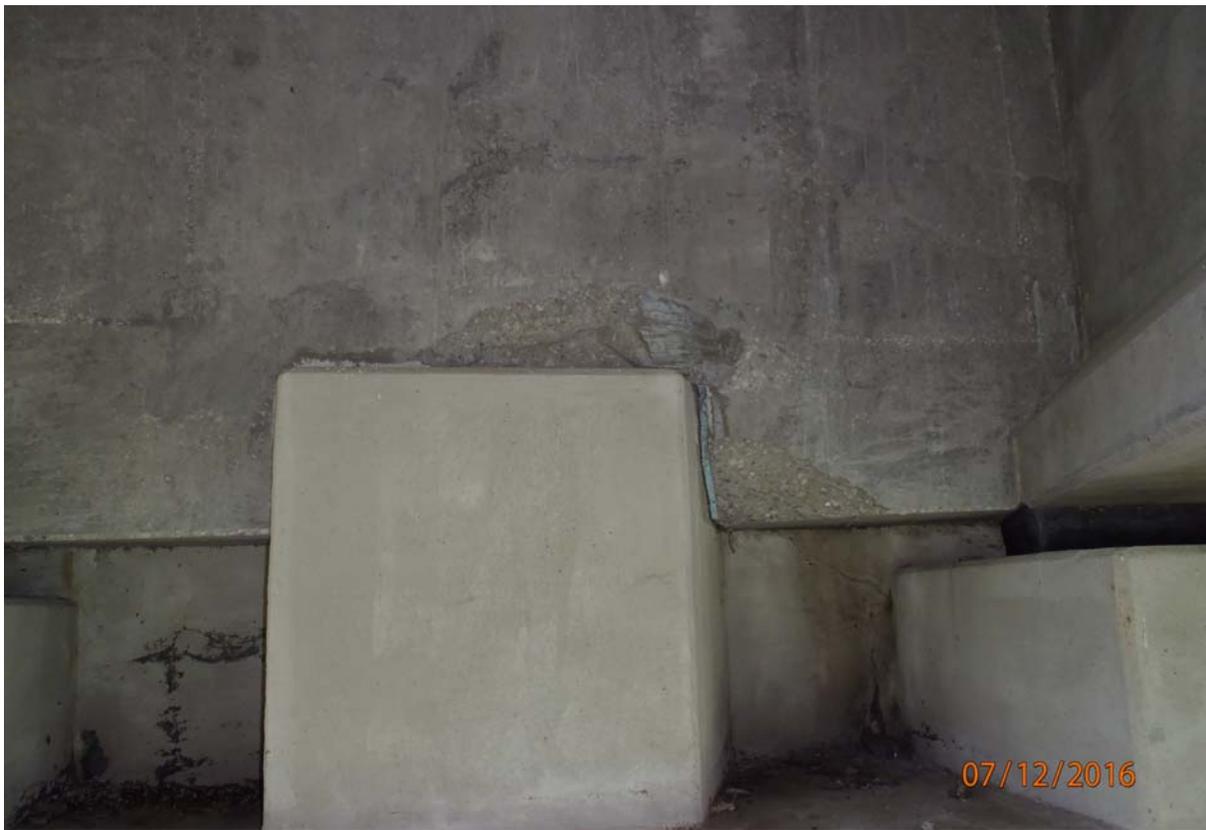
View of the shear key and diaphragm between beams 4 and 5 at abutment 6.
Note the spalling of the back-wall.

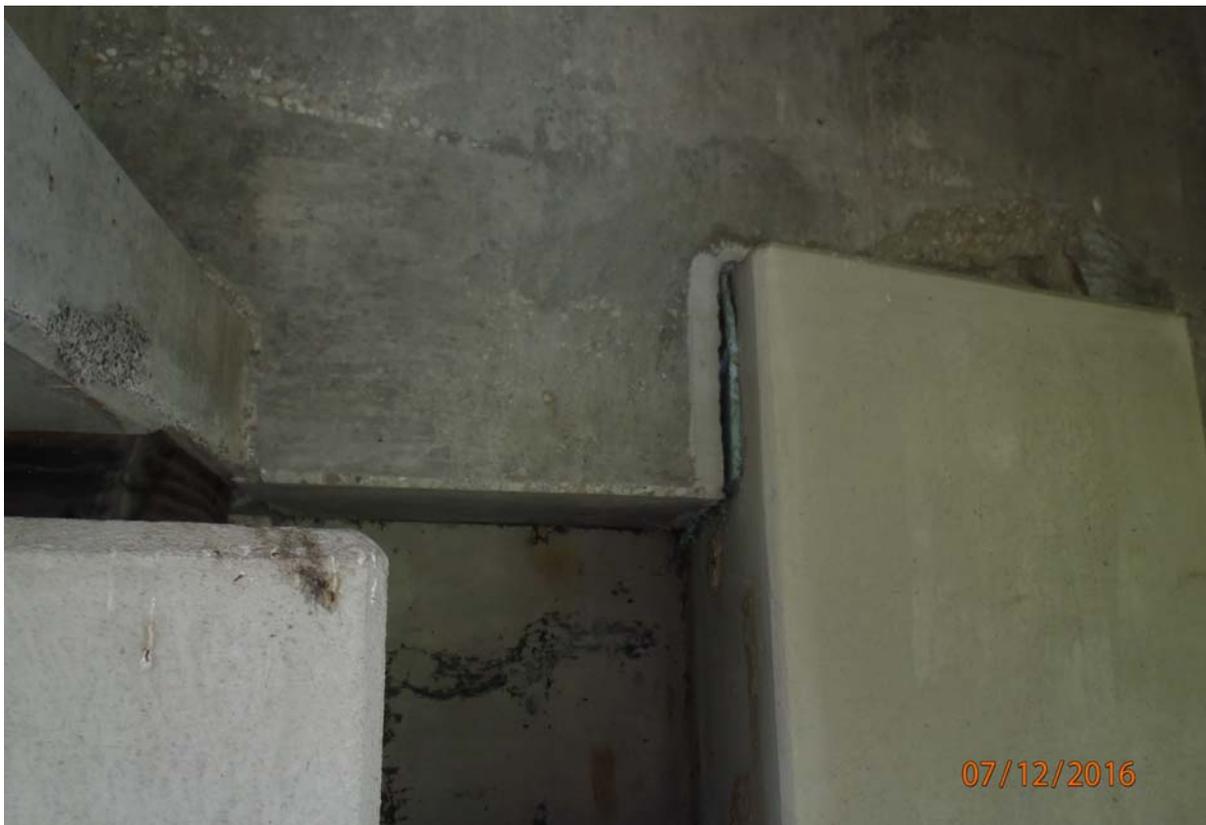
View of the shear key and diaphragm between beams 4 and 5 at abutment 6.
Note the gap/movement of the superstructure towards the downstream.
