Inspection Report with SI&A Data

Structure Description: 766.08 Foot - 5 Span Prestressed concrete continuous Stringer/Multi-beam or Girder

7 Facility Carried: US-62

6A Feature Intersected: LAWRENCE CREEK

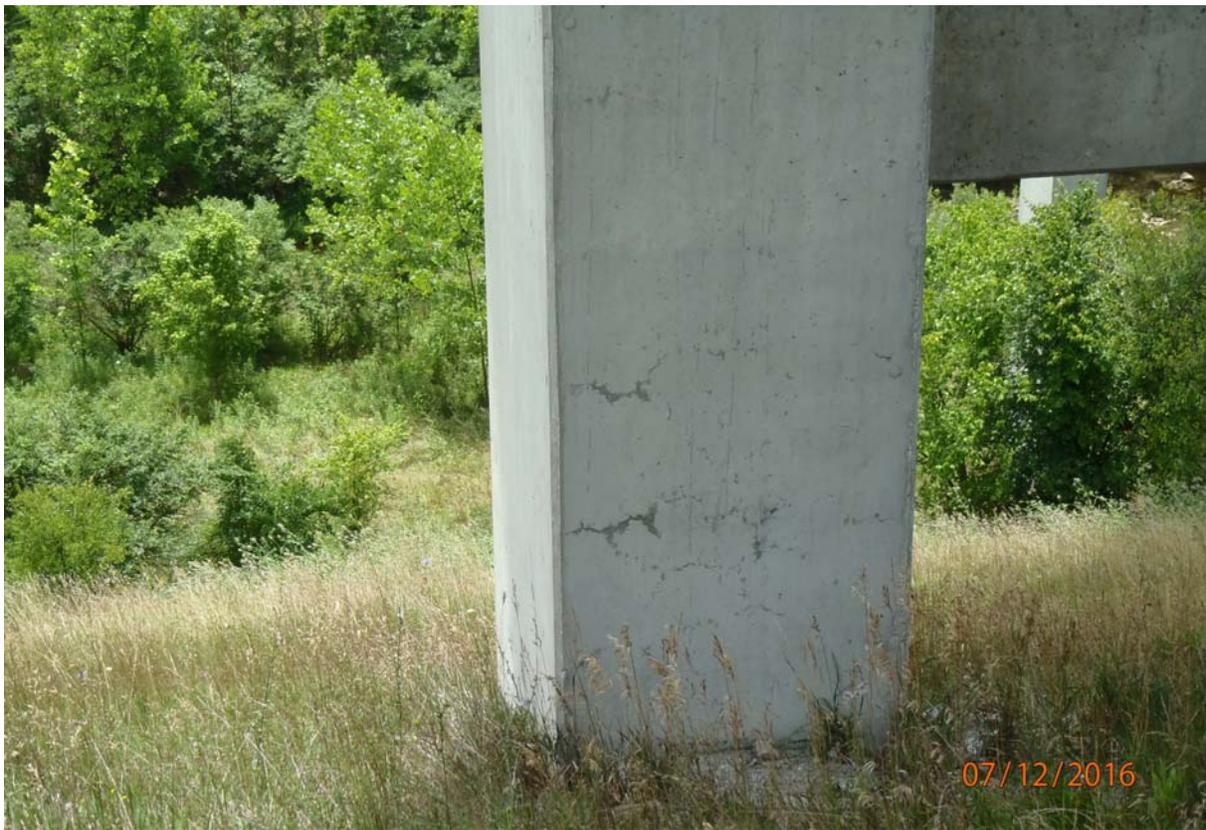
View of minor cracking on the north face of the upstream column of pier 5.

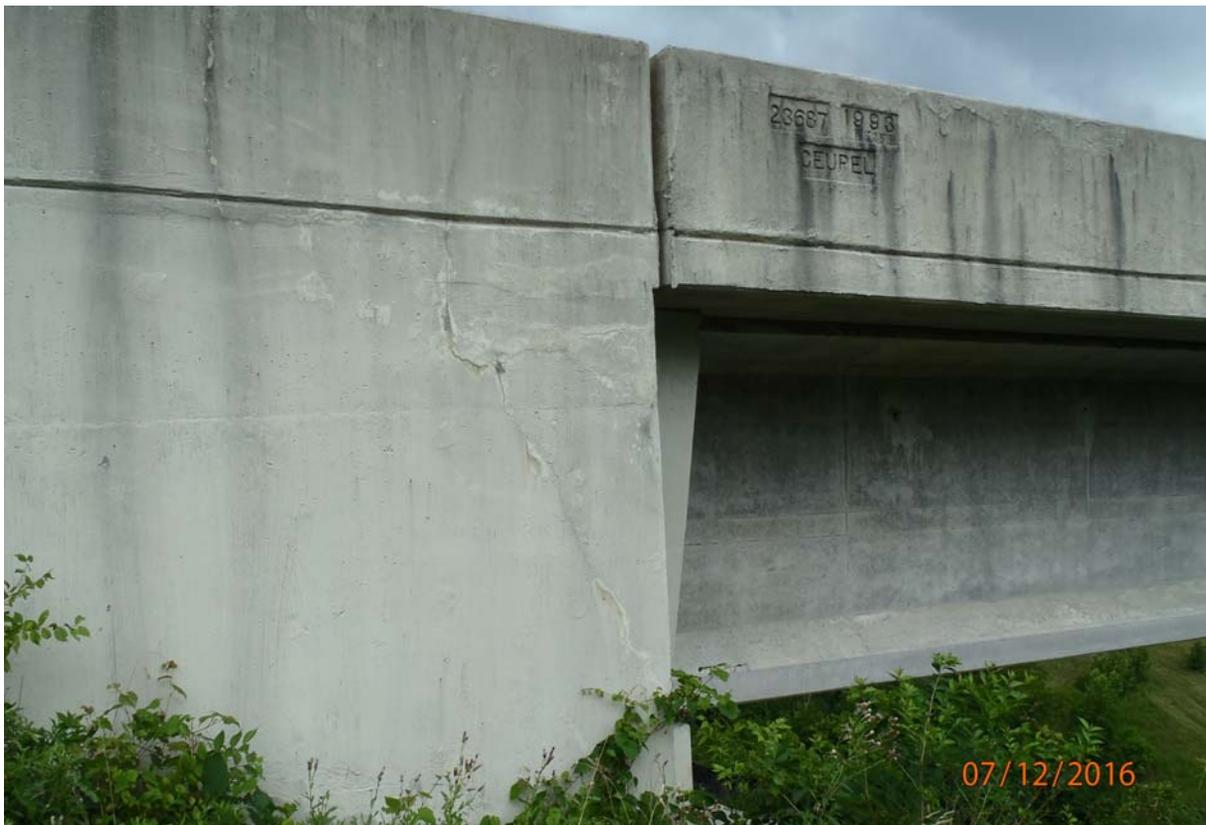
View the upstream wingwall of abutment 1 (Wingwall B per plans).
Note the shear cracking with effloresce staining.

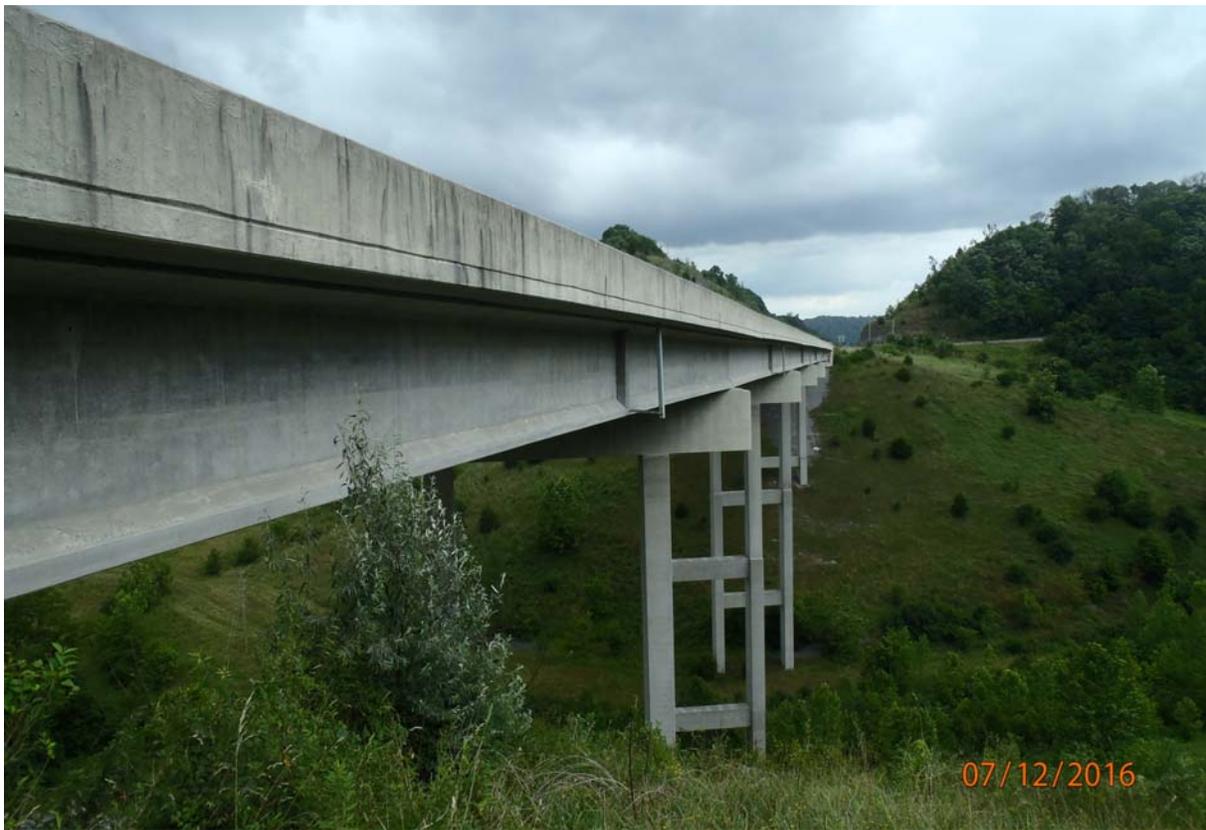
View along the upstream face of beam 6 looking from abutment 1.
Note the waviness of the superstructure.

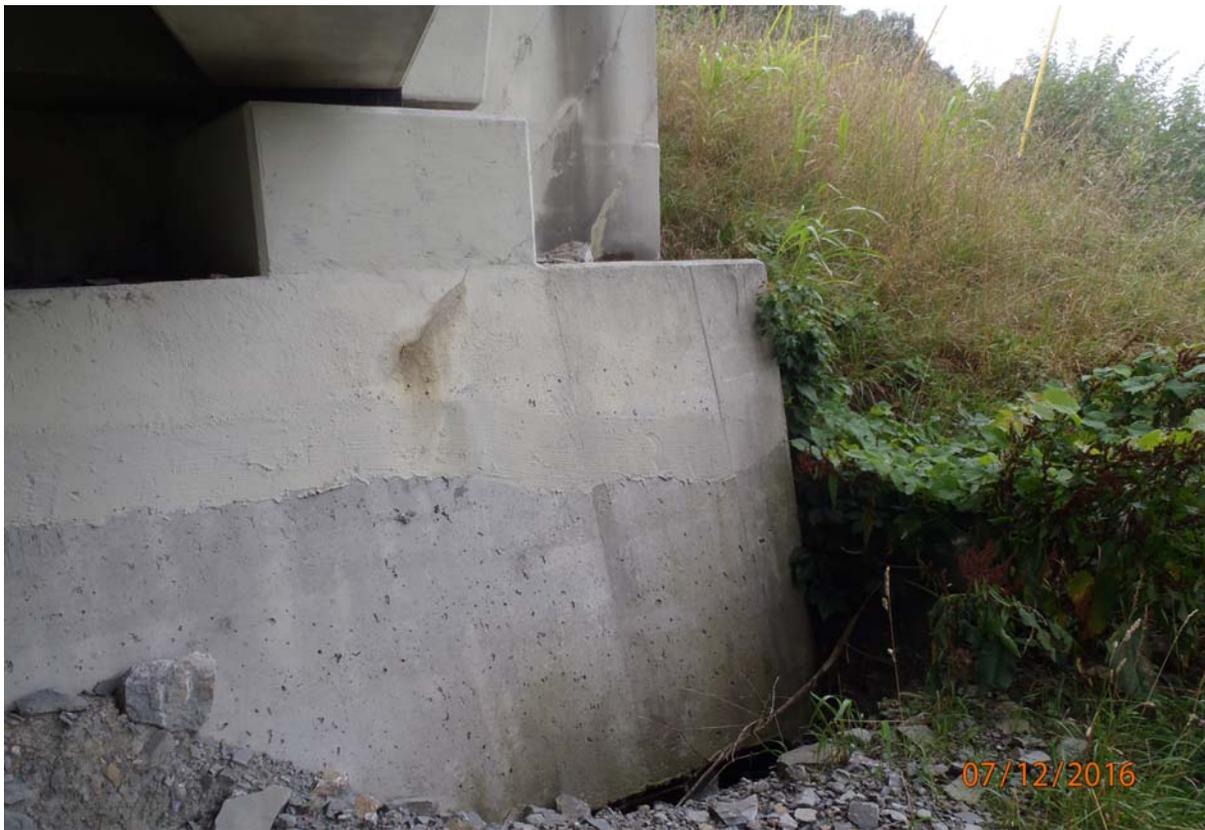
View of erosion and voided area/undermining of the downstream side of the pile cap of abutment 1 at/near beam 1. No piles are exposed or could be detected.

Generated by user "BJONES" on 8/11/2016 Repair erosion around abutment 1.

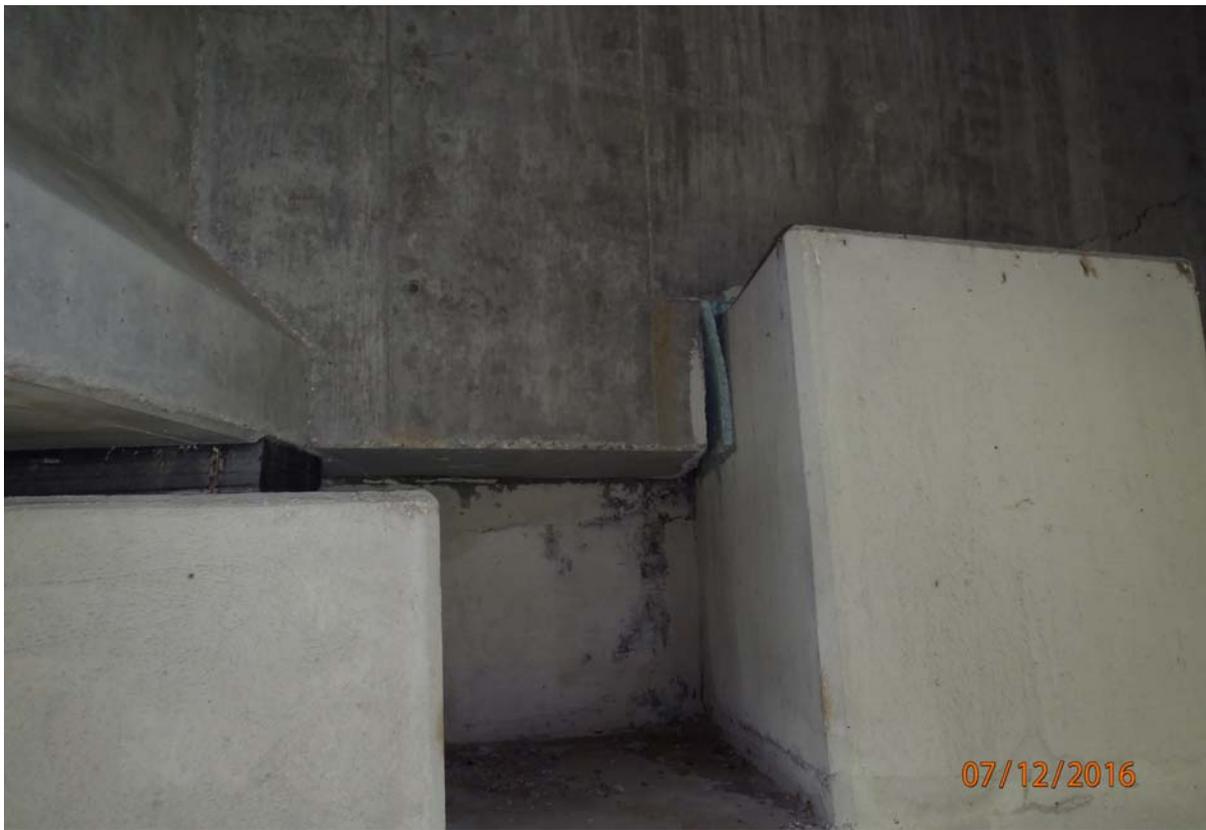
View of the horizontal gap between the diaphragm and shear block between beams 4 and 5 at abutment 1; indicating the superstructure has moved towards the upstream at this location.

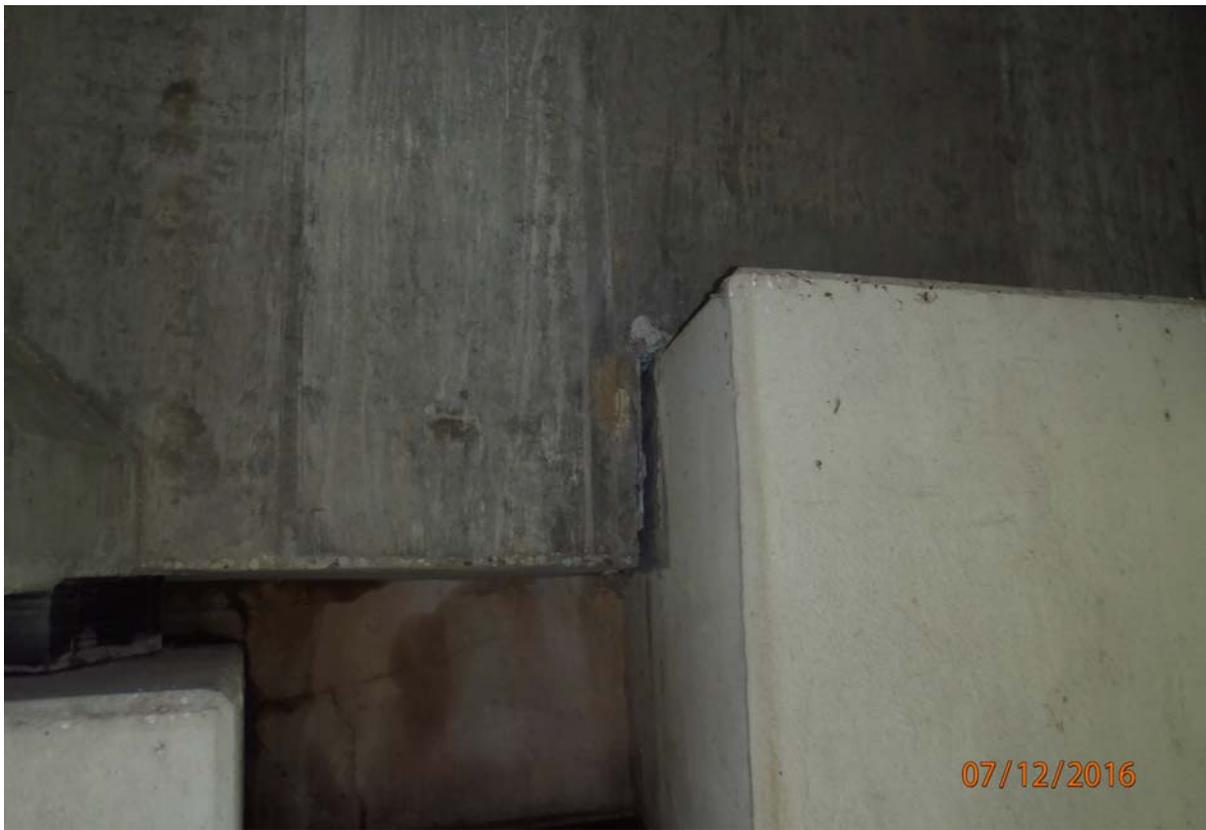
View of the horizontal gap between the diaphragm and shear block between beams 2 and 3 at abutment 1; indicating the superstructure has moved towards the downstream at this location.

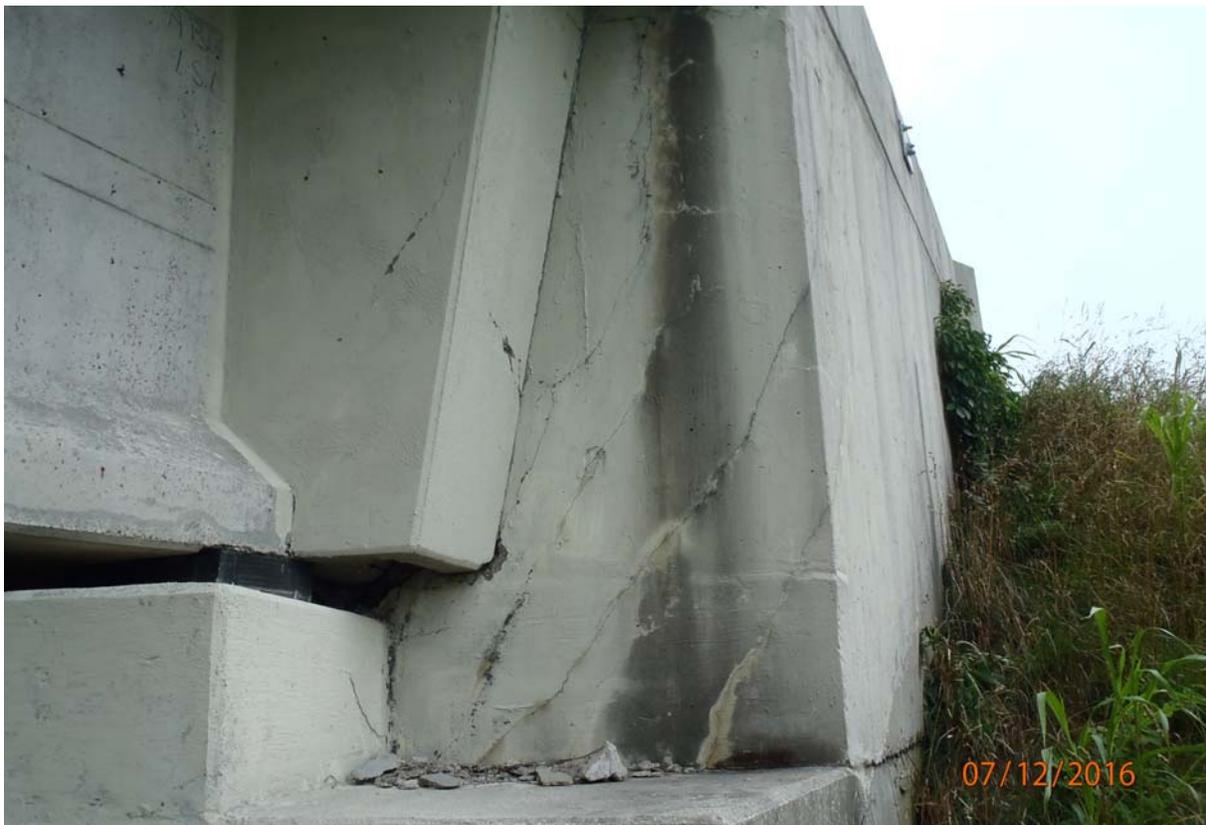
View of the back-wall downstream of beam 6.
Note the cracking in the back.

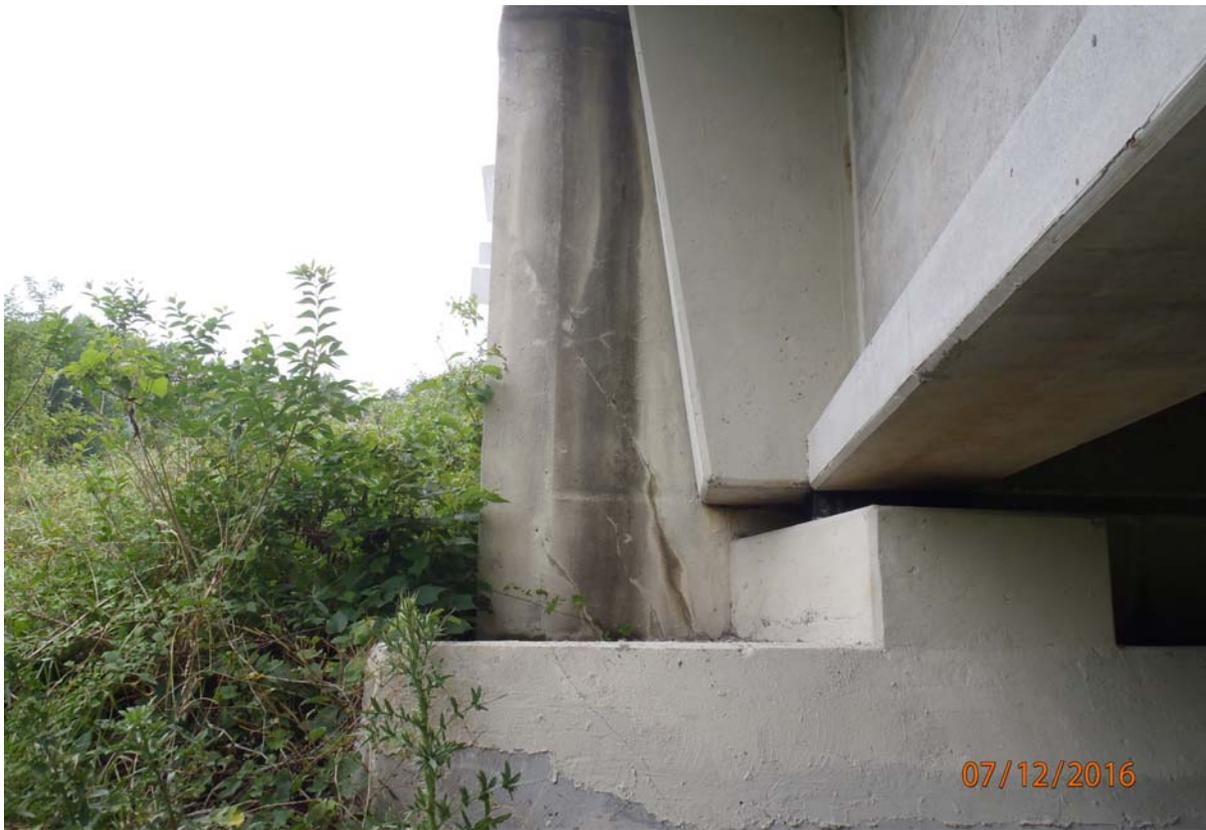
View of the back-wall upstream of beam 1.
Note the cracking in the back.

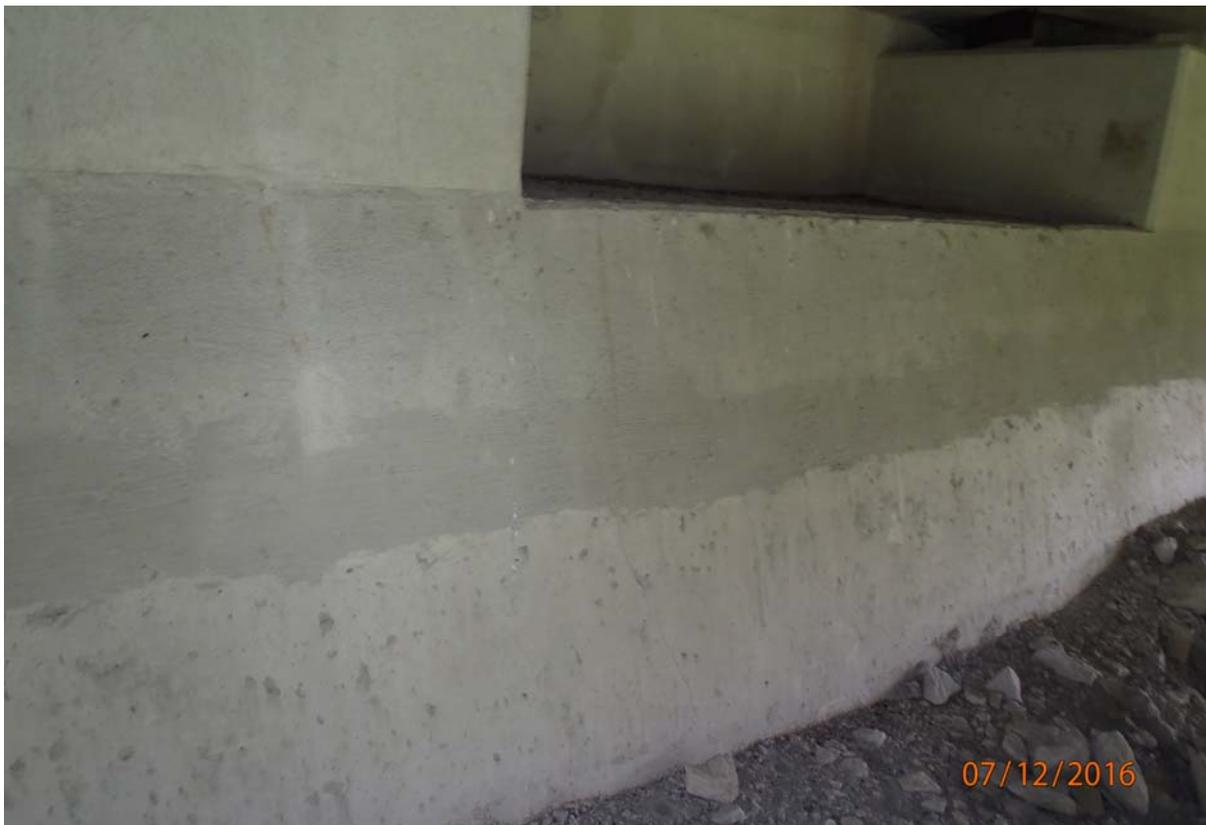
View of typical minor vertical cracking under the beam seats
and spaced throughout between the beam seats of abutment 1.

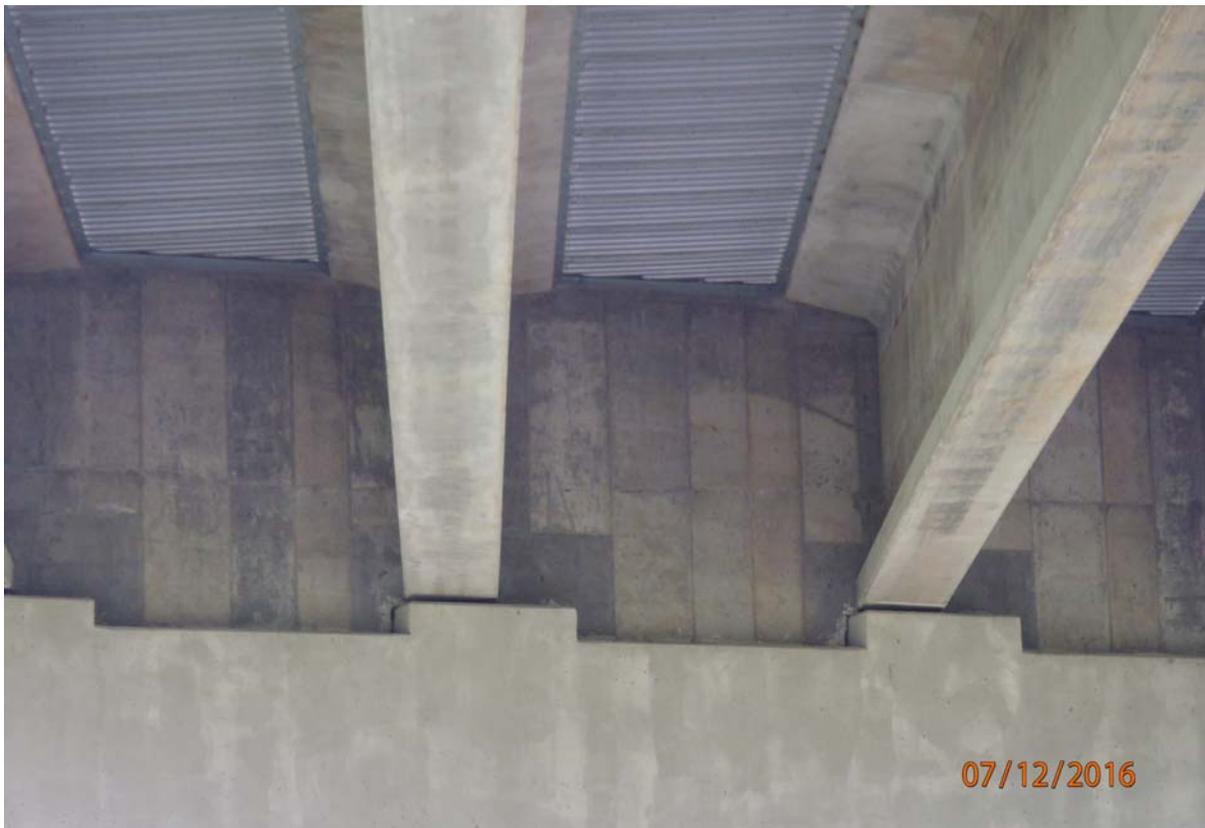
View of the south face of the diaphragm and superstructure of span 1 at pier 2. Note the gap between the diaphragm and beam seats indicating the superstructure has moved towards the downstream.
