## Inspection Report with SI&A Data

**Structure Description:** 121.06 Foot - Single Span Steel Truss - Thru

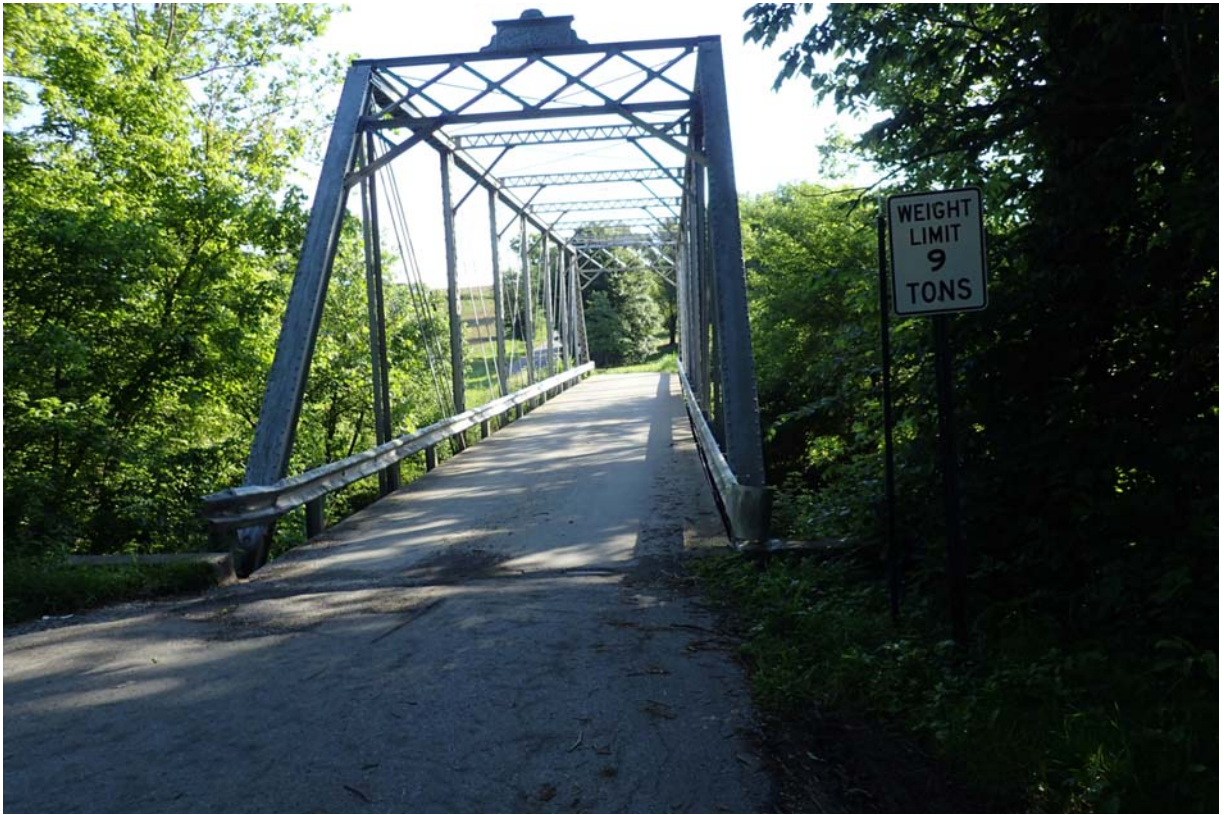
View of the west 9 tons posting.

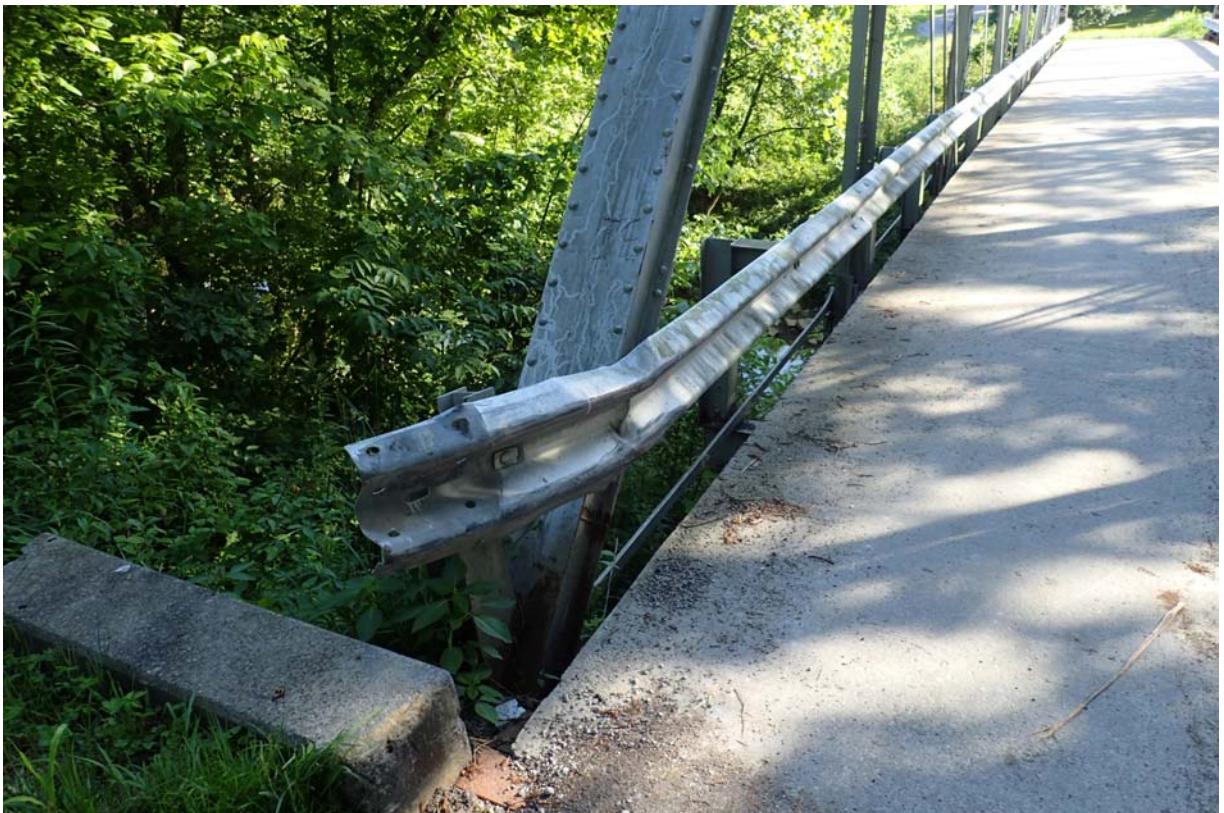
View of moderate impact damage to the downstream rail at the west abutment.

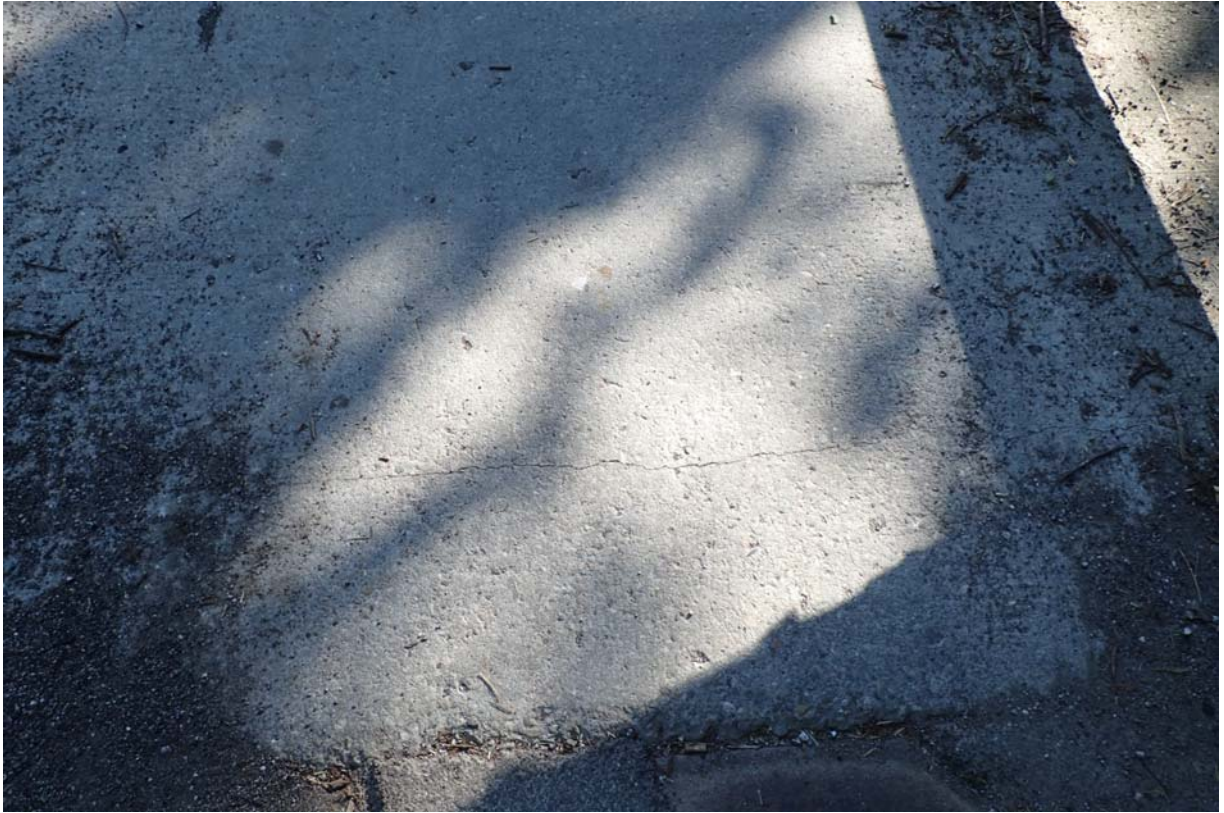
View of minor sized transverse cracking in the wearing surface near the west abutment.

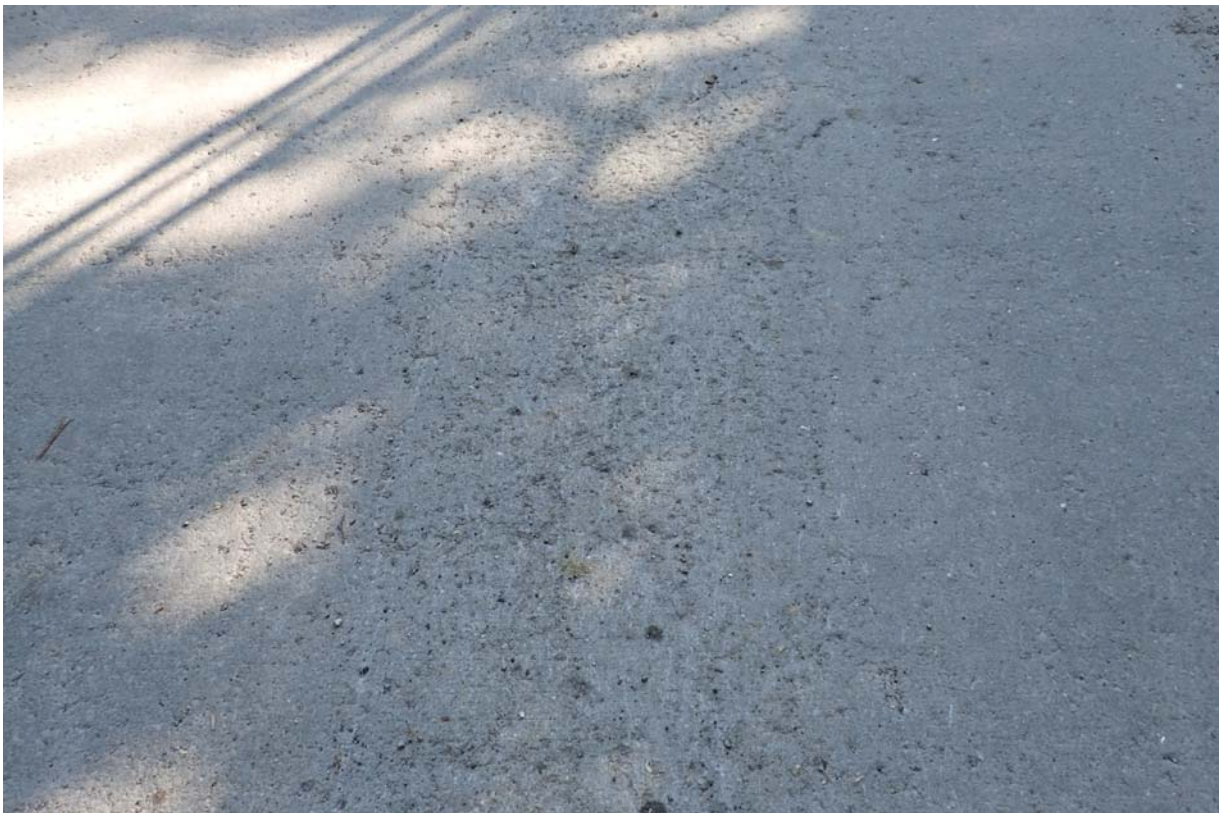
The wearing surface is rough along the centerline of the bridge. This is in Amish country and the bridge sees alot of horseshoes.

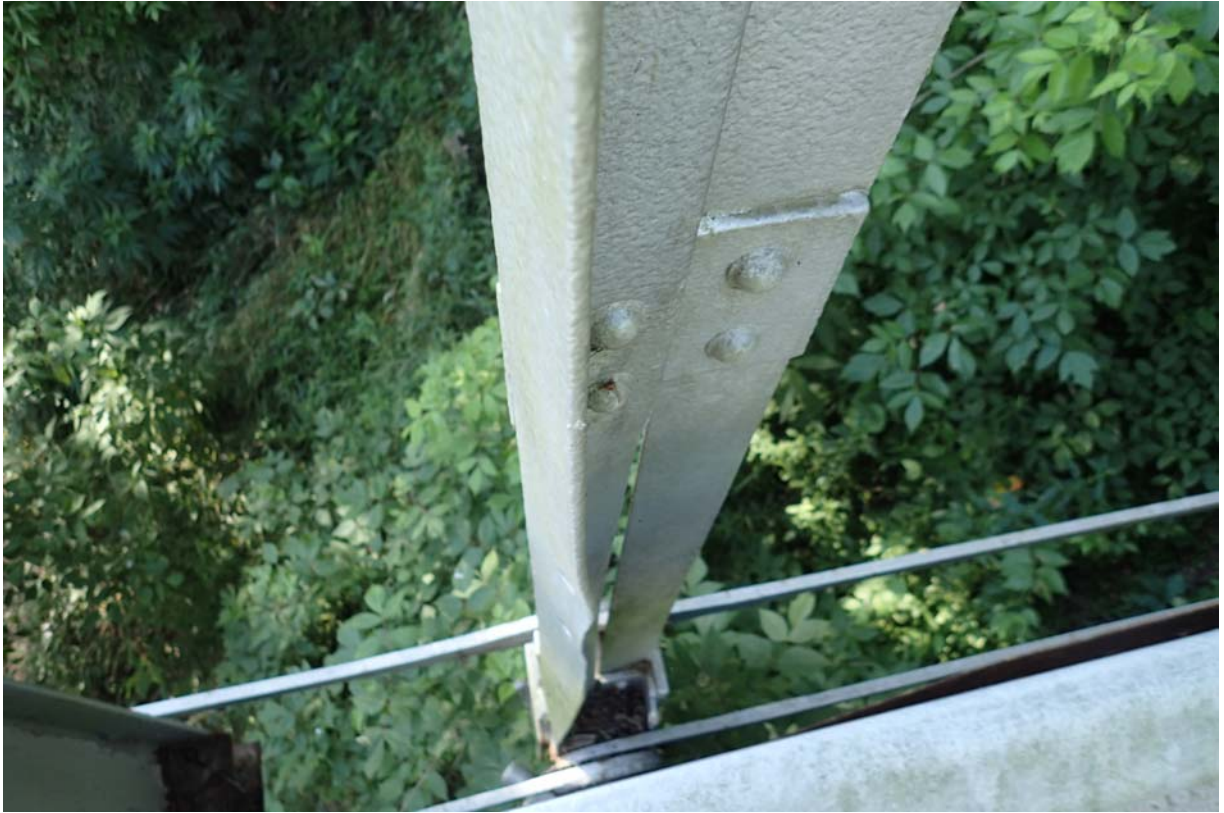
View of a bend in the lower section of the upstream L1 vertical.

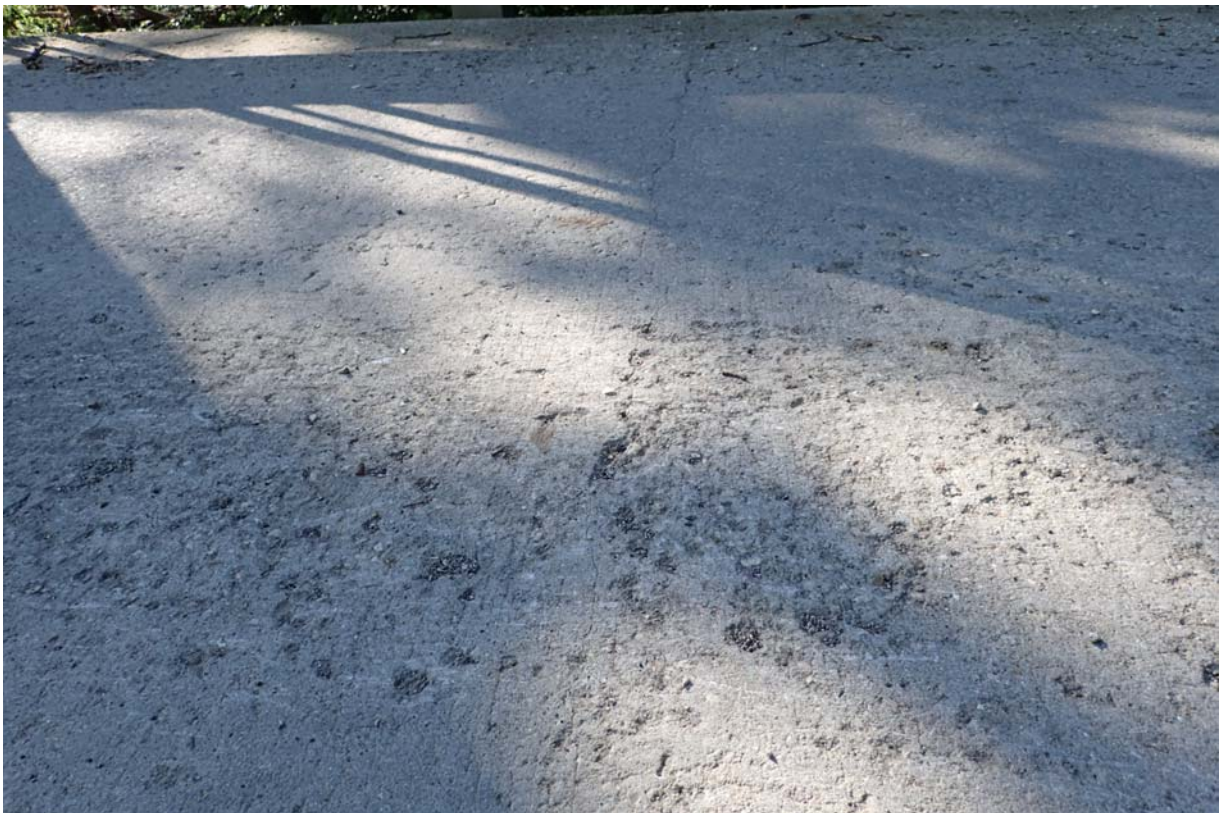
View of a minor sized full width transverse crack in the wearing surface between the L1 and L2 connections.

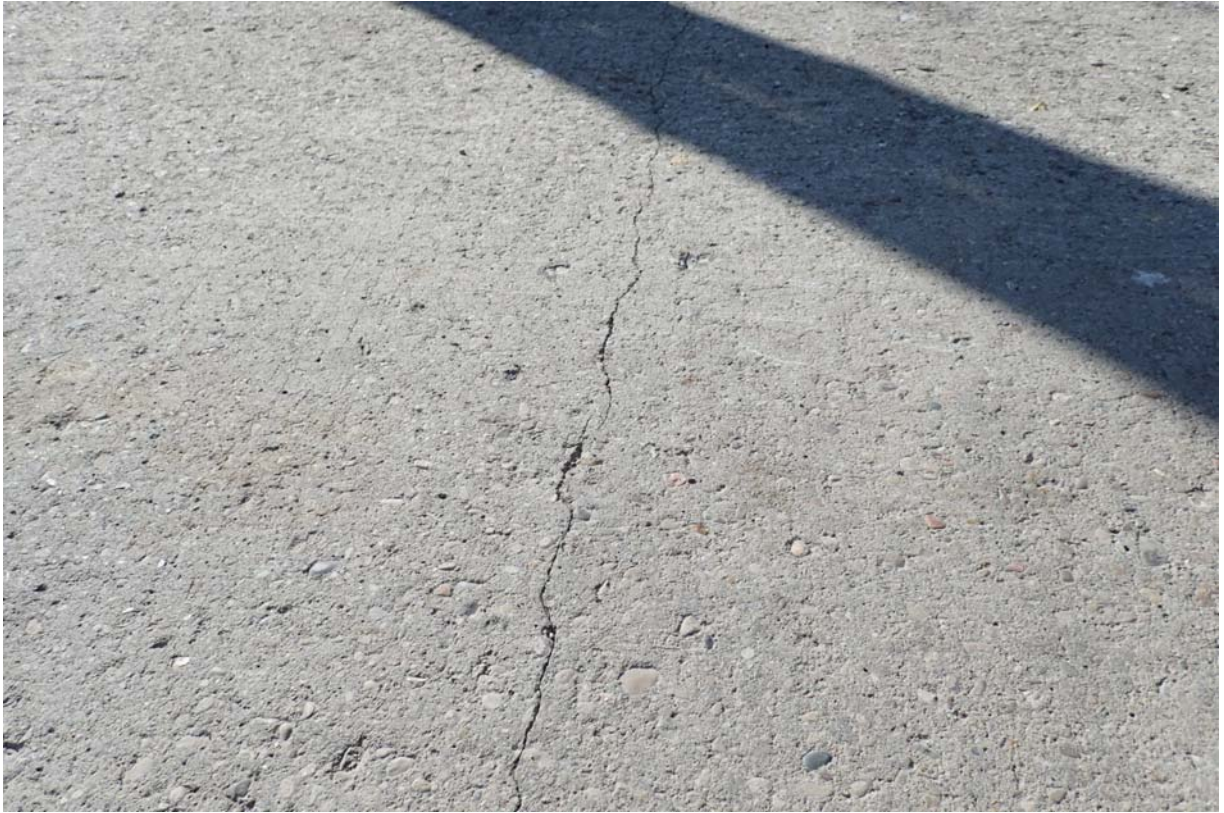
View of a minor sized full width transverse crack in the wearing surface between the L4 and L5 connections.

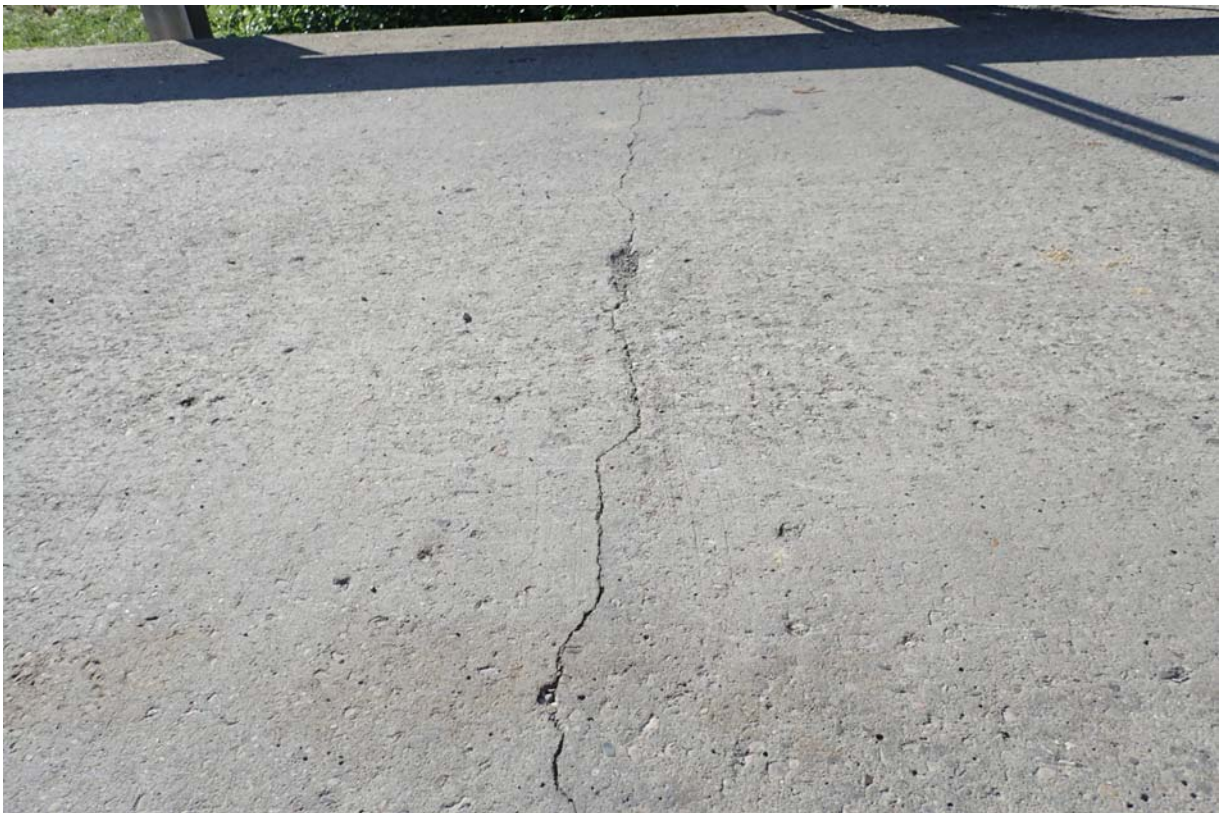
View of a more moderate sized (~1/16") full width transverse crack in the wearing surface near the L5 connection.

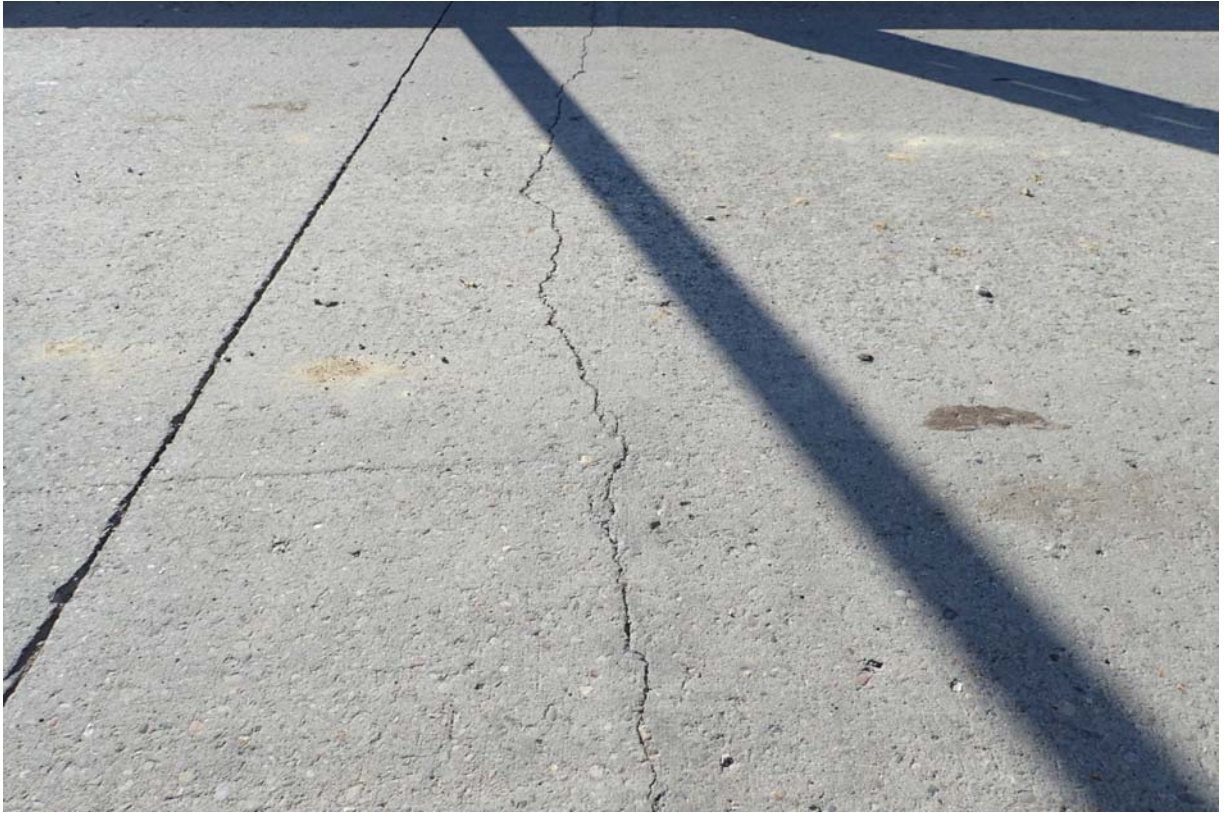
View of a more moderate sized (~1/16") full width transverse crack in the wearing surface near the L6 connection.

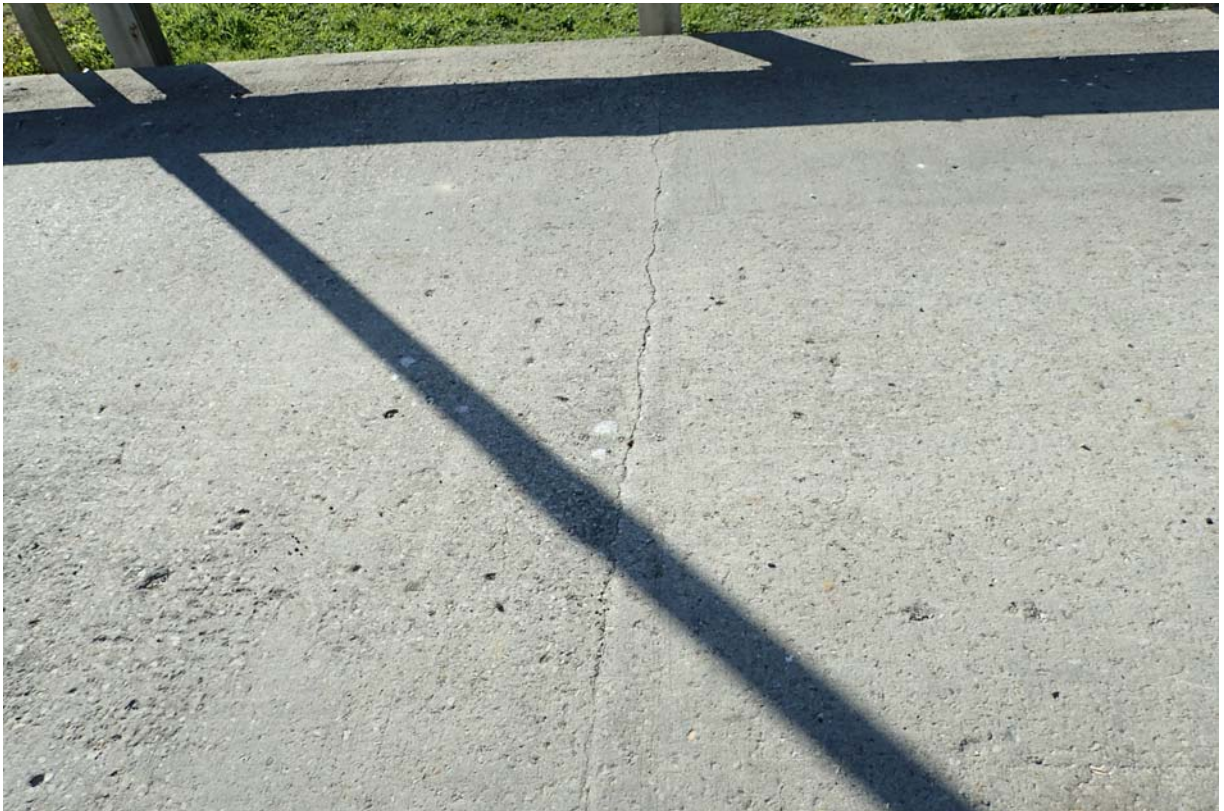
View of a minor sized full width transverse crack in the wearing surface between the L6 and L7 connections.

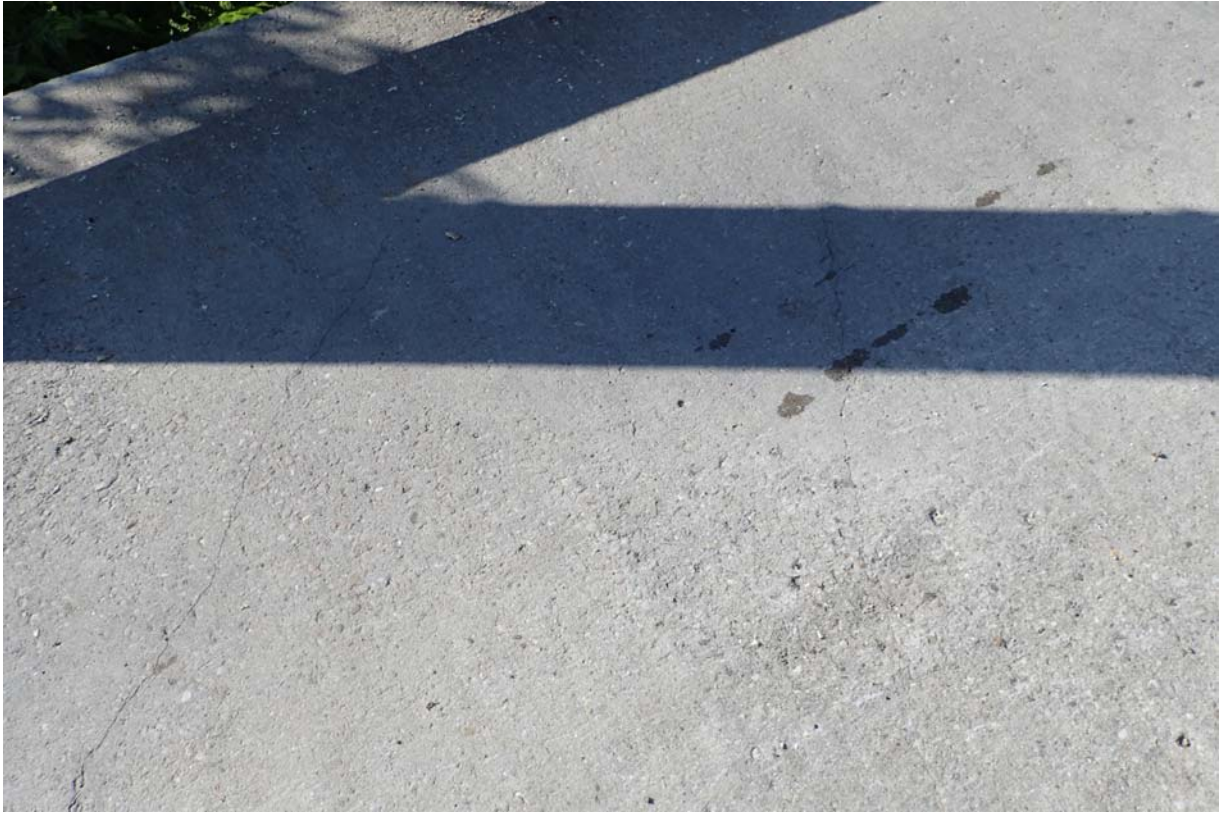
View of 2 minor (there is actually 3, one is not visible in photo) sized diagonal trending cracks in the wearing surface between the L7 and L8 connections

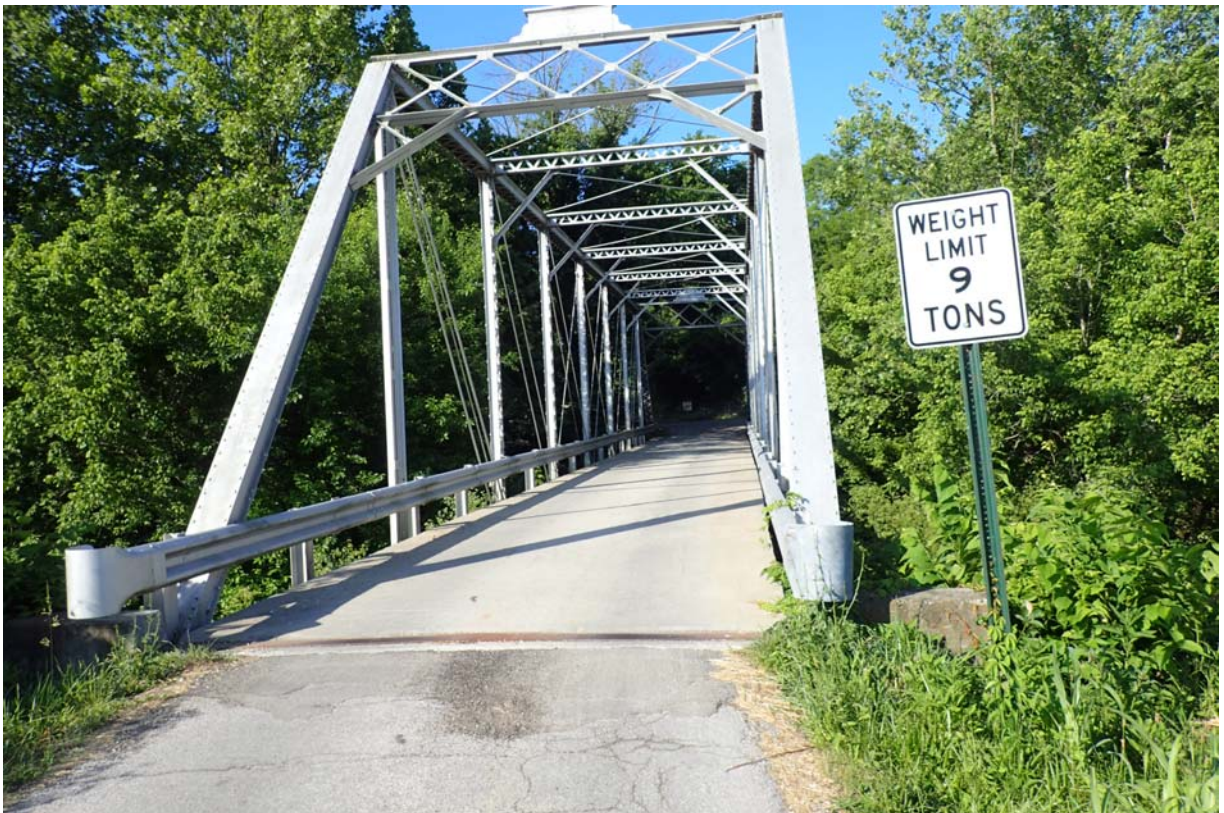
View of the east 9 tons posting.

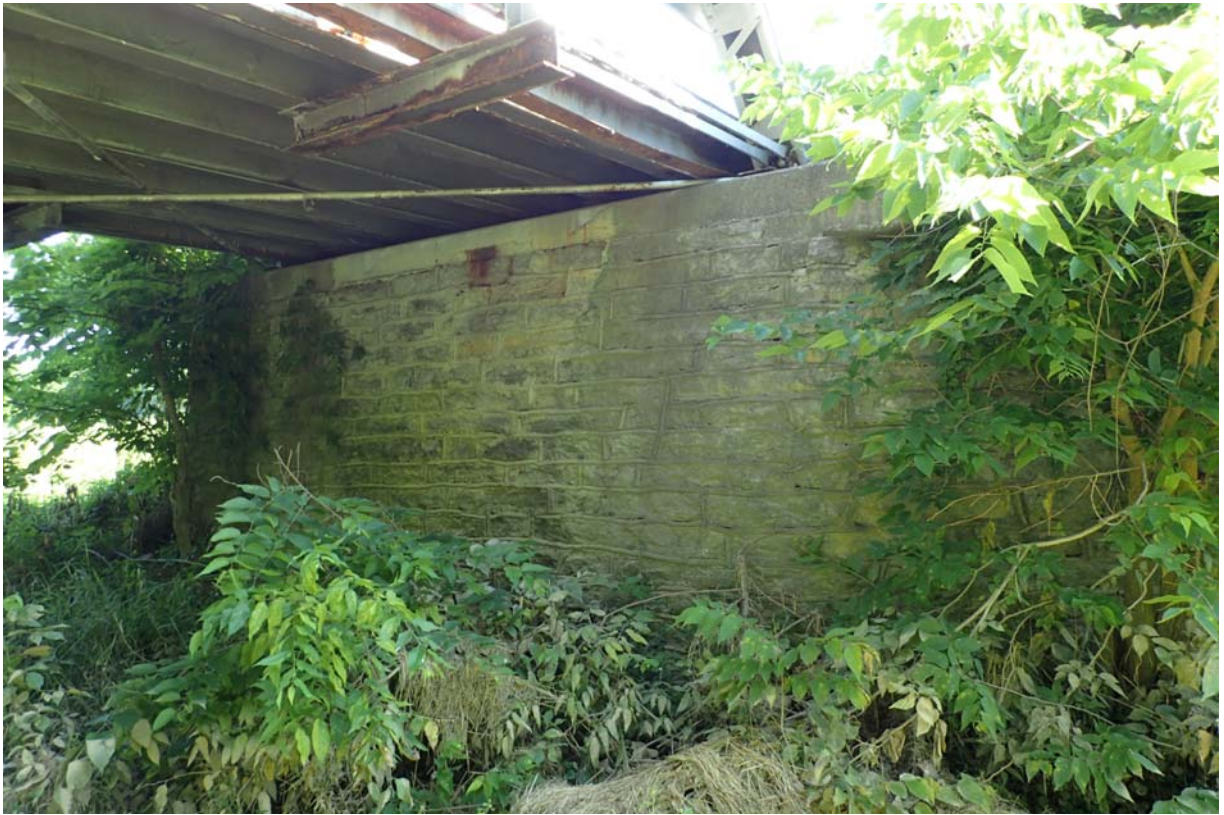
Typical view of the east abutment. Notice the minor sized horizontal cracking in the concrete cap.

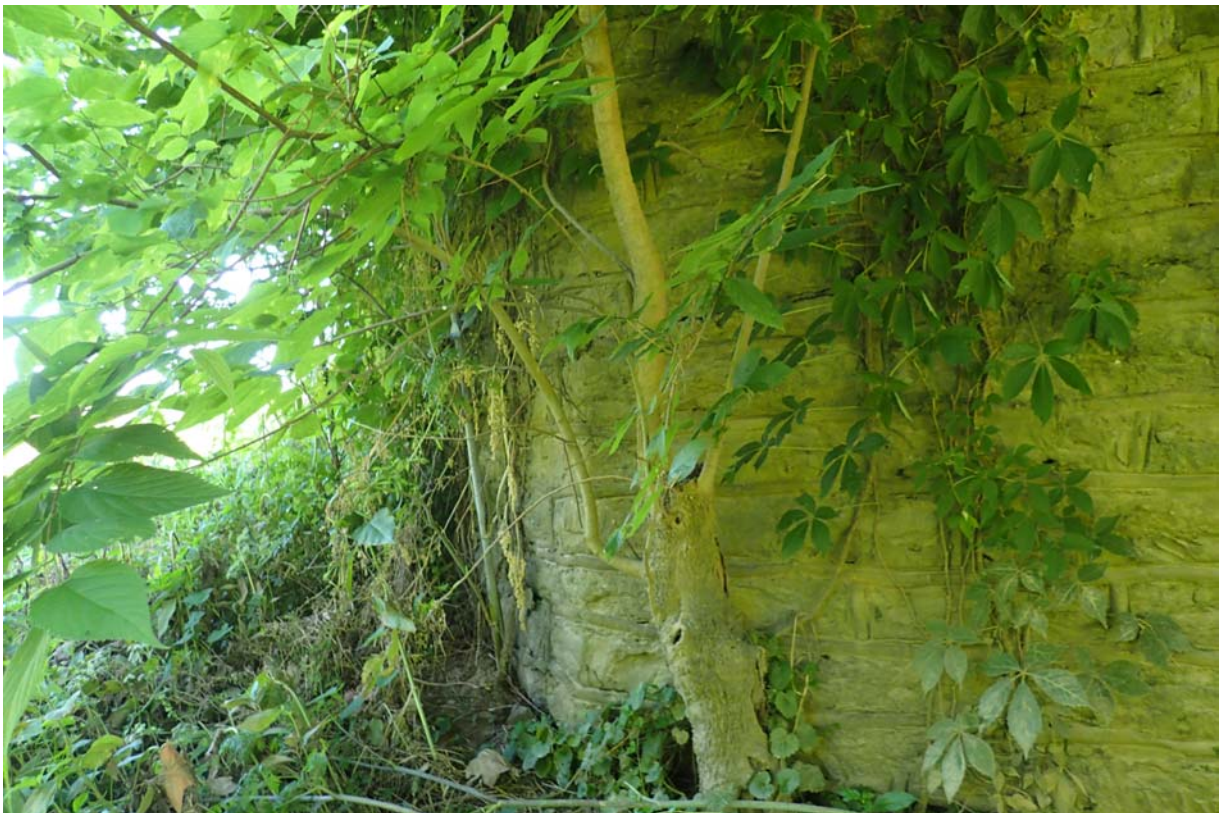
View of heavy vegetation growth at the downstream end of the east abutment.

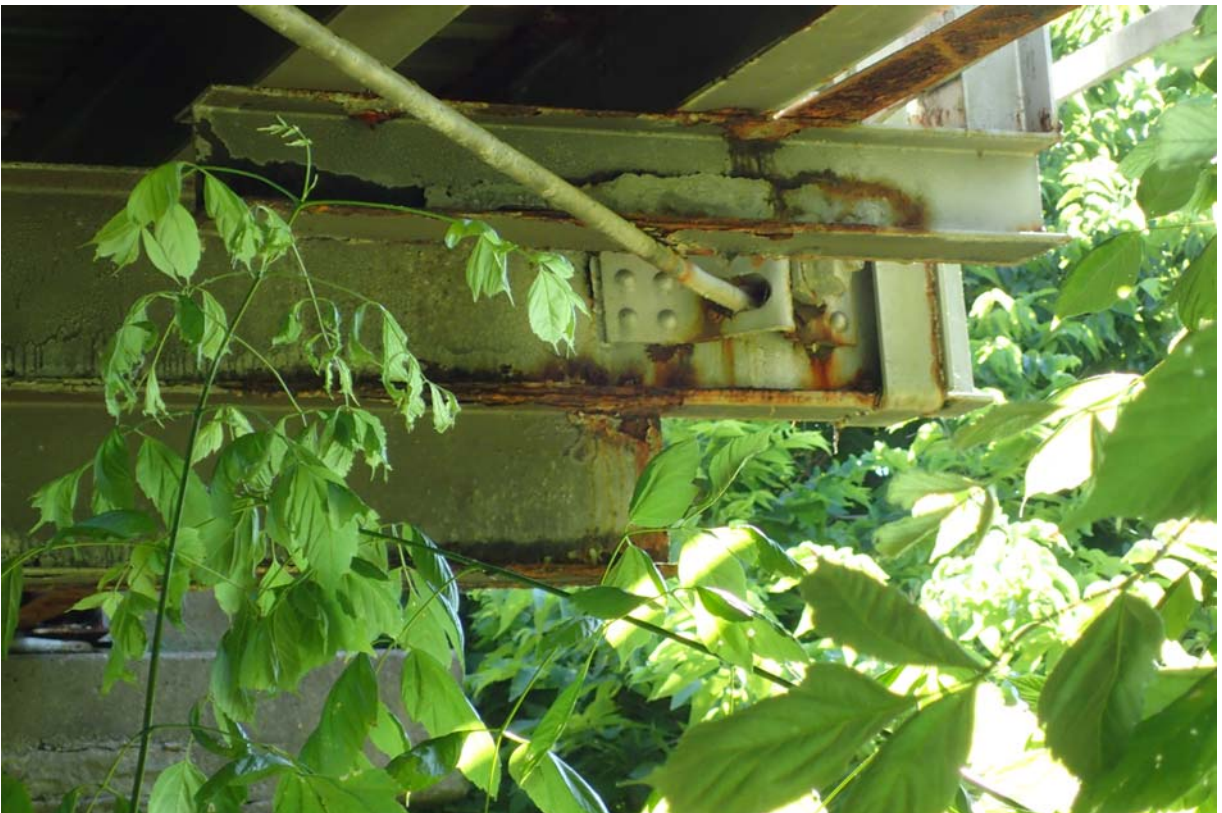
Typical view of heavy corrosion at the upstream end of the floorbeam at L7.

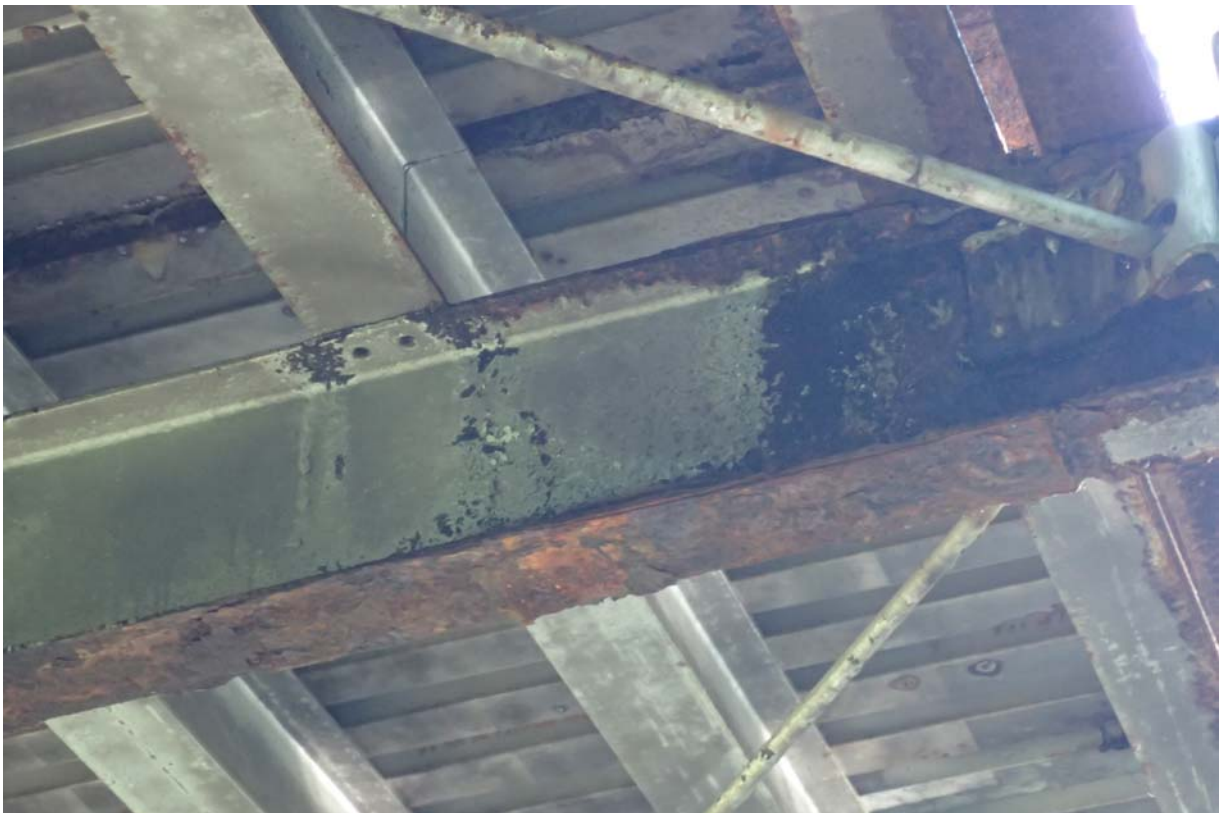
View of the floorbeam near the upstream L2 connection. Notice that the retrofitted floorbeam that was welded to the bottom flange of the original floorbeam has fallen off. Note the heavy corrosion.

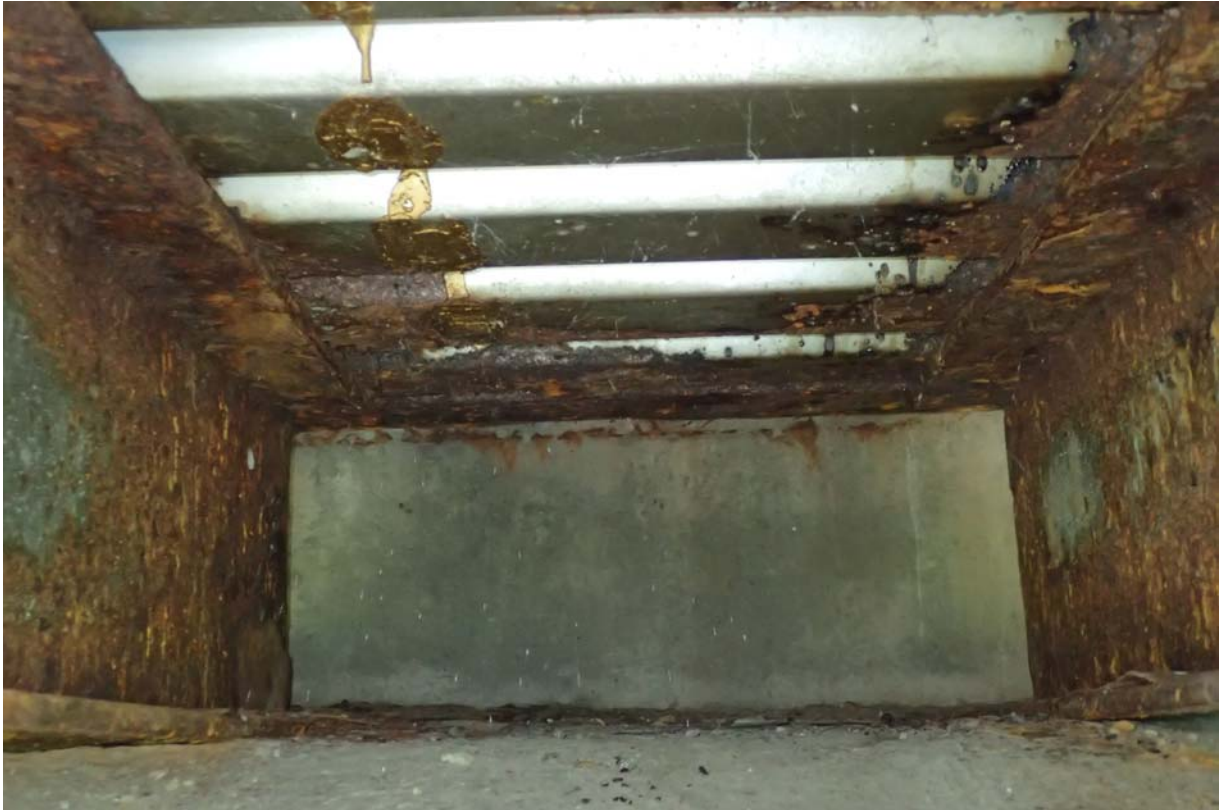
Typical view of moderate to heavy corrosion of the stringer ends at the west abutment.

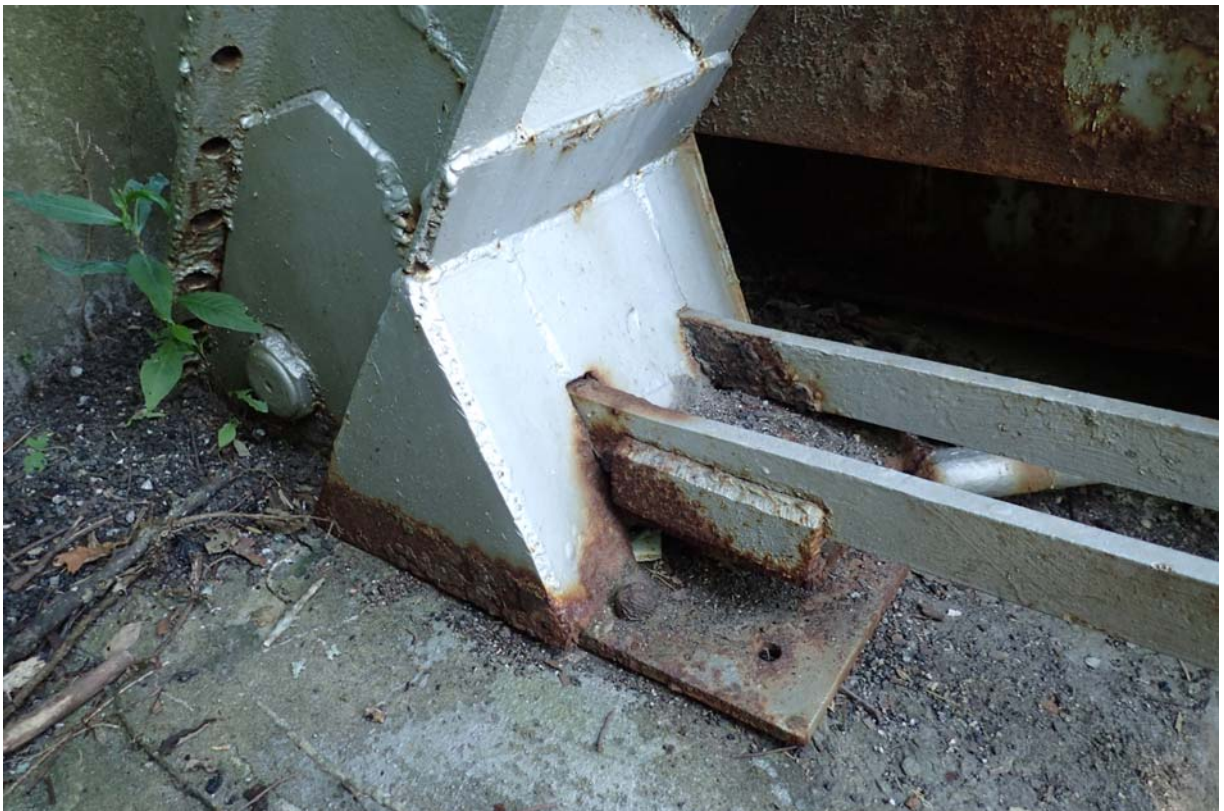
Typical view of the upstream bearing at the west abutment.
