Inspection Date: 10/20/2011
 Inspector: GCRUMP (26)
 Primary Type: Substandard (12 Months)

Bridge ID (8):	042C00252N MAP BRIDGE	District Number:	1
Route Carried (7):	CANTER PIT ROAD	County (3):	83 Graves
Mile Point:	0.67	Feature Intersected (6):	CALDWELL CREEK
Location (9):	.6 MI S OF JCT CR 5221	Road Name:	CANTER PIT RD
Structure Description:	64.96 Foot - 3 Span Wood or Timber Stringer/Multi-beam or Girder

KYTC Bridge Inspection Report

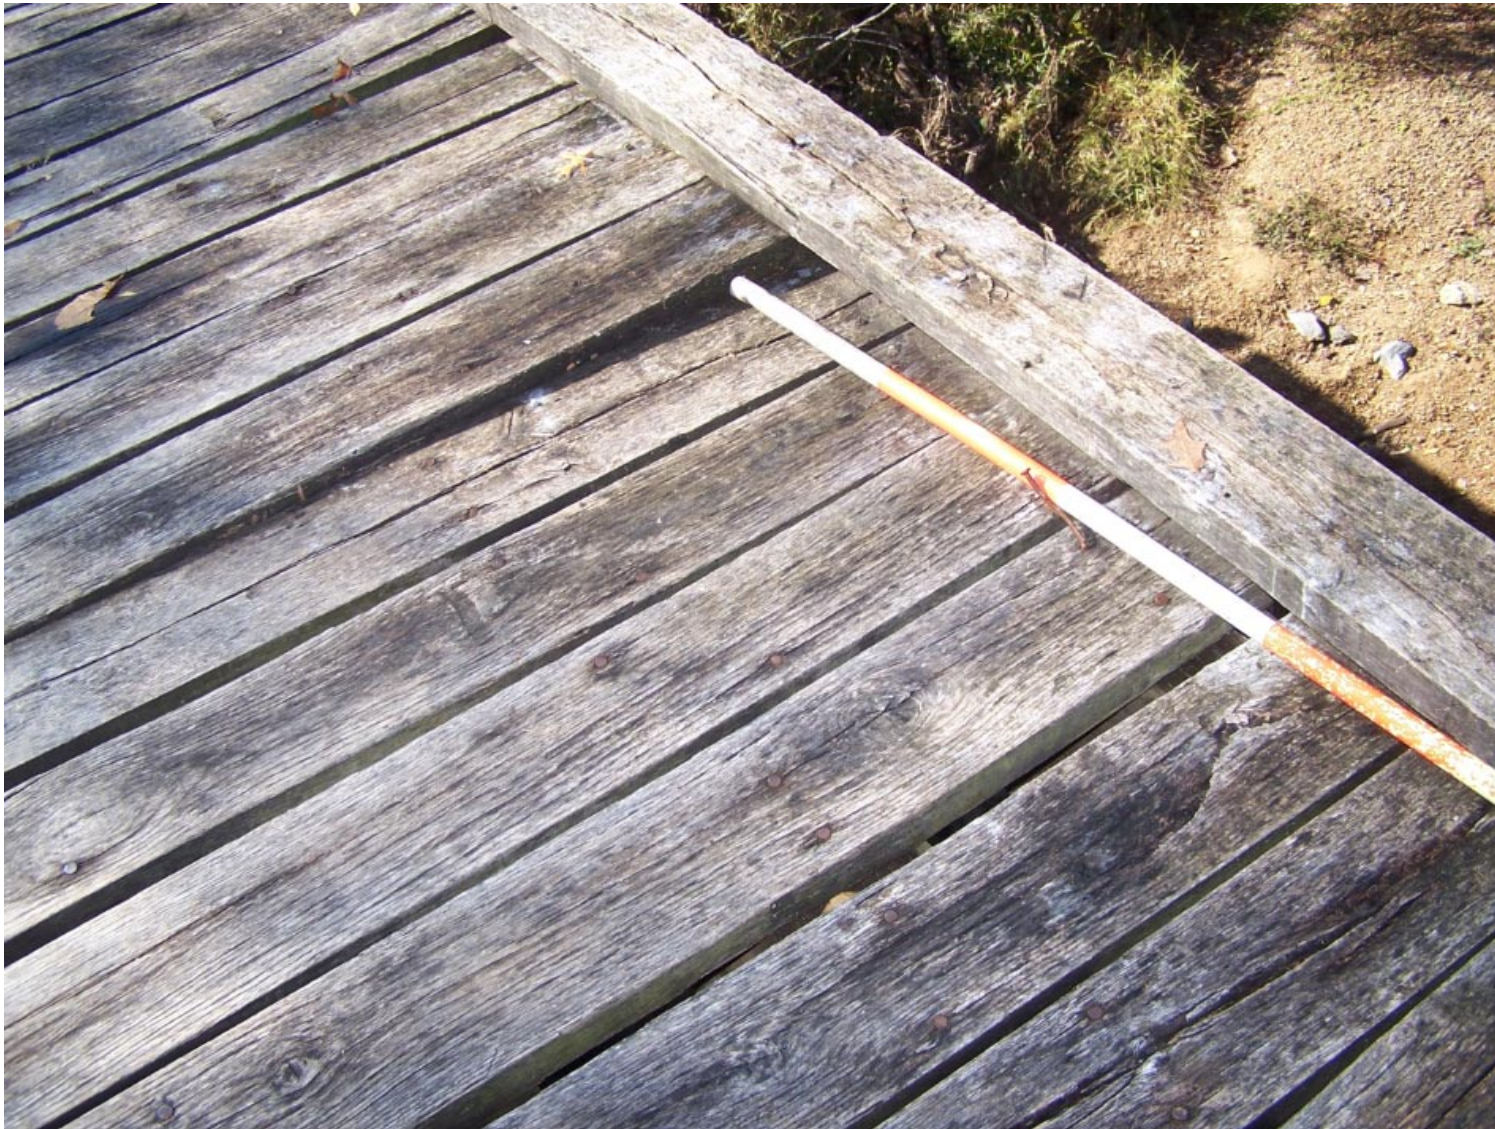
042-C252
LOOSE BOARDS
10/20/2011

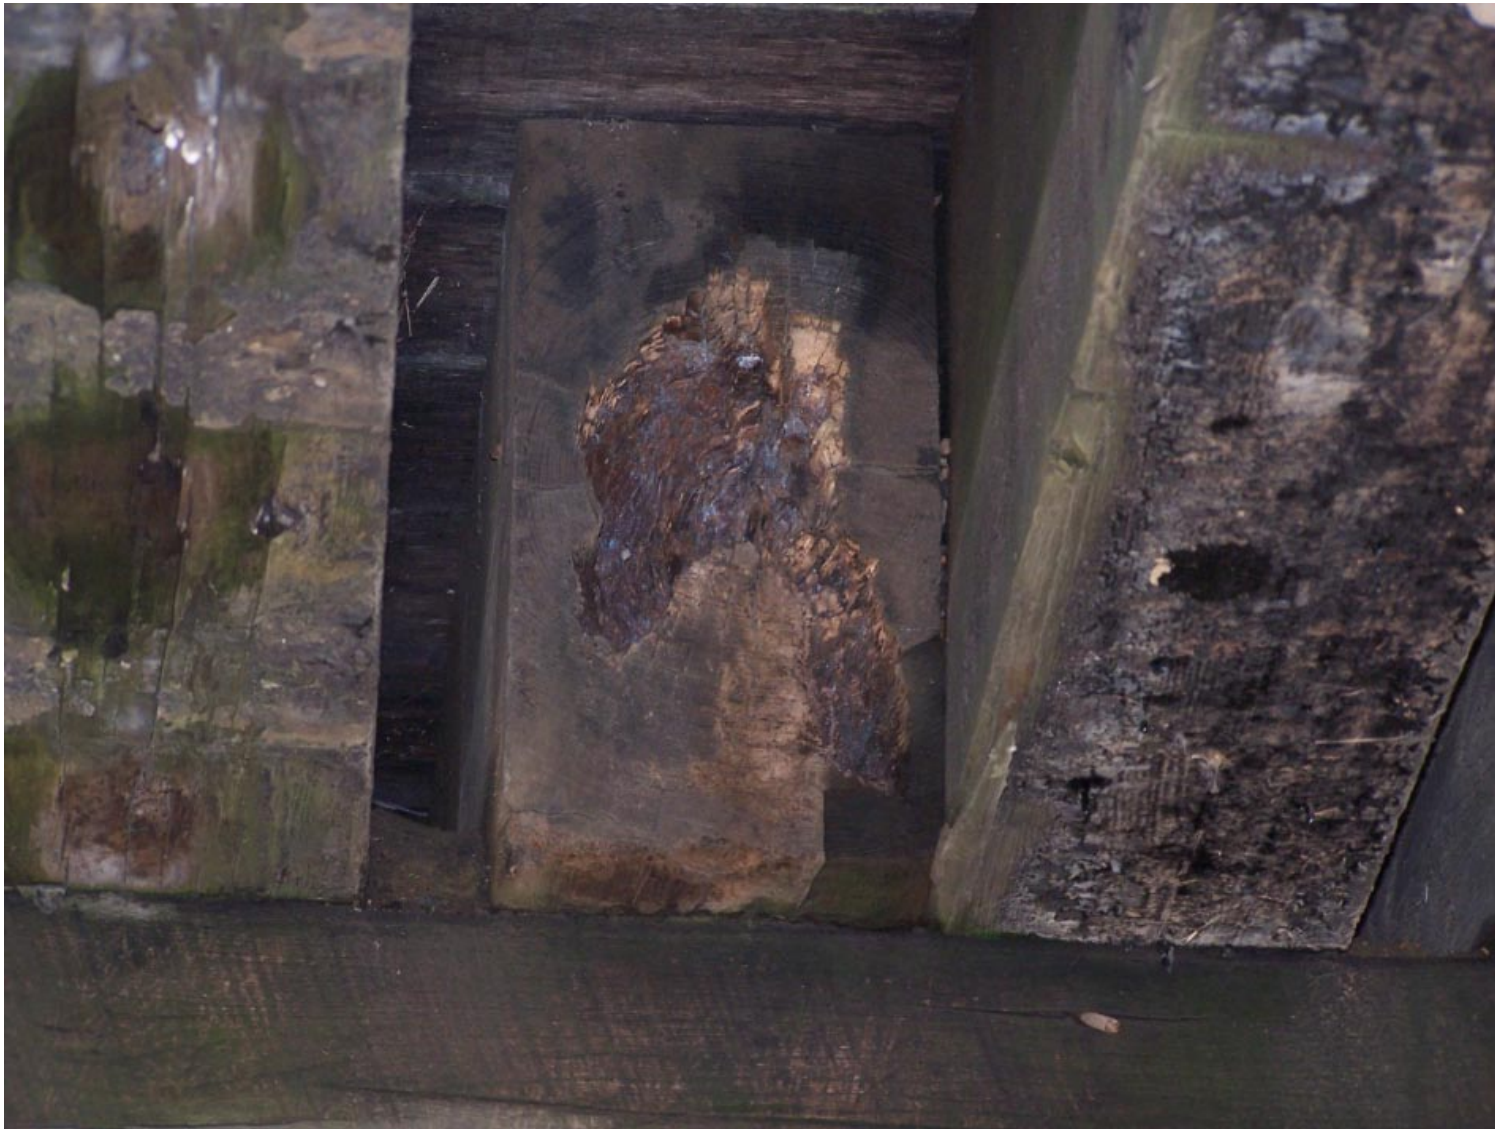
042-C252
DECAYED BEAM END OVER BENT 3
10/20/2011

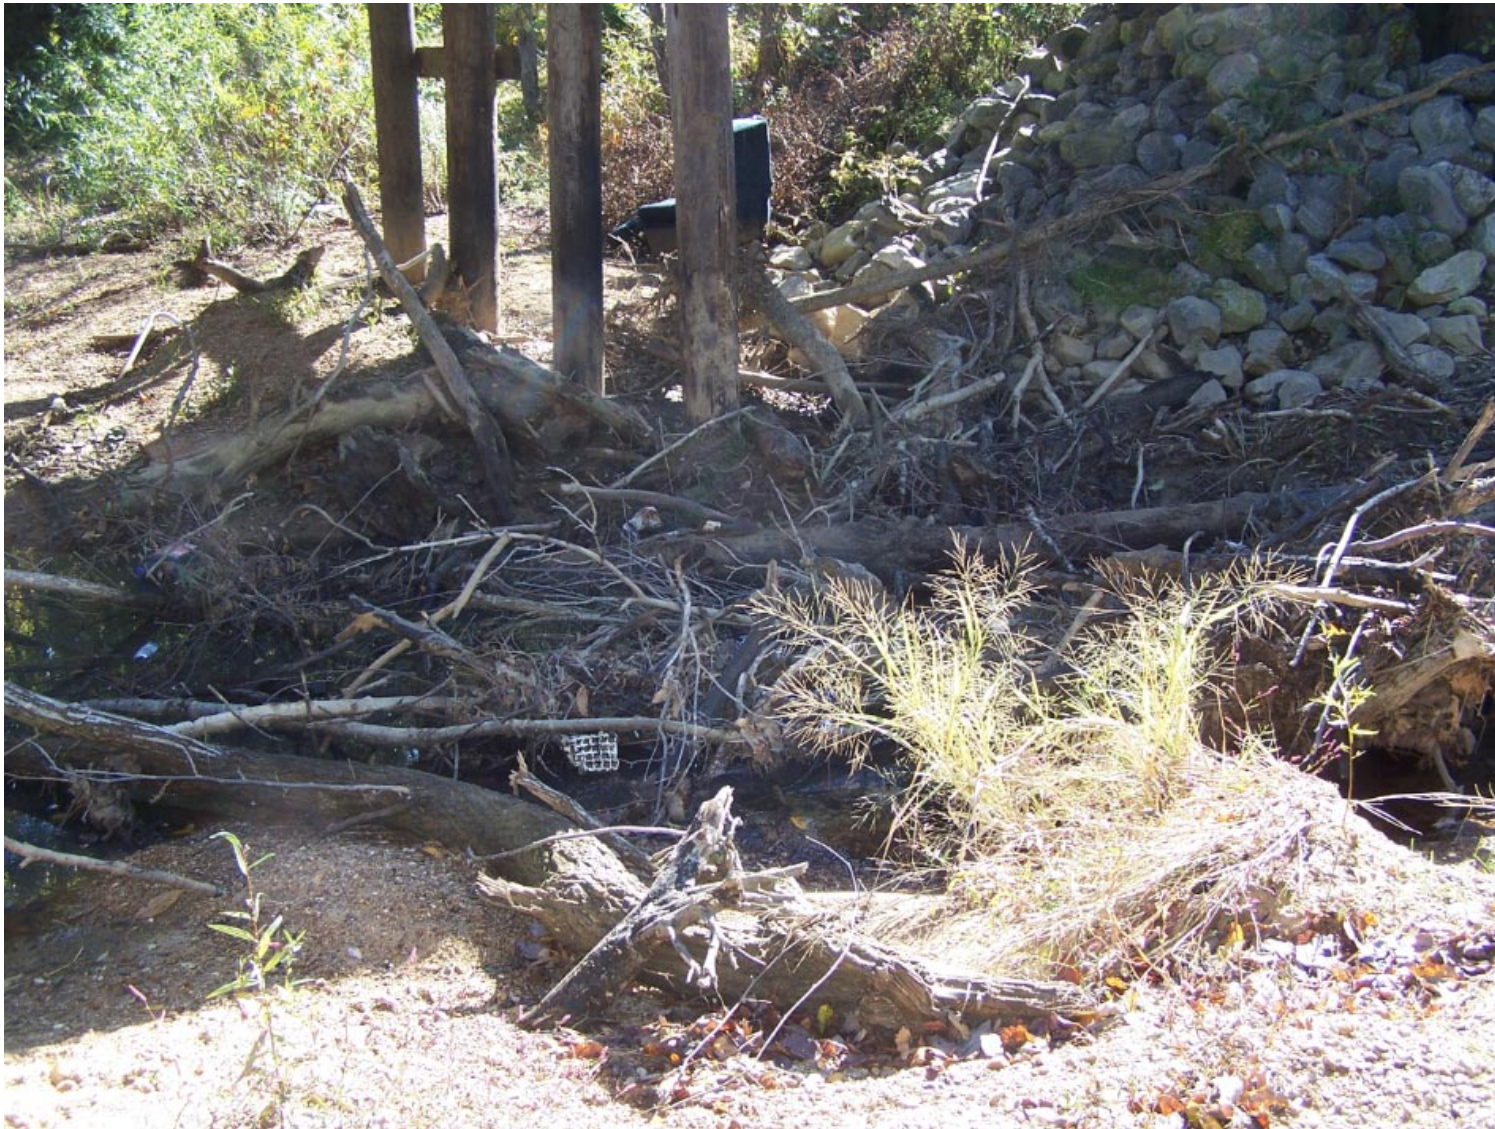
042-C252
SCOUR & DRIFT AT BENT 2
10/20/2011
