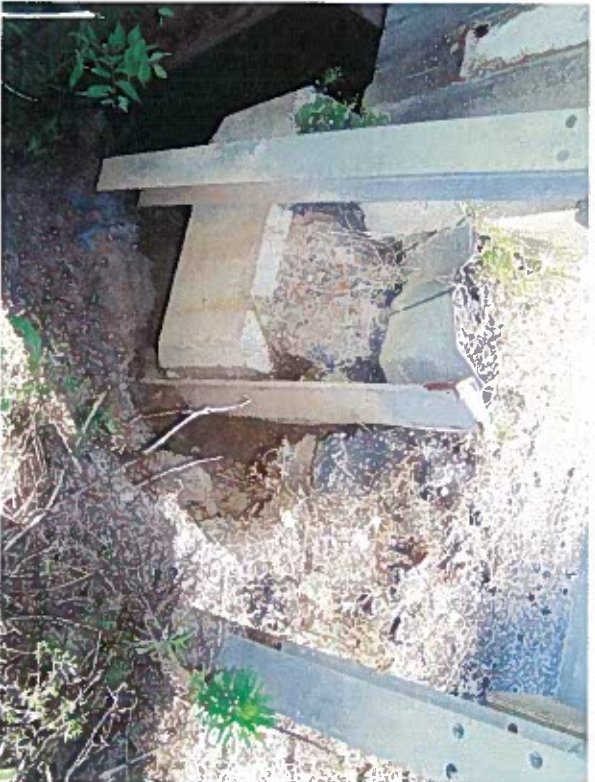
Erosion in SW corner

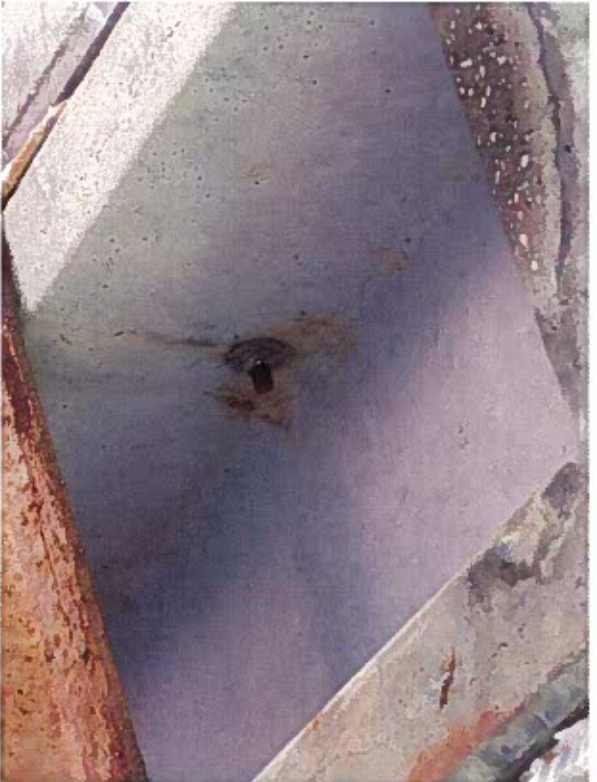
Typical, new tie bolts
installed various locations

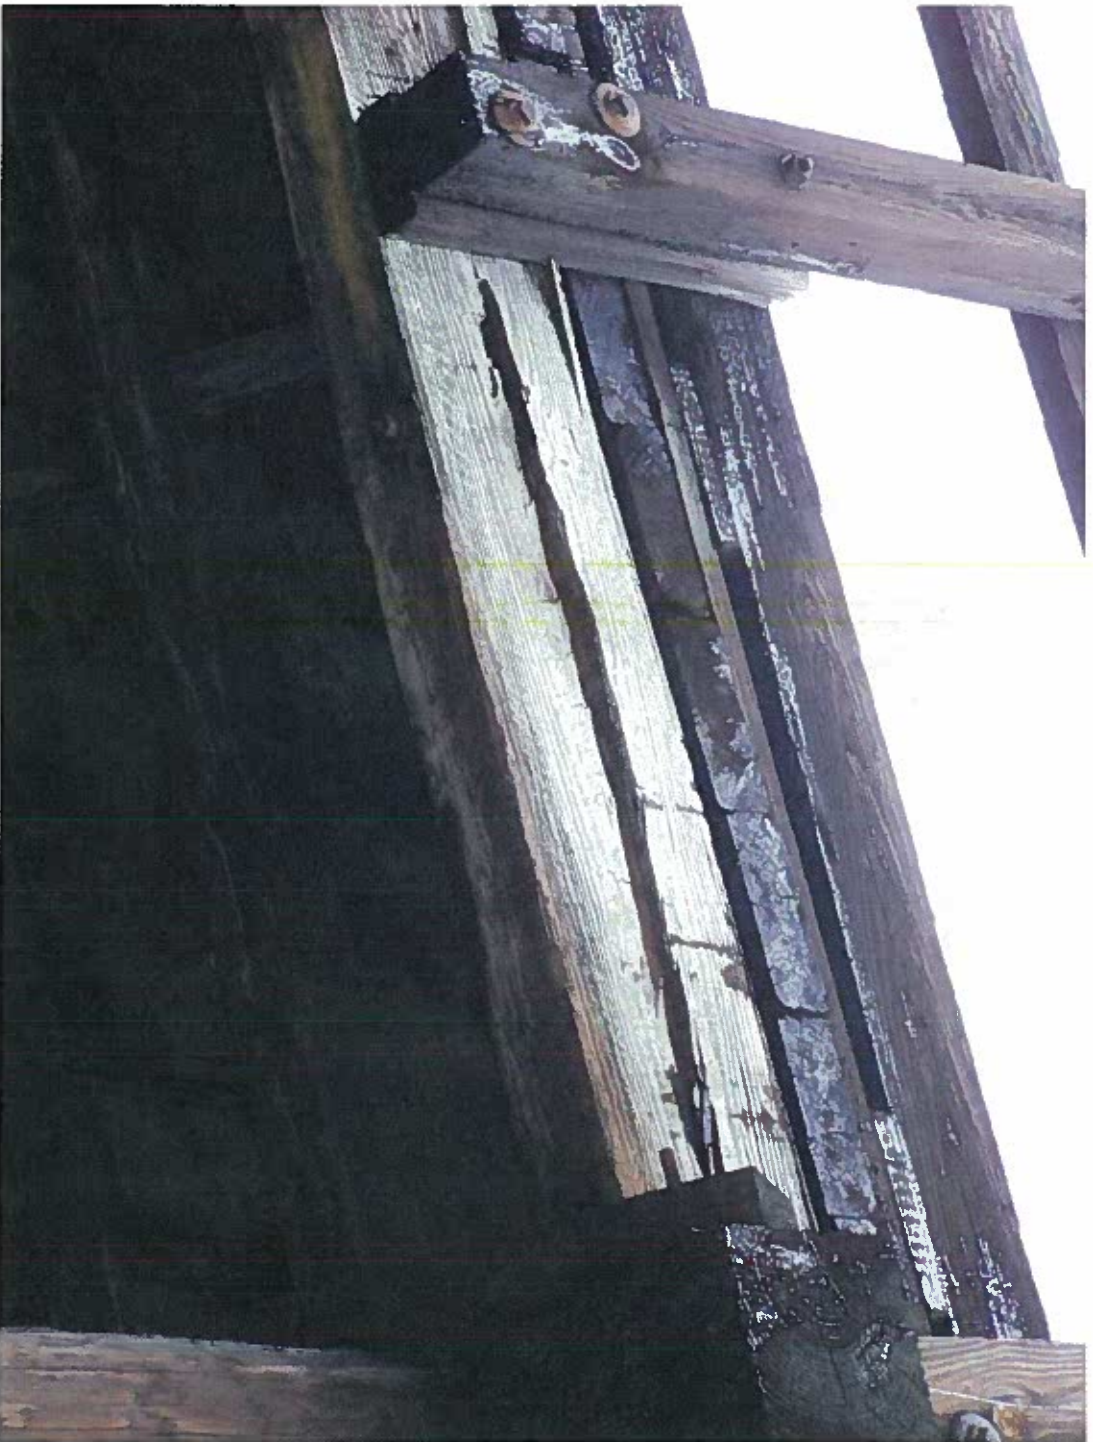
042-C146

EXT BEAM SOUTH SIDE BENT 4
