Inspection Report with SI&A Data

Structure Description: 339.9 Foot - 3 Span Steel continuous Stringer/Multi-beam or Girder

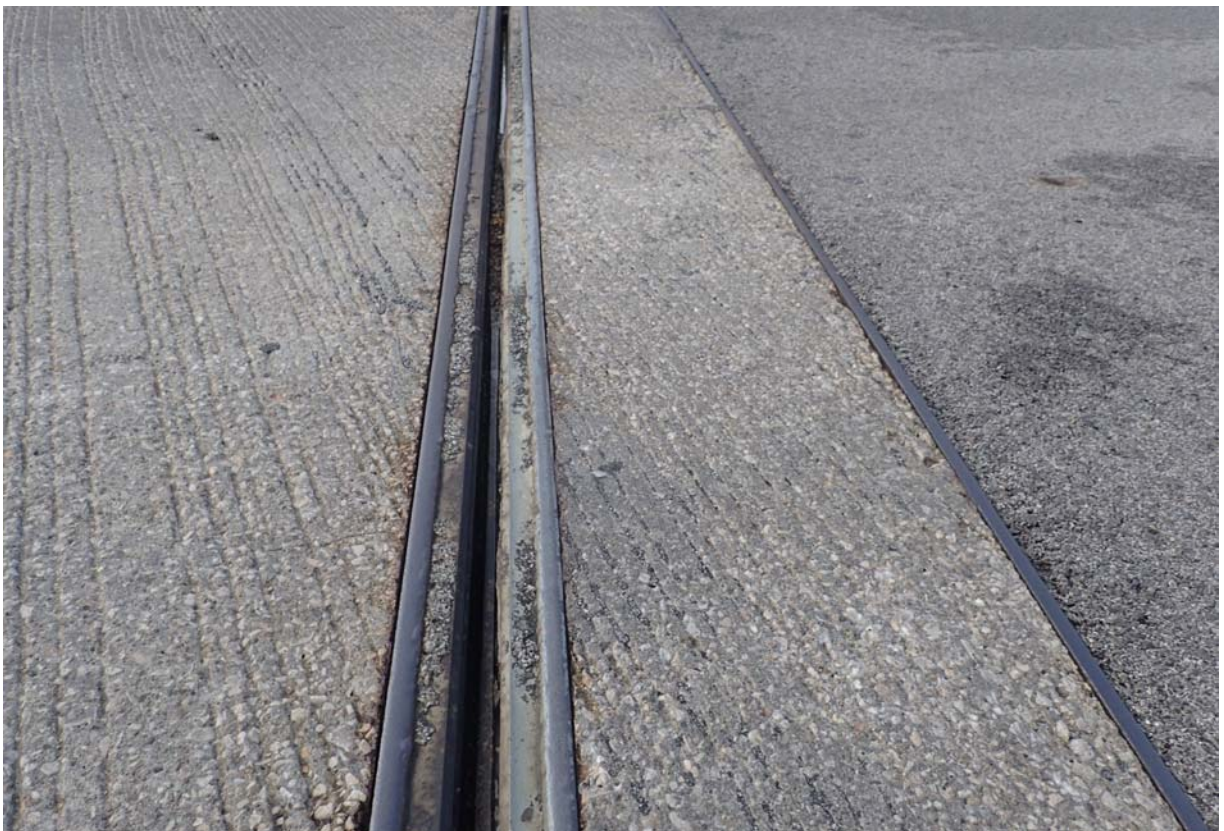
View of the transverse joint at abutment 1. It measured ~ 1.5" along the dashed white line. The gland is partially full of debris, it has a few tears, and it is allowing leakage.

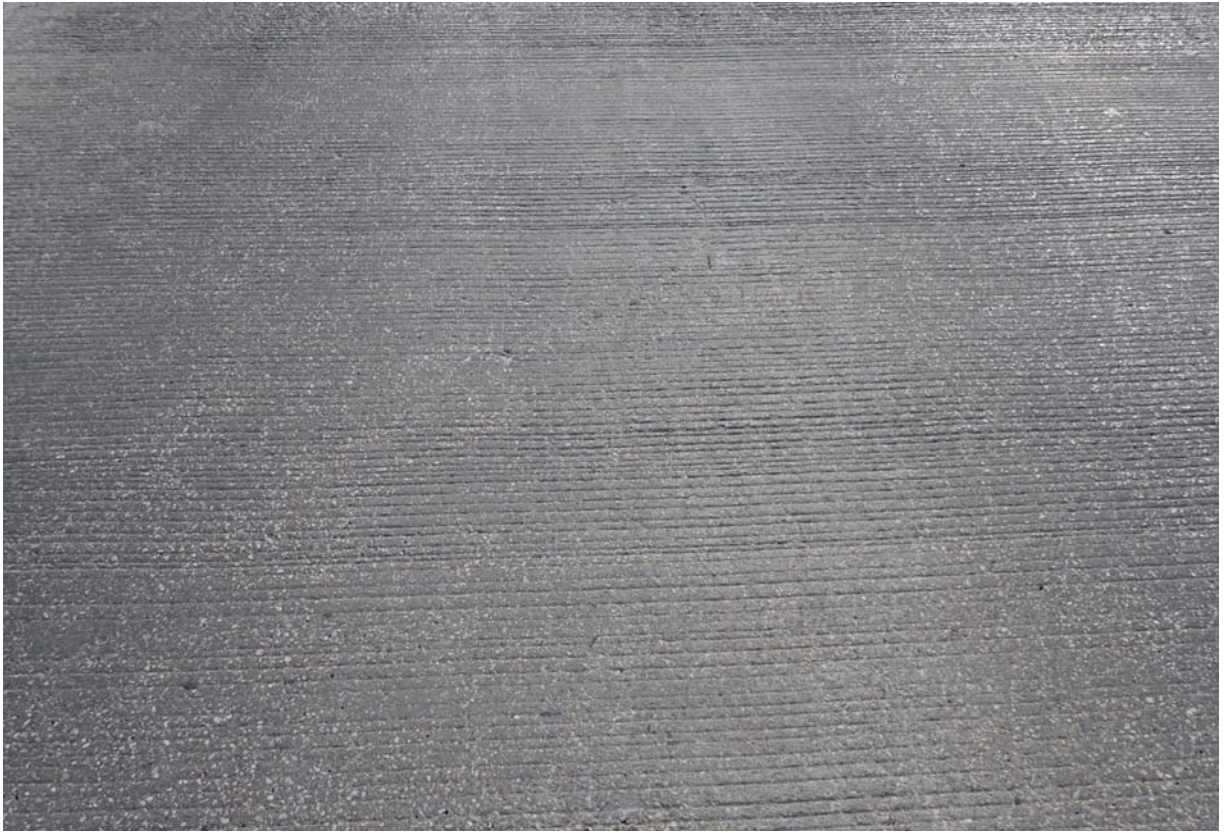
Typical view of the wearing surface.

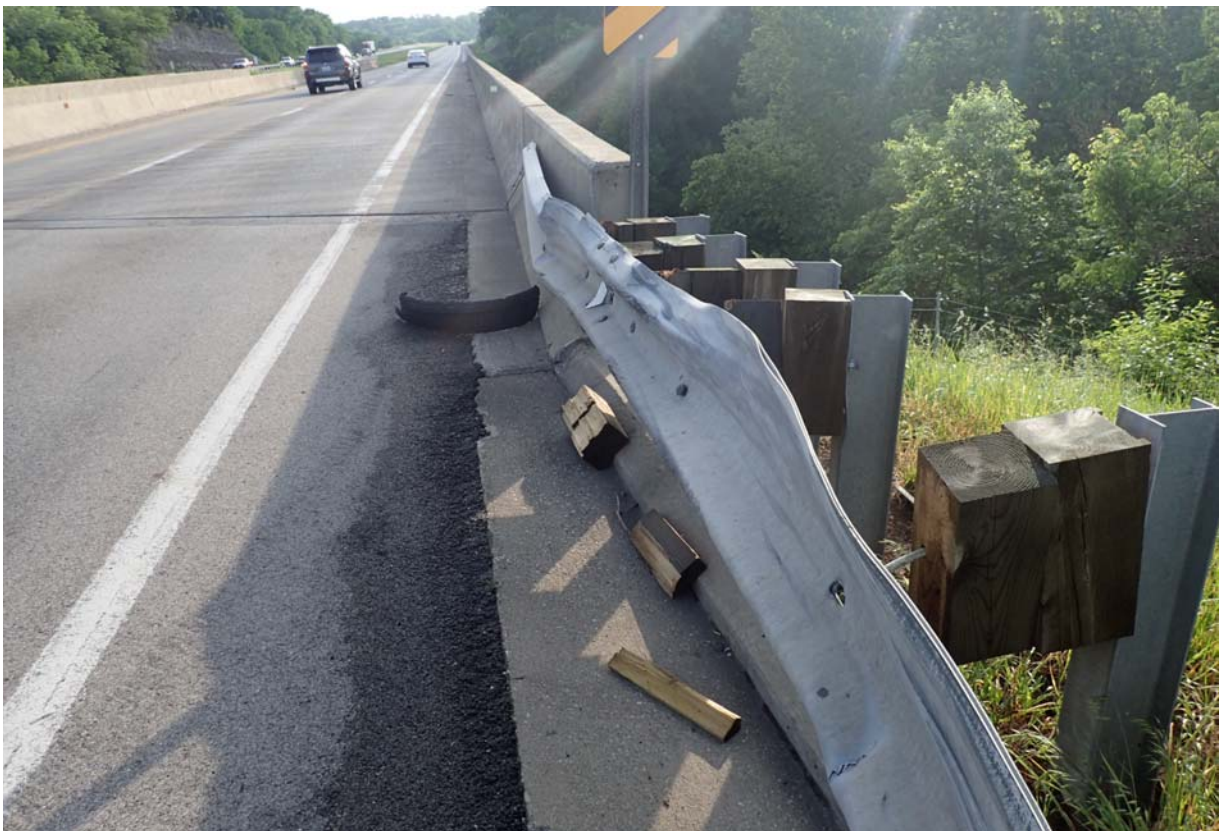
View of impact damage to the south approach railing at abutment 1.

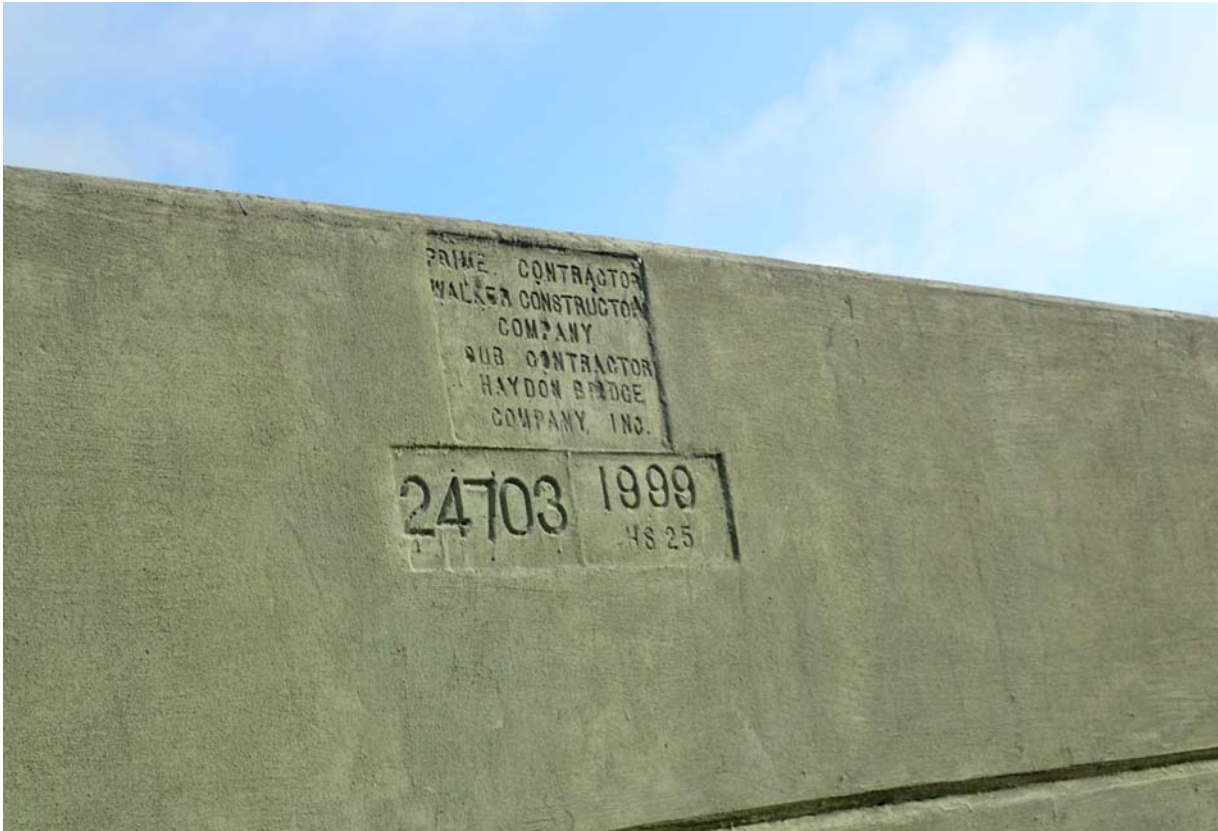
View of the stamps on the south face of the south barrier.

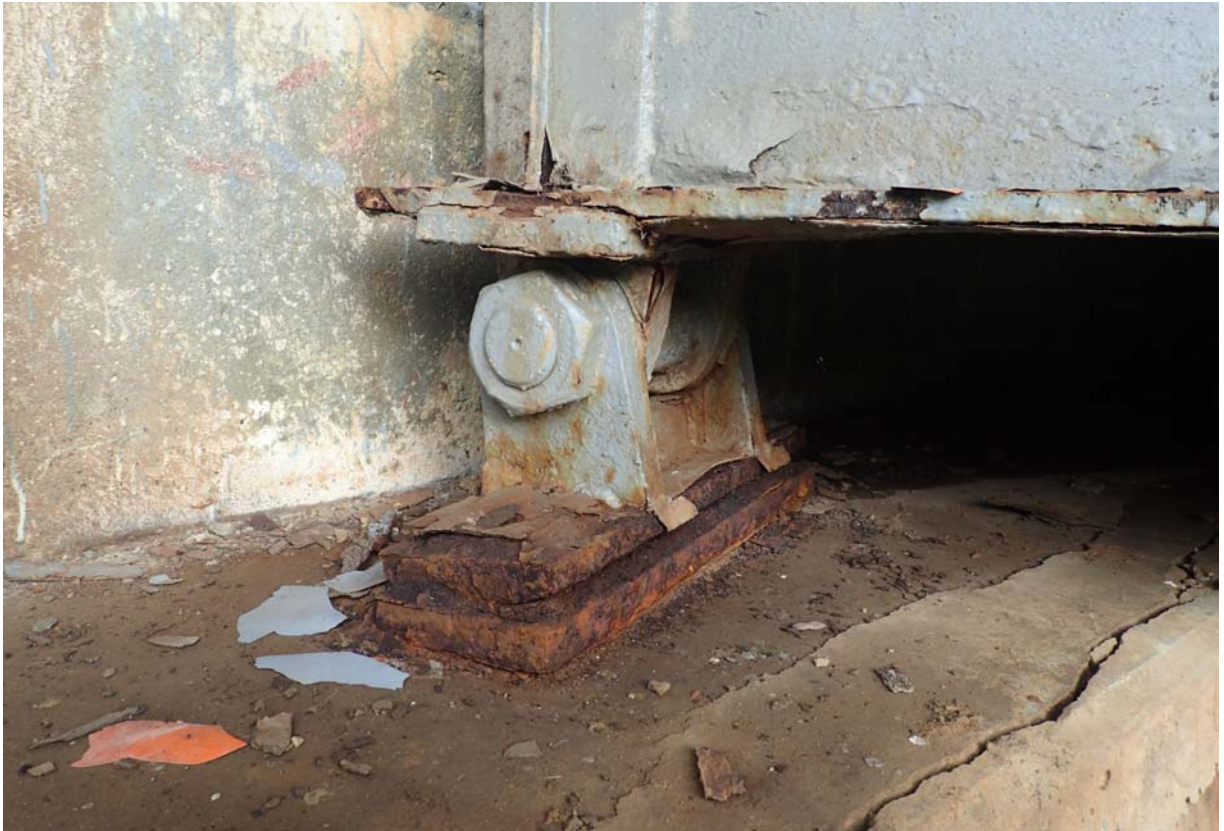
View of the south bearing at abutment 1. Notice the moderate to heavy corrosion in the lower rocker and masonry plate. Both anchor bolts are missing.

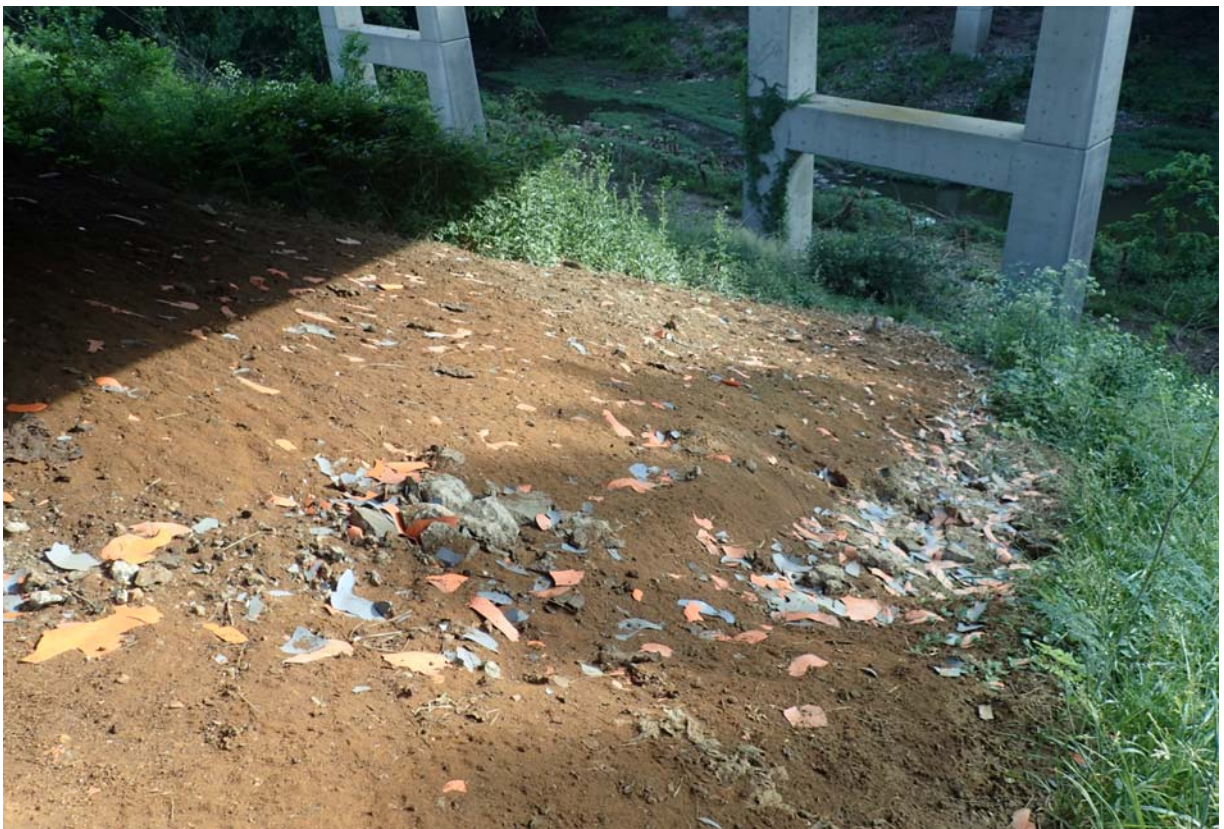
View of a large amount of flaking/peeling paint along the embankment in front of abutment 1.

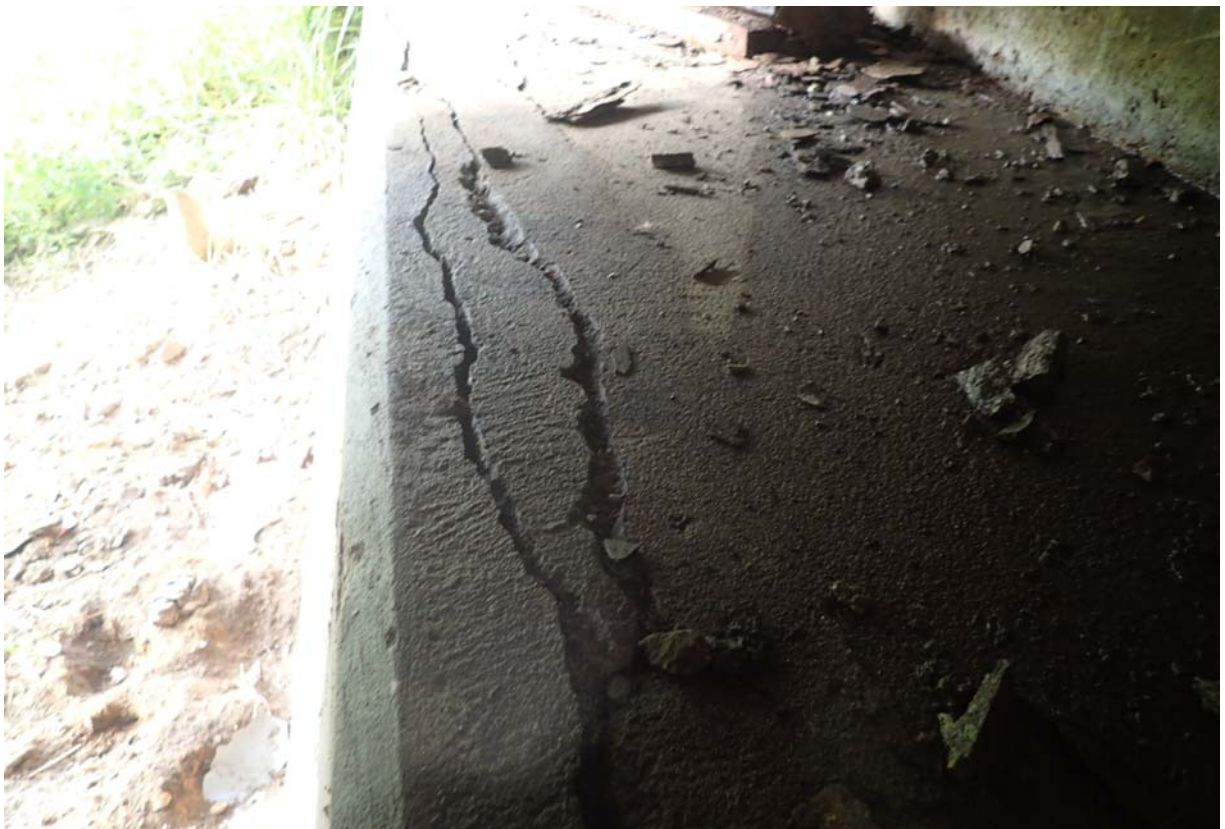
View of up to a 1/2" wide horizontal crack in the top south end of abutment 1s breastwall.

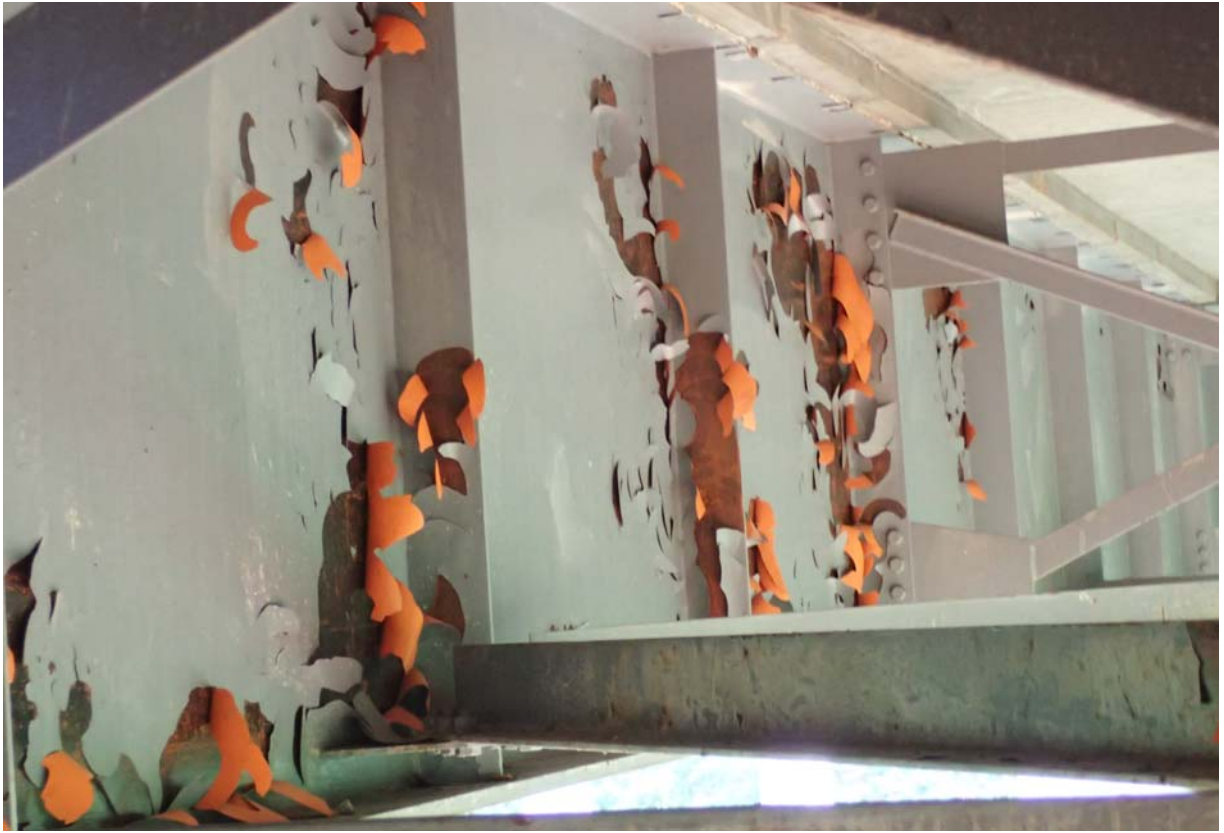
View of several large areas of flaking/peeling paint on the south face of girder 3 from the south in span 1.

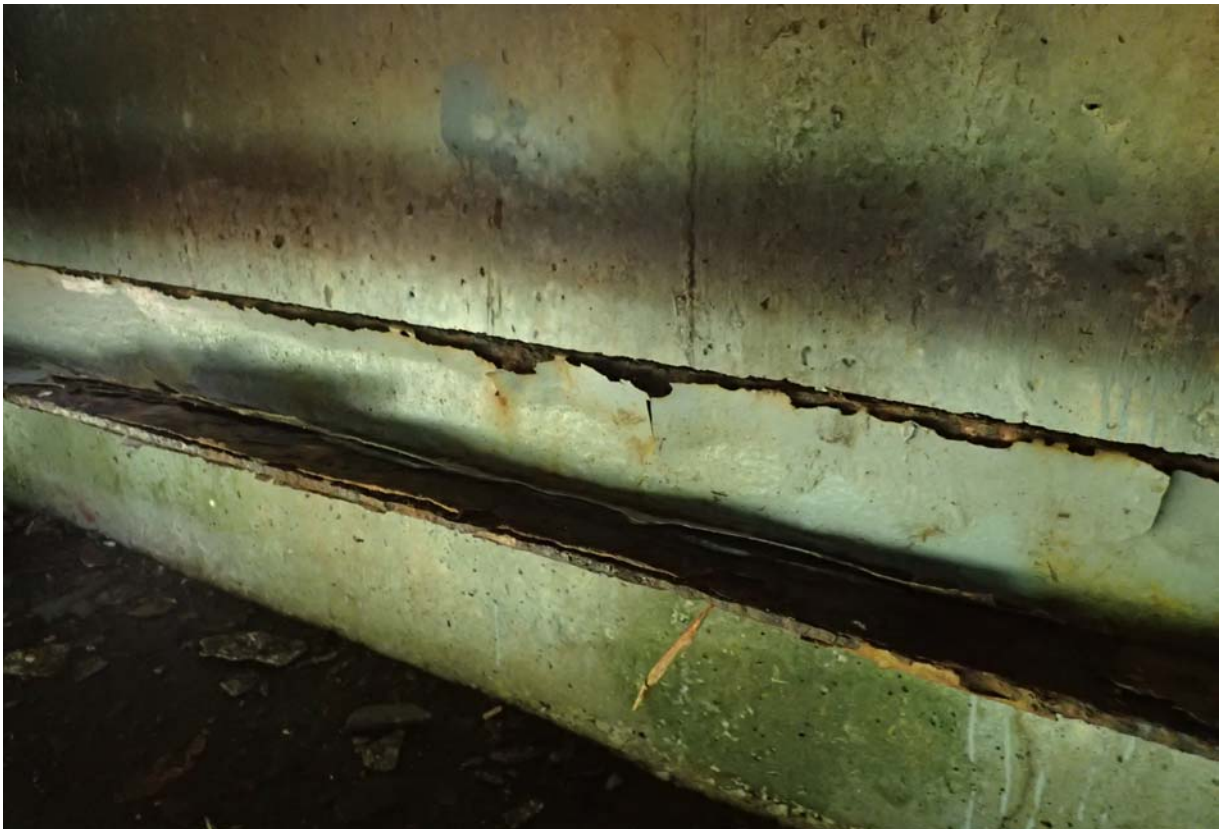
View of flaking paint with heavy corrosion and pitting of the lower angle of the cross bracing of the diaphragm between girders 2 and 3 from the south at abutment 1.

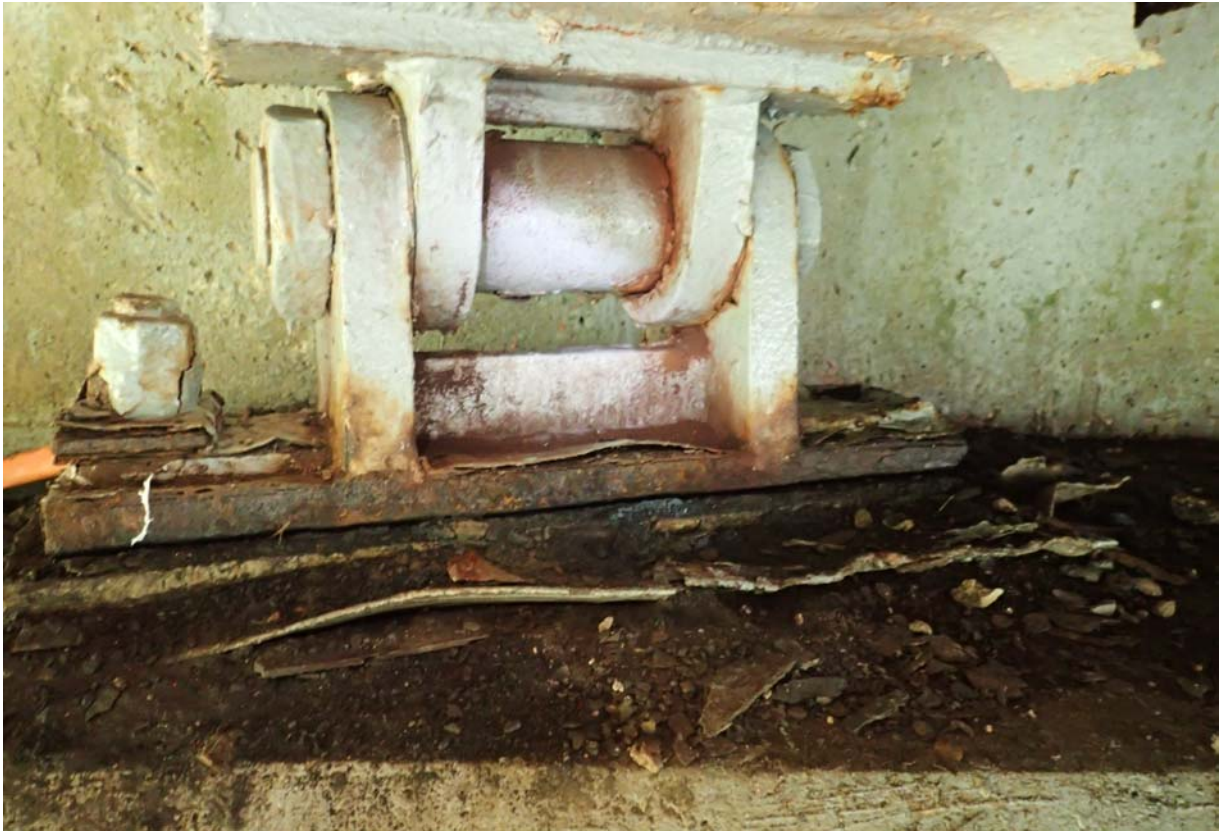
View of bearing 2 from the south at abutment 1. Notice the fretting, moderate to heavy corrosion, and the north anchor bolt is missing.

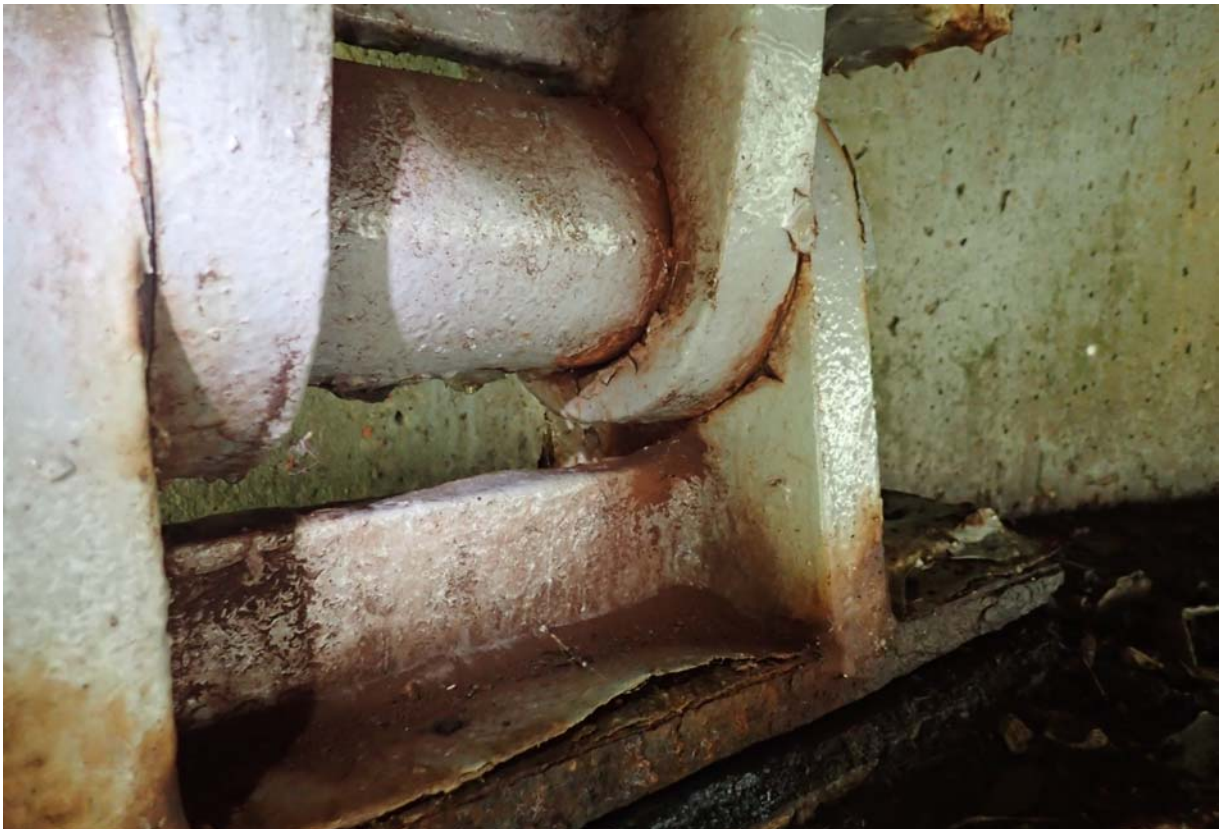
View of bearing 2 from the south at abutment 1. Notice the fretting.

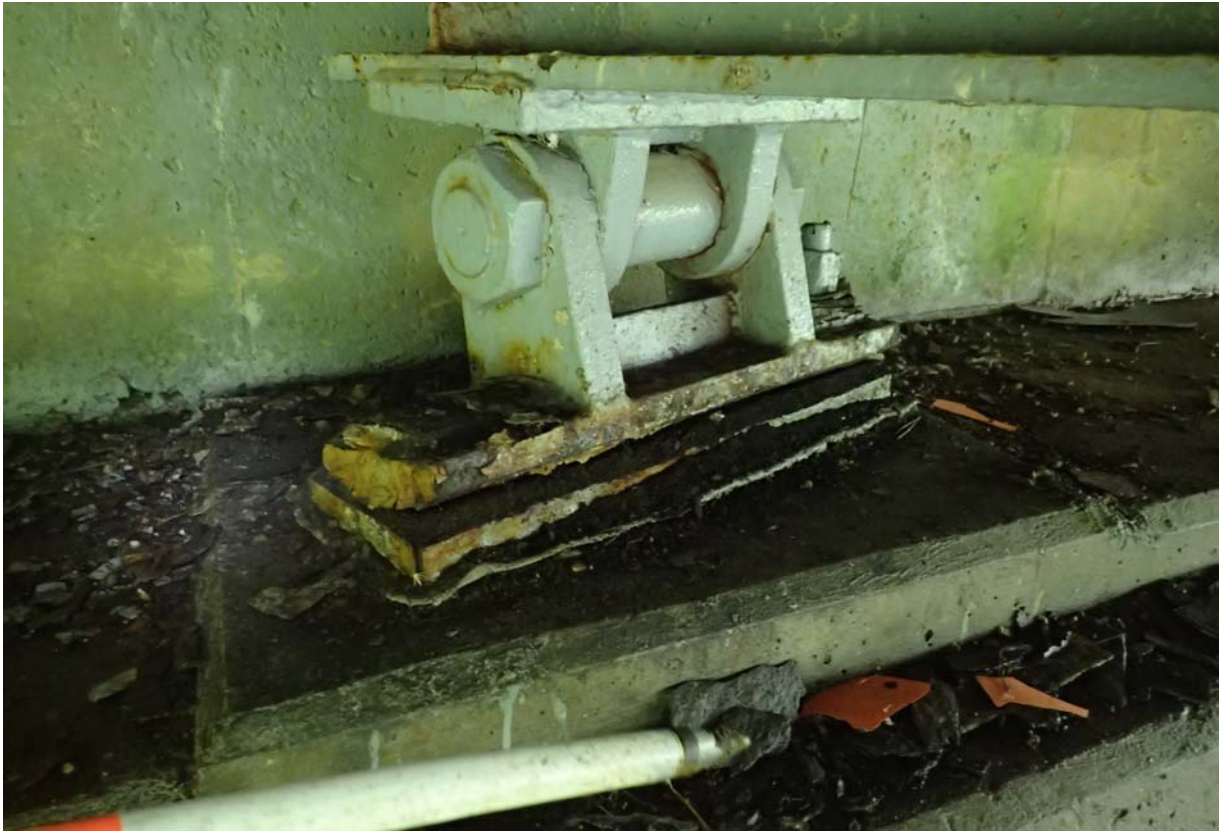
View of bearing 3 from the south at abutment 1. It is missing the south anchor bolt and is tilted toward the backwall ~ 16 degrees. The measurement was taken on a tapered surface so the actual rotation is a little less.

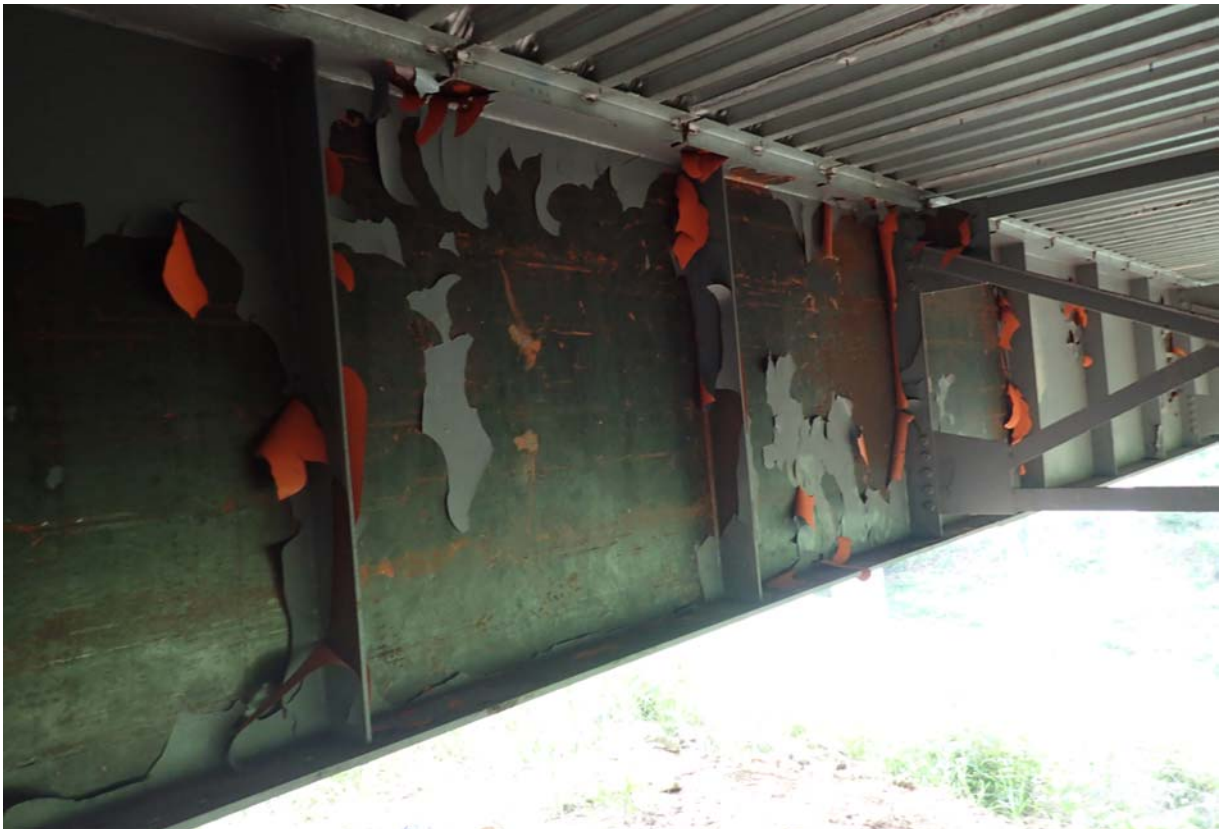
View of large widespread areas of flaking/peeling paint on the south face of the north girder in span 1.

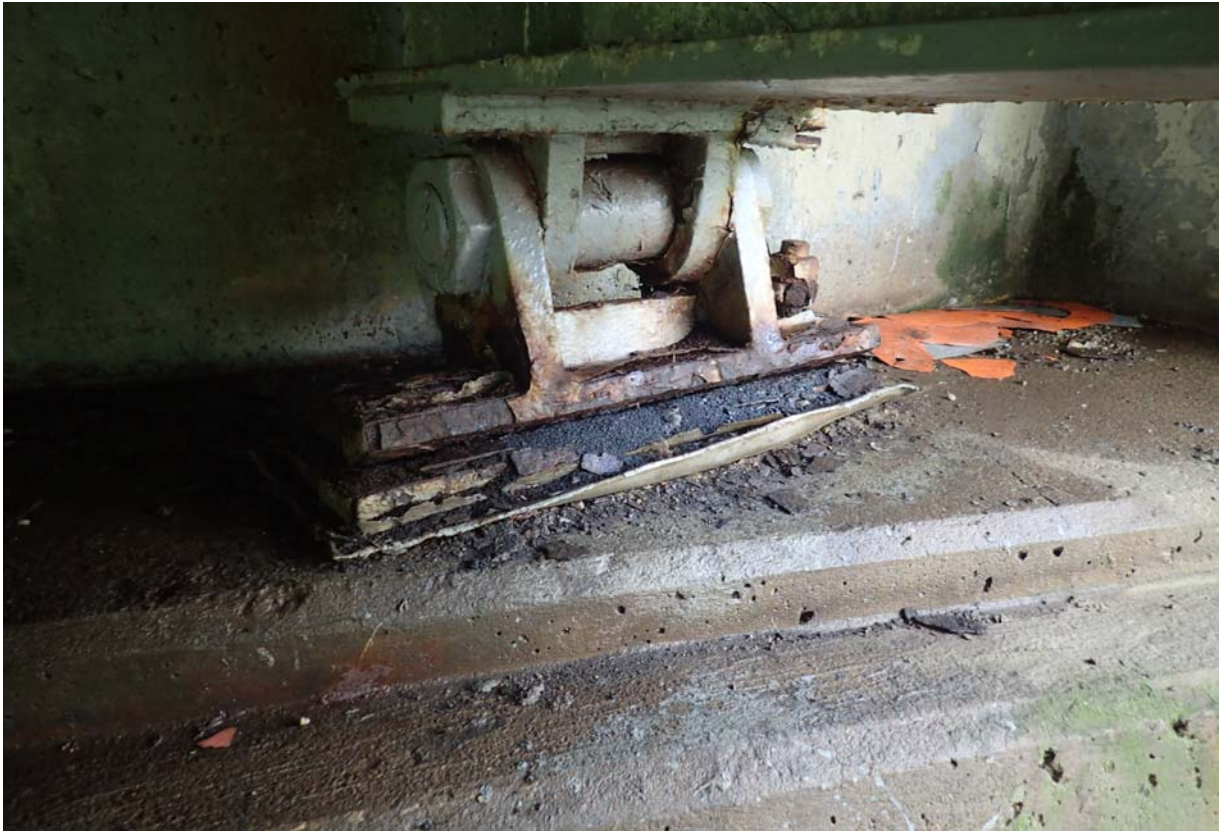
View of the north bearing at abutment 1. Notice the moderate to heavy corrosion. It is missing the south anchor bolt and is tilted toward the backwall ~ 19 degrees. The measurement was taken on a tapered surface so the actual rotation is a little less.

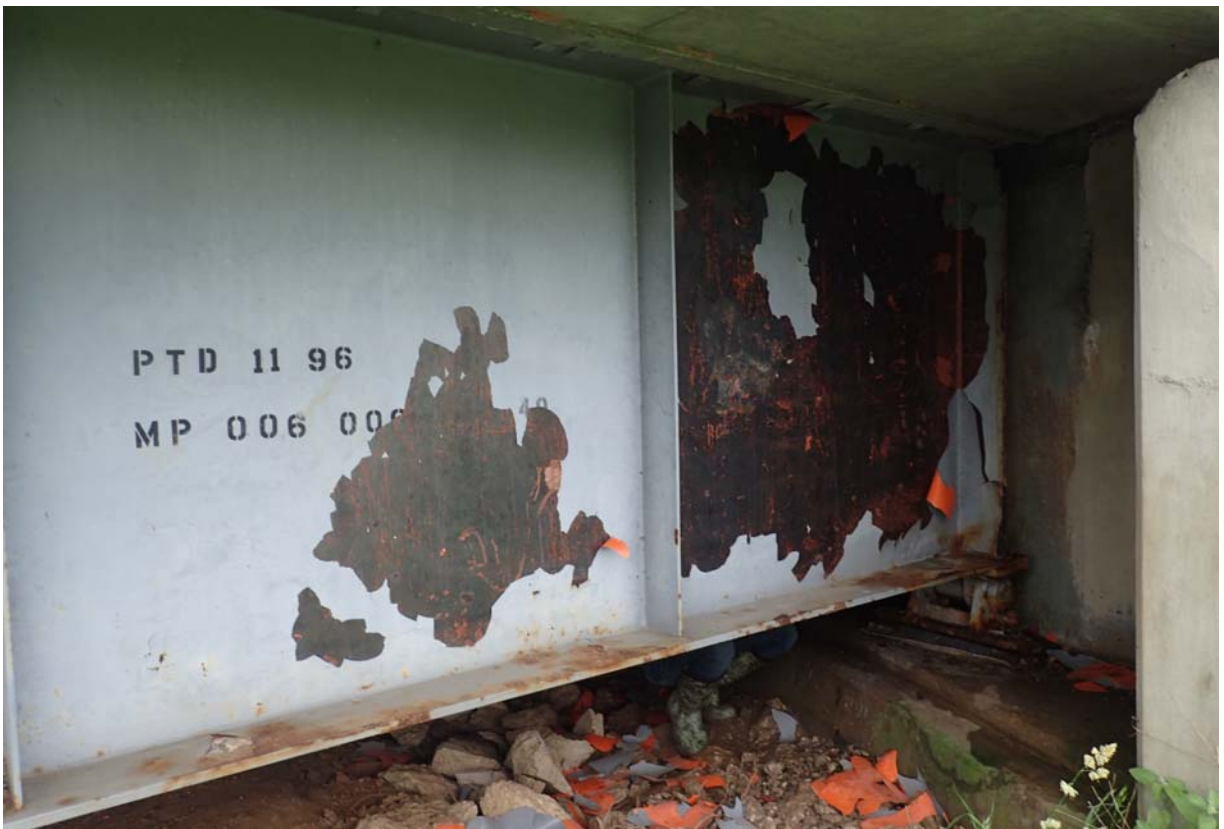
View of a large area of paint failure on the exterior face of the north girder at abutment 1.

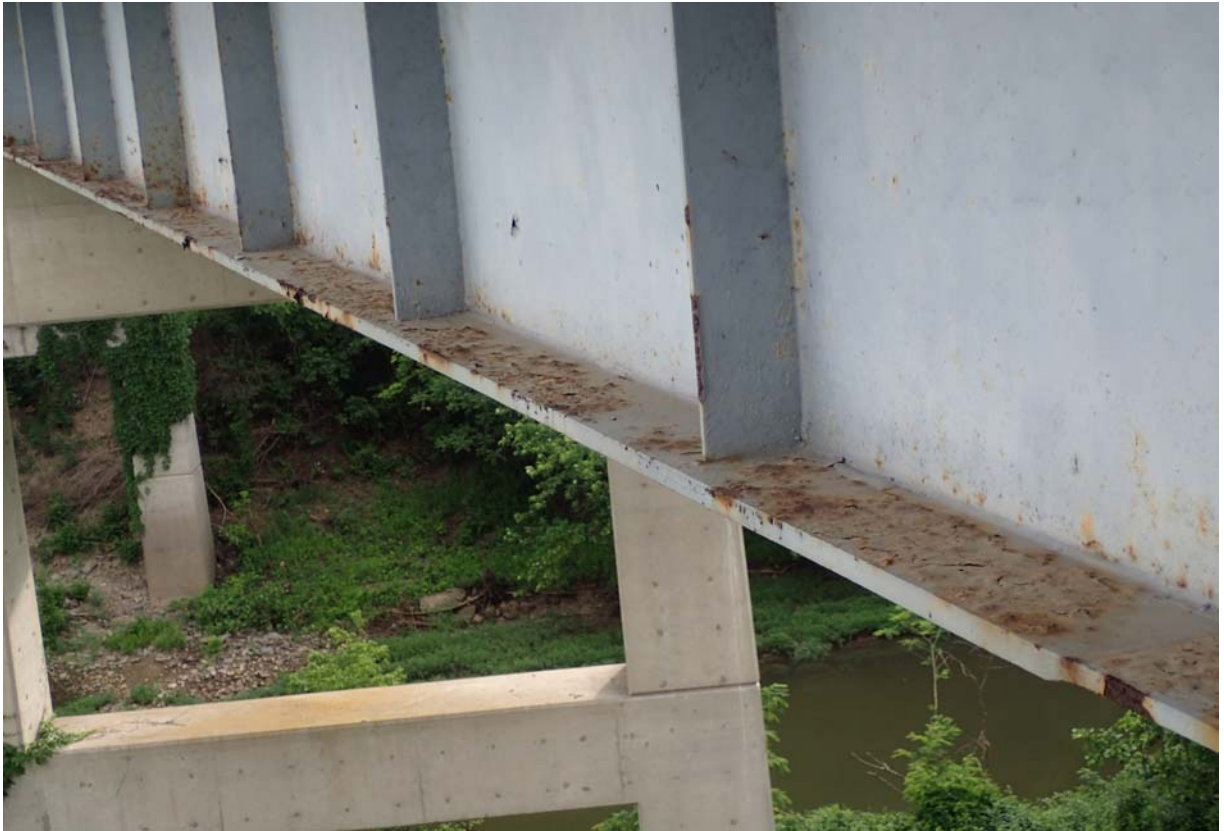
View of bubbling paint along the top of the exterior bottom flange of the north girder in span 1.

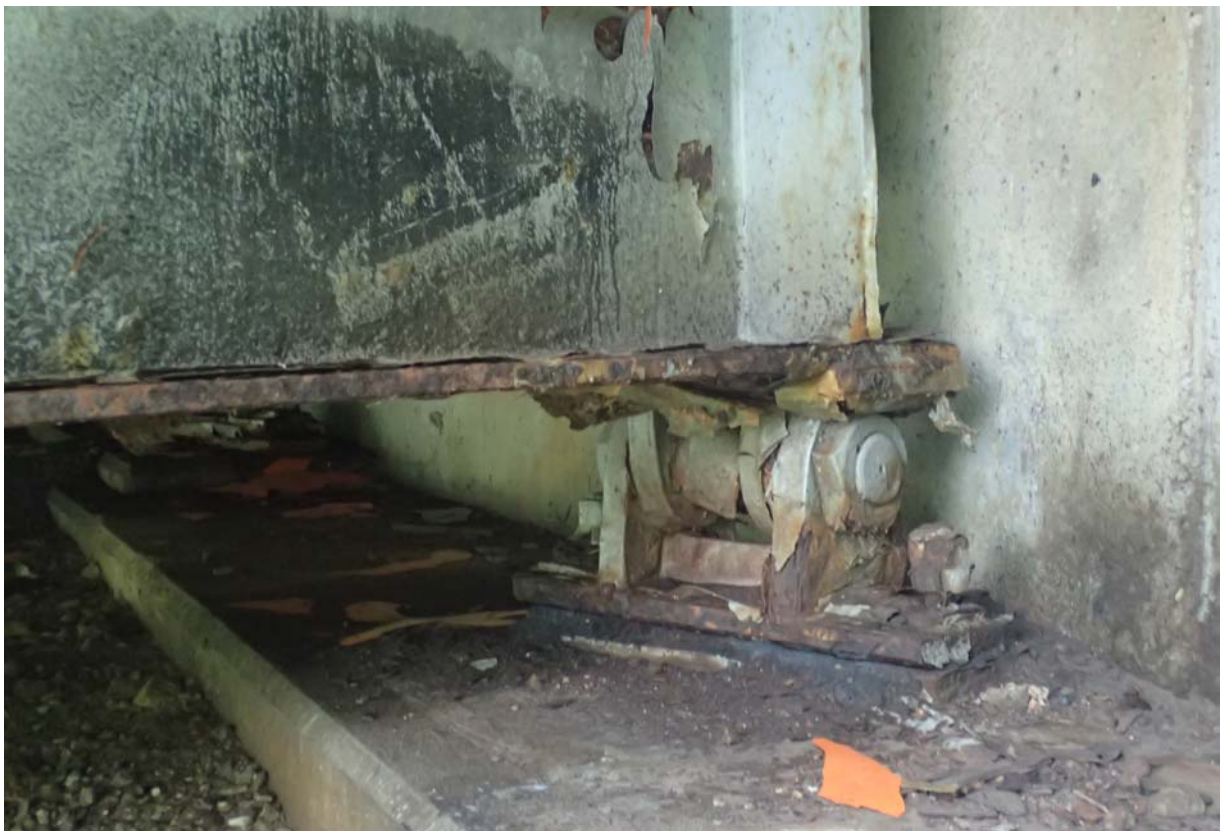
View of the south bearing of abutment 4. Notice the moderate to heavy corrosion in the lower portions of the bearing. Notice the flaking paint and corrosion along the bottom flange of the girder.

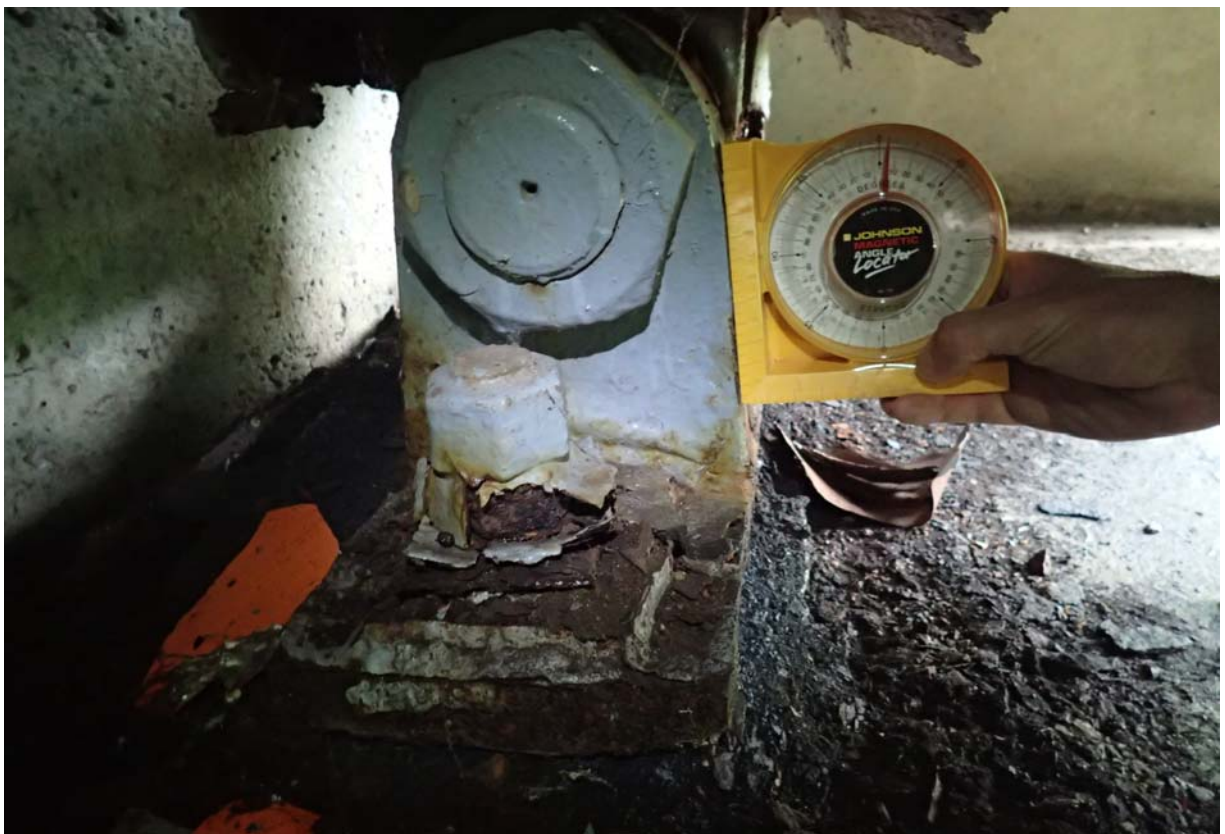
View of the south bearing at abutment 4. It is tilted toward the backwall ~ 6 degrees. The measurement was taken on a tapered surface so the actual rotation is a little less.

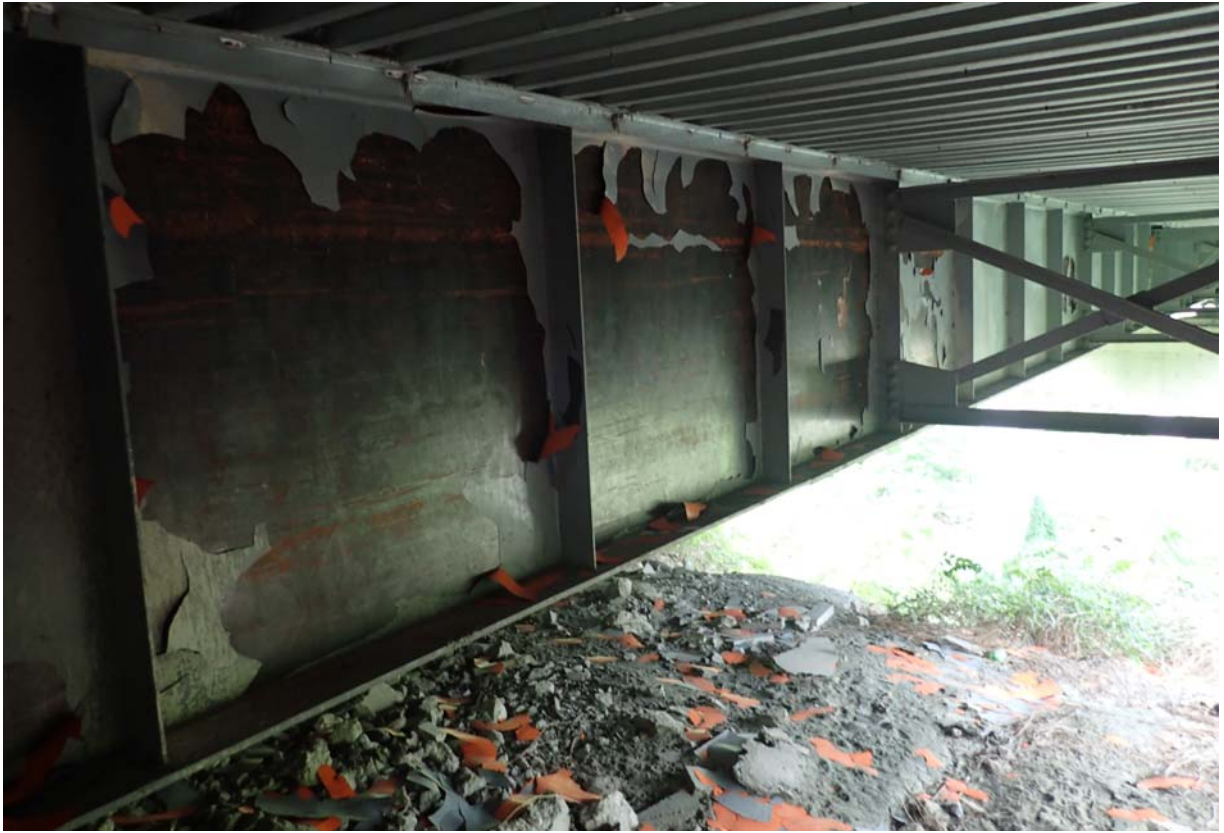
View of large areas of paint failure on girder 3 from the south near abutment 4.

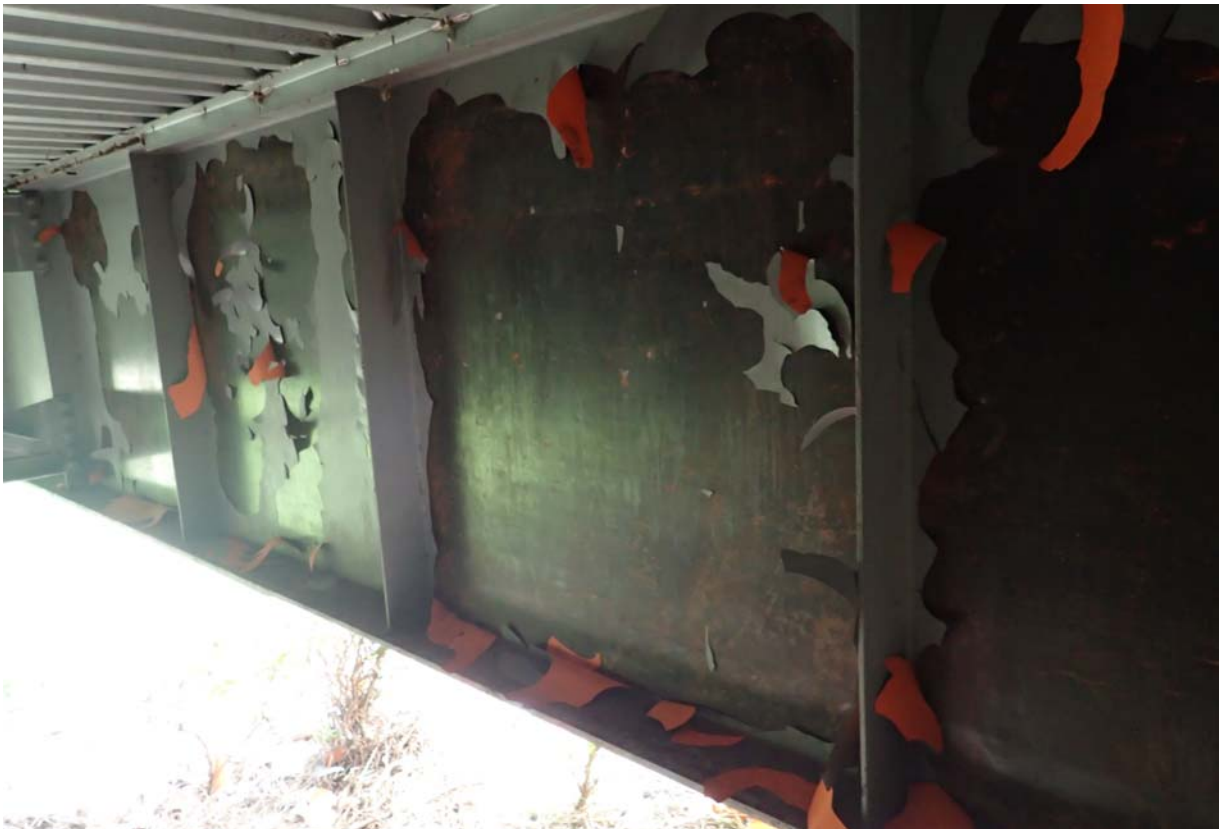
View of large areas of paint failure on the interior face of the north girder near abutment 4.

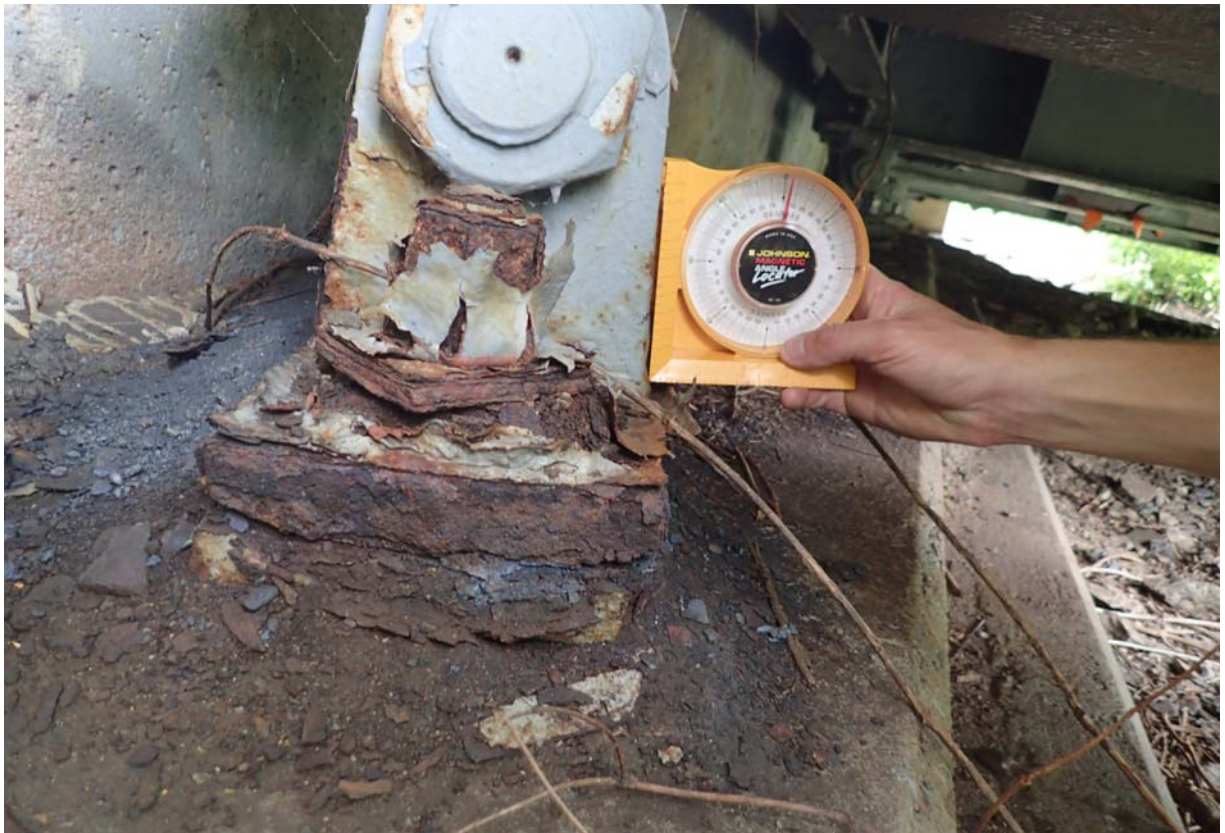
View of the north bearing at abutment 4. Notice the heavy corrosion in the lower rocker and masonry plate. It is tilted toward the backwall ~ 6 degrees. The measurement was taken on a tapered surface so the actual rotation is a little less.

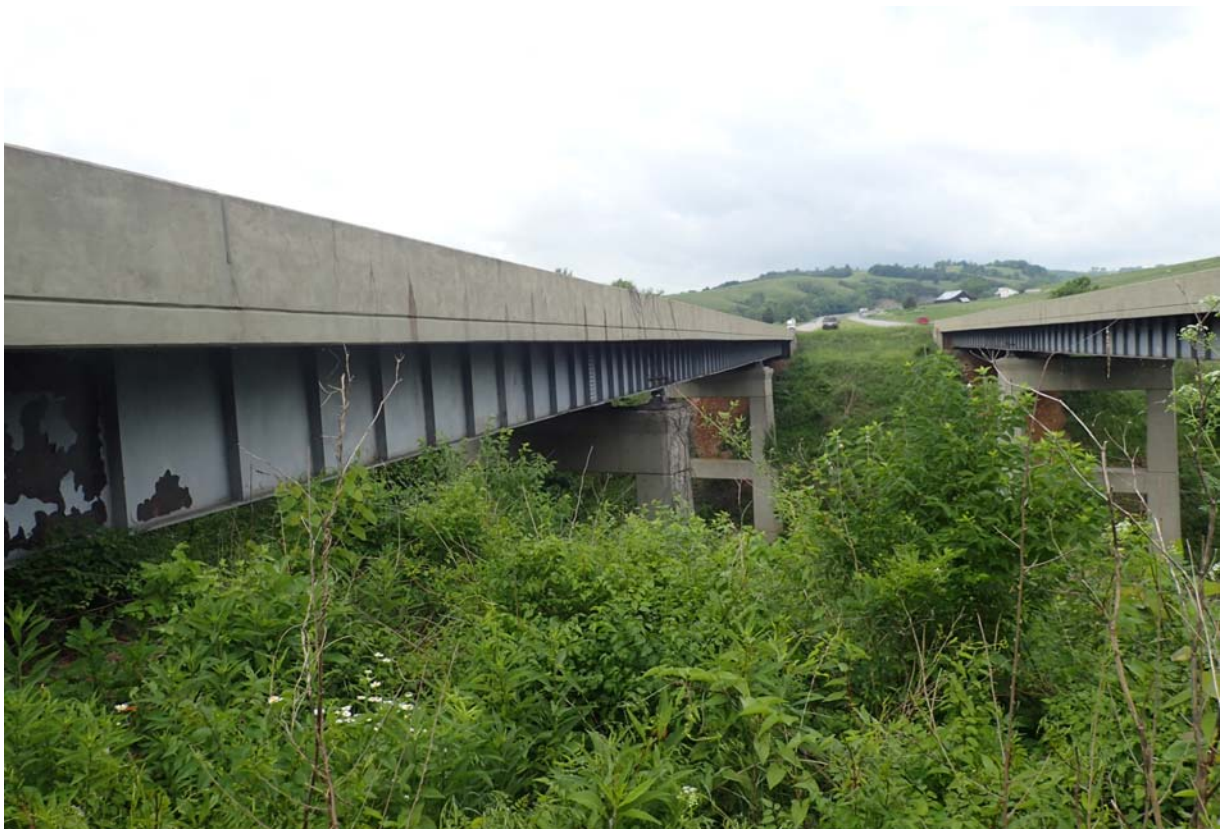
View from the north end of abutment 4.
