Inspection Report with SI&A Data

Structure Description: 339.9 Foot - 3 Span Steel continuous Stringer/Multi-beam or Girder

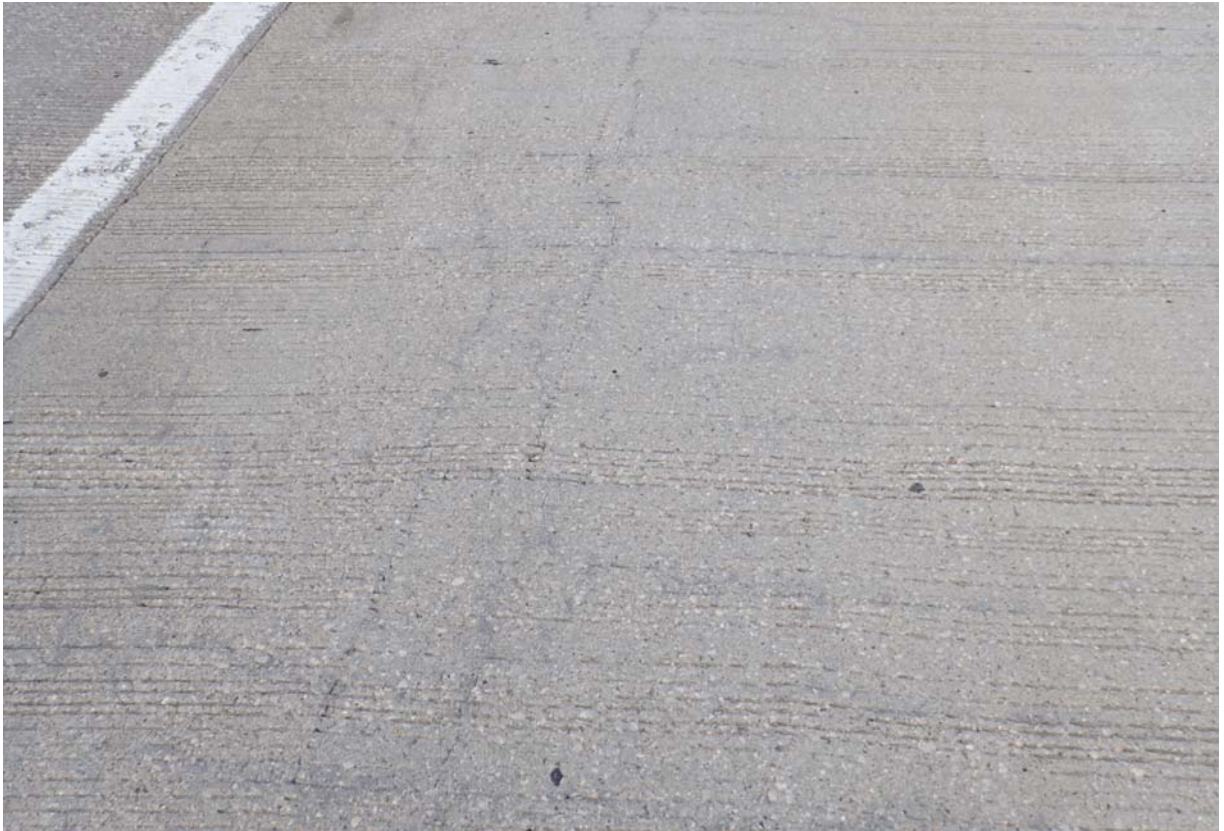
Typical view of some minor sized longitudinal cracking in the left lane.

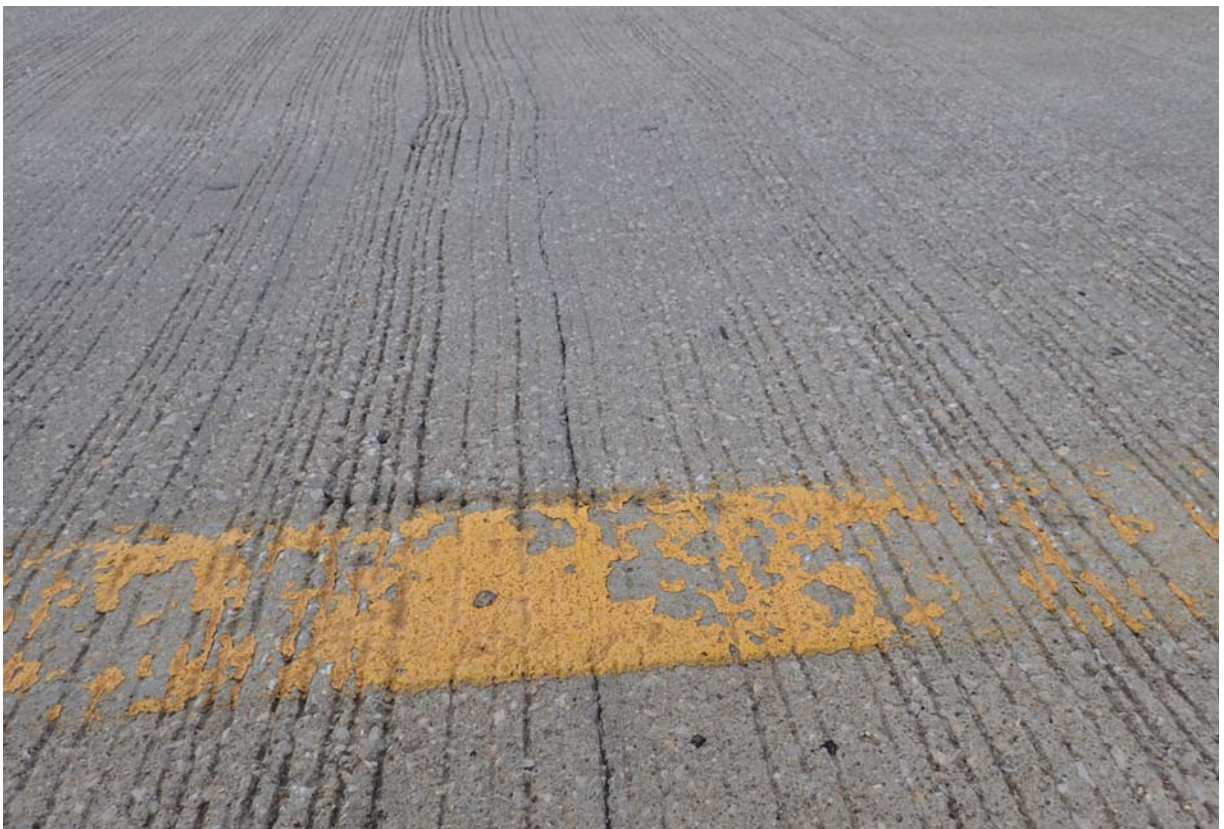
View of a minor sized transverse crack in the wearing surface in span 2 near midspan.
