Inspection Report with SI&A Data

Structure Description: 305.12 Foot - 3 Span Steel continuous Stringer/Multi-beam or Girder

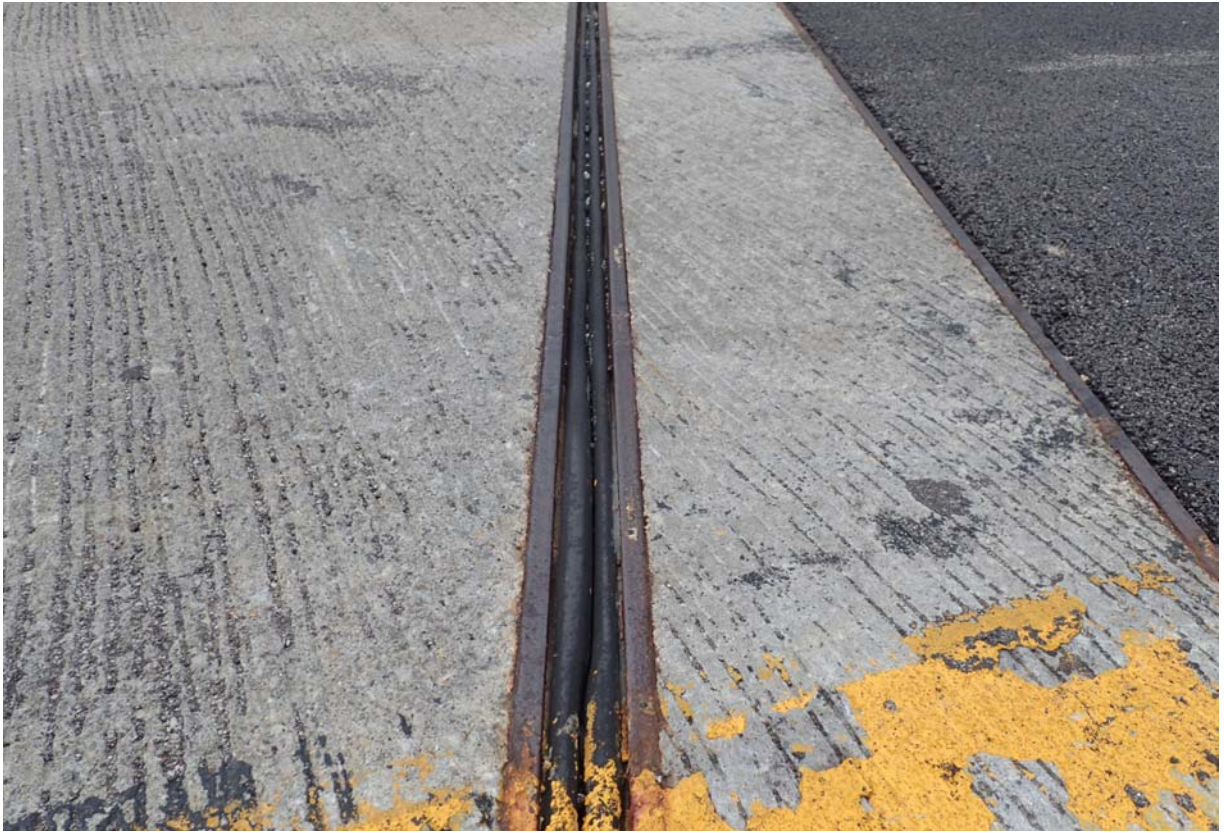
View of the transverse joint at abutment 1. It is impacted with minor debris and has some adhesion failure.

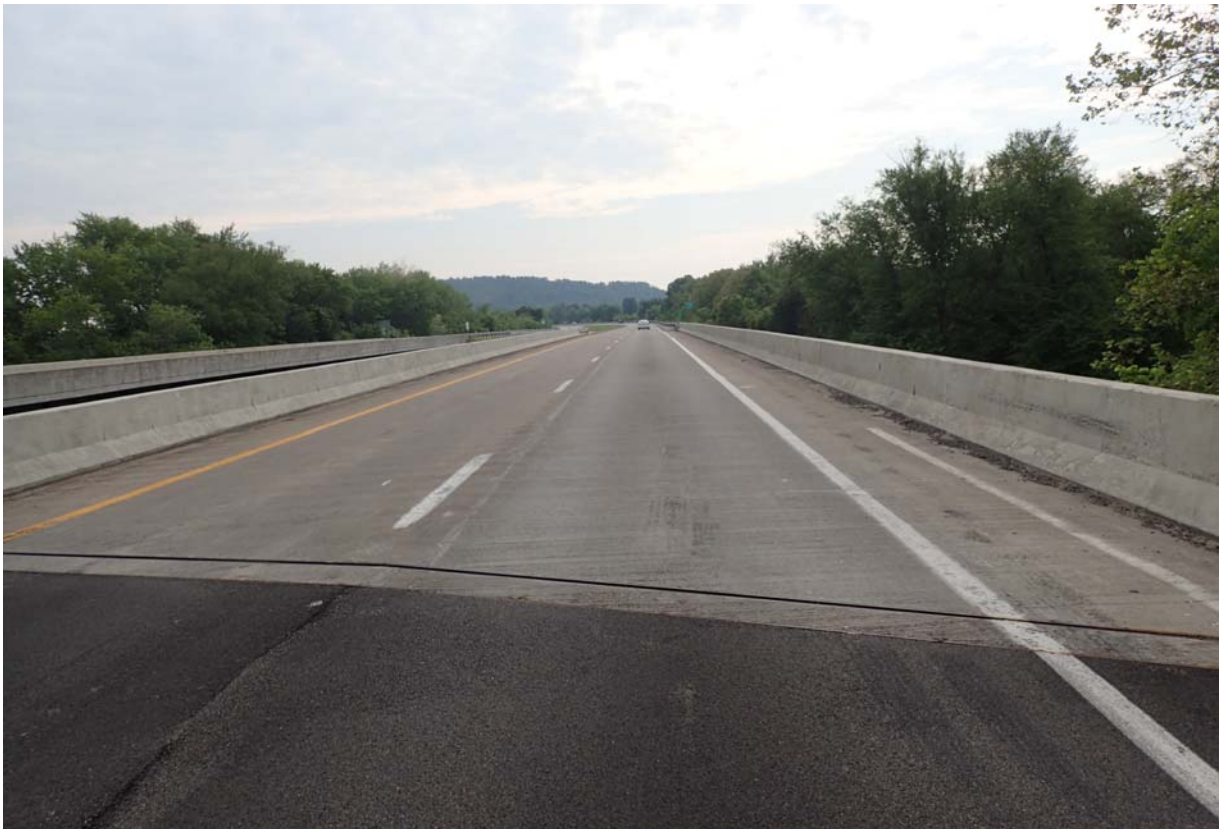
View from the approach to abutment 1.

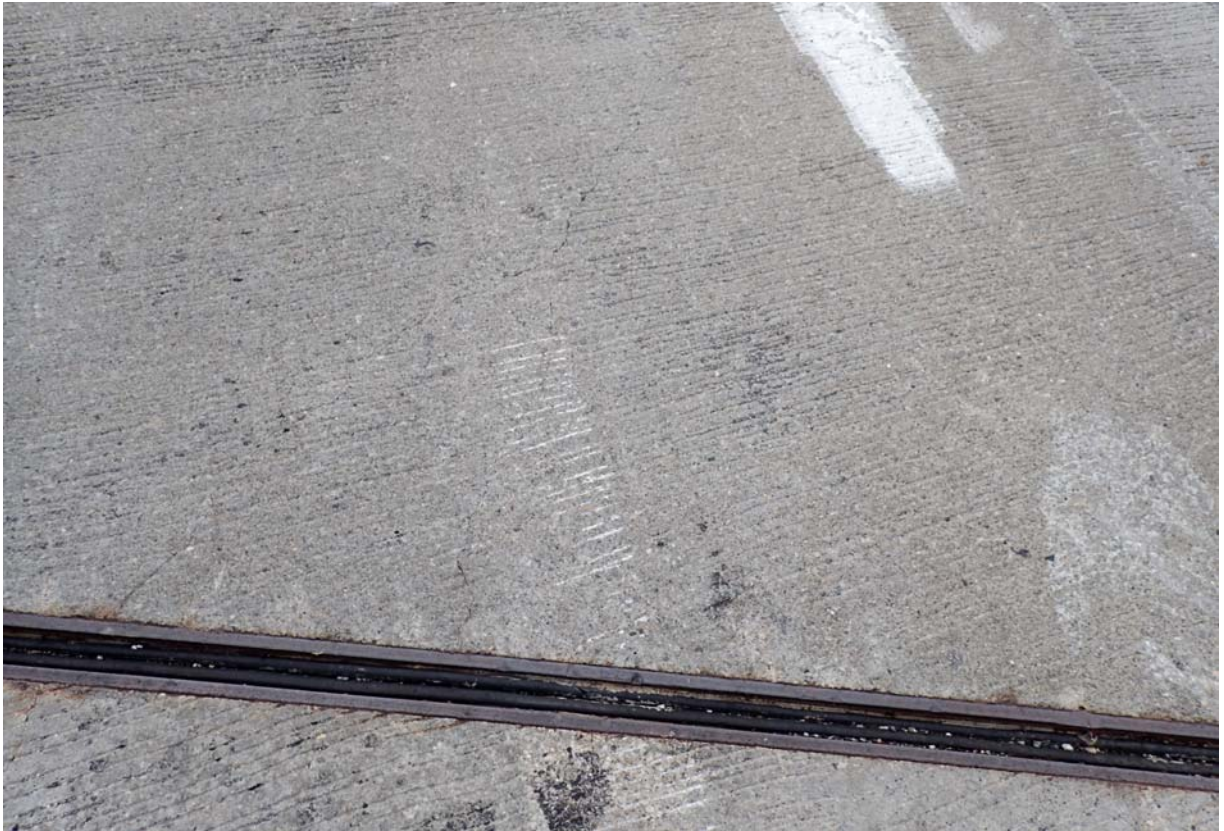
View of some minor sized diagonal cracking in the wearing surface near abutment 1.

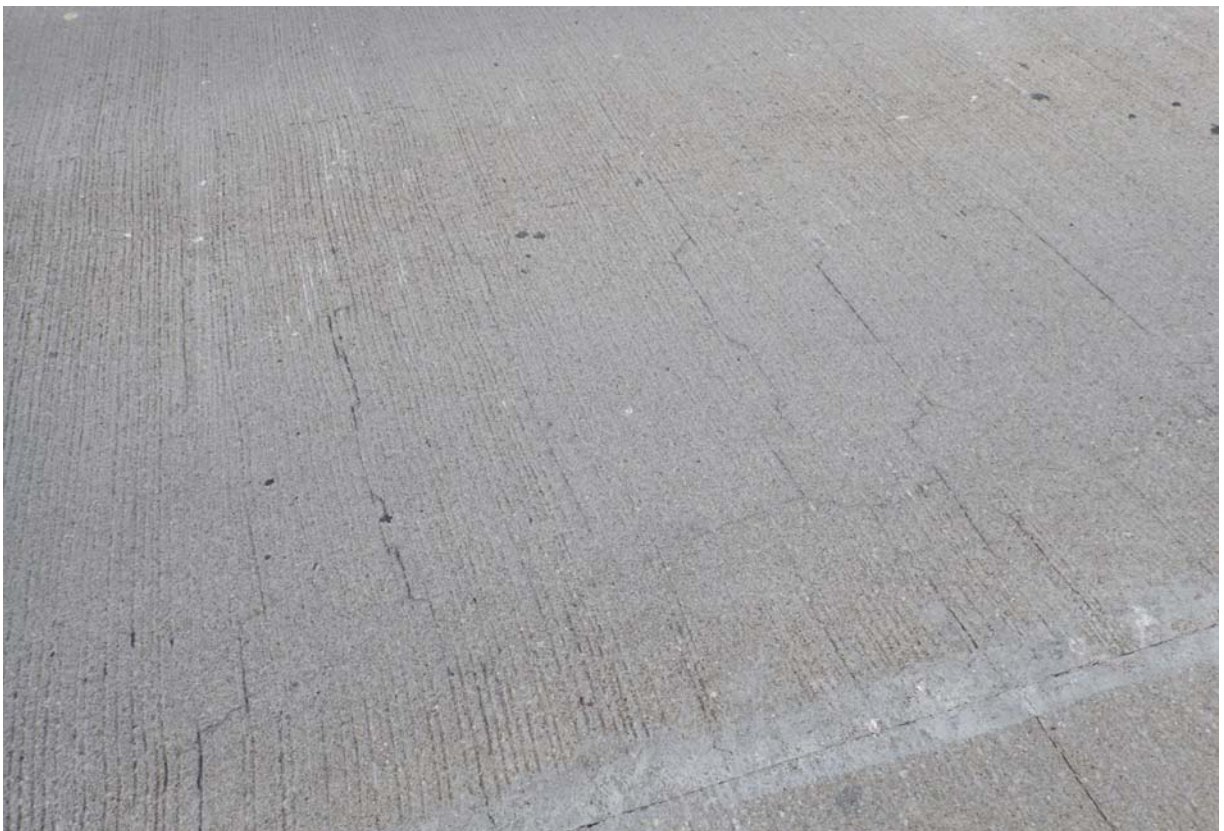
View of several minor sized transverse cracks in the wearing surface of the slow lane

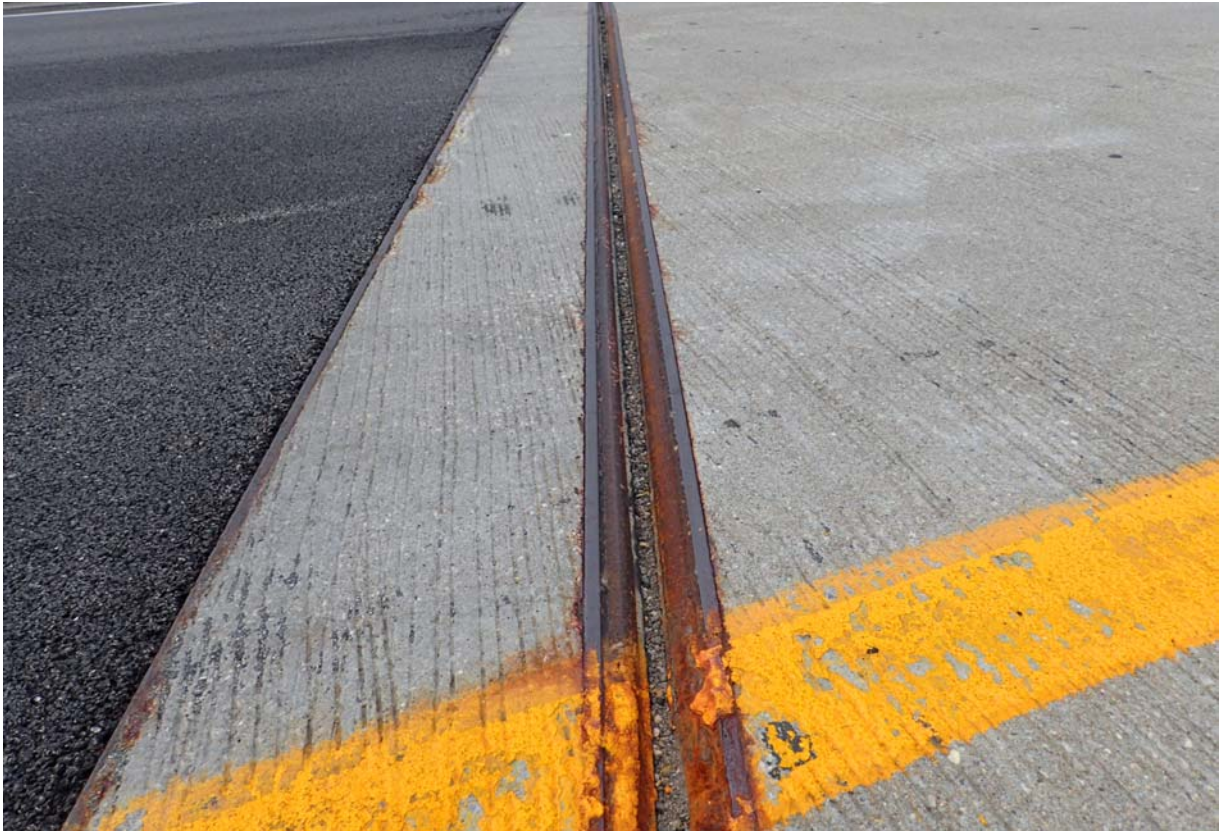
View of the transverse joint at abutment 4.

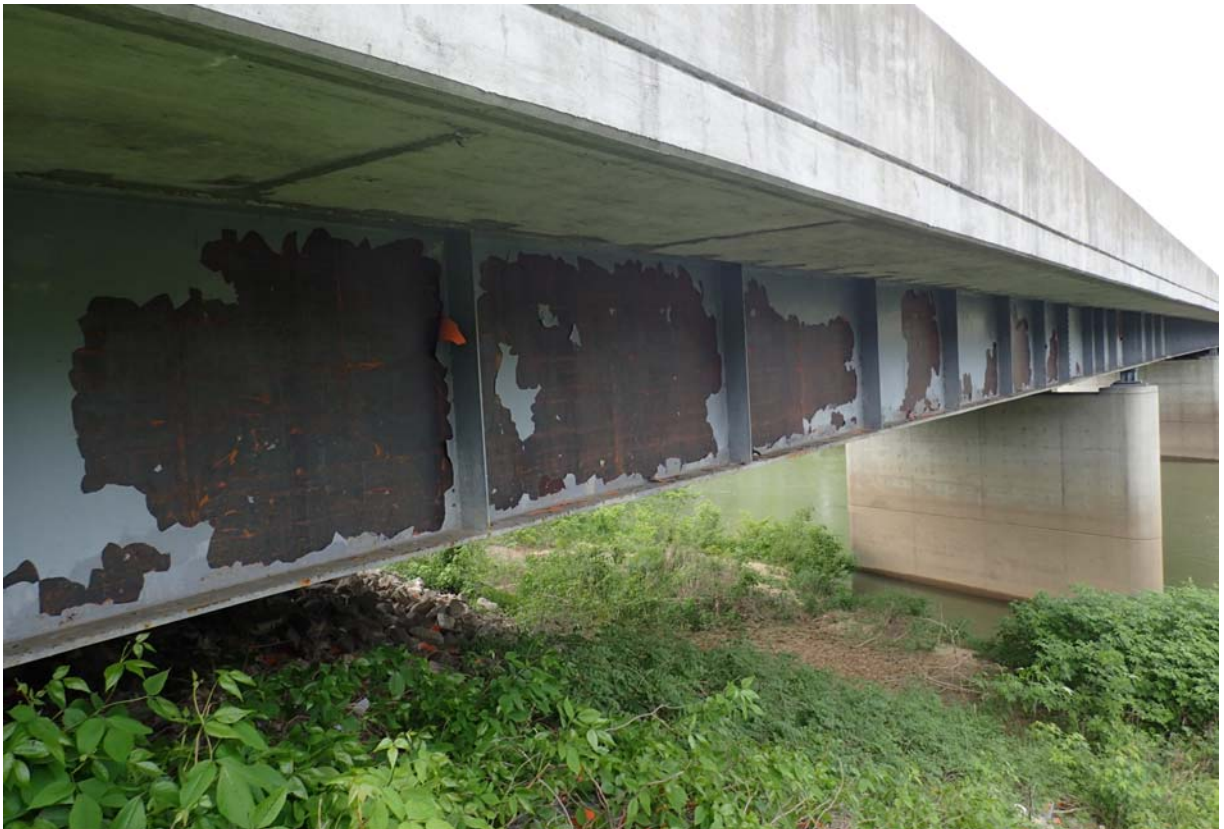
View of widespread paint failure on the exterior face of the downstream girder in span 3.

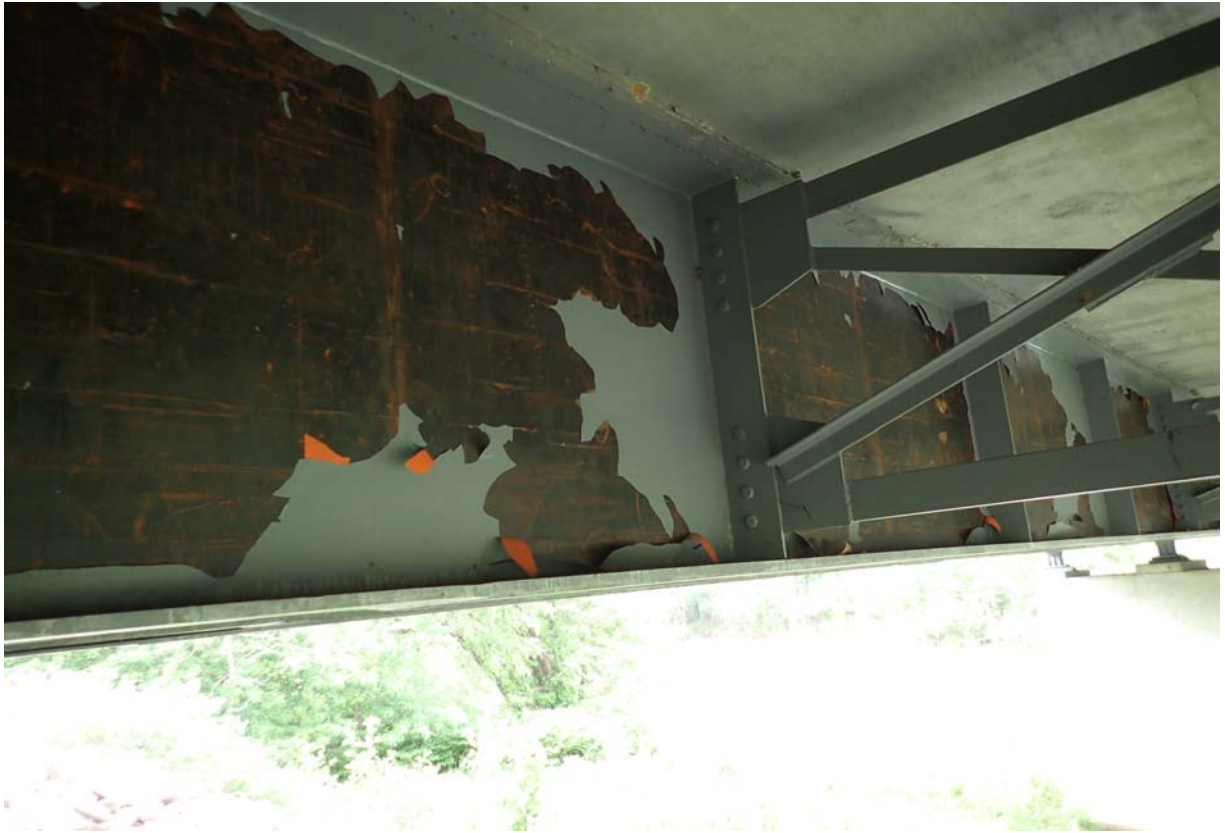
View of widespread paint failure on the downstream face of girder 3 in span 3.

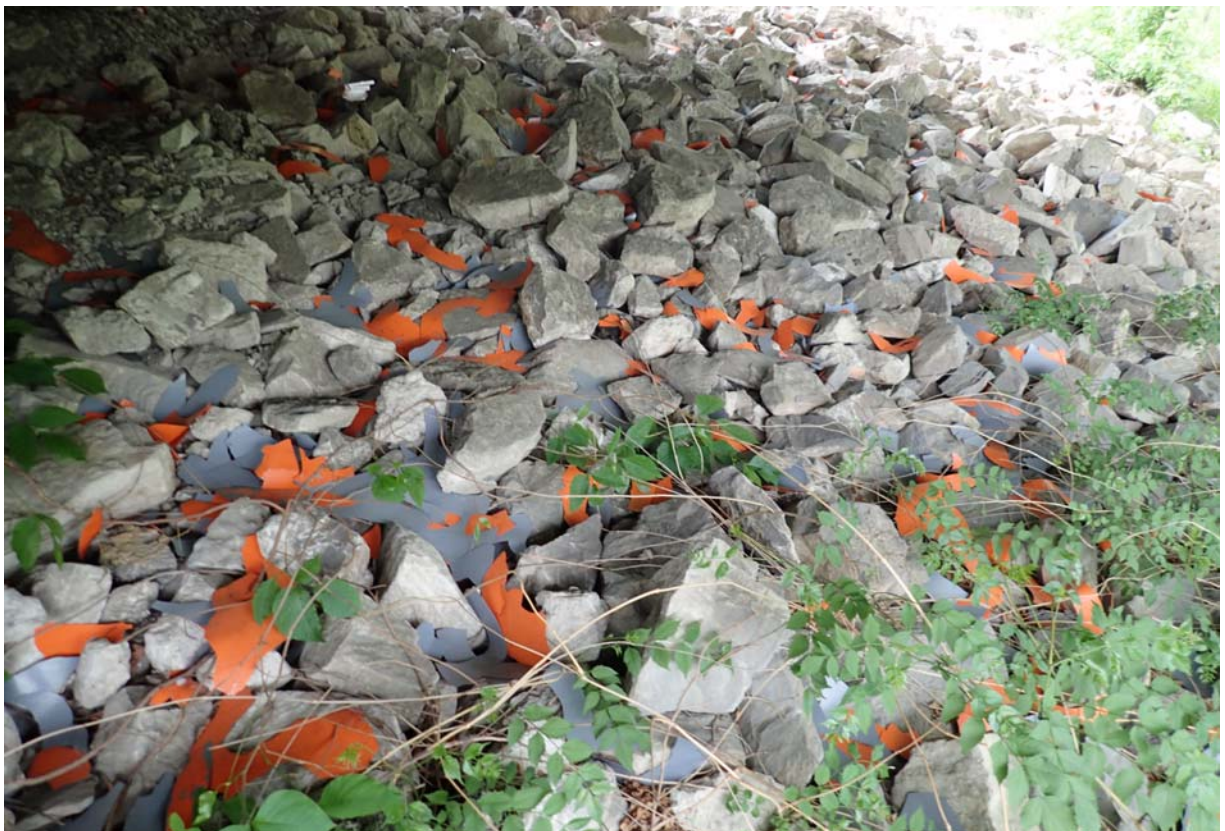
View of paint lying on the ground in span 3.

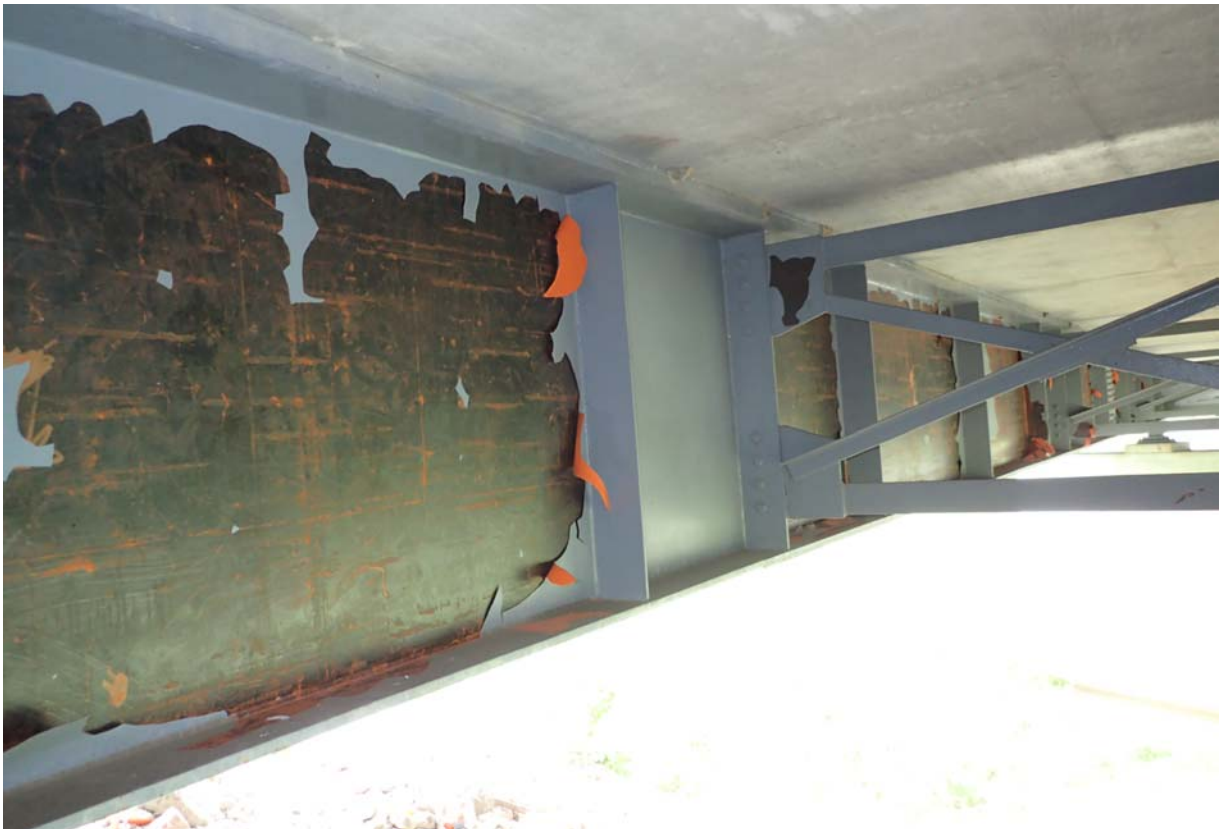
View of widespread paint failure on the downstream face of girder 2 in span 3.

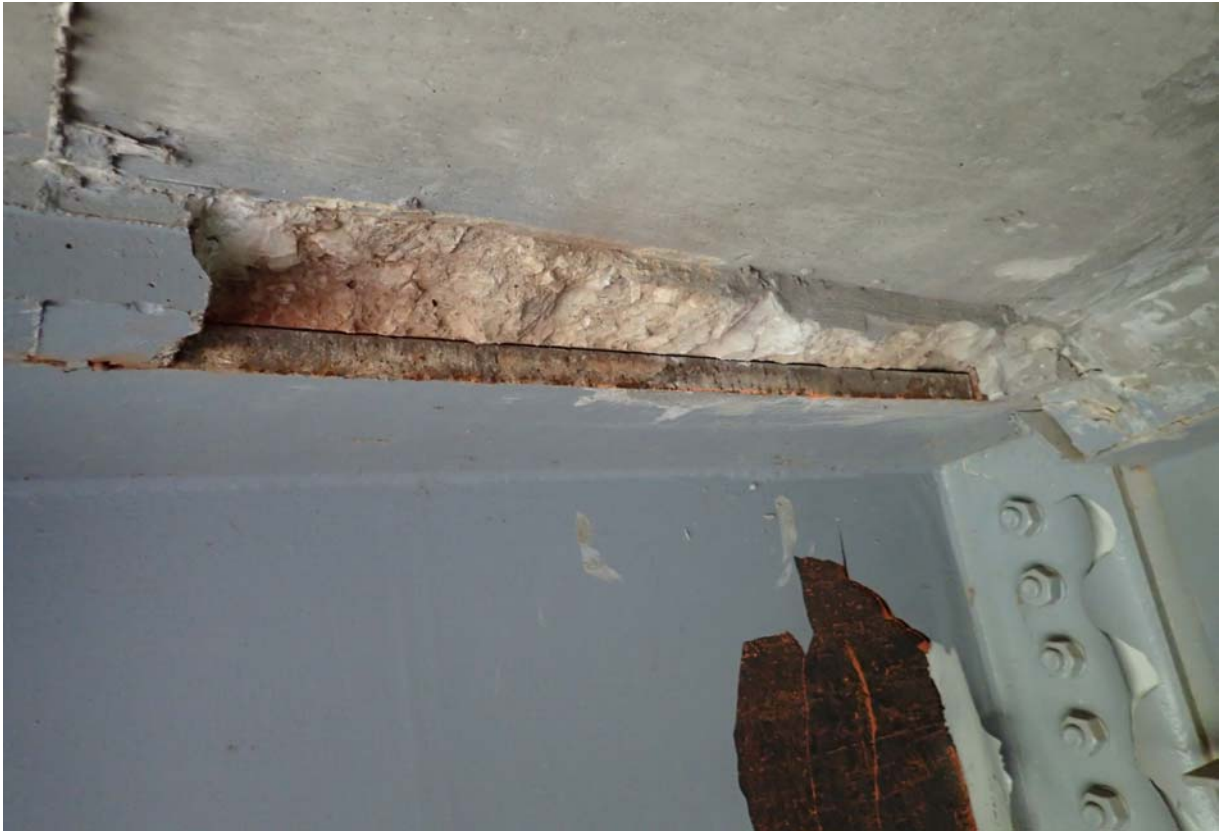
View of spalling along the fillet above girder 2 from upstream at abutment 4.

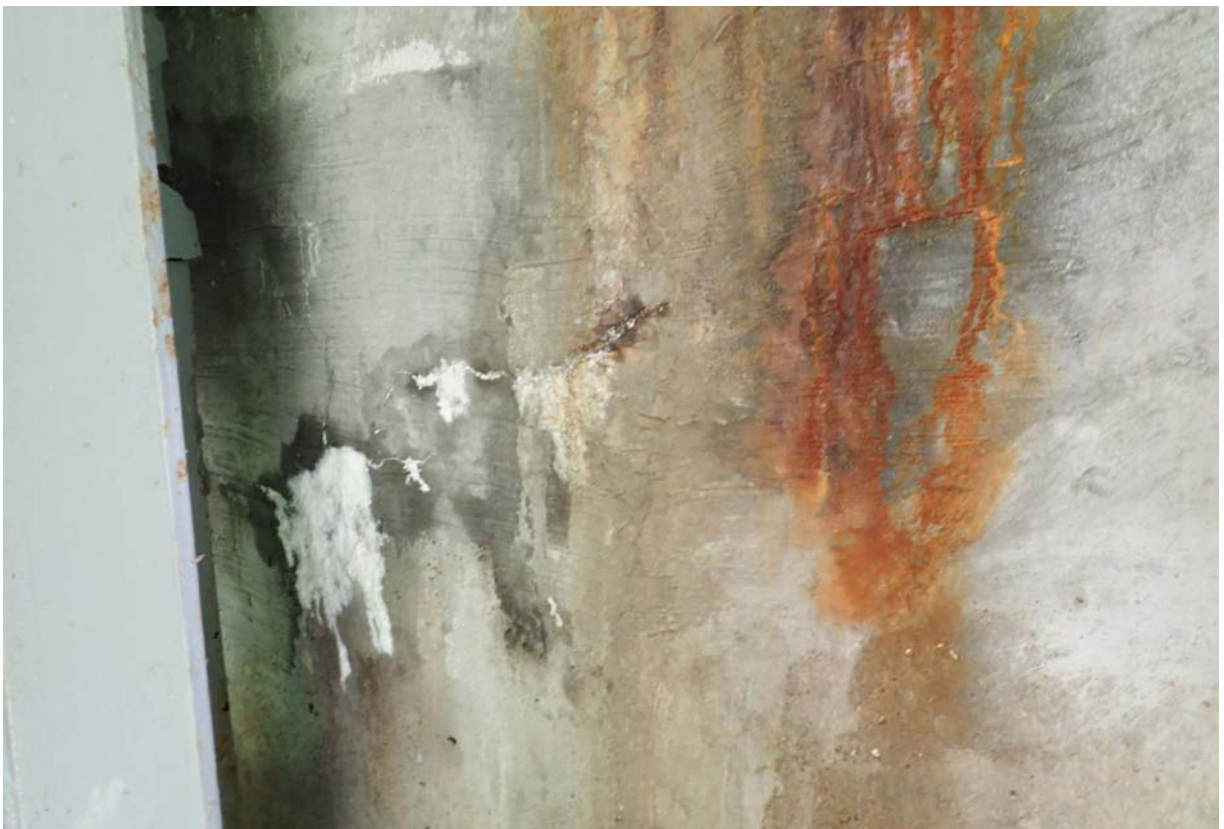
View of minor sized cracking with efflorescence and rust staining in the upstream backwall of abutment 4.

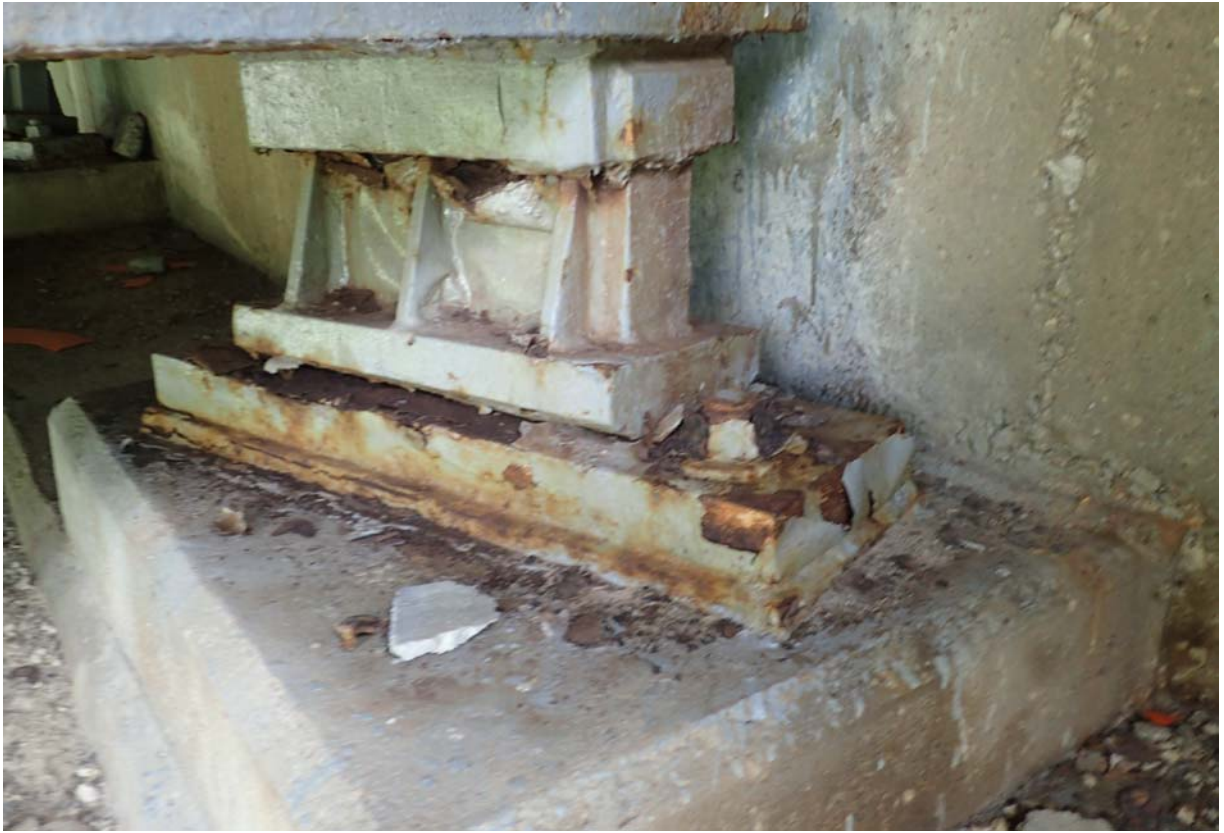
Upstream bearing at abutment 4; flaking paint with some moderate corrosion.

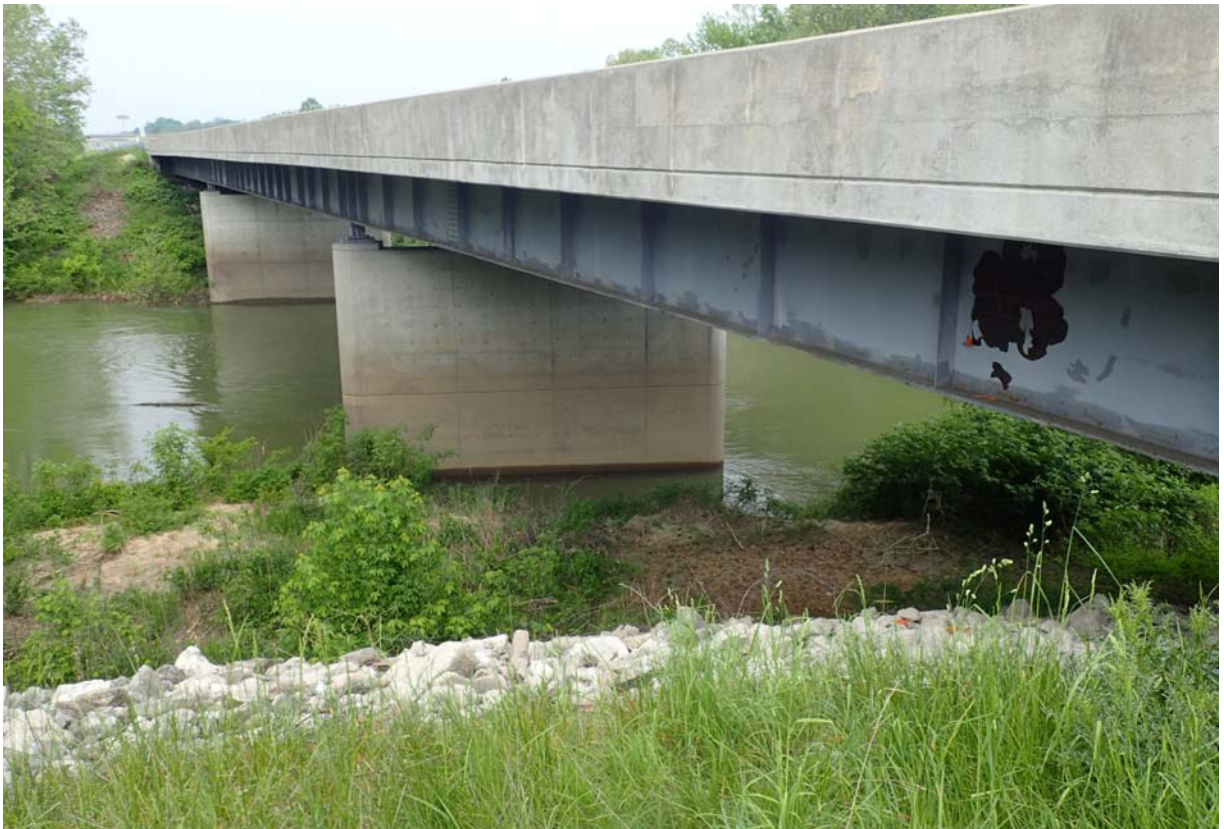
Upstream view from abutment 4.

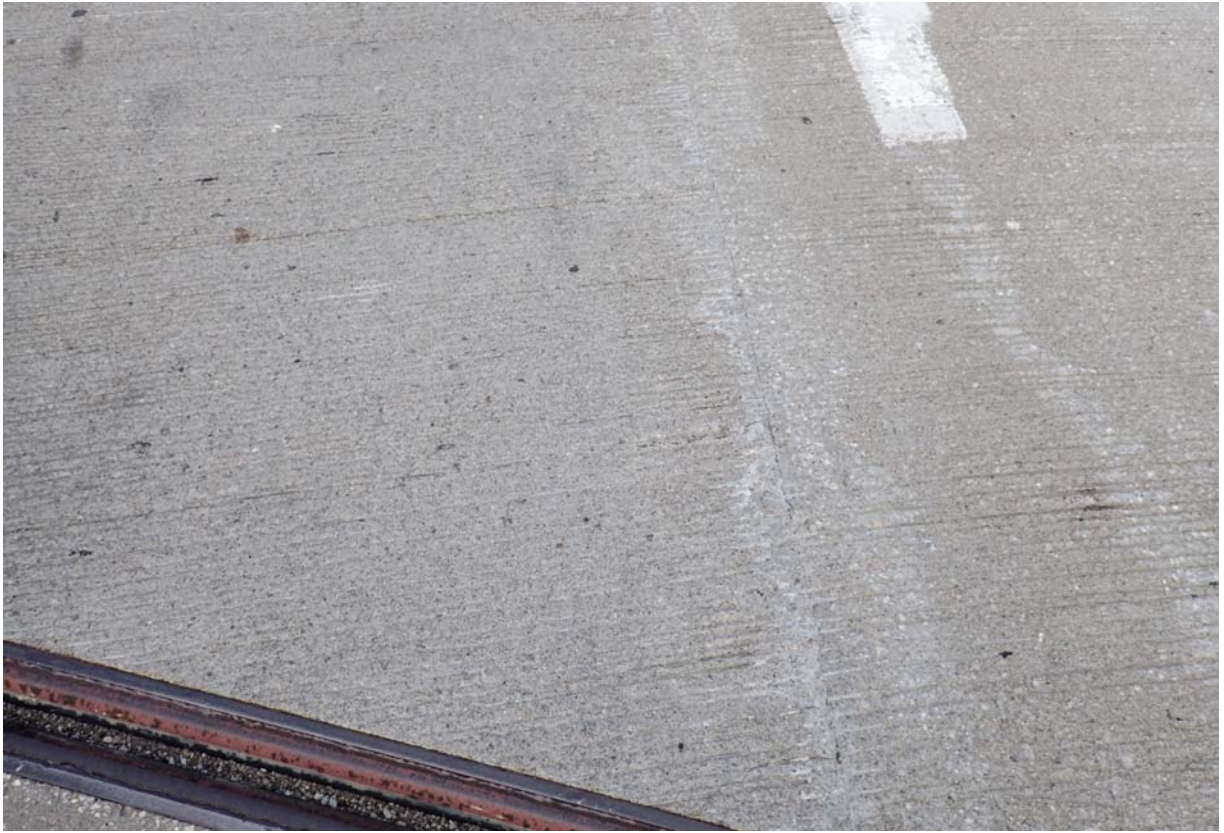
View of minor sized longitudinal cracking in the wearing surface of the slow lane at abutment 4.

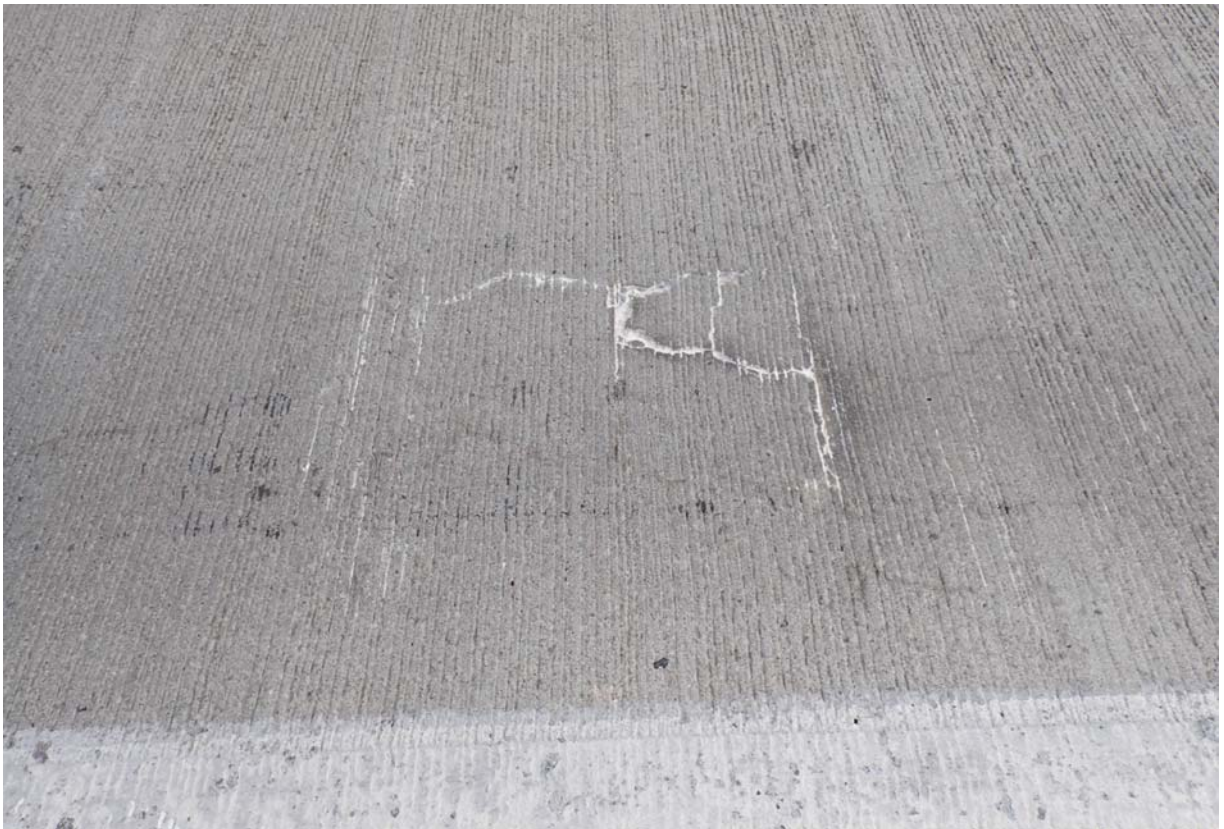
View of an area of moderate cracking with efflorescence in the wearing surface of the slow lane in span 1.

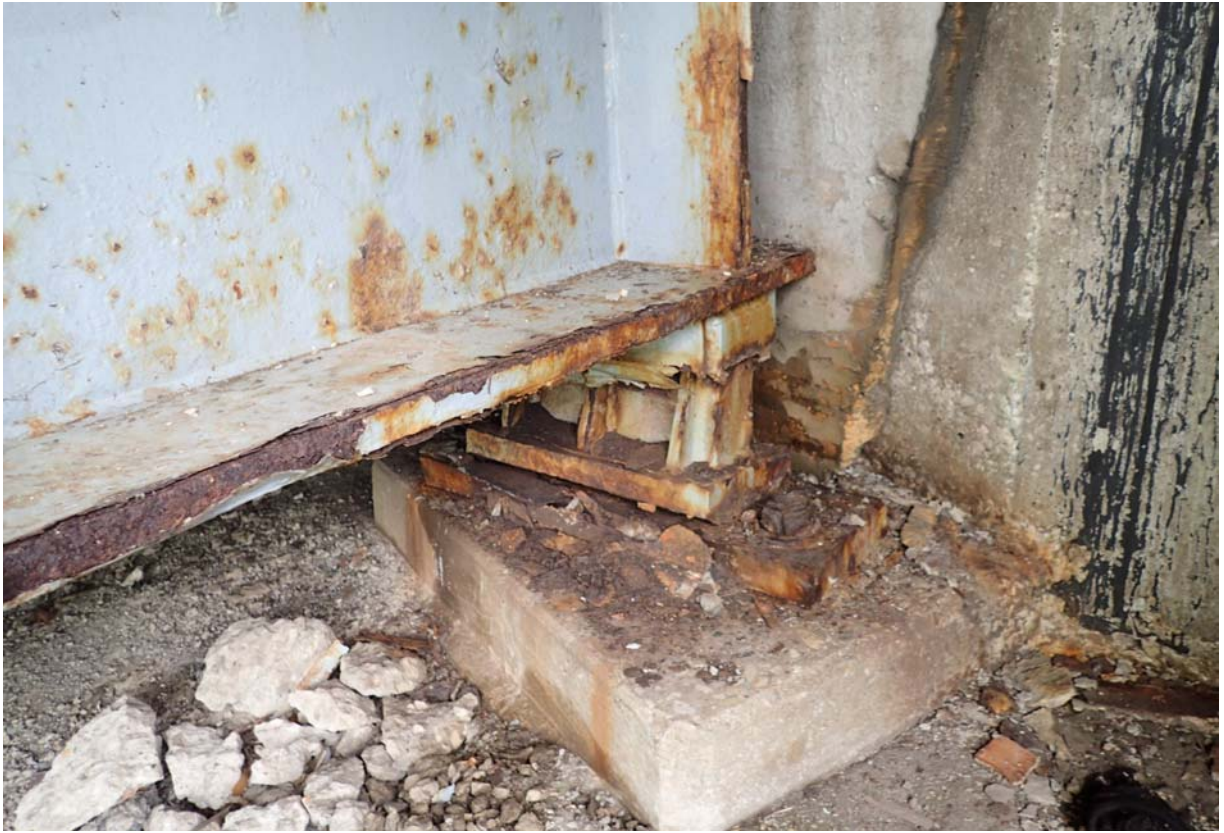
Downstream abutment 1 bearing; flaking paint with moderate corrosion. Notice the flaking paint along the girders bottom flange and the exposed steel has moderate rusty corrosion.

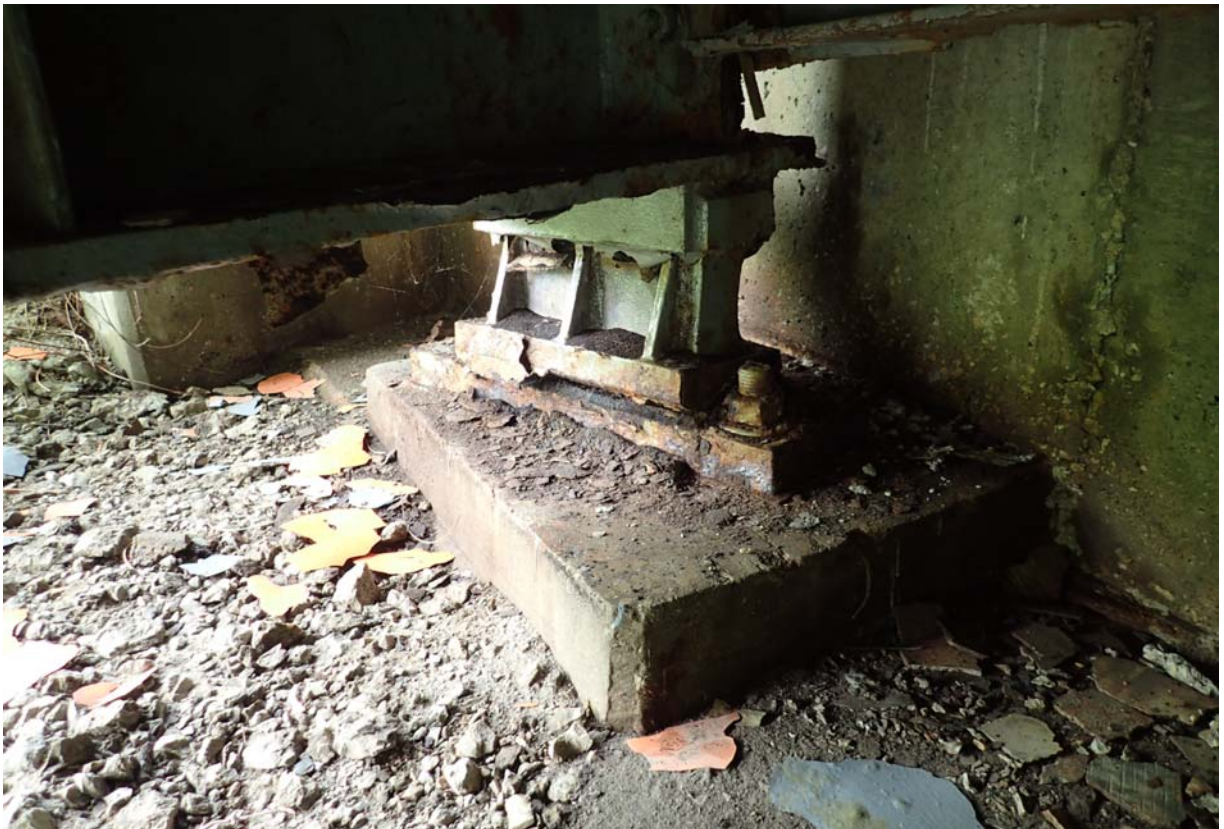
Upstream abutment 1 bearing; flaking paint with moderate corrosion.

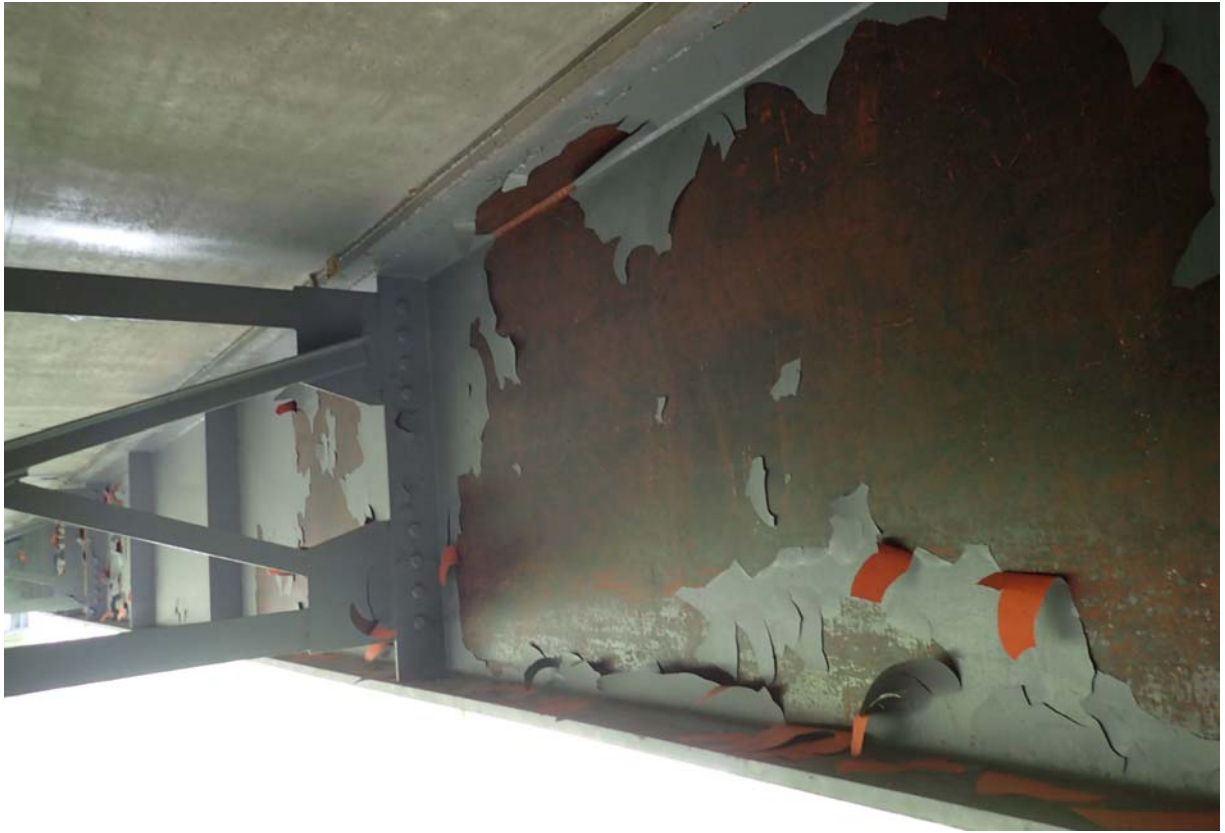
Several large areas of paint failure on the downstream face of the upstream girder near abutment 1.

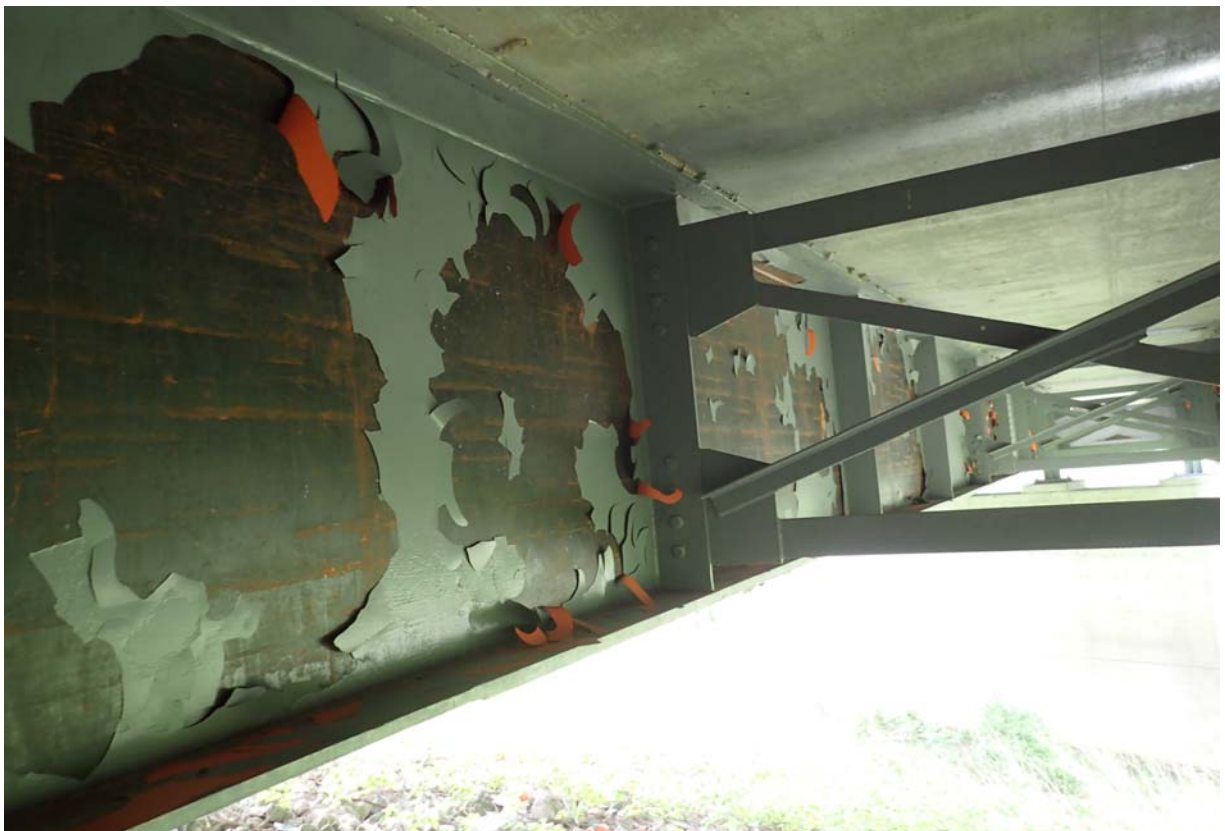
Several large areas of paint failure on the upstream face of girder 2 from upstream near abutment 1.

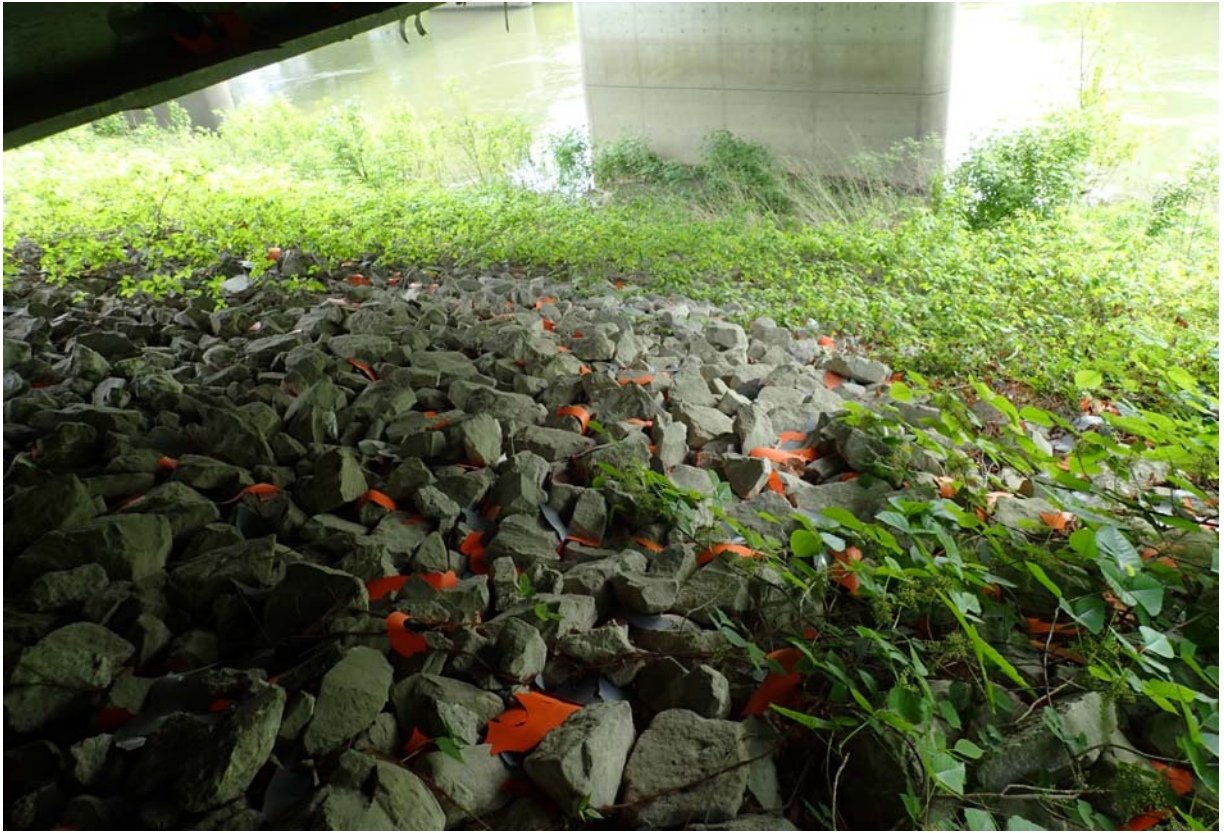
Paint scattered across the ground in span 1.
