Inspection Report with SI&A Data

Structure Description: 33.14 Foot - Single Span Concrete Tee Beam

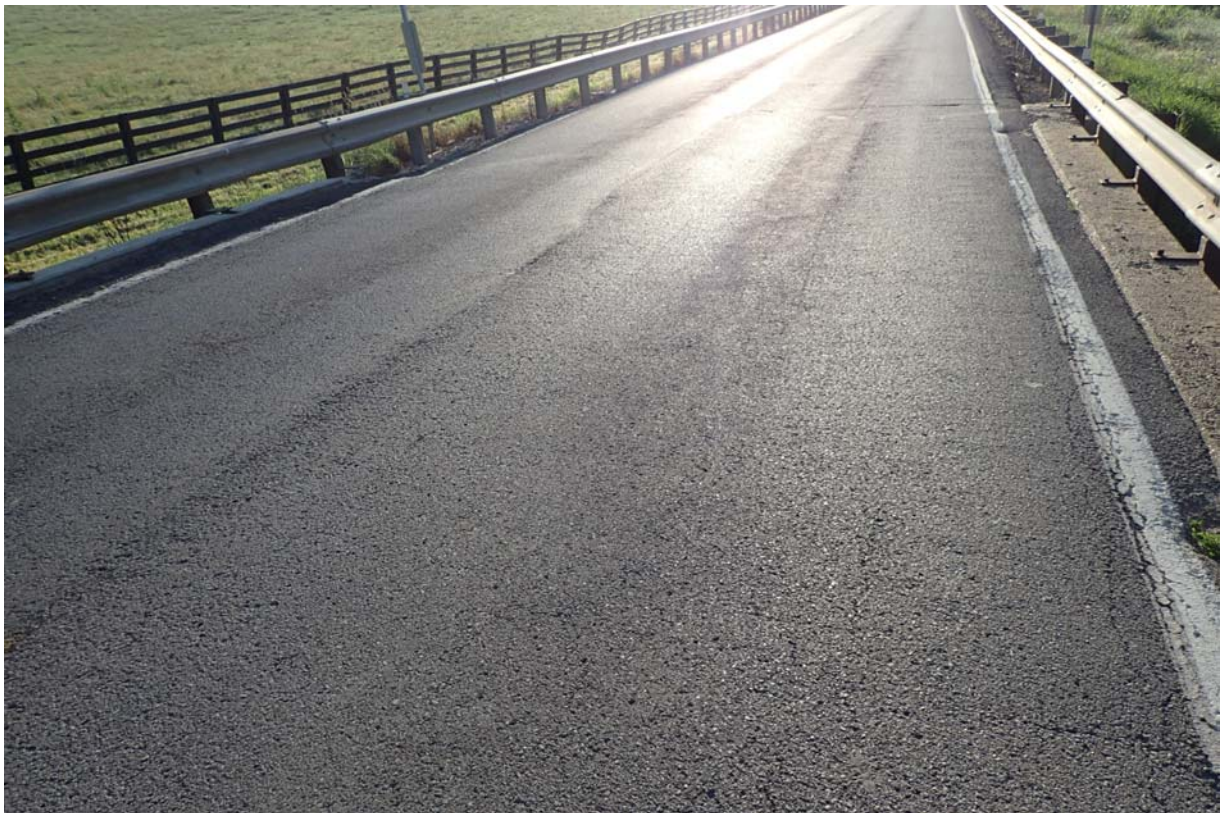
Typical view of the asphalt wearing surface.

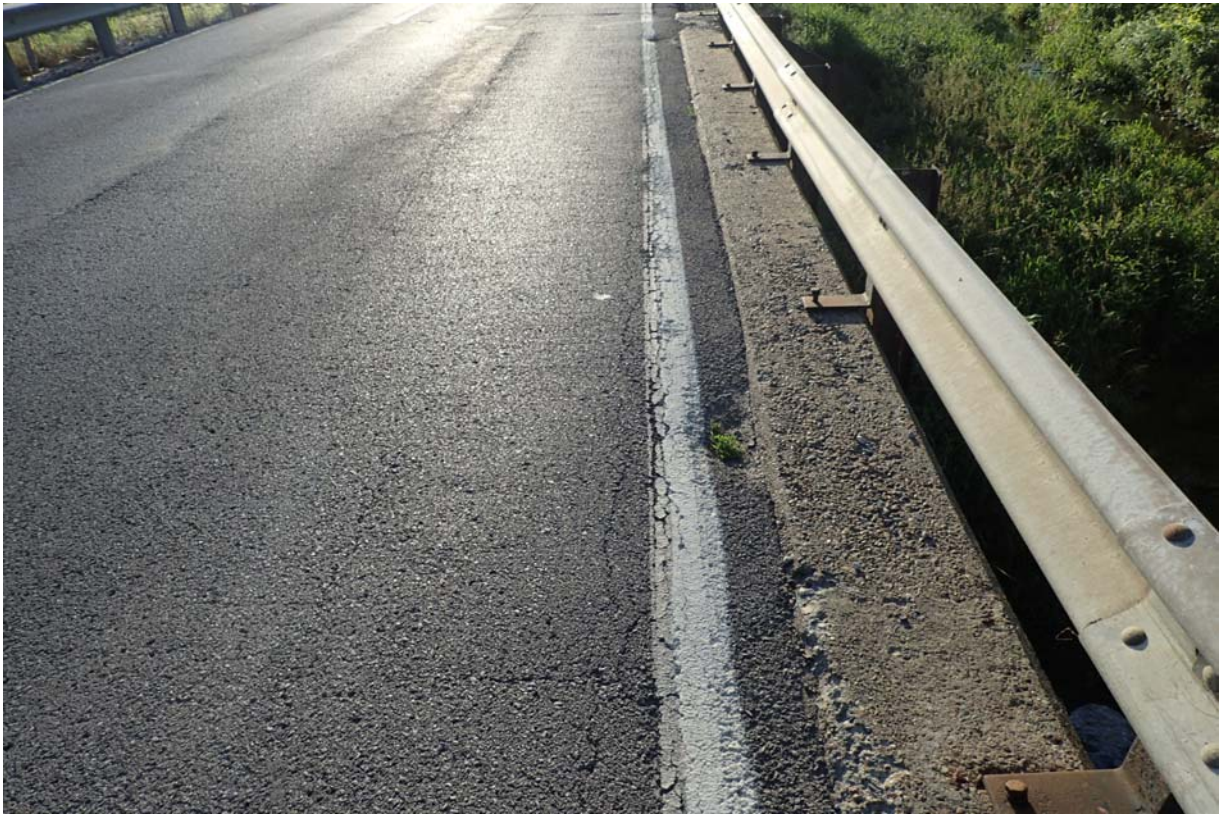
View of minor to moderate scaling/spalling along the downstream curb.

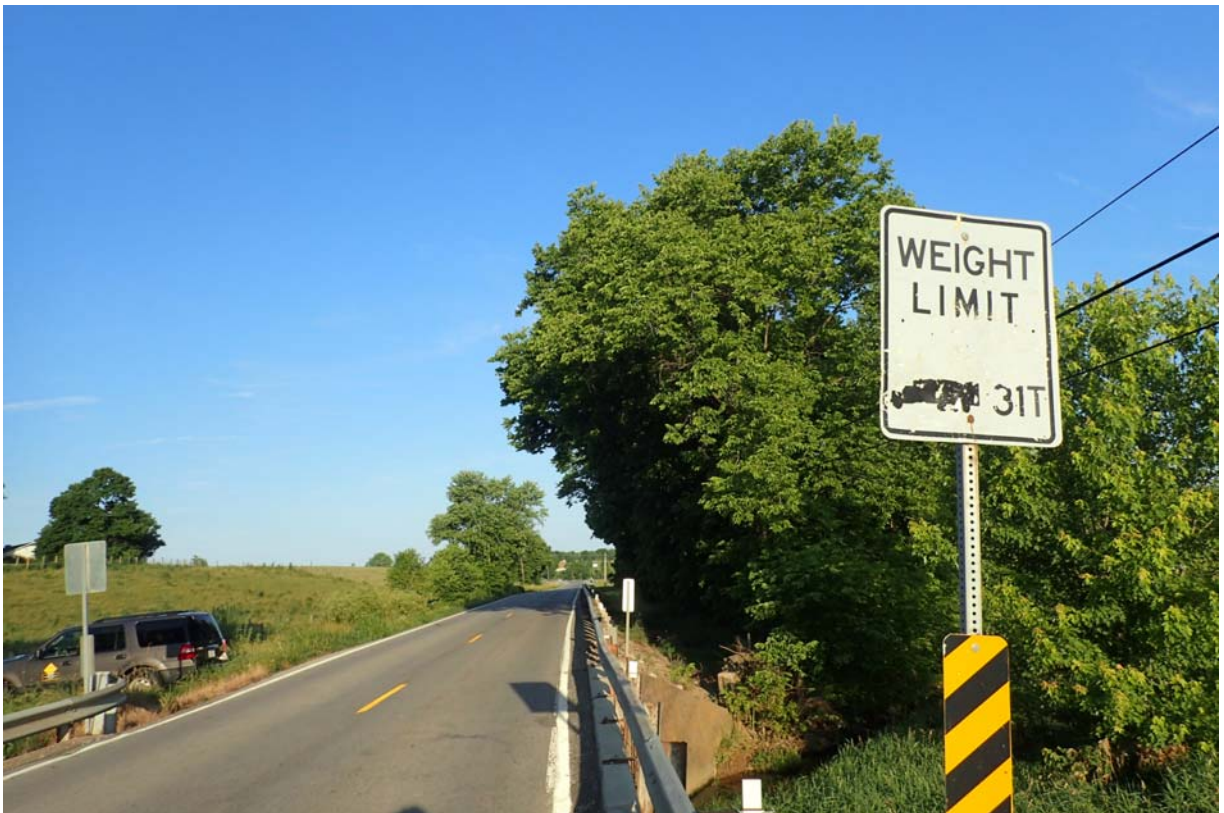
View of the weight limit posting near abutment 2.

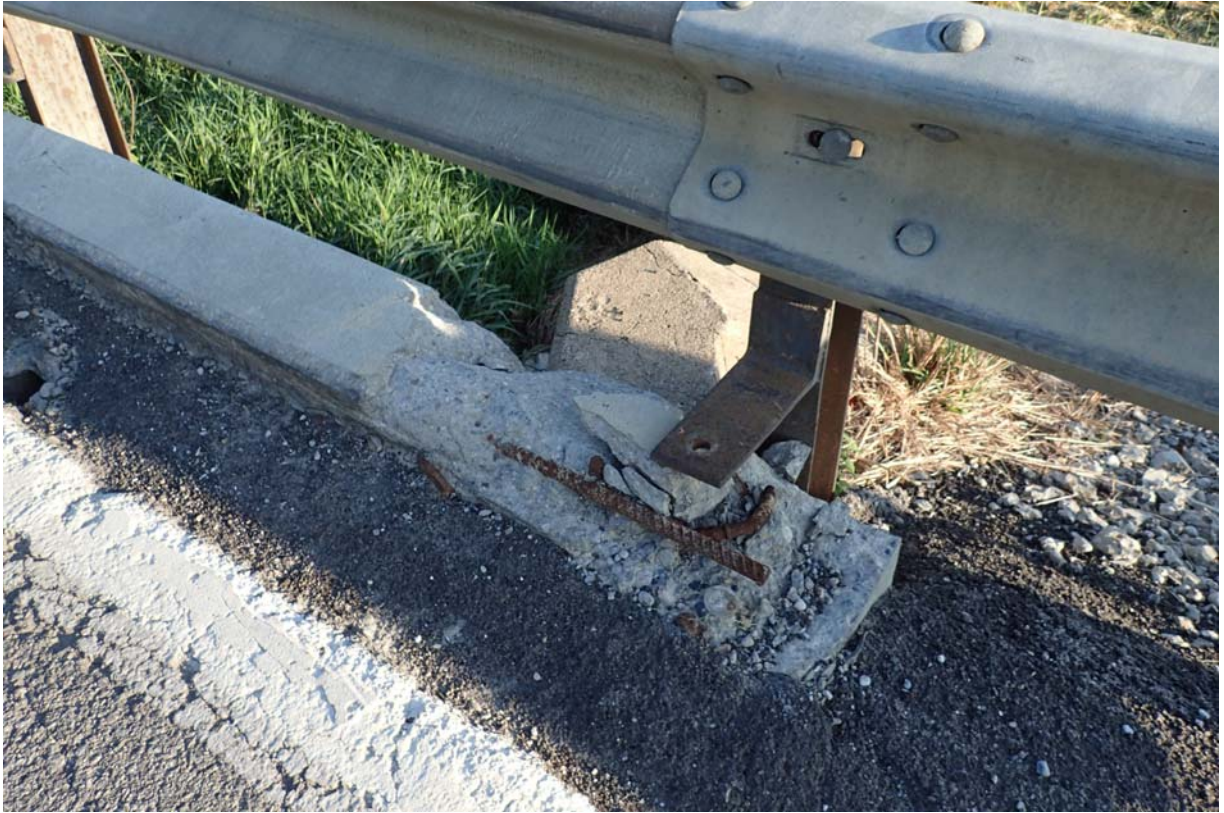
View of broken/spalled area in the downstream curb at abutment 2. Notice the guardrail post is no longer connected

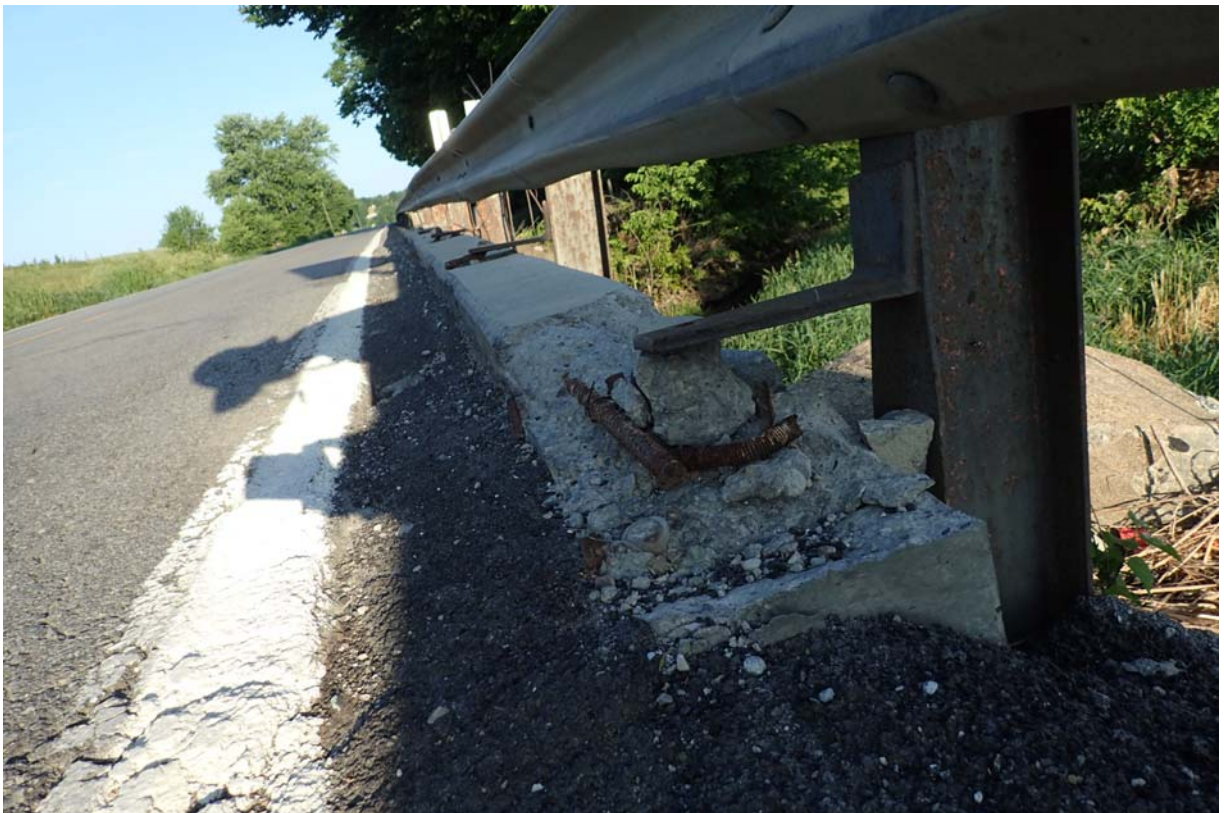
View of broken/spalled area in the downstream curb at abutment 2. Notice the guardrail post is no longer connected.

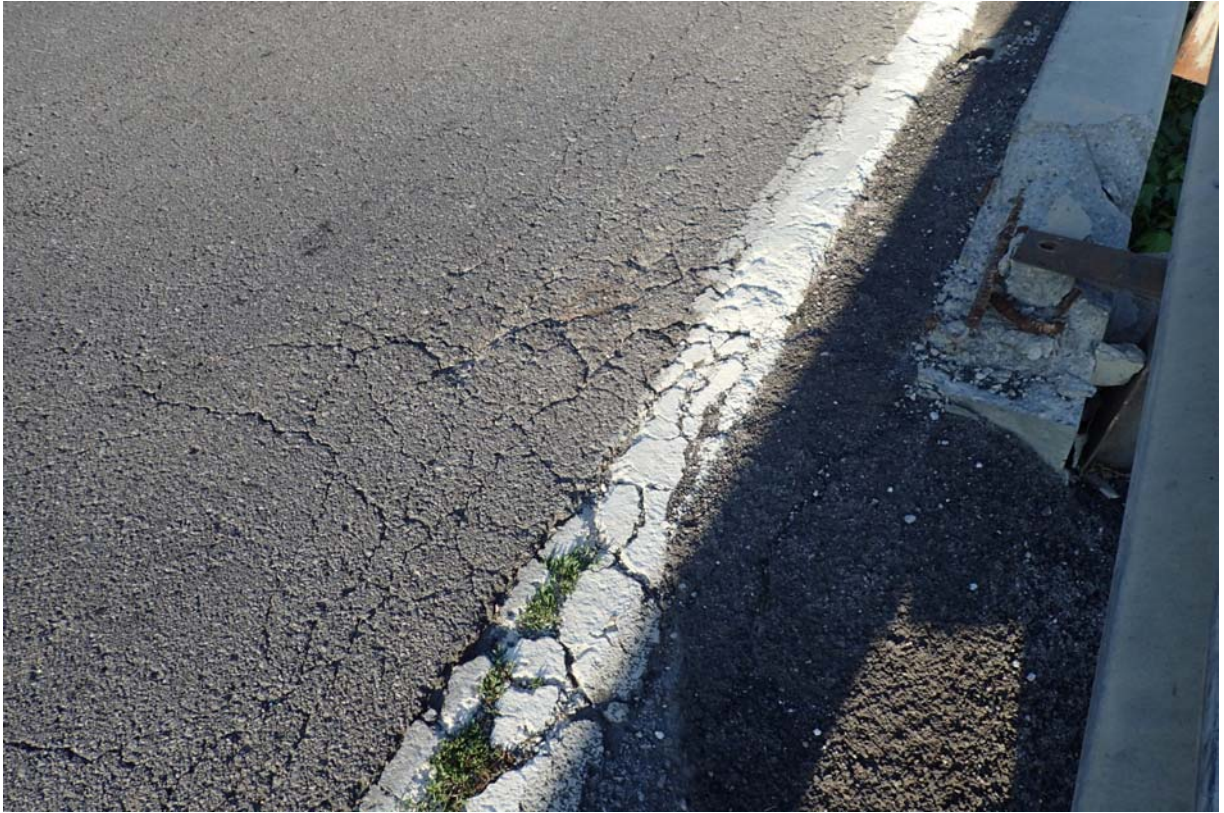
View of rutting and a heavy intensity of cracking along the downstream shoulder of the wearing surface near abutment 2.

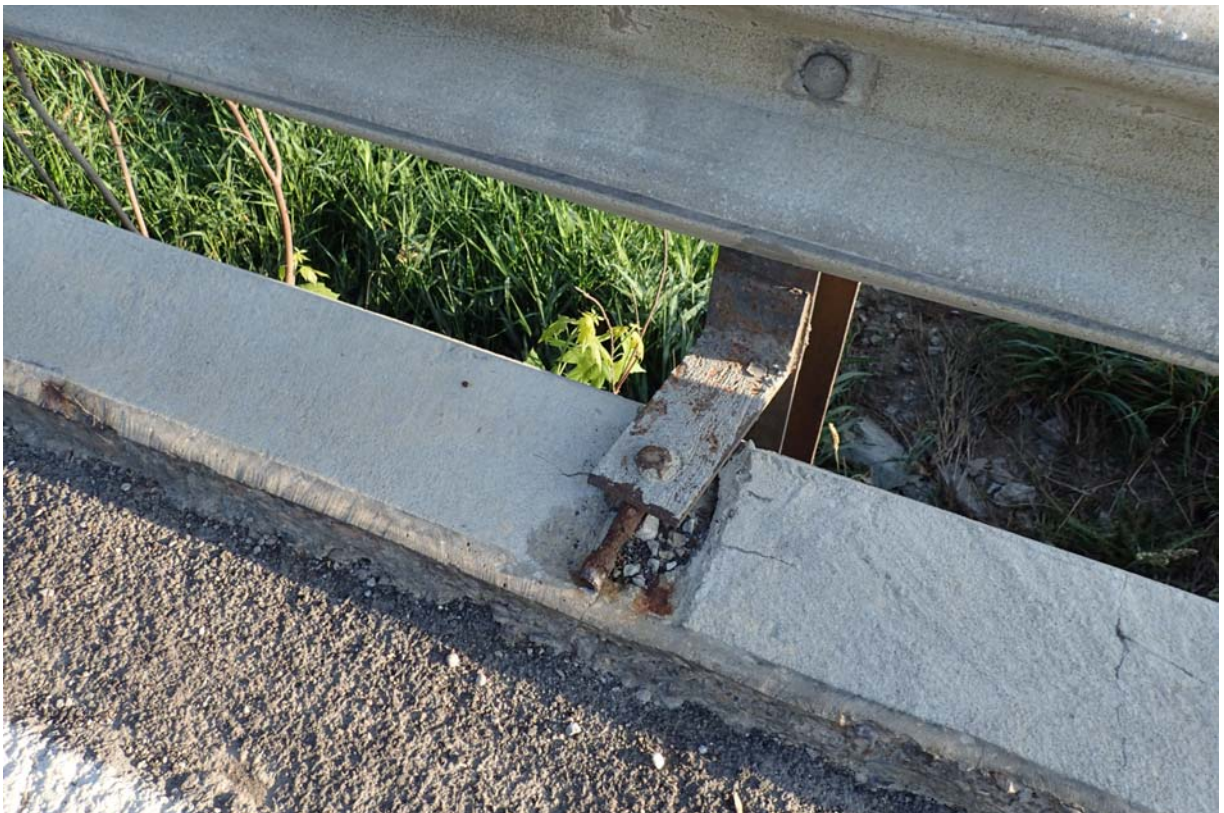
View of disconnected guardrail post 2 from the north in the downstream curb.

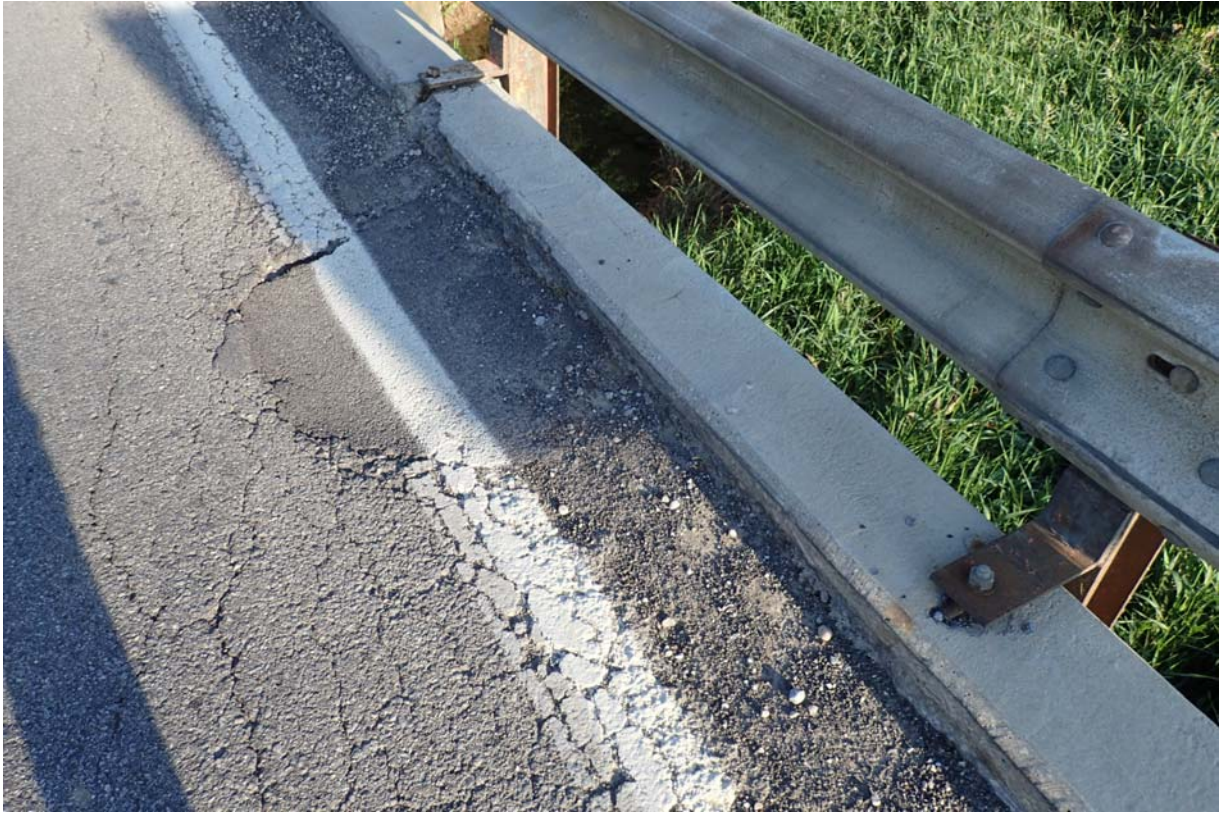
View of rutting, patching, and a heavy intensity of cracking along the downstream shoulder of the wearing surface.

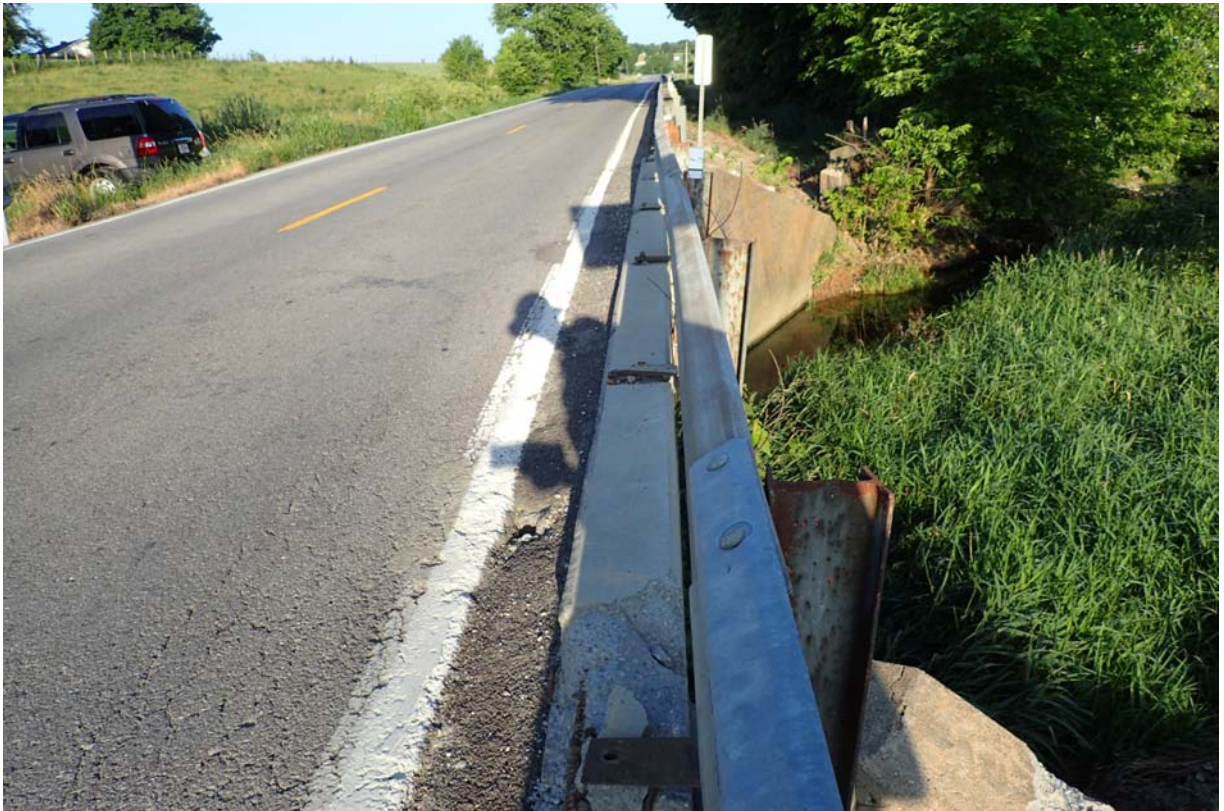
View of the downstream guardrail pushed out from the bridge.

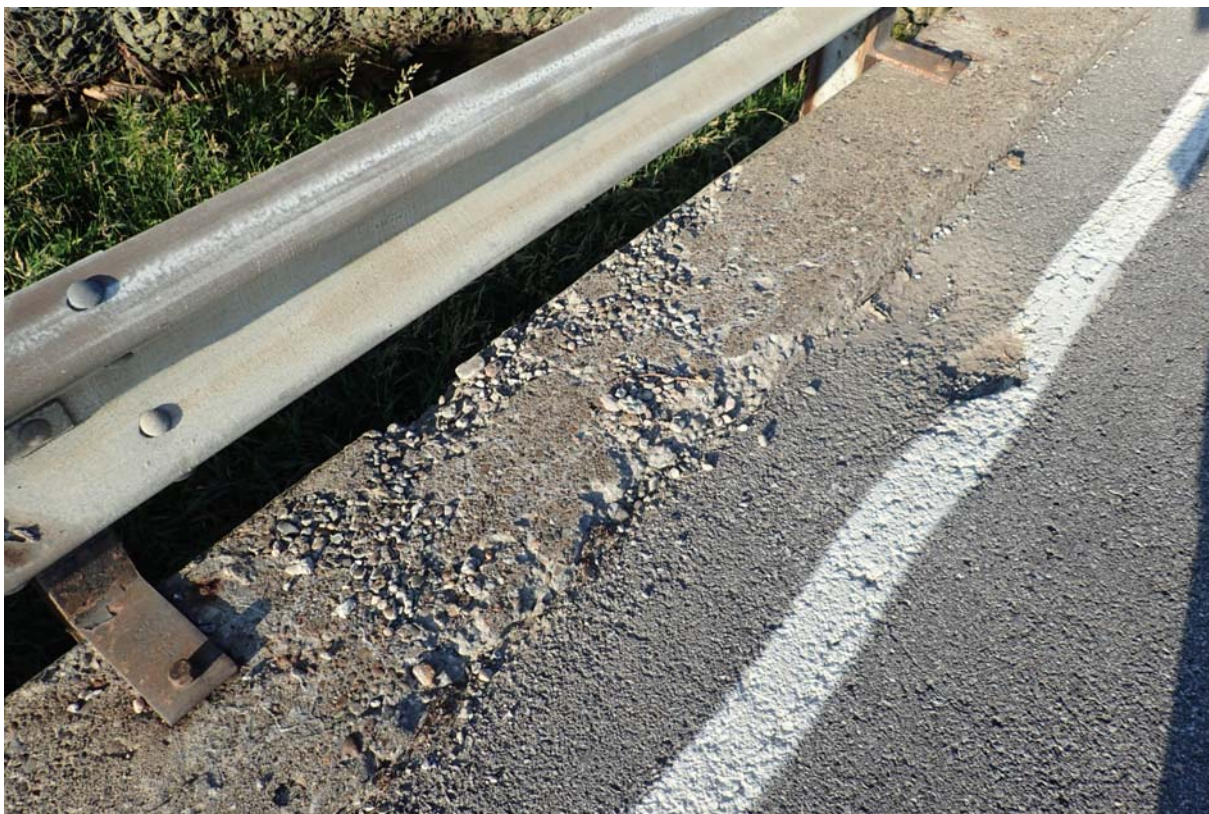
View of moderate spalling in the upstream curb near abutment 2.

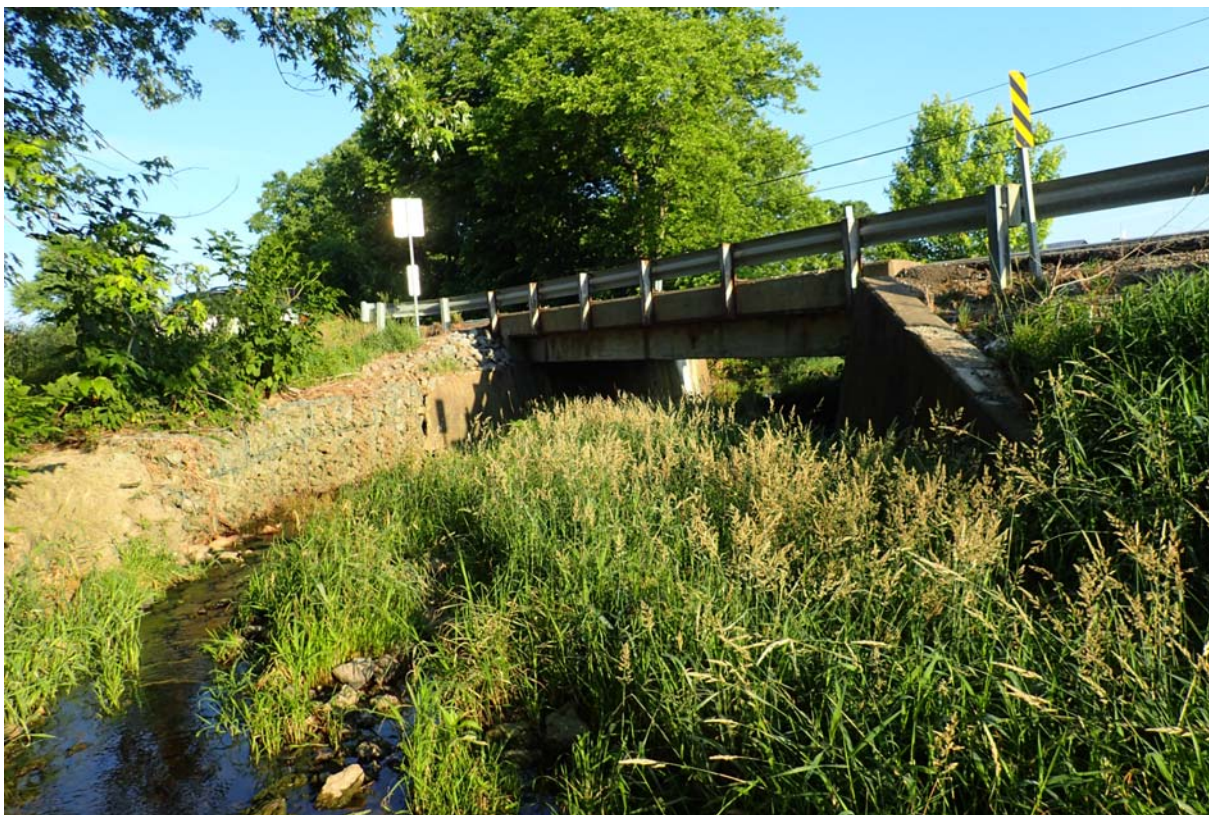
Typical view from upstream.

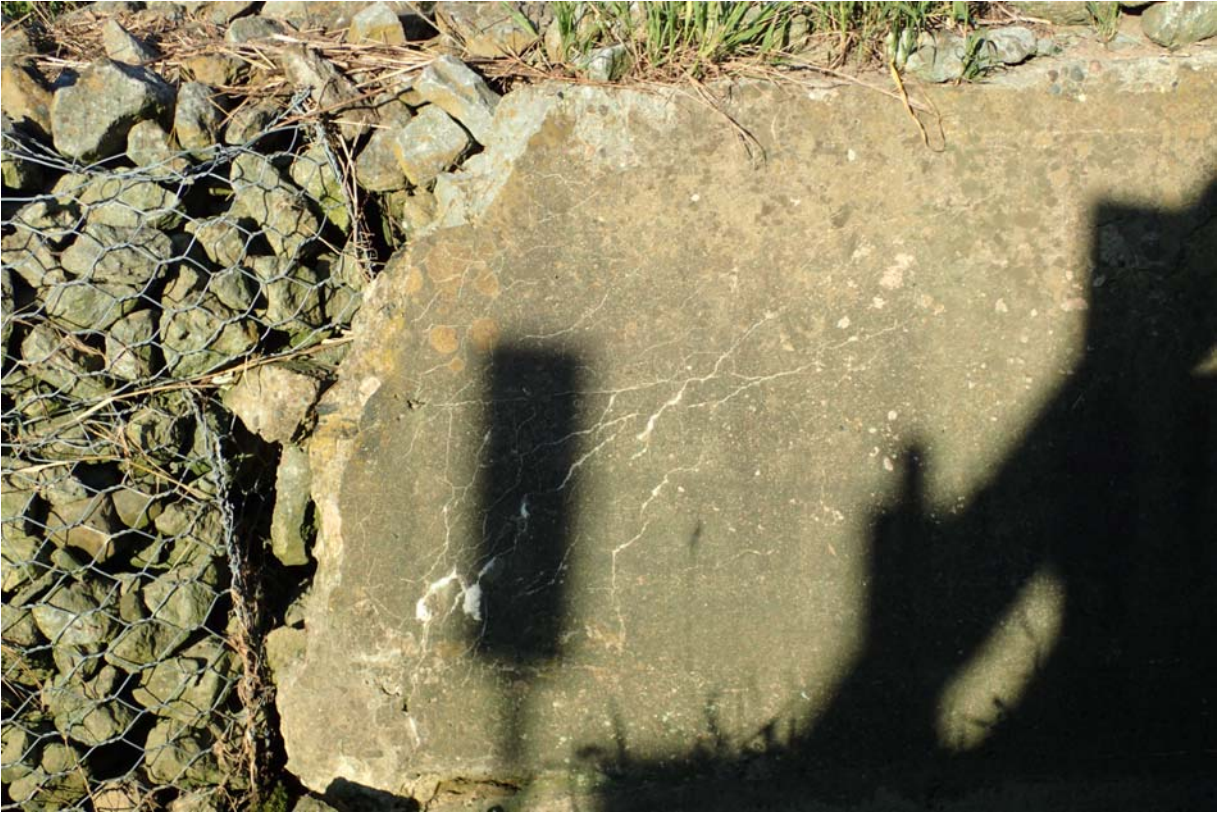
View of moderate spalling and minor sized cracking at the upstream end of abutment 1s wingwall.

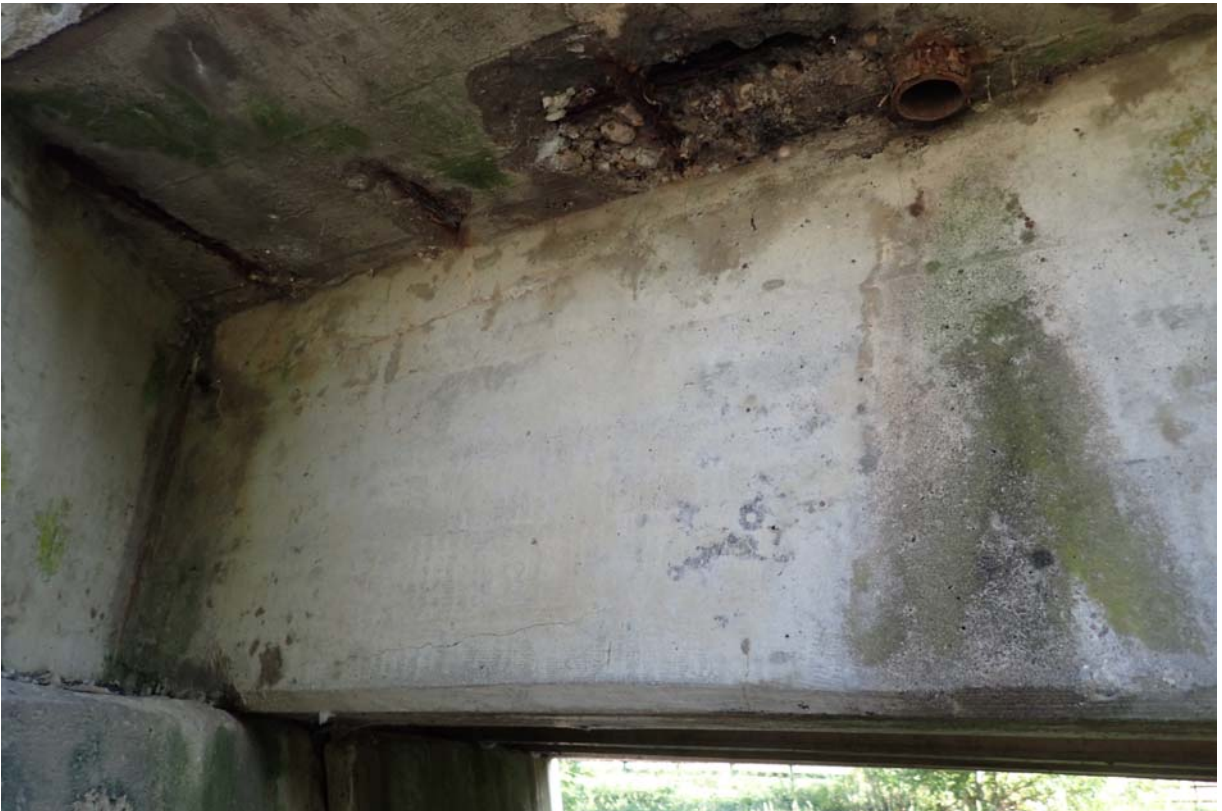
View of minor sized cracking in the upstream beam at abutment 1. Notice the moderate spalling with exposed steel in the deck overhang.

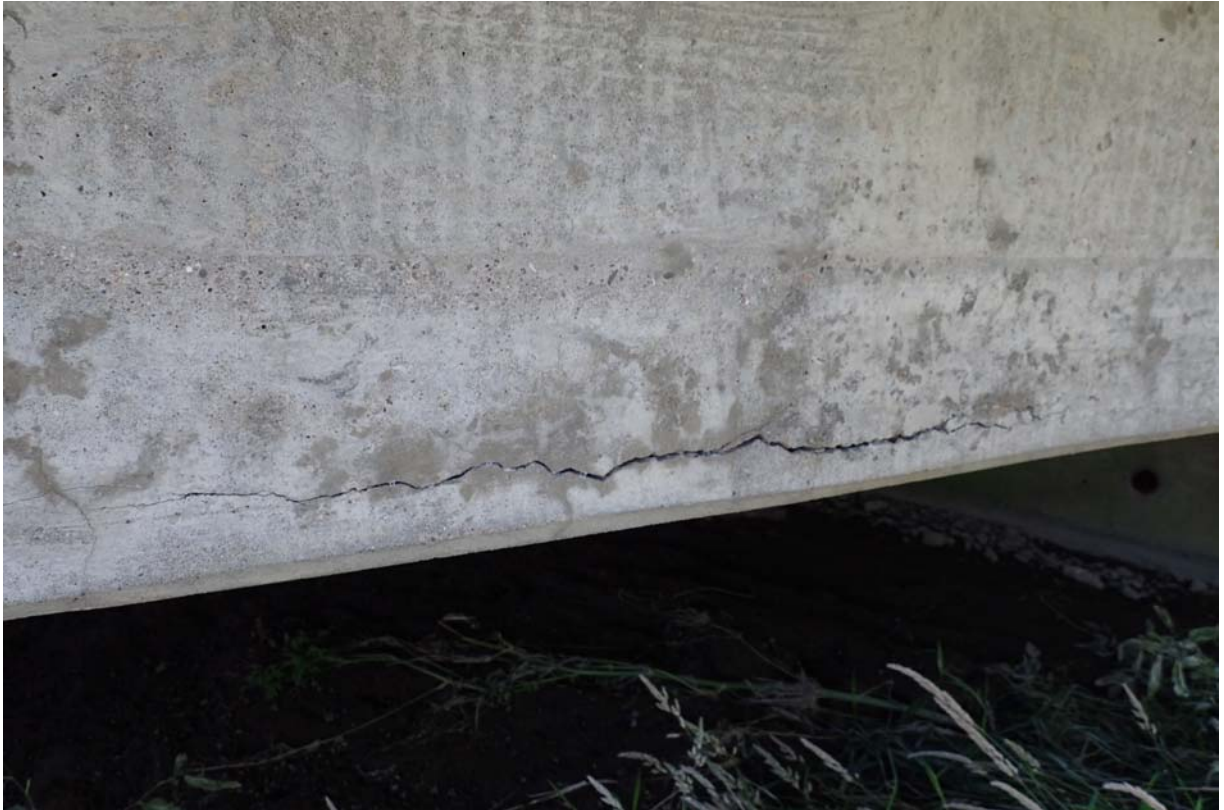
Moderate longitudinal cracking the lower exterior face of the upstream beam near midspan.

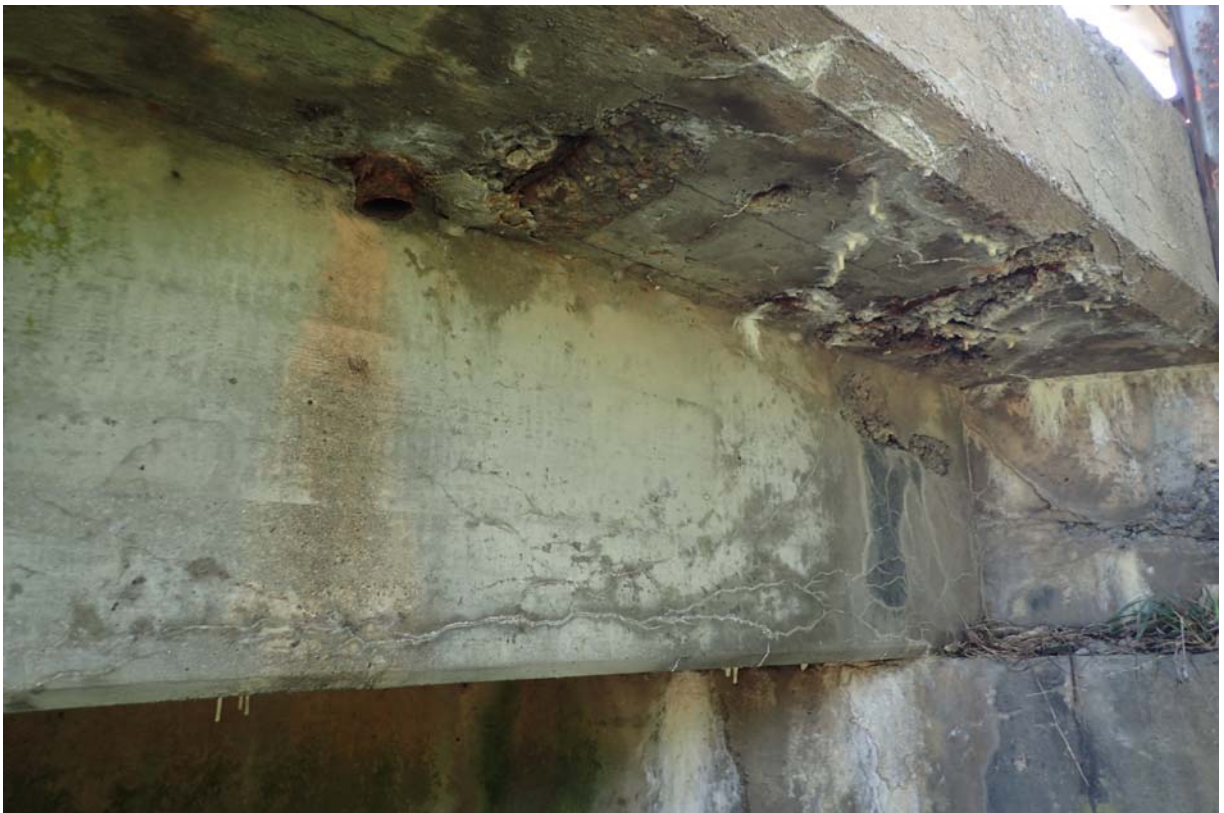
View of minor sized heavy intensity of cracking in the exterior face of the upstream beam and diaphragm at abutment 2. Notice the moderate to heavy spalling in the upstream deck overhang.

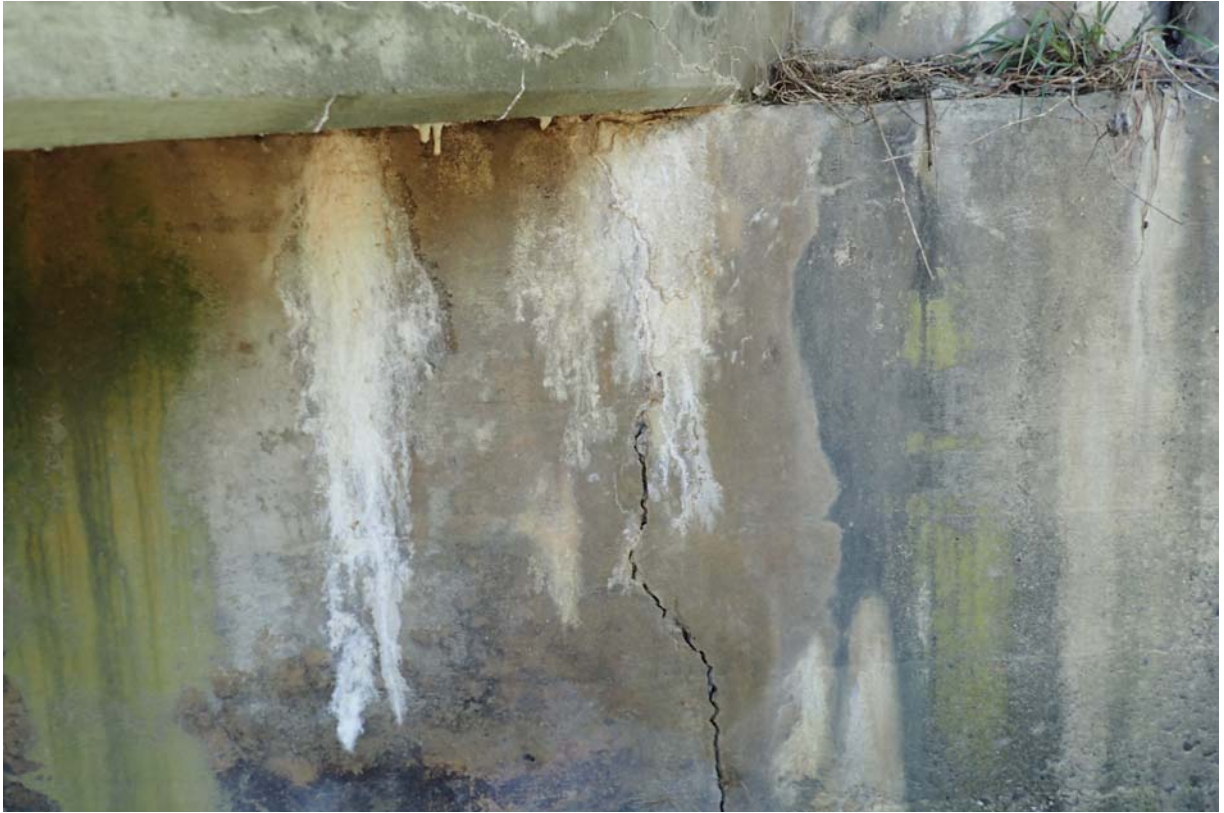
View of a 3/16" wide vertical crack in abutment 2 below the upstream beam.

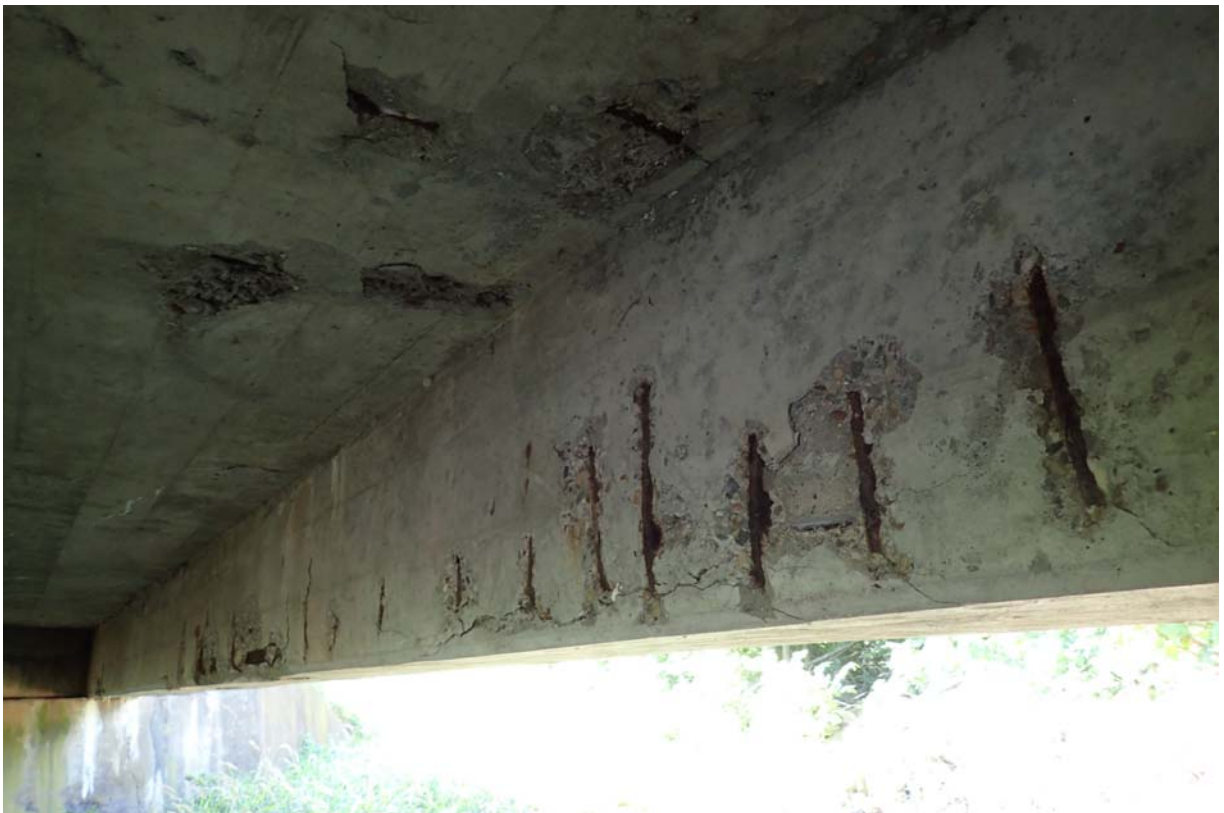
View of several small to medium sized spalls along the interior face of the upstream beam.

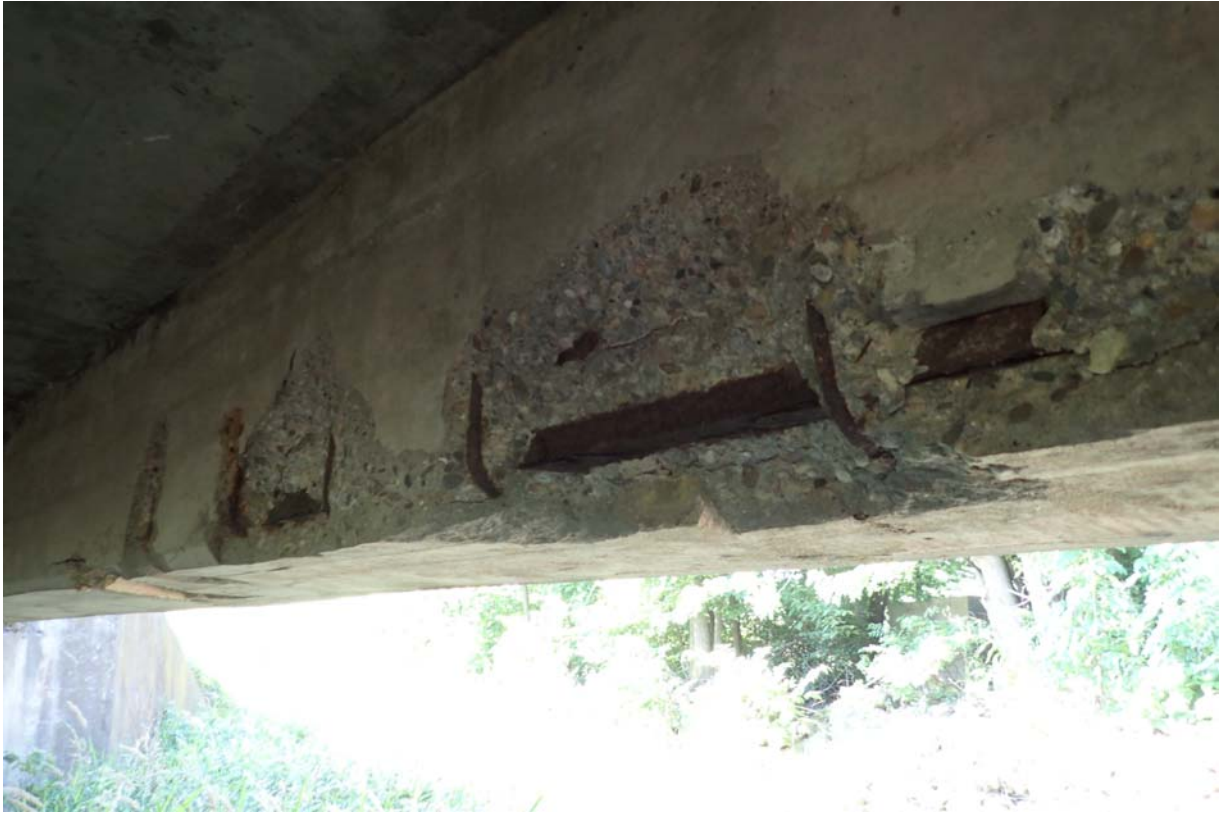
View of heavy spalling with exposed steel in the interior face of the upstream beam near midspan. Notice the exposed longitudinal reinforcement.

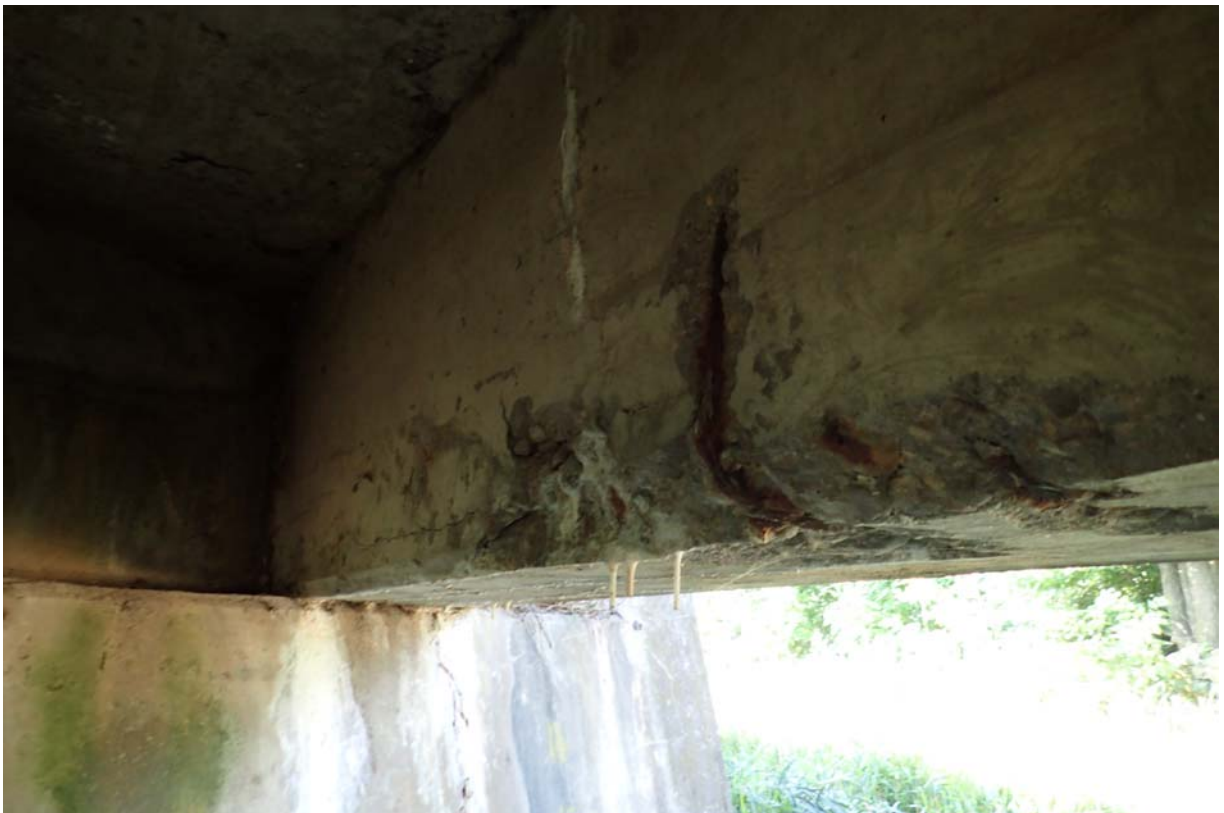
View of moderate cracking and spalling with exposed steel in the interior face of the upstream beam near abutment 2.

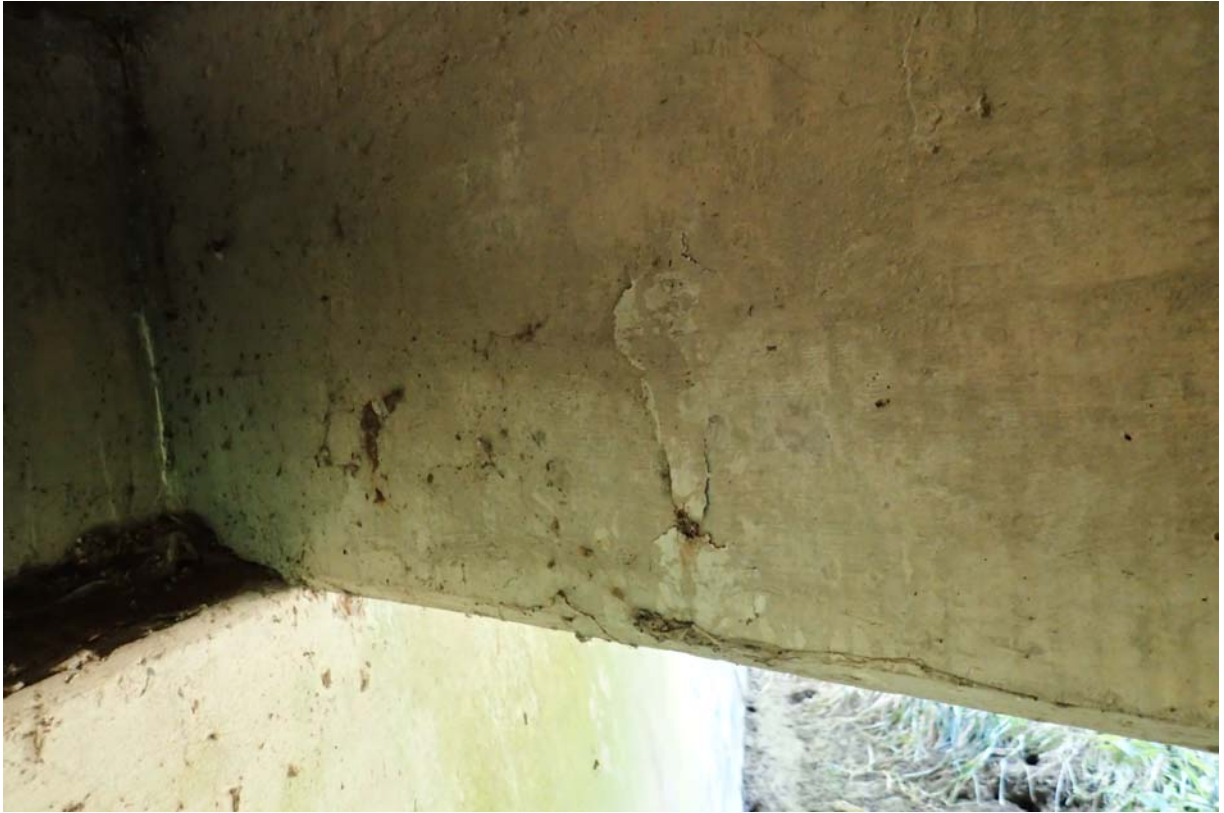
View of minor delamination cracking in the downstream face of beam 2 from upstream near abutment 2.

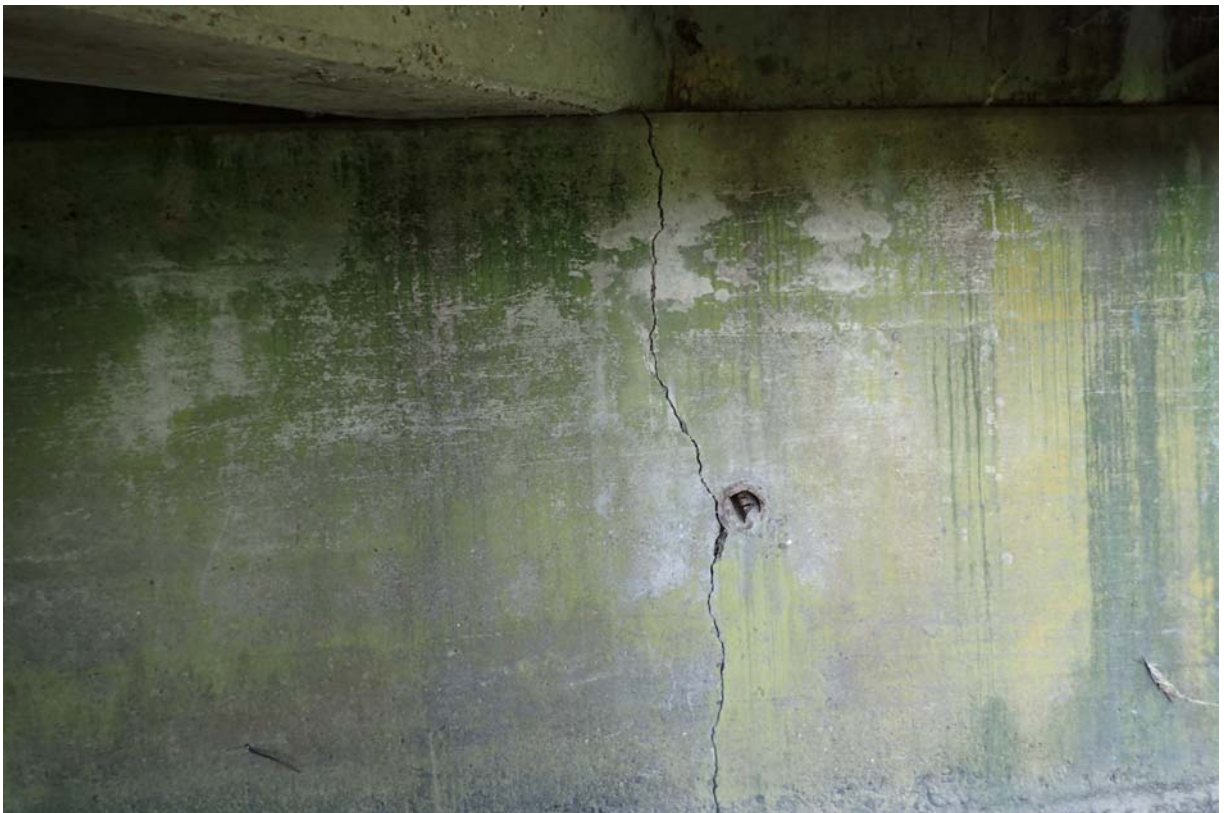
View of a 3/16" wide (typically) crack in abutment 1 below beam 3 from upstream.

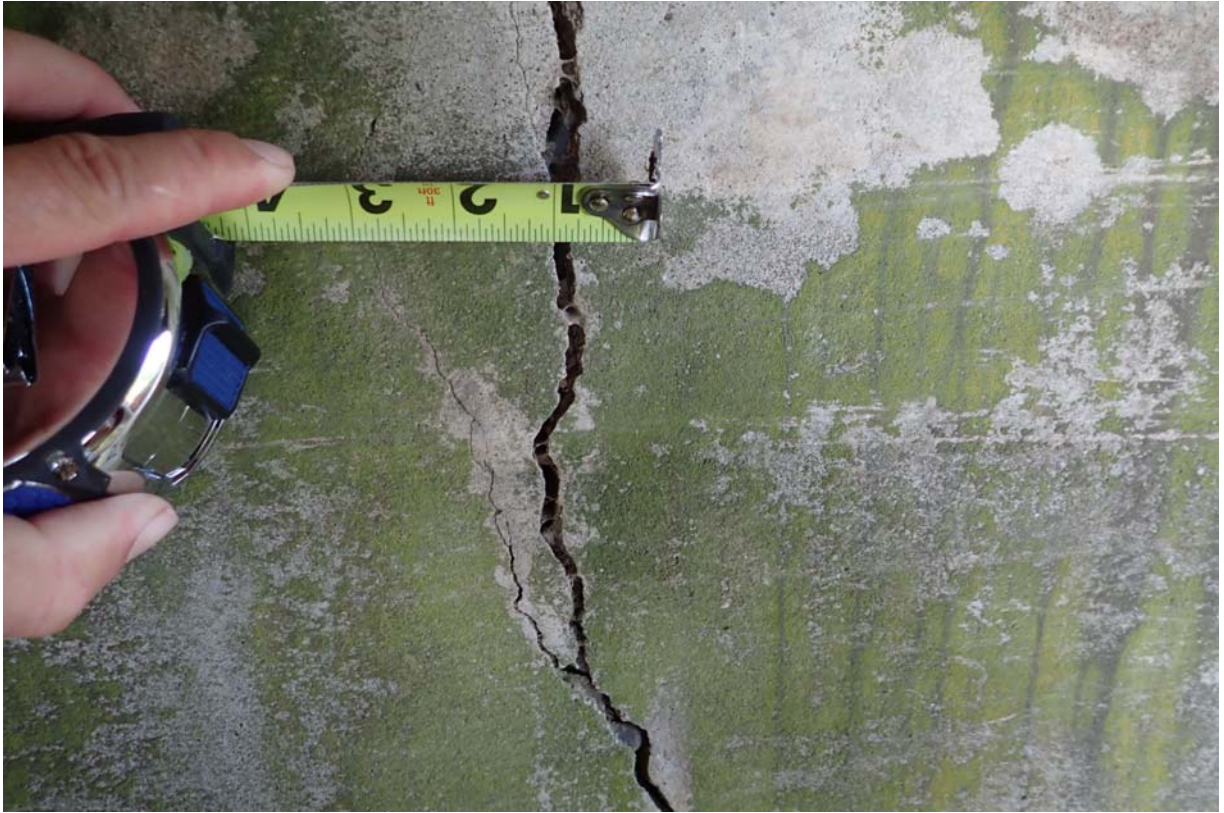
View of a 3/16" wide (typically) crack in abutment 1 below beam 3 from upstream.
