Inspection Report with SI&A Data

Structure Description: 33.14 Foot - Single Span Concrete Tee Beam

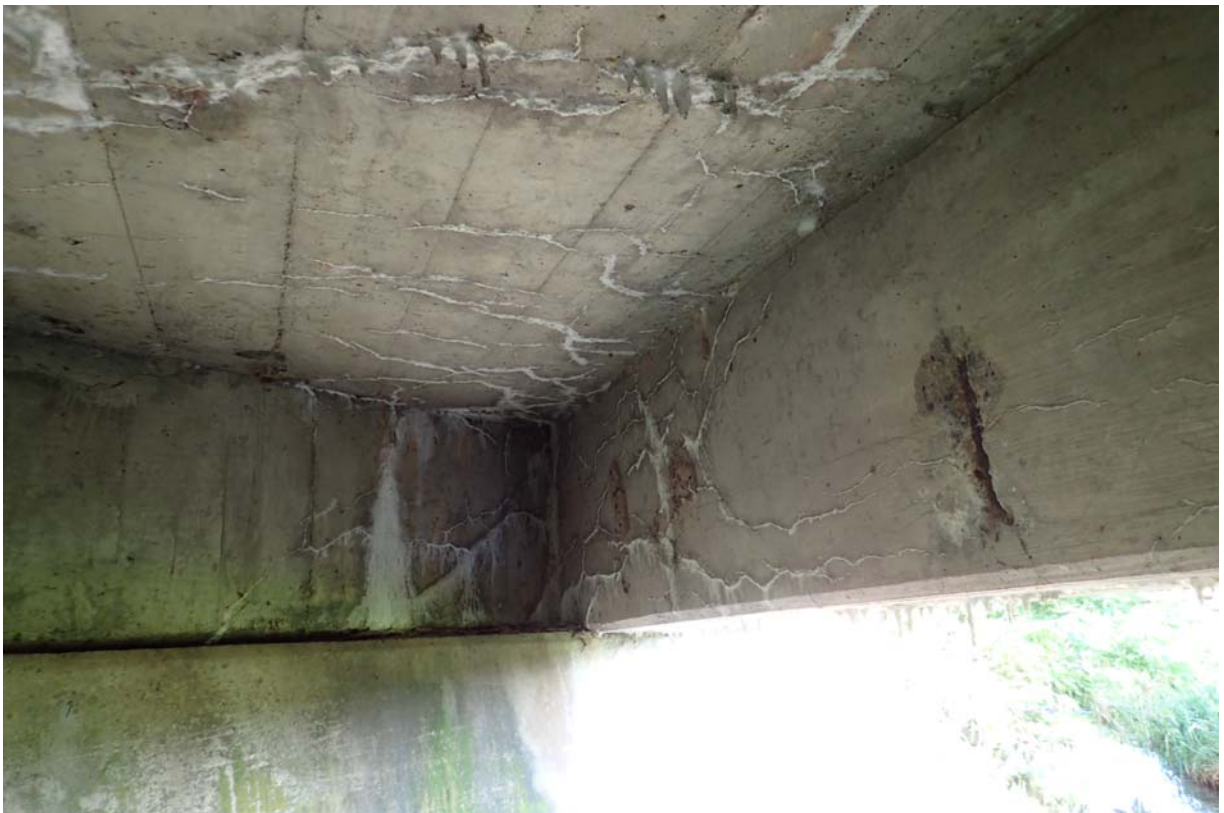
View of a heavy intensity of minor sized cracking with efflorescence in the deck, downstream beam, and diaphragm at/near abutment 1.

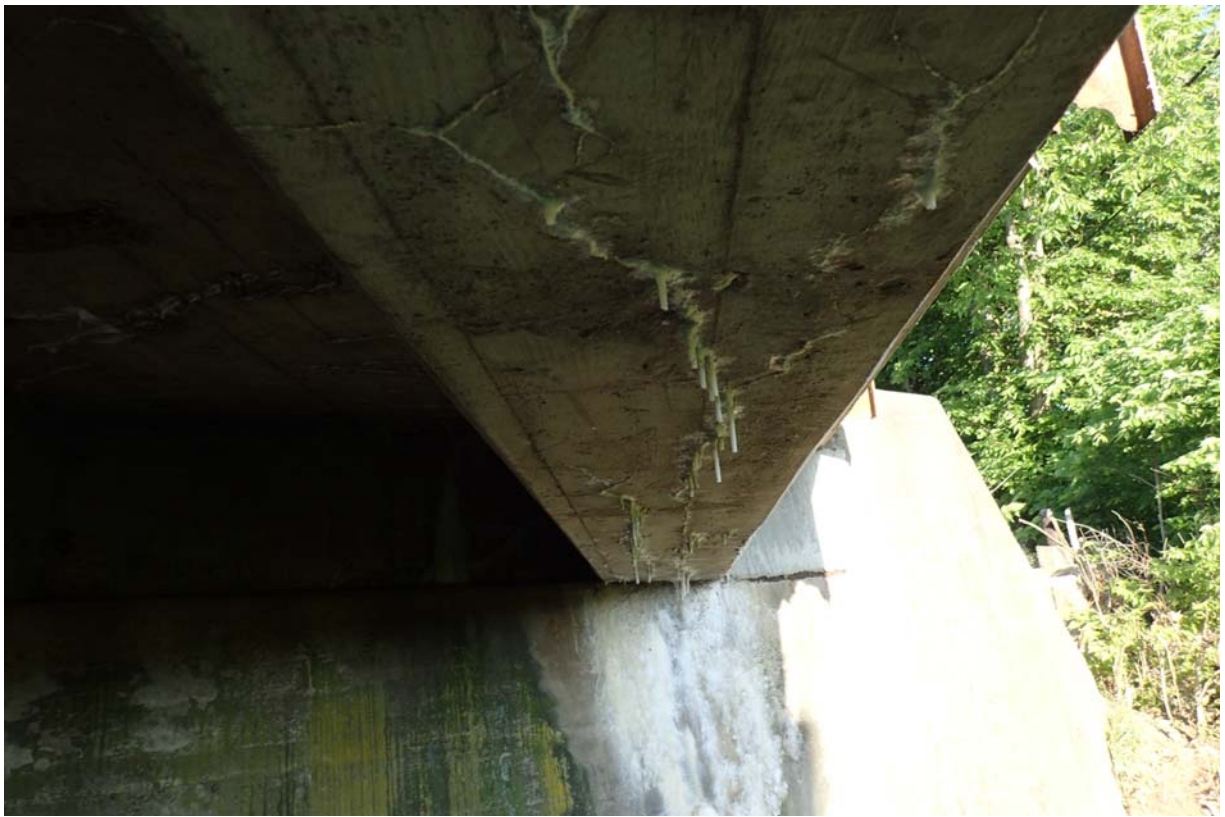
View of cracking with efflorescence in the underside of the downstream beam near abutment 1.

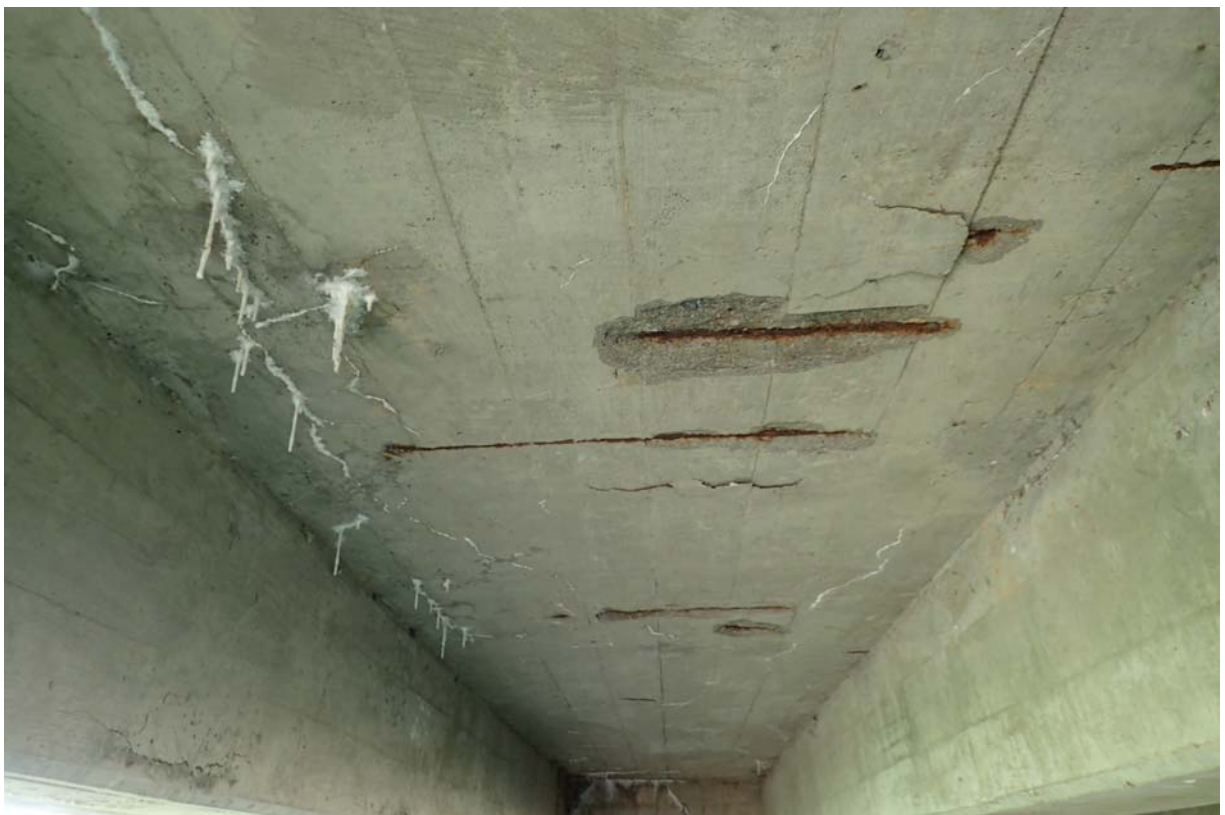
View of scattered cracking with efflorescence and spalling with exposed steel in the deck underside between beams 3 and 4 from upstream.

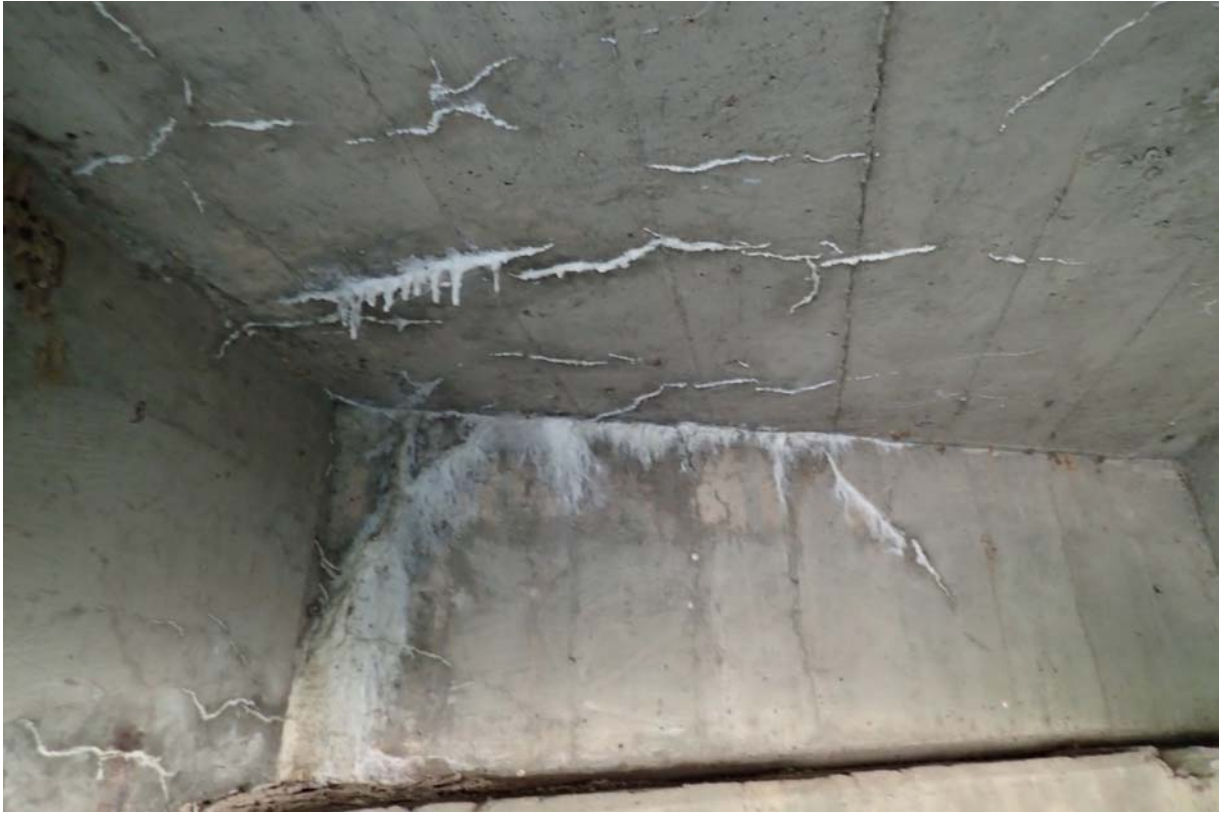
View of moderate to heavy intensity of minor sized cracking with efflorescence in the deck underside and diaphragm between beams 3 and 4 from upstream at abutment 2.

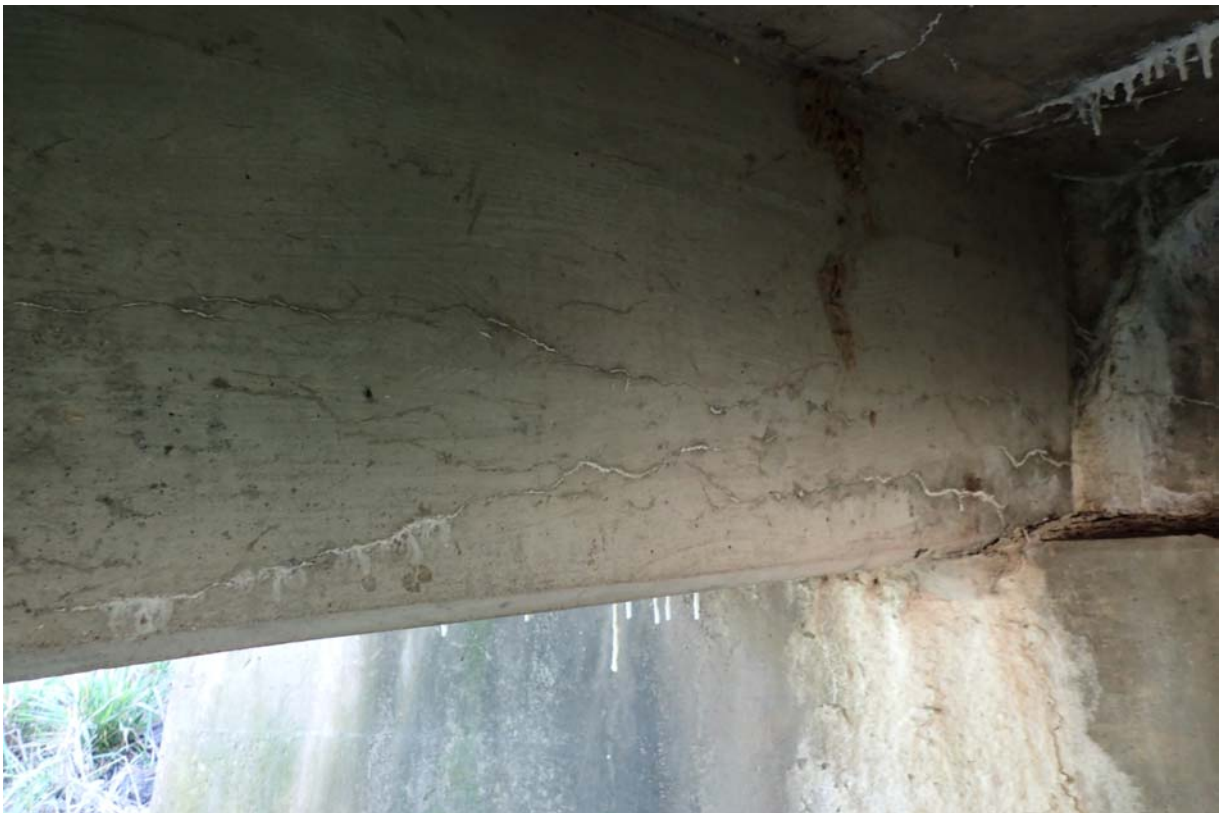
View of minor sized cracking of moderate intensity in the interior face of the downstream beam near abutment 2.

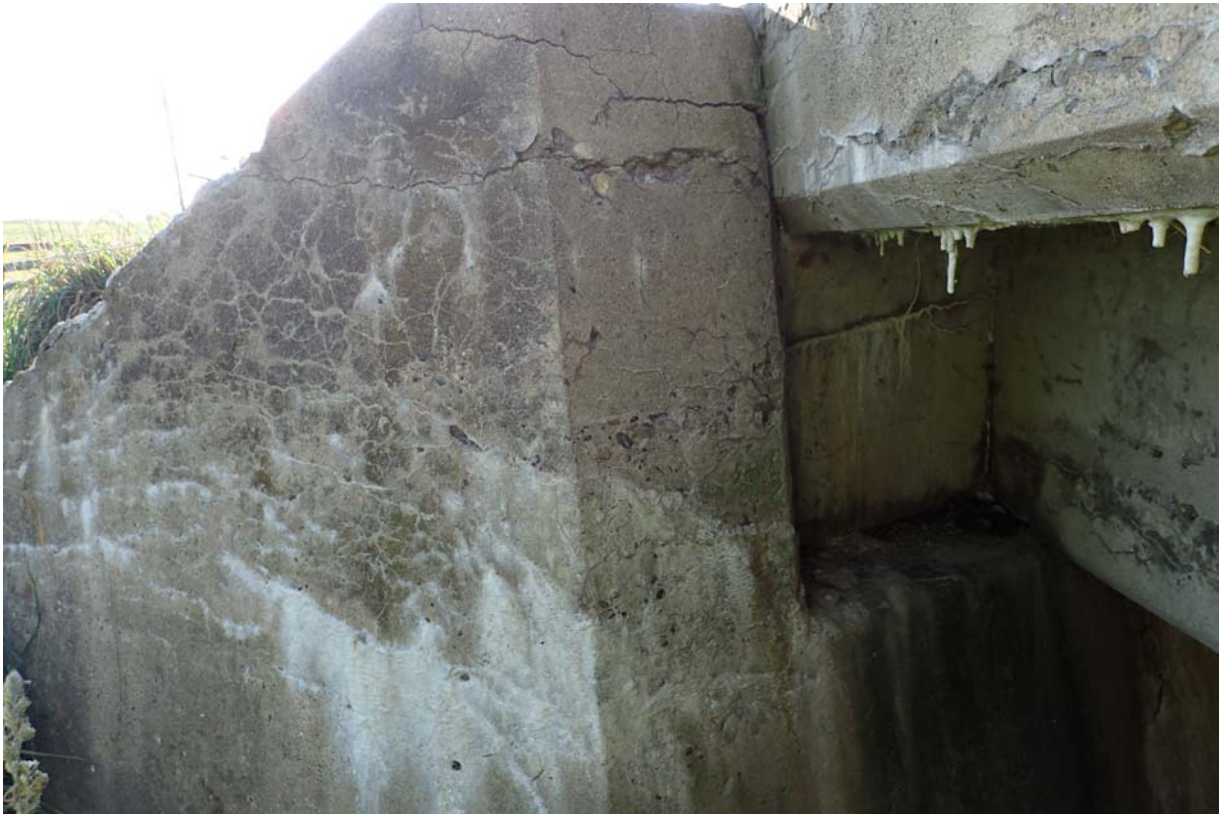
View of minor to moderate sized cracking (heavy intensity) at the downstream end of abutment 2.

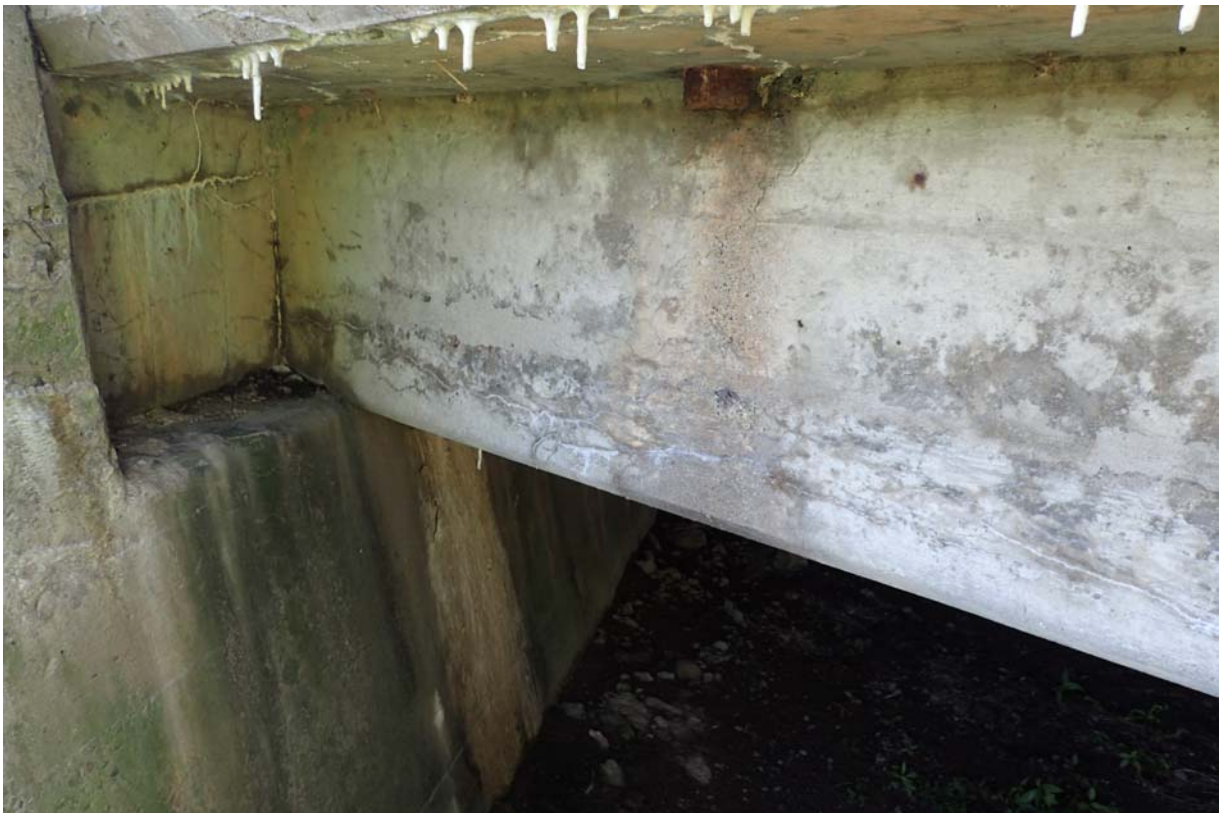
View of minor sized cracking of moderate intensity in the exterior face of the downstream beam near abutment 2.

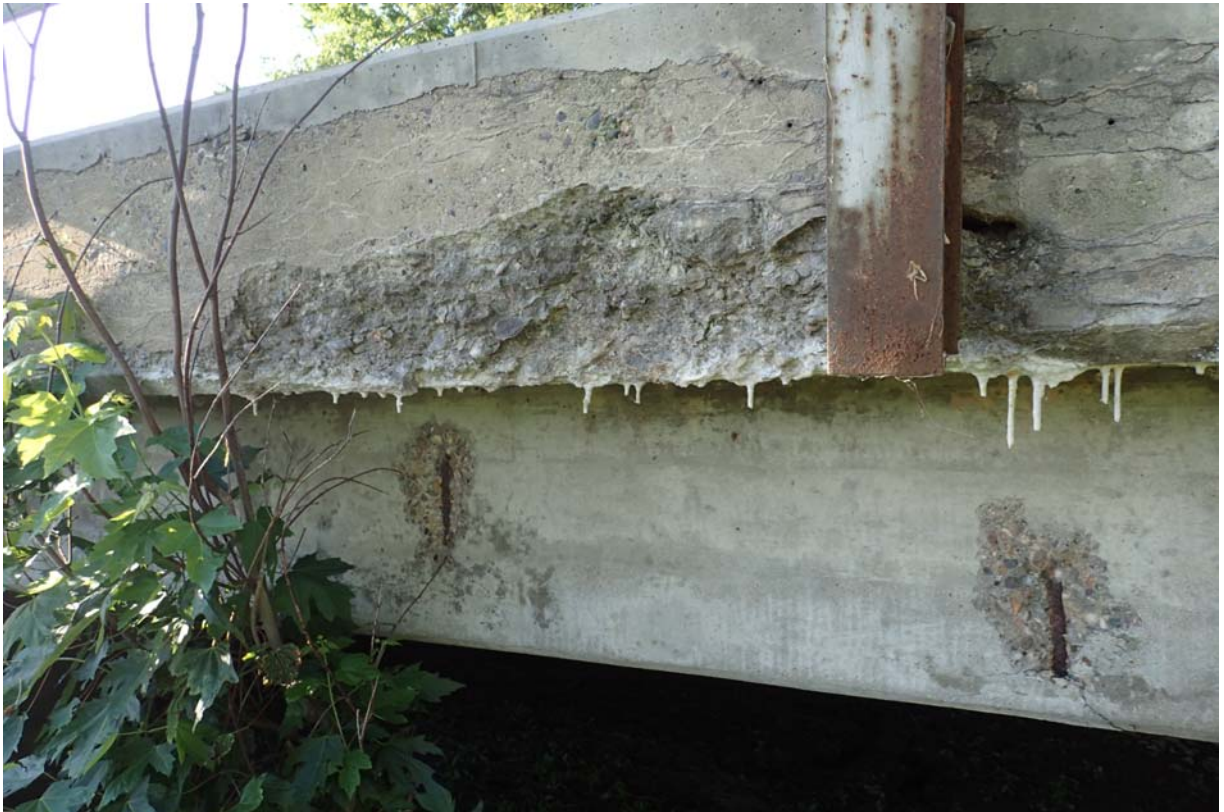
View of heavy spalling in the downstream deck overhang near guardrail post 4 from the south. Notice the moderate spalls with exposed steel in the beam.

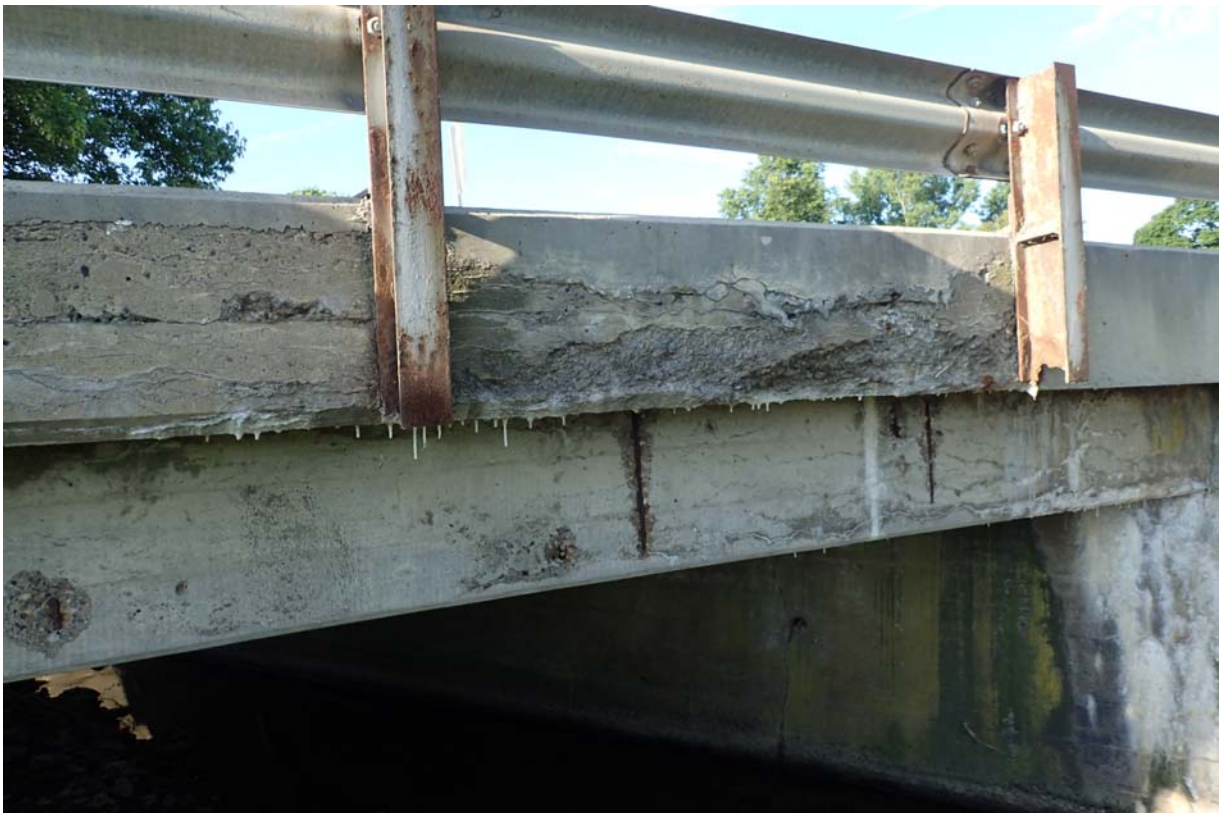
View of heavy spalling in the downstream deck overhang between guardrail posts 2 and 3 from the south. Notice the moderate spalls with exposed steel in the beam.

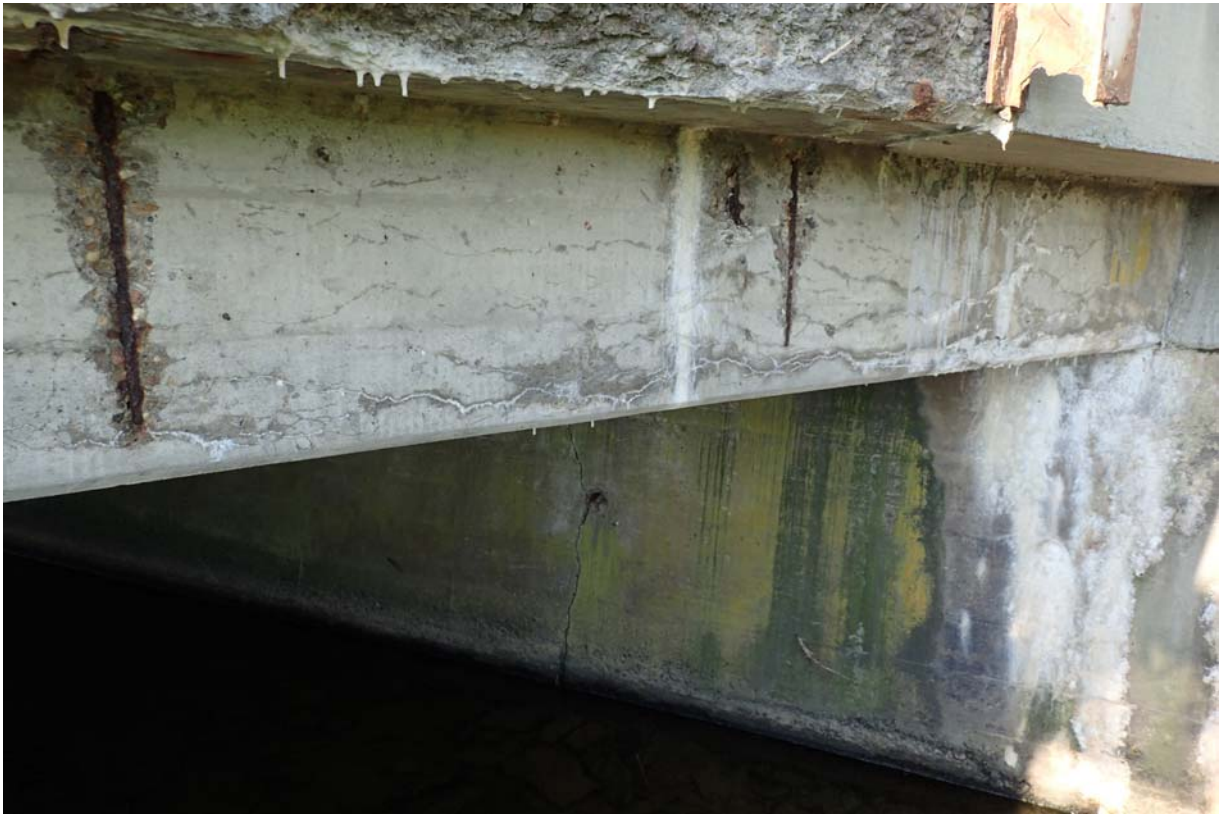
View of minor sized cracking of moderate-heavy intensity in the exterior face of the downstream beam near abutment 1. Notice the shallow spalling with exposed steel in the beam.

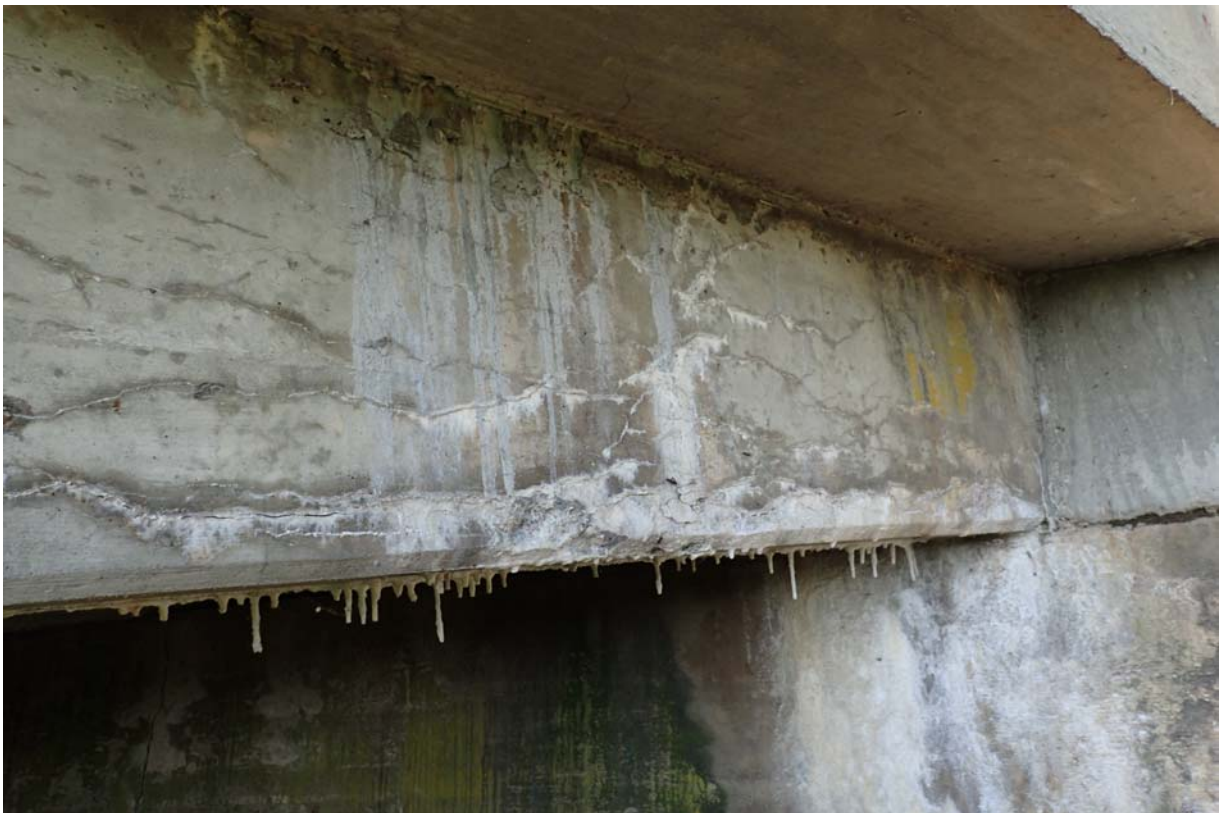
View of minor sized cracking of moderate-heavy intensity in the exterior face of the downstream beam near abutment 1.

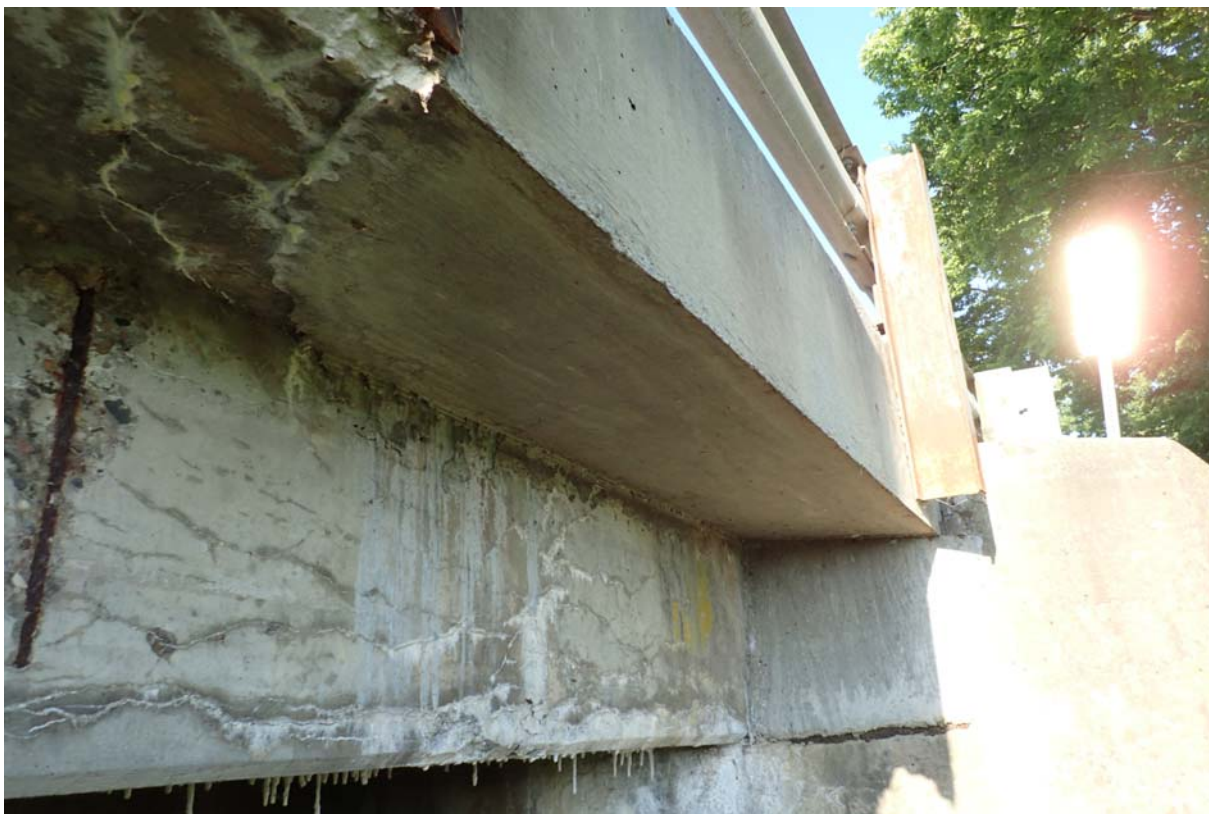
View of a patched area in the downstream overhang near abutment 1.
