**Appendix B**  
**Photographs of Study Area**

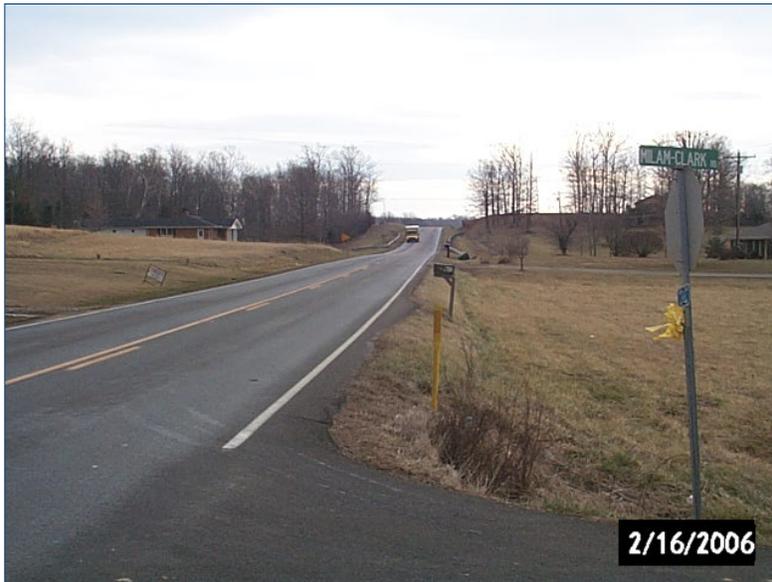
**Photo 1**

Typical section of KY 90 eastbound near Barren-Metcalfe County Line. Narrow lanes and shoulders, steep sides, limited visibility and passing opportunities.

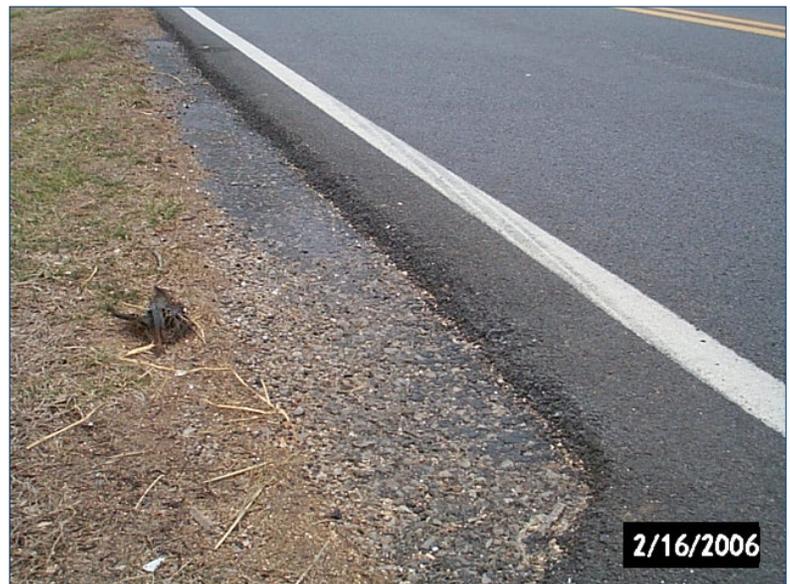
**Photo 2**

Typical KY 90 pavement edge west of Summer Shade.

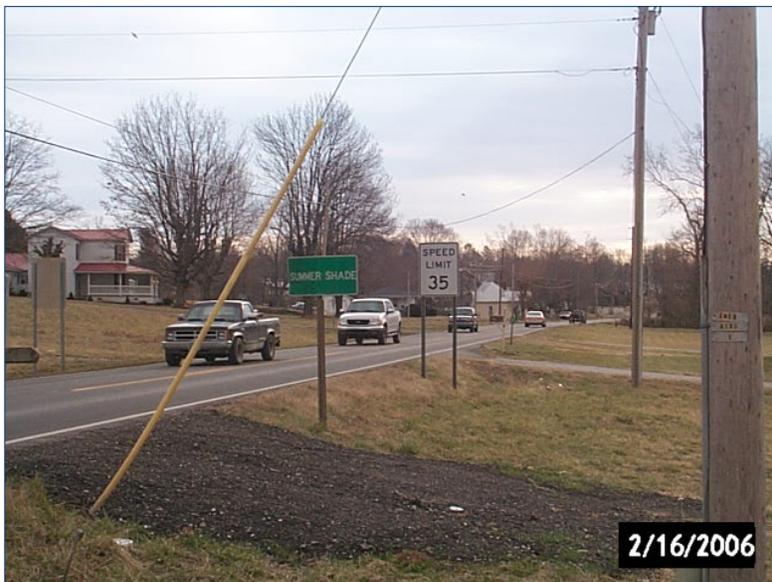
**Photo 3**

Eastbound KY 90 at Summer Shade town limits. Posted speed limit is 35 mph through town.

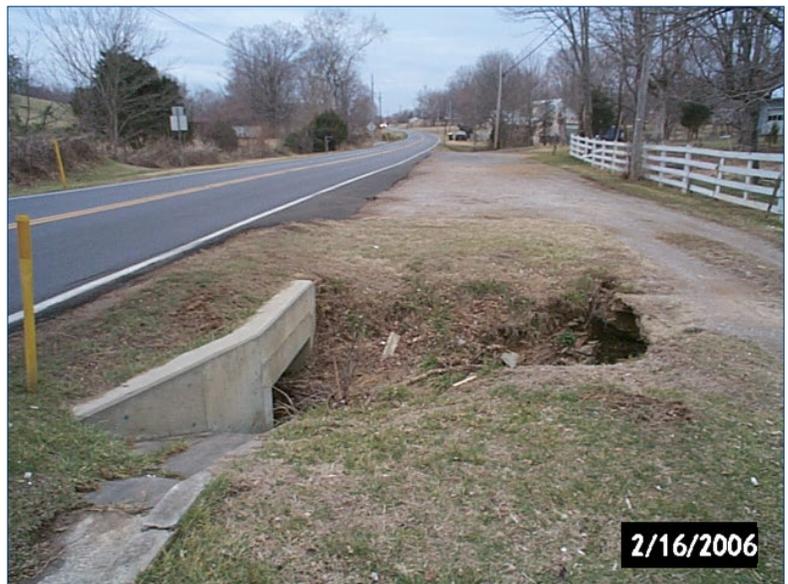
**Photo 5**

KY 90 in west Summer Shade with exposed culvert near pavement edge.

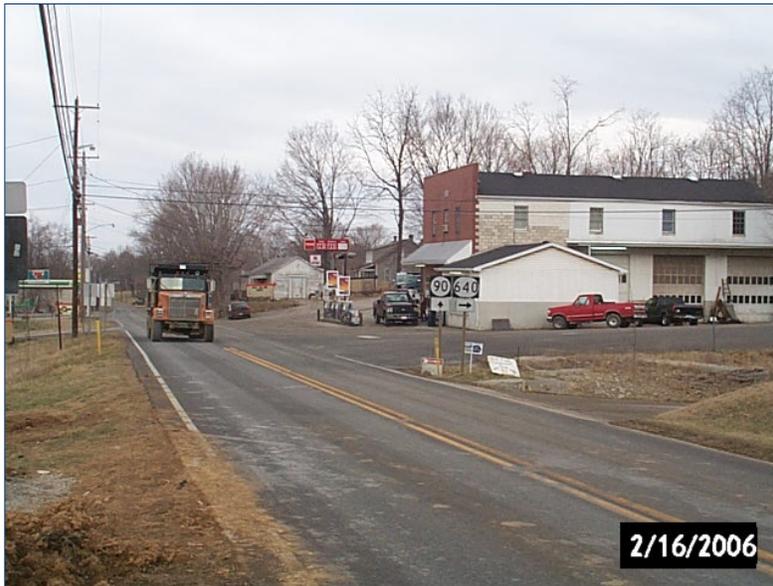
**Photo 10**

Westbound KY 90 at KY 640 intersection in Summer Shade. Possible contamination site number 2 in northwest corner.

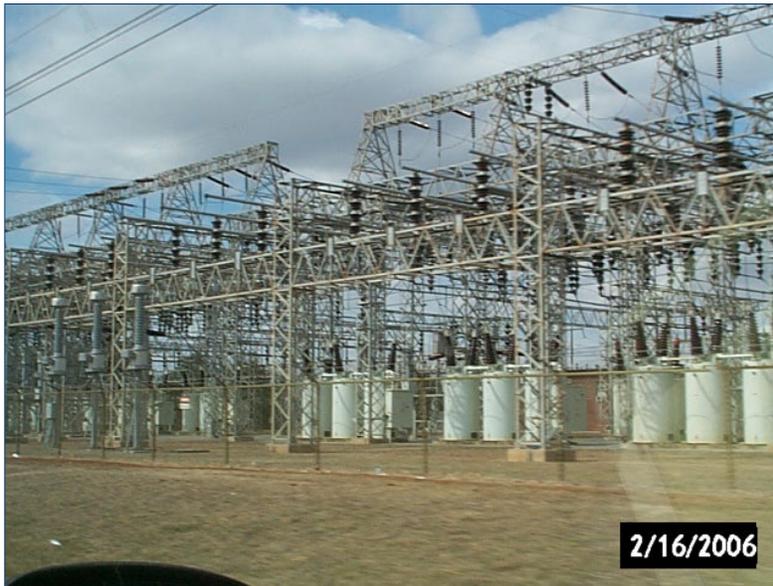
**Photo 13**

Electric substation (possible contamination site number 5) west of KY 163.

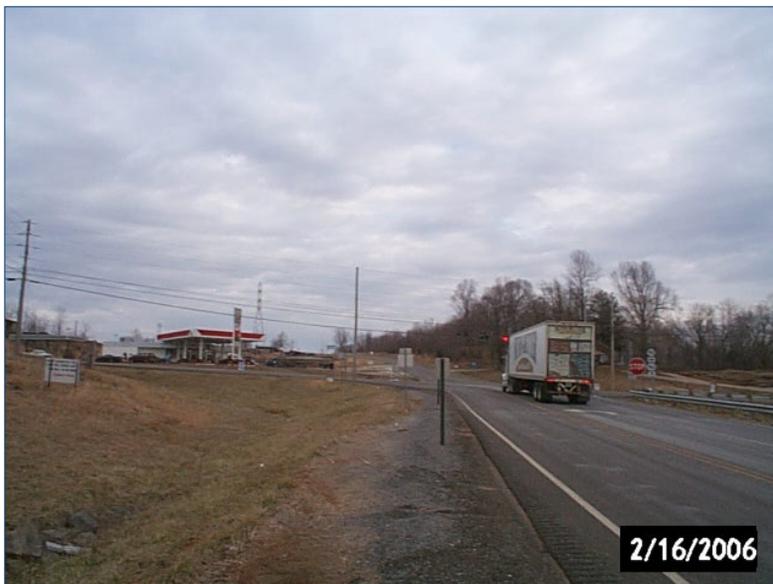
**Photo 15**

Northbound KY 163 at KY 90 intersection. KY 163 has center left turn lane. Flashing overhead traffic lights at intersection, with stop signs for KY 163 traffic.

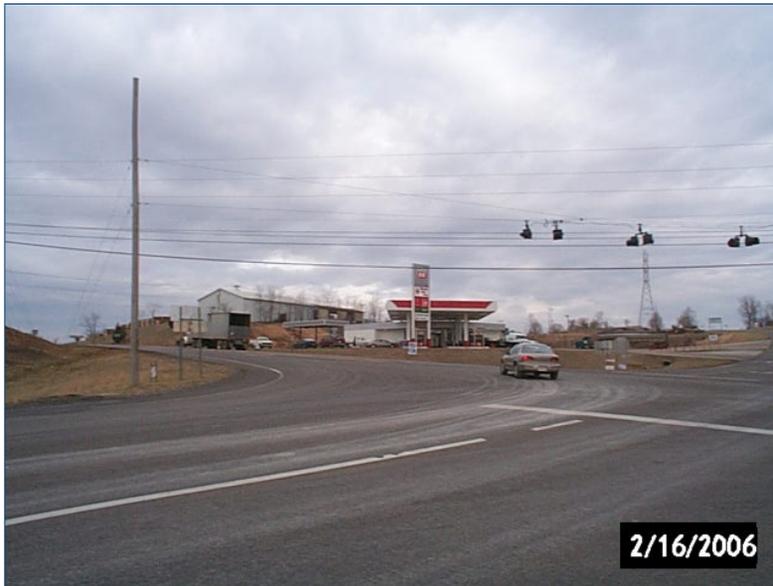
**Photo 16**

KY 90 / KY 163 intersection looking northwest. Possible contamination site number 6 in northwest corner.

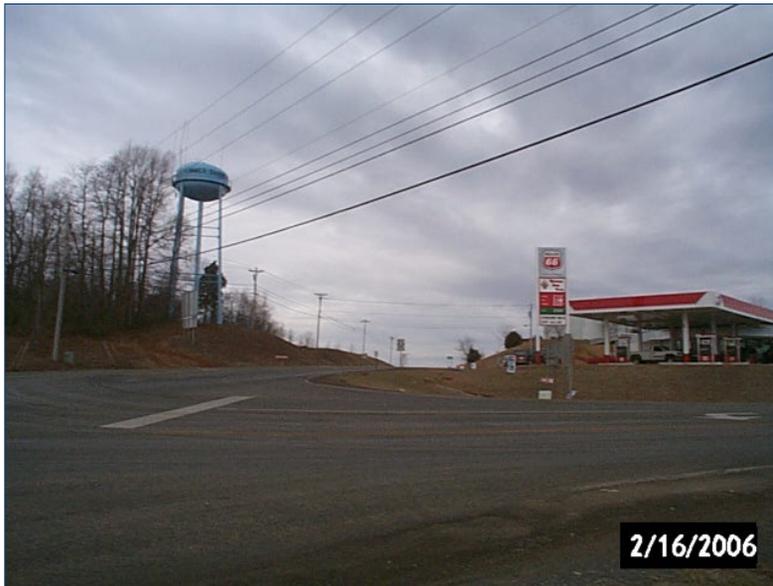
**Photo 19**

KY 90 / KY 163 intersection looking southwest. Possible contamination site number 6 in northwest corner.

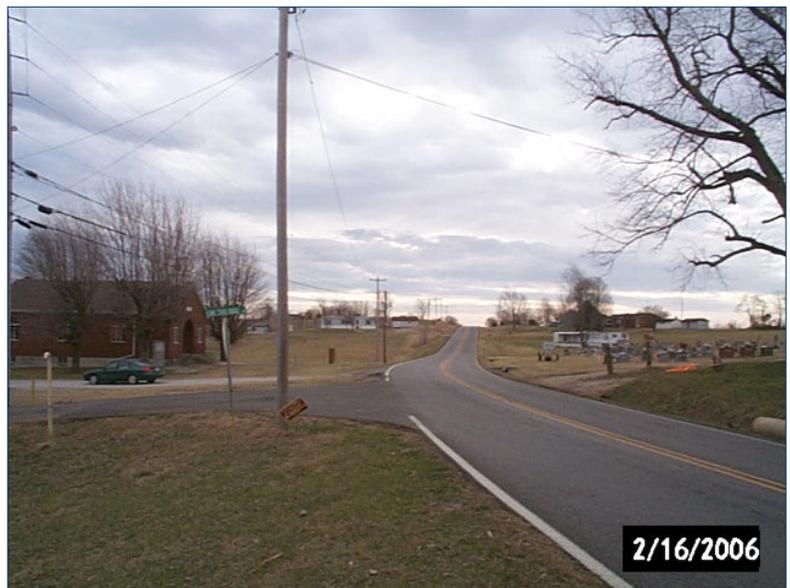
**Photo 20**

Eastbound KY 90 at Lone Star Ridge Road in Beaumont showing curve and limited visibility. Small cemetery on right.

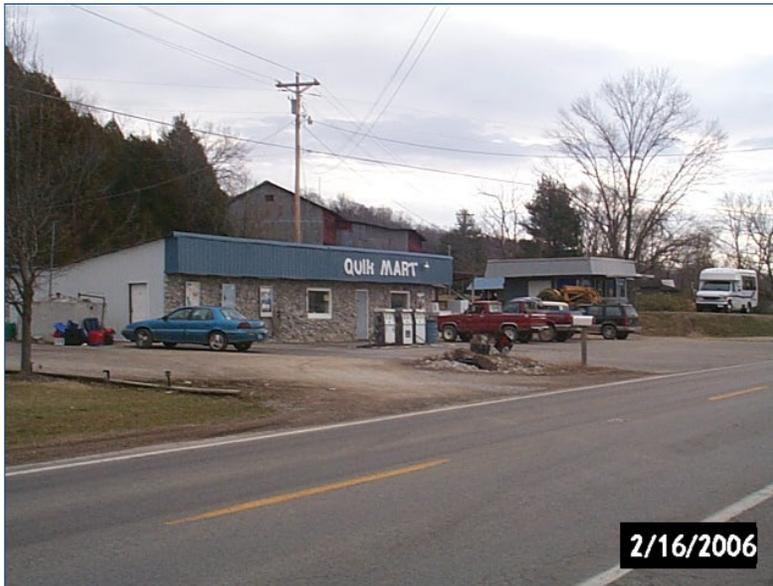
**Photo 25**

Quick Mart (possible contamination site number 10) in Marrowbone.

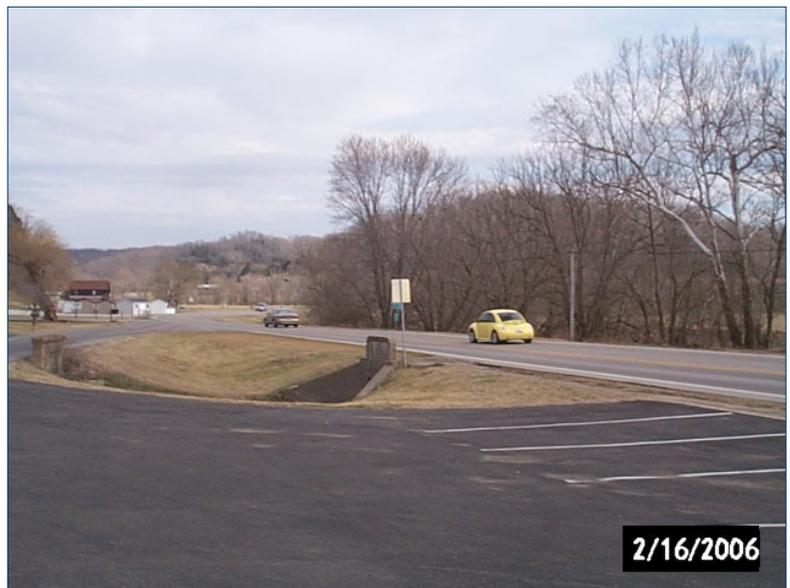
**Photo 26**

Eastbound KY 90 exiting Marrowbone. Area prone to flooding. Marrowbone Creek on right, sharp curve leading to Wisdom Creek Bridge in background.

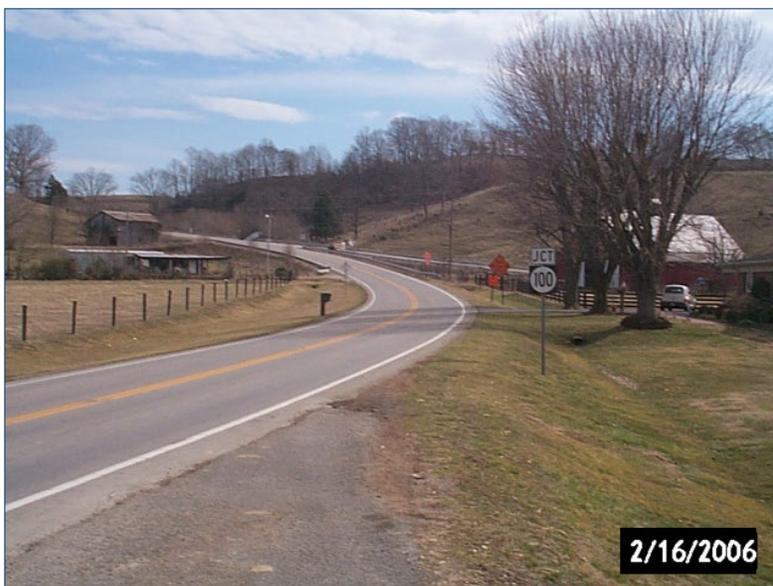
**Photo 30**  
Eastbound KY 90 approaching KY 100 intersection. Sharp curve, limited visibility, KY 100 intersects at an oblique angle.

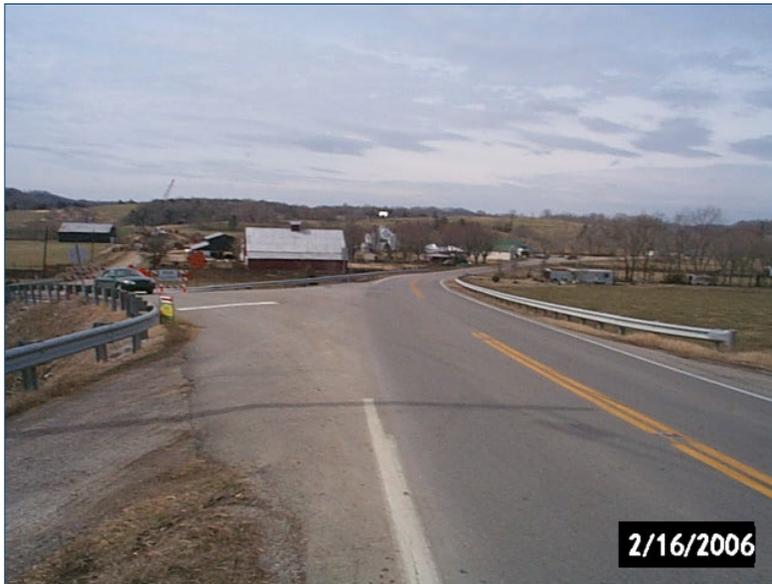
**Photo 31**

Westbound KY 90 and KY 100 intersection. Sharp curve, limited visibility, KY 100 intersects at an oblique angle.

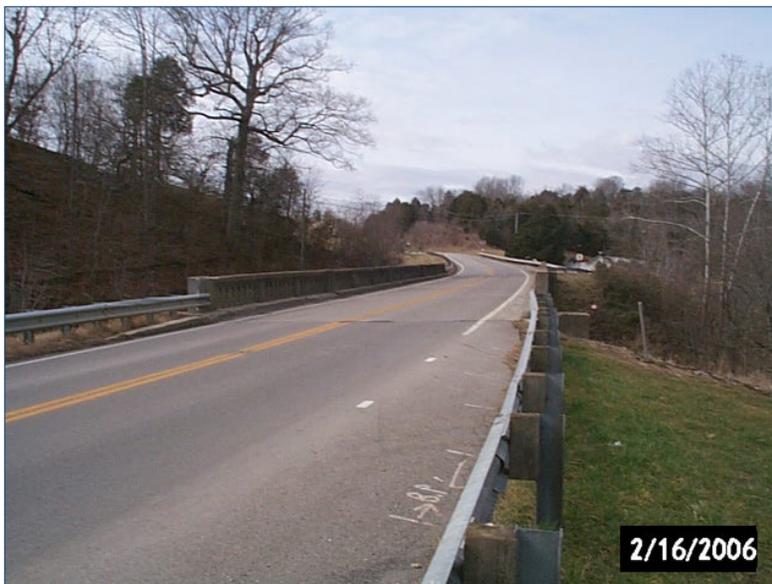
**Photo 33**

Westbound KY 90 at Dutch Creek Bridge. Sharp curve, limited visibility.

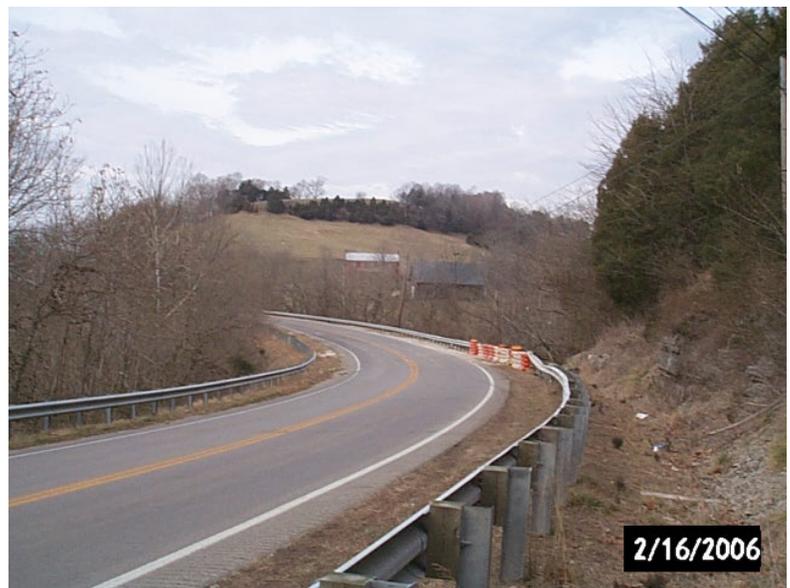
**Photo 38**

Westbound KY 90 east of Norris Branch Road. Sharp curve shows evidence of recent crash into guardrail. Left side drops off sharply to Marrowbone Creek floodplain.

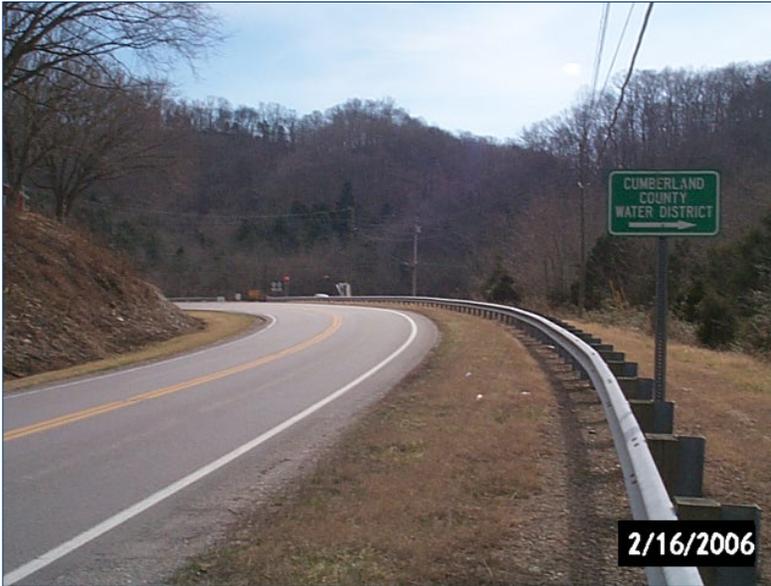
**Photo 40**

Eastbound KY 90 approach to KY 691 intersection. Sharp curve, downhill, limited visibility.

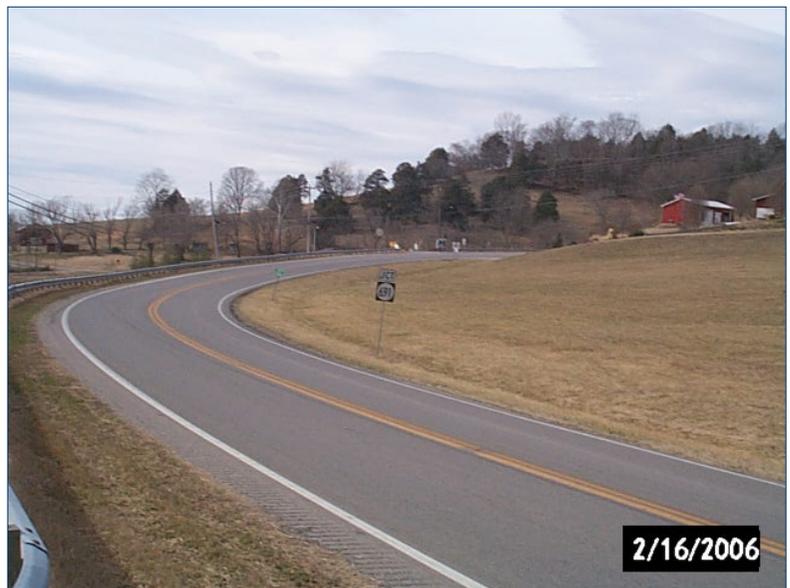
**Photo 41**

Westbound KY 90 approach to KY 691 intersection. Sharp curve, uphill, limited visibility.

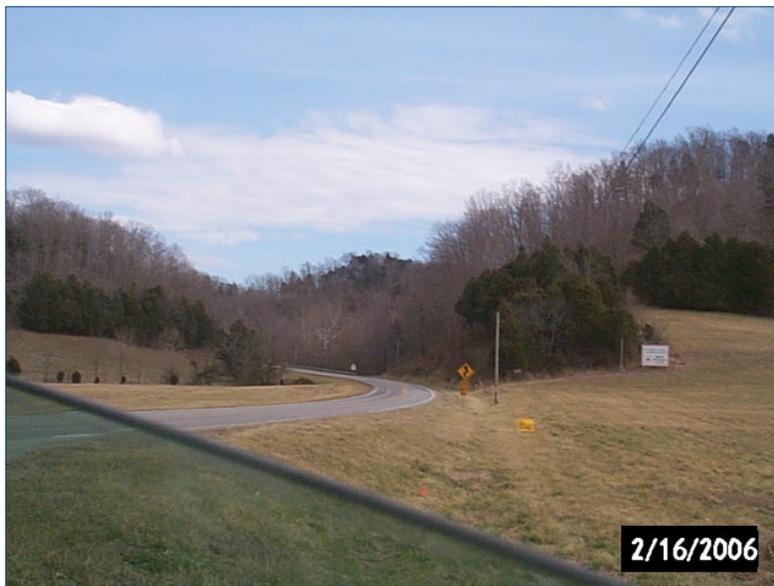
**Photo 42**

Eastbound KY 90 approach to Burkesville Hill Road/Saw Mill Cut. Sharp curve, uphill, limited visibility.

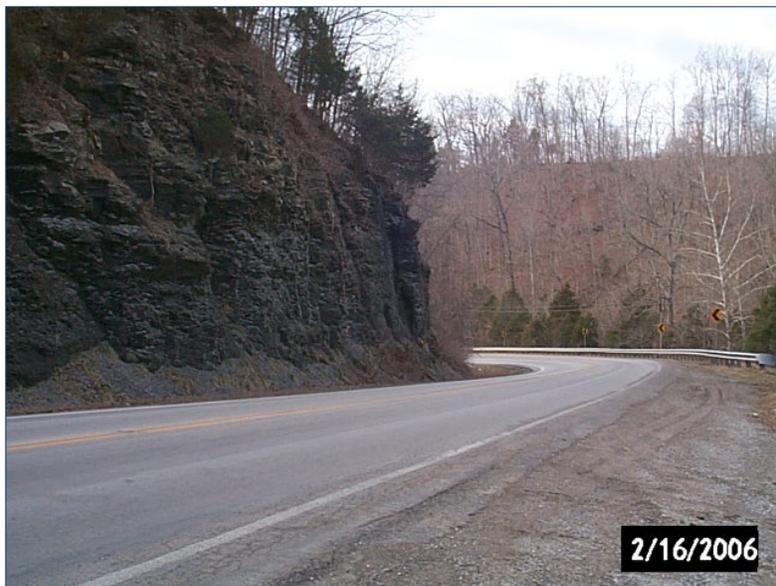
**Photo 45**

Westbound KY 90 on Burkesville Hill.  
Sharp curve, deep rock cuts.

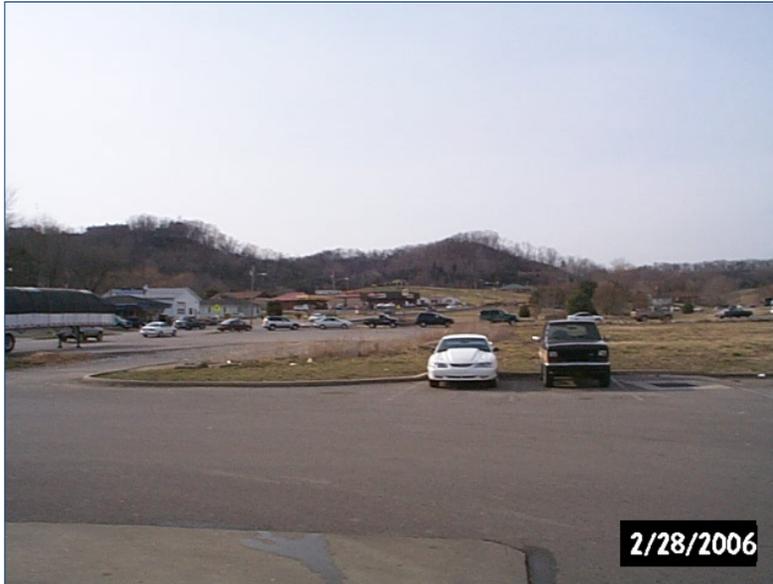
**Photo 49**

Westbound KY 90 at elementary school entrance near KY 61 intersection at 4:00 pm. Traffic backup extends from school building main entrance, back along drive, and out onto KY 90.
