059C00071N Inspector: Greg Cady Entered by: GCADY 06/25/2018 Standard (24 months)

Inspection Report

STRUCTURE STAMPED 1958

This structure used to be a state structure named 059B00019N and was converted to a city (Erlanger) structure and is now 059C00071N. 03/03/2017 GTC

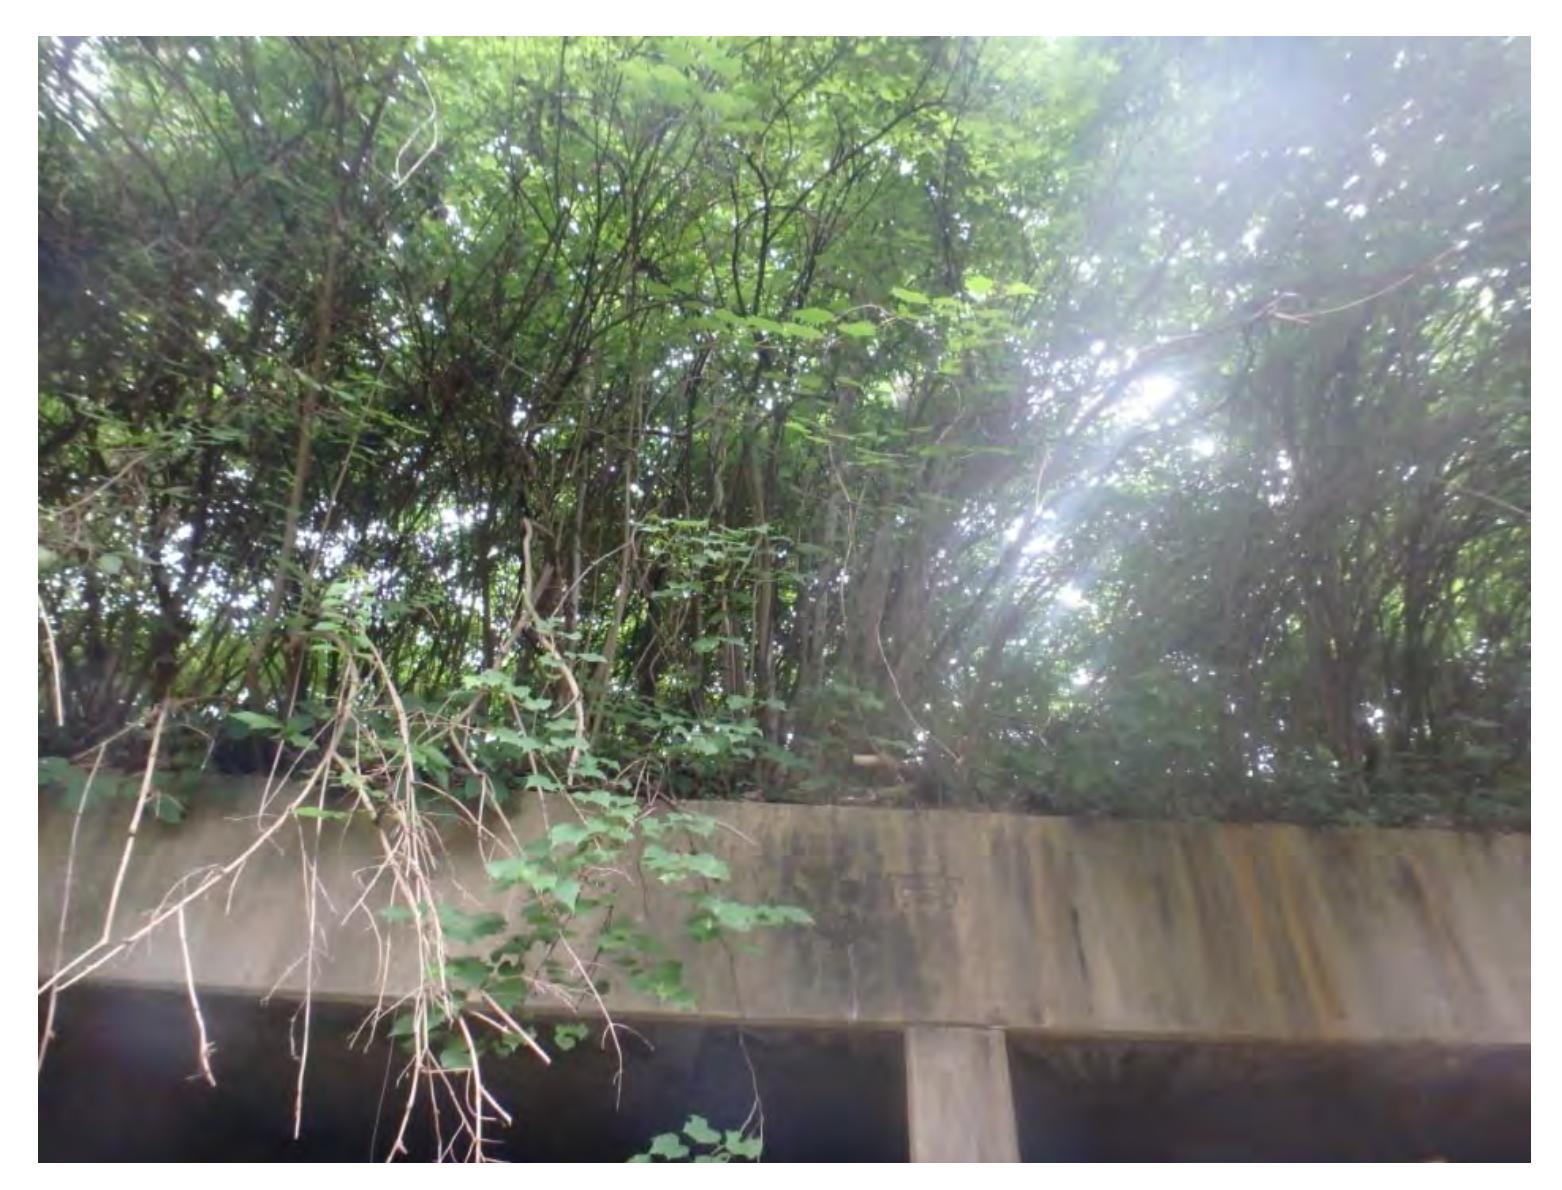
ELEM NBR	ELEMENT NAME	ENV	INSP. DATE	QUANTITY	UNITS	QTY CS 1	QTY CS 2	QTY CS 3	QTY CS 4
859	Vegetation	3	06/25/2018	1.00	(EA)	1.00	0.00	0.00	0.00
Vegetation* Vegetation growth was found to be hanging over the headwalls

Vegetation growth hanging over headwalls

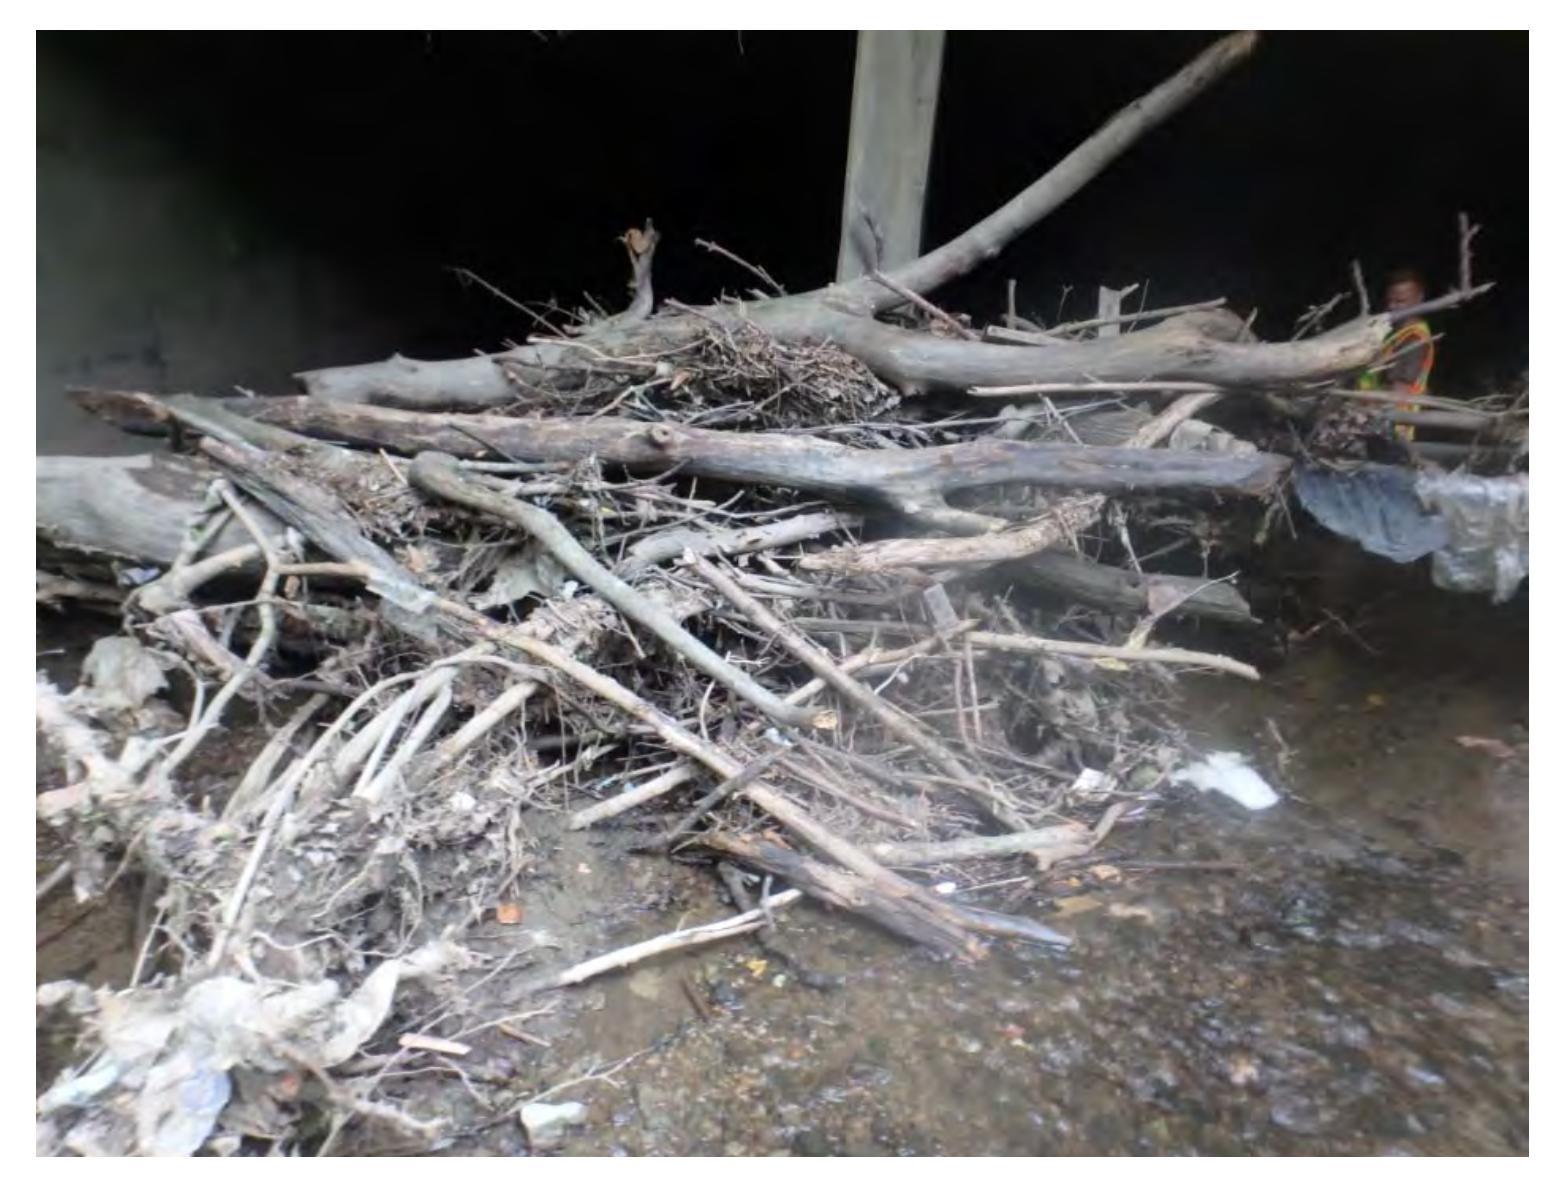
Note that a heavy amount of channel drift debris was found hung on center curtain wall at the inlet of structure, with a heavy amount found hung and built up on center curtain wall at union between downstream end of metal pipe and downstream most double box culvert section.

Stream drift hung at the inlet end of the barrels

All channel drift debris found hung or built up at site of structure needs to be removed as soon as possible. Removal of such drift debris buildup will help relieve stream flow and allow stream depth to recede through portions of structure (restriction of stream flow).

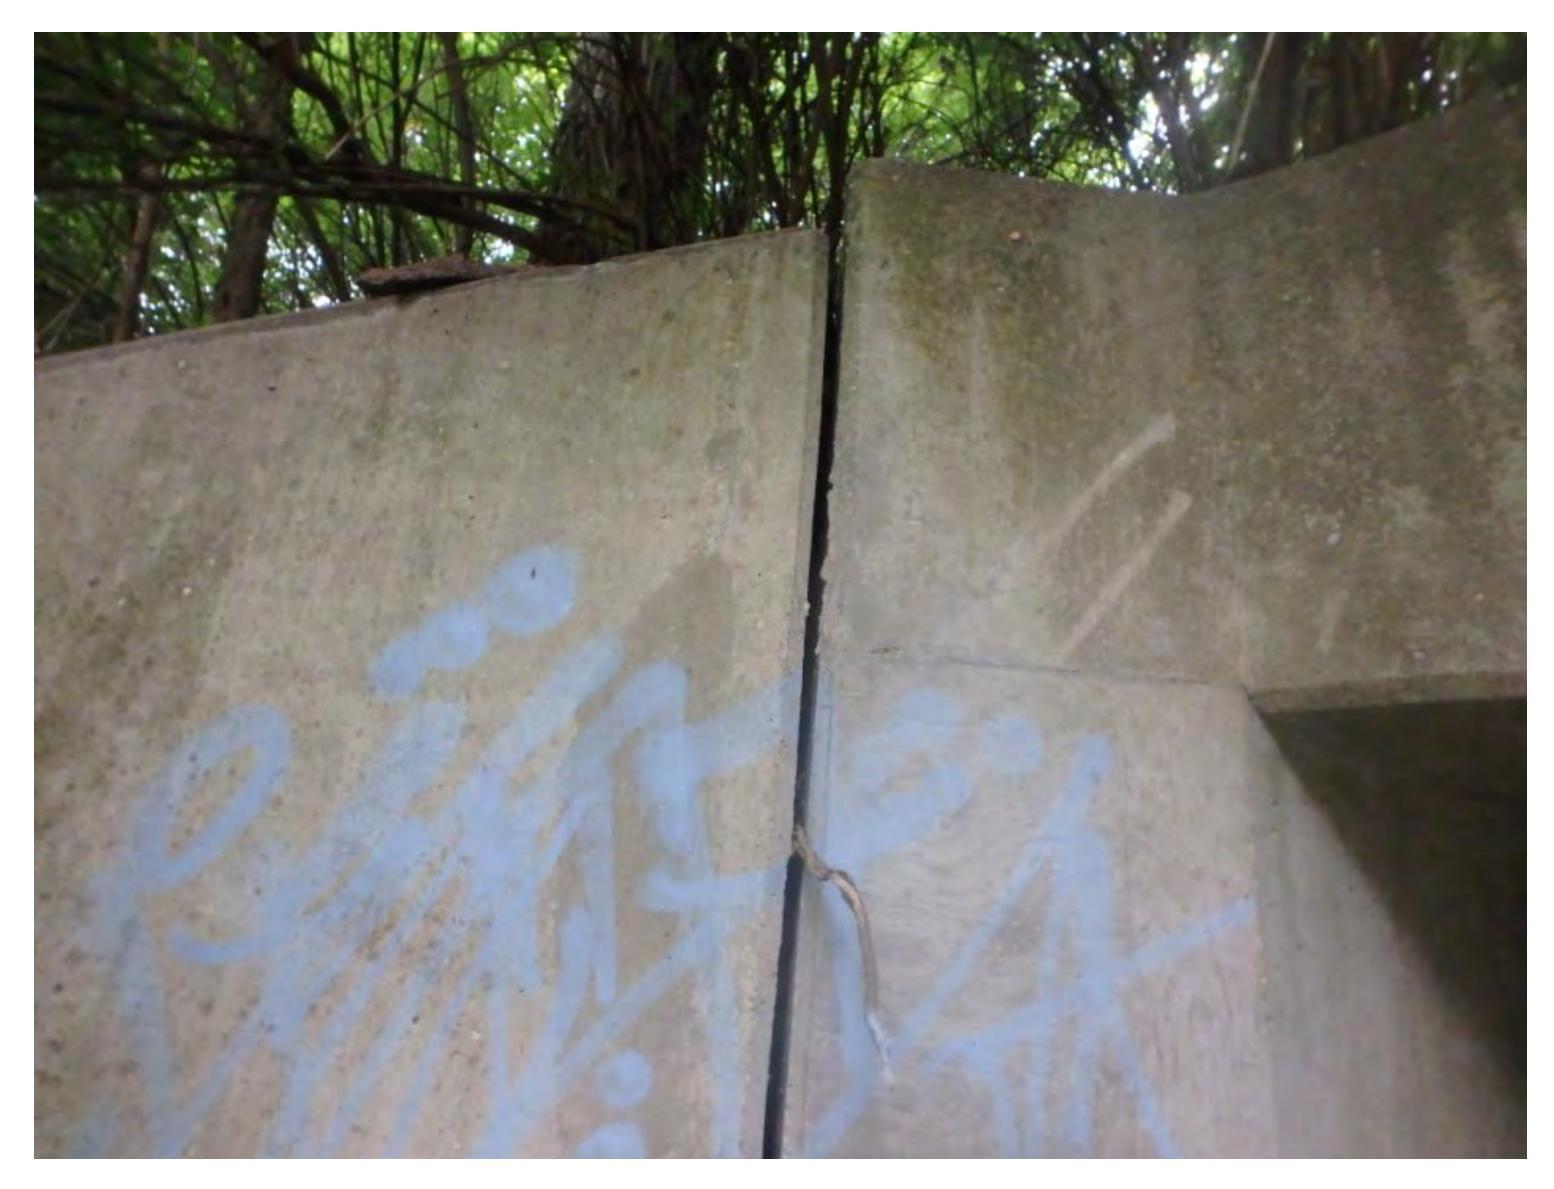
4000 Settlement 3 06/25/2018 17.00 (LF) 0.00 0.00 17.00 0.00 Settlement* Concrete wingwall elements of structure are located at the inlet of structure, which were found starting to showing a minor amount of settlement and displacement/misalignment; otherwise element were found to be performing as designed at this time.

Vertical misalignment/displacement found occurring in both inlet wingwall elements.

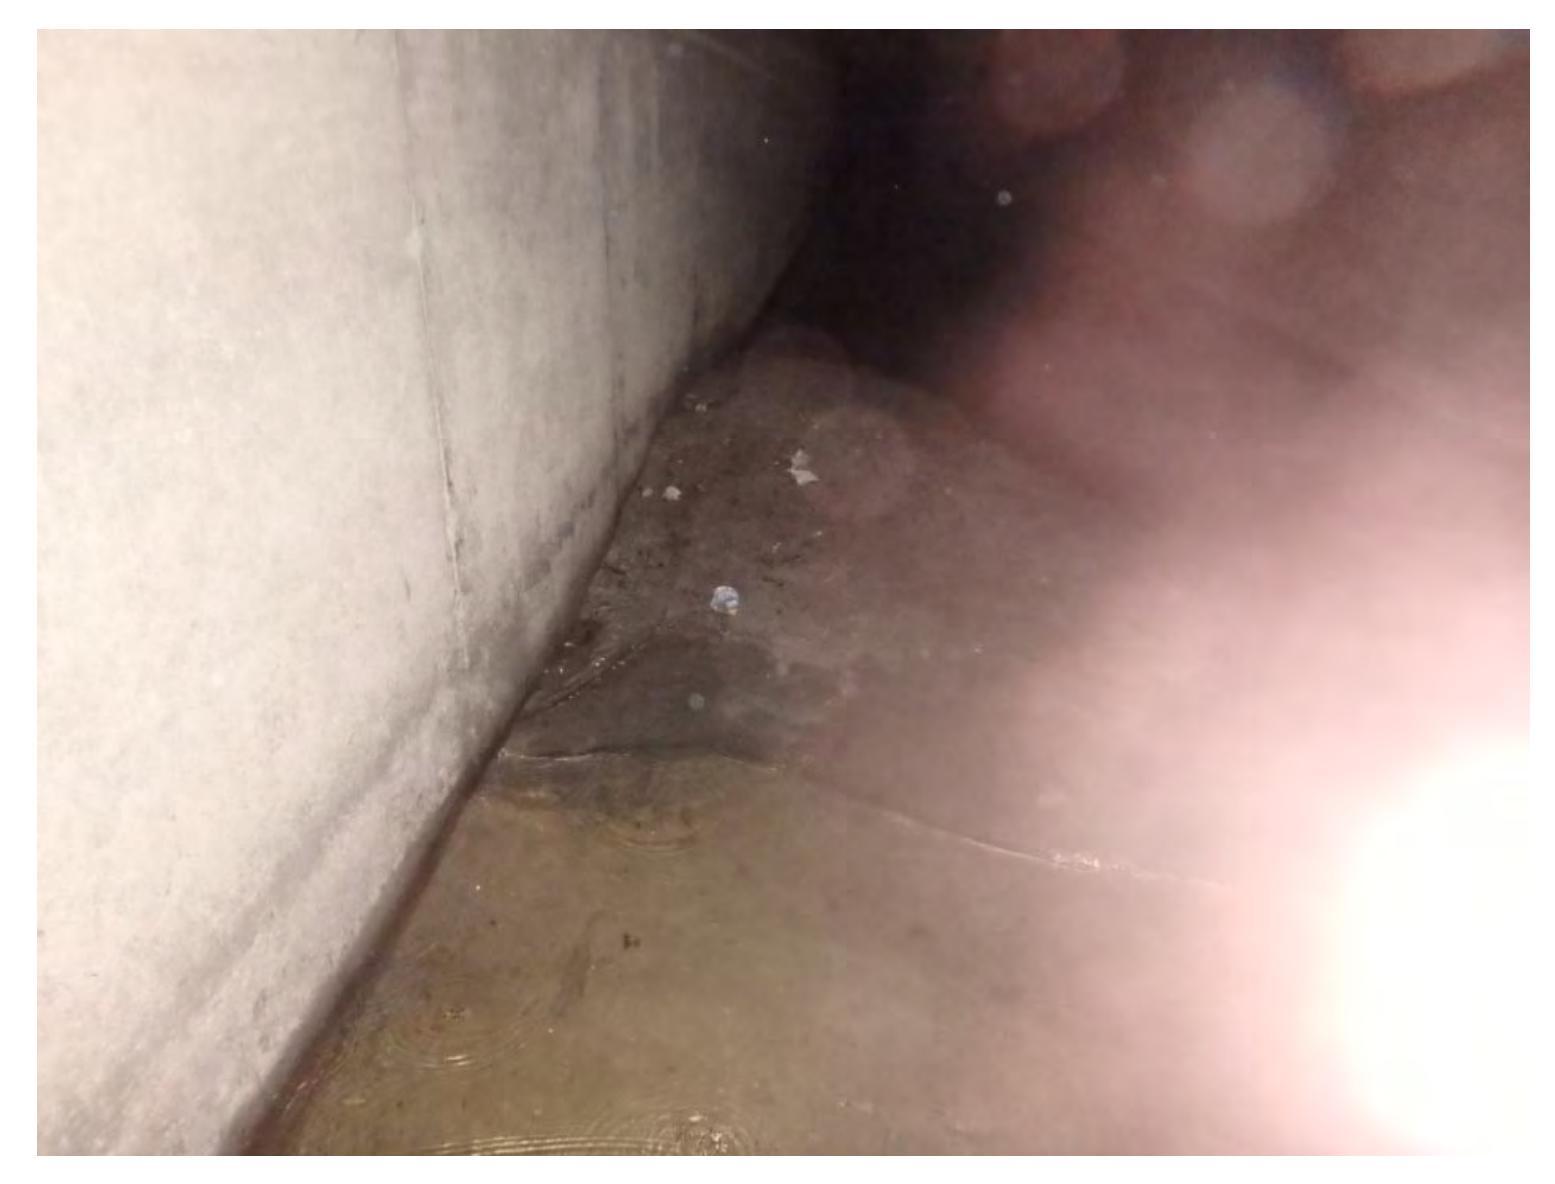
Note that aggradation debris buildup was found throughout channel bed at the inlet site of structure, along with random areas of buildup found throughout interior portions of barrels (silt, sand, stone, etc.). (See Photos)

Aggredation build up found throughout the structure

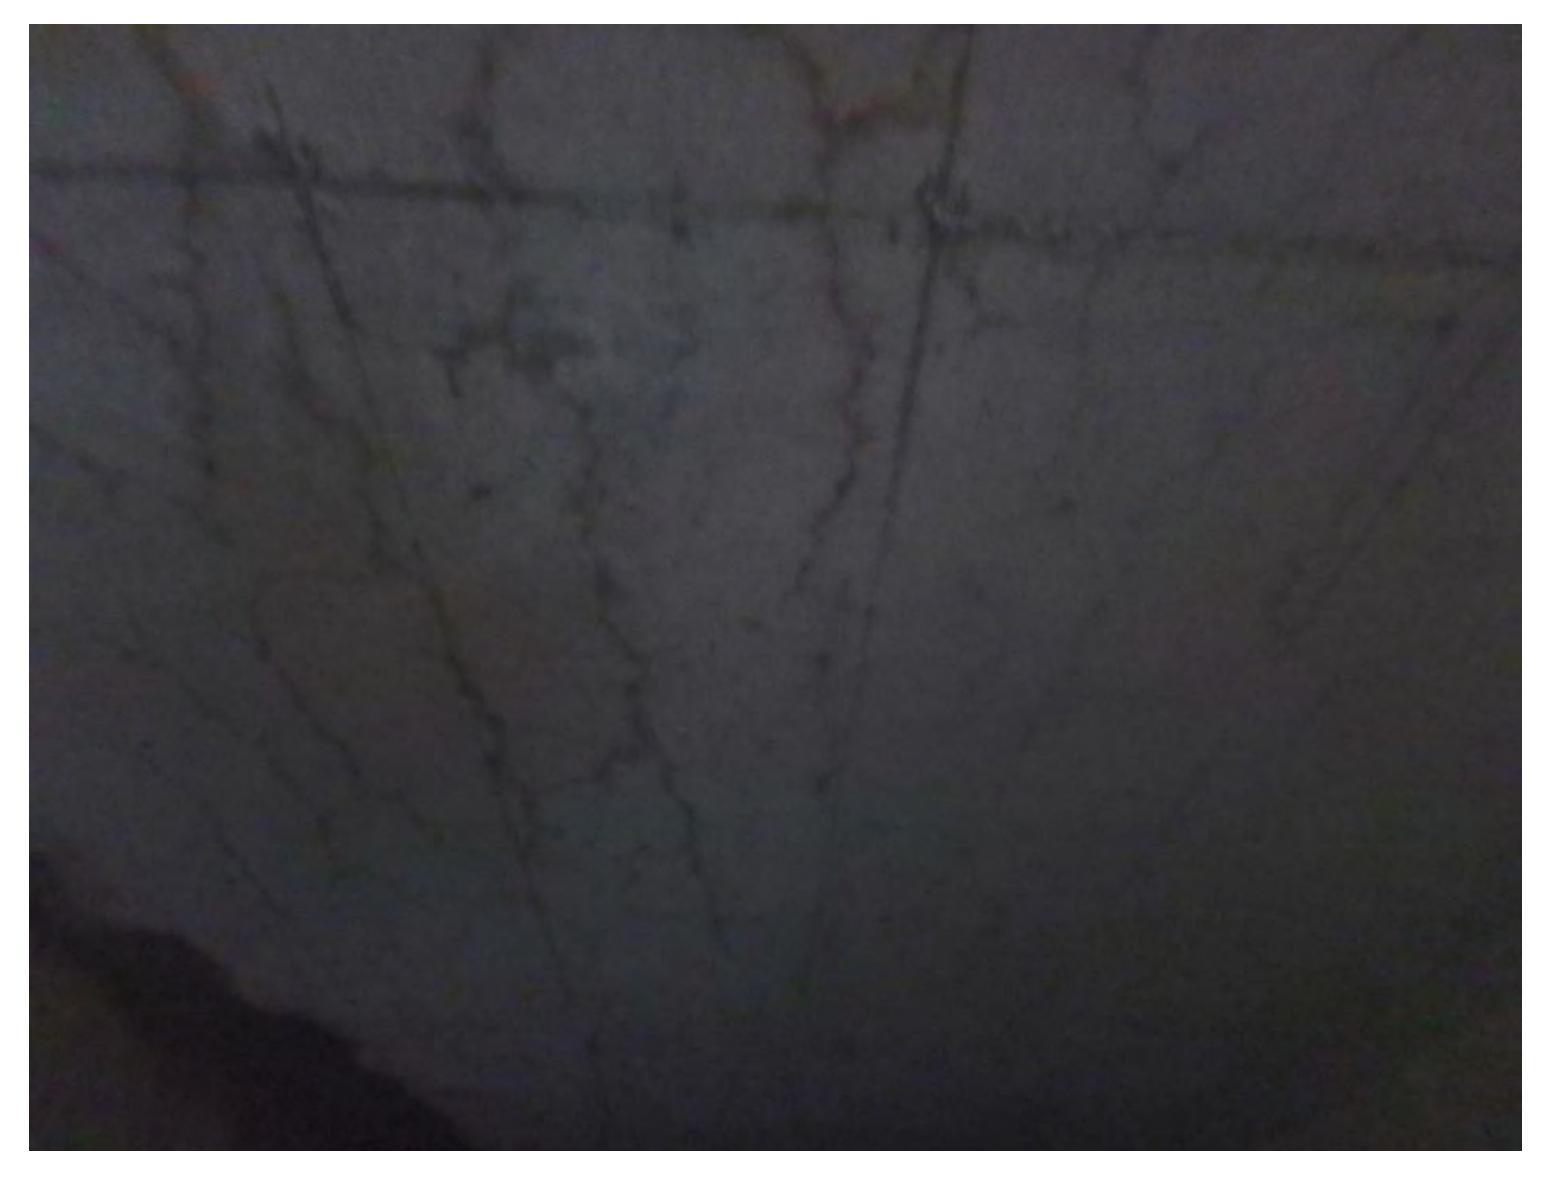
Light cracking with staining found in the barrel roofs.

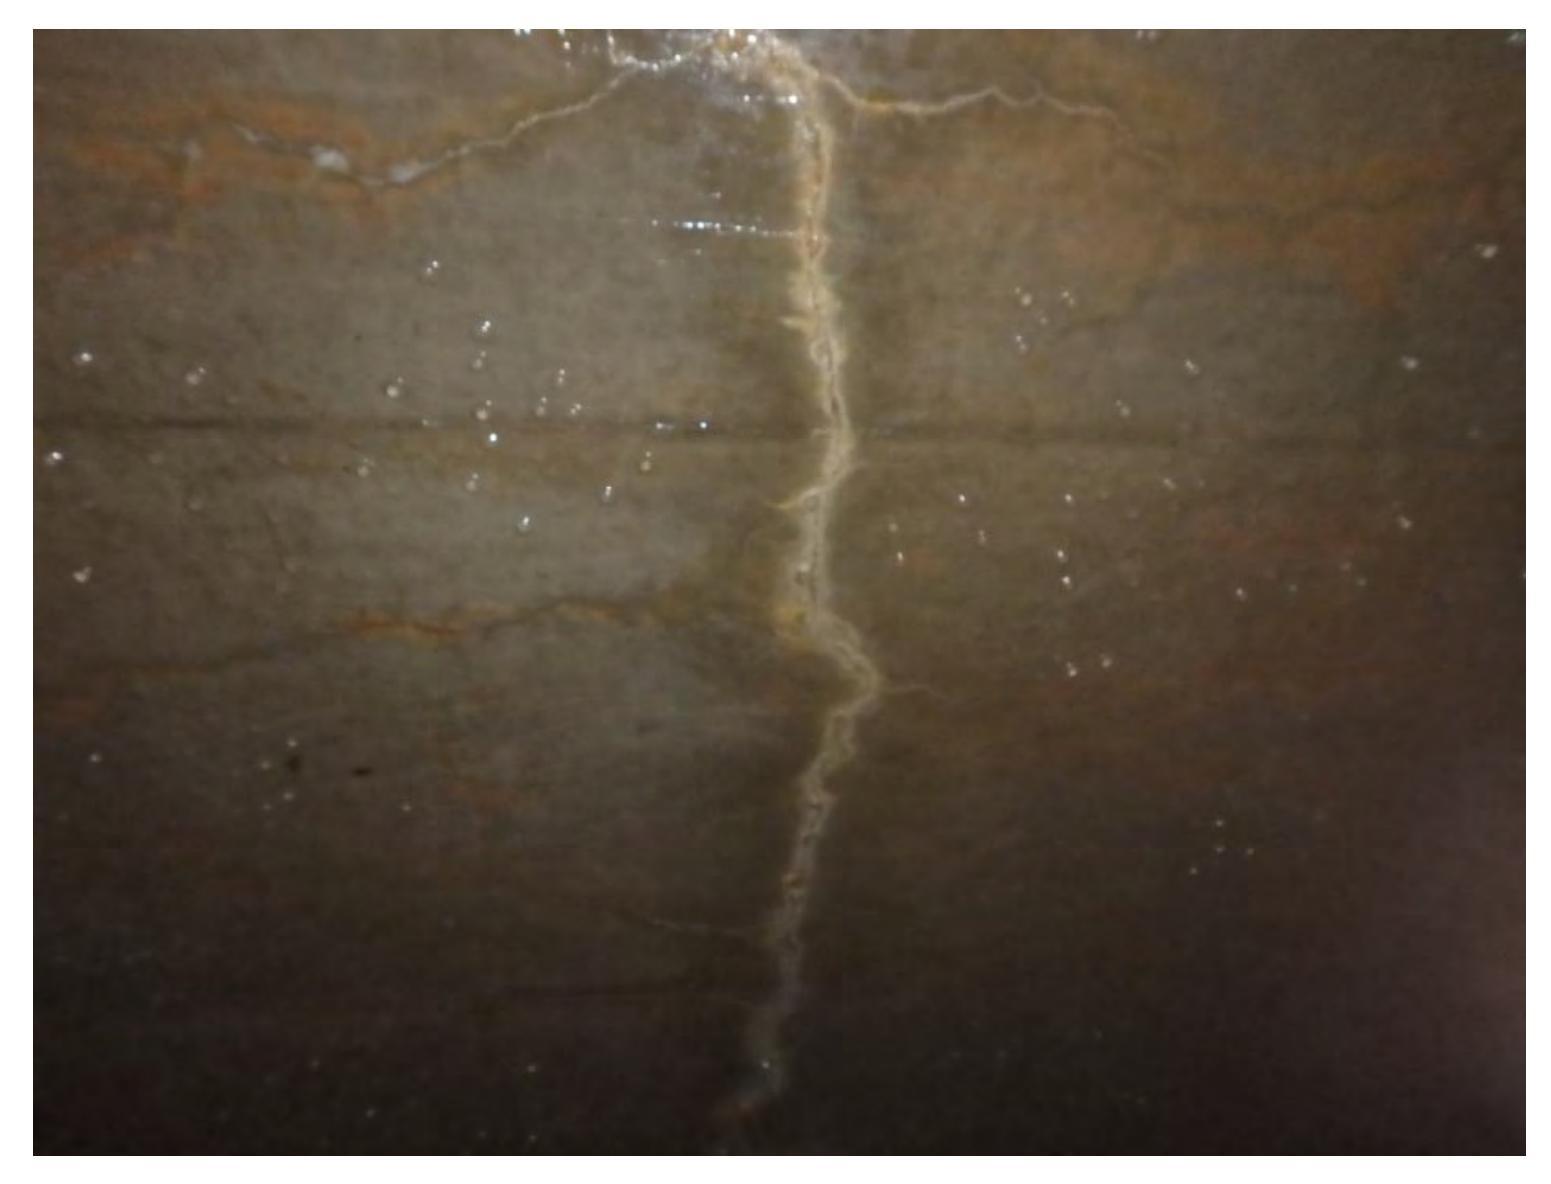
Random transverse cracking with efflorescence staining found in the barrel roofs

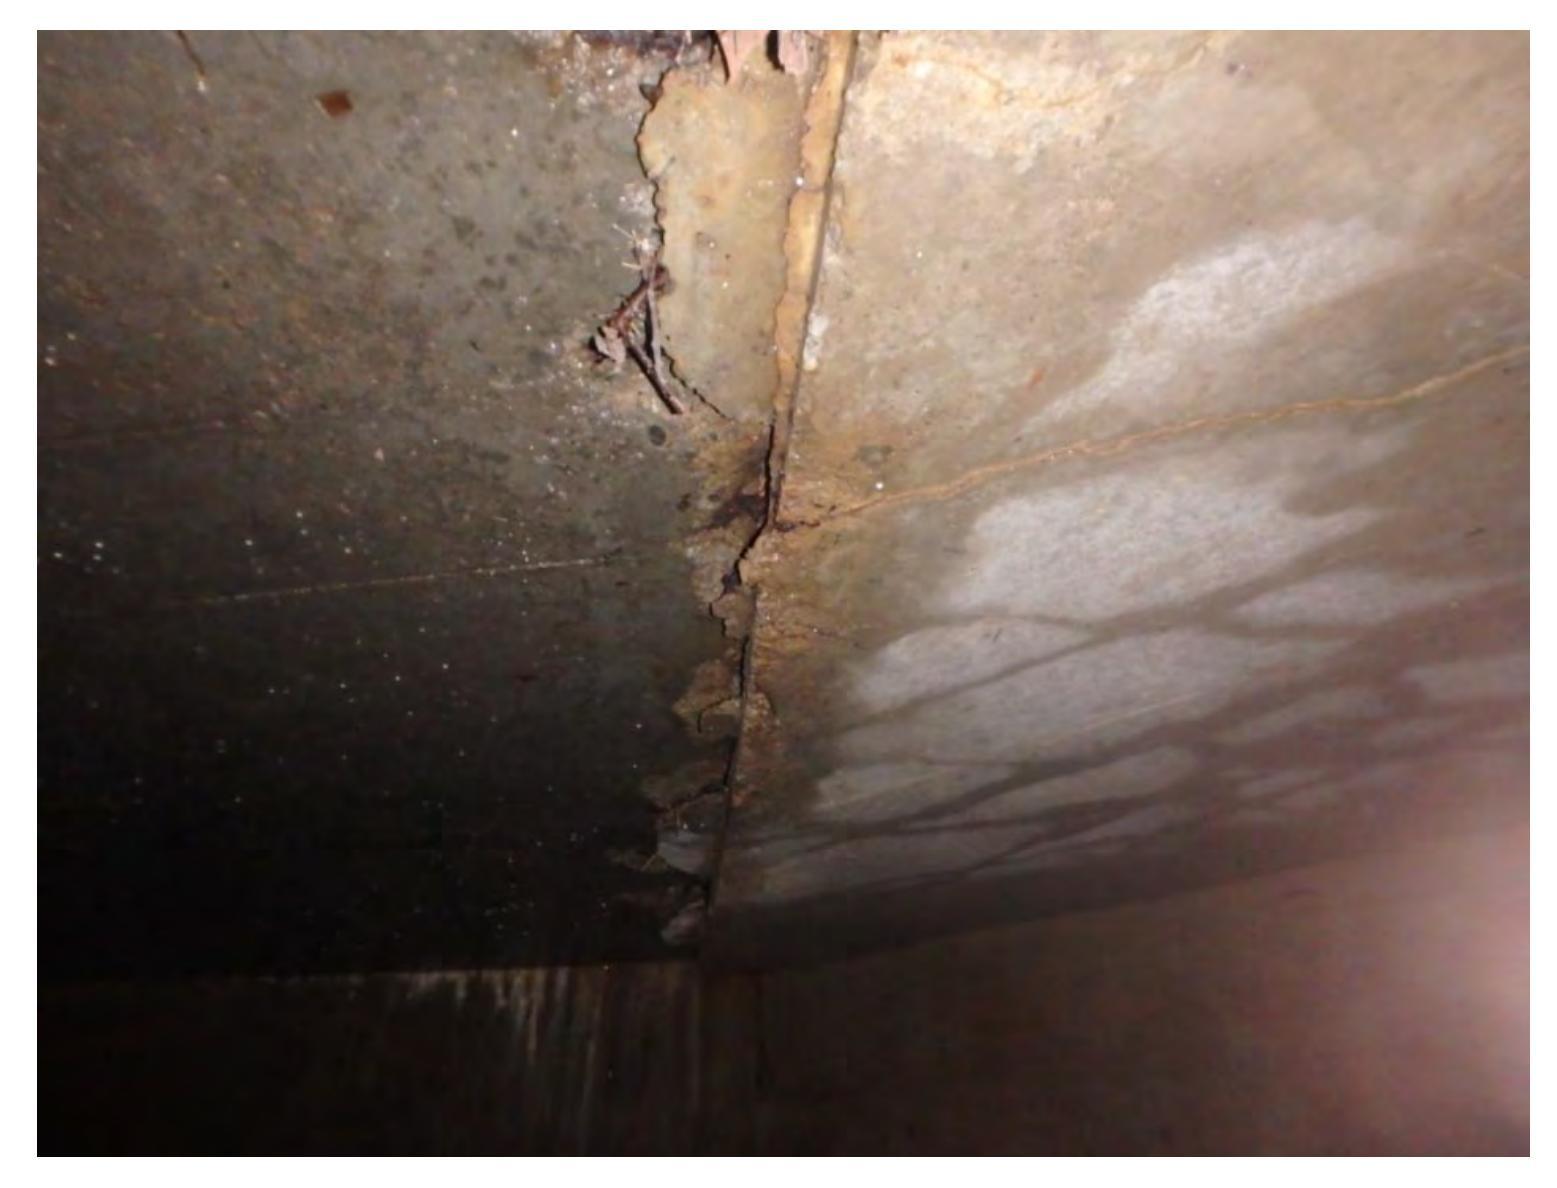
1220	Deterioration (Other)	3	06/25/2018	24.00	ft	0.00	10.00	14.00	0.00
	Deterioration (Oth Deteriorating co	er)* nditions with	some exposed	rusting	reinforcing	steel were	found occurri	ng in concrete	material in
	areas of joints inspection. (See Photos)	in between p	ortions of struct	ure, with	opened jo	oint showing	moderate to he	eavy leakage du	uring time of

Jointed union between double box barrel and single box Note leaking conditions, deteriorating material and settlement occurring. Photo taken of joint in barrel #1

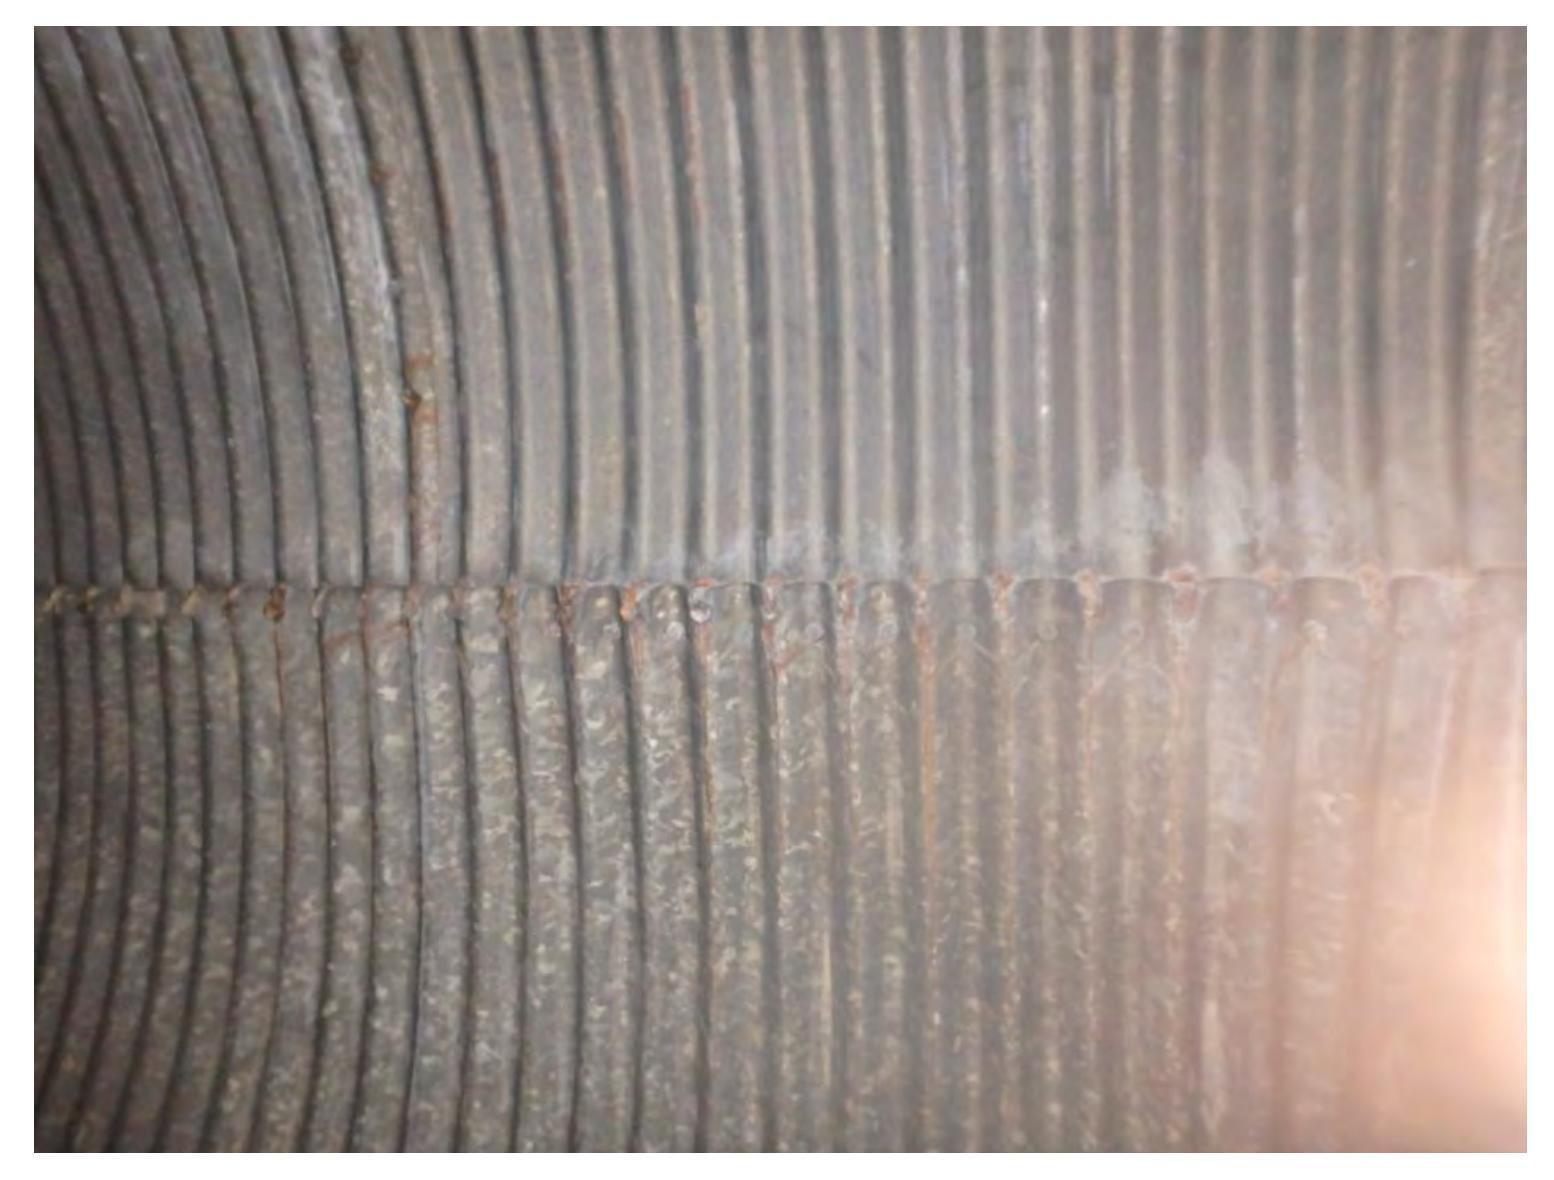
ELEM NBR	ELEMENT NAME	ENV	INSP. DATE	QUANTITY	UNITS	QTY CS 1	QTY CS 2	QTY CS 3	QTY CS 4
240	Steel Culvert	3	06/25/2018	218.00	ft	93.00	50.00	75.00	0.00
Steel Cul	vert*								
Portion	of culvert structure that	is of	Corrugated Met	al Pipe desig	jn is	along cente	r in betwee	n concrete	sections of
structure									
Note the	at access to enter complete	ely t	hrough this porti	on of structur	re (CN	IP) was four	nd to be lir	nited at thi	s time, due
to dept	h of channel, as well as	drift	debris buildup	during time	of ins	spection. M	etal pipe se	ection was	entered into
several fe	eet along both the inlet and outle	t ends	s for inspection revie	ew.					
Metal o	culvert pipe section of s	tructu	ire was found	to have mu	ltiple	large areas	of bulging	conditions	(significant
amount)	at this time, showing	poor	shape (wavy)	randomly thro	ughout	. Areas	of bulging	conditions	were found
randomly	/ throughout both sides and top of	of culv	vert pipe.

Bulging found randomly in the single barrel pipe portion of the culvert

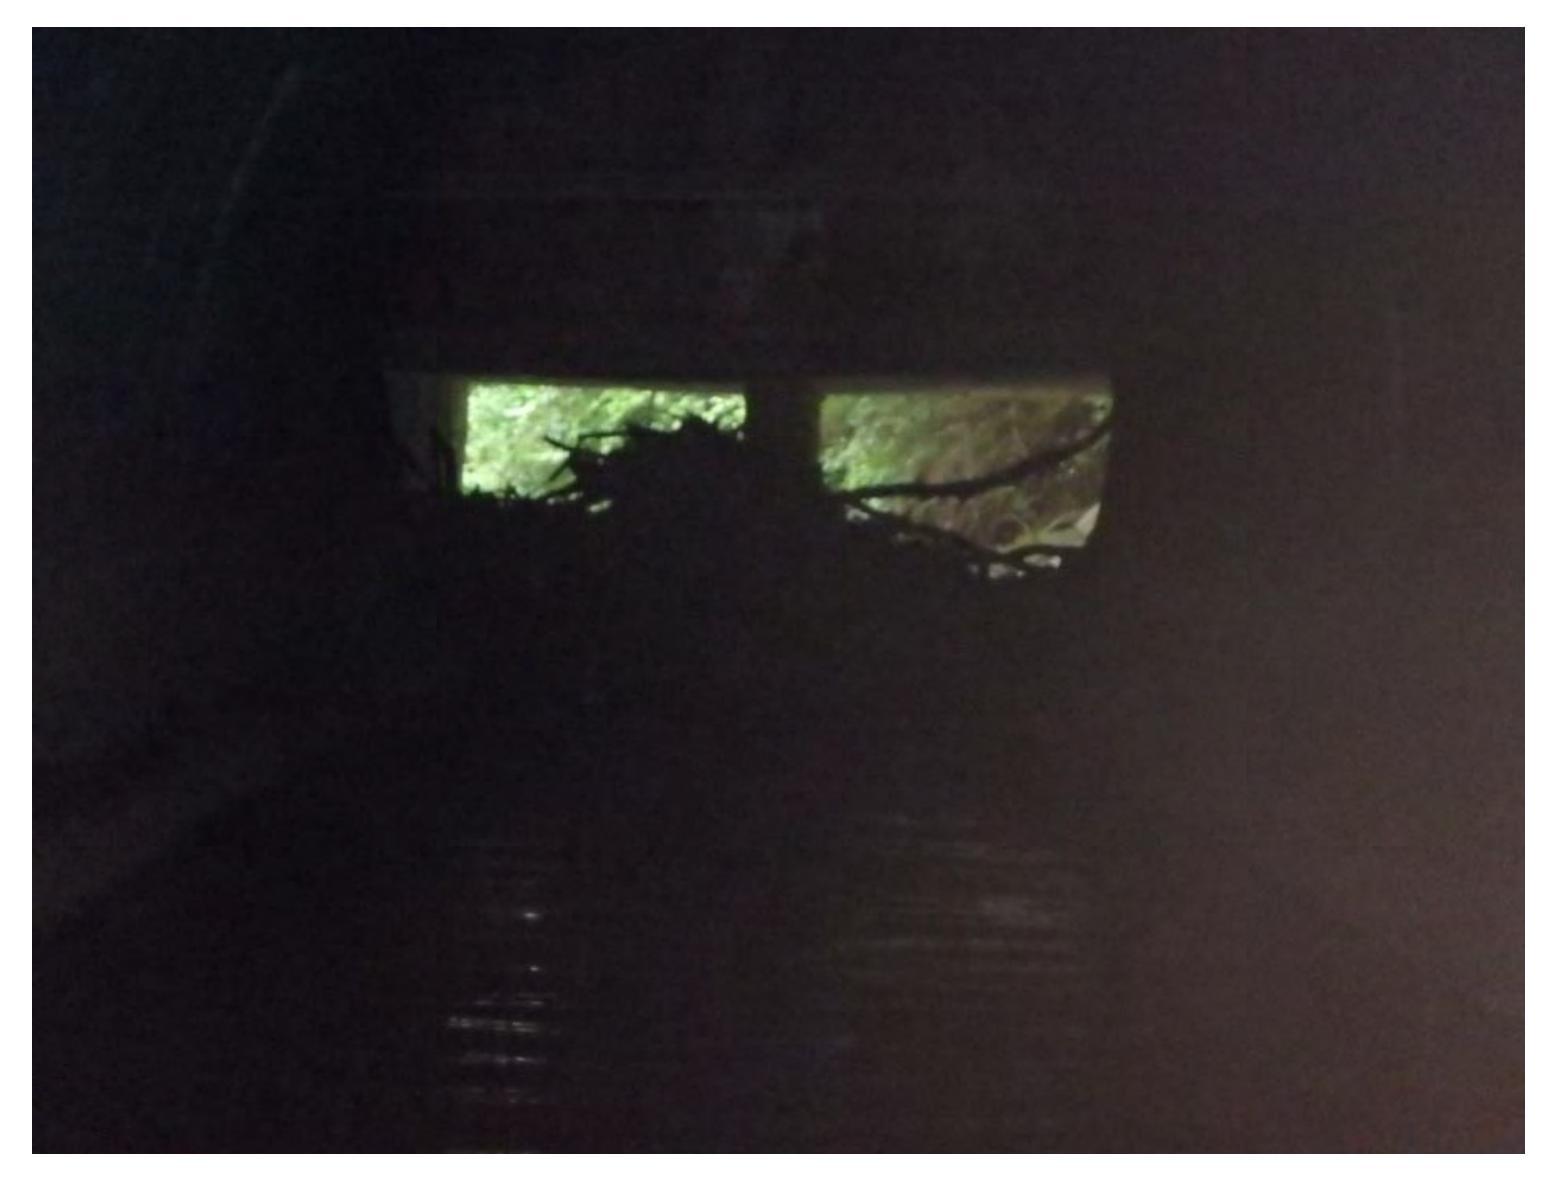
View through culvert, note stream drift bulid up at the beginning of the secont section of double barrel culvert, at outlet end of structure.

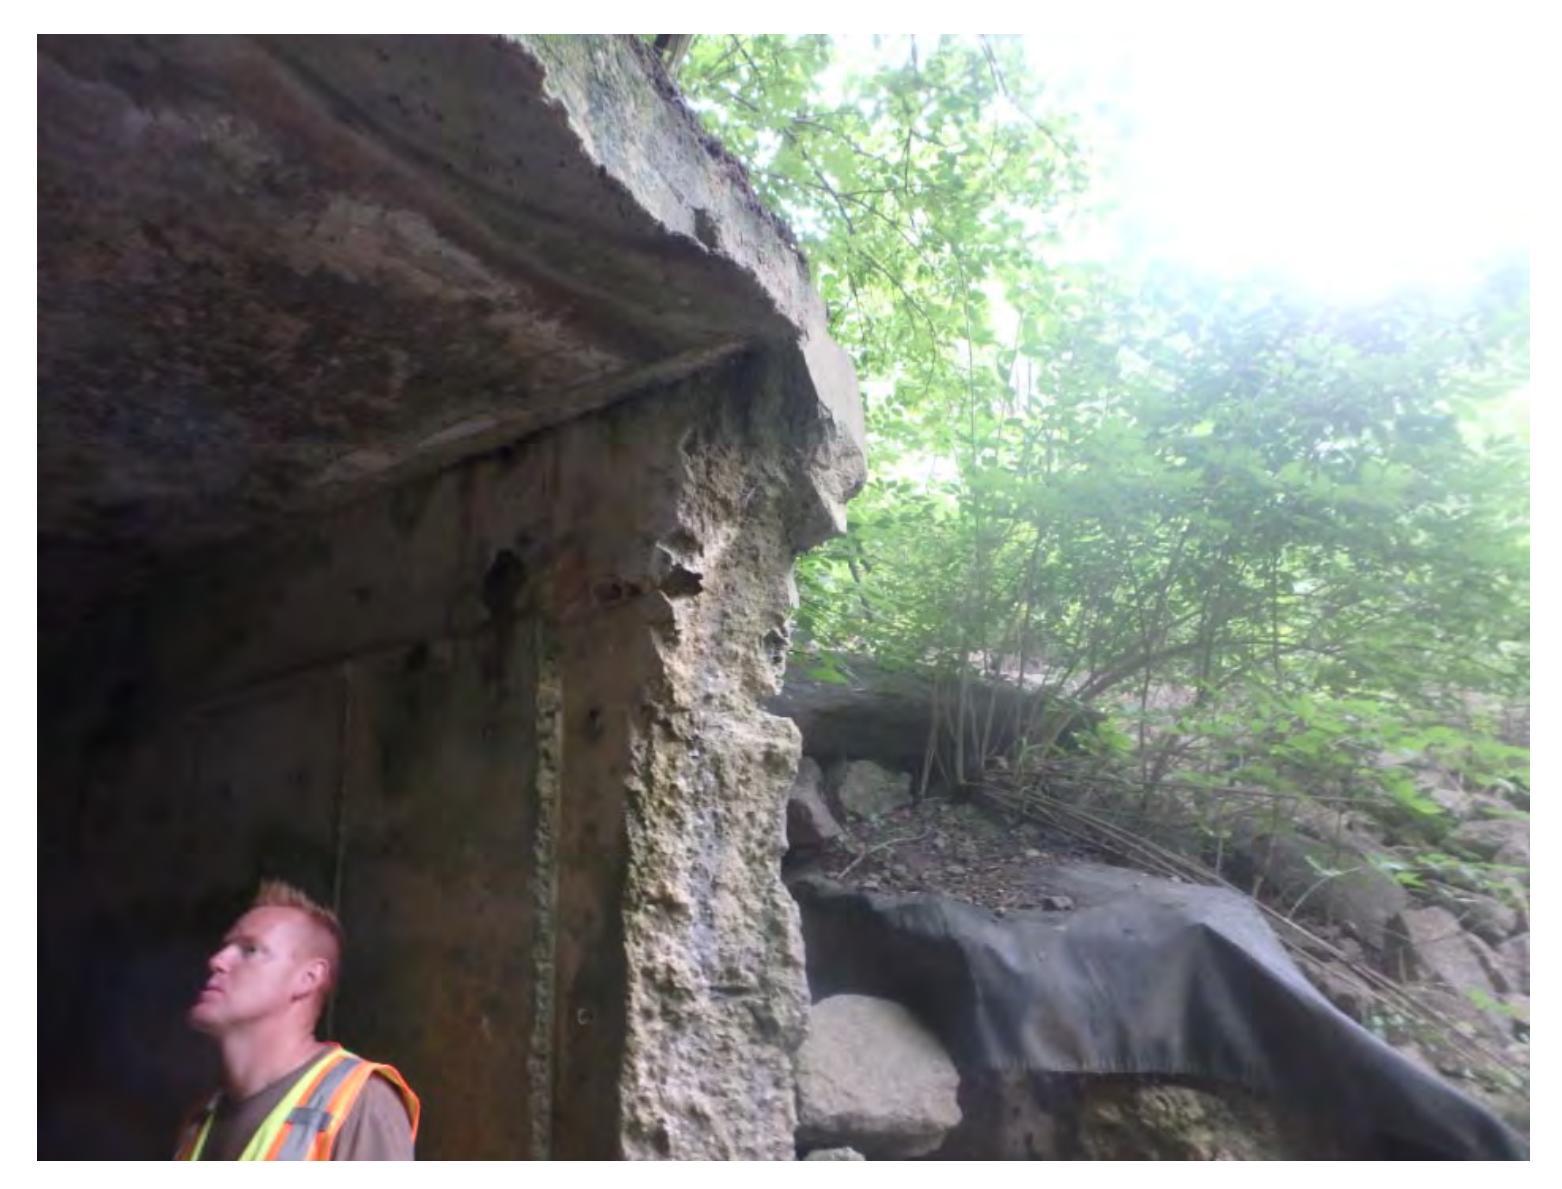
Heavy deterioration at the outlet end of the structure

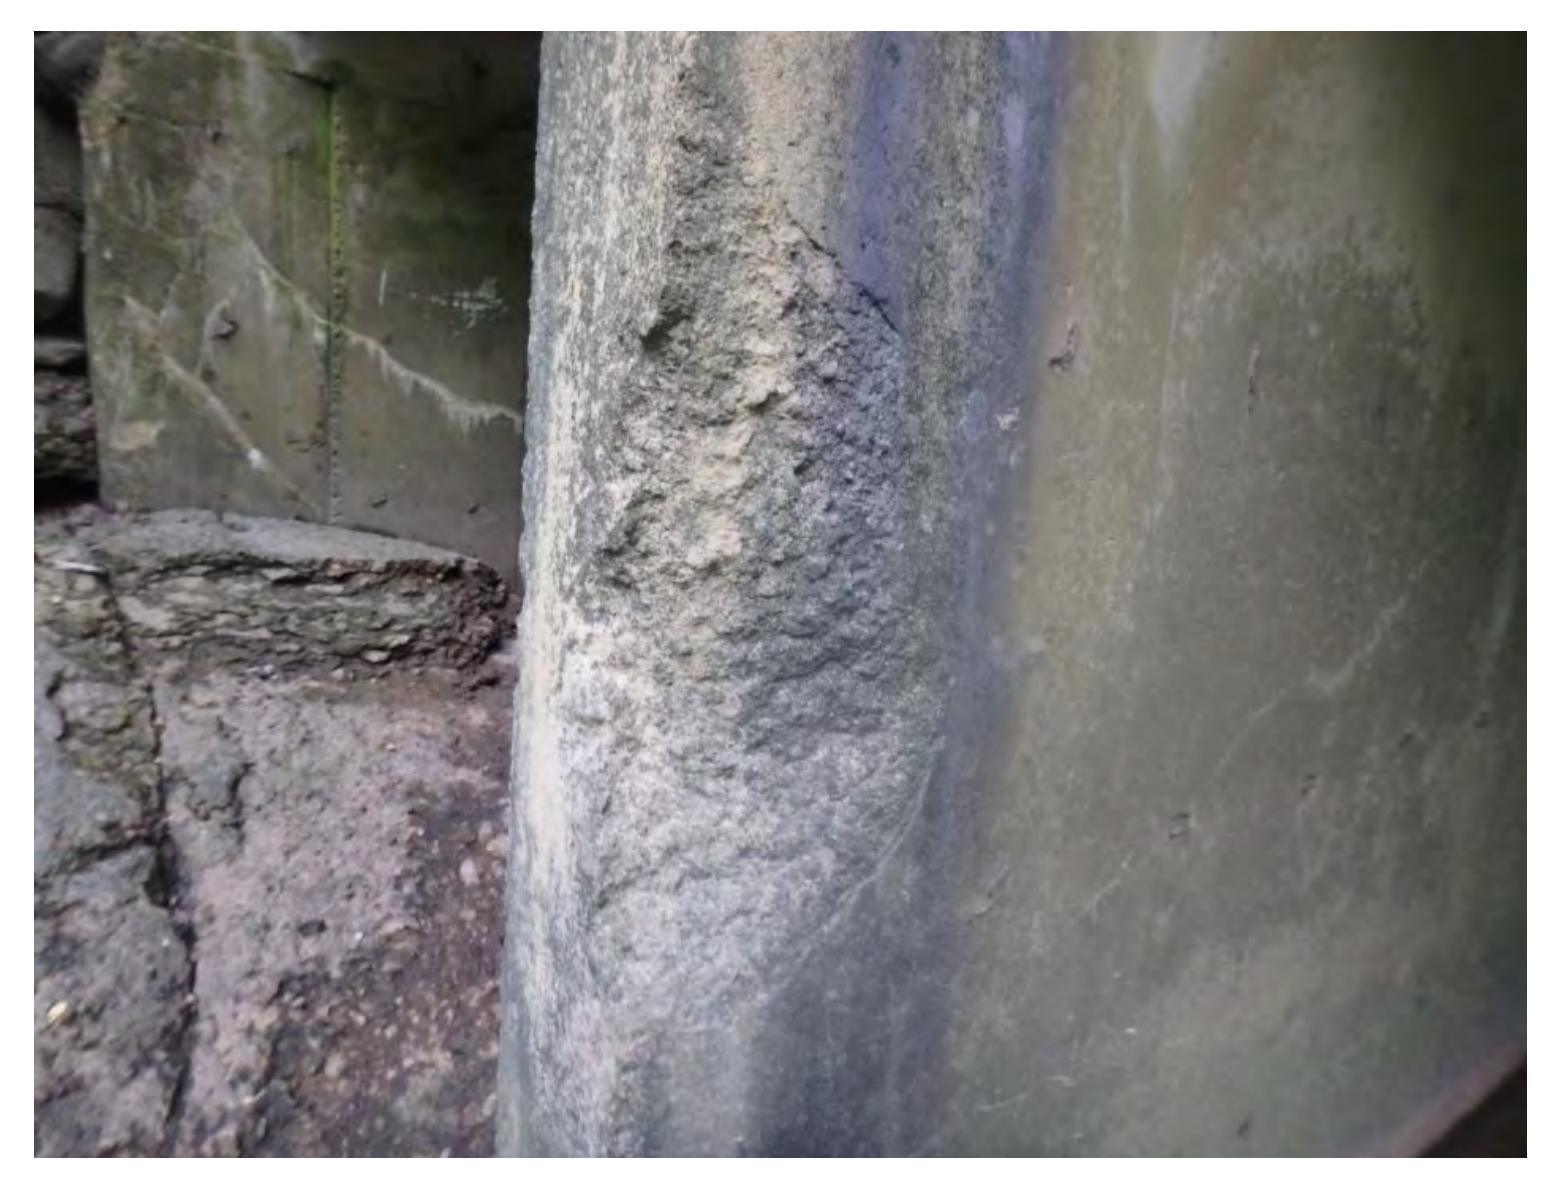
Deterioration of outlet center curtain wall

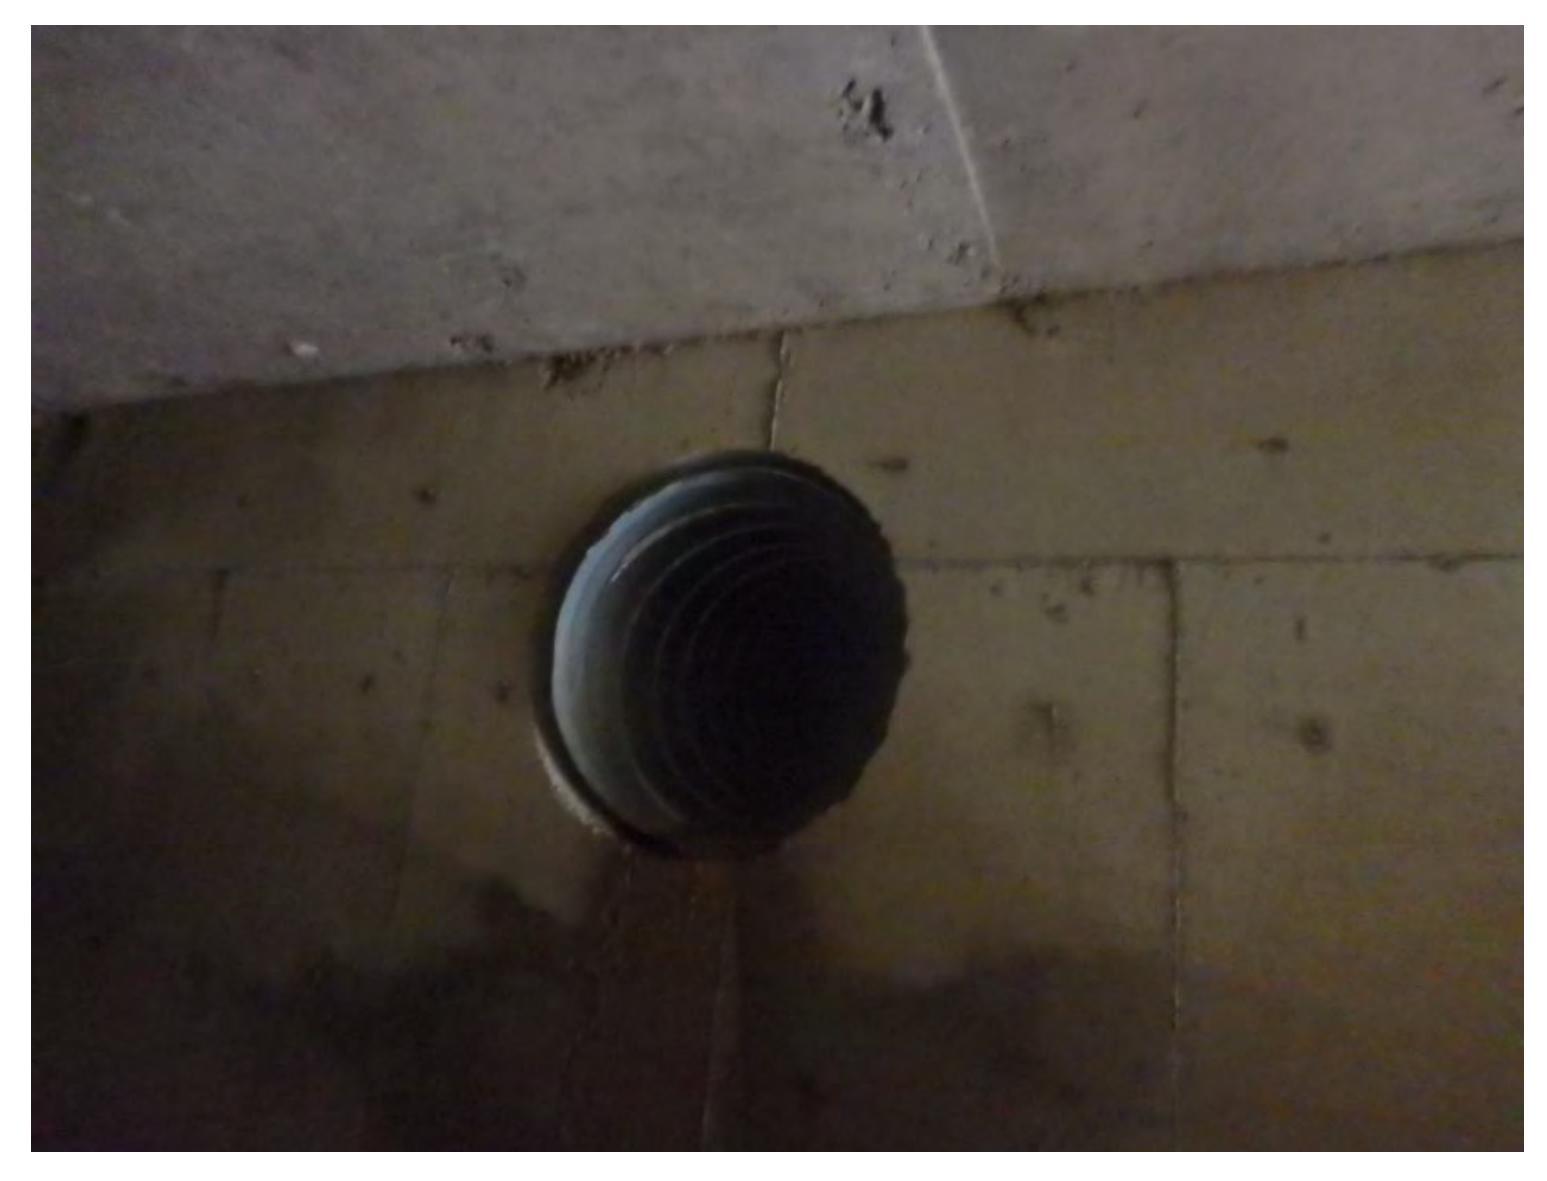
Pipe cast into wall of barrel # 1 near outlet end of structure.
