059C00071N Inspector: Greg Cady Entered by: GCADY 06/25/2018 Standard (24 months)

Inspection Report

STRUCTURE STAMPED 1958

This structure used to be a state structure named 059B00019N and was converted to a city (Erlanger) structure and is now 059C00071N. 03/03/2017 GTC

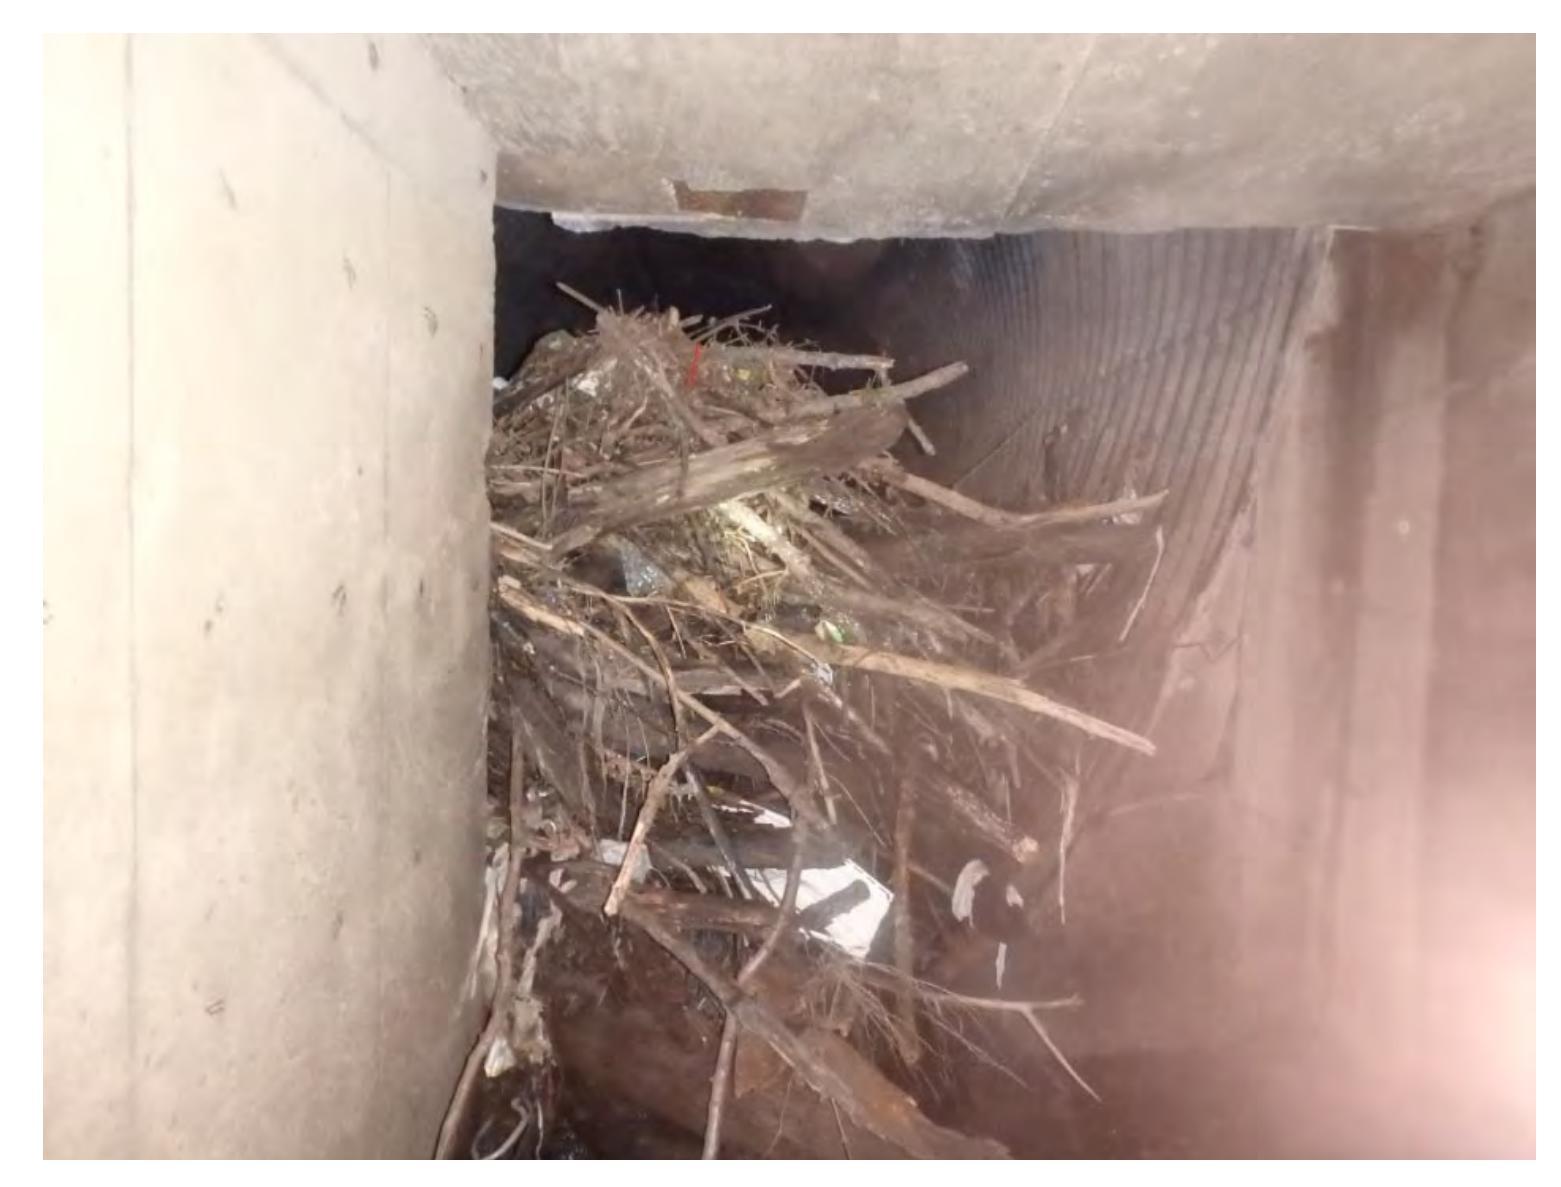
Debris build up in at union of single barrel to double barrel outlet portion.

All channel drift debris found hung or built up at site of structure needs to be removed as soon as possible. Removal of such drift debris buildup will help relieve stream flow and allow stream depth to recede through portions of structure (restriction of stream flow).
