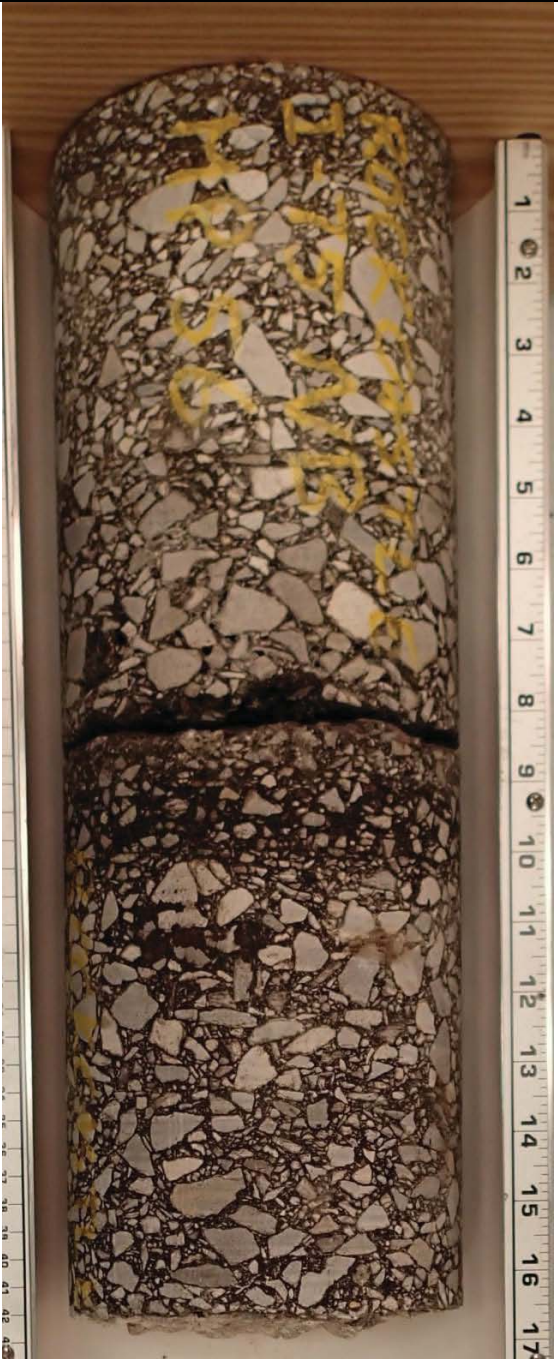
Route	I-75 MP 56 NB, Left Lane

AC Depth	16.75"	
DGA Layer	11.75"	
Rock/ Soil Mix		
Compacted Shale	8.5"	
Depth of Investigation	37"	
Notes:	<p>Located adjacent to shale cut. Approx. 30' north of location, observed CL stripe with rust colored cracking. Core broke in 2 pieces at 8.25" from the surface. 5.25" to 8.25" from surface, observed large number of voids, bitumen oxidizing and flaky.</p>

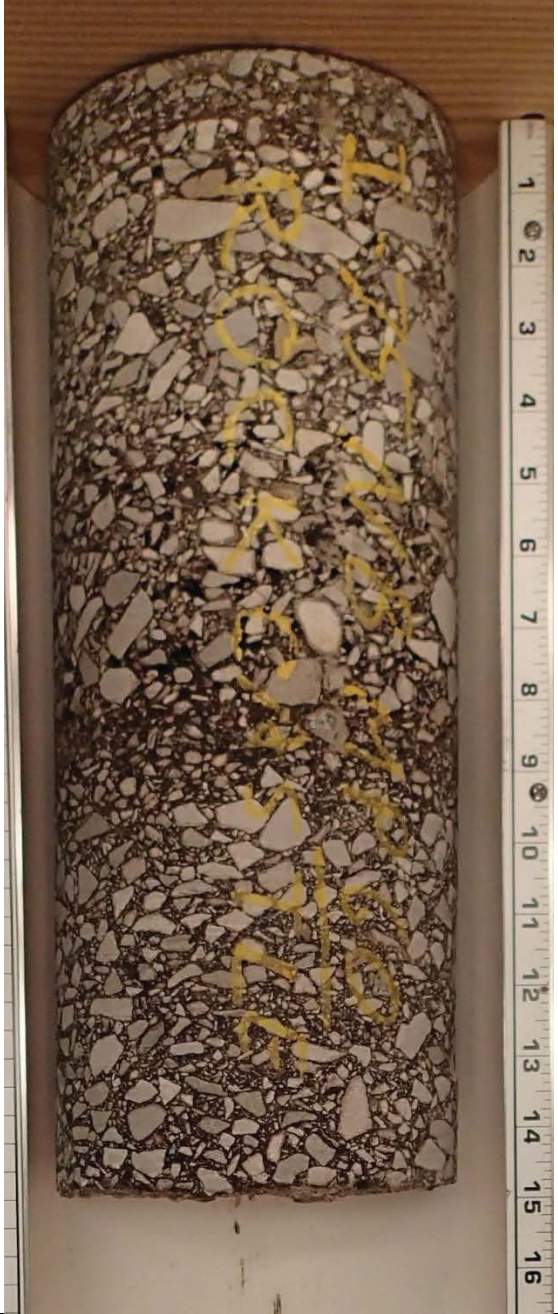
Route	I-75 MP 60 NB, Left Lane

AC Depth	14.75"	
DGA Layer	10.75"	
Rock/ Soil Mix	2"	
Compacted Shale		
Depth of Investigation	27.5"	
Notes:	<p>Located at grade.</p> <p>Moderate amount stripping noted below surface layer, 1.25" to 8.125". Minor air voids noted in surface layer.</p>

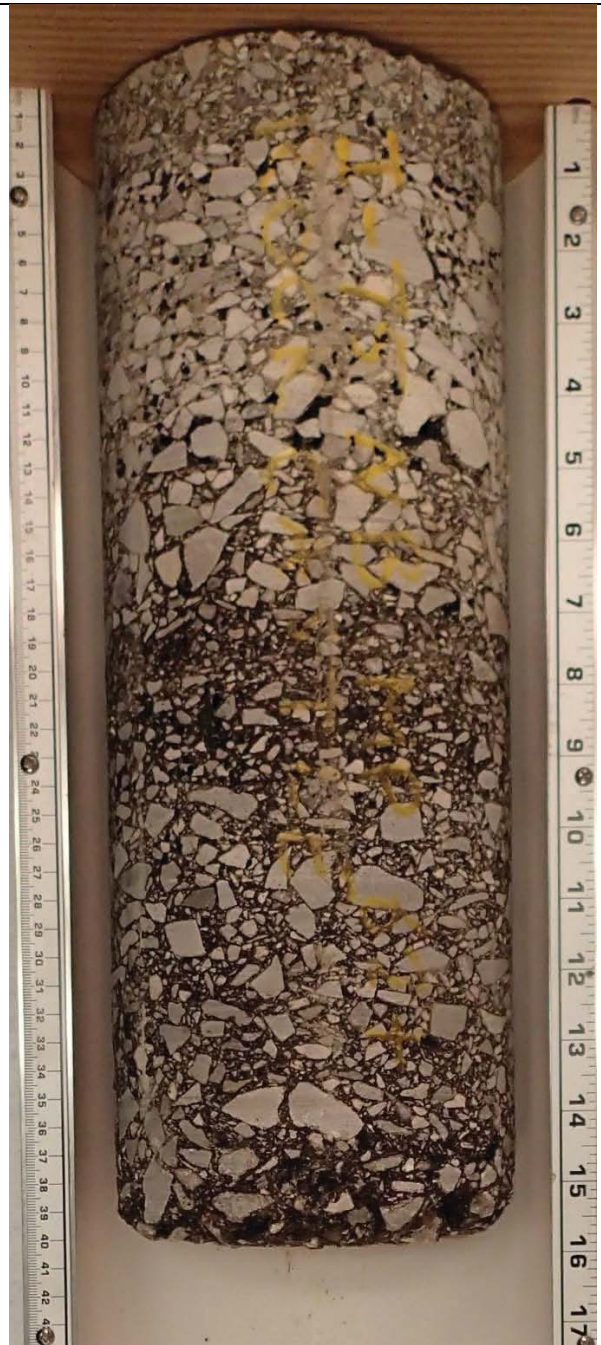
Route	I-75 MP 62.11 NB, Left Lane	
AC Depth	15.75"	
DGA Layer	9.5"	
Rock/ Soil Mix		
Compacted Shale	8.75"	
Depth of Investigation	34"	
Notes:		
<p>Located at grade. Large amount of air voids/stripping noted 1.375" to 7.5" from surface.</p>

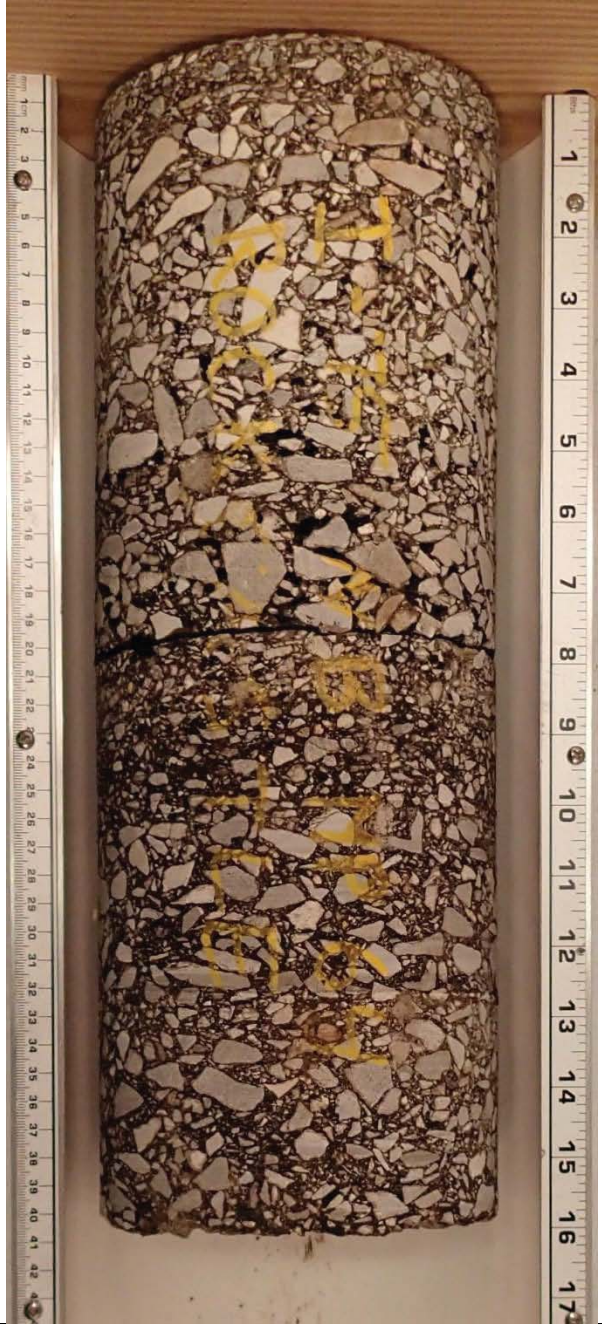
Route	I-75 MP 64 NB, Left Lane

AC Depth	15.875"	
DGA Layer	10.875"	
Rock/ Soil Mix		
Compacted Shale	5"	
Depth of Investigation	31.75"	
Notes:	<p>Located adjacent to cut. Core broke in 2 pieces, 7.875" from surface. 1.125" to 7.875" from surface, observed many air voids, moderate stripping, and oxidized binder.</p>

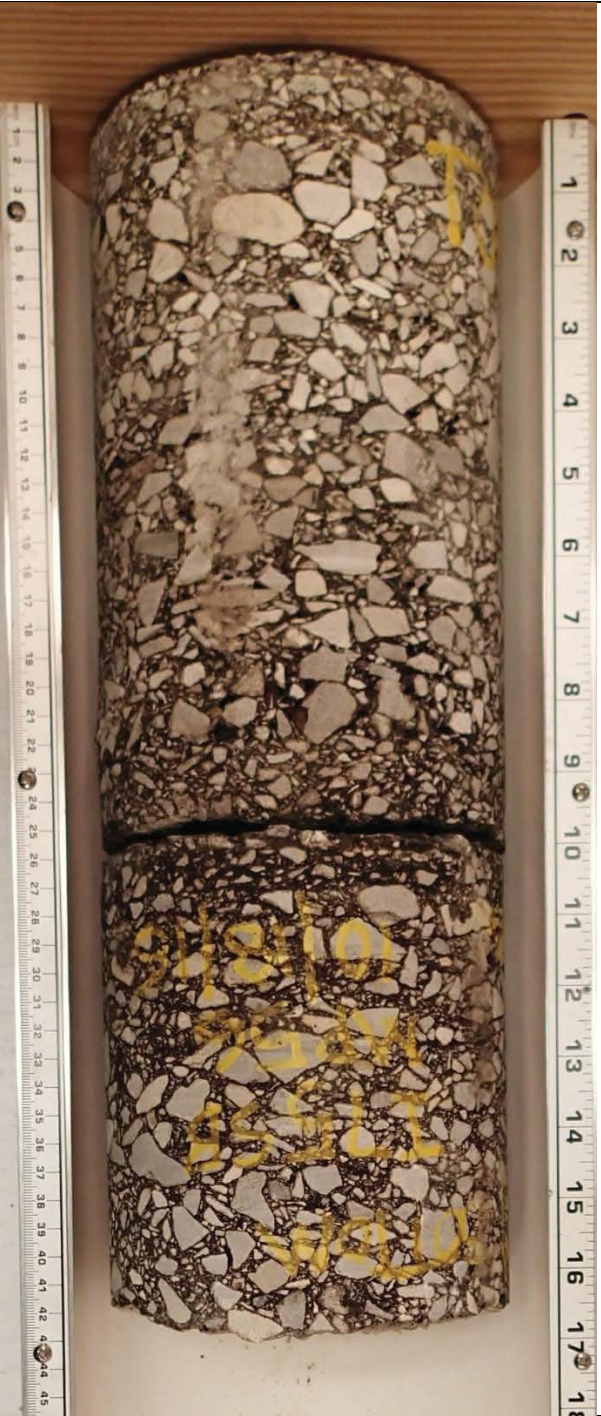
Route	I-75 MP 56 SB, Left Lane
AC Depth	16.5"
DGA Layer	13"
Rock/ Soil Mix	
Compacted Shale	
Depth of Investigation	29.5"
Notes:	
<p>Located adjacent to shale cut. Core broke in 2 pieces, 9.875" from surface. Moderate amount of stripping from 1.125" to 9.875". Material from 9.875" to approx. 11" appears rotten.</p>

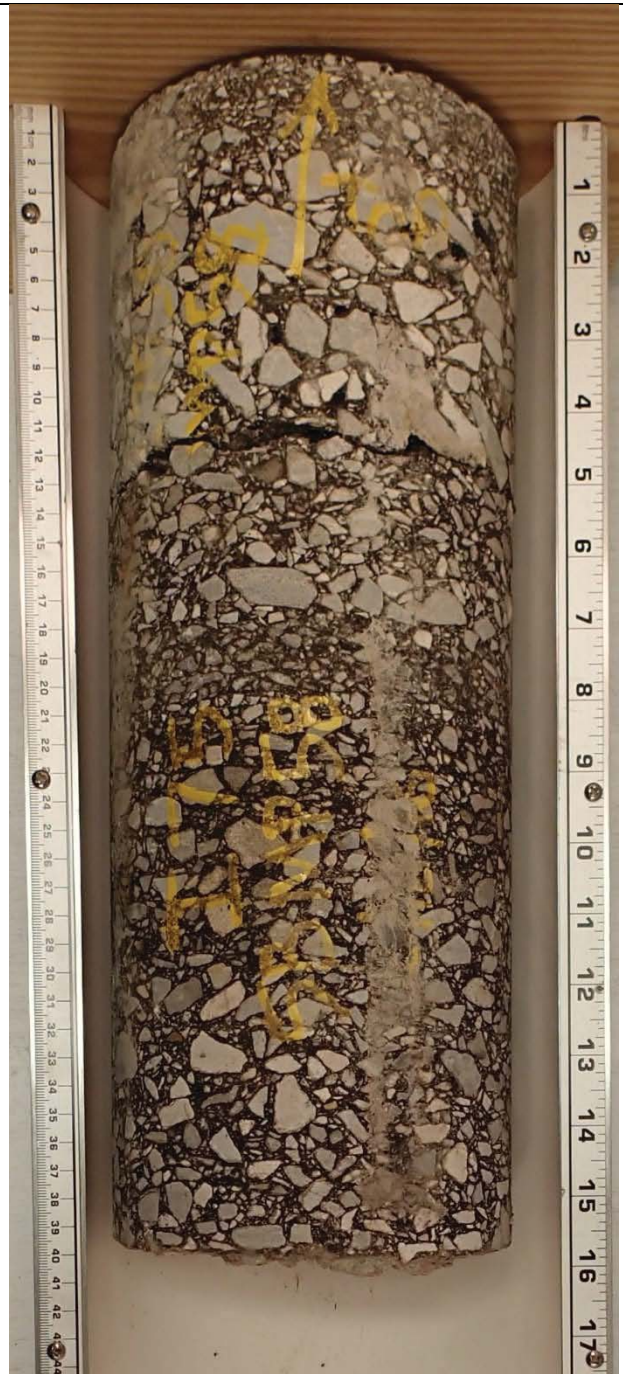
Route	I-75 MP 58 SB, Left Lane
AC Depth	15.5"
DGA Layer	16"
Rock/ Soil Mix	
Compacted Shale	
Depth of Investigation	31.5"
Notes:	
<p>Located adjacent to shale cut. Core broke in 2 pieces, 5" from surface. From 1.125" to 5", voids observed. DGA observed with clay fines mixed in.</p>

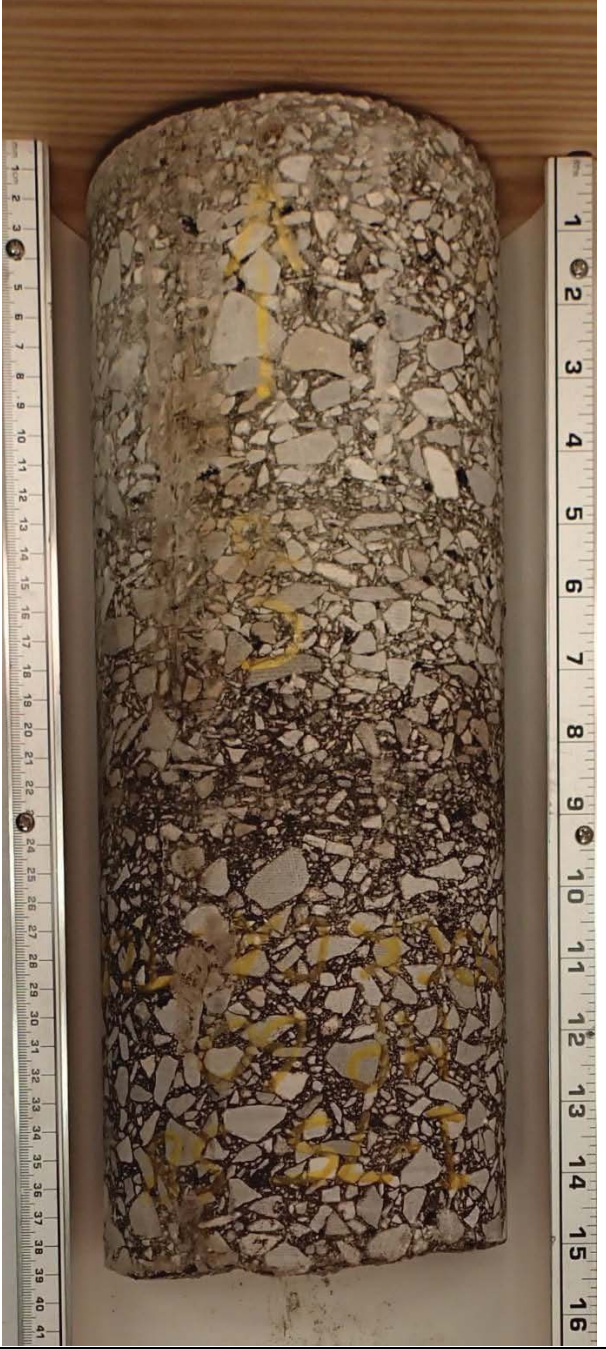
Route	I-75 MP 60 SB, Left Lane
AC Depth	15"
DGA Layer	17"
Rock/ Soil Mix	
Compacted Shale	
Depth of Investigation	32"
Notes:	
Located at grade. 5.25" to 8.25" from surface, moderate stripping observed.

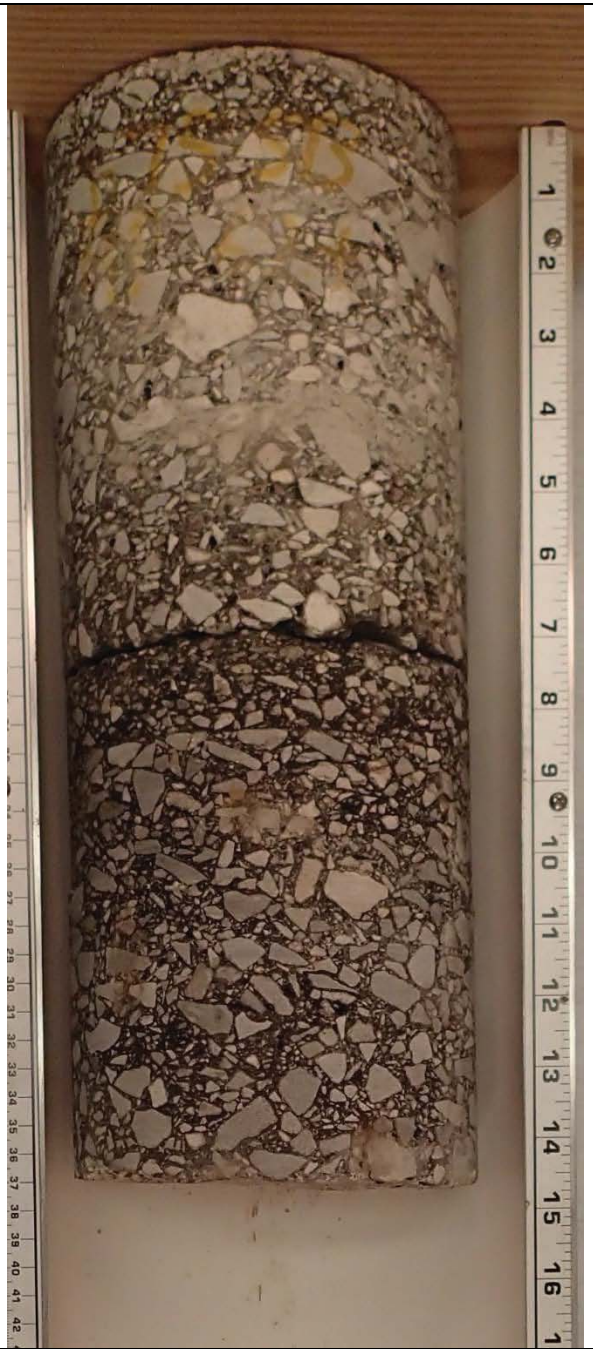
Route	I-75 MP 62.11 SB, Left Lane
AC Depth	14.75"
DGA Layer	10.75"
Rock/ Soil Mix	2.5"
Compacted Shale	
Depth of Investigation	28"
Notes:	<p>Located adjacent to rock cut. Core broke in 2 pieces, 7.5" from surface. Moderate stripping 4.5" to 7.5" from surface.</p>

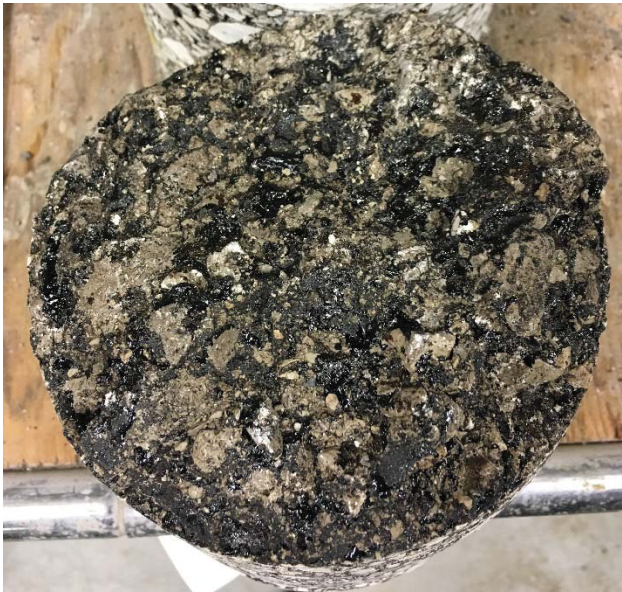
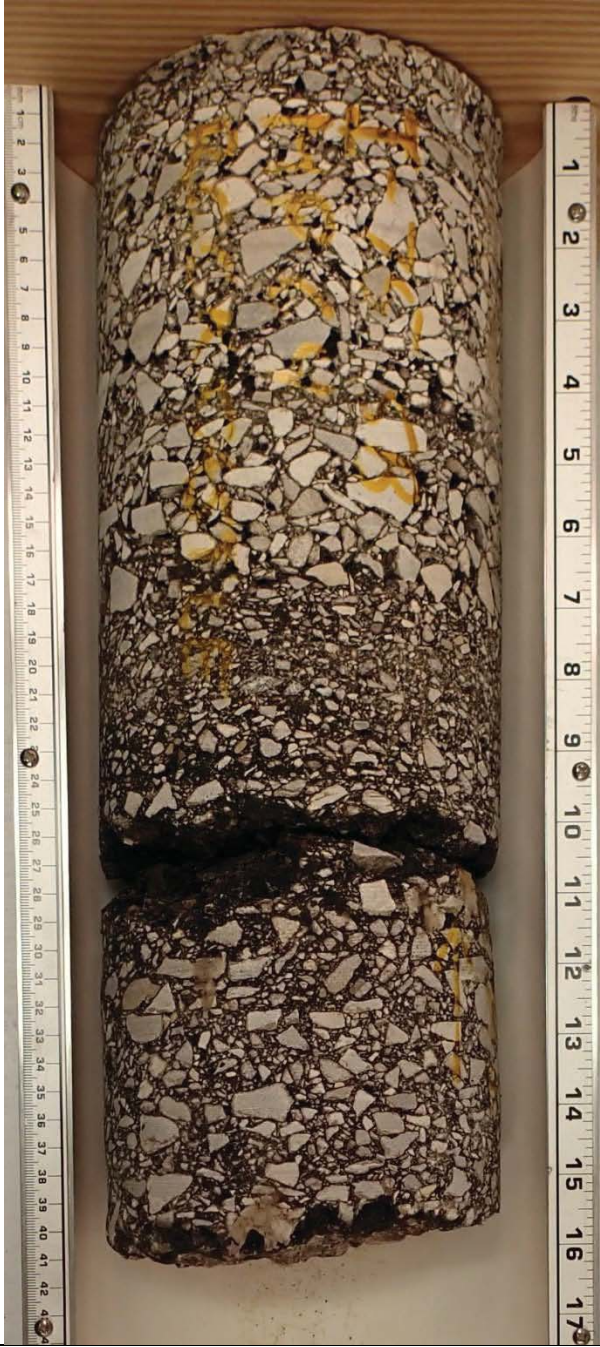
Route	I-75 MP 64 SB, Left Lane
AC Depth	15.75"
DGA Layer	12"
Rock/ Soil Mix	1.25"
Compacted Shale	
Depth of Investigation	29"

Located at grade.
 Core broke in 2 pieces, at 10.5" to 11" from surface. Surface layer (1"), observed air voids.
 From 1" to 7.25", observed moderate stripping in all layers. At 10.5" to 11", observed aggregate not well-coated with binder (see photo below).

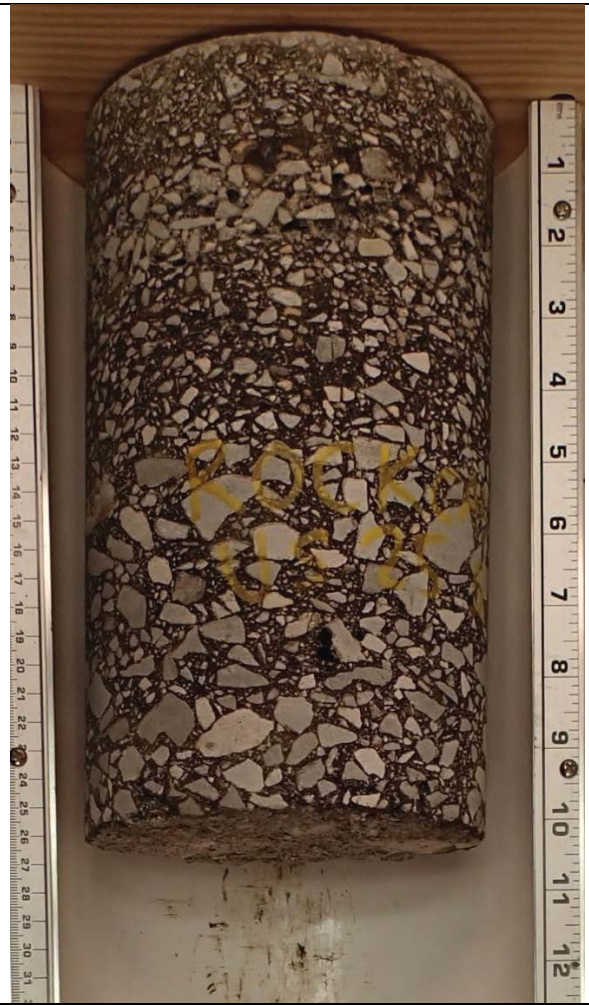
Route	US 25 SB MP 11.86, Right Lane
AC Depth	10.125"
DGA Layer	15.125"
Rock/ Soil Mix	1.5"
Compacted Shale	
Depth of Investigation	26.75"
Notes:	
Located adjacent to fill. From 1.375" to 3.25" from surface, observed major stripping and air voids. From approx. 6" to bottom of core, observed minor stripping.

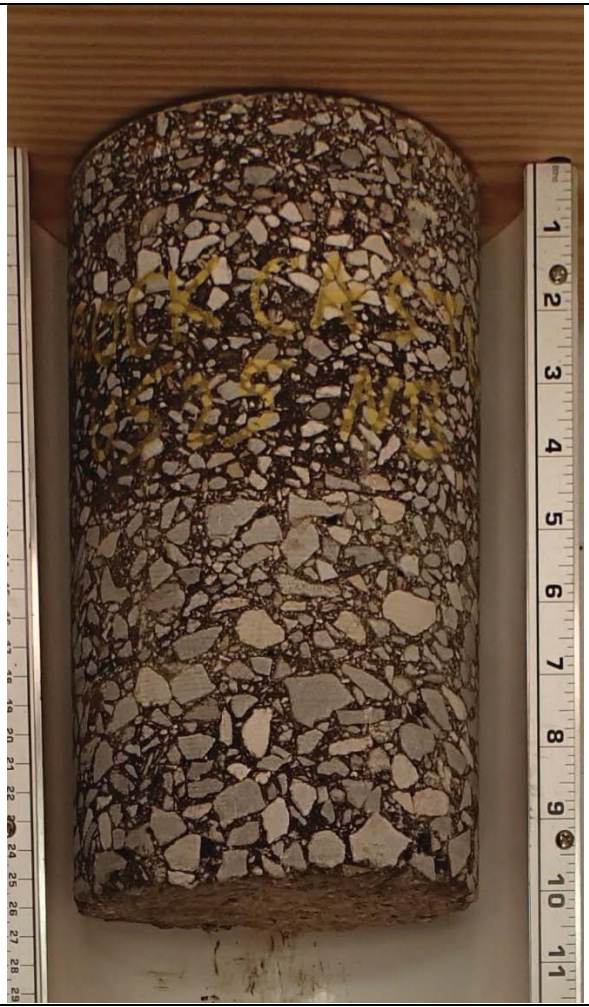
Route	US 25 NB MP 11.92, Right Lane	
AC Depth	10"	
DGA Layer	14.25"	
Rock/ Soil Mix	3.25"	
Compacted Shale		
Depth of Investigation	27.5"	
Notes:	<p>Located at grade. 1.25" to 2.75" from surface, observed minor stripping. From approx. 5" to bottom of core, observed minor stripping.</p>
