PANBOWL LAKE

City of Jackson, Breathitt County

ABOUT PANBOWL LAKE

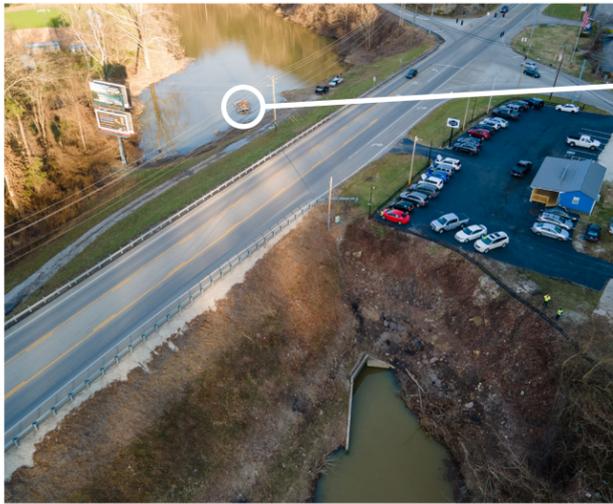
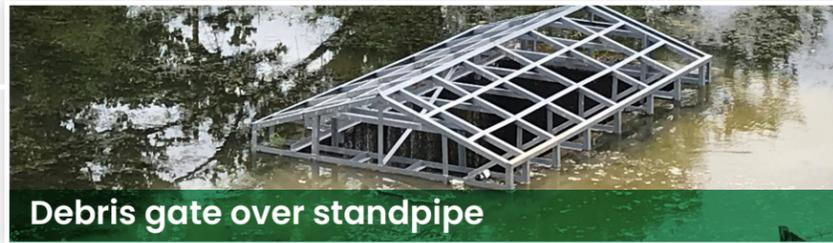
EAST EMBANKMENT

Debris gate over standpipe

The east embankment has the only drainage structure for Panbowl Lake, a standpipe riser connected to a concrete culvert under KY 15. The top of the standpipe has an elevation of 713 feet and helps keep the water in Panbowl Lake at this same level.

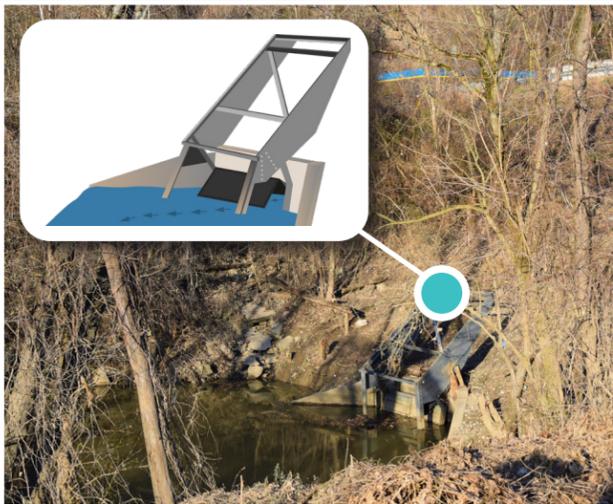
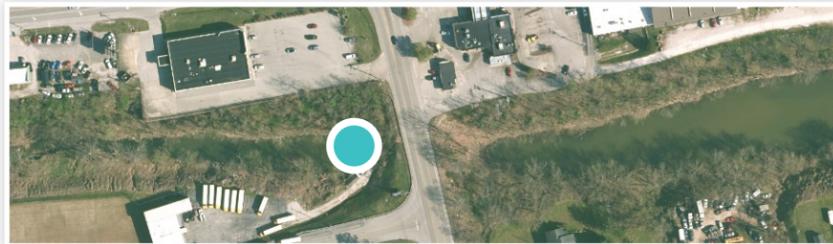
OUTLET CHANNEL AND FLAP GATE

Excess water from the lake flows from the east embankment culvert along an outlet channel that runs parallel to KY 15 and under Washington Avenue. A flap gate helps prevent water from back flowing from the North Fork of the Kentucky River to the lake.

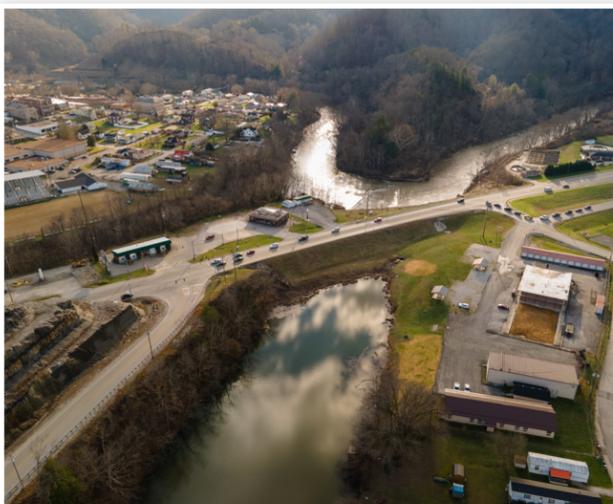
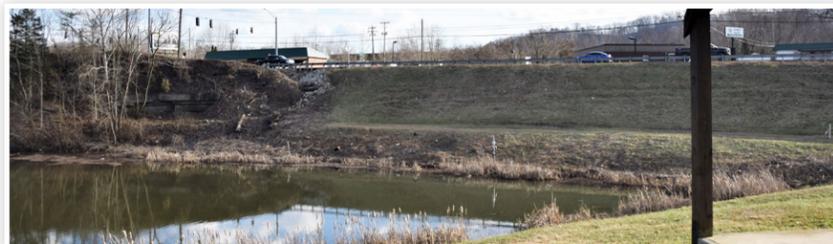
WEST EMBANKMENT

The west embankment separates the river from Panbowl Lake. Like the east embankment, there are different slope measurements on either side of the road. Fill material in the embankments includes topsoil, asphalt, rock, coarse grained alluvium, bedrock, shale/sandstone and groundwater.

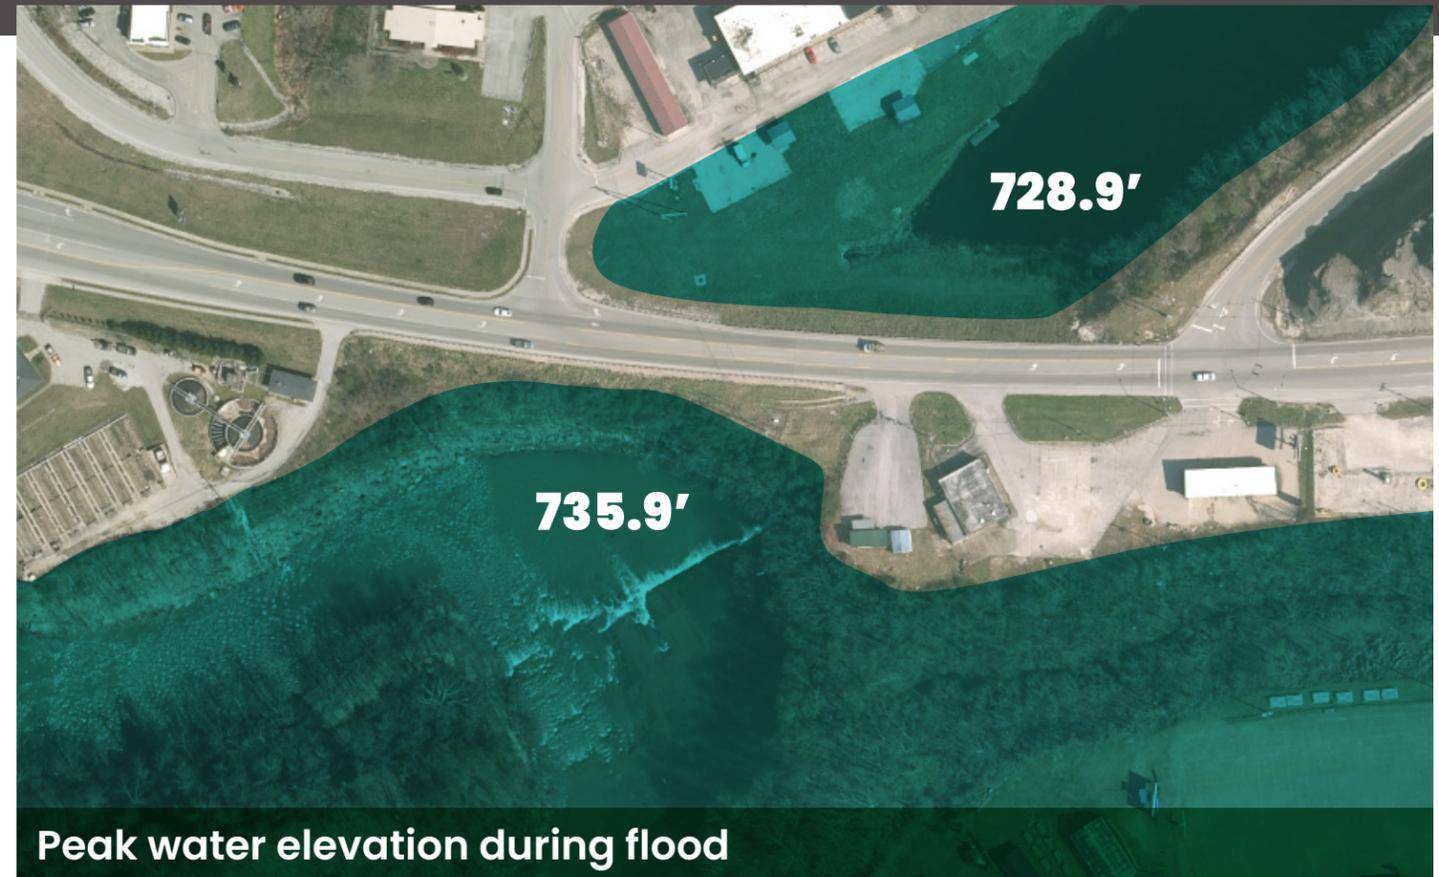
MARCH 2021 FLOOD

In late February and early March 2021, rain and runoff into the North Fork of the Kentucky River caused water levels to rise dramatically in a short amount of time. The river crested on March 1 at an elevation of 735.9 feet. The flood was the 10th highest flood in Jackson's history and the worst since 1984.

Water from the river seeped through west embankment, causing water levels on the lake to rise to an elevation of 728.9 feet (16 feet above normal). This caused a slope stability issue, but the Kentucky Division of Water Dam Safety determined that KY 15 could remain open to traffic and there was no threat of the dam breaching.
