TO:	Stephen De Witte, PE
	Project Management Coordinator
	Division of Planning
FROM:	Michael Carpenter, PE
	Geotechnical Branch Manager
	Division of Structural Design
BY:	Sean House, PG
	Geotechnical Branch
DATE:	October 27, 2020
SUBJECT:	<b>Boyle/Garrard Counties</b>
	FD52 011 052 000-005P
	FD52 040 052 000-004P
	Evaluate options for improving safety on KY 52
	Between Danville and Lancaster
	Item # 7-104.00
	Mars # 1207801P (Boyle)

Mars # 1207802P (Garrard) Geotechnical Overview Report

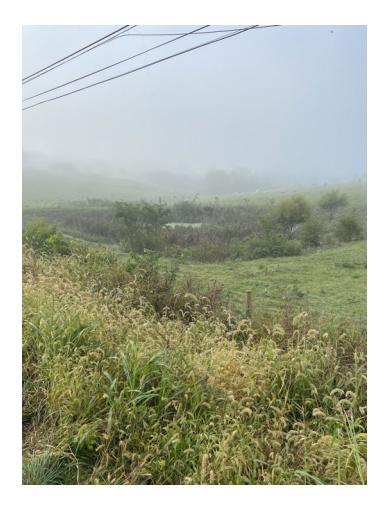
Figure 3. Water filled sinkhole south side of KY 52 in Boyle Co.

Geologic mapping and field observations indicate the presence of sinkholes (Appendix D). Any open sinkhole and/or solution cavities within the limits of construction, whether shown on the plans or not, that are not used for drainage purposes, shall be filled and/or capped in accordance with the current edition of Section 215 of the Standard Specifications for Road and Bridge Construction.

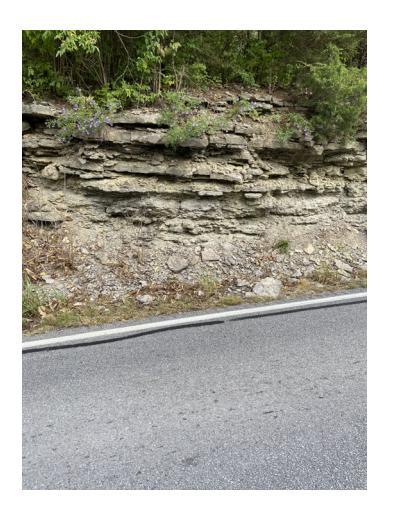
Cuts located in the Upper Ordovician aged bedrock formations, east of the Dix River, contained interbedded limestone and shale. These cuts displayed differential weathering that resulted in large pieces of limestone filling the ditches. Cuts widened or created can be anticipated to be constructed on 2H:1V slopes with adequate ditches to catch debris.

Figure 5. Rock cut east of the Dix River

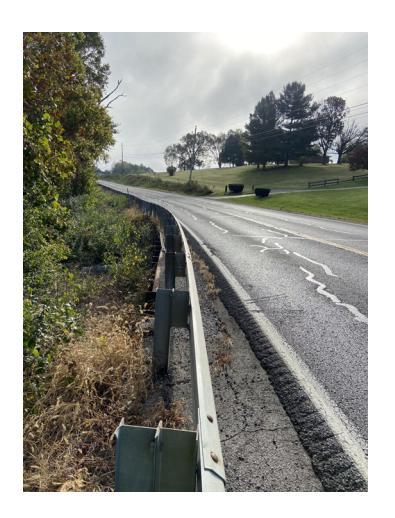
There are locations on the eastern portion of the study area where embankment failure mitigations, rails/lagging and additional asphalt, have been used. The failures could be a result of poor construction techniques, poor embankment material, poor foundation material, or sharp cut/fill transitions on the steeper slopes in the area. Special shale compaction construction, flatter side slopes, partial rock embankment, and constructed embankment platforms are some of the techniques used to reduce these issues.

# Figure 6. Rails and lagging mitigation on embankment east of the Dix River
