November 11, 2020

RE: Cultural Historic Overview Survey for
the KY 52 Planning Study in
Boyle and Garrard Counties, Kentucky
(Item No. 7-104.00)
CRA Project No.: K20Q008
Contract Publication Series: 20-425

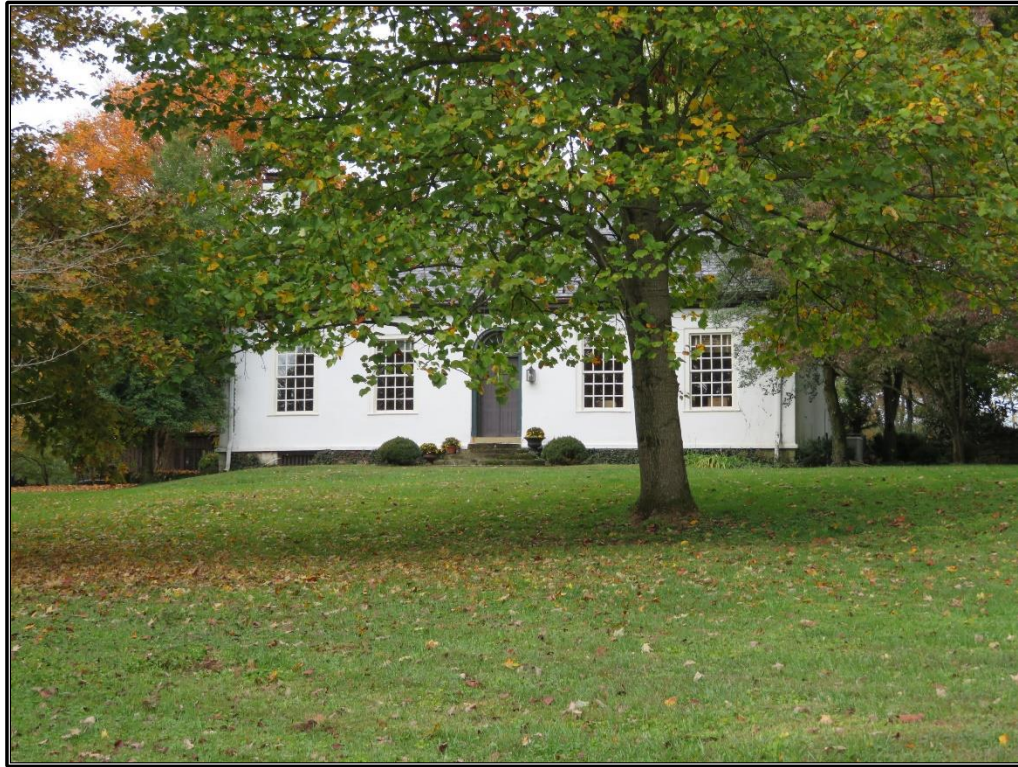
Figure 3. BO 311: Façade and northeast elevation of residence, looking west.

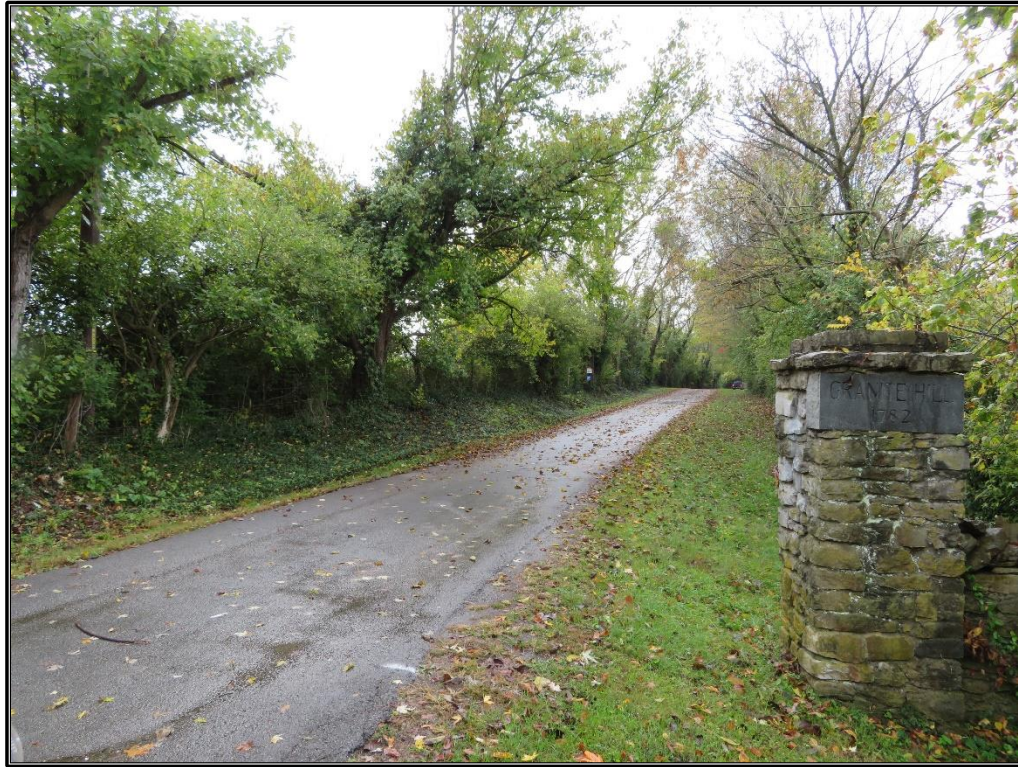
Figure 11. BO 368: Overview towards residence, looking south-southeast.

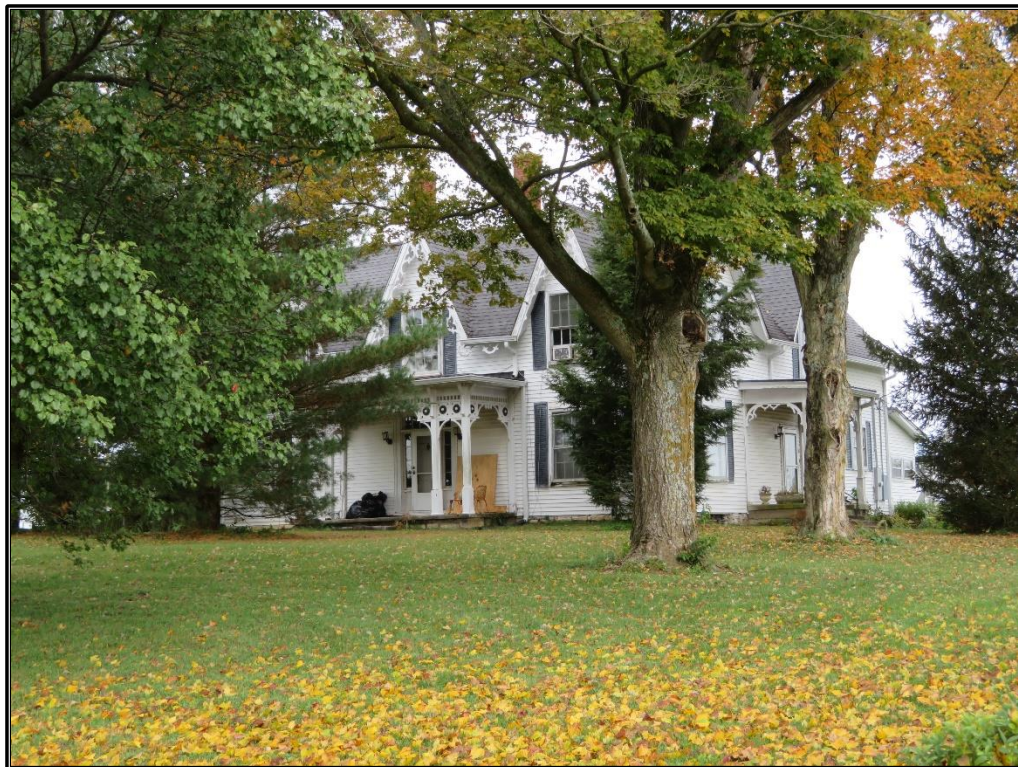
Figure 12. BO 382: Façade and southeast elevation of residence, looking north-northwest.

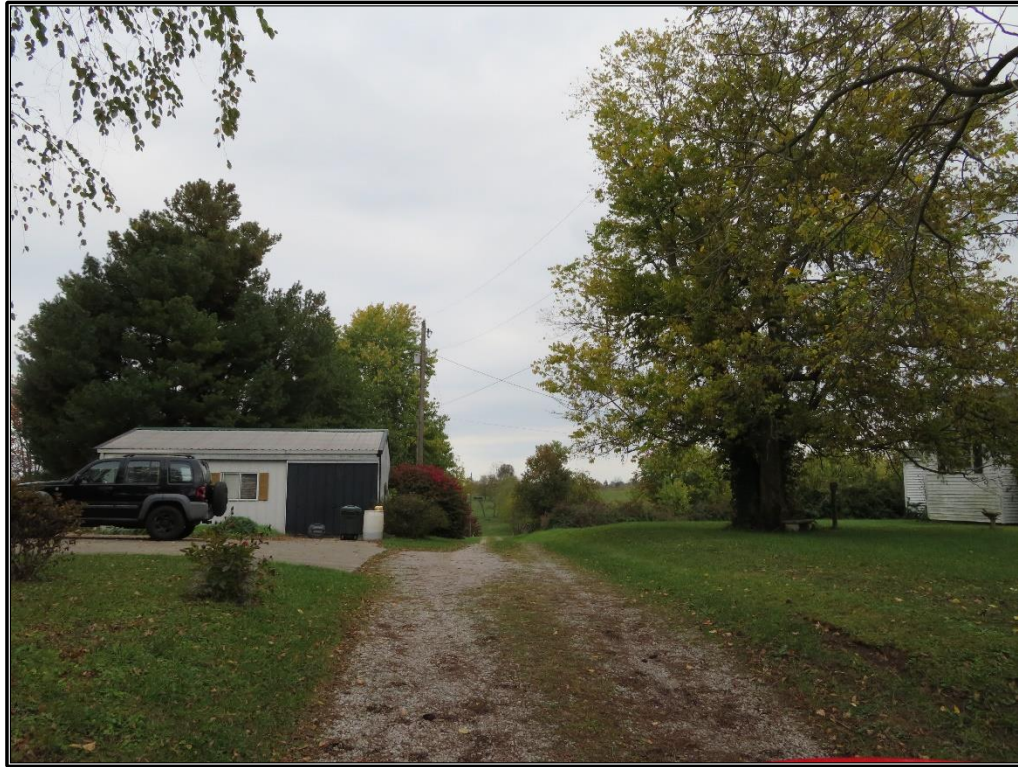
Figure 21. GD 16: Overview toward residence, looking north-northeast.

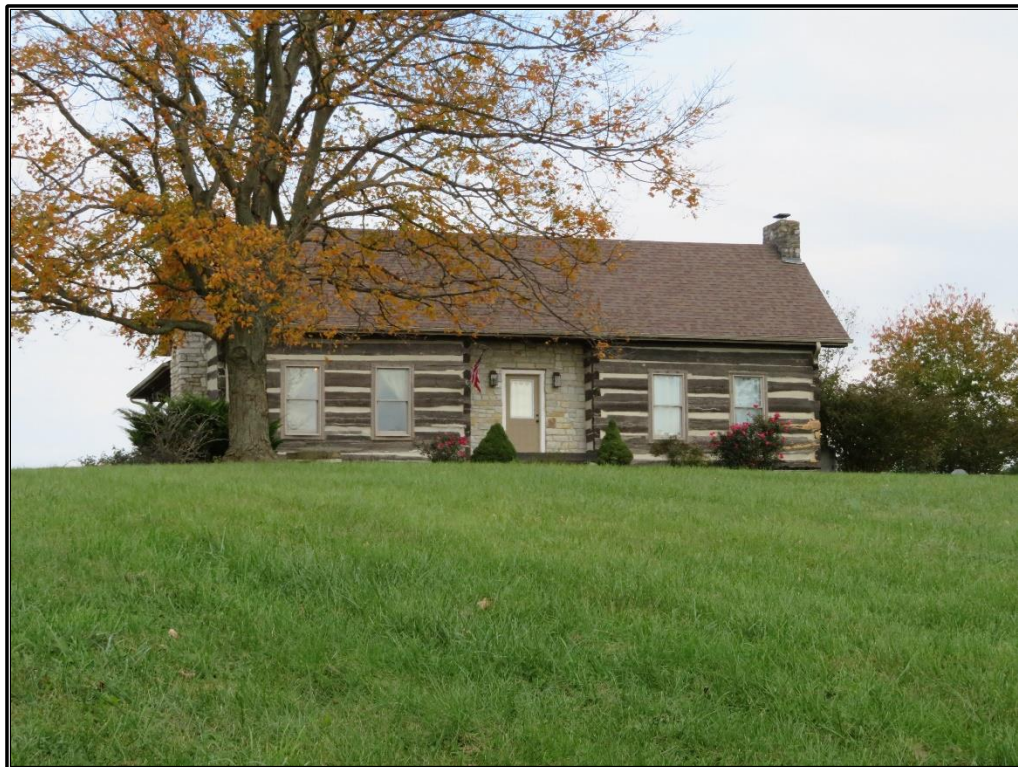
Figure 22. GD 27: Façade of residence, looking north-northeast.

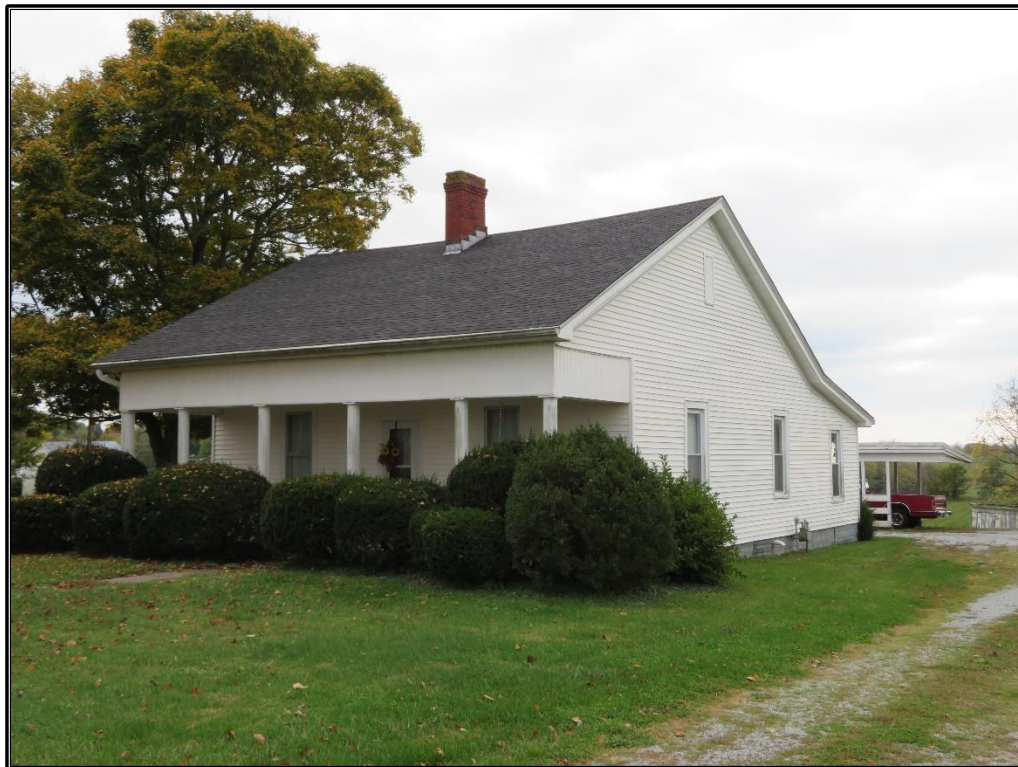
Figure 28. GD 417: Façade and northwest elevation of residence, looking southeast.

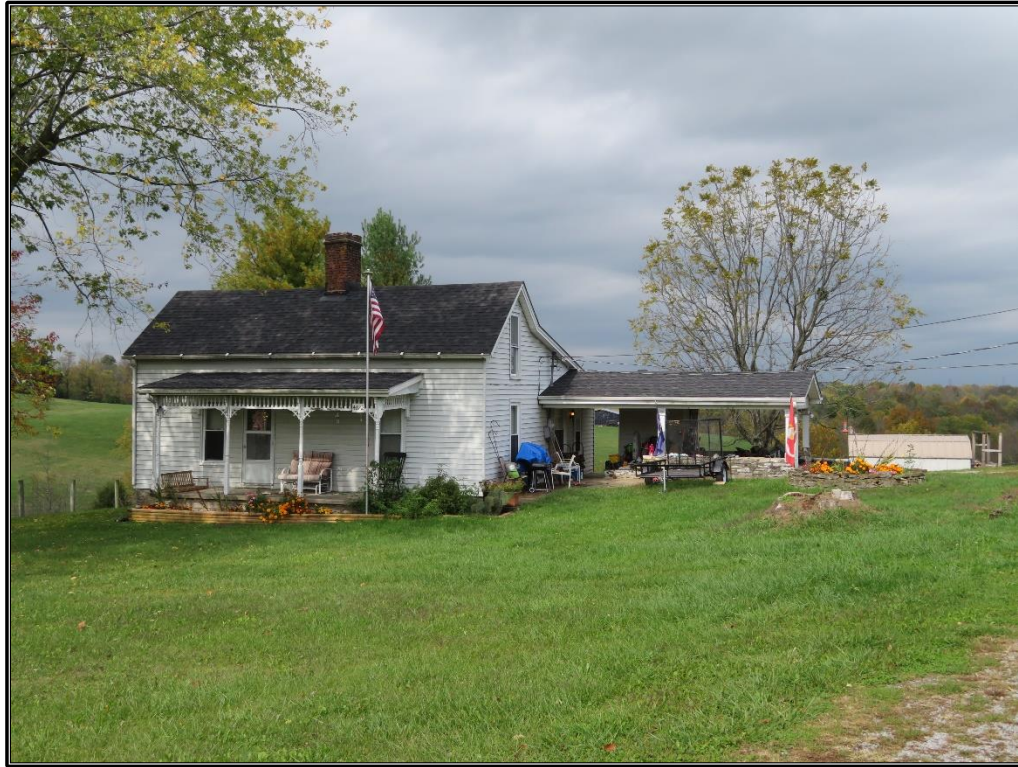
Figure 41. CRA 6: Façade and east elevation of residence, looking north-northwest.

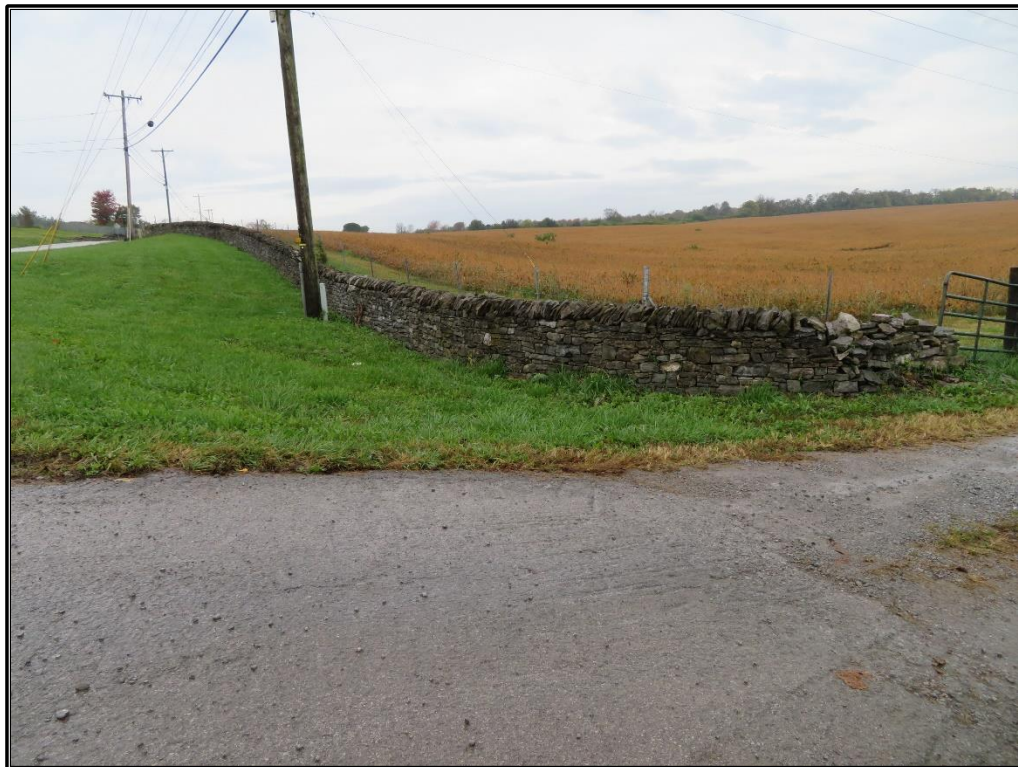
Figure 44. CRA 7: Overview of Segment A on north side of KY 52 near BO 367, looking northwest.

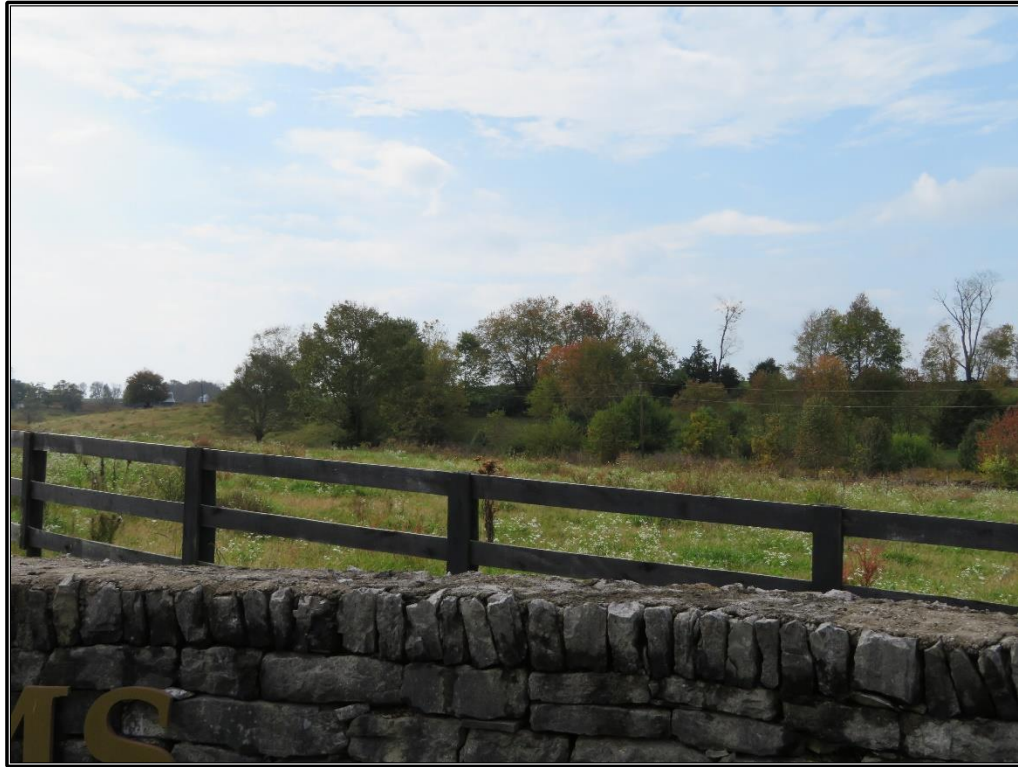
Figure 59. BO 380: Overview towards ruins, looking south-southwest.

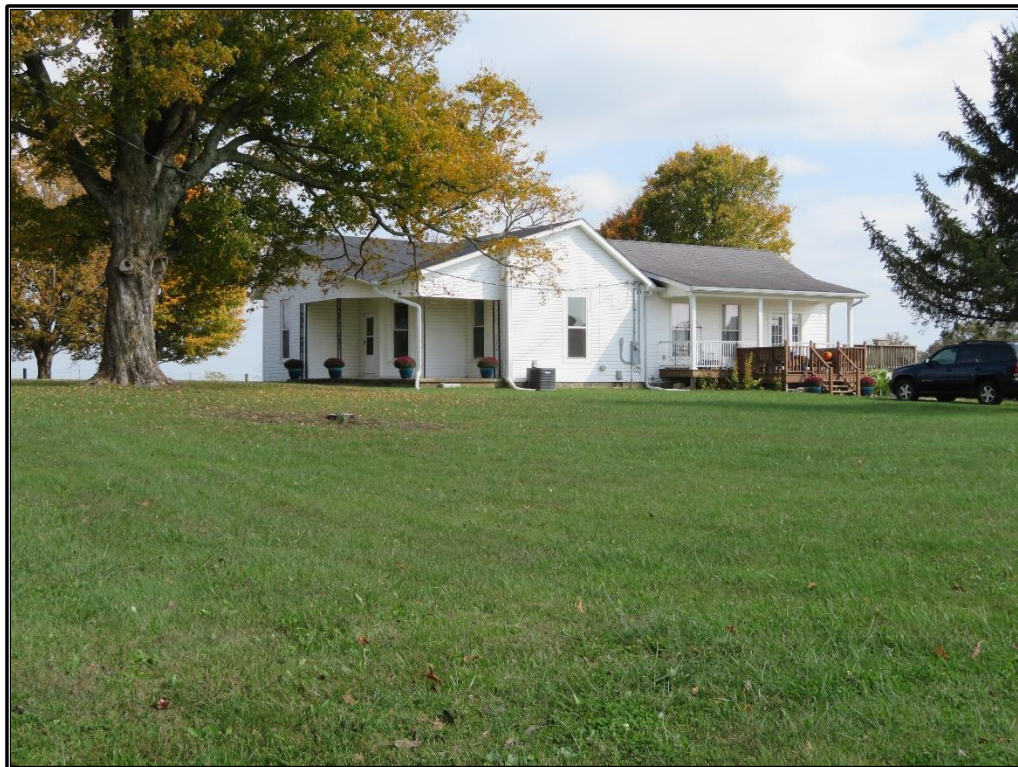
Figure 66. BO 47: Façade and northwest elevation of residence, looking east.

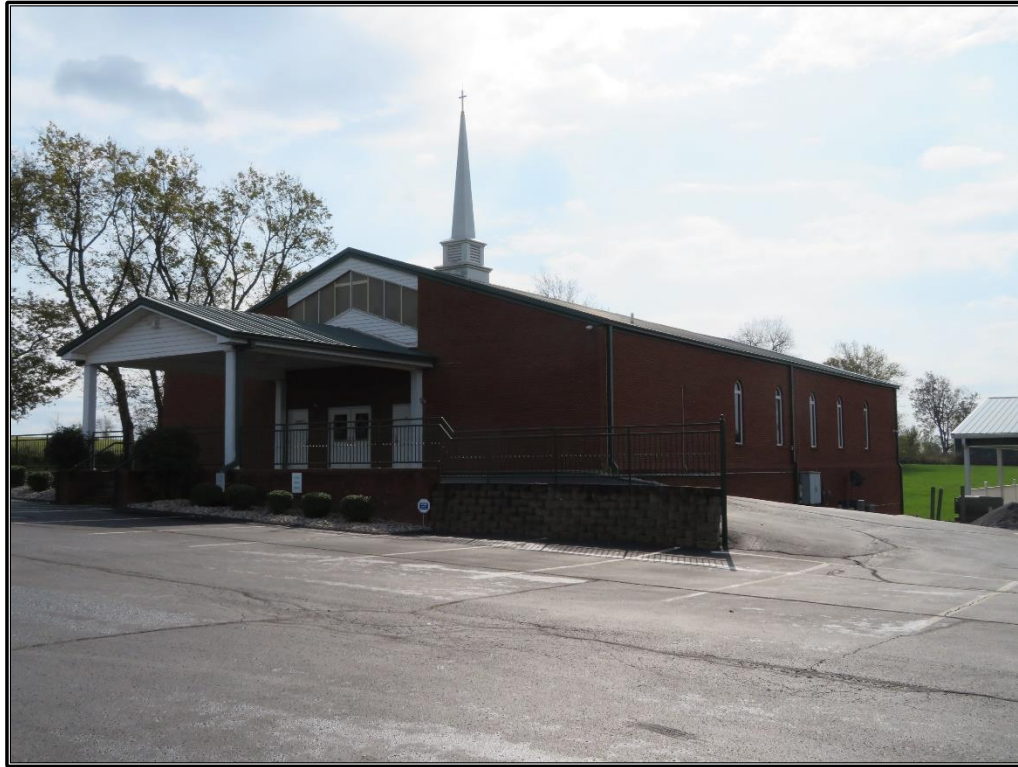
Figure 69. BO 49: View of non-historic church on former site of BO 49, looking southeast.

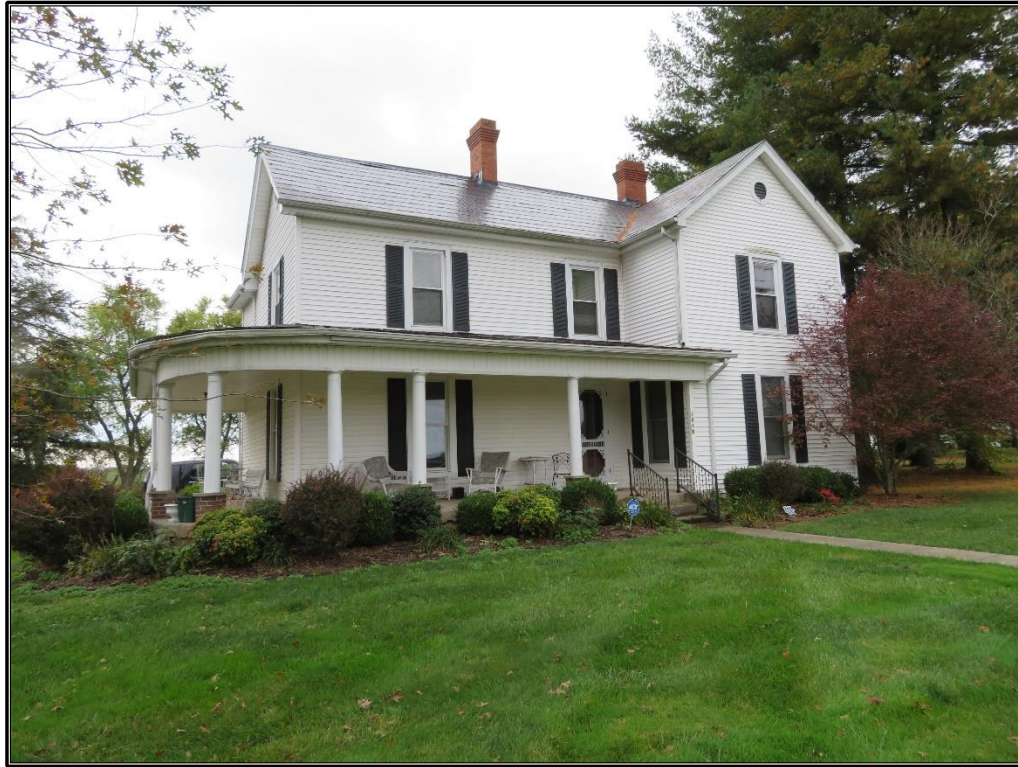
GD 416	Residence and outbuildings	1015 Lancaster Road (KY 52)	Previously recommended ineligible (McCarley and Spurlock 2003); KHC concurred. Recommended ineligible based on field observations.	Common residential form with integrity compromised by replacement materials and non-historic addition	79–80
GD 418	Residence and outbuilding	Ledford Drive	Previously recommended ineligible (McCarley and Spurlock 2003); KHC concurred. Recommended ineligible based on field observations.	Common residential form with integrity compromised by replacement materials and non-historic additions	81
GD 420	Residence and outbuildings	42 Ledford Drive	Previously recommended ineligible (McCarley and Spurlock 2003); KHC concurred. Recommended ineligible based on field observations.	Common residential form with integrity compromised by replacement materials and enclosed porch	82
GD 421	Residence and outbuilding	118 Ledford Drive	Previously recommended ineligible (McCarley and Spurlock 2003); KHC concurred. Recommended ineligible based on field observations.	Common residential form with integrity compromised by replacement materials	83

Figure 79. GD 416: Façade and southeast elevation of residence, looking southwest.

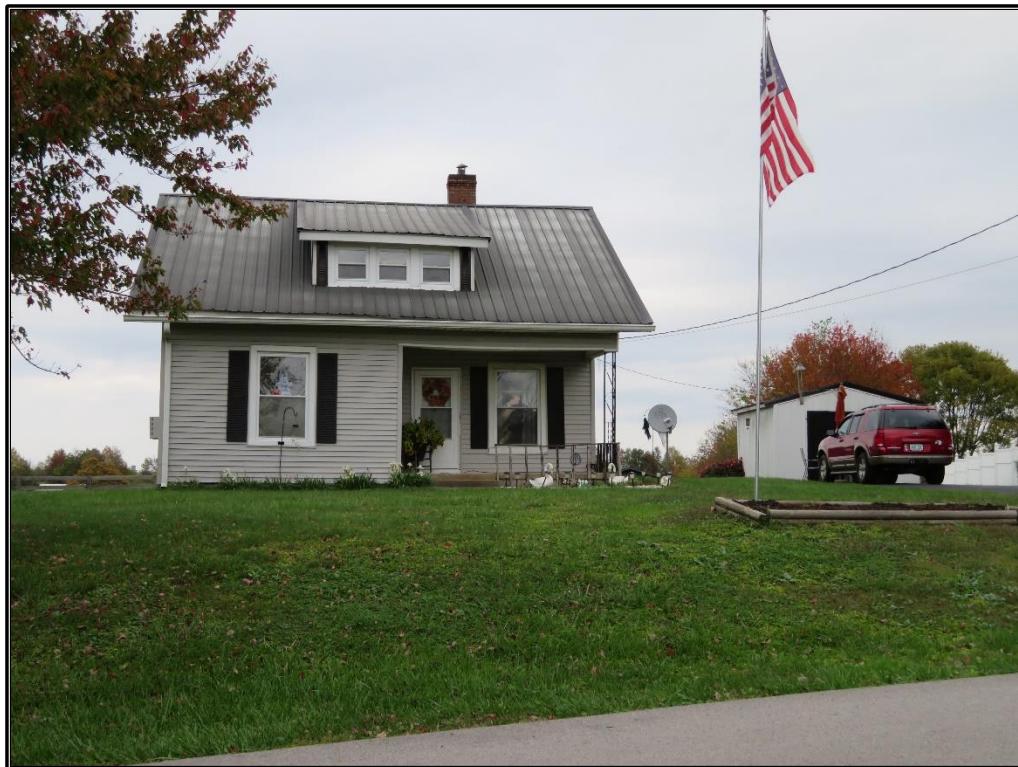
GD 422	Residence and outbuilding	Ledford Drive	Previously recommended ineligible (McCarley and Spurlock 2003); KHC concurred. Recommended ineligible based on field observations.	Common residential form with integrity compromised by replacement materials	84
GD 423	Residence and outbuildings	144 Ledford Drive	Previously recommended ineligible (McCarley and Spurlock 2003); KHC concurred. Recommended ineligible based on field observations.	Common residential form with integrity compromised by replacement materials and non-historic additions	85
GD 424	Residence and outbuildings	1942 Lancaster Road (KY 52)	Previously recommended ineligible (McCarley and Spurlock 2003); KHC concurred. Recommended ineligible based on field observations.	Common residential form with integrity compromised by replacement materials	86–89
GD 538	Residence and outbuildings	Lancaster Road (KY 52)	Previously recommended ineligible (McCarley and Spurlock 2003); KHC concurred. Recommended ineligible based on field observations.	Common residential form with integrity compromised by multiple additions	90–91

Figure 84. GD 422: Façade of residence and view of garage (Resource A), looking north-northeast.

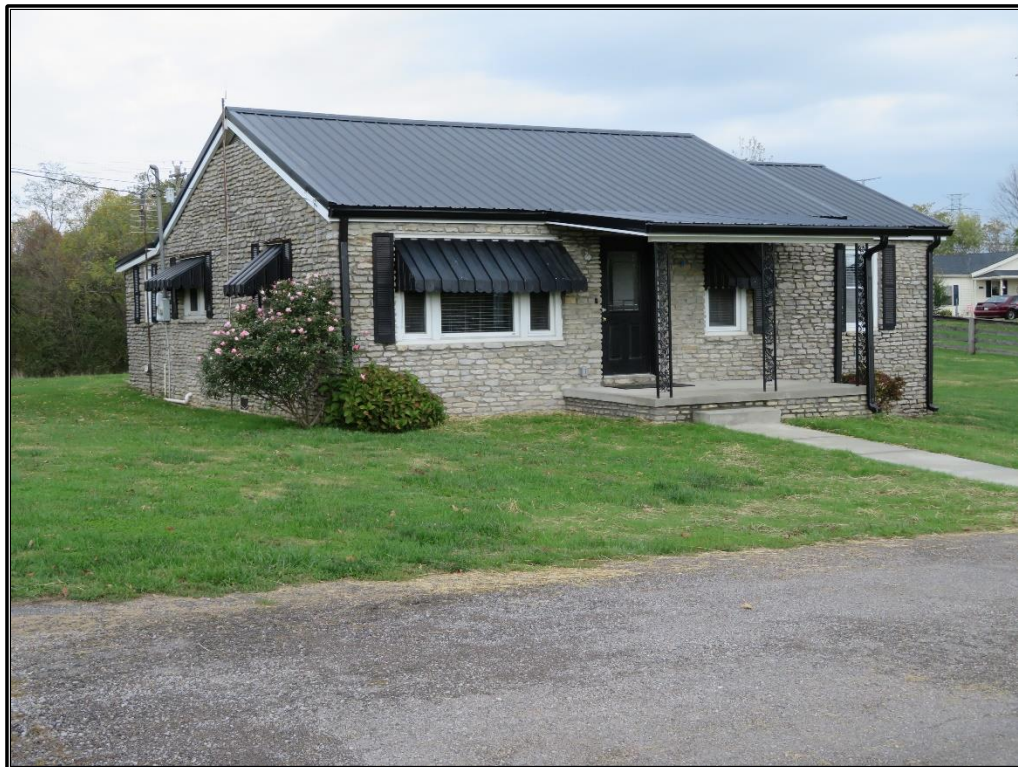
GD 539	Residence and outbuildings	3068 Lancaster Road (KY 52)	Previously recommended ineligible (McCarley and Spurlock 2003); KHC concurred. Recommended ineligible based on field observations.	Common residential form with integrity compromised by replacement materials	92–93

Figure 92. GD 539: Façade and west elevation of residence, looking northeast.

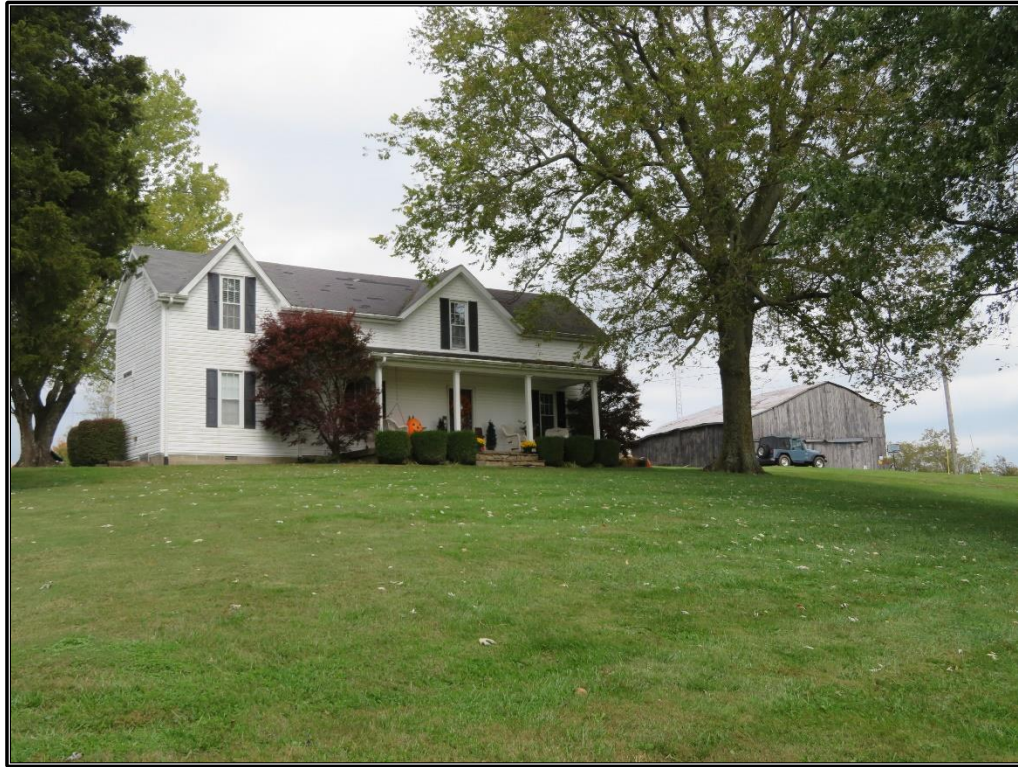
GD 544	Residence and outbuildings	3544 Lancastre Road (KY 52)	Previously recommended ineligible (Spurlock and McCarley 2003); KHC concurred. Recommended ineligible based on field observations.	Common residential form with integrity compromised by replacement materials and non-historic addition	99
GD 545	Residence and outbuildings	Lancaster Road (KY 52)	Previously recommended ineligible (Spurlock and McCarley 2003); KHC concurred. Recommended ineligible based on field observations.	Common residential form with integrity compromised by replacement materials	100-101
GD 546	Agricultural outbuildings	Lancaster Road (KY 52)	Recommended ineligible based on field observations; undetermined status in KHC database	Integrity compromised by loss of associated residence	102
GD 547	Residence and outbuildings	3237 Lancaster Road (KY 52)	Previously recommended ineligible (Spurlock and McCarley 2003); KHC concurred. Recommended ineligible based on field observations.	Common residential form with integrity compromised by replacement materials	103-104

Figure 99. GD 544: Façade and west elevation of residence, looking east-northeast.

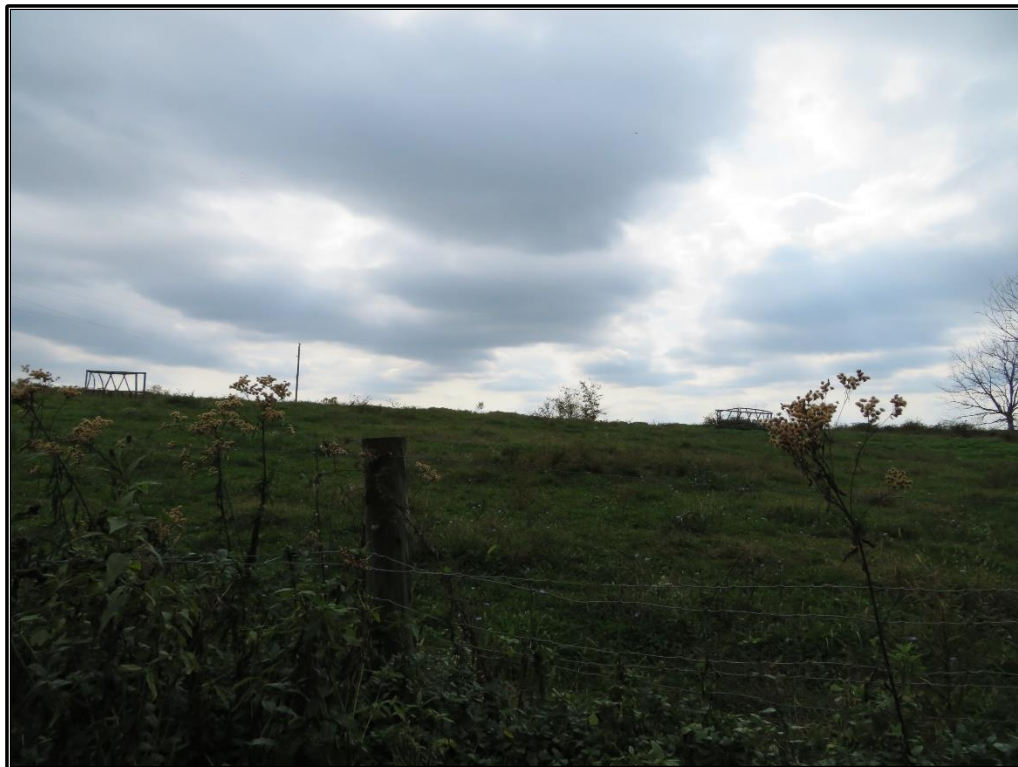
Figure 102. GD 546: Overview towards outbuilding associated with non-extant residence, looking south-southwest.
