Geotechnical Overview Report P-003-2018

Wendell H. Ford
Airport Access Road

Perry County, KY

March 2018

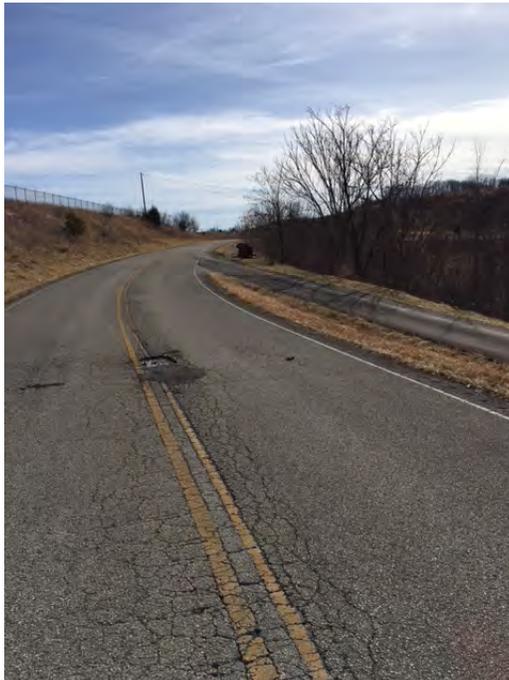
Figure 3 Pavement distress near airport

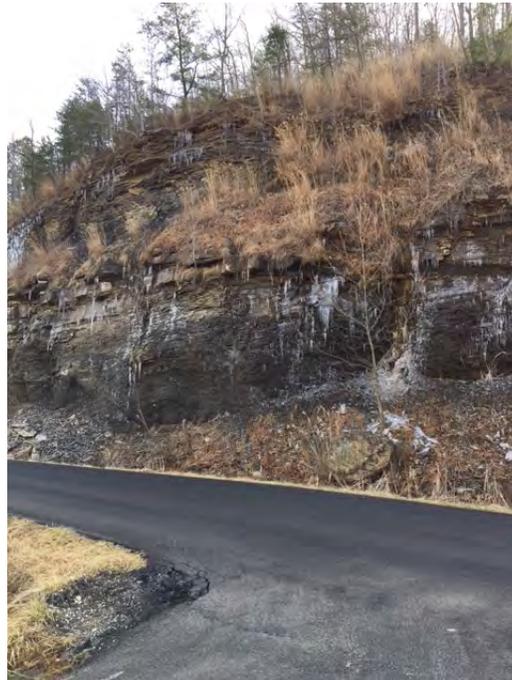
to the area were also reviewed near the proposed intersection with KY 15 across from Trus Joist Lane. The bedrock revealed in these cuts appeared to consist of relatively durable sandstones, e shale and coal. In general, these cuts were relatively vertical with intermediate benches noted in the higher cuts. It was noted that the shales were weathering at a more rapid pace than the sandstone, as a fair amount of talus had collected at the base of some of the cuts and had begun to undermine the more durable sandstones to variable degrees. Both overburden and intermediate benches will be necessary in any sizeable rock cuts.

Figure 5 Open rock face along current access road

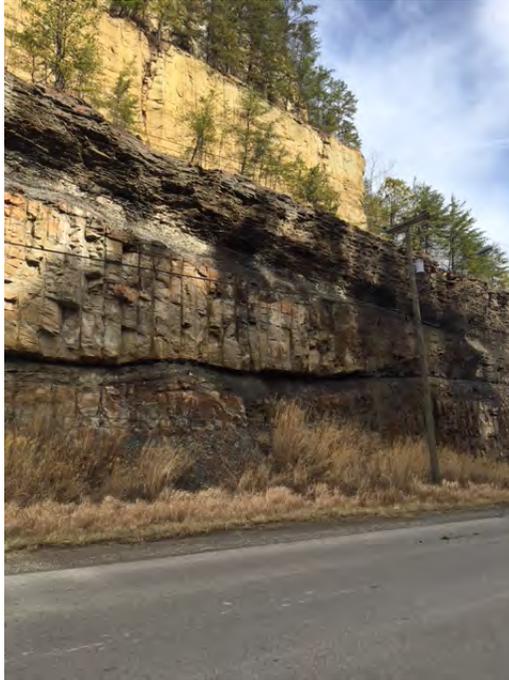
Figure 6 Rock Cut on Trus Joist Lane near KY 15

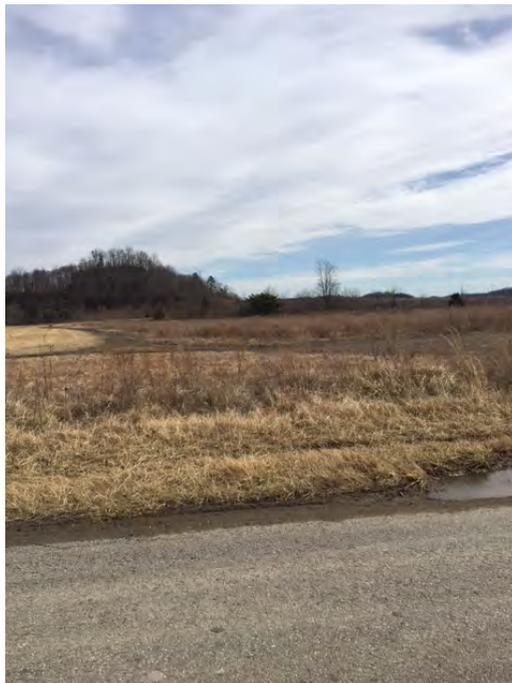
Figure 7 Reclaimed area near airport

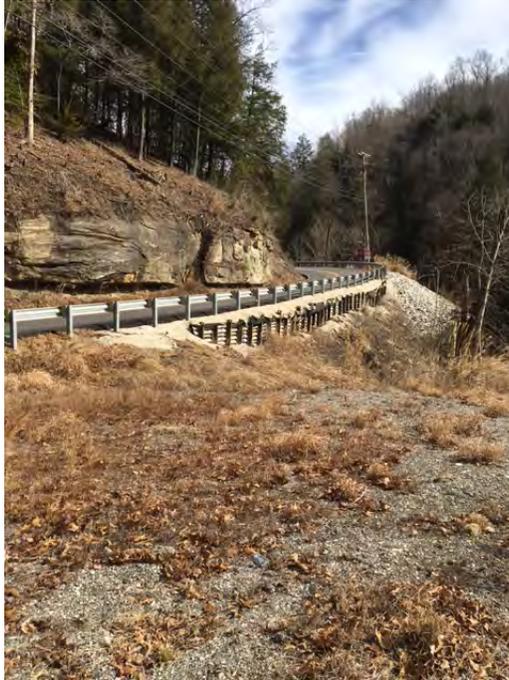
Past mining activity and reclamation was apparent during the review and as evidenced from review of available mine mapping and general geologic mapping. Near the entrance to the airport a sign is posted for ICG Hazard, LLC and lists mining permit number 897-0591. During the field review, it was noted that signs of subgrade distress are apparent in several areas beneath the existing access roadway and in a few instances where no shoulder was present the edge of the roadway was being undermined by drainage within the ditches which are deep and relatively steep. The existing pavement shows signs of cracking, spalling and potholes in a few areas near the airport, however appeared to have been recently overlain on the main access road from KY 15 recently. A previously repaired landslide also exists near the roadway entrance from KY 15.

Figure 8 Remediated landslide area

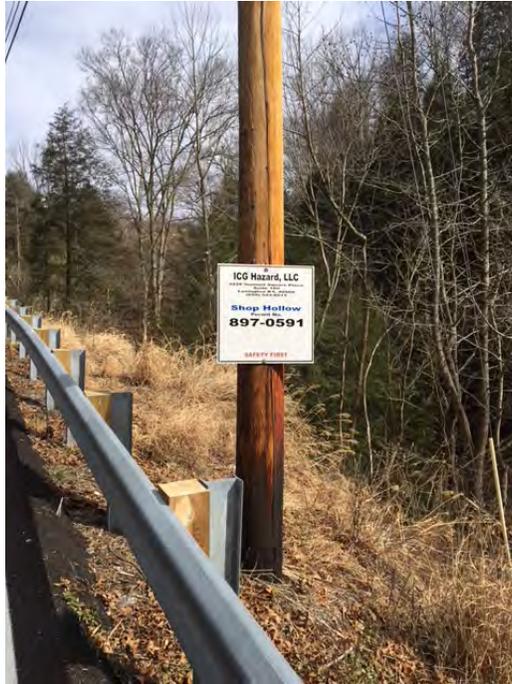
Figure 10 Permit Information Sign

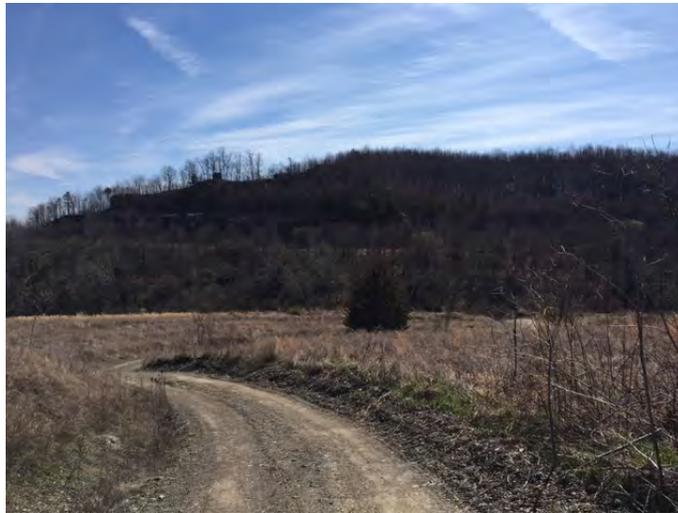
Figure 11 Mined out area east of study area

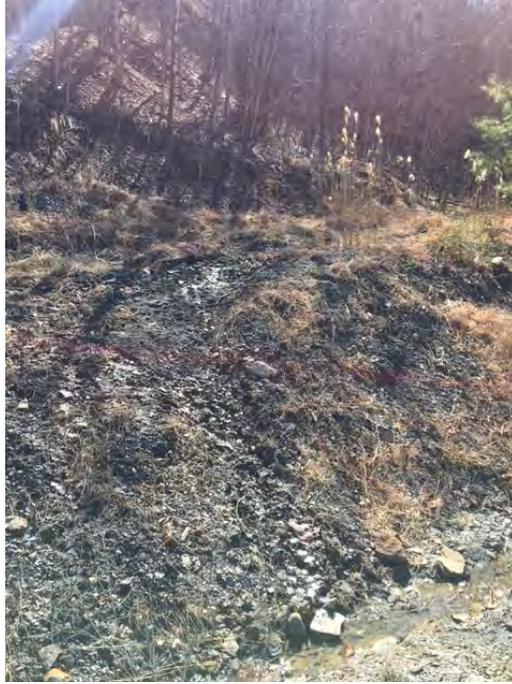
was reviewed for one of the portals. Several indicators were observed which indicated previous mining activity, however an actual portal was not observed and may have been sealed off or collapsed. There is a high probability that the proposed alignment nearest to KY 15 will terminate near the suspected portal. Extensive review of available mining records should be conducted along with settlement analyses to determine the potential for settlement in reclaimed areas. Since the area is prone to landslides, contains significant relief and has been previously mined, measures to increase factors of safety will likely be required for construction of any significant embankments. Some of these measures include construction with flatter than typical slopes, zoning of embankment materials, avoidance of past mines, especially underground mines and adits; promotion of surface and subsurface drainage, promotion of vegetation growth and construction of retaining walls may be required. Actual recommendations for slope geometries and means of stabilization would follow a thorough geotechnical investigation. Several landslides were previously identified proximate to the study area. The alignment near the airport will also be bound to a large degree by terrain and residential development near the airport.

Figure 12 Debris observed near map indicated mine portal

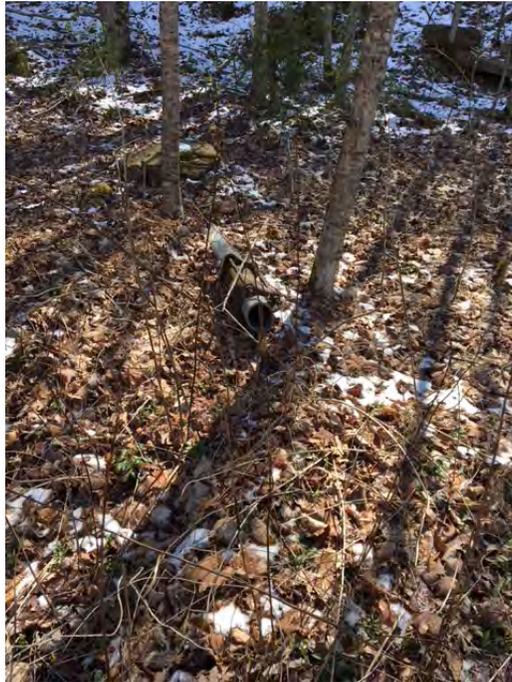
Figure 13 Abandoned pipe near map indicated mine portal
