## Appendix H: Supplemental Flooding Analyses

### US 51 Hickman County, Approx MP 14-15 (Obion Creek)

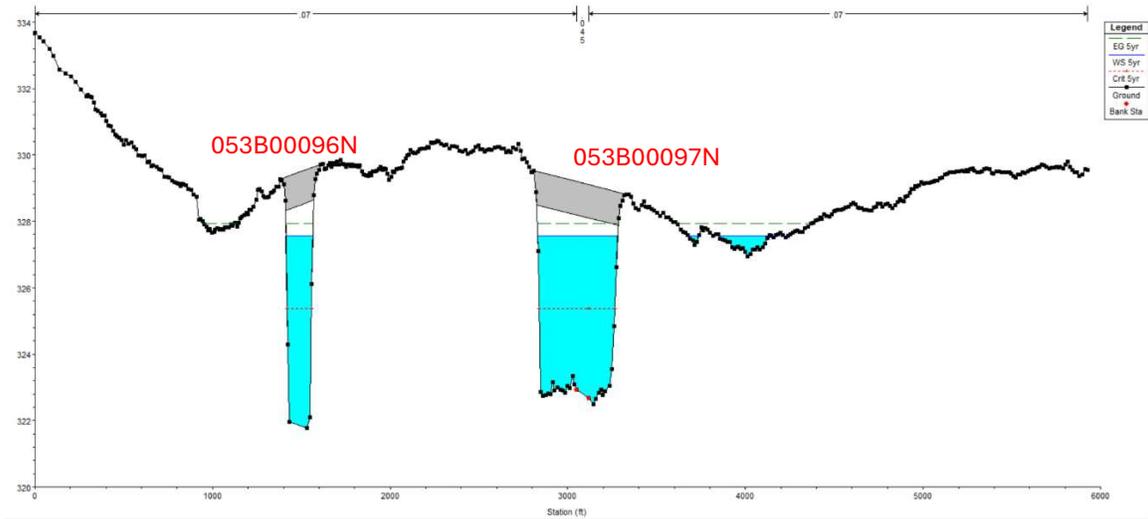
Figure 1: Existing Model, 5-year storm

Existing HEC-RAS Model (**Figure 1**) shows 5-year storm does not overtop bridges but it does overtop in the sag point towards the north. A 50-year storm reaches elevation 330.4, about 2 feet above the low-lying sag.

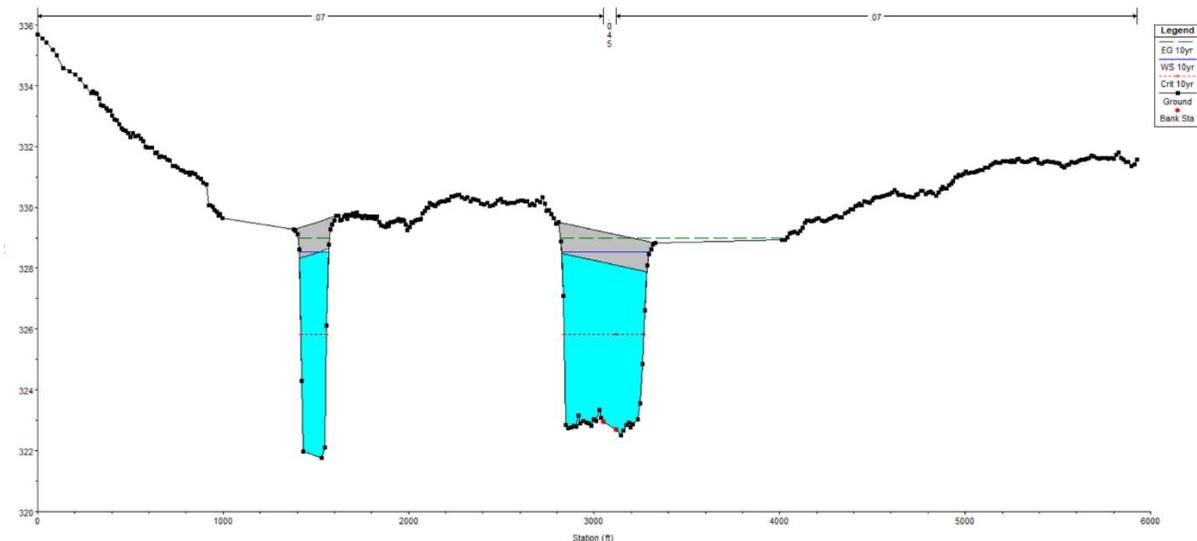
Figure 2: Proposed Model, 10-year storm

Raising roadway elevation 2 feet (not touching bridges), 10-year storm reaches bottom of the bridges (**Figure 2**) and 25-year storm overtops (**Figure 3**). Both bridges currently in Fair condition. This solution is shown in attached PDF; a higher profile would convey more water but substantially increase costs to replace bridges.

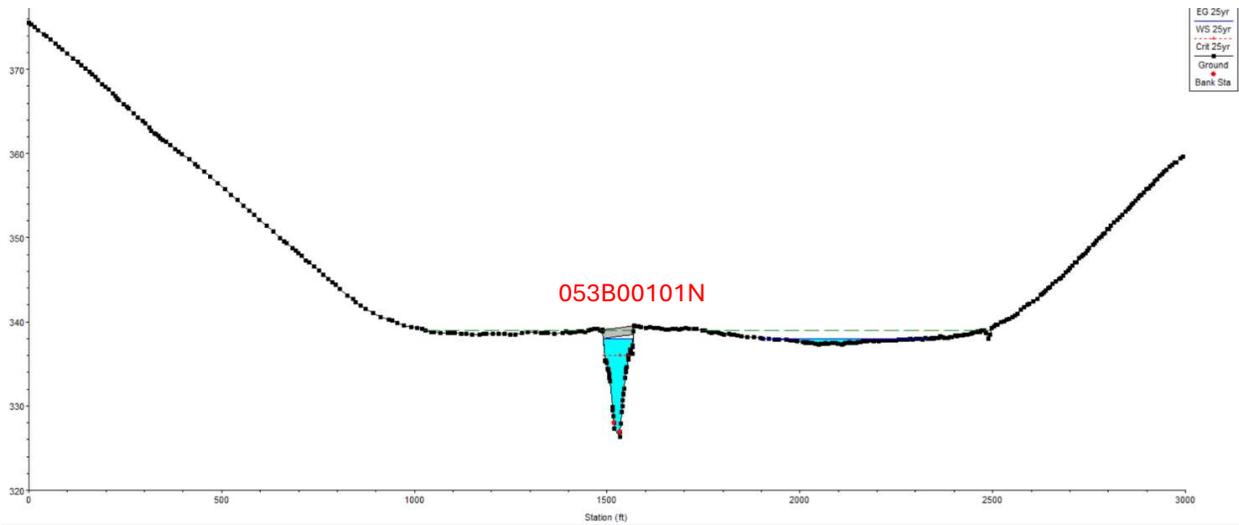
Figure 4: Existing Model, 25-year storm

Existing HEC-RAS model shows a 25-year storm approaching bottom of Bridge 053B00101N and starting to overtop sag in roadway to north.

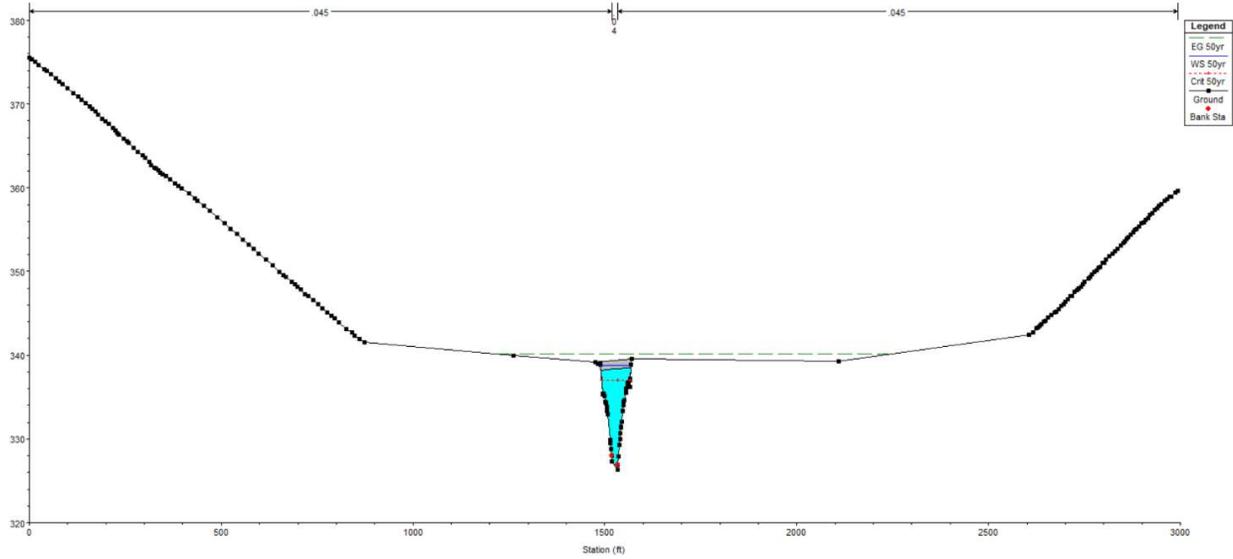
Figure 5: Proposed Model, 50-year storm

Raising roadway elevation 2-2.5 feet (not touching bridge), 50-year storm reaches the bottom of the bridge (Figure 5). See attached PDF for plan/profile sketch.

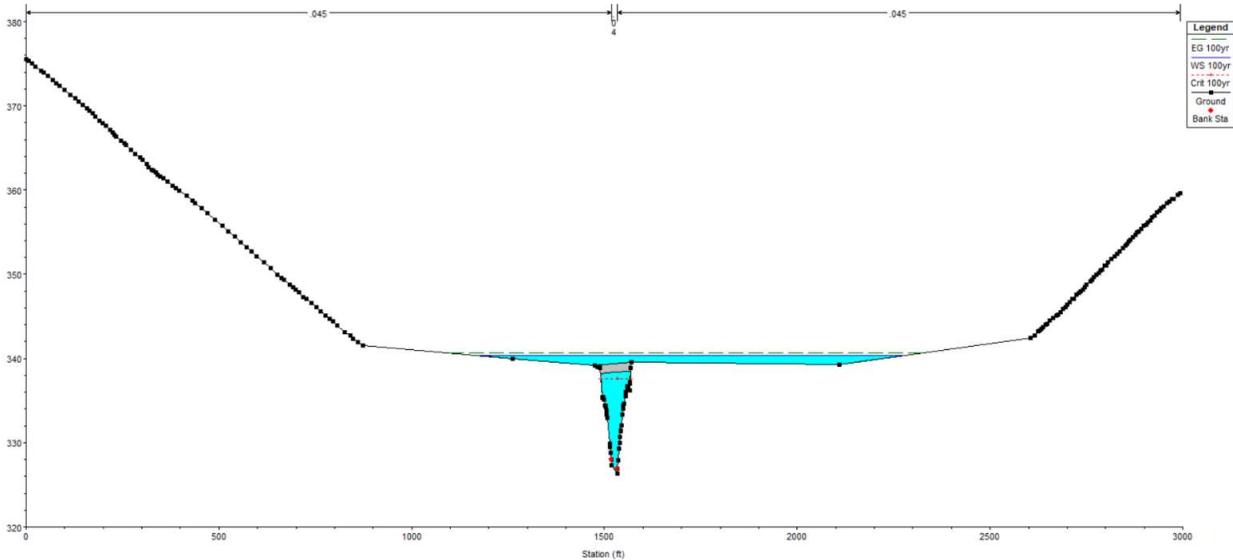
Figure 6: Proposed Model, 100-year storm

Shown in **Figure 6**, a 100-year storm overtops the bridge and raised road. Raising the roadway another foot and replacing the bridge with a slightly higher/longer bridge should accommodate 100-year storm but with greater costs. (053B00101N is rated in Good condition currently.)

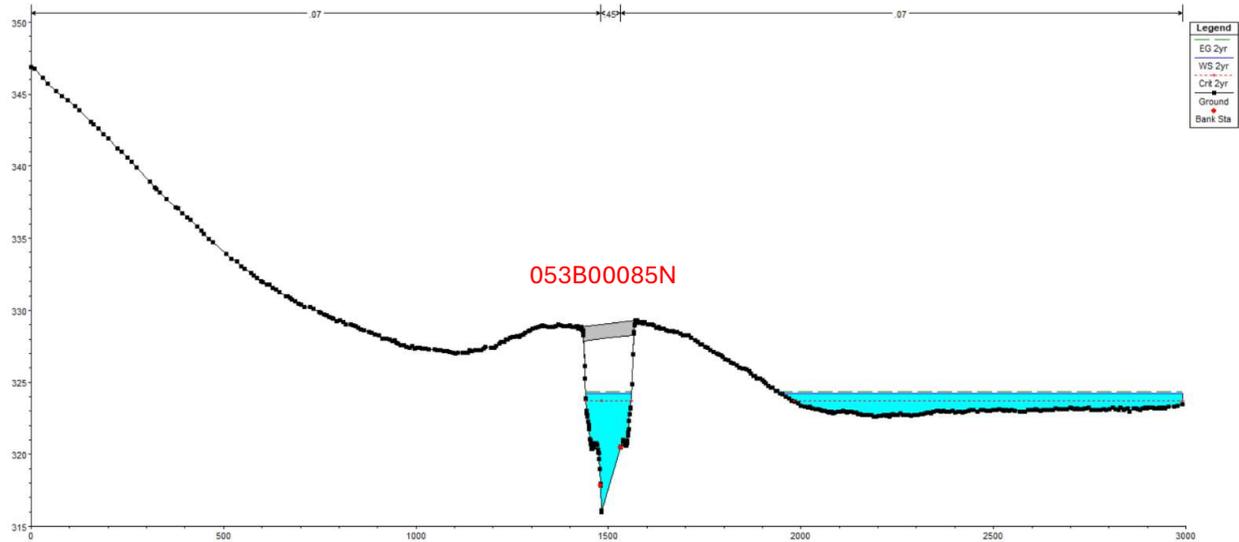
Figure 7: Existing Model, 2-year storm

This one's a bit different. We ran the Existing model (**Figure 7**) that shows a 2-year storm overtopping the sag north of the bridge.

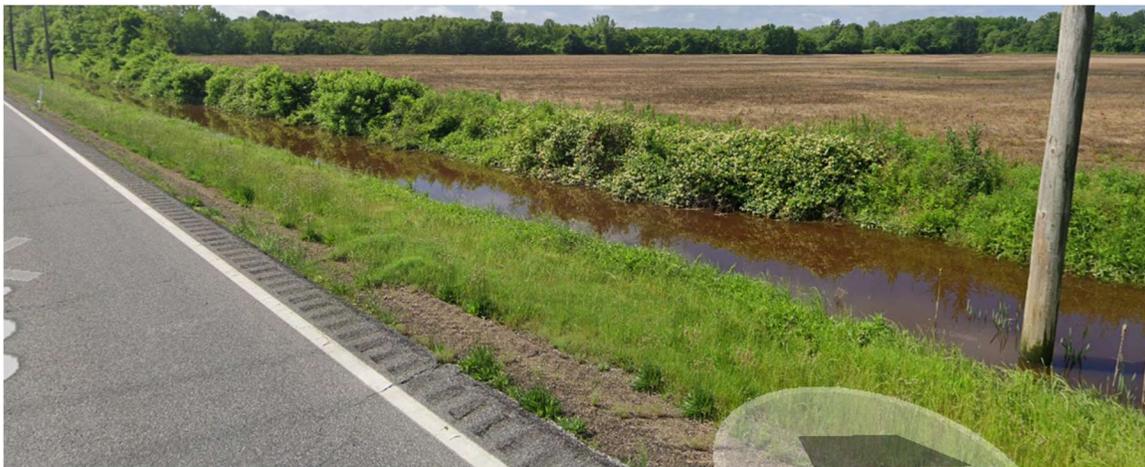
Figure 8: Streetview along Ditch

It's relatively flat through this stretch. Seems like the issue is driven by the 1,500-foot-long embankment northwest of the bridge (**Figure 9-Figure 8**). It's effectively protecting the field behind it and converting the ditch in that stretch into a standing pond.

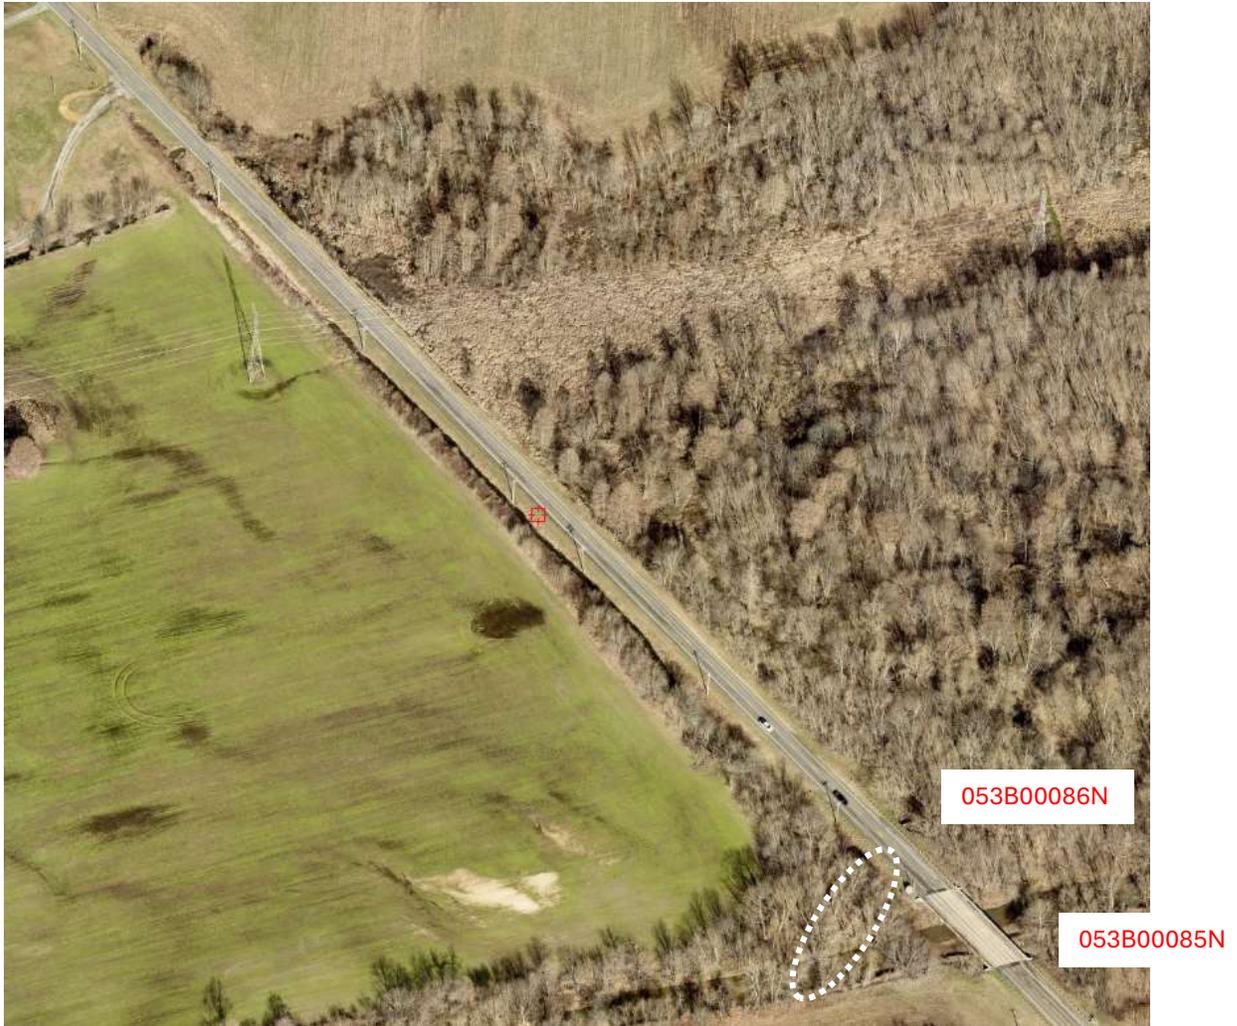
*Figure 9: Aerial north of 053B00085N*

Looking at the 2025 inspection photos for 053B00086N (**Figure 10**), seems like there's a lot of gunk built up at the outlet, restricting the channel that connects over to the main Bayou de Chien stream—circled in **Figure 9**. It's not clear exactly how the ditch to the north and shoulder interact.

Recommended options are to 1) regrade the ditch and potentially upsize the channel to encourage flow or 2) negotiate with property owner so field floods instead of roadway.

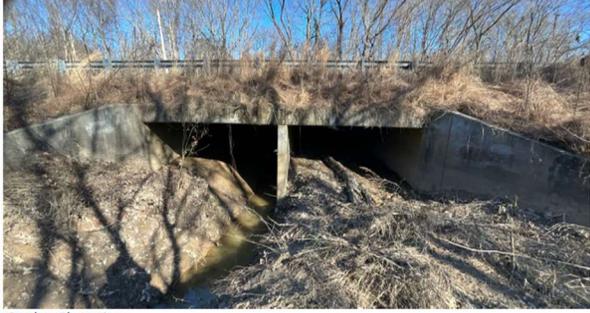
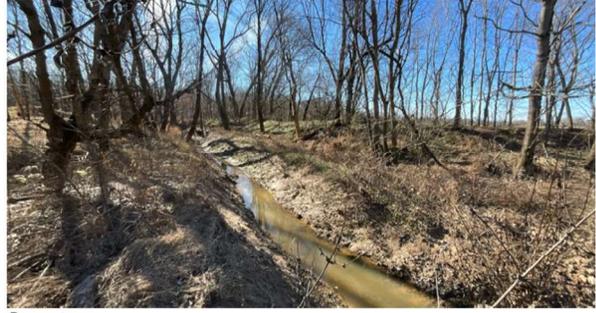
*Figure 10: 053B00086N Inspection Photos*

Outlet Elevation

Downstream
