**7-1116.00 KY-152
BRIDGE REPLACEMENT(P)**

Commonwealth of Kentucky DEPARTMENT OF HIGHWAYS	
COUNTY MERCER	
ROUTE KY 152	CROSSING HERRINGTON LAKE
LAYOUT	
PREPARED BY Division of Structural Design	
BRIDGE NUMBER FE02-084-0152-B00005N	
AMERICAN ENGINEERS, INC.	
SHEET 1 S3	DRAWING 2230

**P-001-2011
Mercer-Garrard County
KY 152 over Lake Herrington**

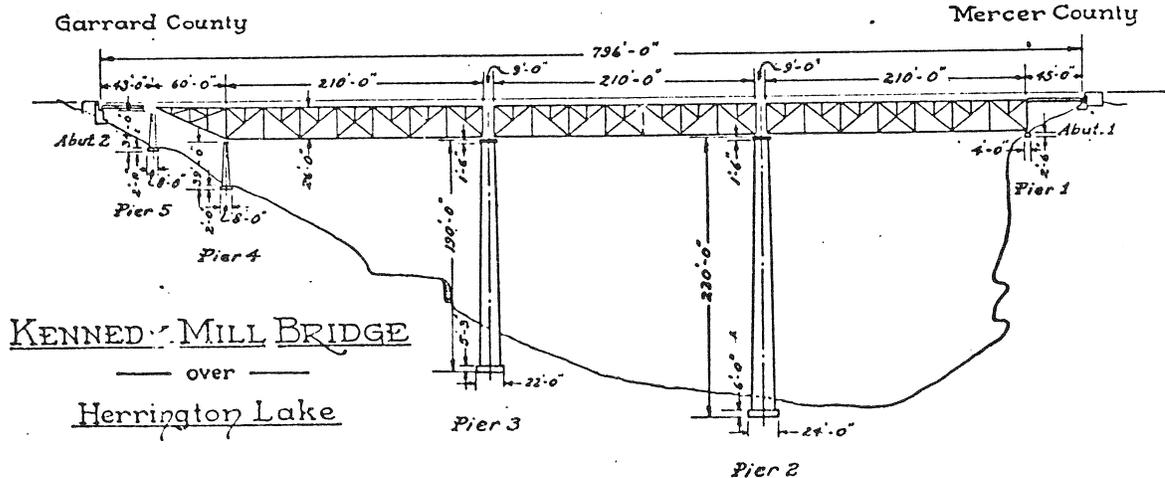
Fig. 1

At about the time the bridge was completed the "Engineering News Record" had a very good description of the two taller piers. (See Figure No. 1.) These piers are hollow reinforced concrete tubes, similar to chimneys. They were built by the Weber Chimney Company of Chicago by its regular chimney building procedure. The foundation for the 230' pier has a 6 1/2" reinforced concrete slab and the shaft or stack is anchored to the footing with 1" steel bars. The shell thickness at the bottom is 26 7/8". Both piers are 12' wide and 22'-0" long at the top and covered with a concrete slab, and both piers have 3' square ports at top and bottom to permit them to fill with water. They are flat on the sides and round on both ends and the shell thickness gradually decreases toward top.

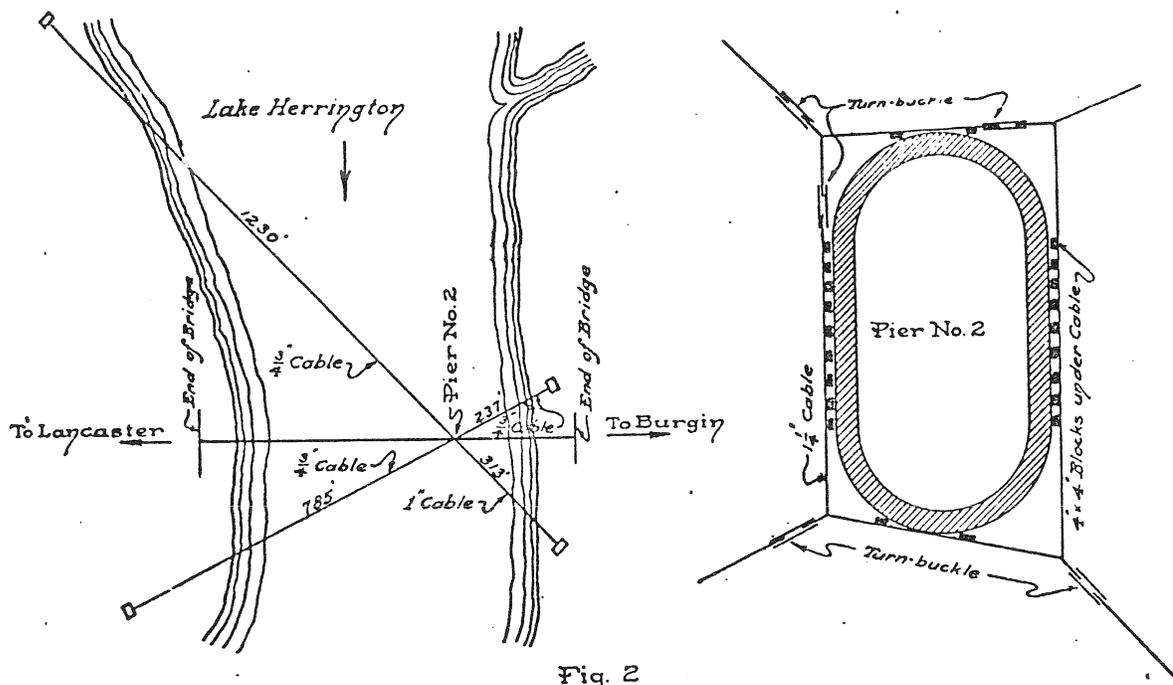
Fig. 2

the pier with 4"x4" wood blocks inserted between the cable and the concrete masonry. From the four corners of the pier, cables were stretched to anchor on the lake shores. Turn buckles were inserted in each line to obtain uniform tension in all cables. (See Figure 2.)

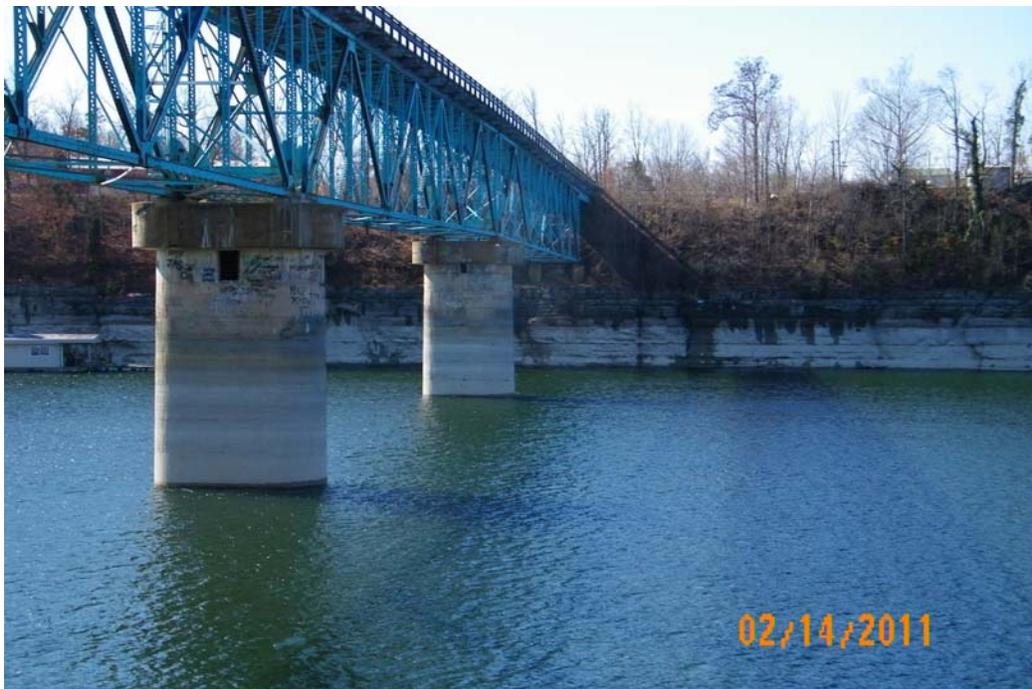
Pier 3 (front) Pier 2 (rear)

A site visit was performed to review the existing piers. It is unlikely that it would be desirable or economically viable to reuse abutment number 1, abutment number 2, or piers 1, 4 or 5 as shown in the below schematic (retrieved from the Division of Structural Design's plan database). Due to their size and location in the lake, it could be very desirable to reuse piers 2 and/or 3.

An article by F.C. Mahan from the *Kentucky Engineer* (year unknown - see appendix) supplied to this office by the District indicates that there have been some significant problems at Pier 2. Once the downstream dam was constructed and water began to back up around the piers it was noted that Pier 2 was actually rising and rotating. In the article Mahan states that the earliest inspection on record was in March of 1932 and that the top of Pier 2 was 1.33 feet higher than pier 3. (Mahan indicates that earlier records had been lost in a fire). Both were supposedly constructed to the same elevation. Mahan also states that “At the height of the movement the pier had risen approximately 30” and had tilted upstream and toward the Mercer County side approximately 12”.” This office does not have current information that indicates the elevation difference between the two piers.

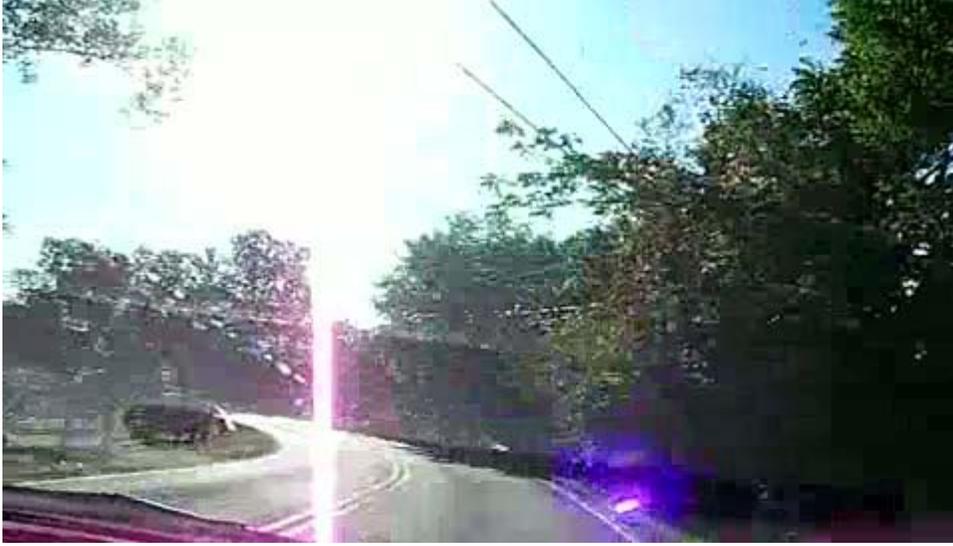
Sharp curve on KY 152 entering the bridge from west side – reason for some crashes

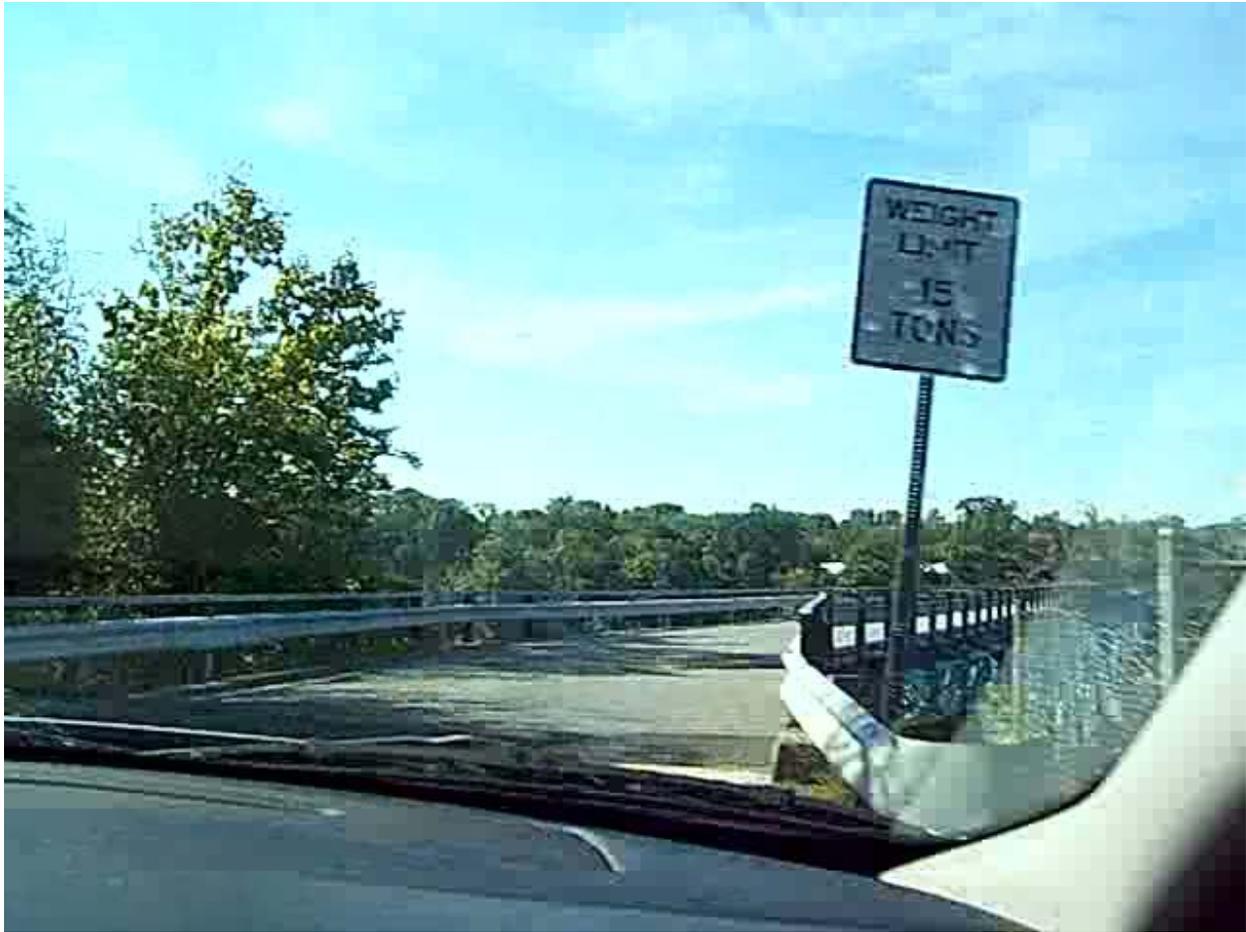
Crashes occurred at the curve to the bridge on the east side
